ATTACHMENT A  
Property Inspection Checklist  
Abandoned Mining Wastes - Torch Lake Non-Superfund Site  
Calumet and Hecla - Tamarack City Operations

Ahmeek Mill Processing Area

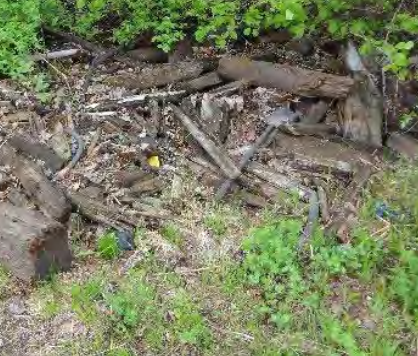
Suspect ACM									
Residual Process Materials									
Potentially Abandoned Containers									
Soil Staining/Stressed Vegetation									
Potential PCB or Mercury Containing Equipment		Longitude:							
Other: _____									
Suspect ACM									
Residual Process Materials									
Potentially Abandoned Containers									
Soil Staining/Stressed Vegetation		Longitude:						View looking southeast at debris observed in the western portion of the subject property.

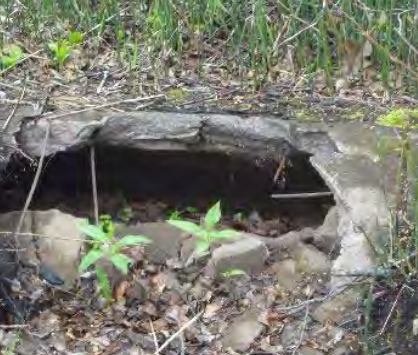
Soil Staining/Stressed Vegetation									
Potential PCB or Mercury Containing Equipment									
Other: _____									
Suspect ACM									
Residual Process Materials		Latitude:							
Potentially Abandoned Containers									
Soil Staining/Stressed Vegetation									
Potential PCB or Mercury Containing Equipment									
Other: _____									
Suspect ACM		Longitude:							
Residual Process Materials									
Potentially Abandoned Containers									
Soil Staining/Stressed Vegetation									
Potential PCB or Mercury Containing Equipment									
Other: _____		Latitude:							
Suspect ACM									
Residual Process Materials									
Potentially Abandoned Containers									
Soil Staining/Stressed Vegetation									
Potential PCB or Mercury Containing Equipment		Longitude:						View looking east at partially buried concrete piping observed at the subject property.

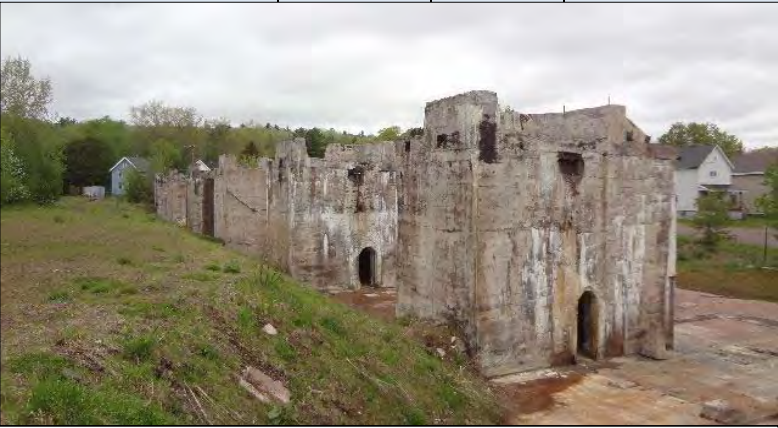
View looking northwest at stamp mill foundations present on the subject property.

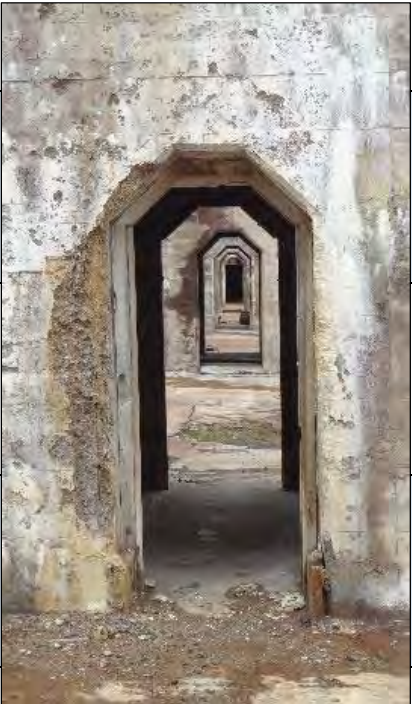
View looking west at doorways in the concrete stamp mill pillars.

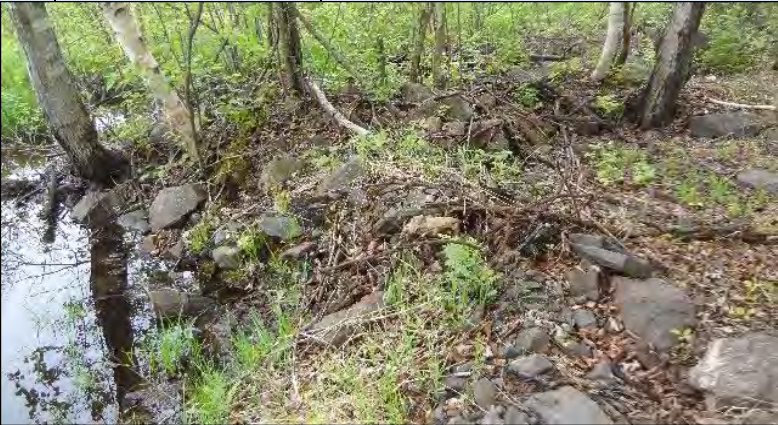
View looking south at a typical debris pile observed on the subject property.

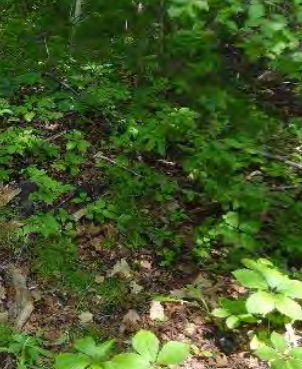
Material samples CHTC-ASBBLK10-062915 and CHTC-ASBBLK11-062915 collected during targeted inspection activities are representative of the materials identified during reconnaissance activities.
Residual Process Materials								
Potentially Abandoned Containers								
Soil Staining/Stressed Vegetation		Longitude: -88.436622417						
Potential PCB or Mercury Containing Equipment								
Other: _____

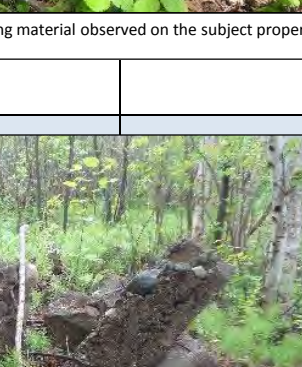
Soil and groundwater samples collected from boring location CHTC-SB47 and CHTC-GW43 are representative of environmental conditions in the vicinity of the reconnaissance location.
Residual Process Materials								
Potentially Abandoned Containers								
Soil Staining/Stressed Vegetation		Longitude: -88.43634201						
Potential PCB or Mercury Containing Equipment								
Other: <u>Partially buried pipe</u>	✓							
Suspect ACM		Latitude:

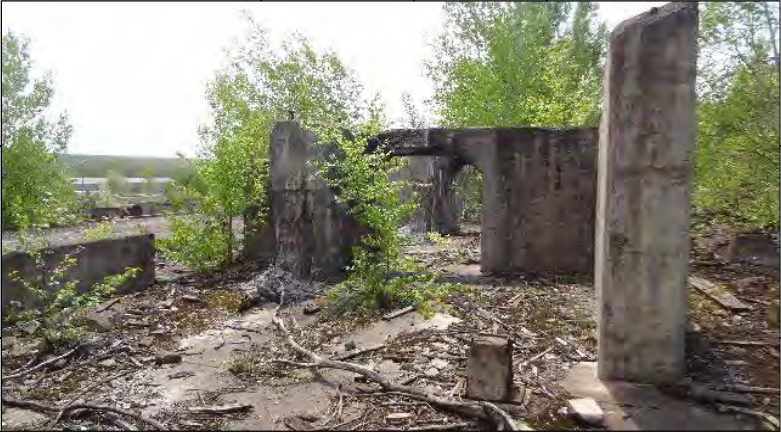
Material sample CHTC-ASBBLK05-062915 collected during targeted inspection activities is representative of the materials identified during reconnaissance activities.
Residual Process Materials								
Potentially Abandoned Containers								
Soil Staining/Stressed Vegetation		Longitude: -88.443005828						
Potential PCB or Mercury Containing Equipment								
Other: _____								
Suspect ACM	✓	Latitude: 47.165494686	CHTC-SACM04 (Transite): Grayish white transite fragments, commingled with building debris and glass on the upper floor of the former stamp mill/reclamation plant floor.

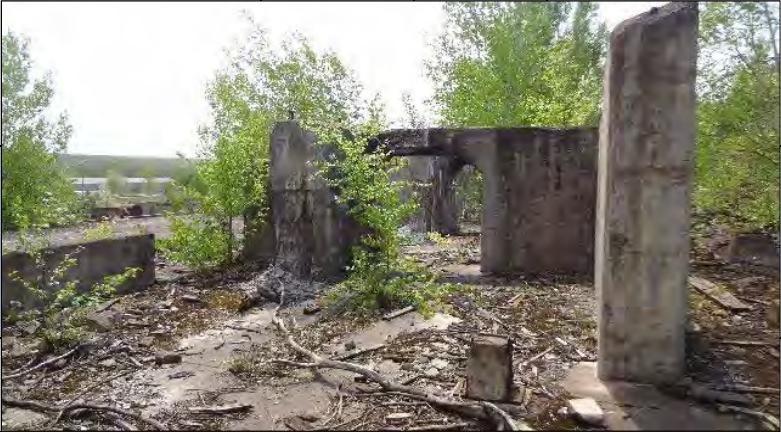
Material sample CHTC-ASBBLK04-062915 collected during targeted inspection activities is representative of the materials identified during reconnaissance activities.
Residual Process Materials								
Potentially Abandoned Containers								
Soil Staining/Stressed Vegetation		Longitude: -88.443161759						
Potential PCB or Mercury Containing Equipment								
Other: _____								
Suspect ACM	✓	Latitude: 47.165138015	CHTC-SACM06 (Transite): Grayish white transite fragments, commingled with debris on the lower floor of the former stamp mill/reclamation plant floor.

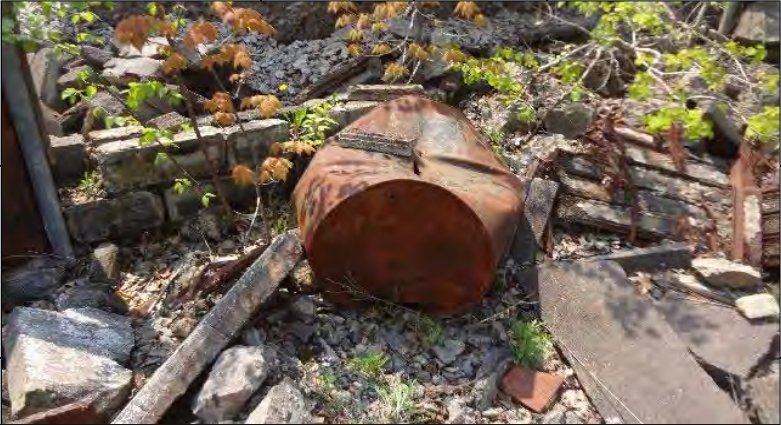
Material samples CHTC-ASBBLK04-062915 and CHTC-ASBBLK05-062915 collected during targeted inspection activities are representative of the materials identified during reconnaissance activities.
Residual Process Materials								
Potentially Abandoned Containers								
Soil Staining/Stressed Vegetation		Longitude: -88.44278333						
Potential PCB or Mercury Containing Equipment								
Other: _____								
Suspect ACM	✓	Latitude: 47.165569902	CHTC-SACM08 (Roofing): Black asphaltic roofing material in a small debris pile in a wooded area. The debris pile is approximately 30 feet north of the gravel drive. The pile is approximately 6 feet in diameter.

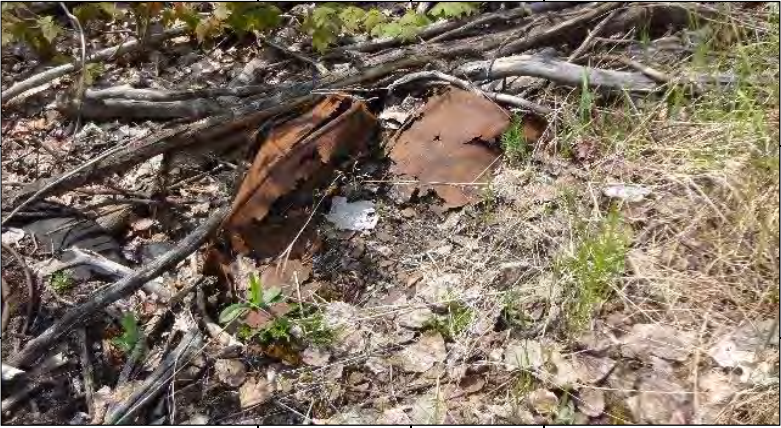
Surface soil location CHTC-SS02-0-6" is representative of environmental conditions in the vicinity of the reconnaissance location.
Residual Process Materials								
Potentially Abandoned Containers	✓							
Soil Staining/Stressed Vegetation								
Potential PCB or Mercury Containing Equipment								
Other: _____		Latitude: 47.165026394  Longitude: -88.443400219	CHTC-DM03: Rusted, partially crushed, open and damaged, 55-gallon drum, lying on its side. The drum is labeled "Dowfroth 250, manufactured by Dow Chemical Company".

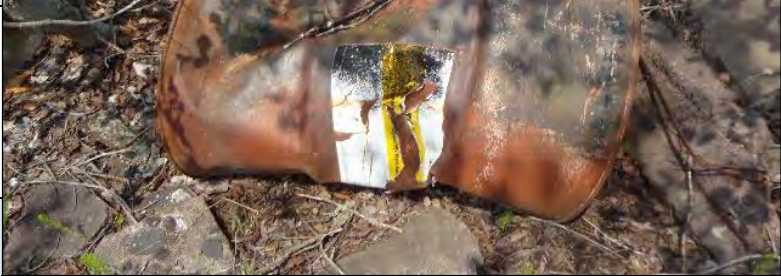
Surface soil location CHTC-SS06-0-6" is representative of environmental conditions in the vicinity of the reconnaissance location.
Residual Process Materials								
Potentially Abandoned Containers	✓							
Soil Staining/Stressed Vegetation								
Potential PCB or Mercury Containing Equipment								
Other: _____		Latitude: 47.16559848  Longitude:-88.4423566	CHTC-DM07: Rusted, empty drum, crushed, damaged, lying in a wooded area.

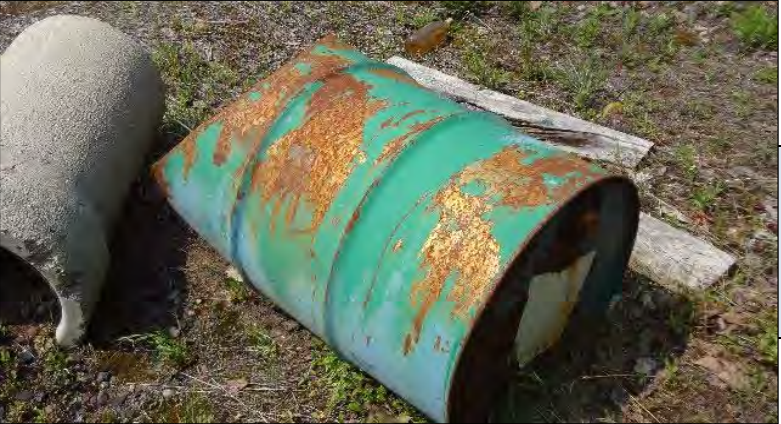
Surface soil location CHTC-SS04-0-6" is representative of environmental conditions in the vicinity of the reconnaissance location.
Residual Process Materials								
Potentially Abandoned Containers	✓							
Soil Staining/Stressed Vegetation								
Potential PCB or Mercury Containing Equipment								
Other: _____		Latitude: 47.165355601  Longitude: -88.442145957	CHTC-DM09: Bluish-green, rusted, partially crushed drum lying on its side. Does not appear to be empty. No obvious labeling on the drum.

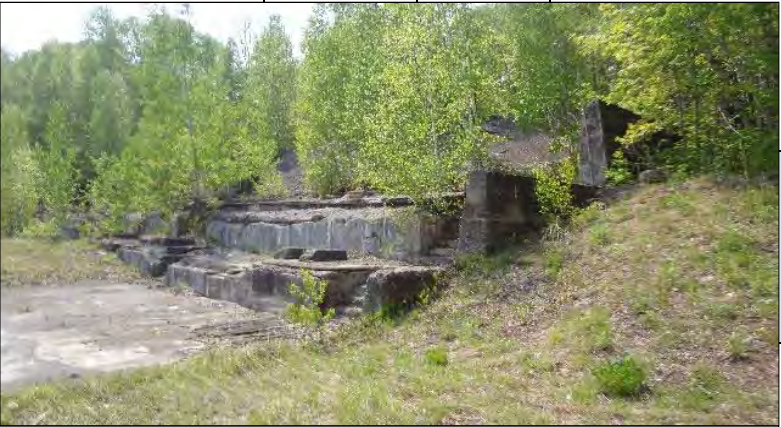
Material samples CHTC-ASBBLK07-062915 and CHTC-ASBBLK08-062915 collected during targeted inspection activities are representative of the materials identified during reconnaissance activities.
Residual Process Materials								
Potentially Abandoned Containers								
Soil Staining/Stressed Vegetation								
Potential PCB or Mercury Containing Equipment								
Other: _____		Latitude: 47.163934225  Longitude: -88.444589959	CHTC-DM11: Seven rusted drum carcasses, piled, crushed, and damaged in a trench in the former stamp mill foundation. Wooded area midway up the hill between the warehouse and Junction Road.

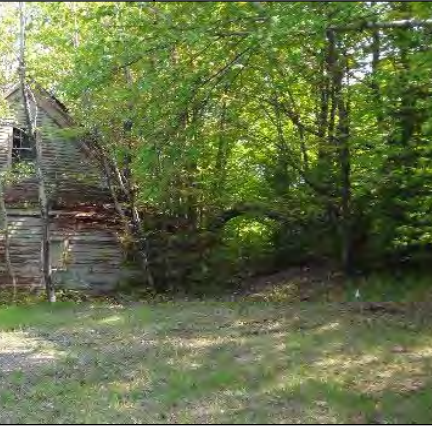
View looking east at the dilapidated carriage house on the subject property.

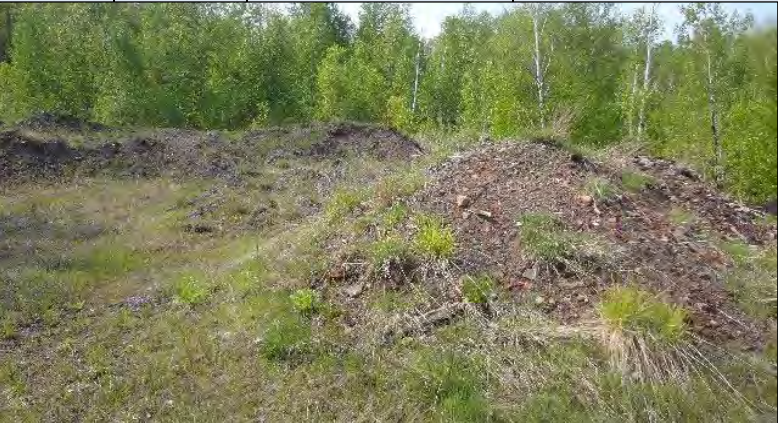
View looking northwest at soil stockpiles at the subject property.
