Appendix D
Potential Physical and Health Hazard Inventory - Reconnaissance Logs
Abandoned Mining Wastes - Torch Lake Non-Superfund Site
Calumet and Hecla - Lake Linden Operations

Trap Rock Dump - Shoreline Development Group

10/6/2014

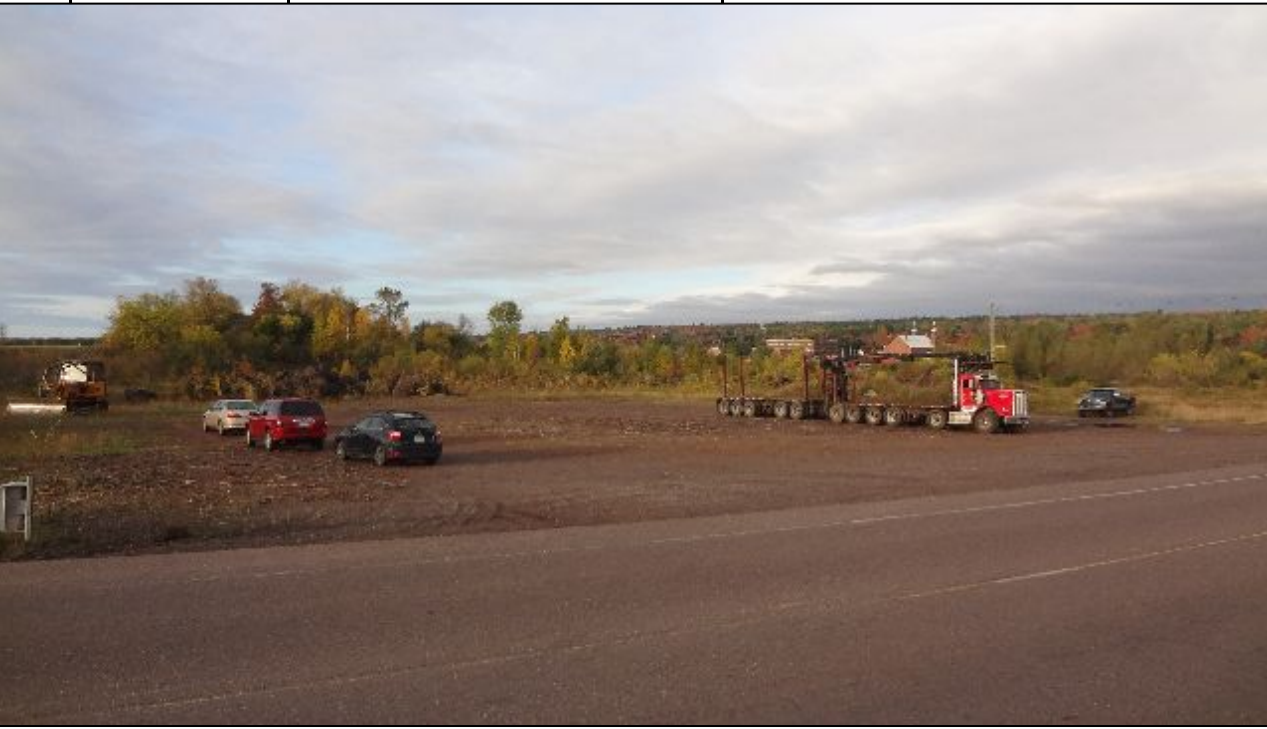
View looking south/southwest at the Trap Rock dump property.

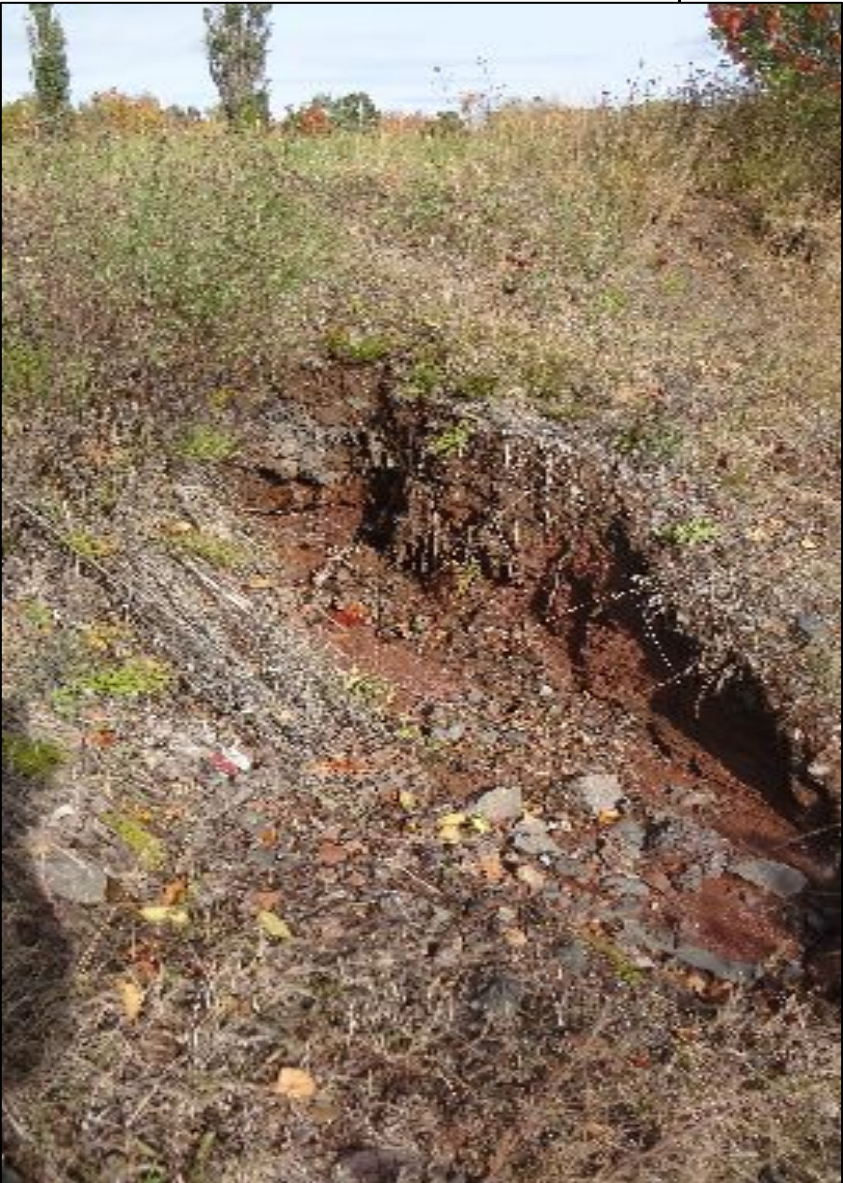
View looking west/northwest at an area of cap/shoreline erosion north of the marina.

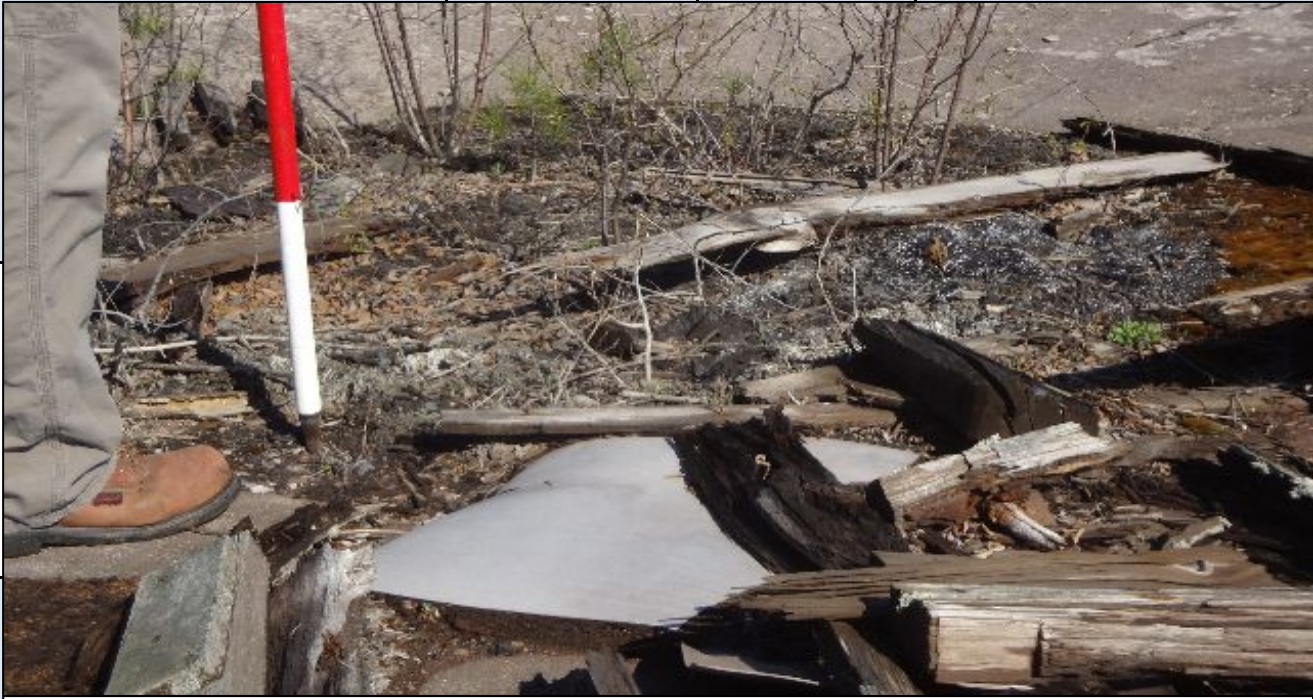
Material sample CHLL-ASBBLK42-063015 collected during the targeted inspection activities is consistent with the material identified during the reconnaissance activities.
Residual Process Materials								Material sample CHLL-ASBBLK42-063015 collected during the targeted inspection activities is consistent with the material identified during the reconnaissance activities.
Potentially Abandoned Containers								
Soil Staining/Stressed Vegetation		Longitude: -88.410803

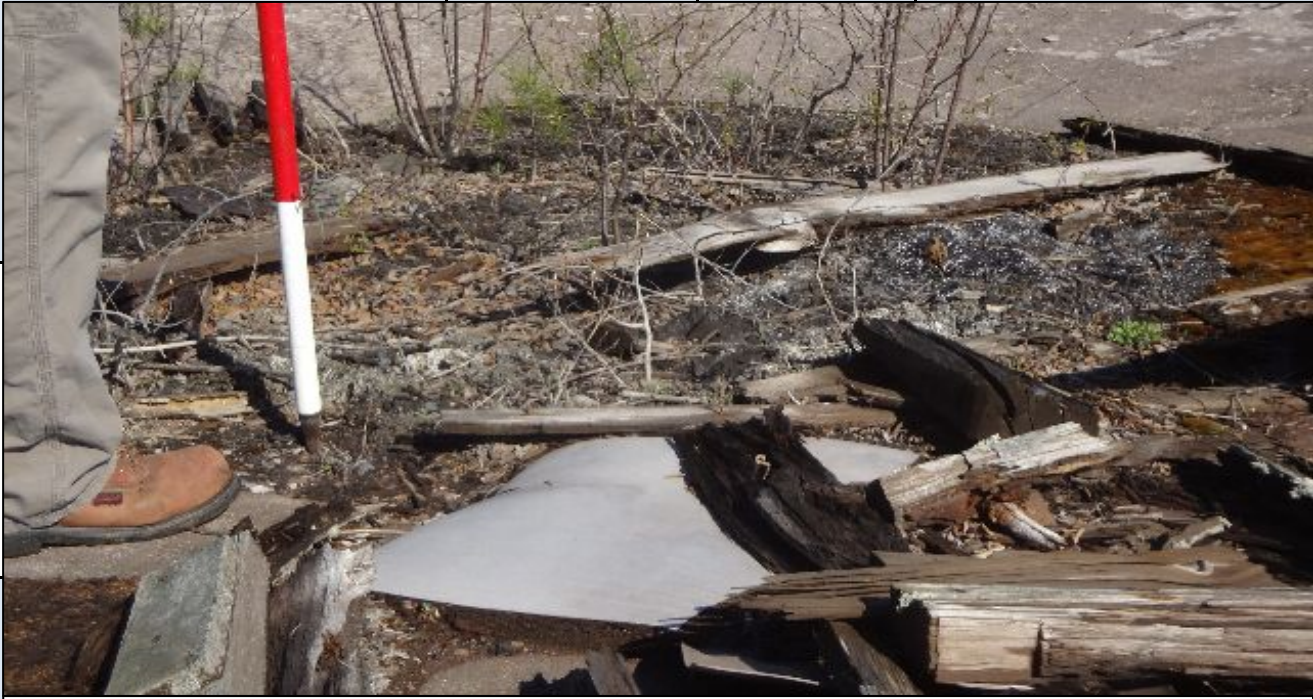
Material sample CHLL-ASBBLK42-063015 collected during the targeted inspection activities is consistent with the material identified during the reconnaissance activities.
Residual Process Materials								Material sample CHLL-ASBBLK42-063015 collected during the targeted inspection activities is consistent with the material identified during the reconnaissance activities.
Potentially Abandoned Containers								
Soil Staining/Stressed Vegetation		Longitude: -88.410839						
Potential PCB or Mercury Containing Equipment								
Other: _____								
Suspect ACM	✓	Latitude: 47.187619	CHLL-SACM06 - Center of floatation table, suspect thermal systems insulation and highly weathered asphaltic roofing material, damaged, friable.

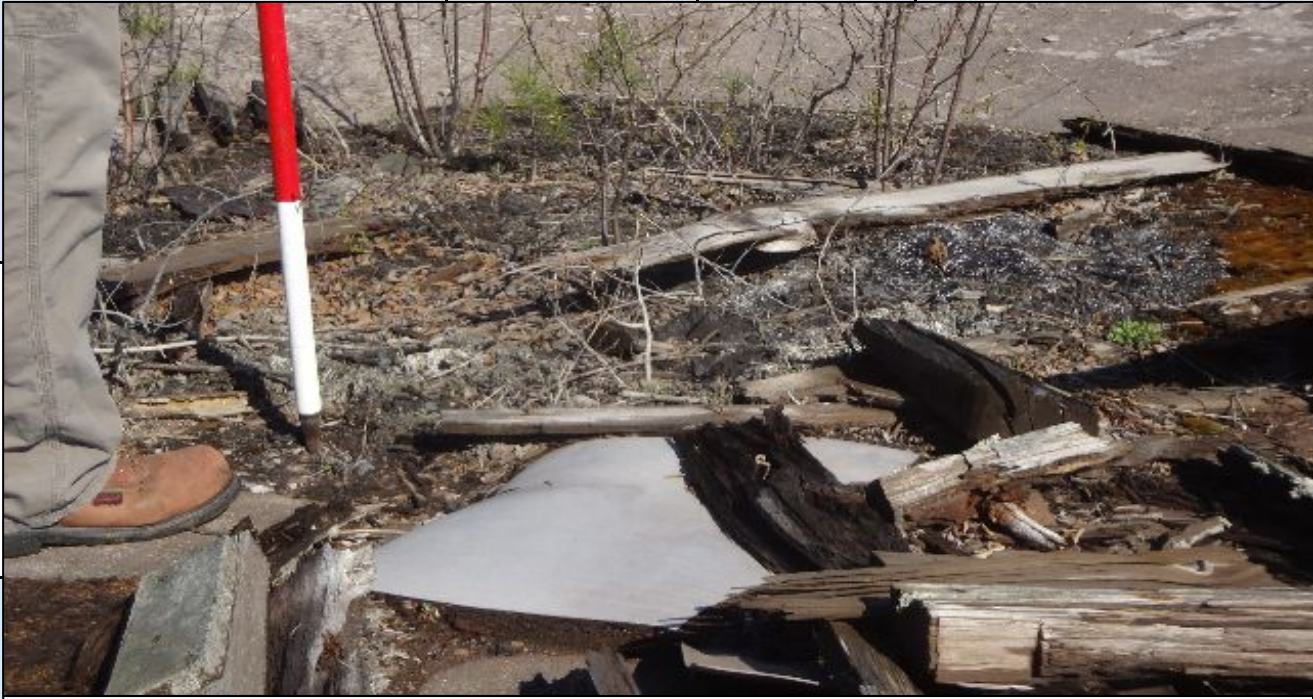
Material samples CHLL-ASBBLK46-063015 and CHLLASBBLK39-063015 collected during the targeted inspection activities are consistent with the materials identified during the reconnaissance activities.

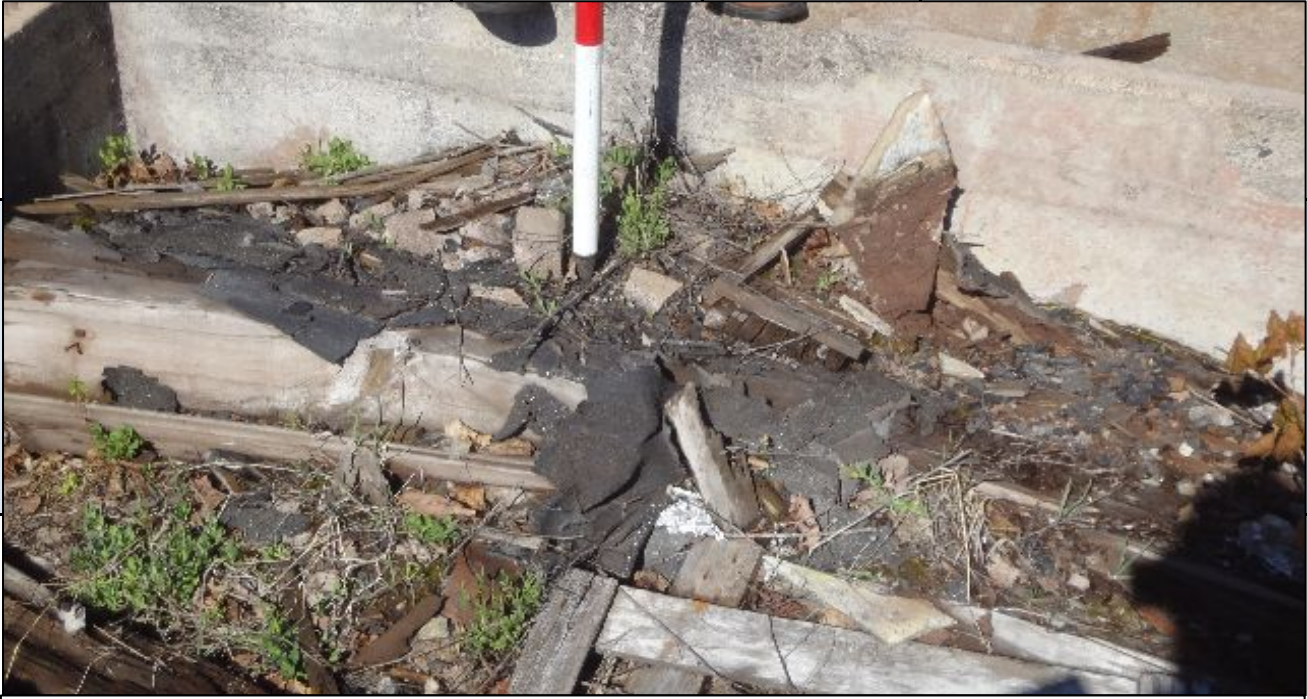
Material sample CHLL-ASBBLK39-063015 collected during the targeted inspection activities is consistent with the material identified during the reconnaissance activities.
Residual Process Materials								Material sample CHLL-ASBBLK43-063015 collected during the targeted inspection activities is consistent with the material identified during the reconnaissance activities.
Potentially Abandoned Containers

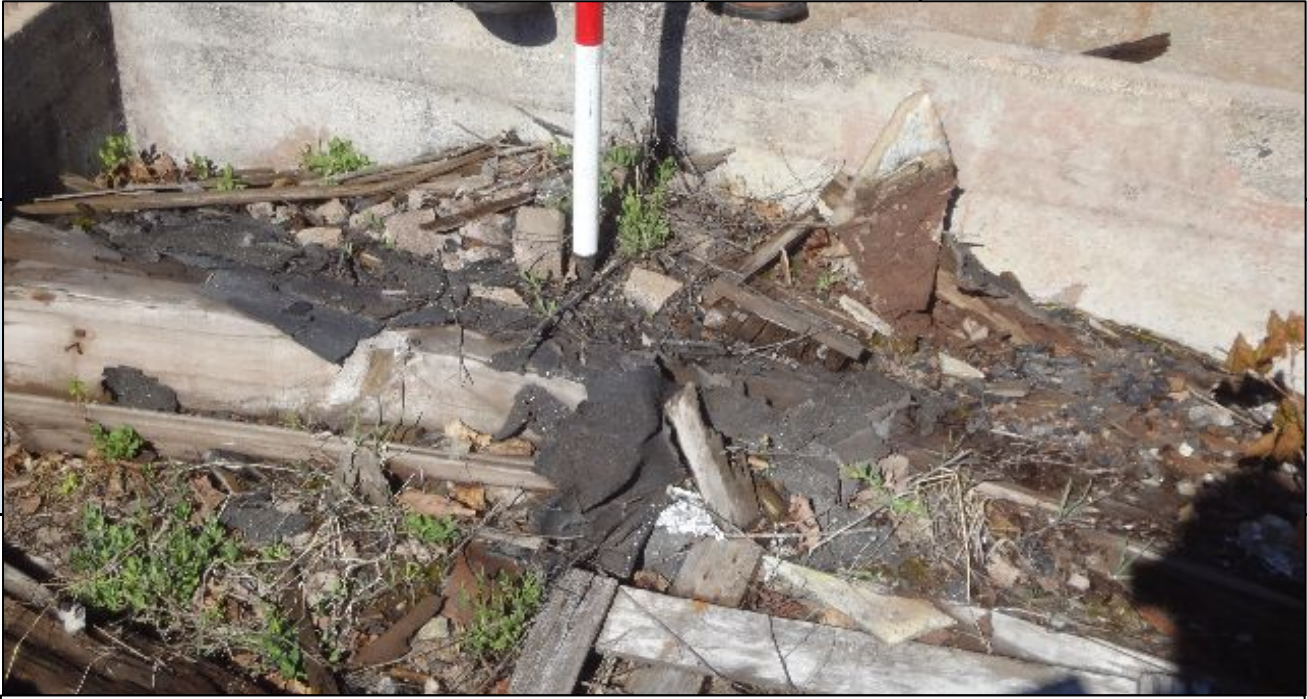
Material sample CHLL-ASBBLK44-063015 collected during the targeted inspection activities is consistent with the material identified during the reconnaissance activities.
Residual Process Materials								Material sample CHLL-ASBBLK44-063015 collected during the targeted inspection activities is consistent with the material identified during the reconnaissance activities.
Potentially Abandoned Containers								
Soil Staining/Stressed Vegetation		Longitude: -88.410897						
Potential PCB or Mercury Containing Equipment								
Other: _____								
Suspect ACM	✓	Latitude: 47.187462	CHLL-SACM10 - Suspect transite and asphaltic roofing material in a subgrade vault in the floor of the former stamp mill/reclamation plant. The material is weathered, damaged, and friable.

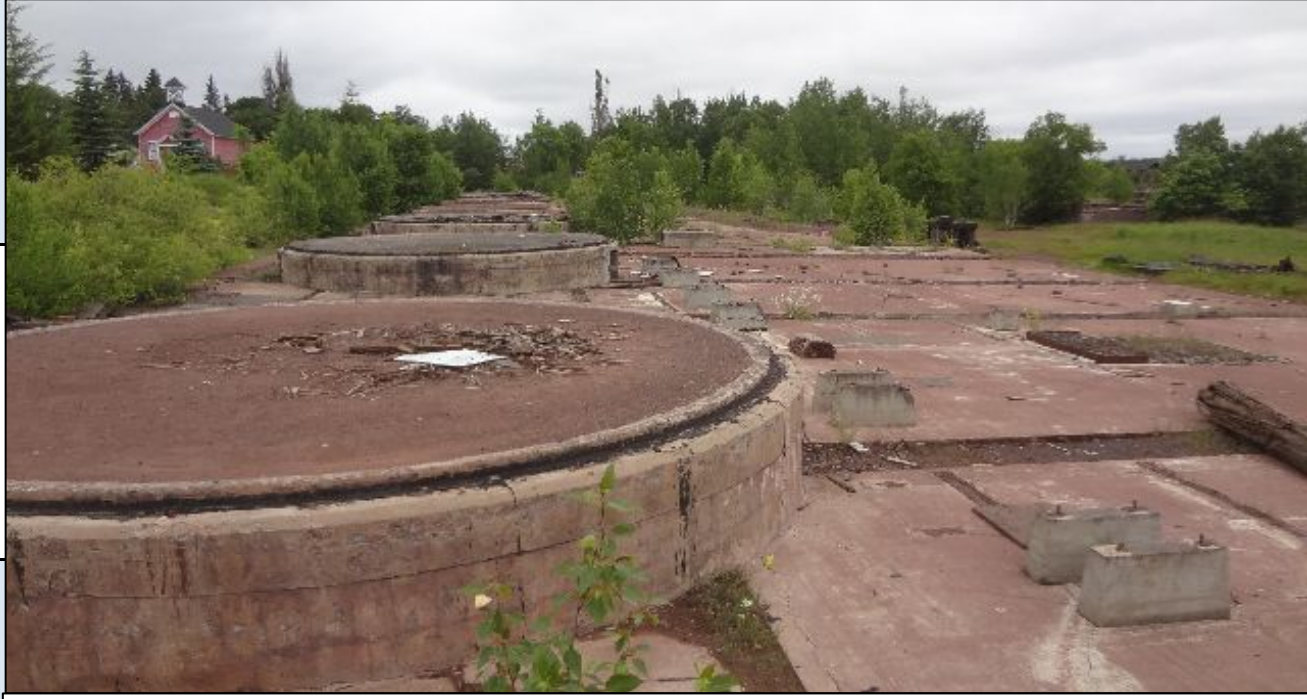
Material samples CHLL-ASBBLK46-063015 and CHLLASBBLK43-063015 collected during the targeted inspection activities are consistent with the materials identified during the reconnaissance activities.

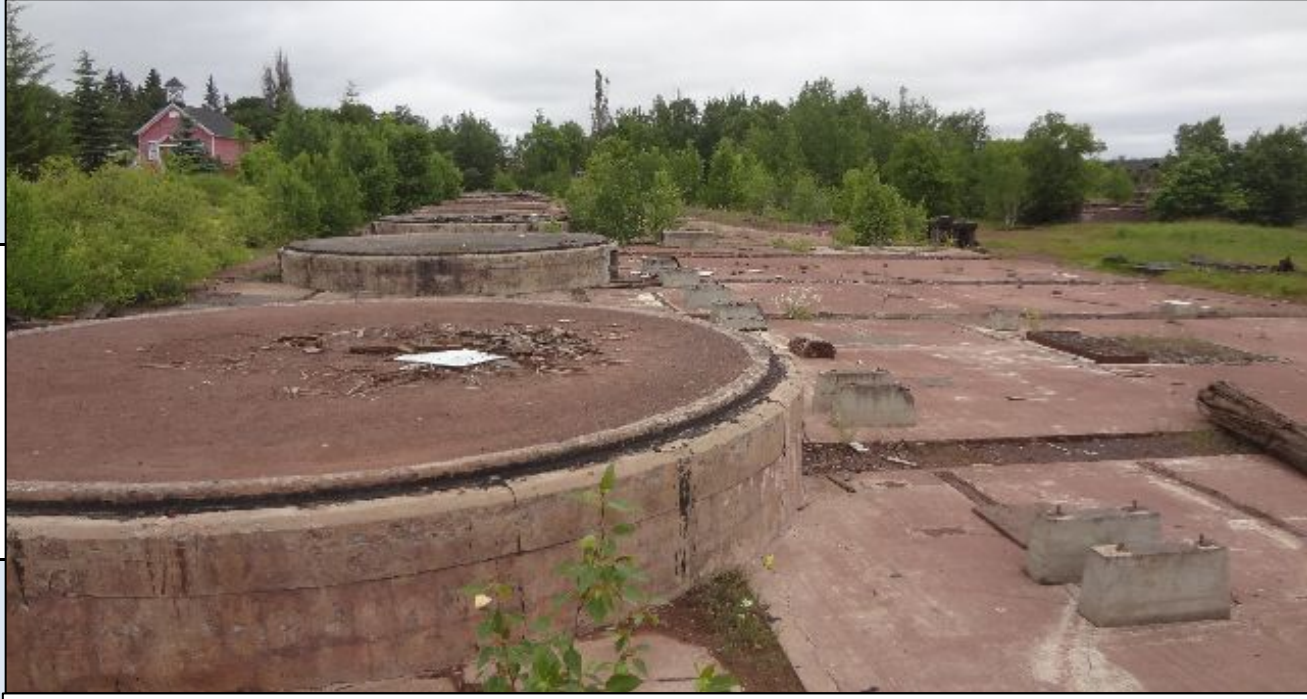
Material sample CHLL-ASBBLK42-063015 collected during the targeted inspection activities is consistent with the material identified during the reconnaissance activities.
Residual Process Materials								Material sample CHLL-ASBBLK42-063015 collected during the targeted inspection activities is consistent with the material identified during the reconnaissance activities.
Potentially Abandoned Containers

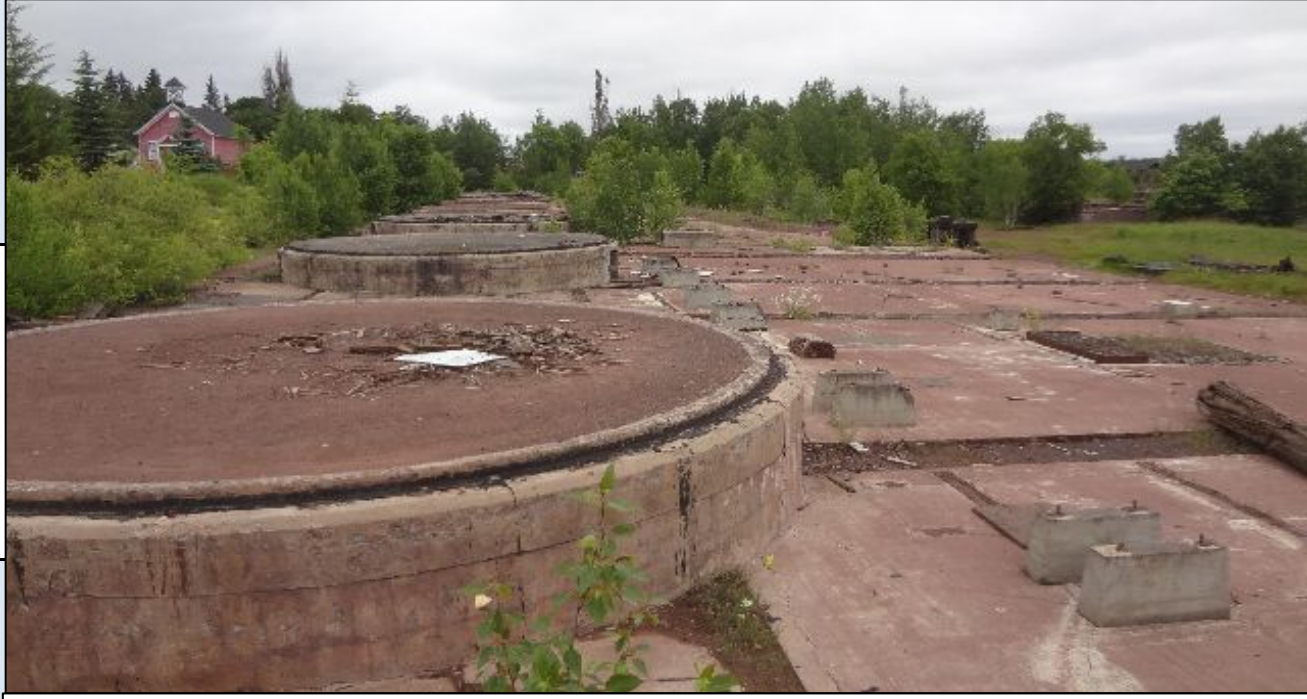
Material sample CHLL-ASBBLK42-063015 collected during the targeted inspection activities is consistent with the material identified during the reconnaissance activities.
Residual Process Materials								Material sample CHLL-ASBBLK42-063015 collected during the targeted inspection activities is consistent with the material identified during the reconnaissance activities.
Potentially Abandoned Containers								
Soil Staining/Stressed Vegetation		Longitude: -88.41093						
Potential PCB or Mercury Containing Equipment								
Other: _____

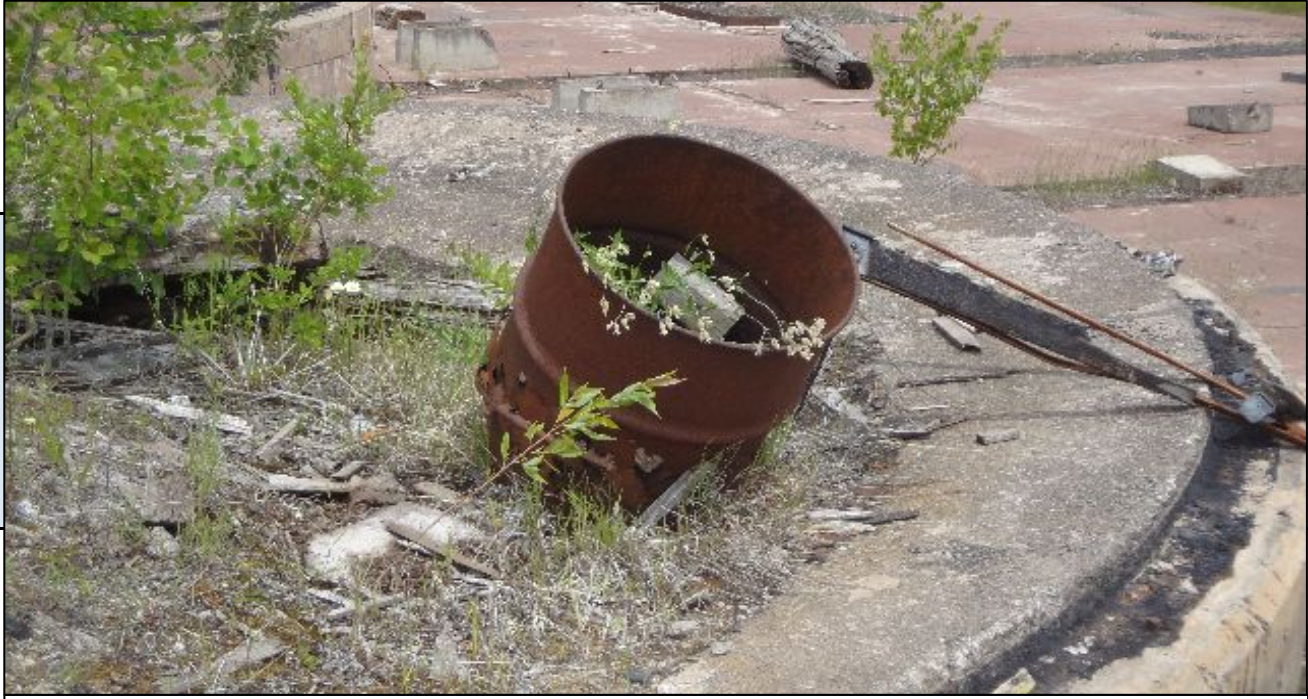
Material sample CHLL-ASBBLK42-063015 collected during the targeted inspection activities is consistent with the material identified during the reconnaissance activities.
Residual Process Materials								Material sample CHLL-ASBBLK42-063015 collected during the targeted inspection activities is consistent with the material identified during the reconnaissance activities.
Potentially Abandoned Containers								
Soil Staining/Stressed Vegetation		Longitude: -88.411255

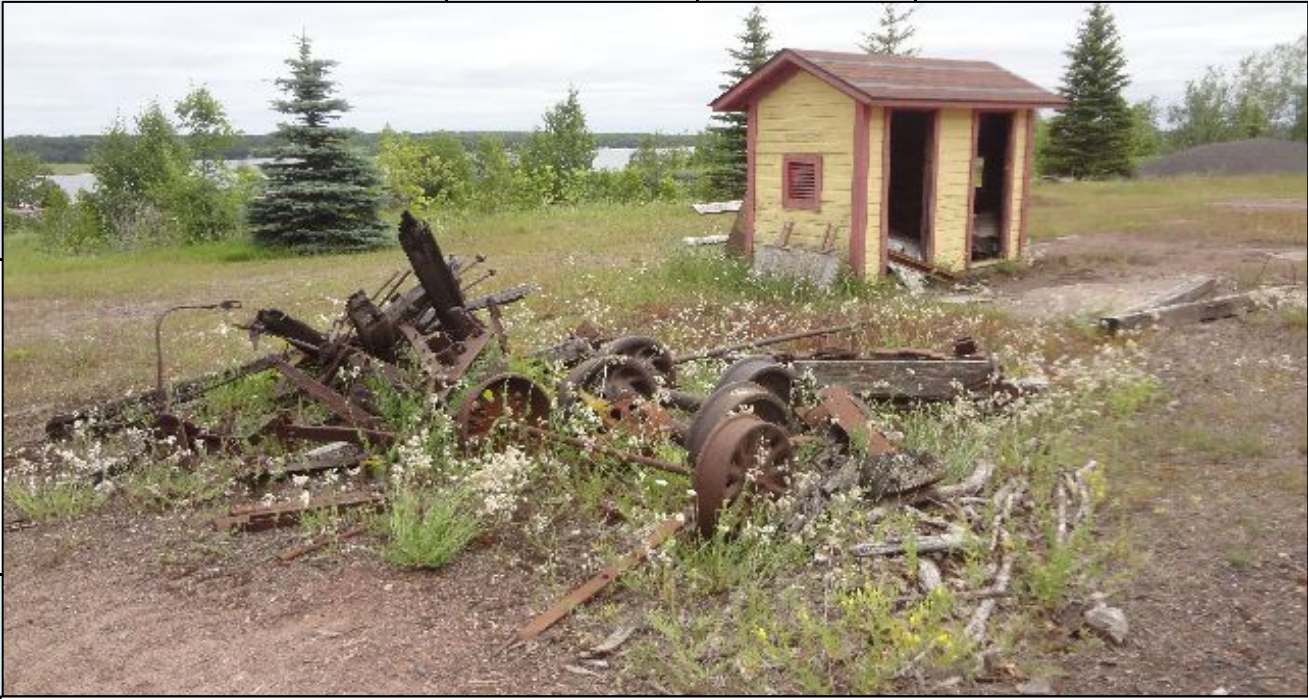
Residual Process Materials								
Potentially Abandoned Containers	✓							
Soil Staining/Stressed Vegetation		Longitude: -88.411473447						
Potential PCB or Mercury Containing Equipment								
Other: _____								
Suspect ACM		Latitude: 47.186617169	CHLL-DRUMCARCASS02: Yellow, rusted, 55 gallon drum, crushed, damaged.

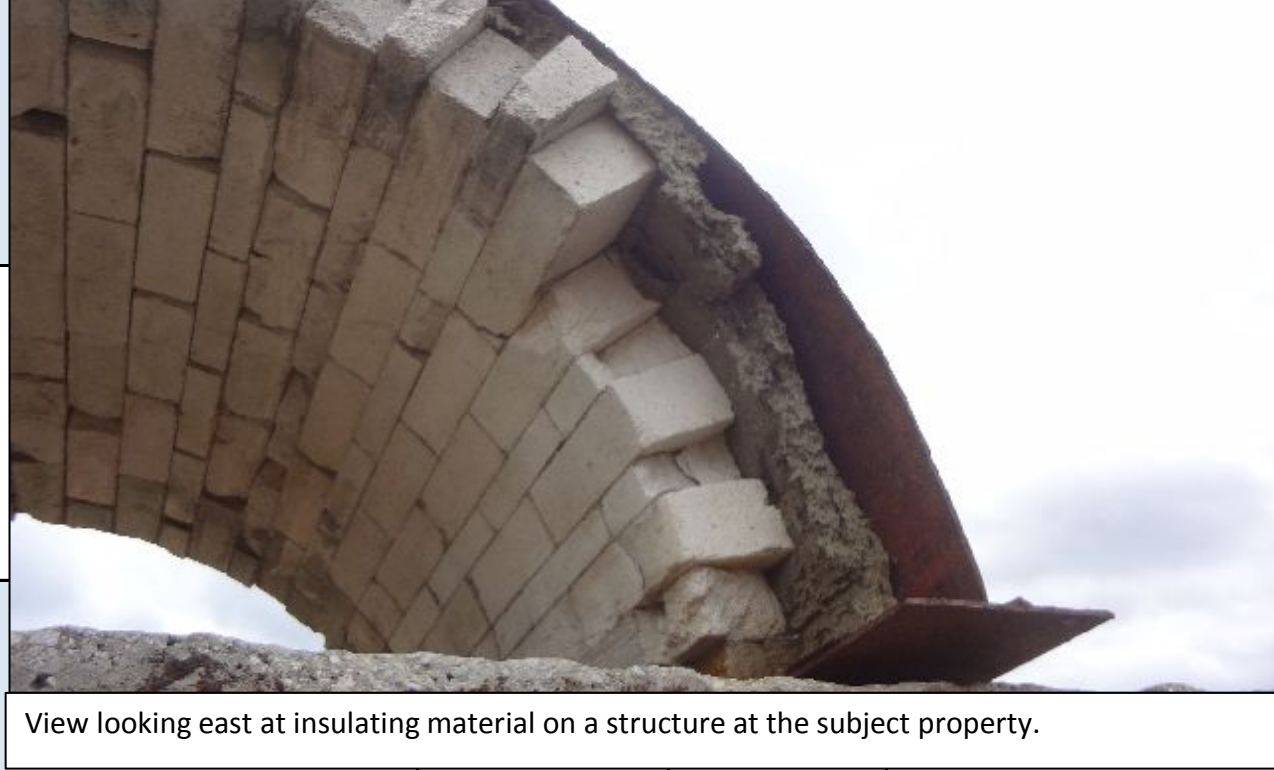
Material sample CHLL-ASBBLK27-101514 was collected from the vicinity of location SACM-18 during targeted inspection activities.

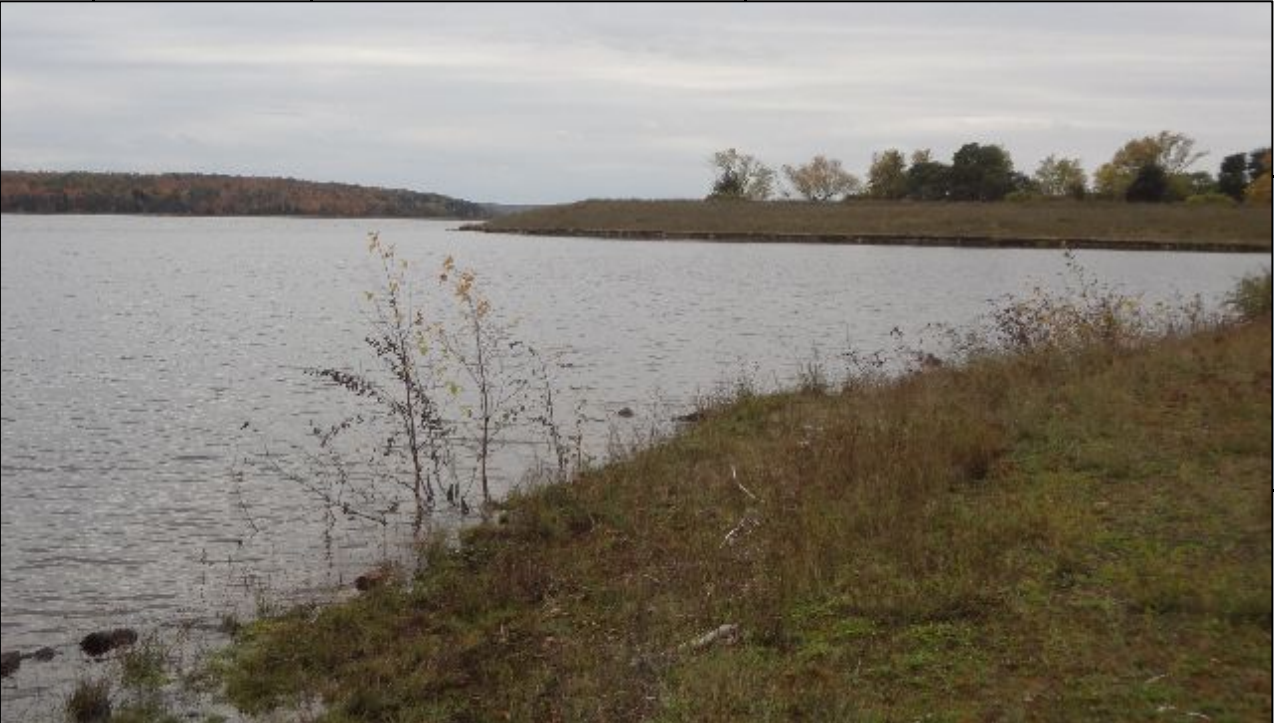
View looking east at the capped shoreline of the subject property.
