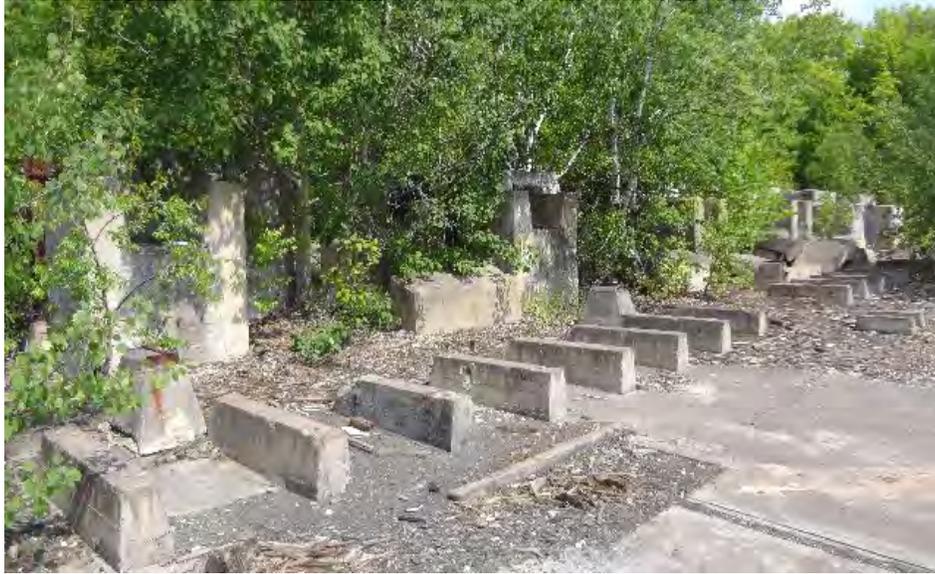
**Photograph 1:** 6/29/15: View looking northwest at concrete foundations and structures present along the hillside in the Tamarack Reclamation Plant Complex. Photograph taken by D. Liebau.

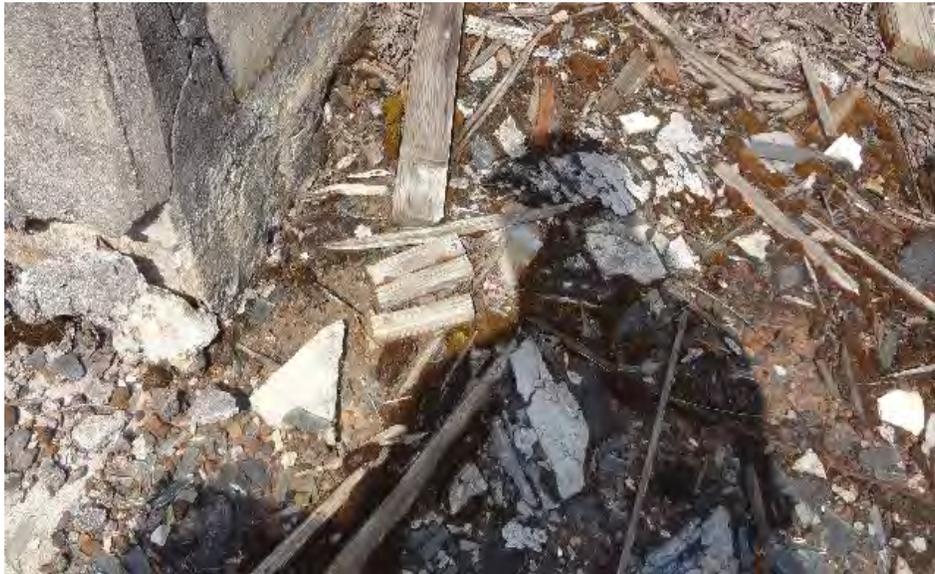
**Photograph 2:** 6/29/15: View looking down at building debris including wood, ceramic, transite, and asphaltic roofing material on the floor of the Tamarack Reclamation Plant. Similar debris was observed on concrete surfaces in all areas of the complex. Photograph taken by D. Liebau.

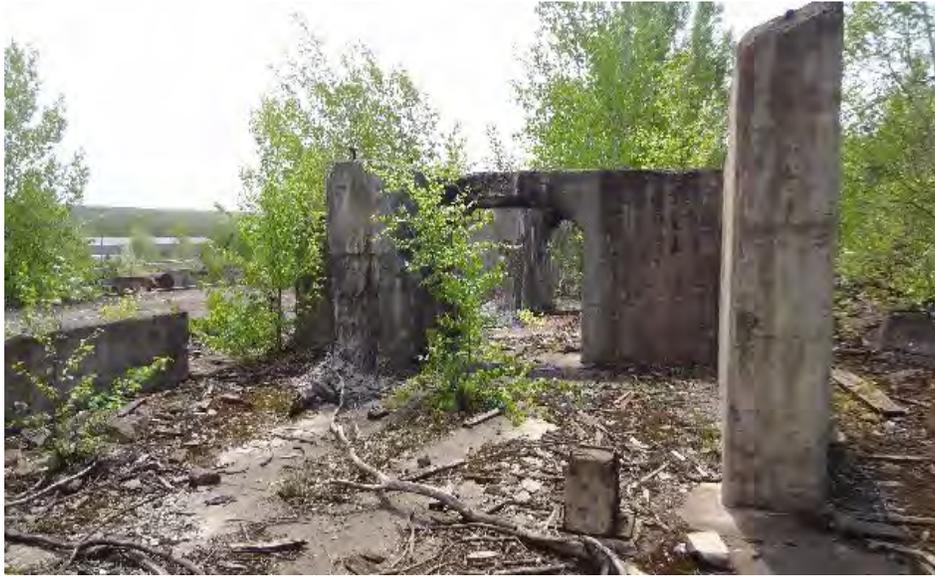
**Photograph 3:** 6/29/15: View looking south at concrete at concrete foundations and structures present along the hillside in the Tamarack Reclamation Plant Complex. Photograph taken by D. Liebau.

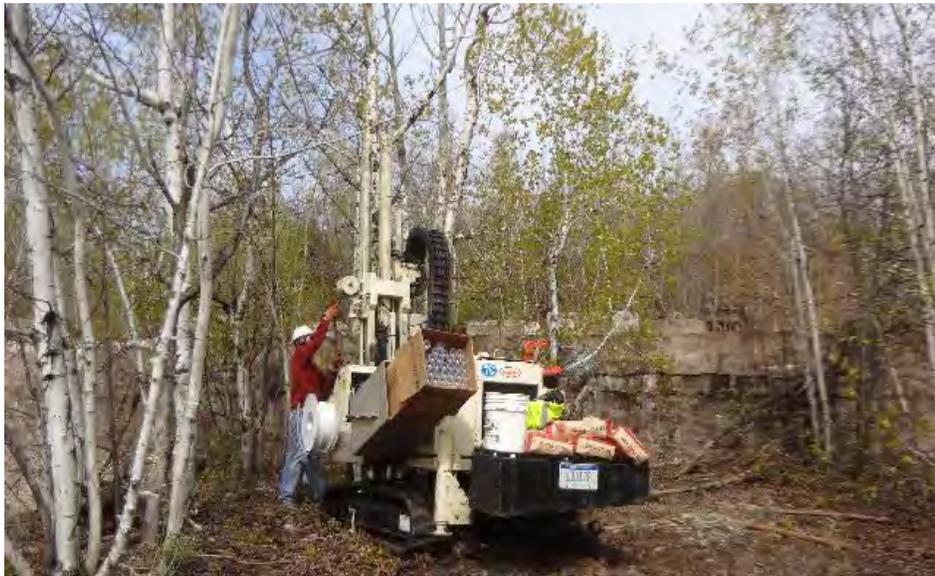
**Photograph 4:** 5/14/15: View looking west at the installation of soil boring SB16 and groundwater sampling location GW12 in the Tamarack Processing Area. Attempts to collect a groundwater sample from this location were unsuccessful due to insufficient groundwater. Photograph taken by D. Liebau.

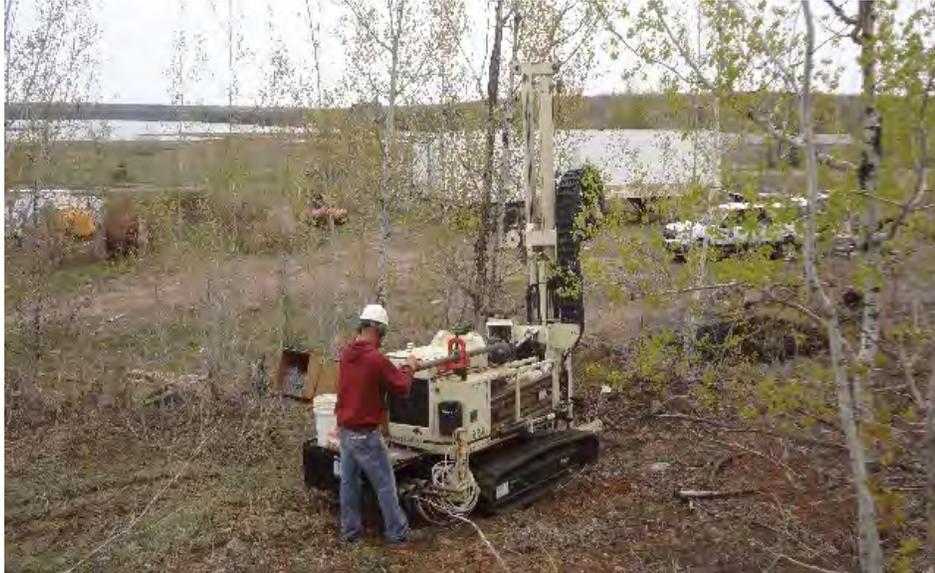
**Photograph 5:** 5/14/15: View looking west at the installation of soil boring SB20 in the Tamarack Processing Area. Photograph taken by D. Liebau.

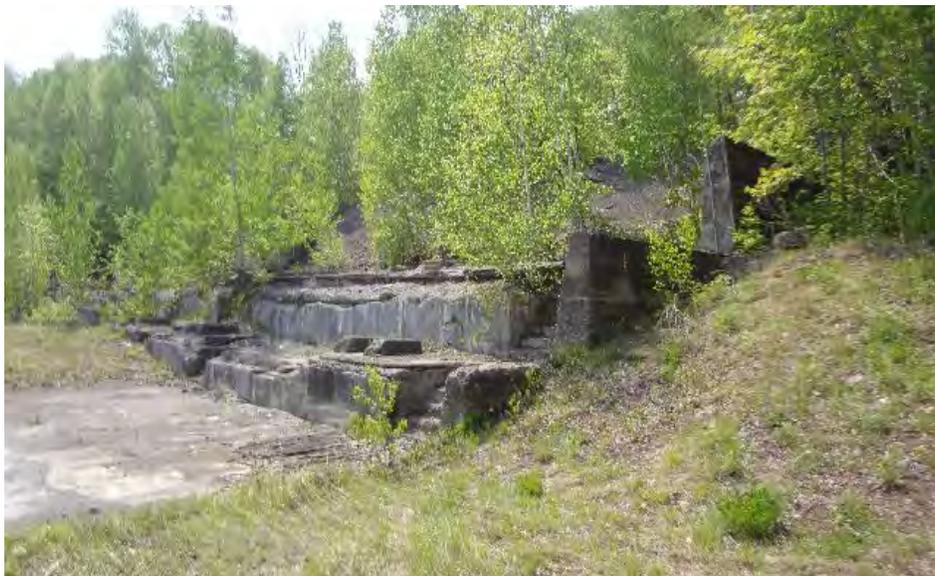
**Photograph 6:** 5/27/15: View looking southwest at the concrete structures and foundations associated with the former Lake Stamp Mill No.2 (Tamarack Mill No.2) in the Tamarack Processing Area. Photograph taken by D. Liebau.

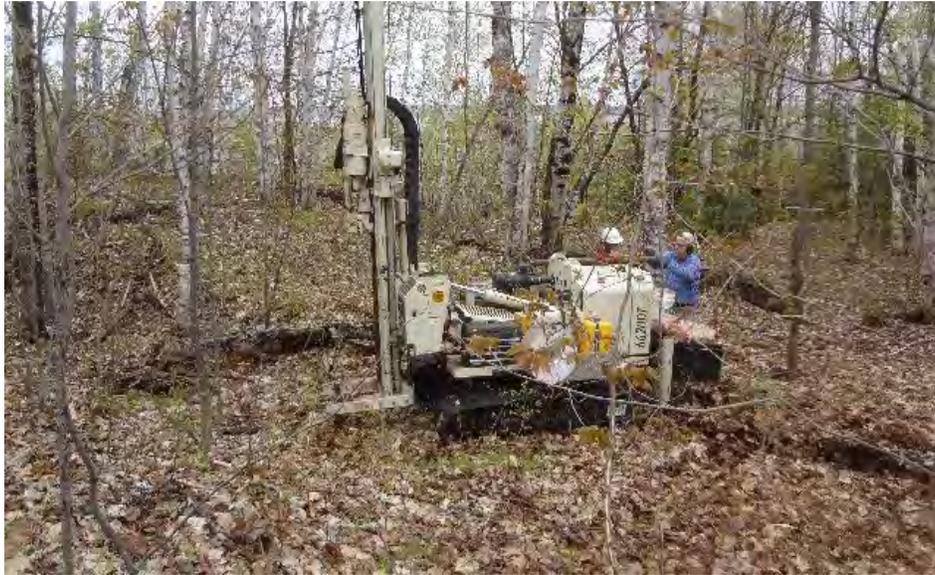
**Photograph 7:** 5/15/15: View looking east at the installation of boring SB27 located in the Tamarack Processing Area. Photograph taken by D. Liebau.

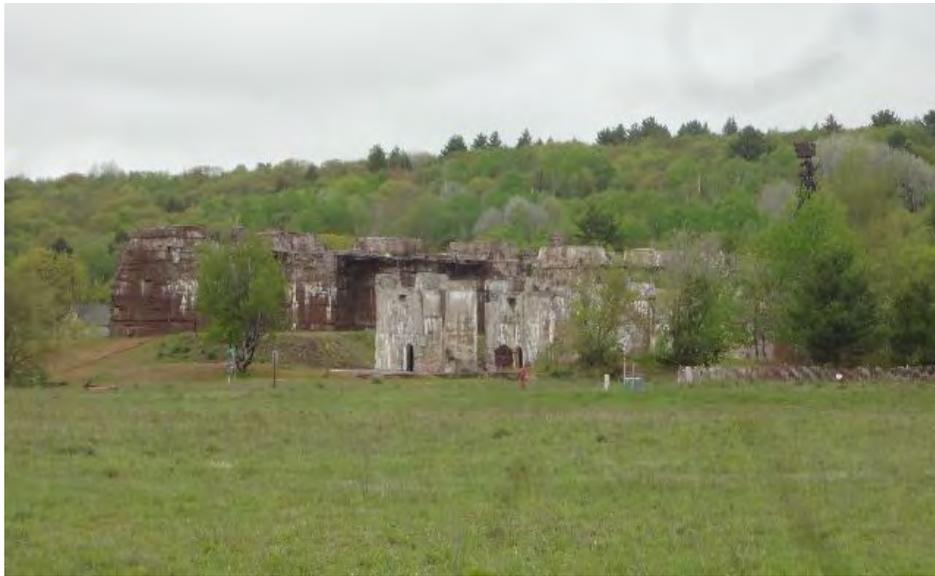
**Photograph 8:** 5/26/15: View looking west at the concrete structures and foundations associated with the former Ahmeek Stamp Mill located in the Ahmeek Mill Processing Area. Photograph taken by D. Liebau.

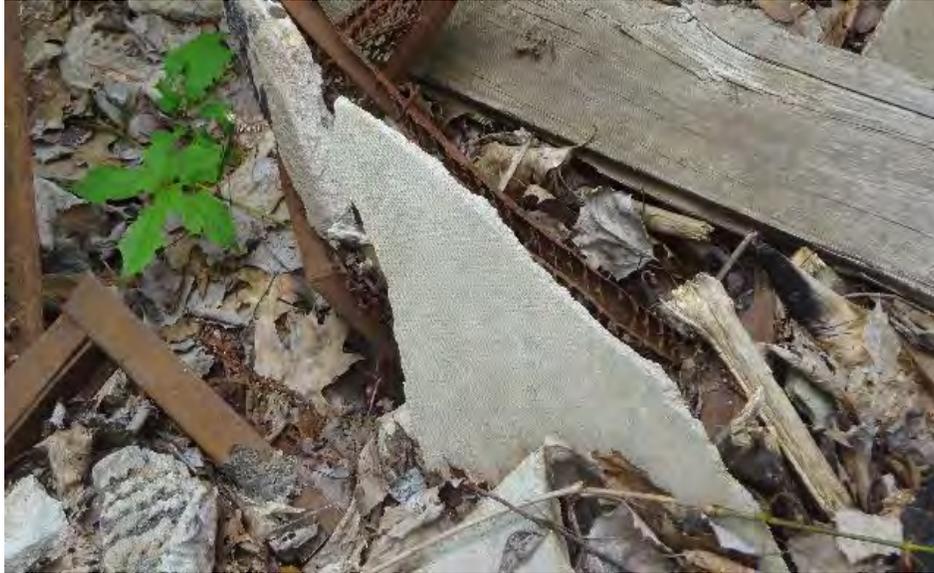
**Photograph 9:** 6/29/15: View looking down/southwest at building debris including wood, cementitious plaster, and transite in a debris pile across the street from the Tamarack City Park in the Ahmeek Mill Processing Area. Photograph taken by D. Liebau.

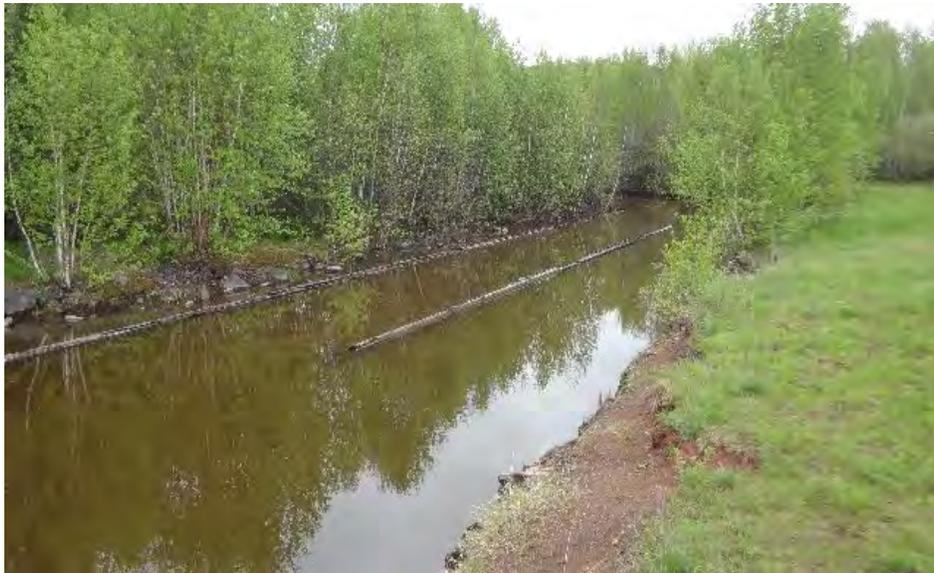
**Photograph 10:** 5/26/15: View looking west at mining era features present in a creek that discharges to Torch Lake in the Ahmeek Mill Processing Area. Similar wooden and metal structures and pilings are present along the shoreline of Torch Lake at the creek outfall. Photograph taken by D. Liebau.

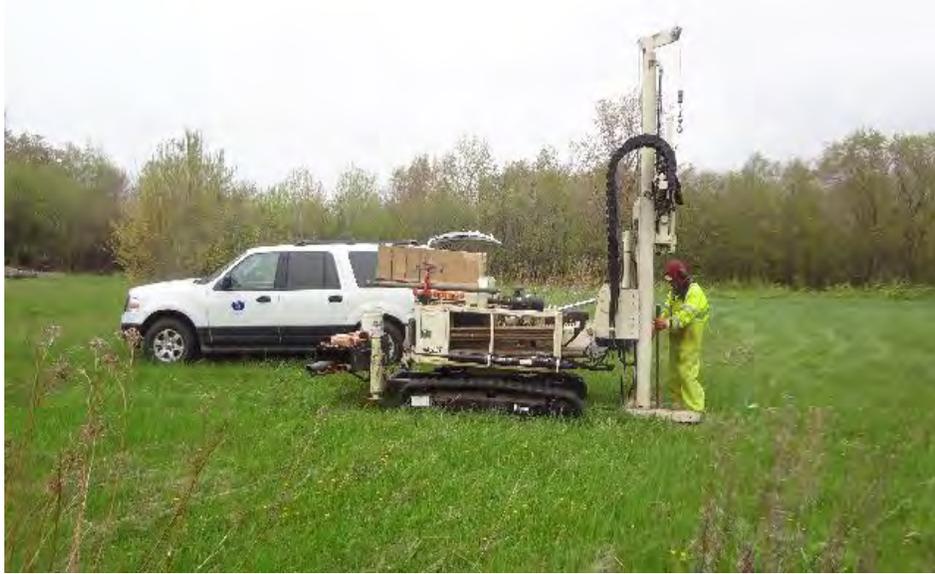
**Photograph 11:** 5/18/15: View looking southeast at the installation of boring SB34 located in the Tamarack Sands Area. The wooded area in the background of the photograph is identified by signage as the Eagle Point Nature Preserve. Photograph taken by D. Liebau.

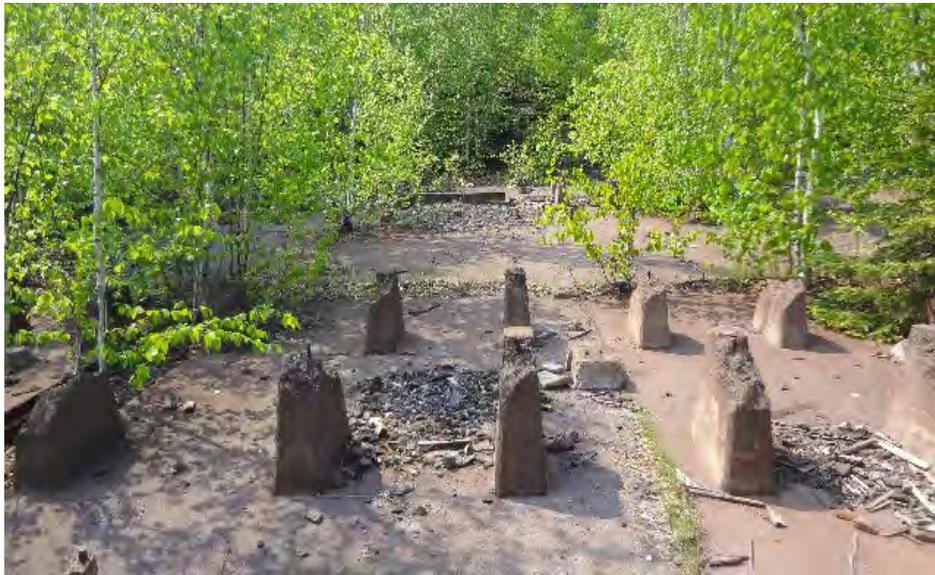
**Photograph 12:** 5/27/15: View looking east southeast at concrete structures and foundations associated with the former Osceola Stamp Mill located in the Tamarack Processing Area. Photograph taken by D. Liebau.

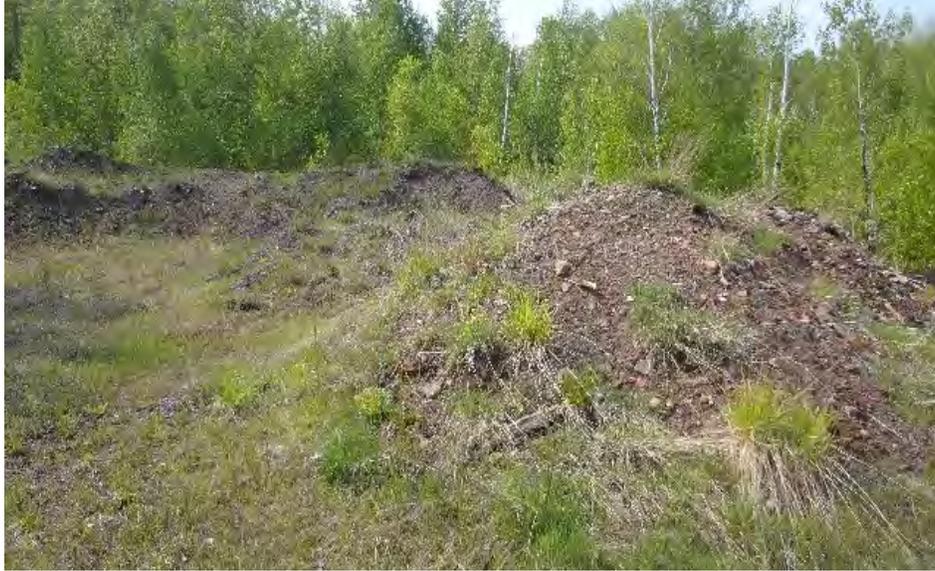
**Photograph 13:** 5/27/15: View looking west/northwest at vegetated debris piles located in the vicinity of the former Osceola Stamp Mill located in the Tamarack Processing Area. Photograph taken by D. Liebau.
