**ABANDONED MINING WASTES TORCH LAKE NON-SUPERFUND SITE  
CALUMET AND HECLA – LAKE LINDEN OPERATIONS  
TARGETED INSPECTION FORM**

Inspection Date: 6/30/15 Feature Identification/Name: CALUMET STAMP MILL

Geographic Area: LAKE LINDEN PROCESSING AREA Property Identification Number: 014-306-003-00

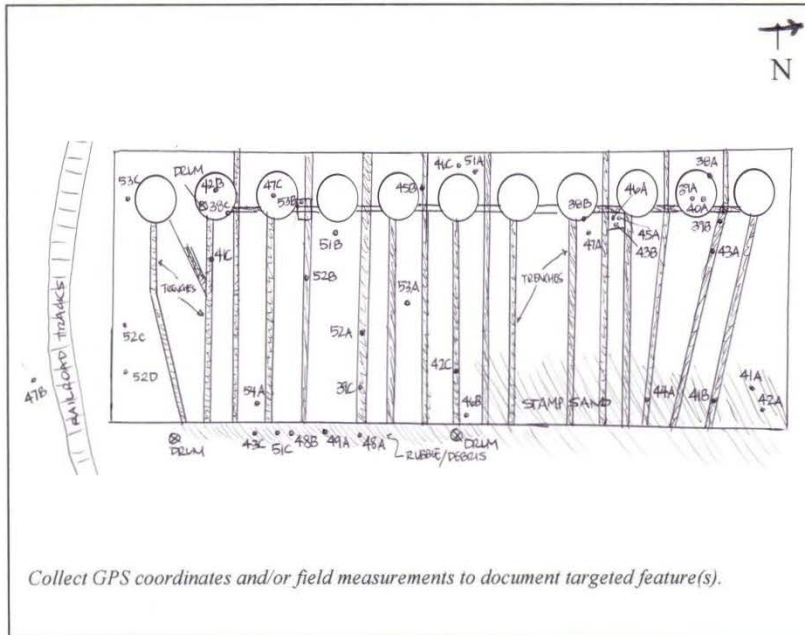
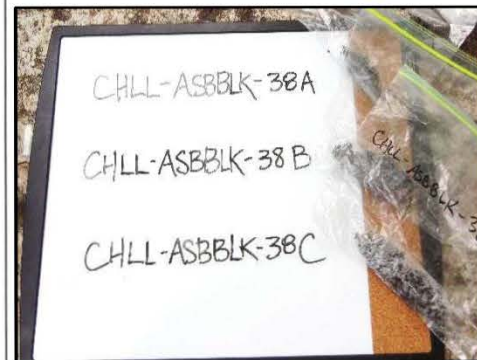
LARGE DIAMETER CONCRETE SORTING TABLES ON THE WEST SIDE OF THE FORMER STAMP MILL FLOOR. FEATURE A TAR AND ROPE-LIKE CASSET AROUND THE OUTER RIM OF THE STRUCTURES

ROPE IS GENERALLY COATED IN TAR, BUT IS EXPOSED AND DETEQUIZATING IN AREAS. TAR BECOMES VISCOUS IN THE HEAT OF THE SUN AND MAY ADHERE TO CLOTHING AND SKIN. EXPOSED AREAS OF ROPE WILL

**Other Relevant Below and Above Ground Features (Conduit, Drainage Swales, Culverts):** LIKELY CONTINUE WORKERS AND VISITORS COULD BE EXPOSED TO TO DEGRADATE HAZARDOUS MATERIALS VIA CONTACT.

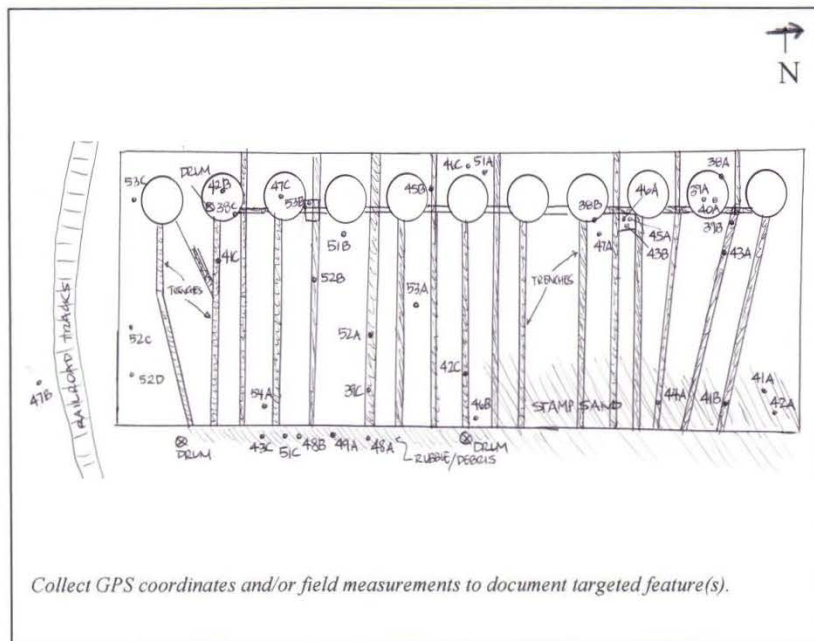
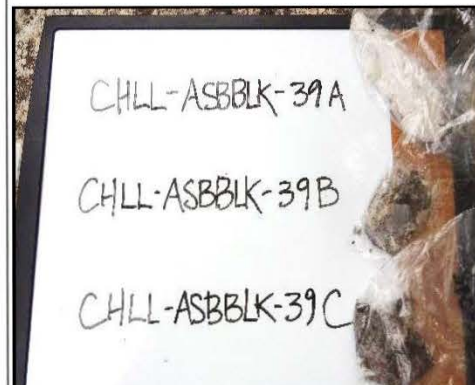
THE STAMPMILL FLOOR FEATURES NUMEROUS TRENCHES GENERALLY ORIENTED FROM EAST TO WEST. THE TRENCHES ARE FILLED WITH VARIOUS TYPES OF DEBRIS AND LIKELY ACT AS CONDUIT FOR MATERIAL TO BE MOVED VIA WIND AND WATER TO THE EAST SIDE OF THE STAMP MILL FOUNDATION

THE SUSPECT TS1 IS HIGHLY WEATHERED AND HIGHLY FRIABLE. THE MATERIAL IS SUSCEPTIBLE TO FUTURE DEGRADATION DUE TO WIND AND WATER. WORKERS AND VISITORS COULD BE EXPOSED THROUGH PARTICULATE INHALATION

LIKE MATERIAL WAS OBSERVED COMMINGLED WITH STAMP SAND AND RUBBLE ALONG THE EASTERN LIMITS OF THE FOUNDATION

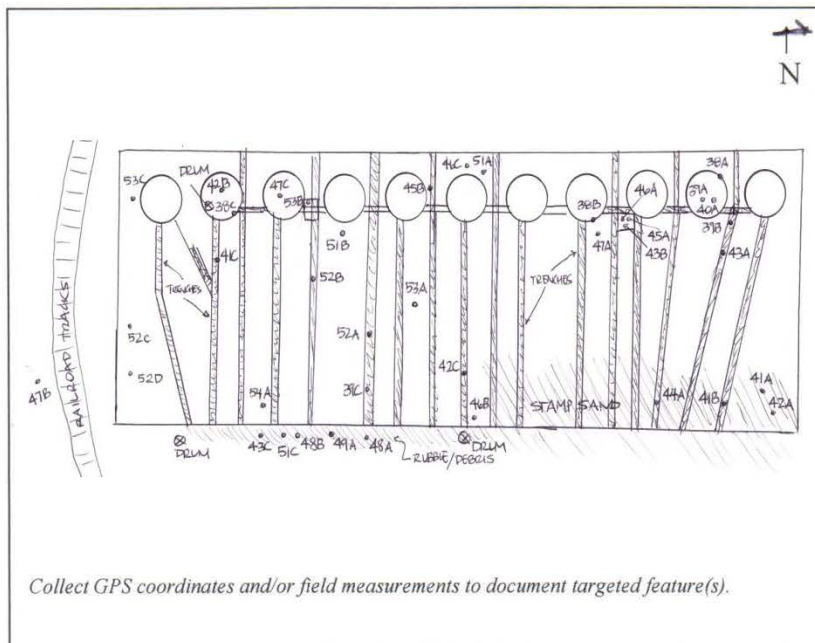
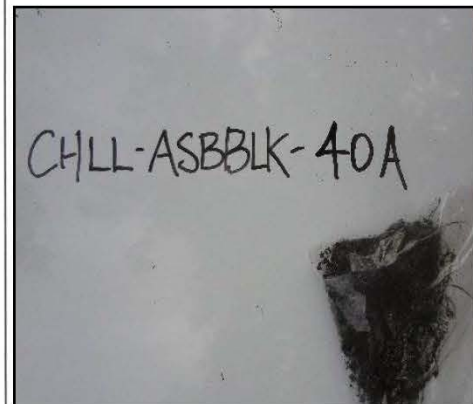
BLACK AND SILVERY STRANDS OF MATERIAL IN A MASS. THE MATERIAL APPEARS LIKE A THREADED FIBROUS MESH. POTENTIALLY CONSISTENT WITH A WEATHERED/DETERIORATED TARP.

THE MATERIAL IS HIGHLY WEATHERED AND DEGRADED. IF DETERMINED TO BE POSITIVE FOR ASBESTOS THE MATERIAL WOULD POSE INHALATION RISKS TO WORKERS AND VISITORS AT THE SITE

THE MATERIAL WAS ONLY IDENTIFIED IN ONE AREA OF THE SITE, LOCATED IN THE CENTER OF ONE OF THE SORTING TABLES

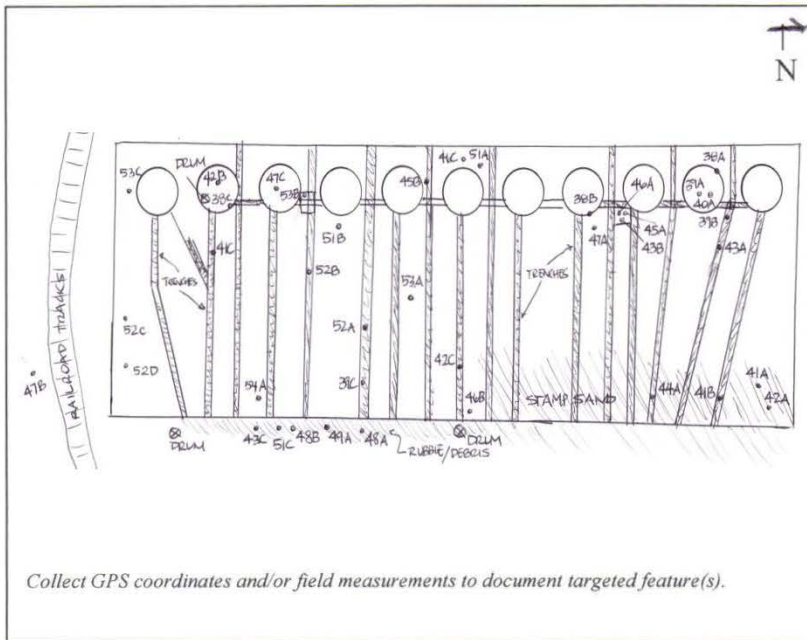
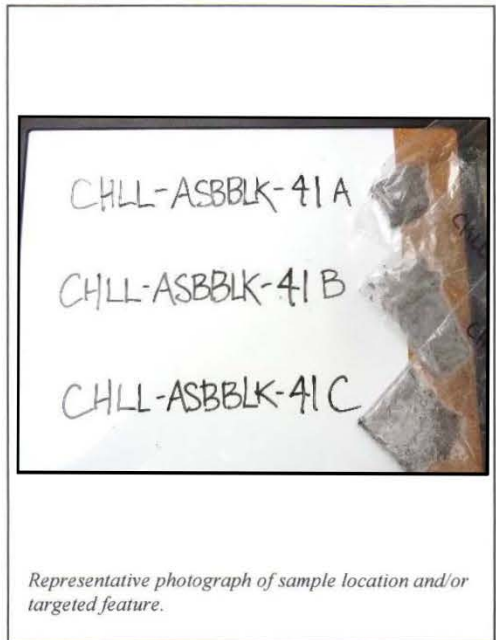
THE MATERIAL WAS OBSERVED IN SMALL BROKEN FRAGMENTS IN DIFFERENT AREAS OF THE STAMP MILL FLOOR, LOCATED IN TRENCHES AND COMMINGLED WITH STAMP SAND

THE LOCATION OF THE MATERIAL IN TRENCHES AND ON THE MILL FLOOR MAKE IT SUSCEPTIBLE TO EROSION VIA WIND AND WATER

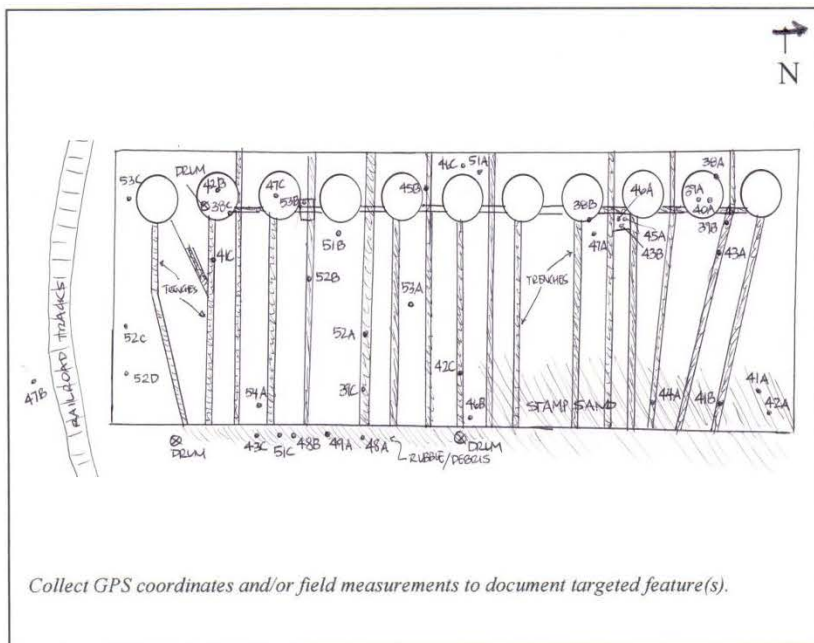
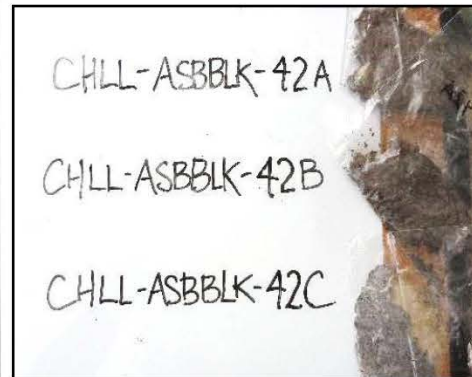
THE SUSPECT MATERIAL PRESENTS A POTENTIAL HAZARD TO WORKERS AND VISITORS FROM A DIRECT CONTACT AND INHALATION PERSPECTIVE DUE TO THE WEATHERED NATURE OF THE MATERIAL. CONTINUED

ALSO OBSERVED IN TRENCHES AND ON THE GROUND SURFACE AROUND THE STAMP MILL FOUNDATION

EXPOSURE TO WIND AND WATER WILL FURTHER DEGRADE THE MATERIAL

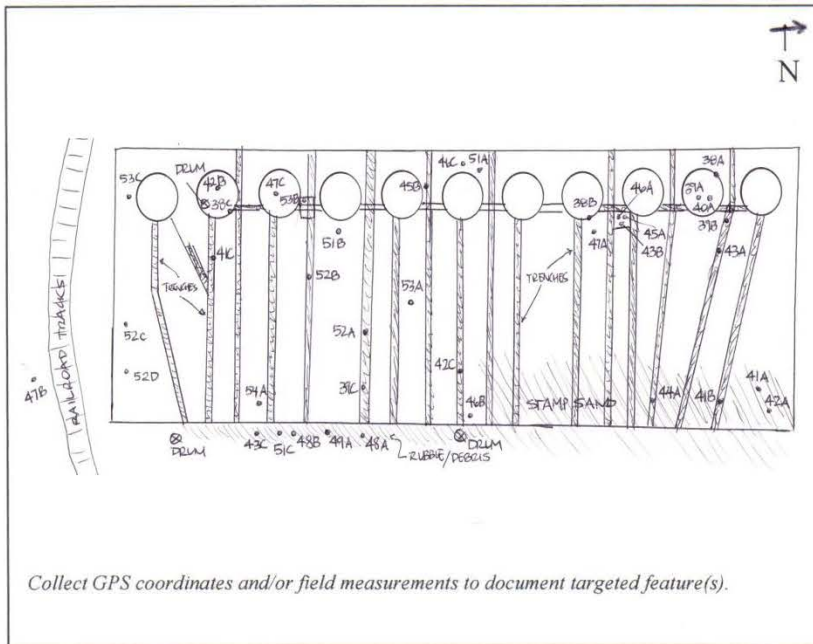
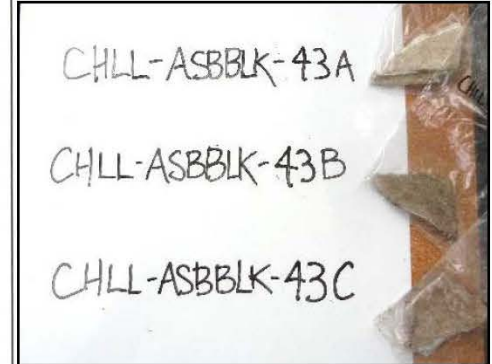
THE MATERIAL WAS NOT OBSERVED IN ABUNDANCE BUT WAS OBSERVED AT SEVERAL DIFFERENT LOCATIONS ACROSS THE STAMP MILL SURFACE IN TRENCHES AND IN DEBRIS ON THE EAST SIDE OF THE FOUNDATION

THE MATERIAL POSES AN INHALATION RISK TO WORKERS AND VISITORS ACCESSING THE STAMP MILL AREA.

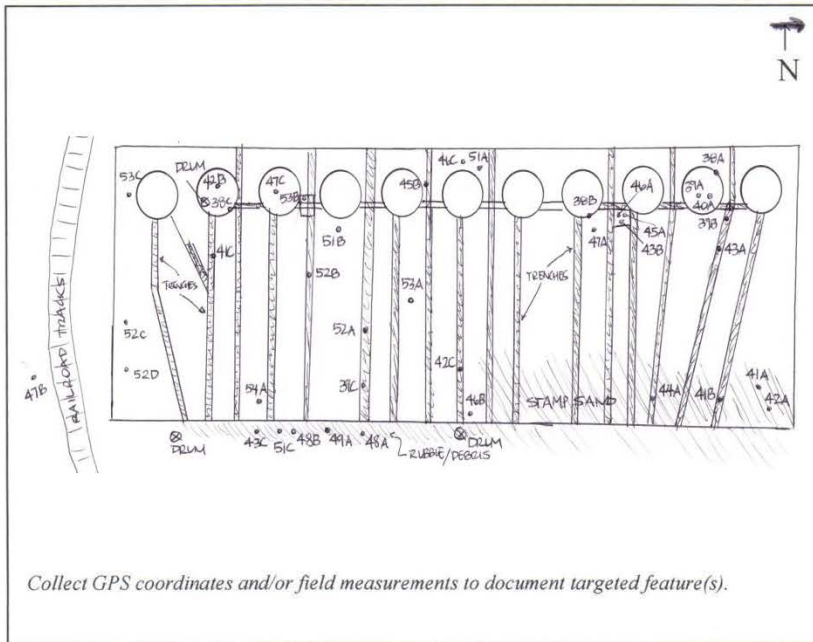
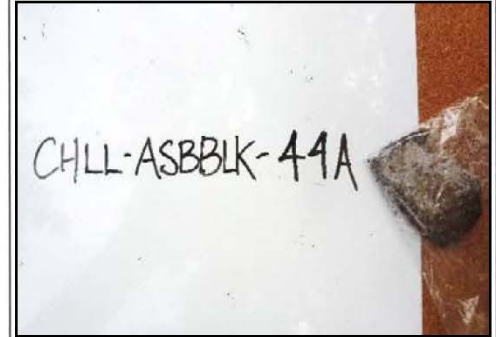
SMALL 1-3" FRAGMENT OF TRANSITE, GRAYISH WHITE, LOCATED IN TRENCH AND COMMINGLED WITH STAMP SAND. OBSERVATIONS OF THIS MATERIAL WERE NOT WIDESPREAD ACROSS THE STAMP MILL FOUNDATION  
Sampling Activities (Sample Description, Sample Time, Requested Analyses):  
CHLL-ASBBLK 44A-063015, COLLECTED AT 0845

THE LOCATION OF THE MATERIAL, COMMINGLED WITH STAMP SAND SUGGESTS THAT MORE COULD BE PRESENT, BURIED WITHIN THE STAMP SAND.

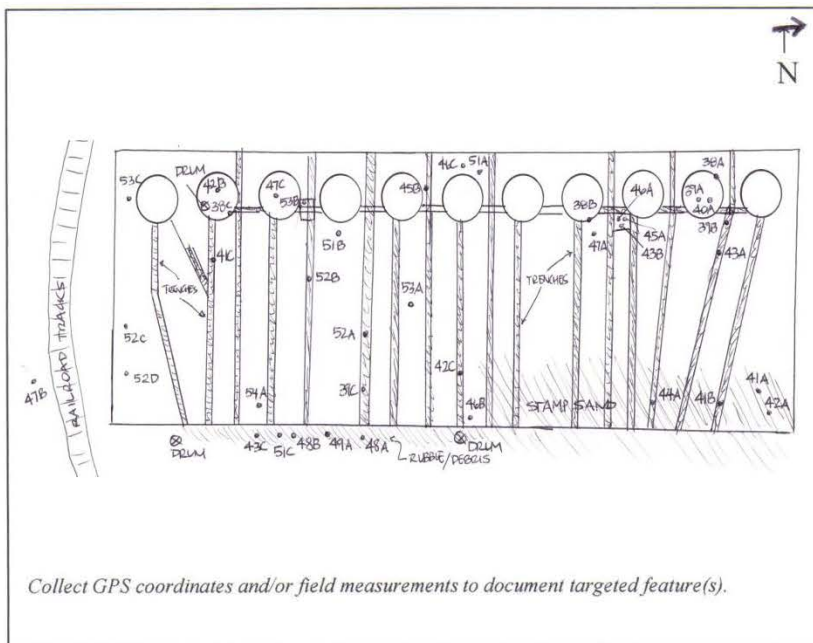
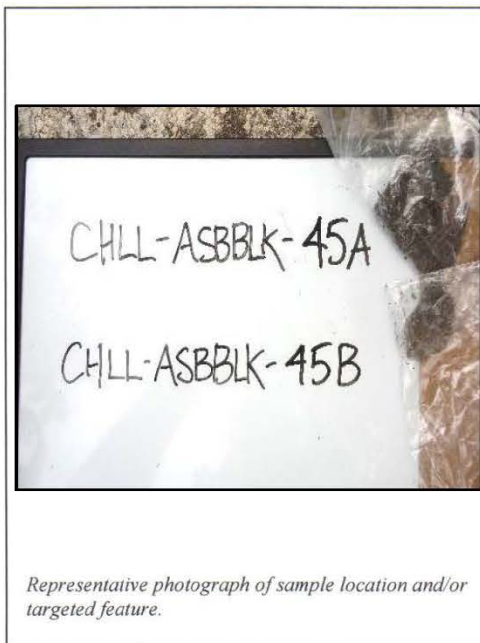
SMALL 6" FRAGMENTS OF GRAYISH WHITE WOVEN SHEETING, APPEARS FIBROUS, WOVEN MESH. NOT FOUND TO BE WIDESPREAD, FOUND IN TRENCH AND ON THE STAMPMILL FLOOR (TWO LOCATIONS), WEATHERED, DAMAGED, FRIABLE

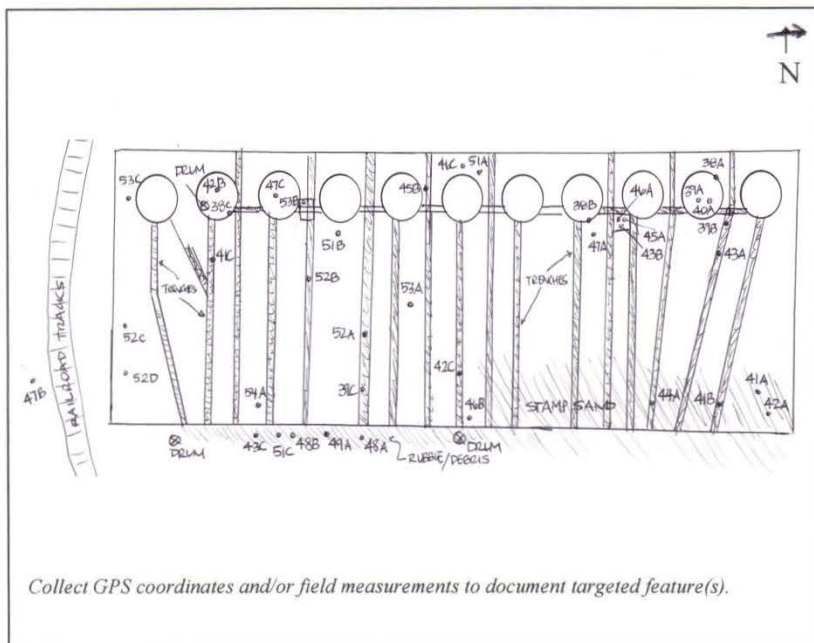
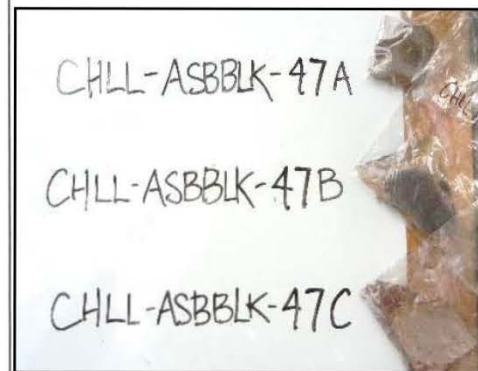
GRAYISH WHITE TILE BOARD PANELING, MATERIAL IS TYPICAL WITH A BROWNISH APPARENT FIBER BOARD CONSTRUCTION, WITH GLOSSY WATER RESISTANT FAUX TILE PATTERN ON ONE SIDE; FOUND IN THREE LOCATIONS ACROSS THE SITE.

MATERIAL IS WEATHERED, BUT GENERALLY INTACT. FOUND IN THREE SMALL TO LARGE SHEETS. IF DETERMINED TO CONTAIN ASBESTOS THE MATERIAL COULD POSE AN INHALATION RISK TO VISITORS AND

Other Relevant Below and Above Ground Features (Conduit, Drainage Swales, Culverts): WORKERS THE PANEL ASSOCIATED WITH SAMPLE CHLL-ASBBLK 47B-063015 IS LOCATED SOUTH OF THE STAMP MILL FOUNDATION AND SOUTH OF THE RAILROAD TRACKS

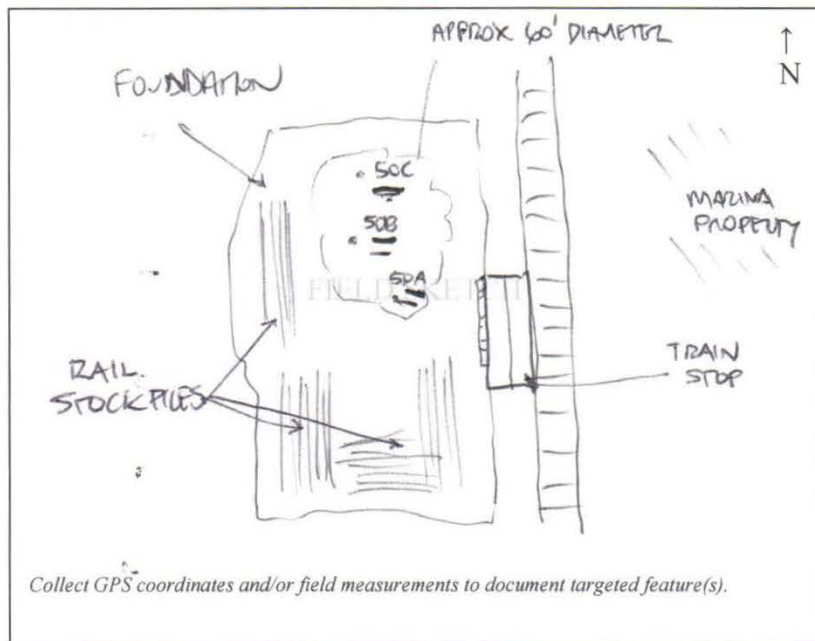
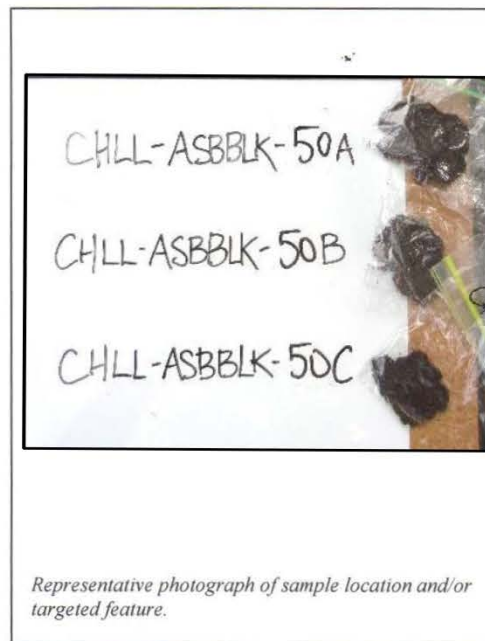
BLACK ASPHALTIC ROOFING MATERIAL IS DISTRIBUTED IN SMALL FRAGMENTS AND PILES ACROSS THE SURFACE OF A DETACHED FOUNDATION AT THE PROPERTY

THE MATERIAL POSES A POTENTIAL INHALATION RISK TO WORKERS AND VISITORS. EVIDENCE OF TRESSPASSING, CAMP FIRE RESIDUE, WAS ALSO OBSERVED ON THE SLAB.

MATERIAL IS LOCATED ON A RAISED FOUNDATION AND THE SOUTHWEST CORNER IS ERODED AND BEING UNDERMINED; THE CONCRETE PAD IS PARTIALLY OVERGROWN WITH TREES

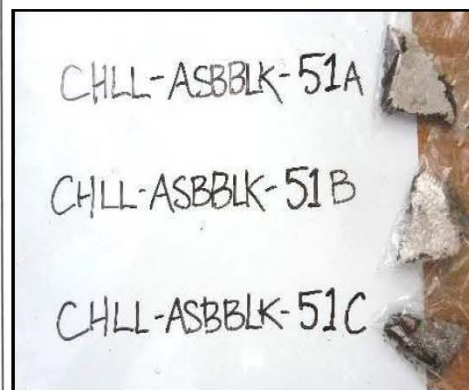
Describe Targeted Feature:  
SEVERAL PIECES OF DENSE GRAY MINERAL-LIKE INSULATING BOARD WERE FOUND IN SEVERAL LOCATIONS RANGING IN SIZE 18"x36", 12"x12", AND 8"x2"; MATERIAL WAS 2-3" THICK WITH SOME HOLES AND METAL BRACKETS AFFIXED TO THE SURFACE, POSSIBLE ELECTRICAL APPLICATION?

MATERIAL IS WEATHERED AND DAMAGED, BUT NOT FLUABLE. POTENTIAL RISKS TO INHALATION WOULD BE PRESENT TO WORKERS AND VISITORS IF THE MATERIAL WAS DAMAGED OR PULVERIZED

MATERIAL IS DENSE AND RELATIVELY RESILIENT.

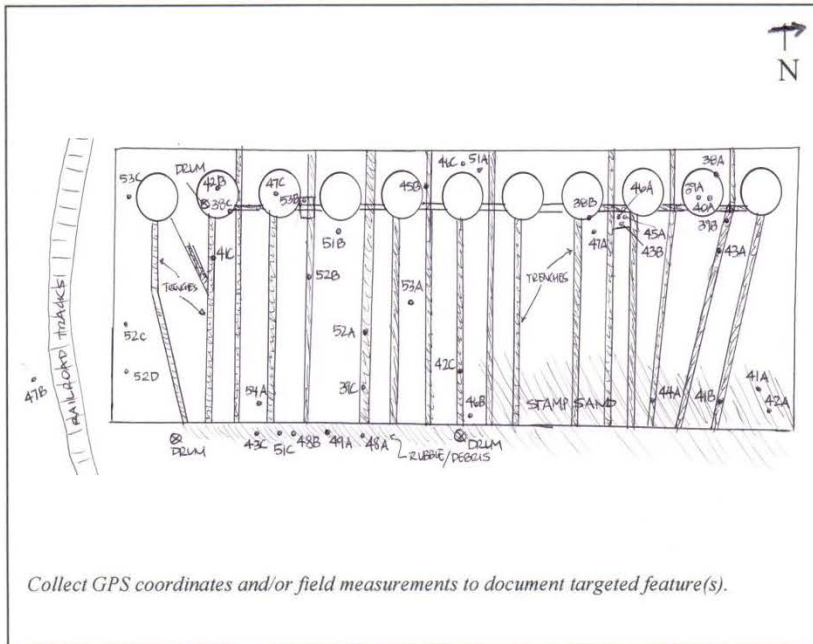
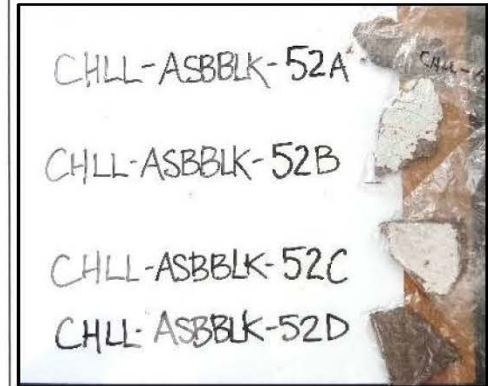
WHITE COATED PAPER BOARD, SIMILAR TO FIBER BOARD BUT NOT AS THICK, OCCASIONAL RED OR BLUE BACKING ON OBSERVED MATERIALS. GENERALLY OBSERVED ACROSS THE FOUNDATION/FLOOR BUT LIKELY MORE CONCENTRATED AT THE SOUTH END OF THE MILL.

MATERIAL IS WEATHERED, DAMAGED, AND RELIABLE POSING A POTENTIAL INHALATION RISK TO WORKERS AND VISITORS; THE MATERIAL IS PAPERLIKE AND SUSCEPTIBLE TO CONTINUED

**Other Relevant Below and Above Ground Features (Conduit, Drainage Swales, Culverts):** DEGRADATION BY WIND AND WATER

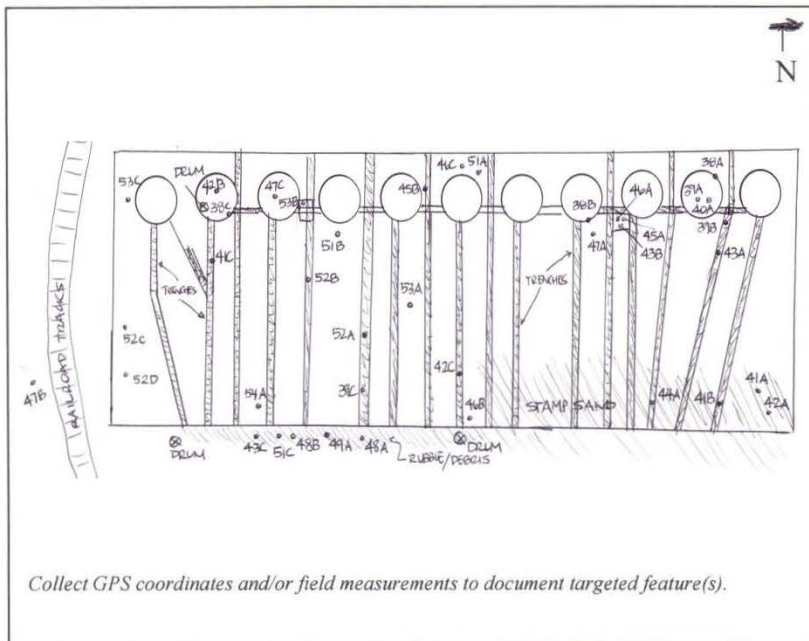
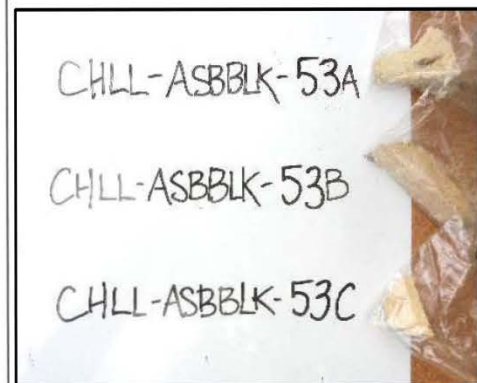
MATERIAL IS DAMAGED AND WEATHERED, BUT GENERALLY NOT FRIABLE, MAY POSE POTENTIAL INHALATION RISK TO WORKERS OR VISITORS IF DAMAGED OR FRIABLE.

FRAGMENTS OF MATERIAL MAY BE FOUND IN EARTHEN BRIMS AND SURROUNDING THE STAMP MILL AREA AS WELL AS TRENCHES IN THE STAMP MILL FLOOR.

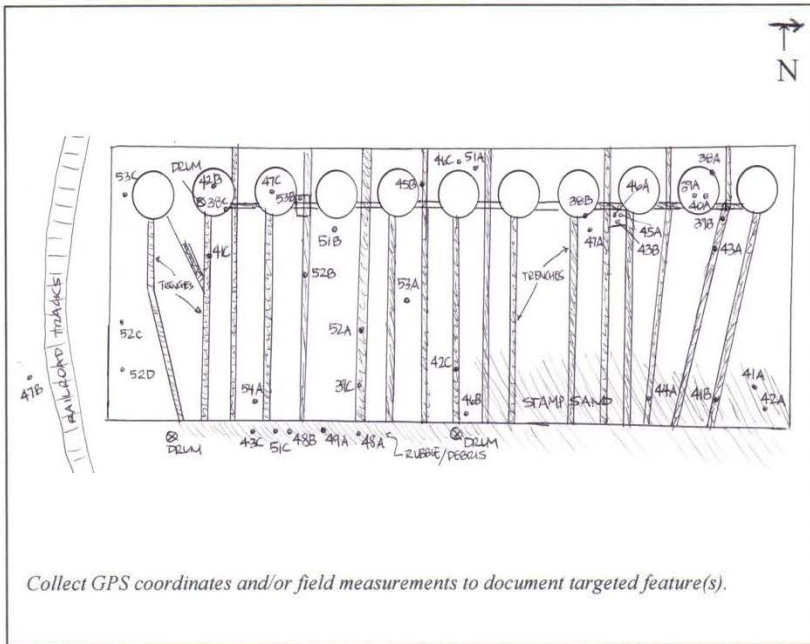
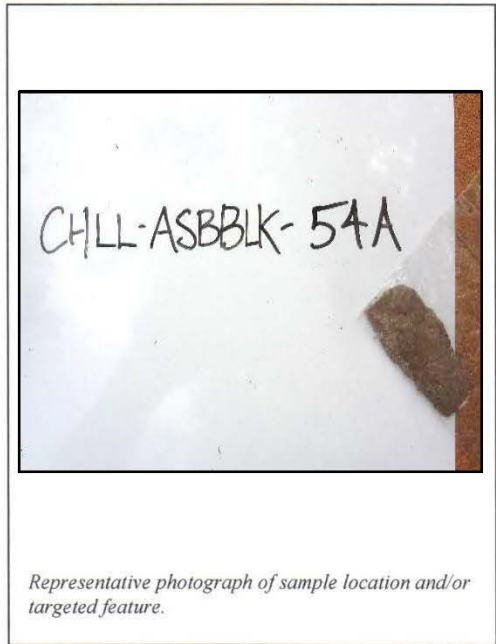
GRAYISH WHITE FLOORING PASTER, APPEARS TO BE A VENEER OVER UNDERLYING CONCRETE, OBSERVED IN THE SOUTH HALF OF THE STAMP MILL FLOOR

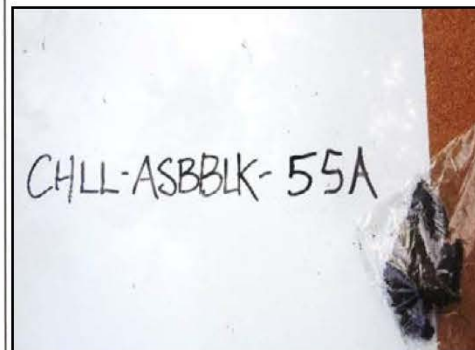
THIS MATERIAL IS LOCATED IN THE OPERATING PORTION OF THE HISTORICAL MUSEUM, ACCESSIBLE BY VISITORS, WORKERS, AND TREE PASSERS

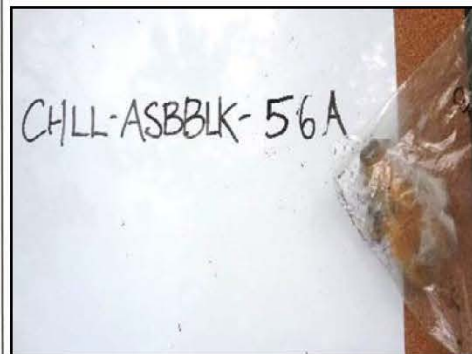
THIS MATERIAL IS LOCATED IN THE OPERATING PORTION OF THE HISTORICAL MUSEUM, ACCESSIBLE BY VISITORS, WORKERS, AND TRESS PASSELS

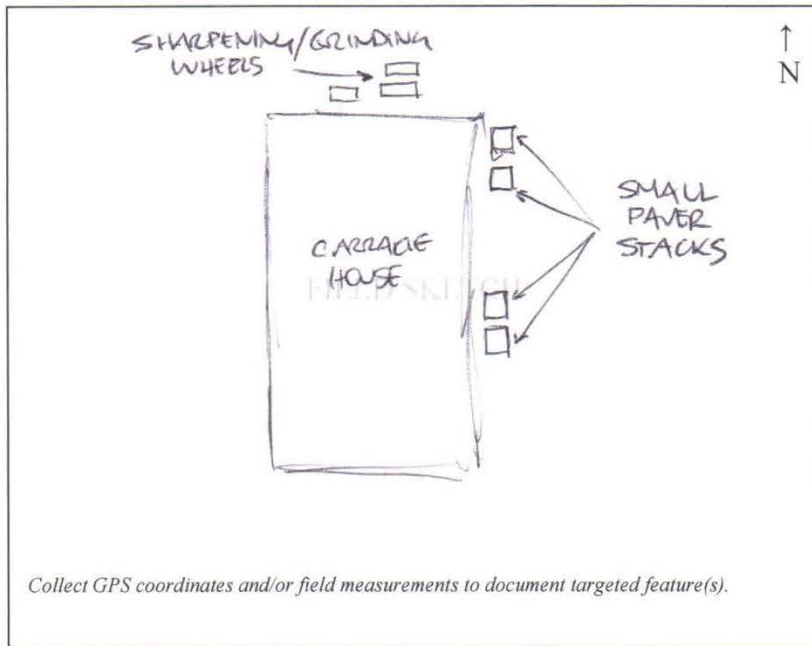
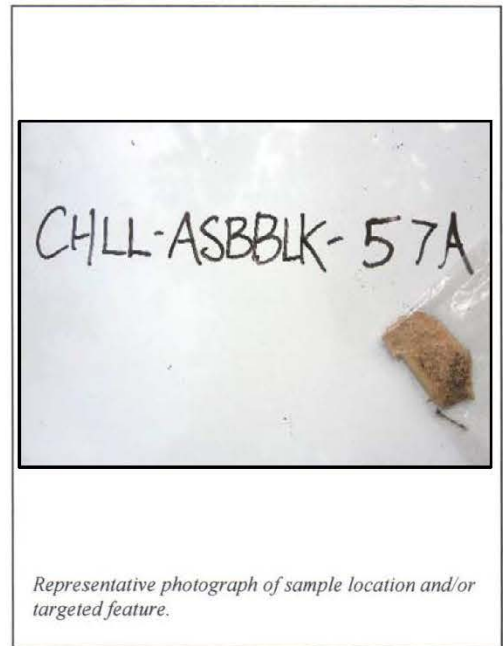
SAMPLE COLLECTED FROM A BROKEN FRAGMENT ON THE GROUND - NO PAVES WERE DAMAGED

DAMAGE OR PULVERIZATION OF THE MATERIAL COULD POSE AN INHALATION RISK TO VISITORS AND WORKERS.

THESE MATERIAL STACKS ARE LOCATED IN THE UPPER PORTION OF THE PROPERTY, ACCESSIBLE BY VISITORS AND WORKERS

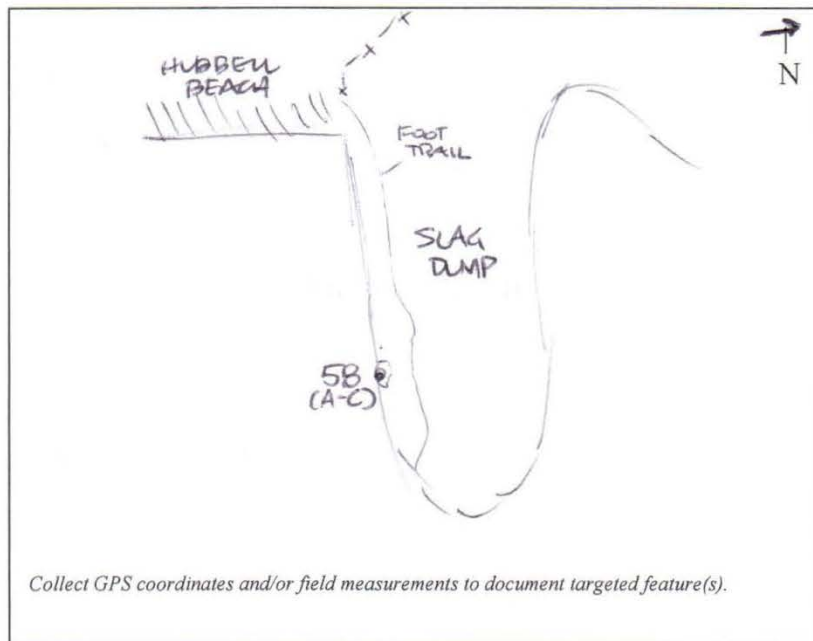
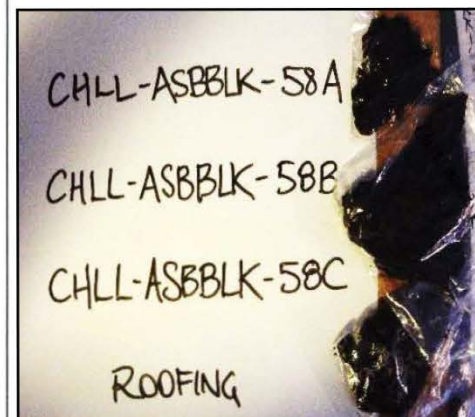
MATERIAL IS WEATHERED AND FRIABLE, THE ASPHALTIC NATURE OF THE MATERIAL MAKES IT SOMEWHAT COHESIVE; EXPOSURE RISKS ARE POTENTIALLY RELATED TO INHALATION AND DIRECT CONTACT HAZARDS

ACCESS TO THE LOCATION IS DIFFICULT, DOWN A VERY STEEP EMBANKMENT, MATERIAL IS PROTRUDING FROM THE HILLSIDE ROUGHLY 3-5' ABOVE THE LAKE LEVEL

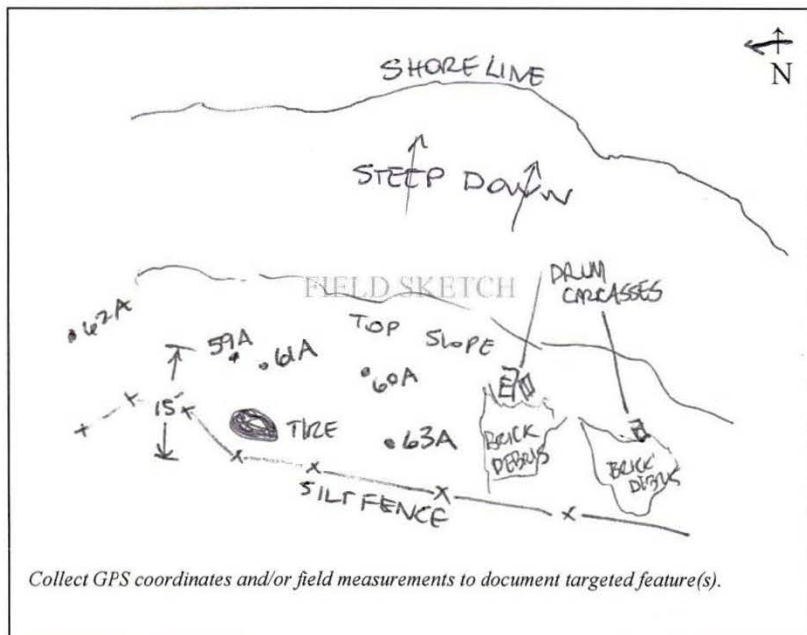
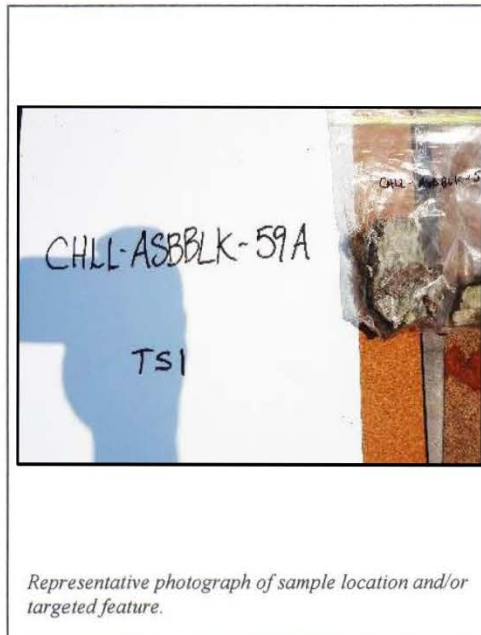
MATERIALS ARE LOCATED ON A RELATIVELY GENTLE SLOPE EAST OF THE EXISTING CAP AND WEST OF THE STEEP SLOPE DOWN TO THE SHORELINE OF TORCH LAKE; SEVERAL DRUM CARCASSES EXPOSED

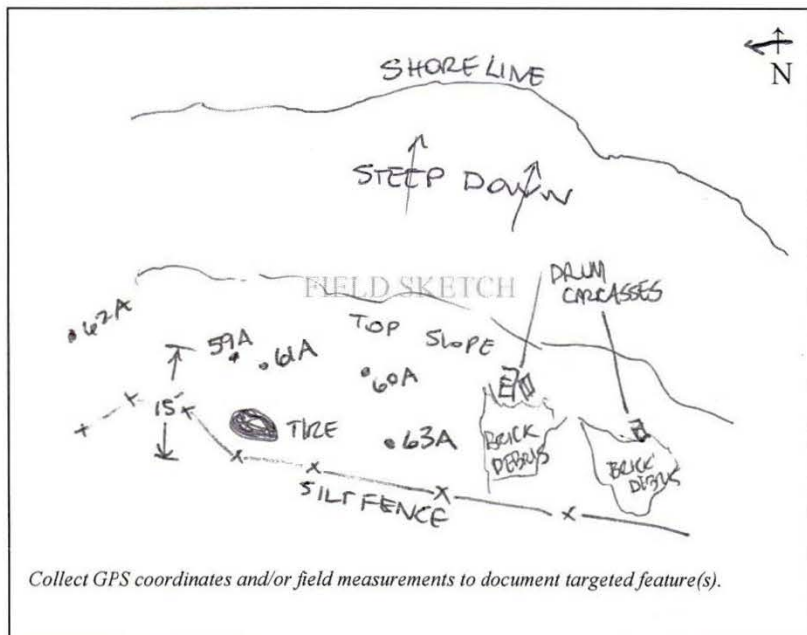
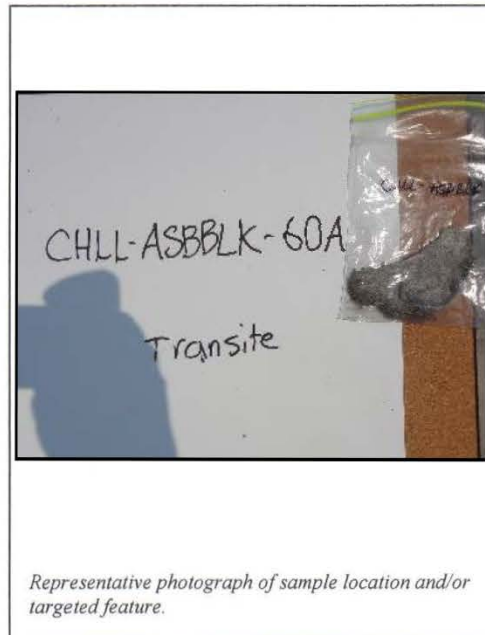
MATERIALS ARE LOCATED ON A RELATIVELY GENTLE SLOPE EAST OF THE EXISTING CAP AND WEST OF THE STEEP SLOPE DOWN TO THE SHORELINE OF TORCH LAKE; SEVERAL DRUM CARCASSES EXPOSED

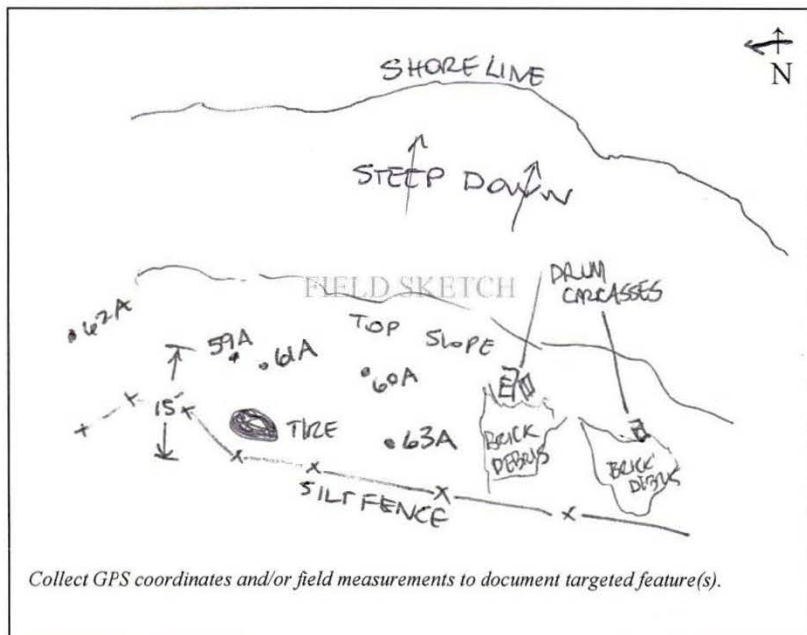
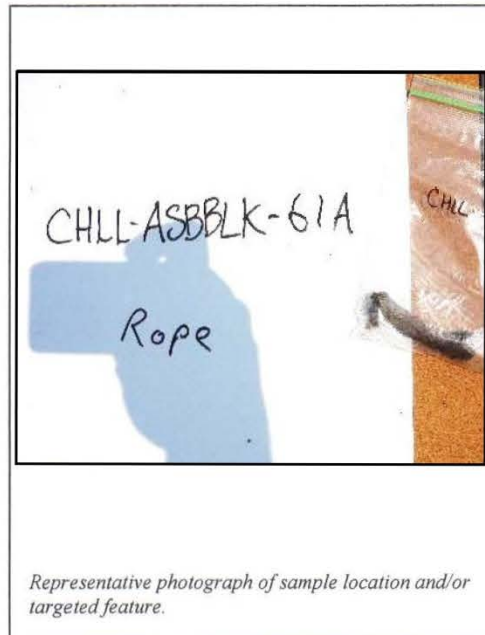
MATERIALS ARE LOCATED ON A RELATIVELY GENTLE SLOPE EAST OF THE EXISTING CAP AND WEST OF THE STEEP SLOPE DOWN TO THE SHORELINE OF TORCH LAKE; SEVERAL DRUM CARCASSES EXPOSED

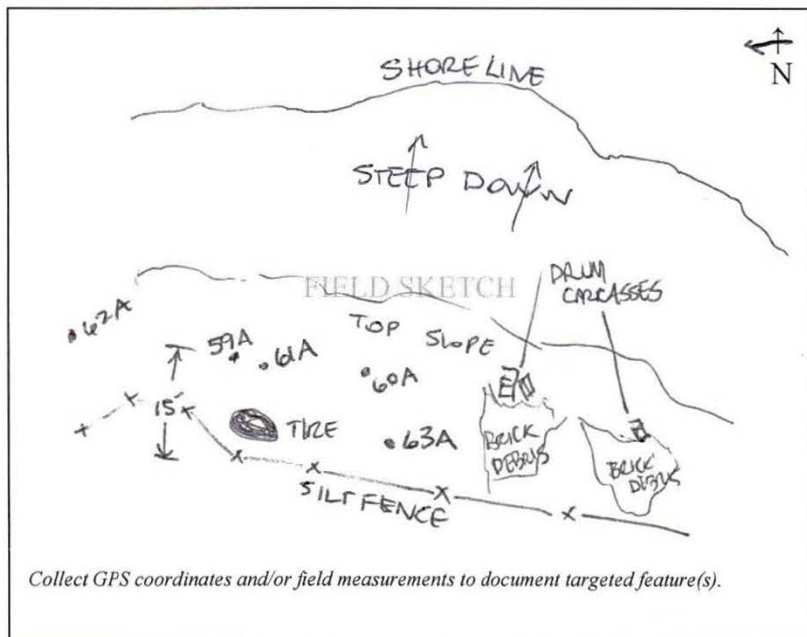
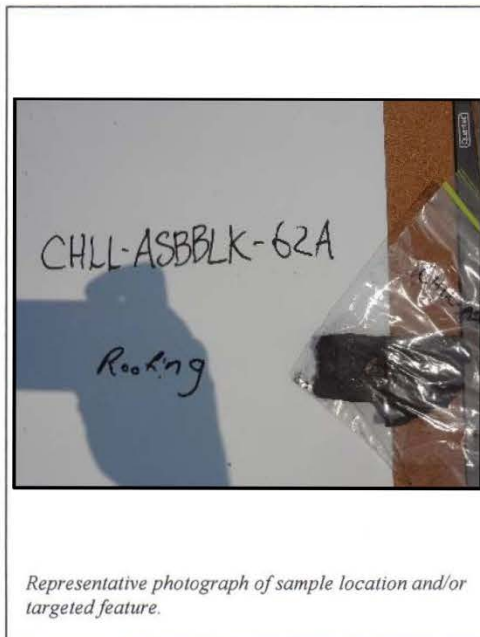
MATERIALS ARE LOCATED ON A RELATIVELY GENTLE SLOPE EAST OF THE EXISTING CAP AND WEST OF THE STEEP SLOPE DOWN TO THE SHORELINE OF TORCH LAKE; DRUM CARCASSES ARE PRESENT IN THE VICINITY

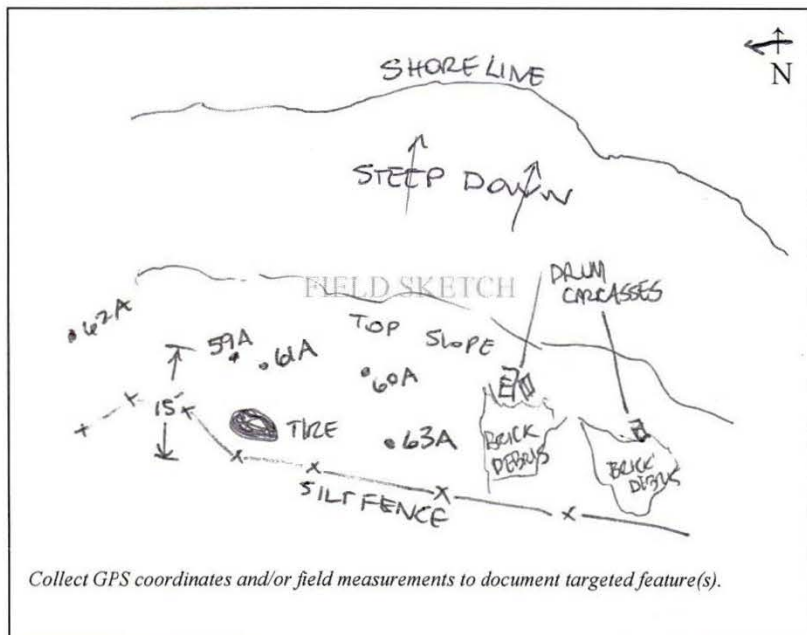
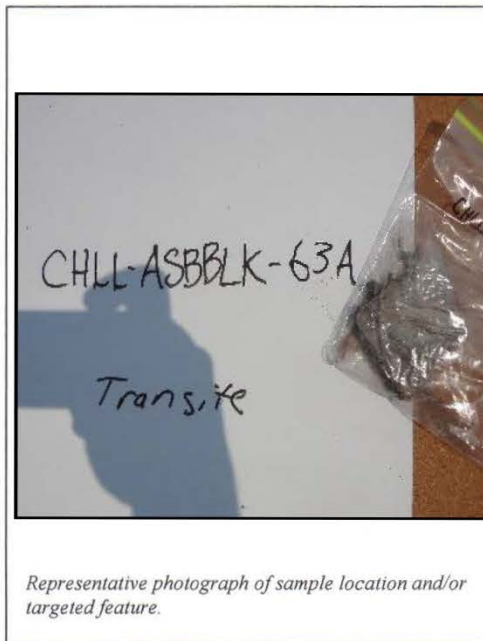
MATERIALS ARE LOCATED ON A RELATIVELY GENTLE SLOPE EAST OF THE EXISTING CAP AND WEST OF THE STEEP SLOPE DOWN TO THE SHORELINE OF TORCH LAKE; DRUM CARCASSES ARE PRESENT IN THE VICINITY
