**ABANDONED MINING WASTES TORCH LAKE NON-SUPERFUND SITE  
CALUMET AND HECLA - LAKE LINDEN OPERATIONS  
TARGETED INSPECTION FORM**

Inspection Date: 10/14/14 Feature Identification/Name COAL DOCK SUBSTATION  
Geographic Area: HUBBEL COAL DOCK Property Identification Number: 014.307.001-25

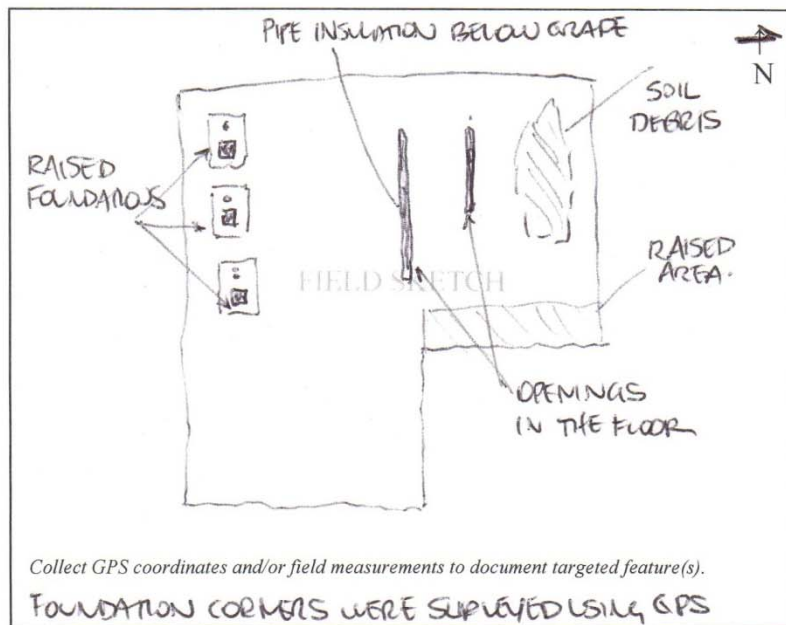
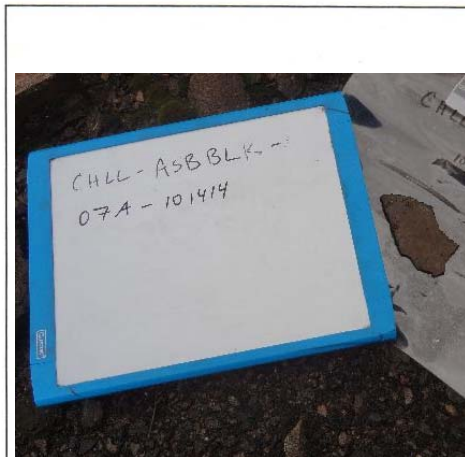
RAISED SLAB, APPROX 3-4' ABOVE GRADE, HOLLOW BENEATH SLAB, VOIDS LOCATED IN FLOOR, METAL DEBRIS NORTHEAST CORNER, PIPING AND ELECTRICAL CONDUIT PRESENT BELOW SLAB

MATERIALS ARE SPREAD ACROSS SLAB SURFACE, POTENTIAL EXPOSURE TO TRESPASSERS DUE TO SACM AND PHYSICAL HAZARDS/VOIDS

ROOFING MATERIAL - DAMAGED  
CHL-ASBBLK08A-C)-101414  
SUSPECT TRANSITE - THICKER BROWN 1/4"  
CHL-ASBBLK09(A-C)-101414

SUSPECT TRANSITE - THIN GRAY 1/16"

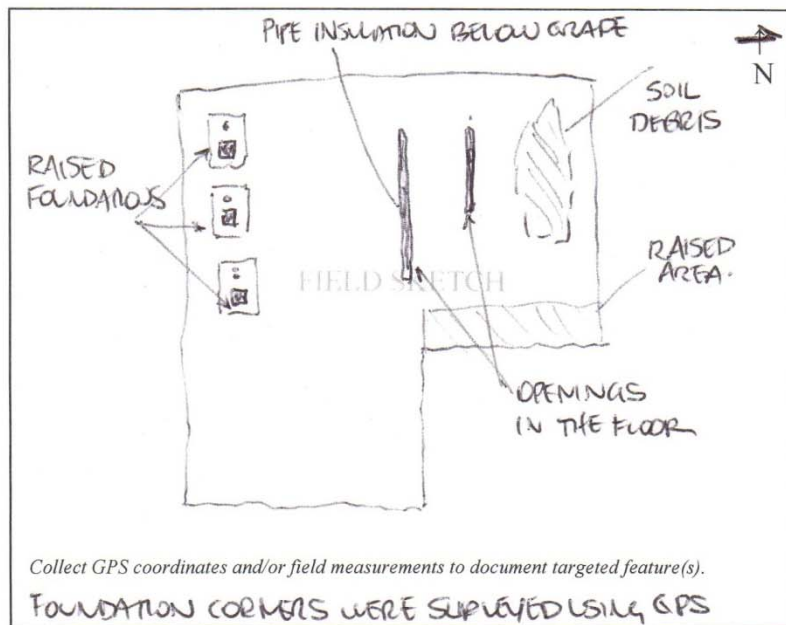
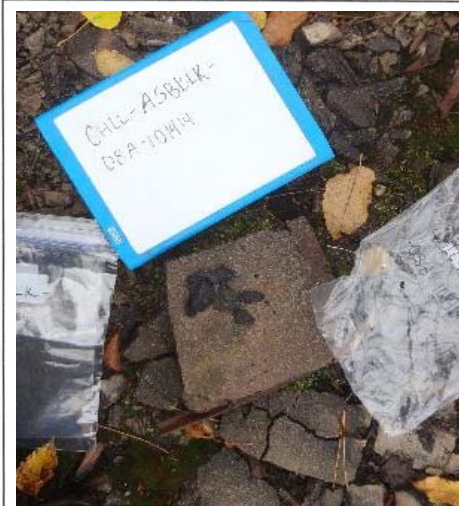
Inspection Date: 10/14/14 Feature Identification/Name COAL DOCK SUBSTATION  
Geographic Area: HUBBEL COAL DOCK Property Identification Number: 014.307.001-25

MATERIALS ARE SPREAD ACROSS SLAB SURFACE, POTENTIAL EXPOSURE TO TRESPASSERS DUE TO SACM AND PHYSICAL HAZARDS/VOIDS

ROOFING MATERIAL - DAMAGED  
CHL-ASBLK08A-C)-101414  
SUSPECT TRANSITE - THICKER BROWN 1/4"  
CHL-ASBLK09(A-C)-101414

SUSPECT TRANSITE - THIN GRAY 1/16"

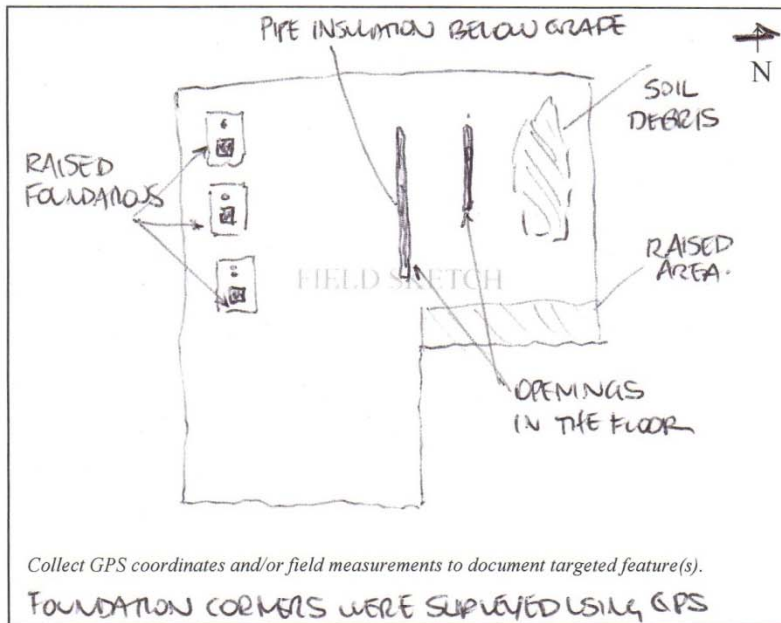
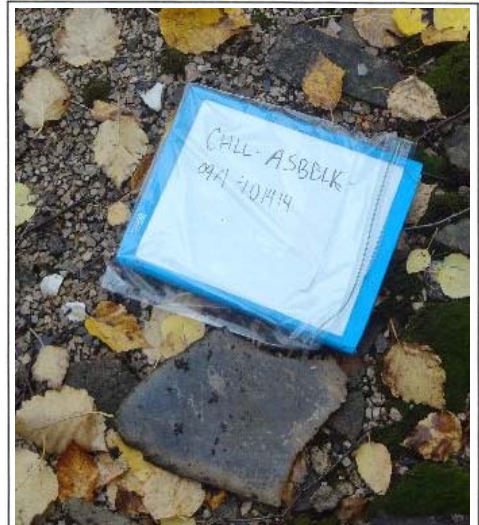
Inspection Date: 10/14/14 Feature Identification/Name COAL DOCK SUBSTATION

MATERIALS ARE SPREAD ACROSS SLAB SURFACE, POTENTIAL EXPOSURE TO TRESPASSERS DUE TO SACM AND PHYSICAL HAZARDS/VOIDS

ROOFING MATERIAL - DAMAGED  
CHL-ASBBLK-08A-C-101414  
SUSPECT TRANSITE - THICKER BROWN 1/4"  
CHL-ASBBLK-09A-C-101414

SUSPECT TRANSITE - THIN GRAY 1/16"

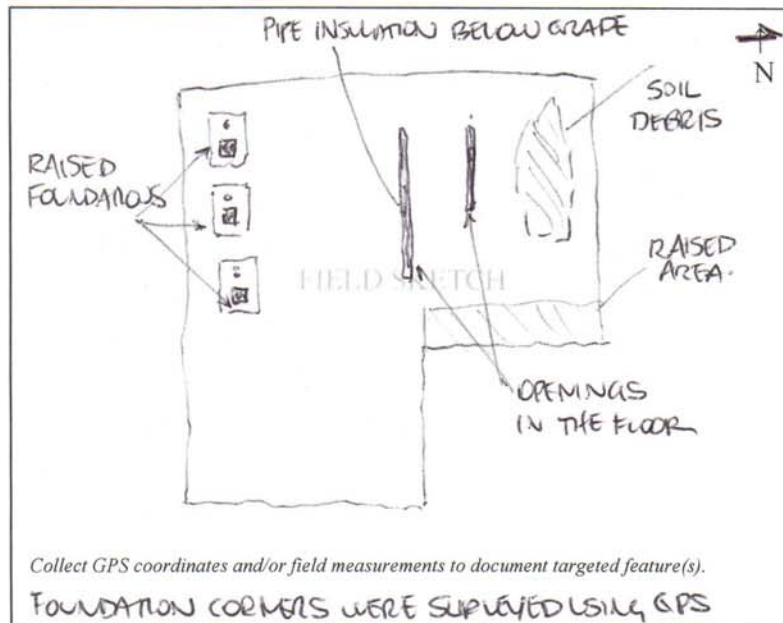
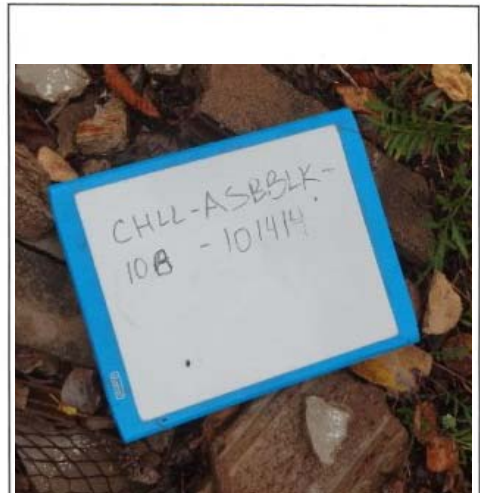
Inspection Date: 10/14/14 Feature Identification/Name COAL DOCK SUBSTATION

MATERIALS ARE SPREAD ACROSS SLAB SURFACE, POTENTIAL EXPOSURE TO TRESPASSERS DUE TO SACM AND PHYSICAL HAZARDS/VOIDS

ROOFING MATERIAL - DAMAGED  
CHL-ASBBLK08A-C)-101414  
SUSPECT TRANSITE - THICKER BROWN 1/4"  
CHL-ASBBLK09(A-C)-101414

SUSPECT TRANSITE - THIN GRAY 1/16"

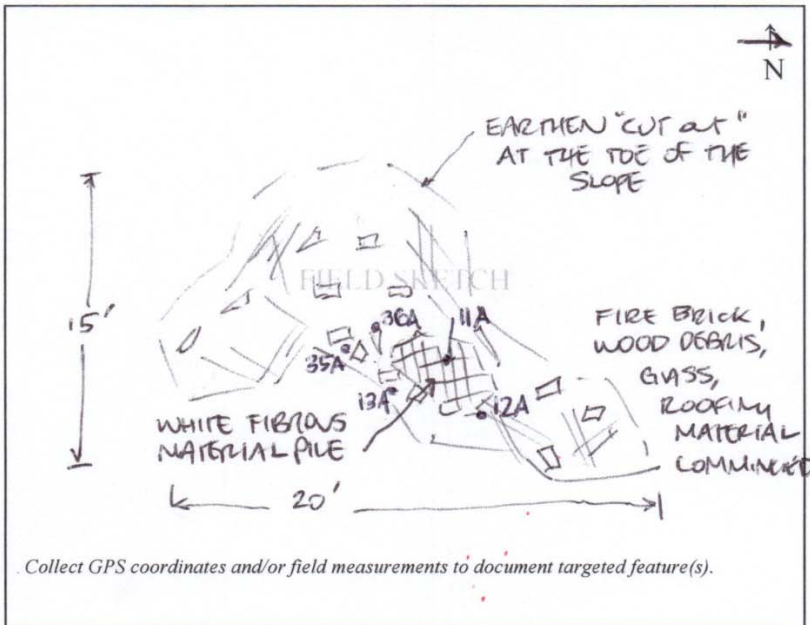
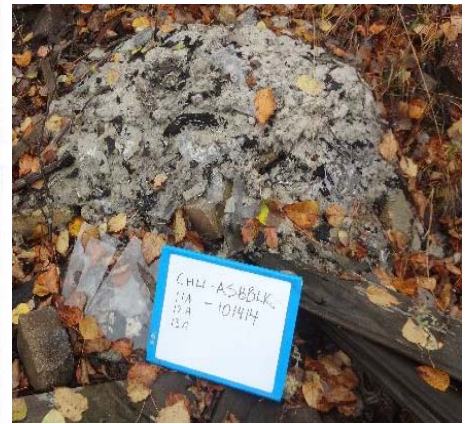
Inspection Date: 10/14/14 Feature Identification/Name COMMINGLED DEBRIS PILE

DEBRIS PILE ALONG THE HILLSIDE INCLUDES BRICK AND BUILDING MATERIALS, WOOD DEBRIS WITH A WHITISH GREY FIBROUS PILE IN THE MIDDLE; MATERIAL IS DAMAGED AND FRAGILE; POTENTIAL EXPOSURE TO TRESPASSERS DUE TO SACM

**Other Relevant Below and Above Ground Features (Conduit, Drainage Swales, Culverts):** AND PHYSICAL HAZARDS

CHU-ASBBLK35A-101514: PINK FIRE BRICK  
CHU-ASBBLK36A-101514: YELLOWISH ORANGE FIRE BRICK  
SAMPLES COLLECTED AT 1030

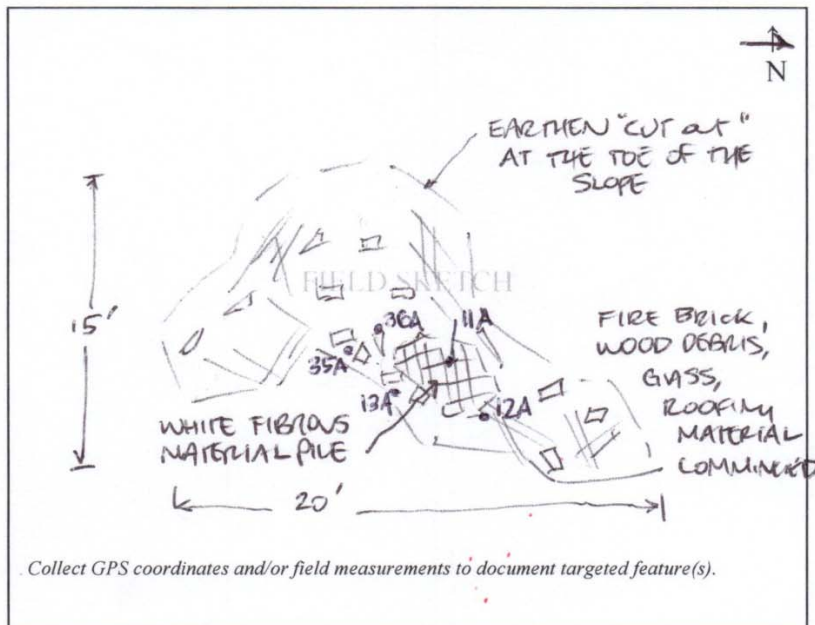
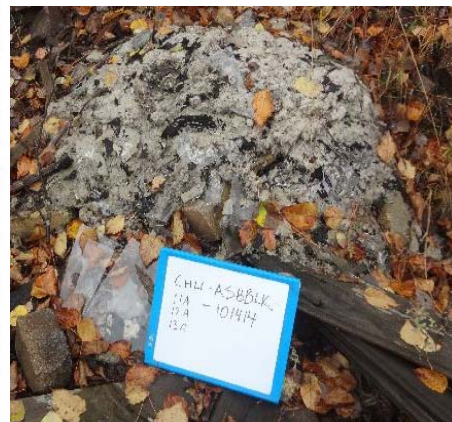
Inspection Date: 10/14/14 Feature Identification/Name COMMINGLED DEBRIS PILE

DEBRIS PILE ALONG THE HILLSIDE INCLUDES BRICK AND BUILDING MATERIALS, WOOD DEBRIS WITH A WHITISH GREY FIBROUS PILE IN THE MIDDLE; MATERIAL IS DAMAGED AND FRAGILE; POTENTIAL EXPOSURE TO TRESPASSERS DUE TO SACM

**Other Relevant Below and Above Ground Features (Conduit, Drainage Swales, Culverts):** AND PHYSICAL HAZARDS

CHL-ASBBK35A-101514: PINK FIRE BRICK  
CHL-ASBBK36A-101514: YELLOWISH ORANGE FIRE BRICK  
SAMPLES COLLECTED AT 1030

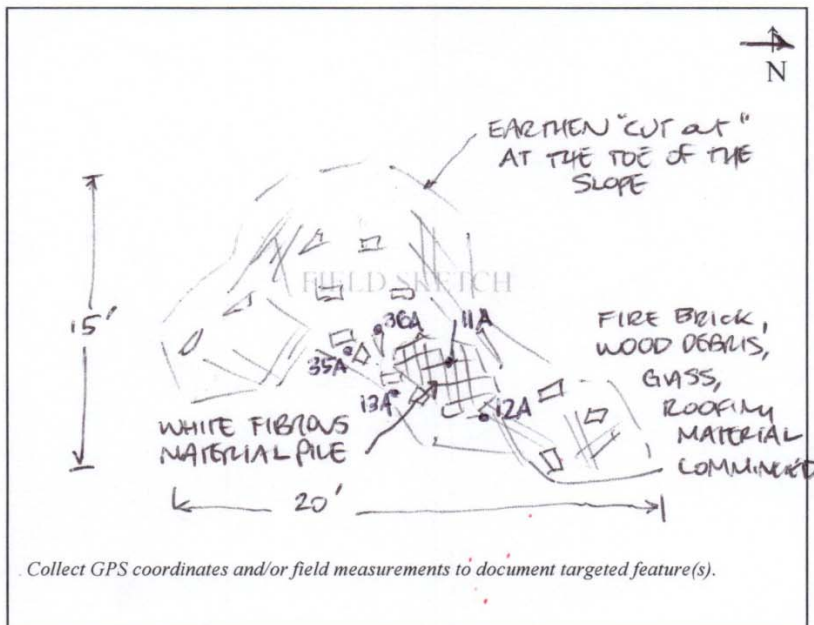
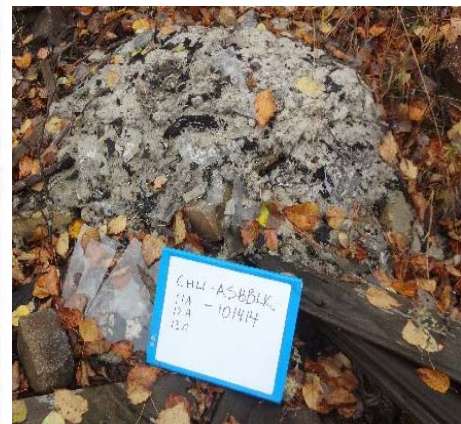
Inspection Date: 10/14/14 Feature Identification/Name COMMINGLED DEBRIS PILE

DEBRIS PILE ALONG THE HILLSIDE INCLUDES BRICK AND BUILDING MATERIALS, WOOD DEBRIS WITH A WHITISH GREY FIBROUS PILE IN THE MIDDLE; MATERIAL IS DAMAGED AND FRAGILE; POTENTIAL EXPOSURE TO TRESPASSERS DUE TO SACM

**Other Relevant Below and Above Ground Features (Conduit, Drainage Swales, Culverts):** AND PHYSICAL HAZARDS

CHL-ASBBLK35A-101514: PINK FIRE BRICK  
CHL-ASBBLK36A-101514: YELLOWISH ORANGE FIRE BRICK  
SAMPLES COLLECTED AT 1030

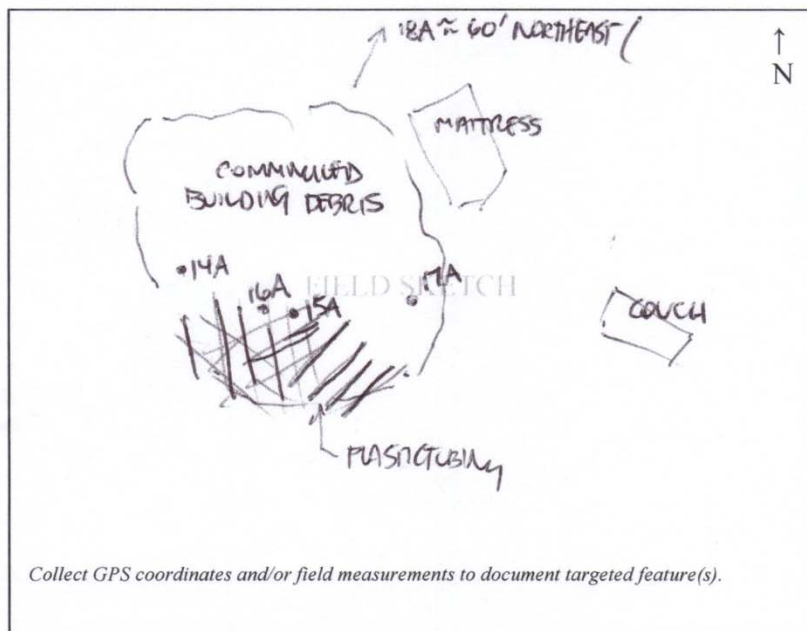
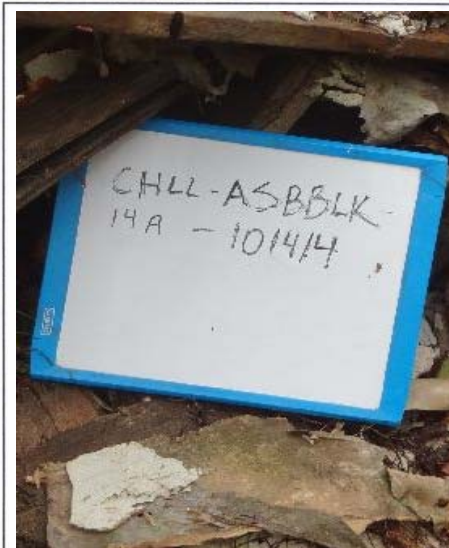
Inspection Date: 10/14/14 Feature Identification/Name HOUSEHOLD DEBRIS PILE

THE PASSERS ARE POTENTIALLY AT RISK DUE TO EXPOSED WEATHERED MATERIALS AND PHYSICAL HAZARDS  
LESS THAN 10 FT OF EACH MATERIAL (14A-18A) - APPROXIMATELY

CHLL-ASBBLK18A-101414 - BLACK CANVAS MATERIAL - LOCATED APPROXIMATELY 60' NORTHEAST OF THE DEBRIS PILE.  
SAMPLE COLLECTED AT 1115

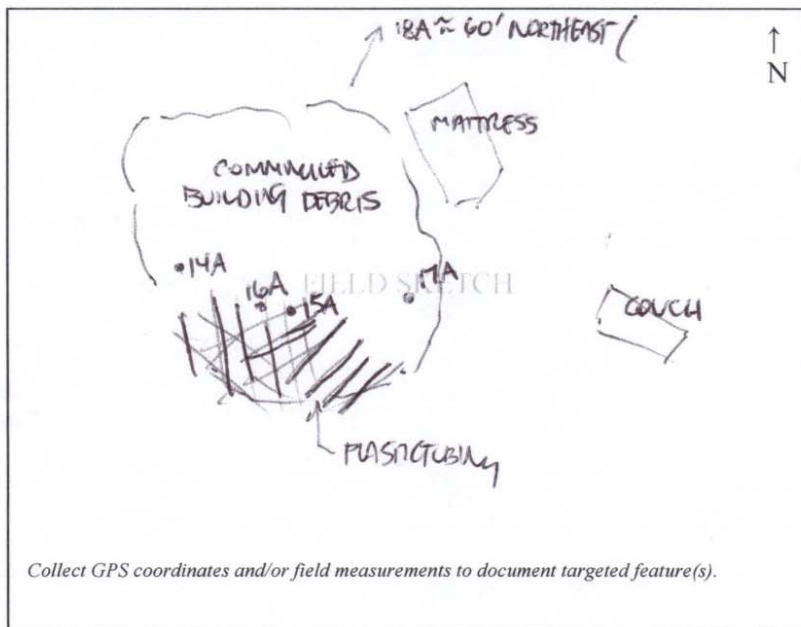
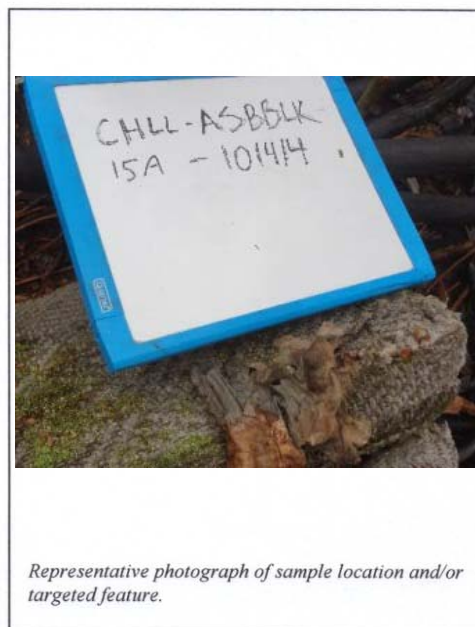
Inspection Date: 10/14/14 Feature Identification/Name: HOUSEHOLD DEBRIS PILE

THE SPASSERS ARE POTENTIALLY AT RISK DUE TO EXPOSED WEATHERED MATERIALS AND PHYSICAL HAZARDS  
LESS THAN 10 ft OF EACH MATERIAL (14A-18A) - APPROXIMATELY

CHL-ASBBK-18A-101414 - BLACK CANVAS MATERIAL - LOCATED APPROXIMATELY 60' NORTHEAST OF THE DEBRIS PILE -  
SAMPLE COLLECTED AT 1115

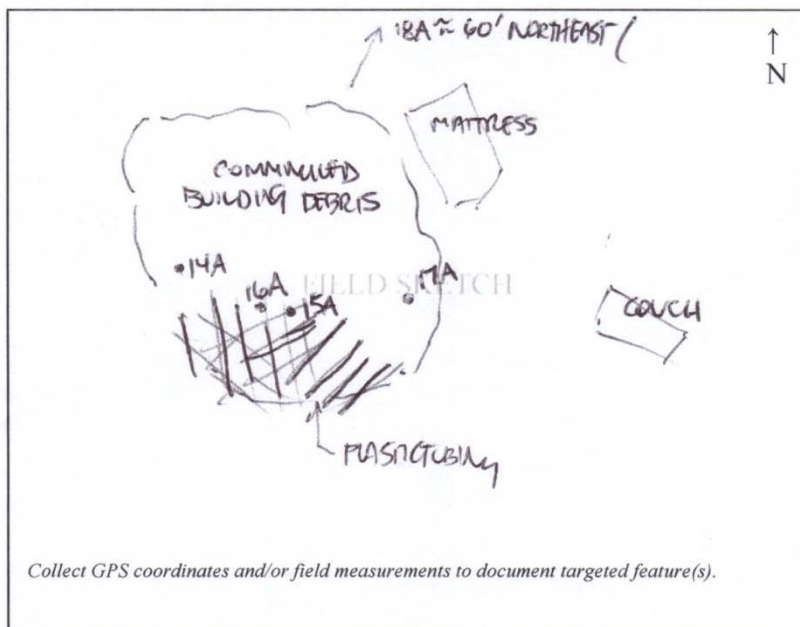
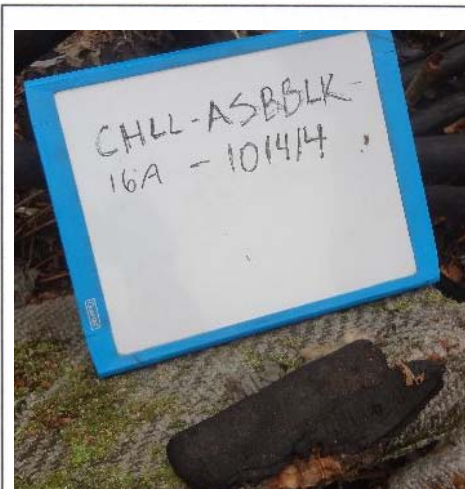
Inspection Date: 10/14/14 Feature Identification/Name: HOUSEHOLD DEBRIS PILE

THREASPASSERS ARE POTENTIALLY AT RISK DUE TO EXPOSED WEATHERED MATERIALS AND PHYSICAL HAZARDS  
LESS THAN 10 ft OF EACH MATERIAL (14A-18A) - APPROXIMATELY

CHLL-ASBBUK-18A-10/14/14 - BLACK CANVAS MATERIAL - LOCATED APPROXIMATELY 60' NORTHEAST OF THE DEBRIS PILE.  
SAMPLE COLLECTED AT 11:15

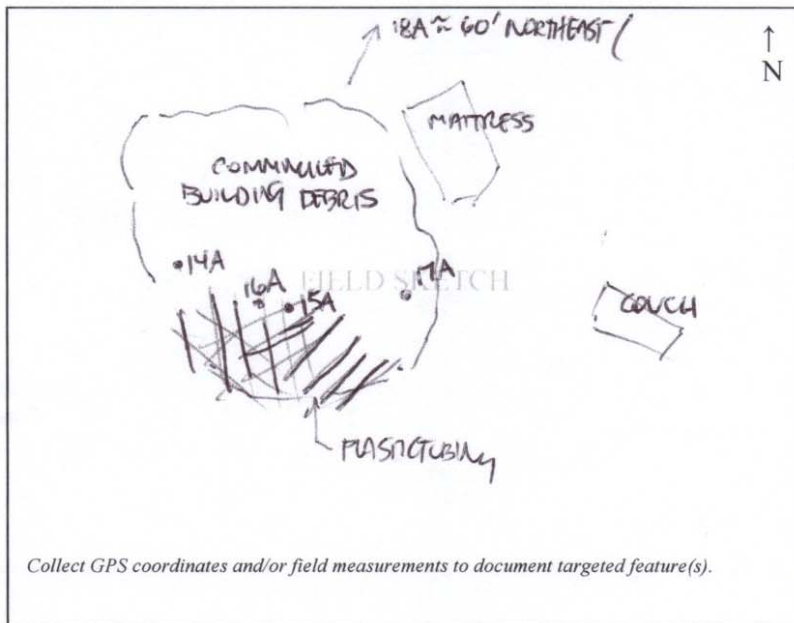
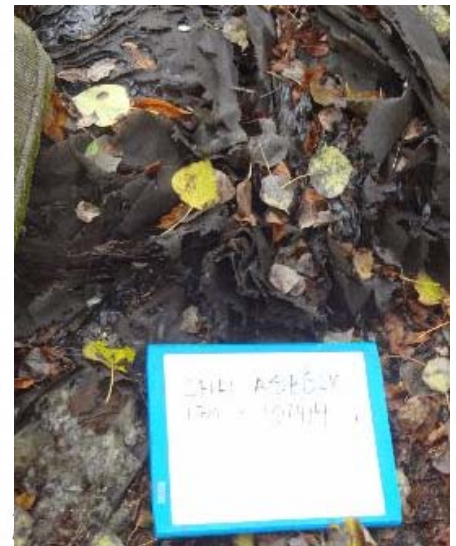
Inspection Date: 10/14/14 Feature Identification/Name: HOUSEHOLD DEBRIS PILE

THREASPASSERS ARE POTENTIALLY AT RISK DUE TO EXPOSED WEATHERED MATERIALS AND PHYSICAL HAZARDS  
10 ft OF EACH MATERIAL (14-18A) - APPROXIMATELY

CHL-ASBBLK18A-101414 - BLACK CANVAS MATERIAL - LOCATED APPROXIMATELY 60' NORTHEAST OF THE DEBRIS PILE.  
SAMPLE COLLECTED AT 1115

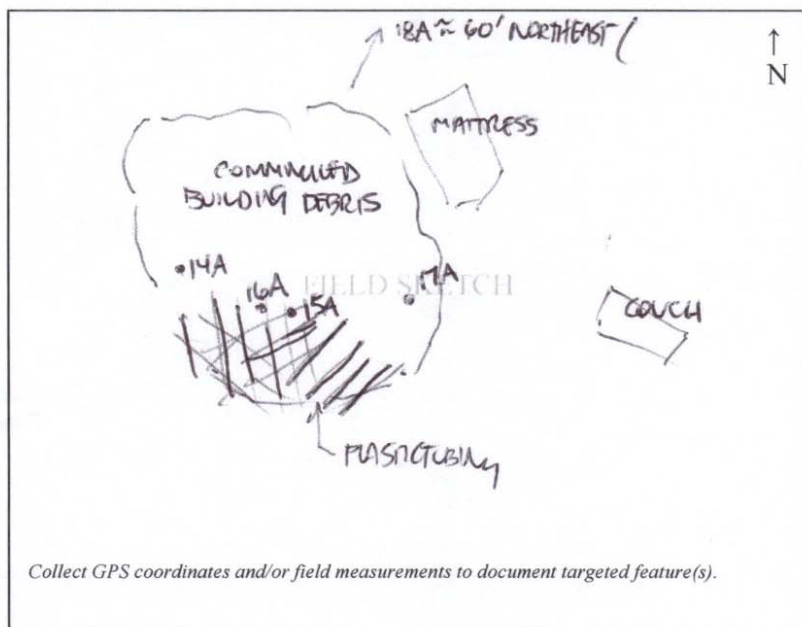
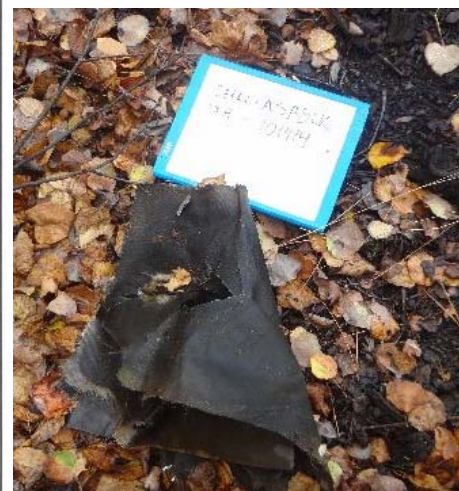
Inspection Date: 10/14/14 Feature Identification/Name: HOUSEHOLD DEBRIS PILE

THESPASSERS ARE POTENTIALLY AT RISK DUE TO EXPOSED WEATHERED MATERIALS AND PHYSICAL HAZARDS  
LESS THAN 10 ft OF EACH MATERIAL (14-18A) - APPROXIMATELY

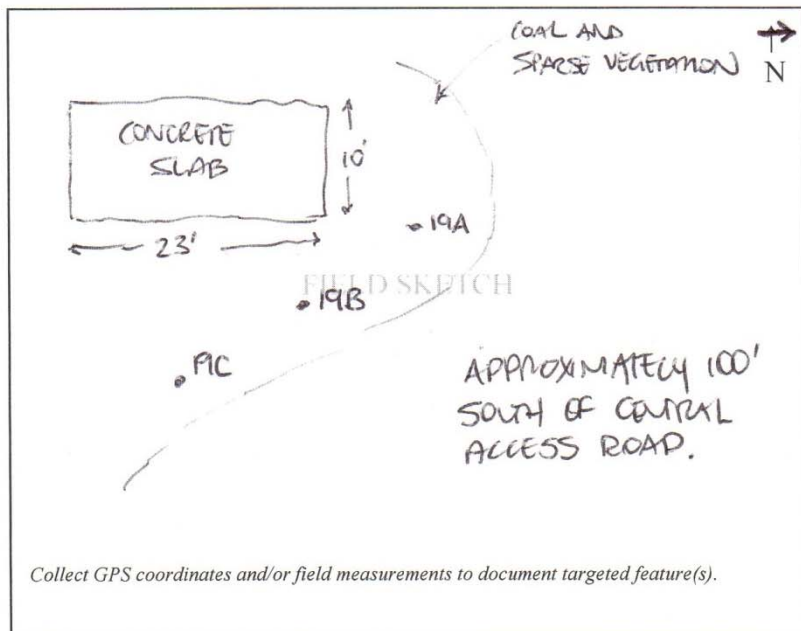
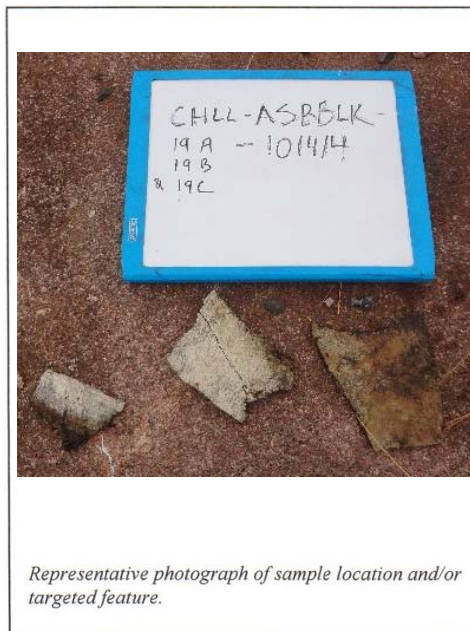
Inspection Date: 10/14/14 Feature Identification/Name: CONCRETE SLAB - TRANSITE FRAGMENTS

TRANSITE FRAGMENTS DISTRIBUTED ACROSS THE GROUND SURFACE, PRIMARILY ON THE NORTH AND EAST SIDE OF THE FOUNDATION, COAL AND CINDERS ON THE GROUND SURFACE

CHLL-ASBBUK19A-10/14/14 - SUSPECT TRANSITE, DAMAGED, FRIABLE SAMPLES COLLECTED  
CHLL-ASBBUK19B-10/14/14 - SUSPECT TRANSITE, DAMAGED, FRIABLE AT 1245.  
CHLL-ASBBUK19C-10/14/14 - SUSPECT TRANSITE, DAMAGED, FRIABLE

**Other Relevant Below and Above Ground Features (Conduit, Drainage Swales, Culverts):** DAMAGE TO THE MATERIAL AREA IS SUBJECT TO FLOODING, SIGNIFICANT RAIN COULD POTENTIALLY TRANSPORT DEBRIS

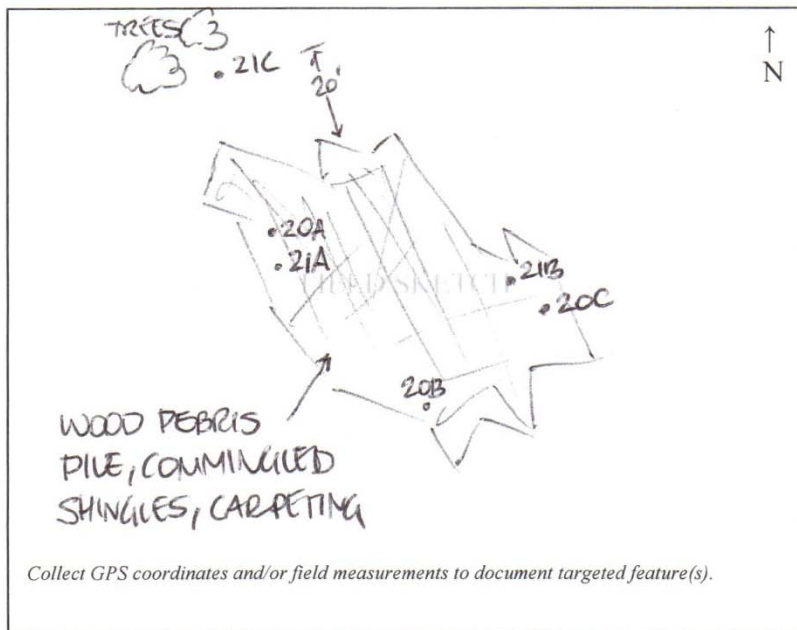
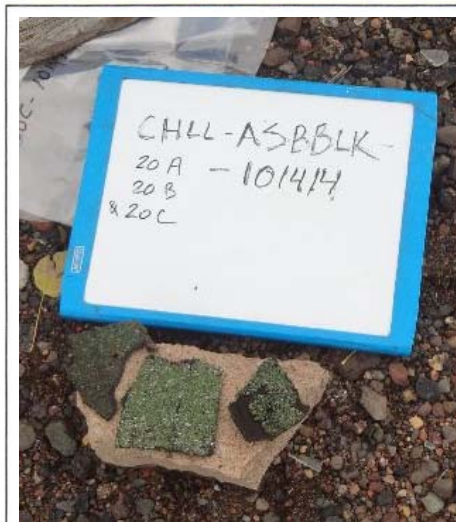
Inspection Date: 10/14/14 Feature Identification/Name BUILDING MATERIAL DEBRIS PILE

INSPECTION LOCATIONS SACM 13, SUSPECT Hg SWITCH, PILE OF WOODEN BOARDS AND BUILDING DEBRIS COMMINGLED DAMAGED SHINGLES, CARPETING AND FIXTURES

TRESPASSERS COULD BE AT RISK DUE TO DAMAGED SACM AND PHYSICAL HAZARDS ASSOCIATED WITH THE DEBRIS PILE. WIND AND WATER EROSION COULD POTENTIALLY BE FACTORS RELATED TO CONTAMINANT TRANSPORT

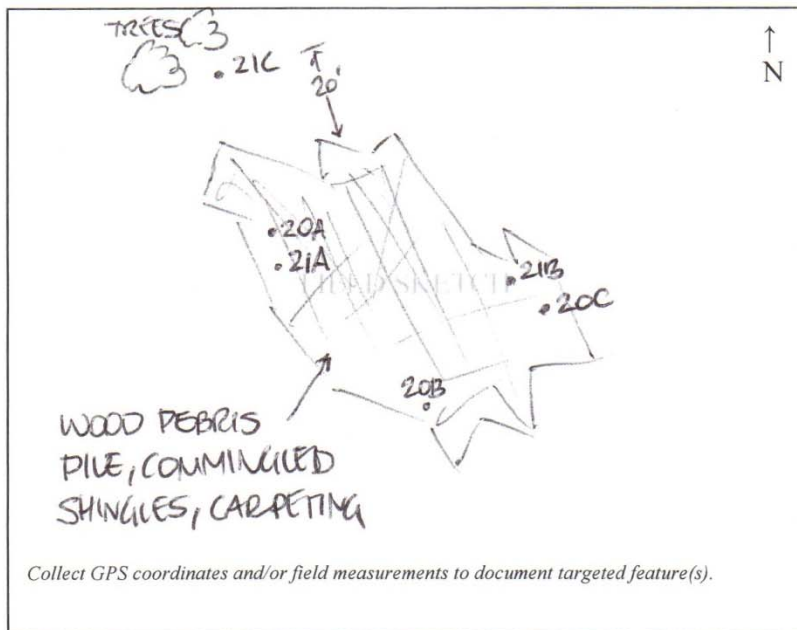
INSPECTION LOCATIONS SACM 13; SUSPECT Hg SWITCH; PILE OF WOODEN BOARDS AND BUILDING DEBRIS COMMINGLED DAMAGED SHINGLES, CARPETING AND FIXTURES

TRESPASSERS COULD BE AT RISK DUE TO DAMAGED SACM AND PHYSICAL HAZARDS ASSOCIATED WITH THE DEBRIS PILE. WIND AND WATER EROSION COULD POTENTIALLY BE FACTORS RELATED TO CONTAMINANT TRANSPORT

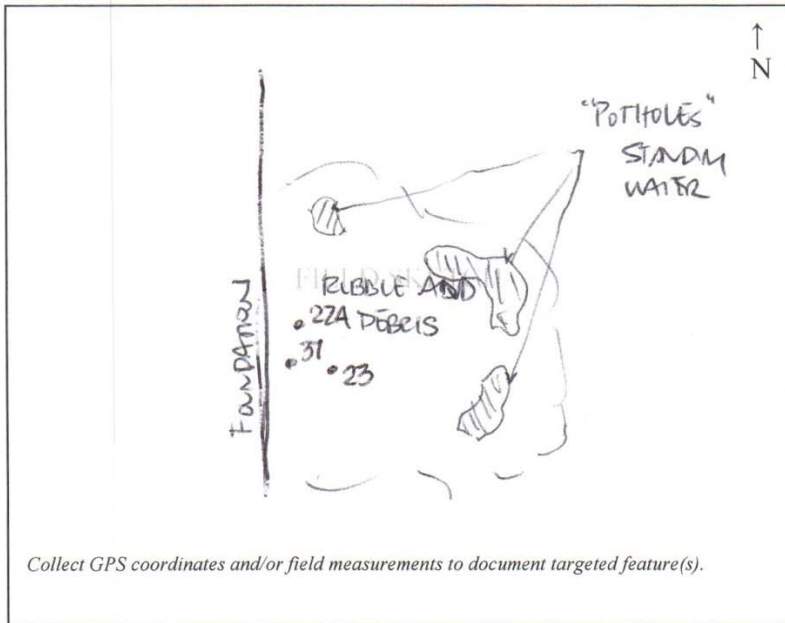
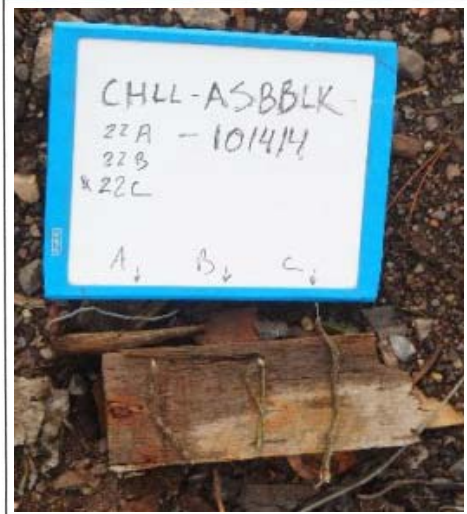
Inspection Date: 10/14/14 Feature Identification/Name: RESIDUAL PROCESS MATERIALS/  
SUSPECT BEN AREA.

**Potential Exposure Pathways (Ingestion, Inhalation, Direct Contact):** SAMPLES WERE COLLECTED AT 1440  
EXPOSURE PATHWAYS INCLUDE THE MIGRATION OF CONTAMINANTS FROM DAMAGED SACM AND CHEMICALLY CONTAMINATED MEDIA. WIND AND WATER EROSION COULD RESULT IN THE MIGRATION OF CONTAMINANTS

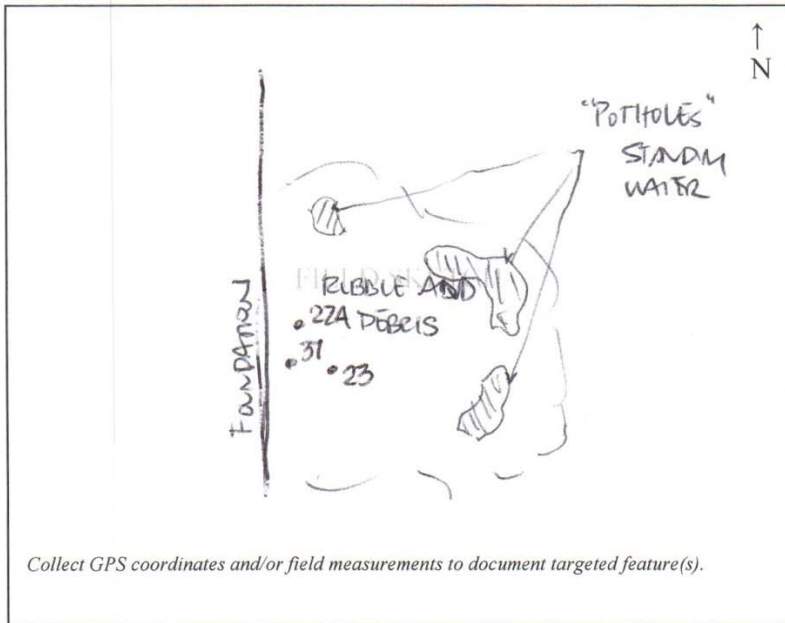
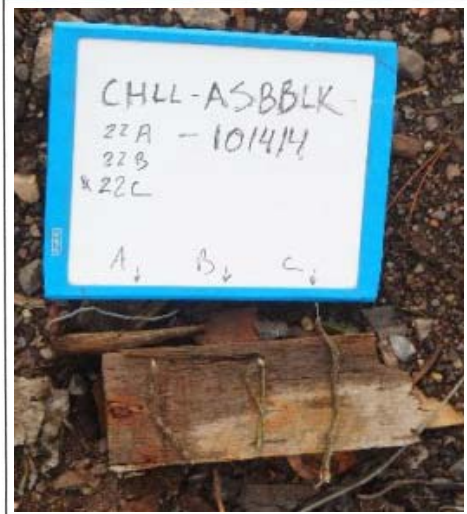
Inspection Date: 10/14/14 Feature Identification/Name: RESIDUAL PROCESS MATERIALS/  
SUSPECT BEN AREA.

EXPOSURE PATHWAYS INCLUDE THE MIGRATION OF CONTAMINANTS FROM DAMAGED SACM AND CHEMICALLY CONTAMINATED MEDIA. WIND AND WATER EROSION COULD RESULT IN THE MIGRATION OF CONTAMINANTS

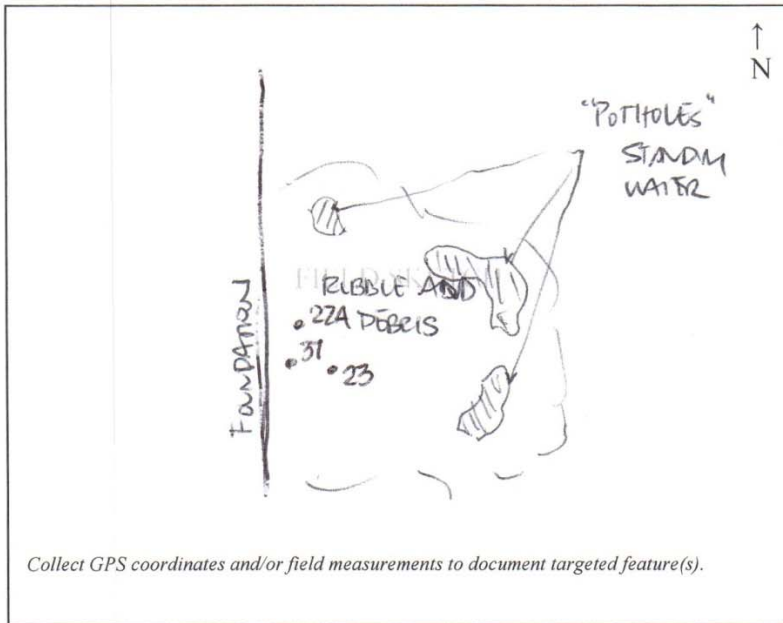
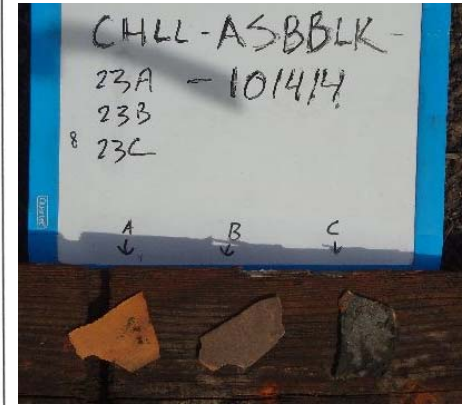
Inspection Date: 10/14/14 Feature Identification/Name: RESIDUAL PROCESS MATERIALS/  
SUSPECT BEN AREA.

**Potential Exposure Pathways (Ingestion, Inhalation, Direct Contact):** SAMPLES WERE COLLECTED AT 1440  
EXPOSURE PATHWAYS INCLUDE THE MIGRATION OF CONTAMINANTS FROM DAMAGED SACM AND CHEMICALLY CONTAMINATED MEDIA. WIND AND WATER EROSION COULD RESULT IN THE MIGRATION OF CONTAMINANTS

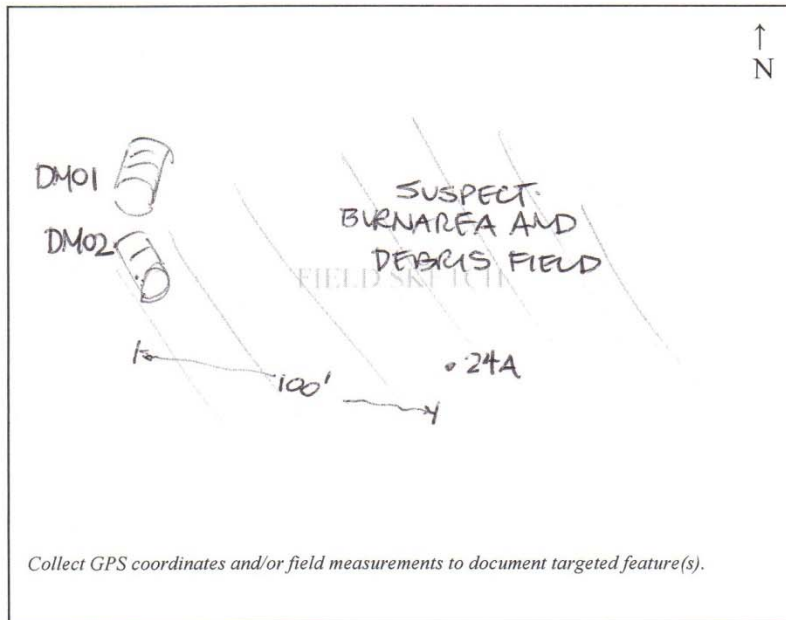
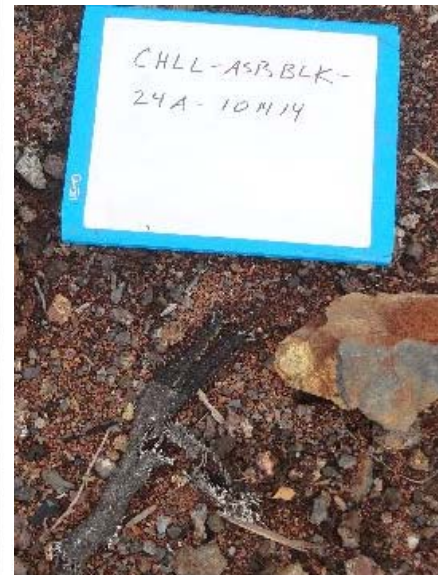
Inspection Date: 10/14/14 Feature Identification/Name DEBRIS FIELD / BURN AREA

FIBROUS BLACK WIRE WRAP LOCATED IN A SUSPECTED BURN AREA, APPROXIMATELY 100 FEET EAST OF DRUMS DM01 AND DM02; VICINITY OF INSPECTION LOCATION SAM15
