**ABANDONED MINING WASTES TORCH LAKE NON-SUPERFUND SITE
CALUMET AND HECLA - LAKE LINDEN OPERATIONS
TARGETED INSPECTION FORM**

Inspection Date: 10/15/14 Feature Identification/Name: COAL DOCK SHORELINE / EROSION CHANNEL

Geographic Area: HUBBELL COAL DOCK AREA Property Identification Number: 014-307-001-25

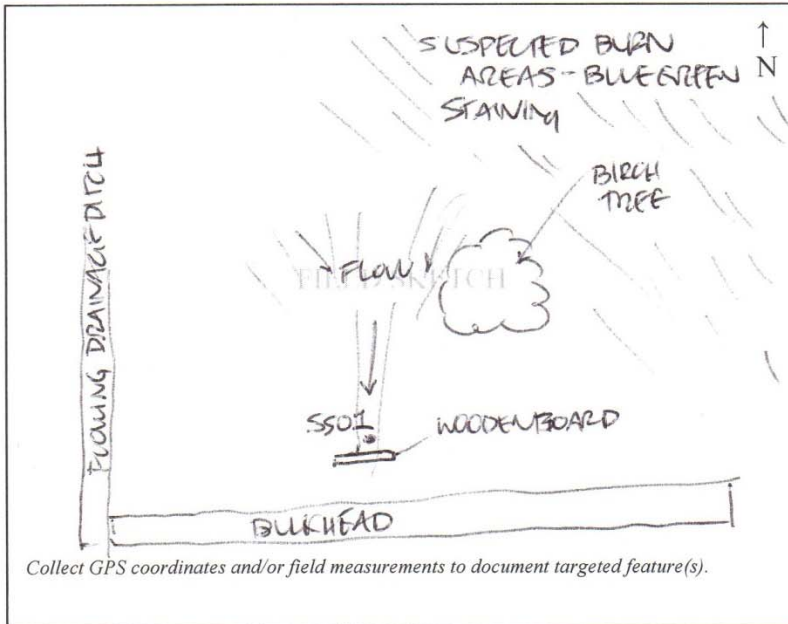
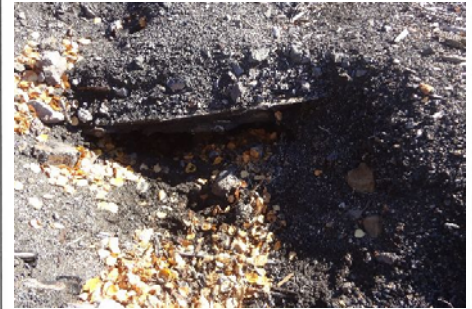
A CHANNELIZED DRAINAGE AREA NEAR THE SOUTHERN PROPERTY BOUNDARY. CHANNEL APPEARS ERODED, RECEIVING RUNOFF FROM THE SITE, THE CHANNEL ENTERS A VOID BEHIND THE BUCKHEAD WHERE TORCH LAKE SURFACE WATER IS VISIBLE.

THE EROSION OF CONTACT WATER AND CONTAMINATED SEDIMENT SURFACE SOIL MAY COULD MIGRATE FROM THE SITE AND ENTER TORCH LAKE. PHYSICAL HAZARDS MAY BE PRESENT DUE TO DEGRADATION OF THE BUCKHEAD

Other Relevant Below and Above Ground Features (Conduit, Drainage Swales, Culverts): (UNDERMINING)

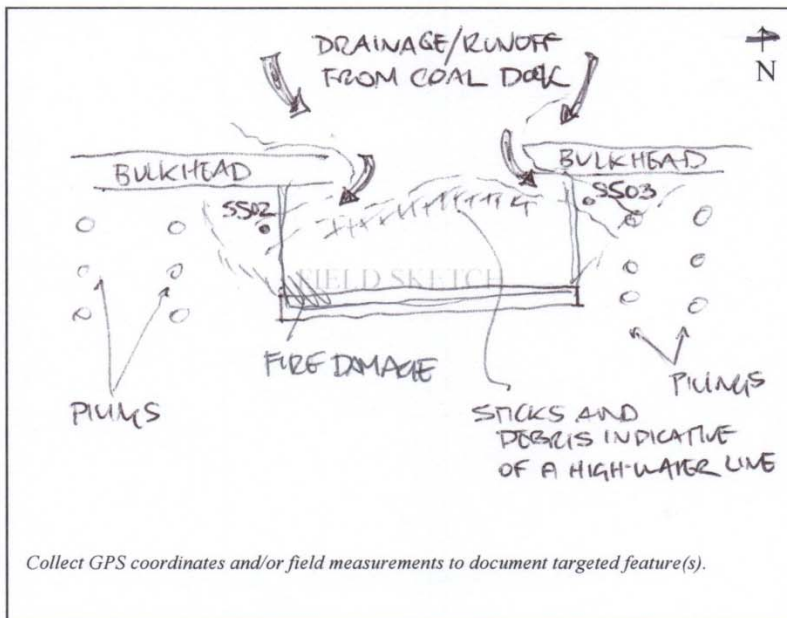
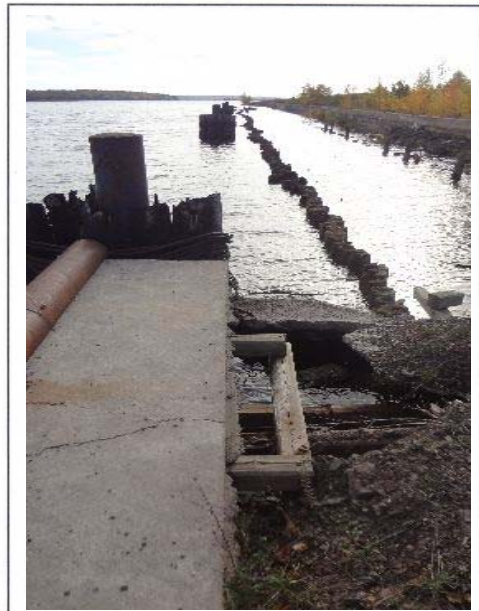
THE OPEN FLAT AREA OF THE COAL DOCK FEATURES BURN AREAS (SUSPECTED) COAL AND OTHER WASTES ON THE GROUND SURFACE; RUNOFF FROM THESE AREAS ARE GENERALLY PREVENTED FROM ENTERING THE LAKE ALONG THE BULKHEAD; ERODED CHANNELS HAVE FORMED THAT APPEAR TO DISCHARGE
SAMPLING ACTIVITIES (Sample Description, Sample Time, Requested Analyses):
SAMPLES COLLECTED FROM 0-6"; BROWN/DARK ~~GRAY~~ SAND AND GRAVEL, COARSE TO MEDIUM GRAINED
CHL-SS02-101514 SAMPLES COLLECTED AT ~~1340~~ 1340 AND 1413
CHL-SS03-101514

POTENTIALLY CONTAMINATED RUNOFF AND SOIL FROM THE SITE MAY WASH/ERODE FROM THE SITE AND DEPOSIT IN THE LAKE THROUGH DRAINAGE PATHWAYS; PHYSICAL HAZARDS ARE PRESENT DUE TO ERODED VOIDS IN THE BULKHEAD.

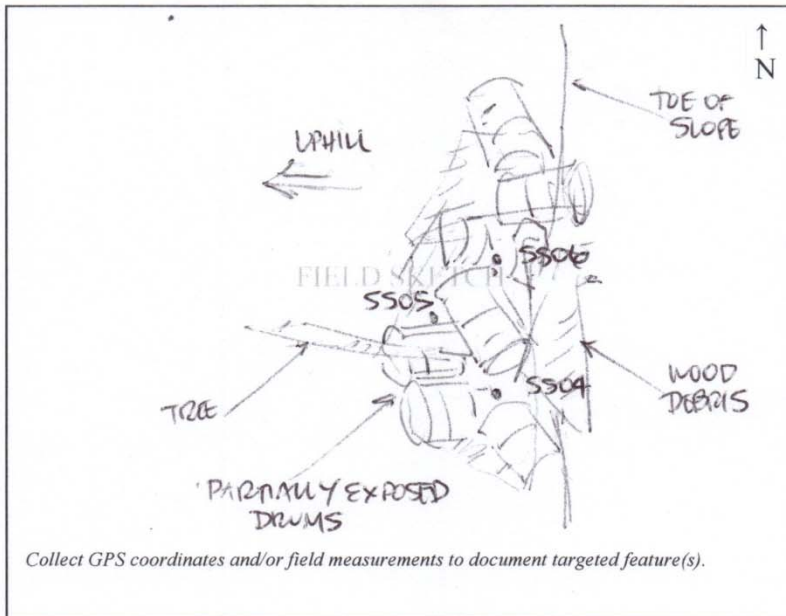
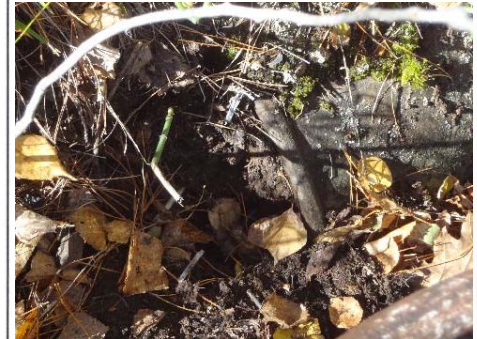
UP TO 10 DRUMS PROTRUDING FROM THE TOE OF THE SLOPE FROM THE UPPER COAL DOCK TO THE LOWER COAL DOCK; DRUMS ARE IN VARIOUS STATES OF DEGRADATION. UNCLEAR IF DRUMS ARE FULL OR EMPTY. COLLECT SOIL SAMPLES FROM 0-6" BROWNISH BLACK SANDY LOAM, ORGANICS, STANDING WATER/WET SOILS CHL-SS04-101514, CHL-SS05-101514, AND CHL-SS06-101514 SAMPLES COLLECTED BETWEEN 1430 AND 1450

DRUMS ARE PARTIALLY BURIED AND STANDING WATER IS PRESENT, MAKING THE POTENTIAL FOR LEAKING DRUM CONTENTS TO SEEP INTO SOIL AND GROUNDWATER, EROSION OF IMPACTED SOILS IS ALSO A POSSIBILITY; PHYSICAL HAZARDS ARE POSED

Other Relevant Below and Above Ground Features (Conduit, Drainage Swales, Culverts): BY THE DRUMS AND POTENTIAL SPILLAGE.

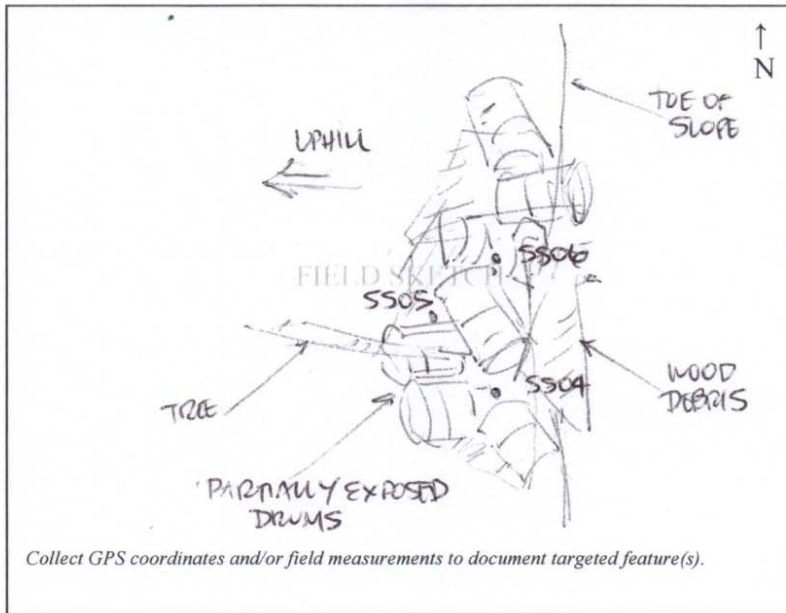
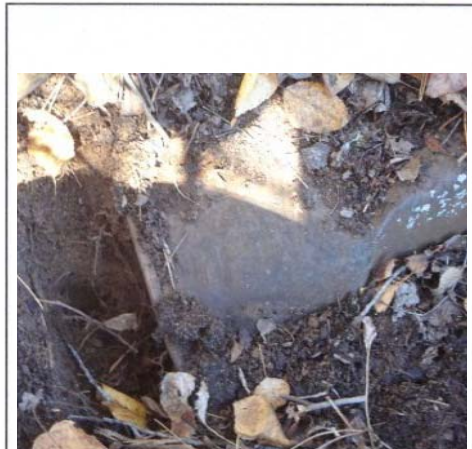
UP TO 10 DRUMS PROTRUDING FROM THE TOE OF THE SLOPE FROM THE UPPER COAL DOCK TO THE LOWER COAL DOCK; DRUMS ARE IN VARIOUS STATES OF DEGRADATION

DRUMS ARE PARTIALLY BURIED AND STANDING WATER IS PRESENT, MAKING THE
POTENTIAL FOR LEAKING DRUM CONTENTS TO SEEP INTO SOIL AND GROUNDWATER,
EROSION OF IMPACTED SOIL IS ALSO A POSSIBILITY; PHYSICAL HAZARDS ARE POSED

Other Relevant Below and Above Ground Features (Conduit, Drainage Swales, Culverts): BY THE DRUMS AND
POTENTIAL SPILLAGE.

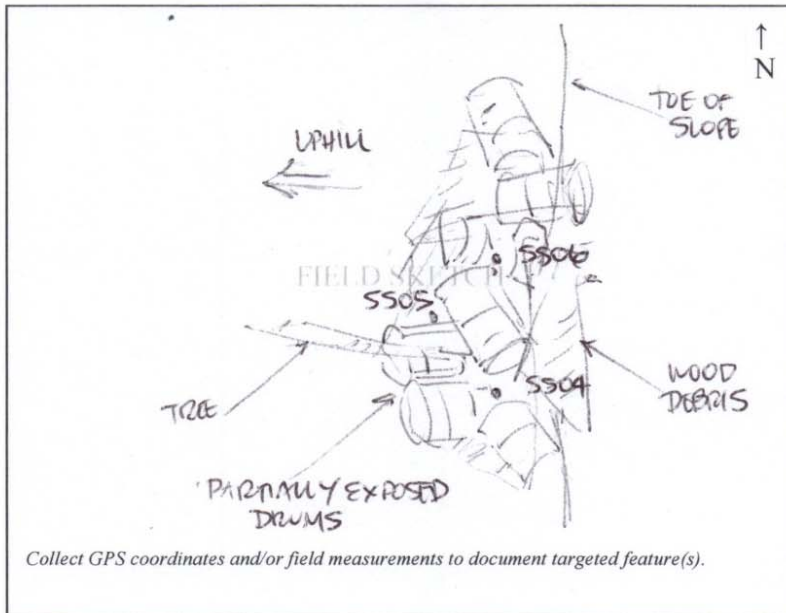
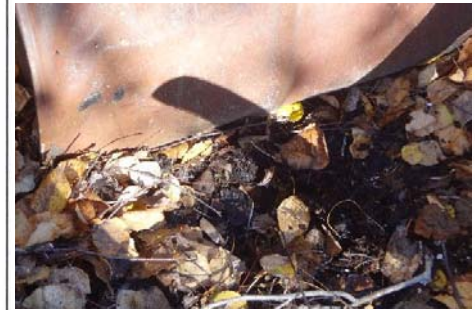
UP TO 10 DRUMS PROTRUDING FROM THE TOE OF THE SLOPE FROM THE UPPER COAL DOCK TO THE LOWER COAL DOCK; DRUMS ARE IN VARIOUS STATES OF DEGRADATION

DRUMS ARE PARTIALLY BURIED AND STANDING WATER IS PRESENT, MAKING THE POTENTIAL FOR LEAKING DRUM CONTENTS TO SEEP INTO SOIL AND GROUNDWATER, EROSION OF IMPACTED SOILS IS ALSO A POSSIBILITY; PHYSICAL HAZARDS ARE POSED

Other Relevant Below and Above Ground Features (Conduit, Drainage Swales, Culverts): BY THE DRUMS AND POTENTIAL SPILLAGE.

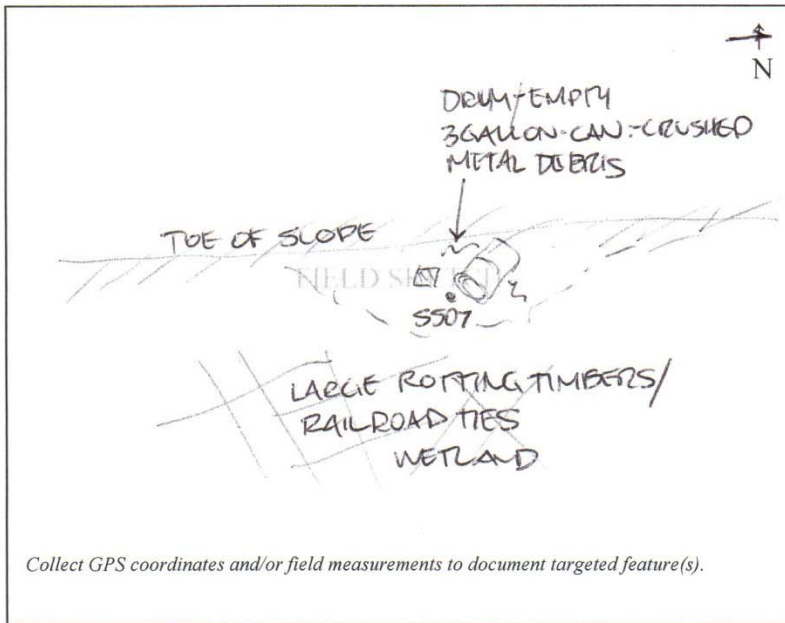
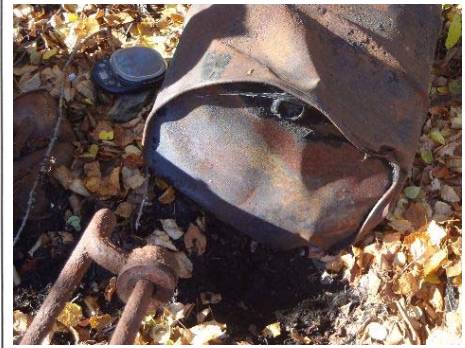
EMPTY 55 GALLON DRUM LYING ON ITS SIDE, INTACT NEXT TO A SMALL CRUSHED APPROX. 3 GALLON CONTAINER; METAL BANDS AND ROPS PROTRUDING FROM THE GROUND ADJACENT TO THE CONTAINERS

CONTAINERS ARE EMPTY, CONTENTS MAY HAVE SEEPED OR LEACHED INTO SOIL OR NEARBY/ADJACENT WETLAND AREA; PHYSICAL HAZARDS ASSOCIATED WITH THE CONTAINERS ARE MINIMAL

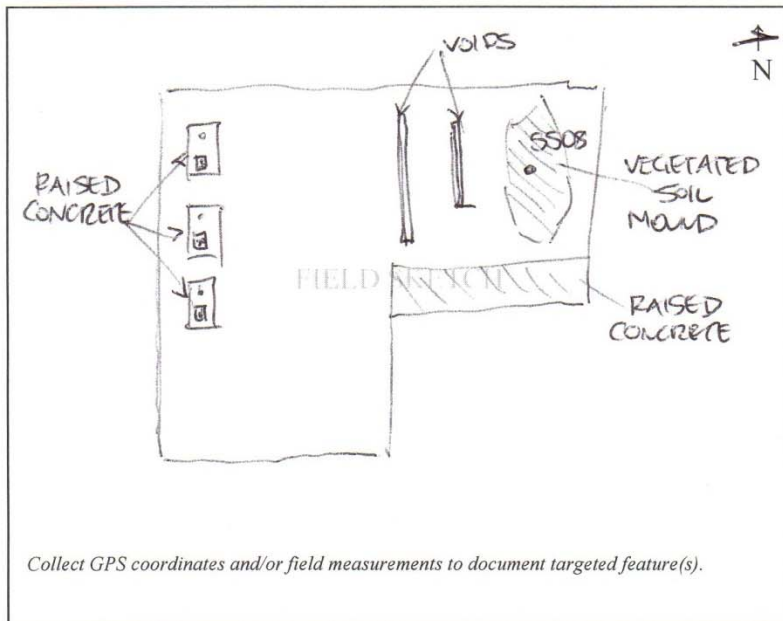
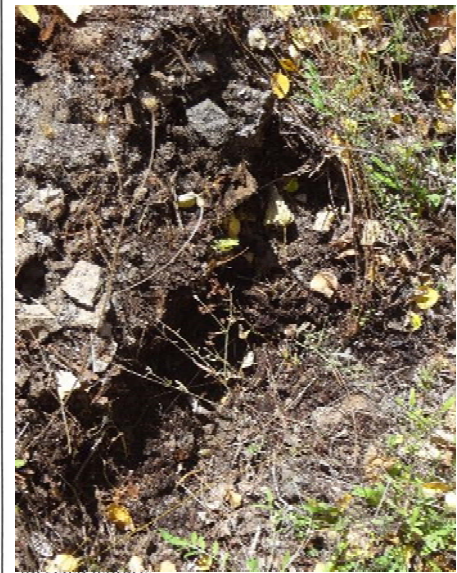
RAISED SLAB APPROXIMATELY 3-4' ABOVE GRADE; SOIL DEPOSIT COMMINGLED WITH BUILDING DEBRIS ON NORTH SIDE OF SLAB; SALM PRESET ON THE SLAB
LIGHT VEGETATIVE COVERING ON SOIL MOUND; ORGANICS

DEBRIS WOULD BE PRONE TO WIND AND WATER EROSION, POTENTIAL DISTRIBUTION ACROSS THE SITE, TRESPASSERS INVESTIGATING MOUND COULD CONTACT POTENTIAL ASBESTOS CONTAMIN MATERIALS IN THE SOIL

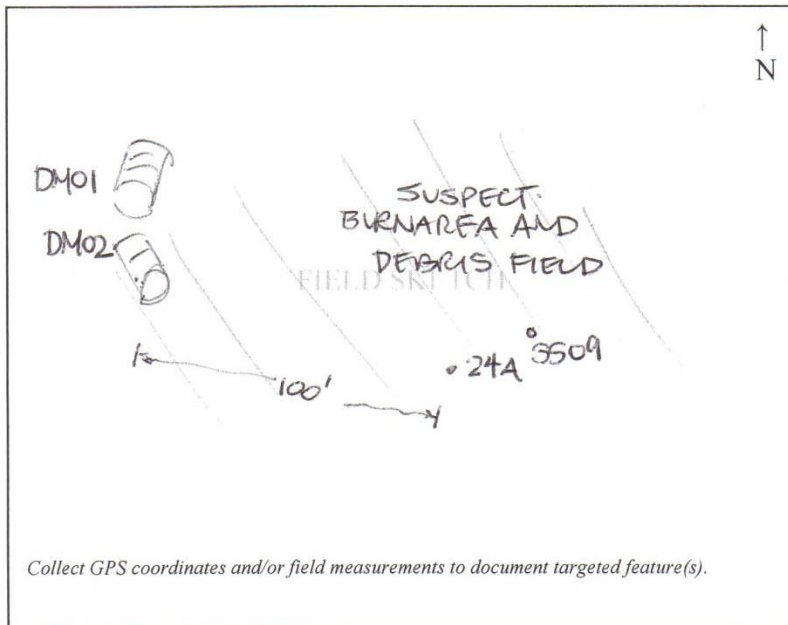
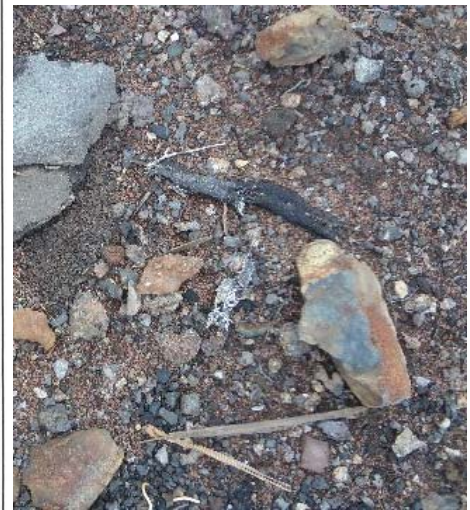
FIBROUS BLACK WIRE WRAP LOCATED IN A SUSPECTED BURN AREA, APPROXIMATELY 100 FEET EAST OF DRUMS DM01 AND DM02; VICINITY OF INSPECTION LOCATION SAKMS

WIND AND WATER EROSION HAVE THE POTENTIAL TO TRANSPORT WASTES AND CONTAMINATED MEDIA TO THE LAKE; EVIDENCE OF TRESSPASSELS BASED ON SMALL EXCAVATIONS, SIMILAR TO THOSE THAT MIGHT BE MADE BY SOMEONE WITH SOIL IN THE AREA IS GENERALLY BLACK, CINDERS AND COAL, BLUE/GREEN STAINING IS PRESENT IN THE SOILS AS WELL AS FRAGMENTS OF WIRE AND WASTE MATERIALS

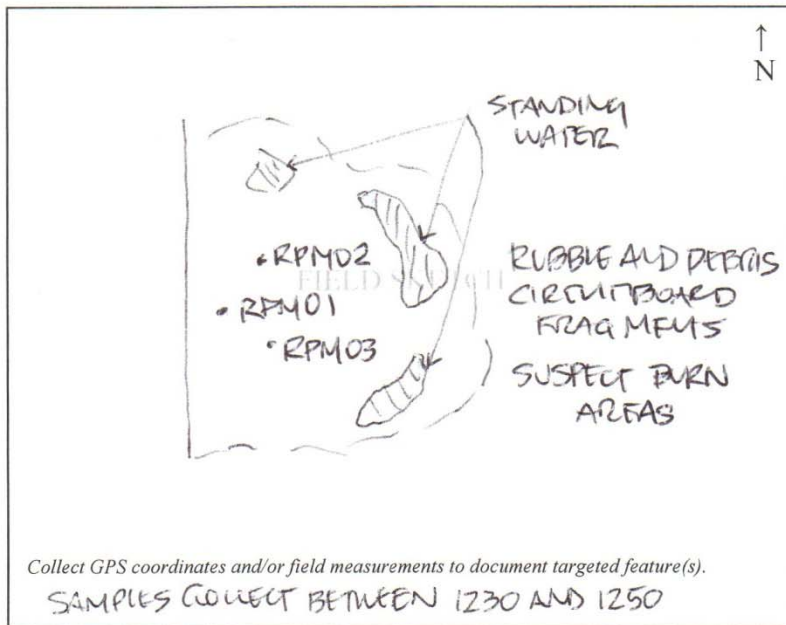
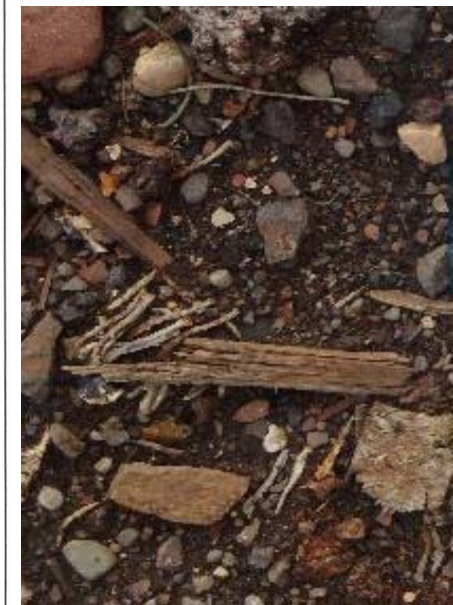
SUSPECTED WIRE AND CABLE WRAP SCRAPS COVERING THE GROUND SURFACE IN SUSPECTED BURN AREAS, MATERIALS WOULD HAVE BEEN WASTE PRODUCTS FROM COPPER RECOVERY/SALVAGE OPERATIONS AT THE PROPERTY, MATERIALS ARE POTENTIALLY OIL-LADEN

EXPOSED MATERIALS MAY BE WEATHERING AND DECOMPOSING, LEACHING/RELEASING HAZARDOUS CHEMICALS TO SOIL AND GROUNDWATER/SURFACE WATER. WIND AND WATER EROSION COULD RESULT IN THE MIGRATION OF CONTAMINANTS TO AGR

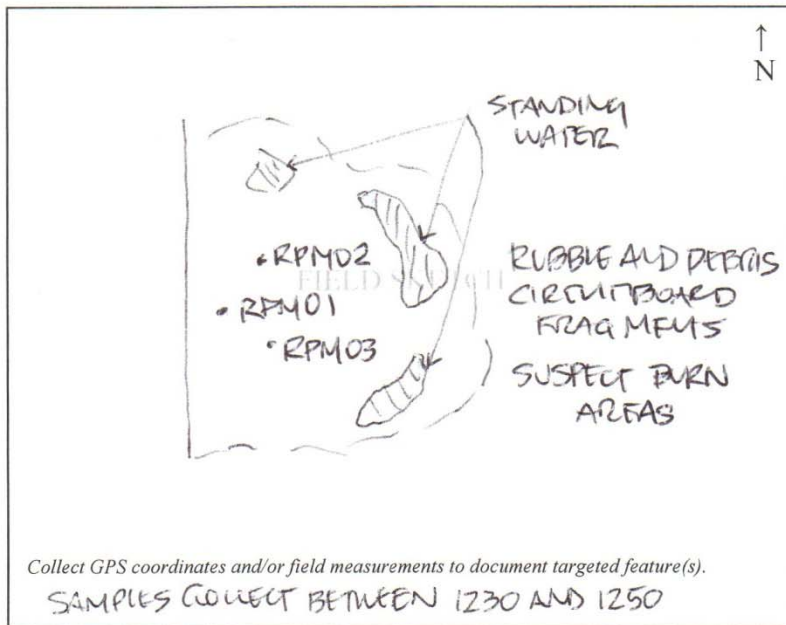
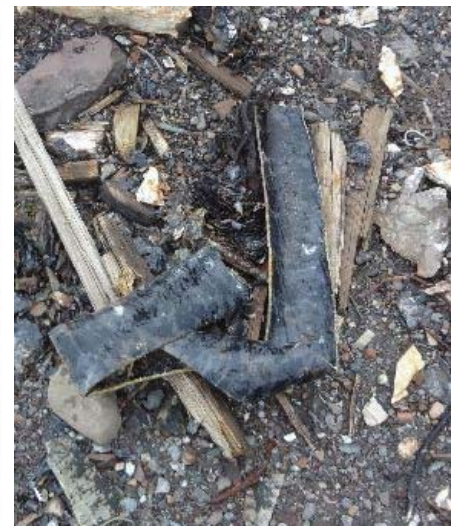
SUSPECTED WIRE AND CABLE WRAP SCRAPS COVERING THE GROUND SURFACE IN SUSPECTED BURN AREAS, MATERIALS WOULD HAVE BEEN WASTE PRODUCTS FROM COPPER RECOVERY/SALVAGE OPERATIONS AT THE PROPERTY, MATERIALS ARE POTENTIALLY OIL-LADEN

EXPOSED MATERIALS MAY BE WEATHERING AND DECOMPOSING, LEACHING/RELEASING HAZARDOUS CHEMICALS TO SOIL AND GROUNDWATER/SURFACE WATER. WIND AND WATER EROSION COULD RESULT IN THE MIGRATION OF CONTAMINANTS TO AGR

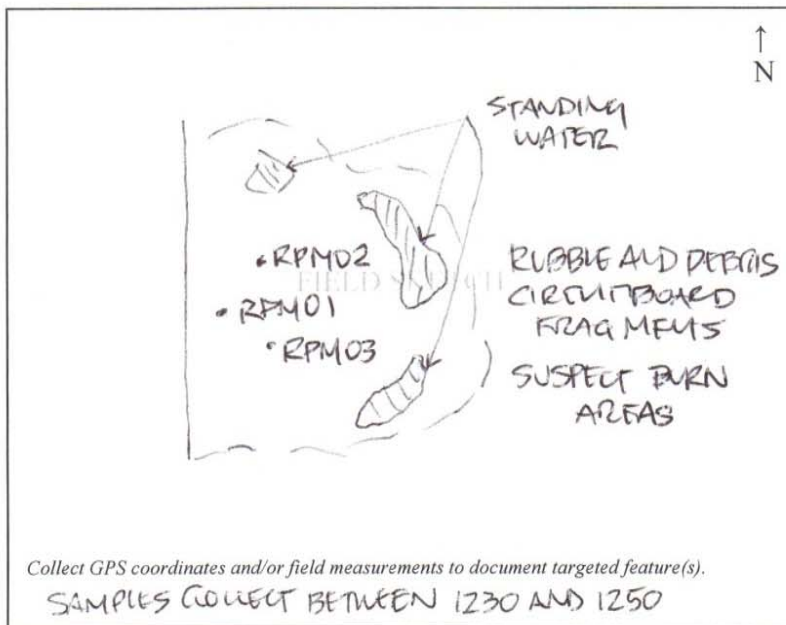
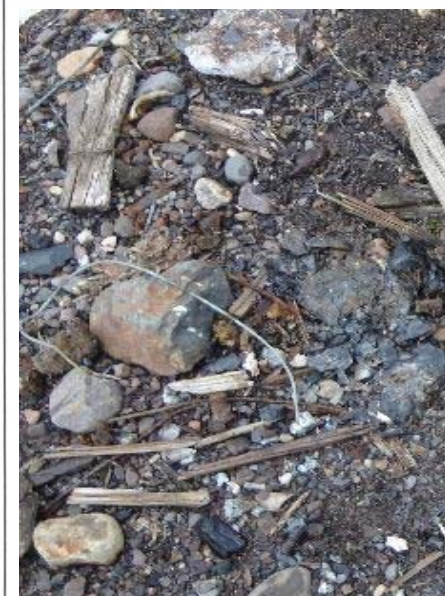
SUSPECTED WIRE AND CABLE WRAP SCRAPS COVERING THE GROUND SURFACE IN SUSPECTED BURN AREAS, MATERIALS WOULD HAVE BEEN WASTE PRODUCTS FROM COPPER RECOVERY/SALVAGE OPERATIONS AT THE PROPERTY, MATERIALS ARE POTENTIALLY OIL-LADEN

EXPOSED MATERIALS MAY BE WEATHERING AND DEGRADING, LEACHING/RELEASING HAZARDOUS CHEMICALS TO SOIL AND GROUNDWATER/SURFACE WATER. WIND AND WATER EROSION COULD RESULT IN THE MIGRATION OF CONTAMINANTS TO AFR

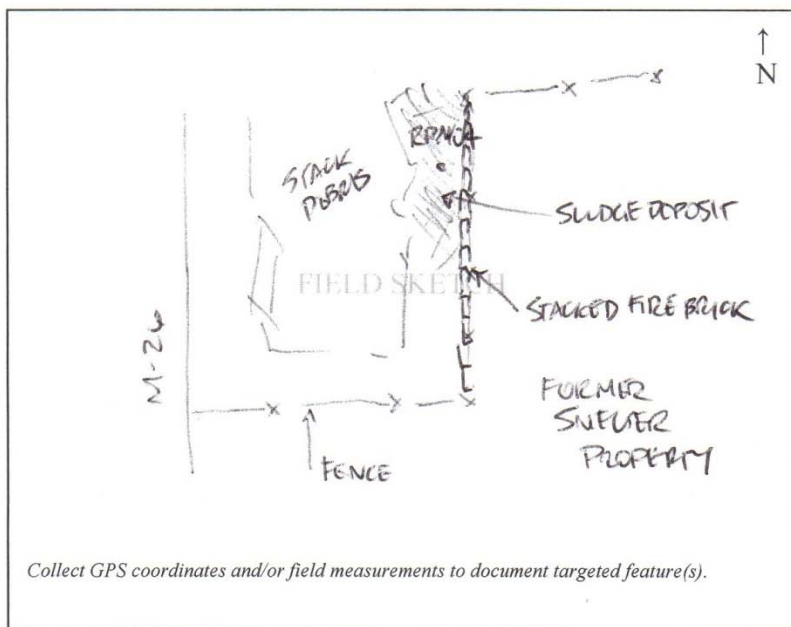
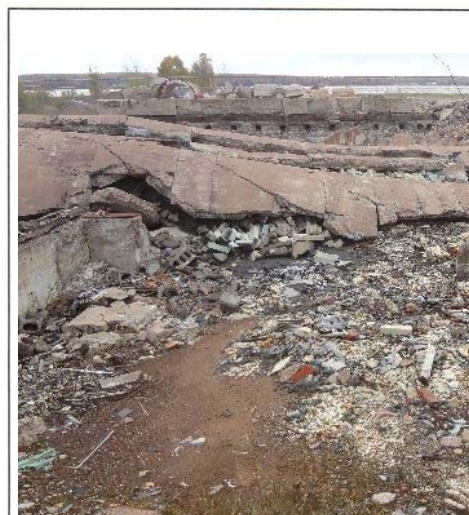
TAN, BLUE-GREEN TINTED FINE SLUDGE ACCUMULATED AT THE BASE OF THE DEMOLISHED STACK; MATERIAL APPEARS TO BE ERODING OUT OF THE STACK DEBRIS AND MIGRATING WITH THE POTENTIAL TO IMPACT THE NEIGHBORING INDUSTRIAL PROPERTY

DIRECT CONTACT, POTENTIAL MIGRATION OFF PROPERTY; STACK AND DEBRIS PRESENT A SIGNIFICANT PHYSICAL HAZARD; WHEN DRY MATERIAL MAY BE DISPOSED BY WIND, WATER LIKELY TO BE MAJOR CONTRIBUTOR IN EROSION AND ACCUMULATION

STACKED FIRE BRICK HAS BEEN PLACED ALONG THE PROPERTY FENCE LINE, PRESUMABLY TO MITIGATE MIGRATION OF THE SLUDGE

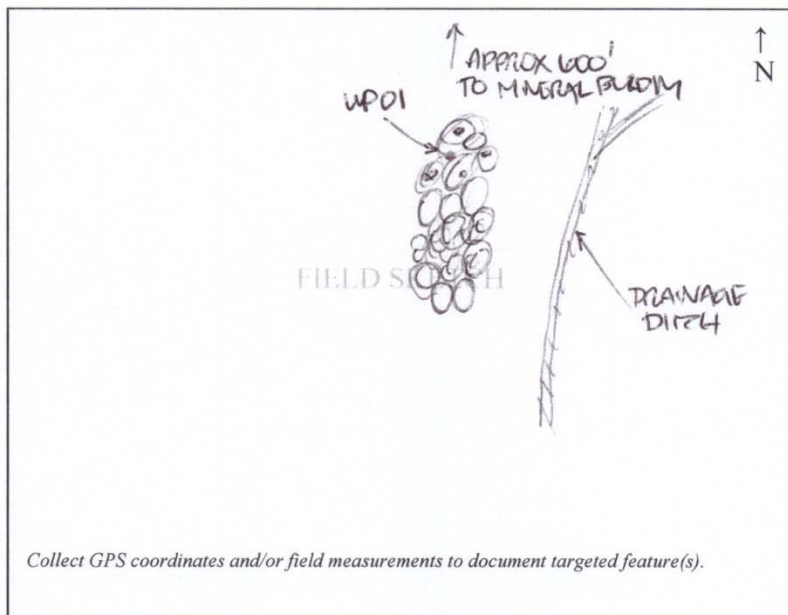
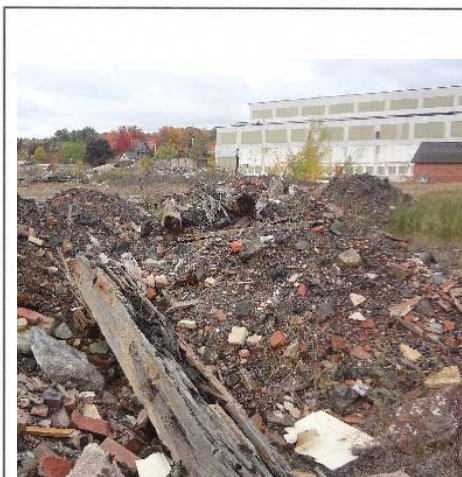
MULTIPLE WASTE PILES IN THE NORTH CENTRAL PORTION OF THE PROPERTY; PILES APPEAR TO BE DUMP TRUCK LOADS CONTAINING BRICKS, TRANSITE, AND OTHER BUILDING MATERIALS BLACK CINDER/COAL MATRIX

DEBRIS PILES POSE PHYSICAL HAZARD TO TRESPASSERS DUE TO ROUGH TERRAIN AND EXPOSED DEBRIS; PILES ARE NOT VEGETATED AND PRONE TO WIND AND WATER EROSION PILES ARE WITHIN 100' OF THE DRAINAGE CHANNEL (FLOWING) THAT DIVIDES THE TWO PROPERTIES THE DRAINAGE CHANNEL DISCHARGES TO TORCH LAKE

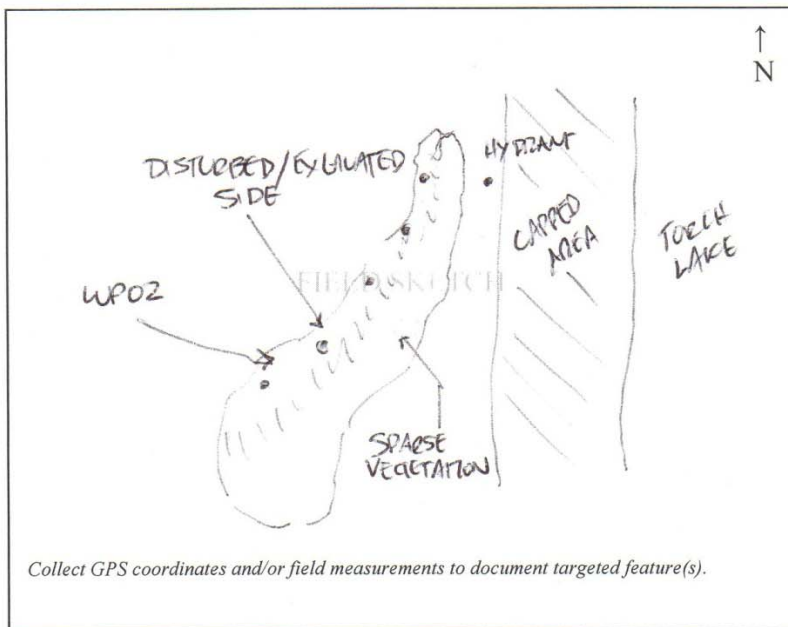
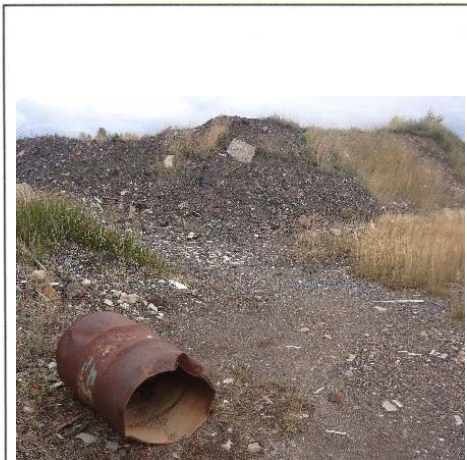
LARGE DEBRIS PILE, GENERALLY PARALLEL TO THE SHORELINE, SPARSELY VEGETATED, WEST SIDE OF PILE APPEARS TO HAVE BEEN OPEN CUT AND IS NOT VEGETATED, BUILDING DEBRIS DRUM CARCASS, AND OTHER MATERIALS ARE PRESENT IN A BLACK CINDER/COAL/SOIL MIX MATRIX

DEBRIS/WASTE PILE IS SPARSELY TO NON VEGETATED, WIND AND RAIN EROSION COULD TRANSPORT SOIL FROM THE PILE TO THE LAKE AND DISPERSE ACROSS THE SITE; PHYSICAL HAZARDS THAT ARE PRESENT WOULD INCLUDE METAL DEBRIS AND BRICK PROTRUDING FROM THE WASTE PILE; CAP AREA BETWEEN THE PILE AND THE LAKE MAY PROVIDE AN
Other Relevant Below and Above Ground Features (Conduit, Drainage Swales, Culverts): EROSION BUFFER

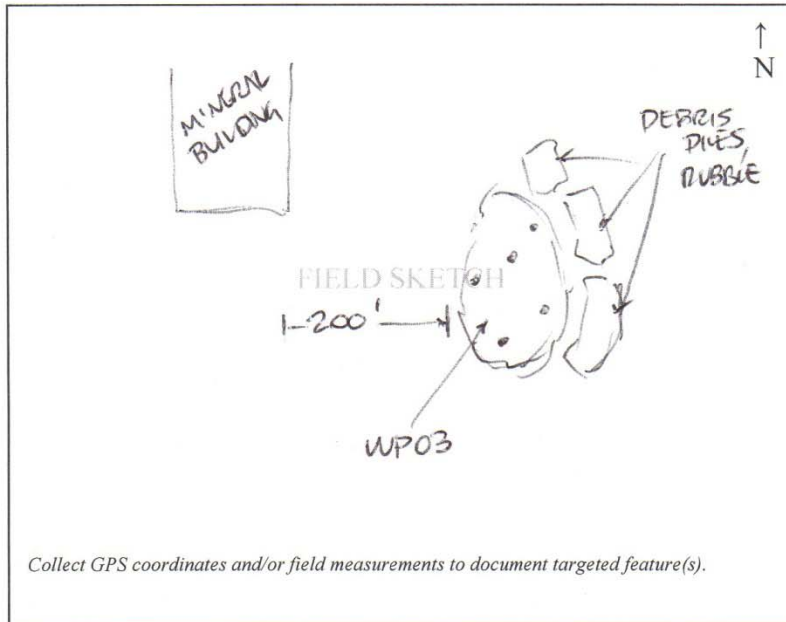
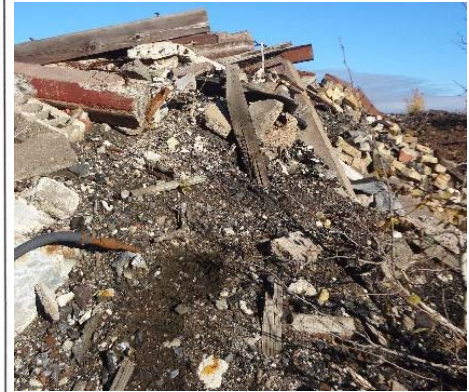
WASTE PILE IS SUBJECT TO WIND AND WATER EROSION, SOIL CAN BE TRANSPORTED/DISPERSED THE COMMINCED NATURE OF THE PILE WITH METAL DEBRIS/CONCRETE, AND DAMAGED ACM MAKES IT A PHYSICAL HAZARD TO TRFESSASSERS
