Appendix E
Monitoring Well Plugging and
Abandonment Reports

*2015 Monitoring Well Abandonment
Report*

Monitoring Well Abandonment Summary

GE Apparatus Service Center
18075 Krause Street, Riverview, Michigan

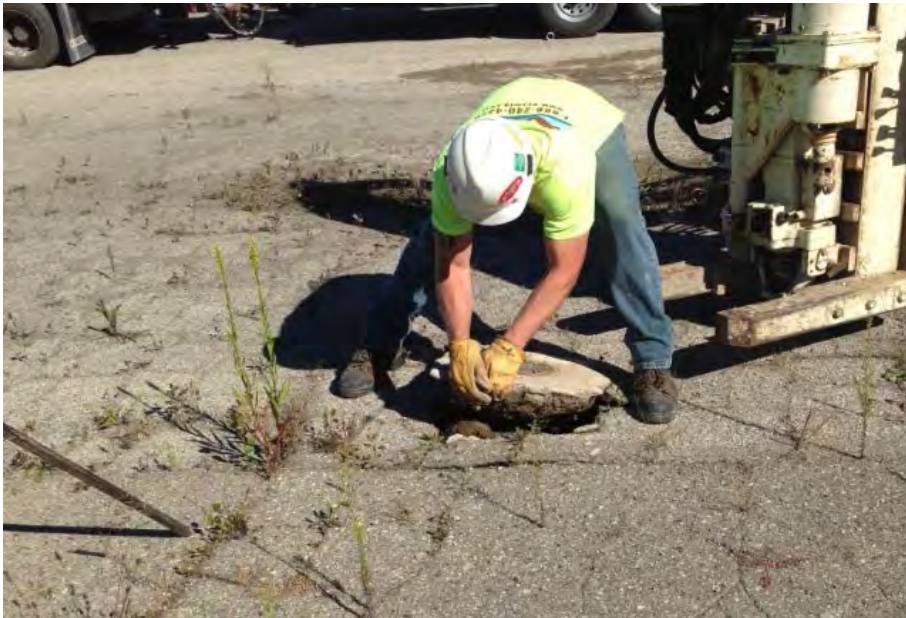
Terra Probe personnel used a breaking bar to loosen and remove the concrete pad and steel protective casing from around each well, as shown below.

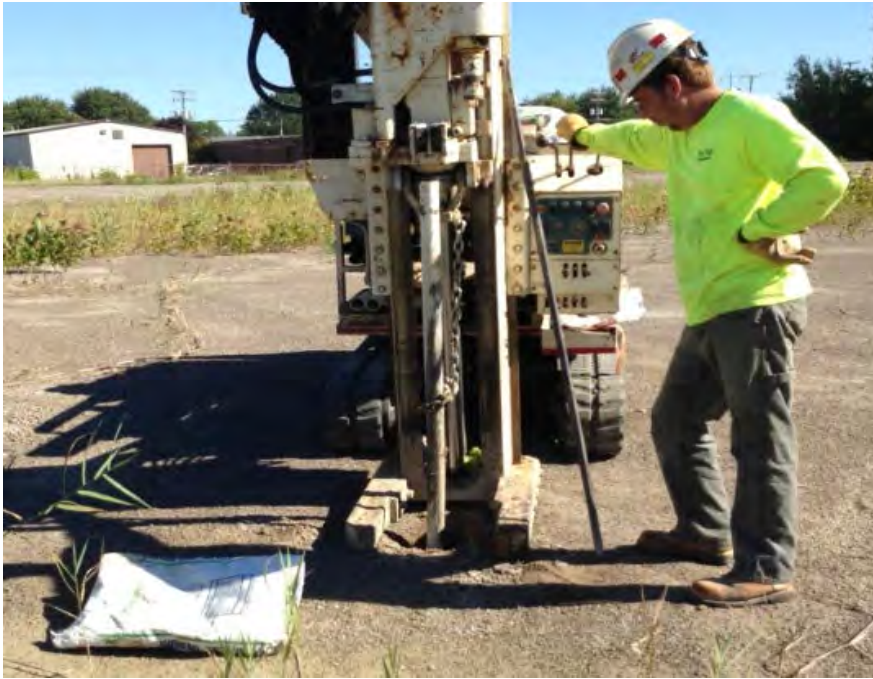
Next, the two-inch diameter PVC well screens and casings were removed from the ground with the assistance of the Geoprobe track rig (a chain was

placed around the well and the hydraulic hammer from the track rig was used to pull the well out of the ground, see photo below).

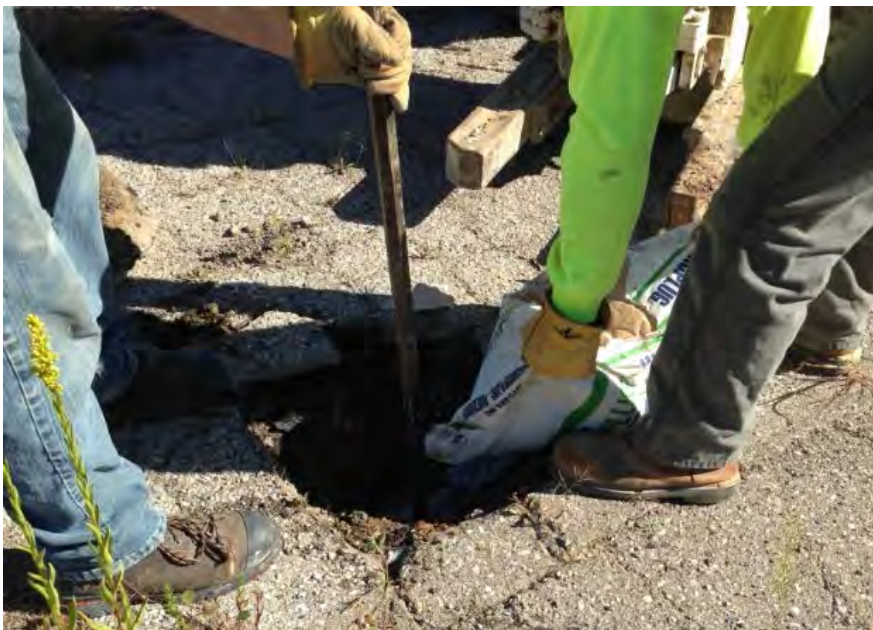
Then each bore hole was sealed to within six inches of the surface with bentonite chips and compacted with the breaking bar to prevent bridging (see photo below).

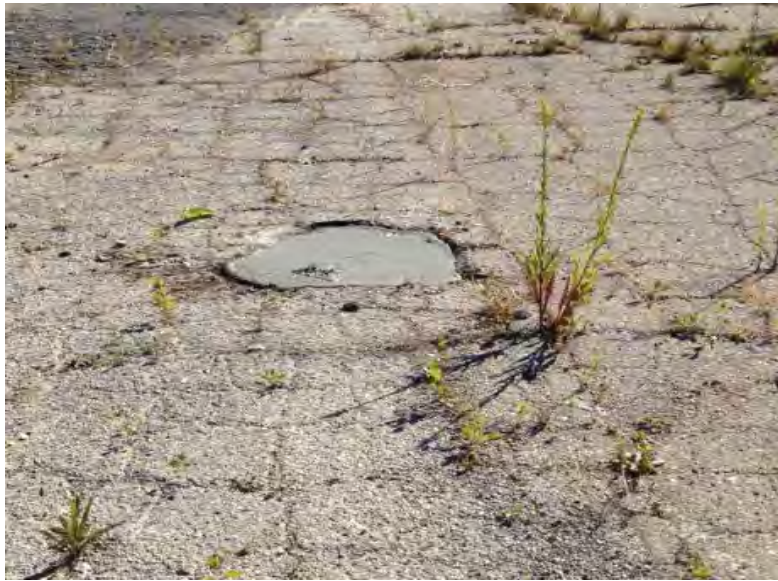
Finally, the surface at each location was restored to a similar condition. In the gravel covered areas, the final six inches were filled with gravel. In the asphalt area at OW-9, the final six inches were filled with concrete (see photo below).

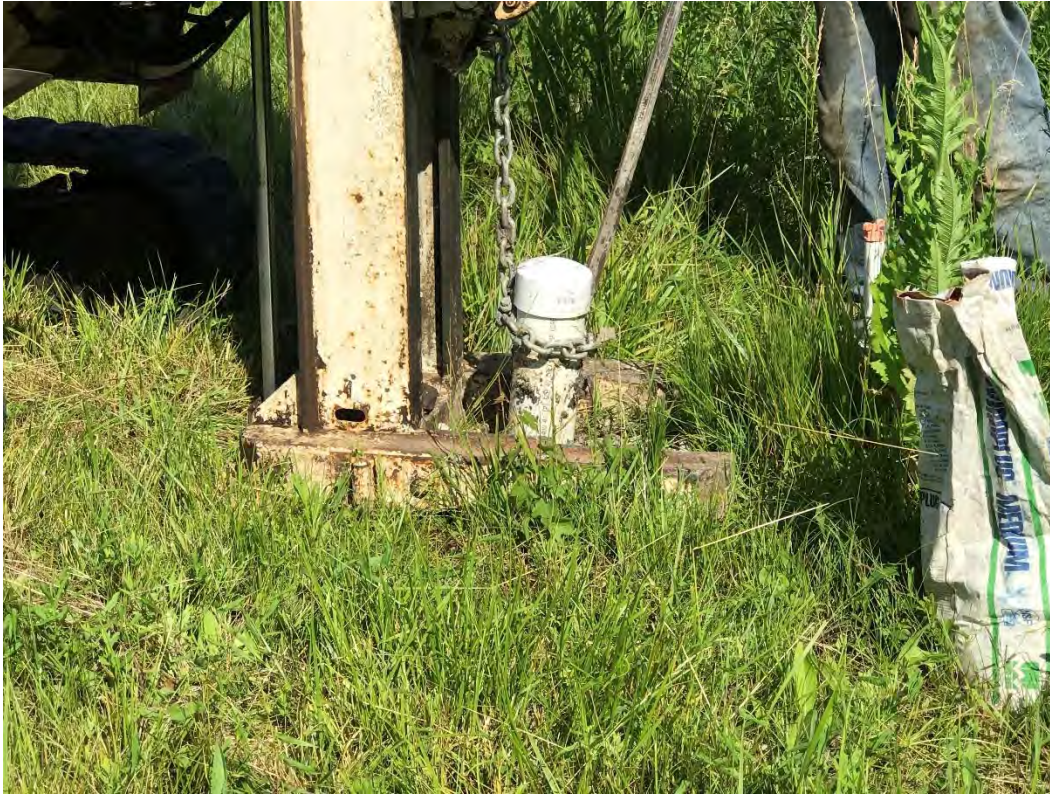
Terra Probe personnel used a breaking bar to loosen and remove the concrete pad around soil vapor and monitoring wells VP-7 and VP-8, as shown below.

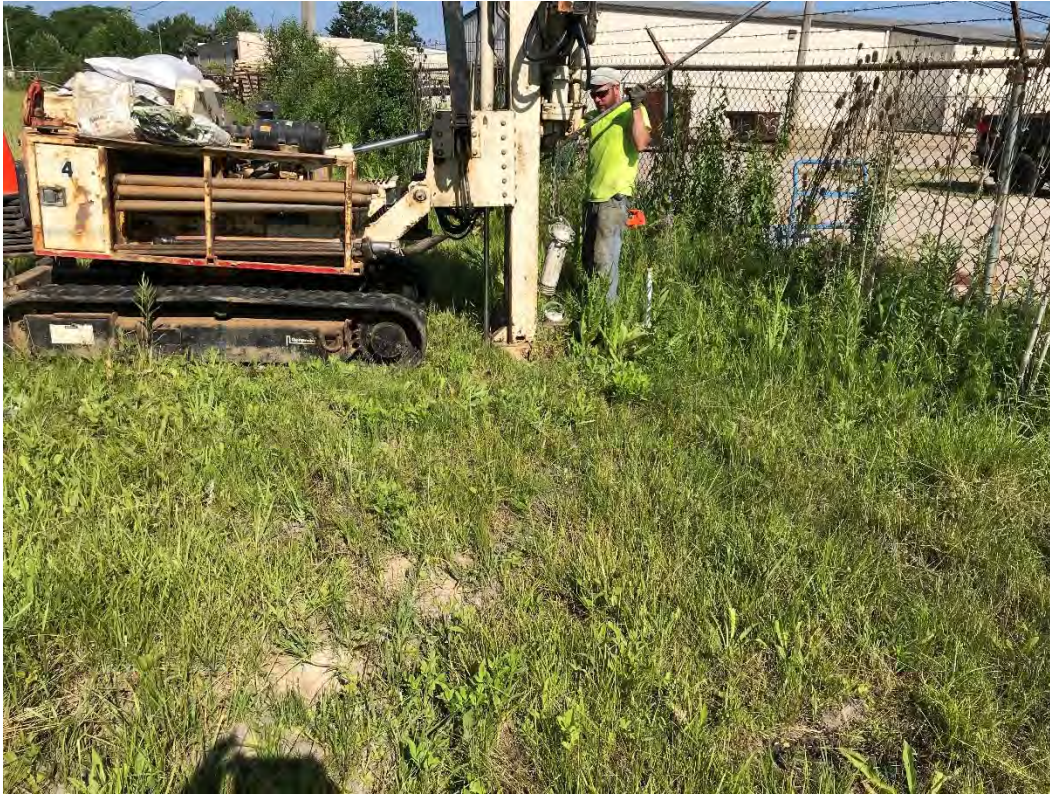
Next, the one-inch diameter PVC well screens and casings were removed from the ground with the assistance of the Geoprobe track rig (a chain was placed around the well and the hydraulic hammer from the track rig was used to pull the well out of the ground, see photo above). Tubing associated with the soil vapor probe was detached from the vapor probe and pulled from the ground.

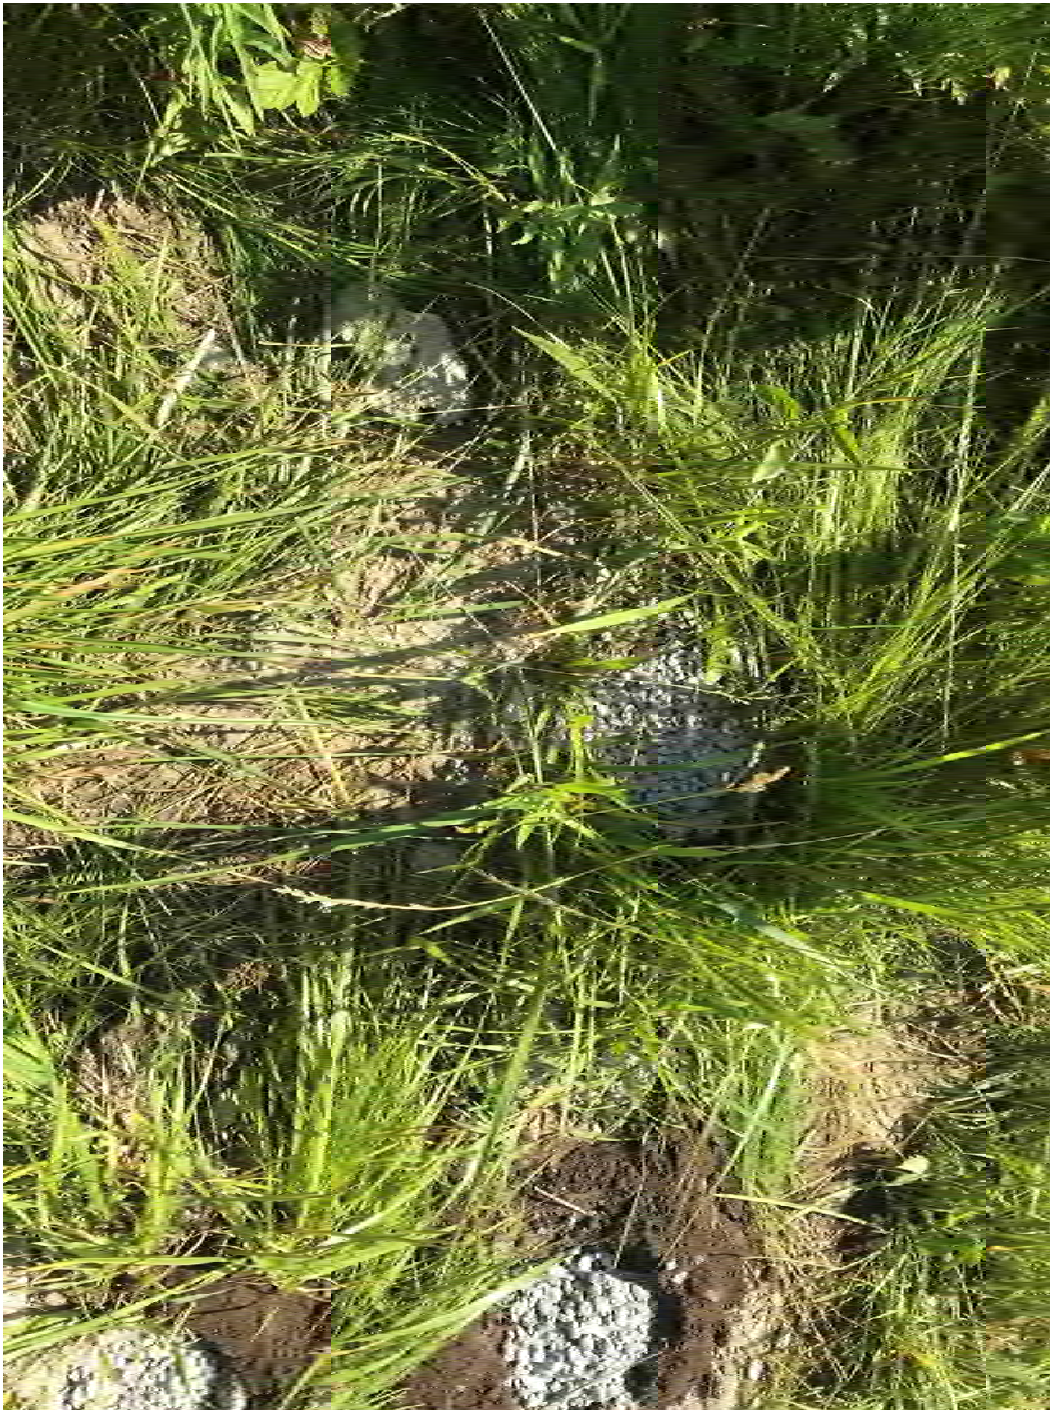
Then each borehole was sealed to the surface with bentonite chips and compacted with the breaking bar to prevent bridging.

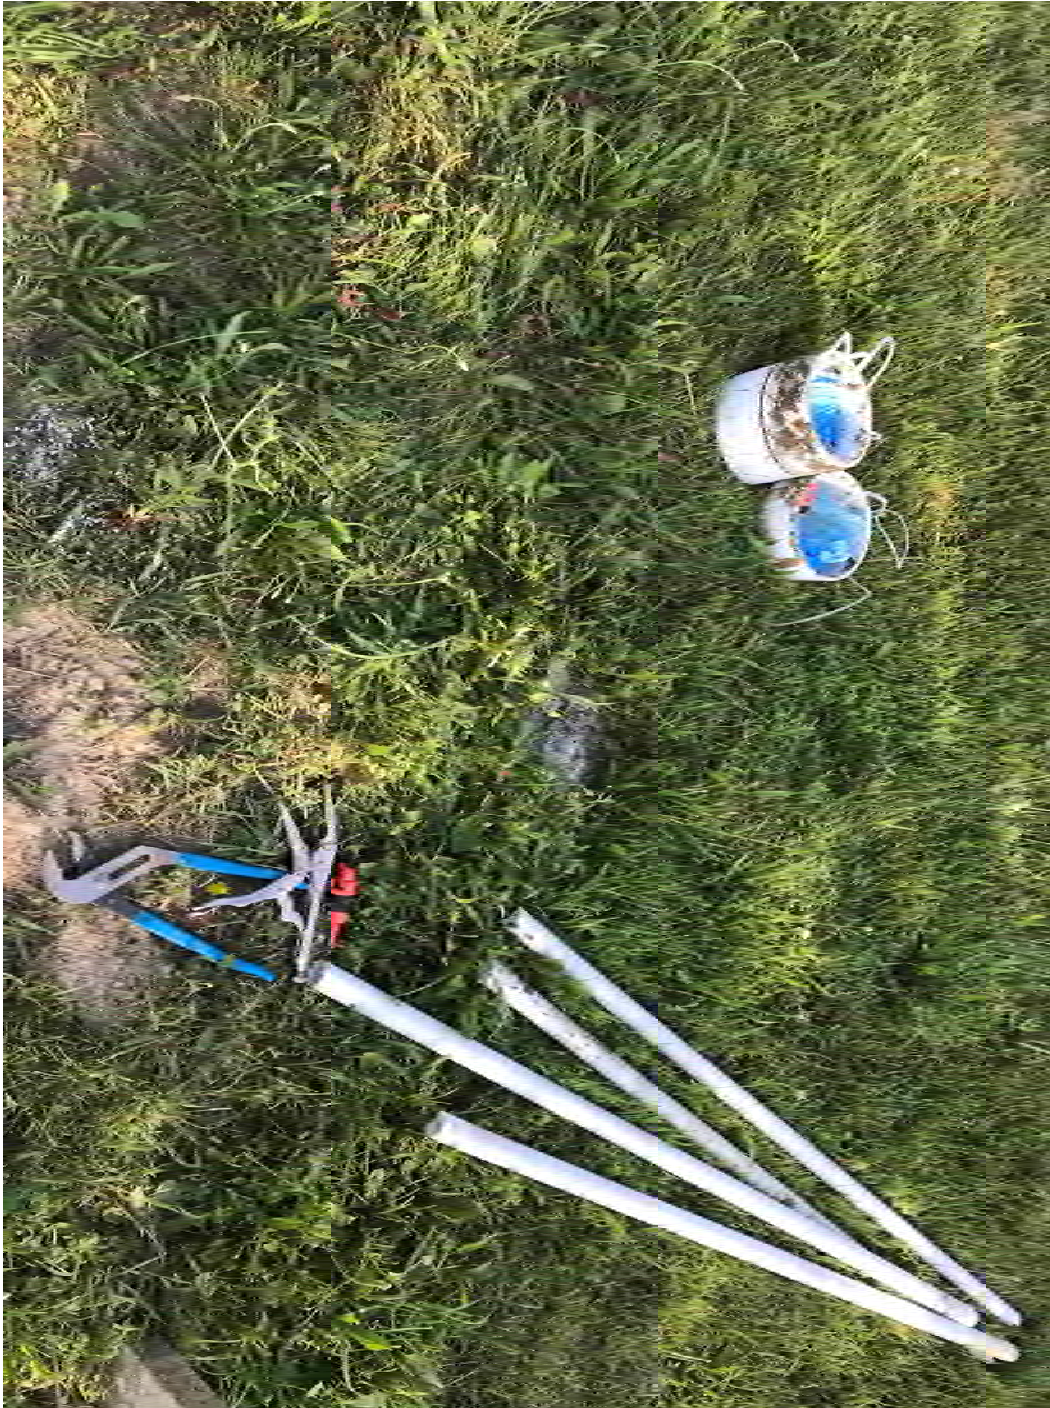
Finally, the surface at each location was restored to a similar condition. Fill sand was placed over the around the former borehole (see photo below).
