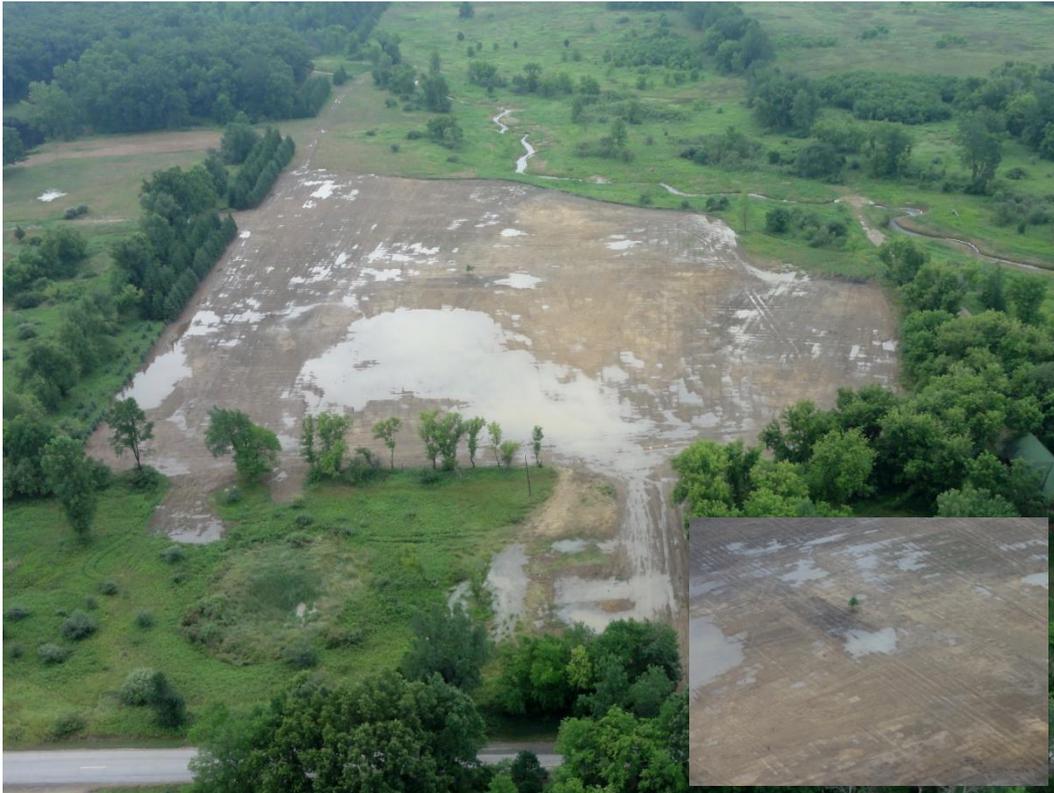
1. Standing water in Division A staging area due to overnight rain.

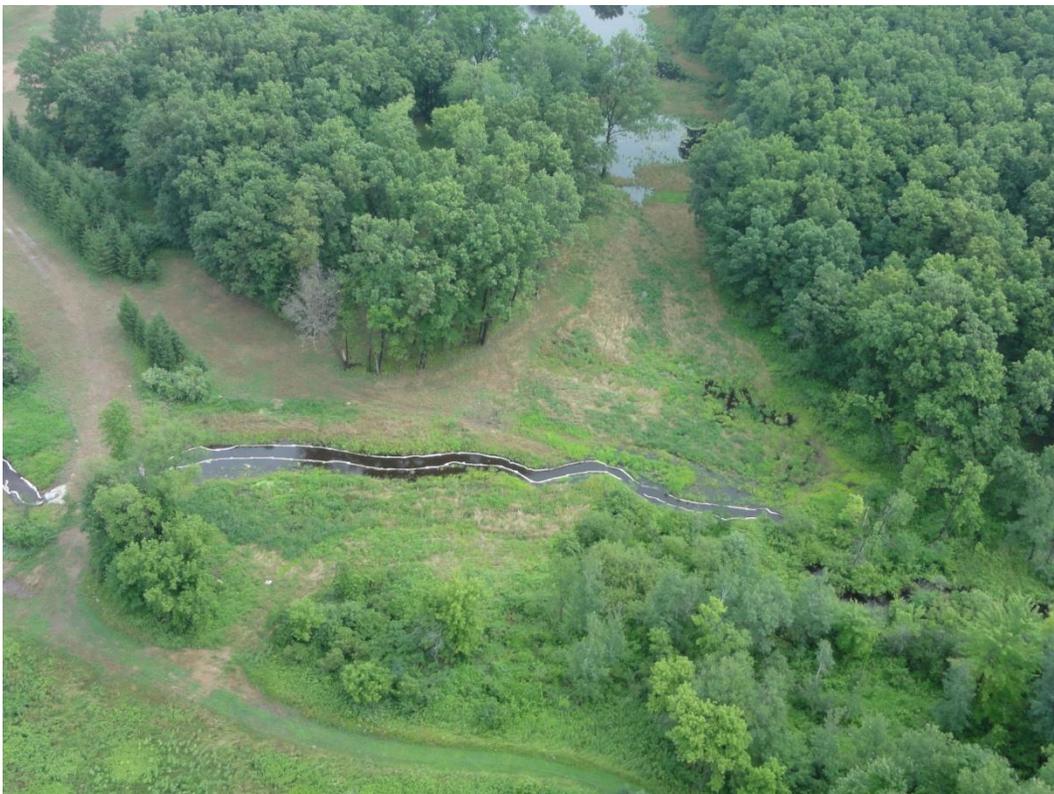
2. Release point and Talmadge Creek. Creek level is over the banks.

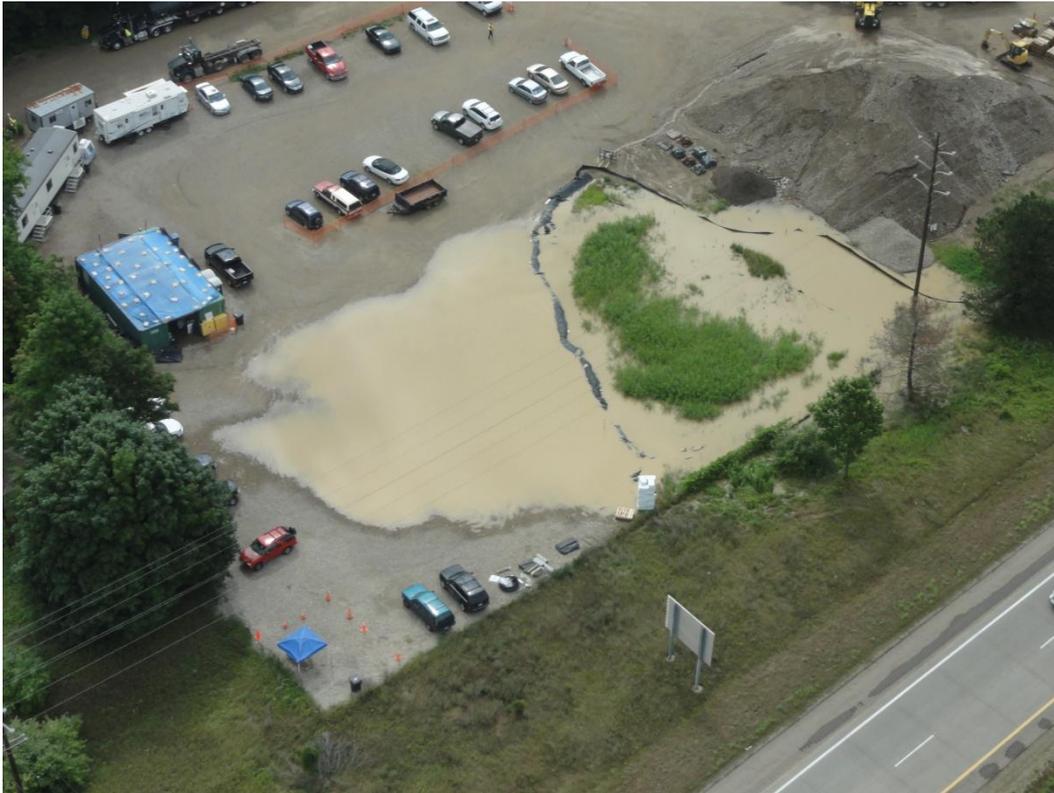
3. Standing water at north end of Frac Tank City.

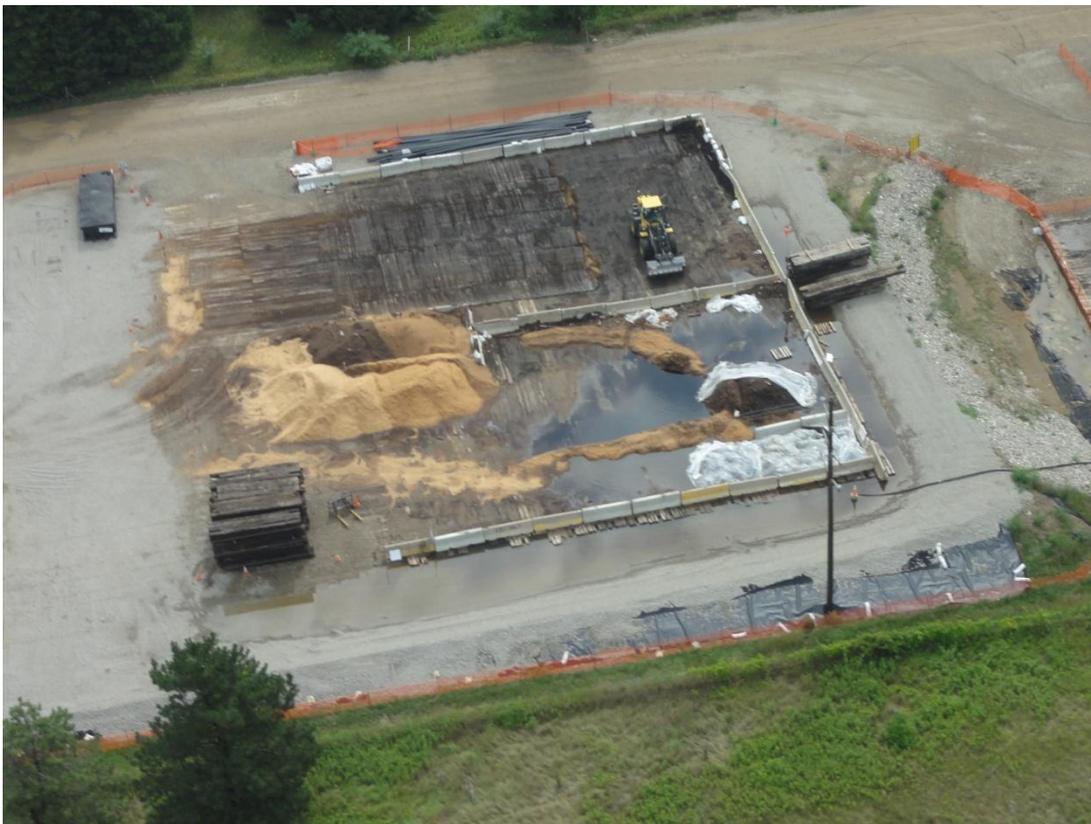
4. Frac-City Soil Cells, standing water in southwest corner of staging area.

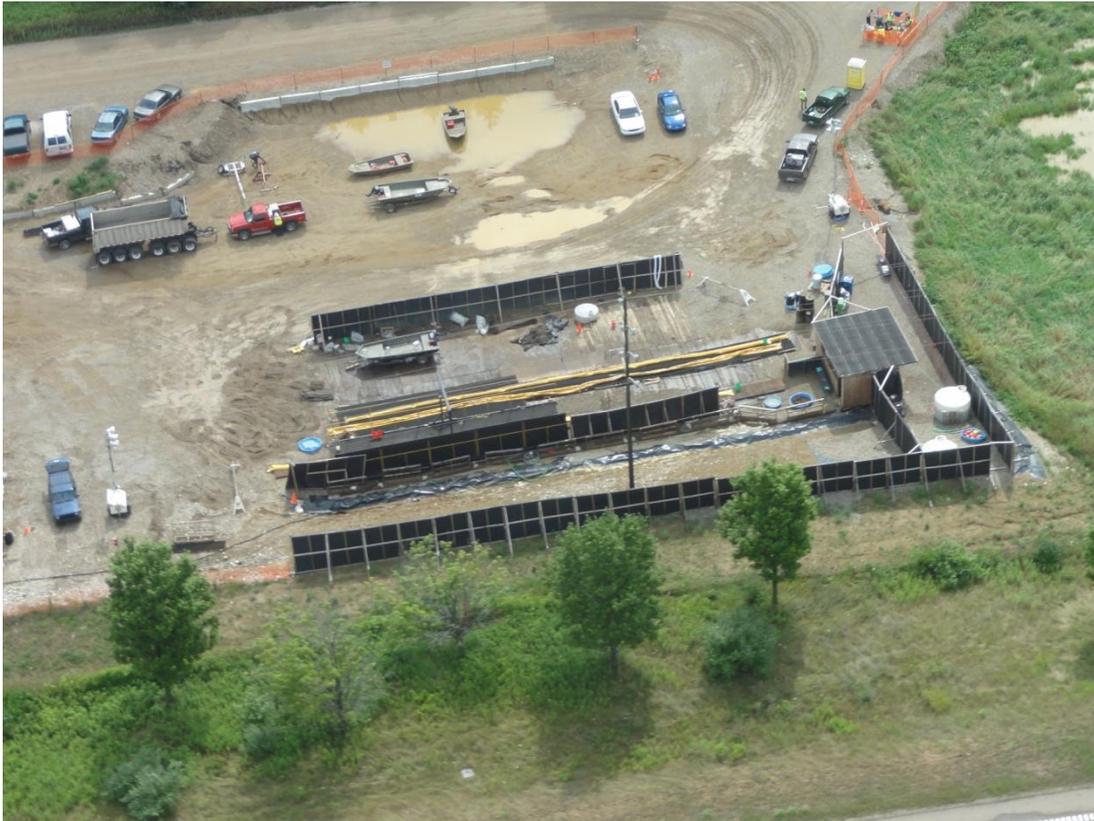
5. Frac City decon area, boom and boat staged for decon.

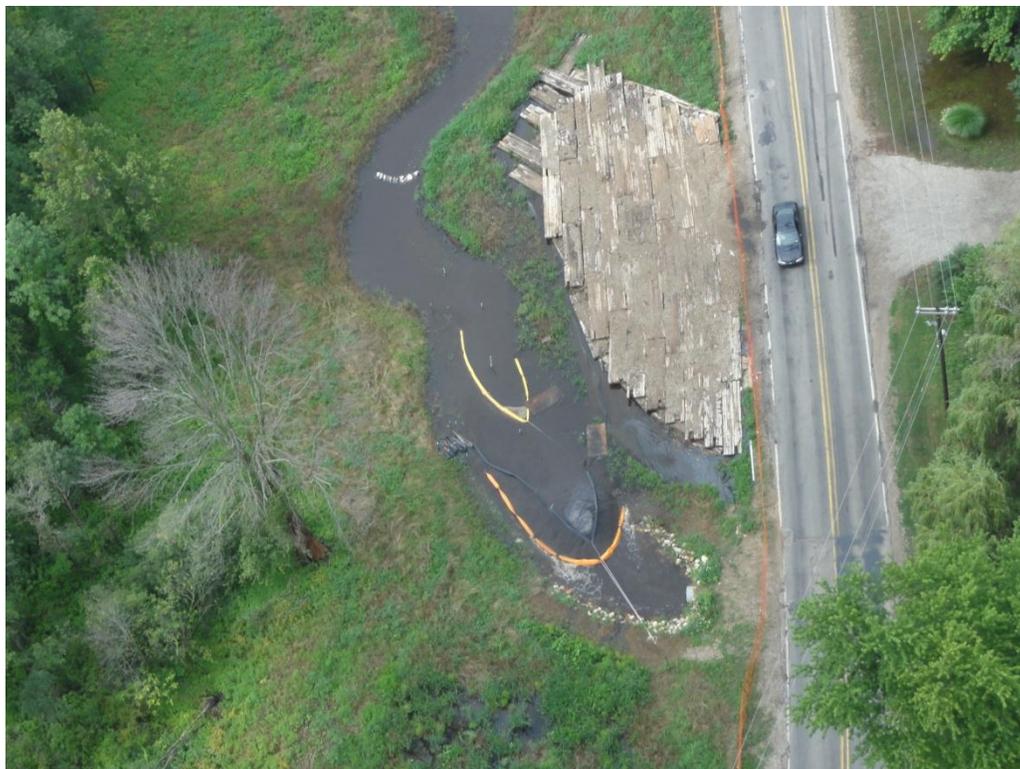
6. B5 Sediment Trap, water levels higher than containment.

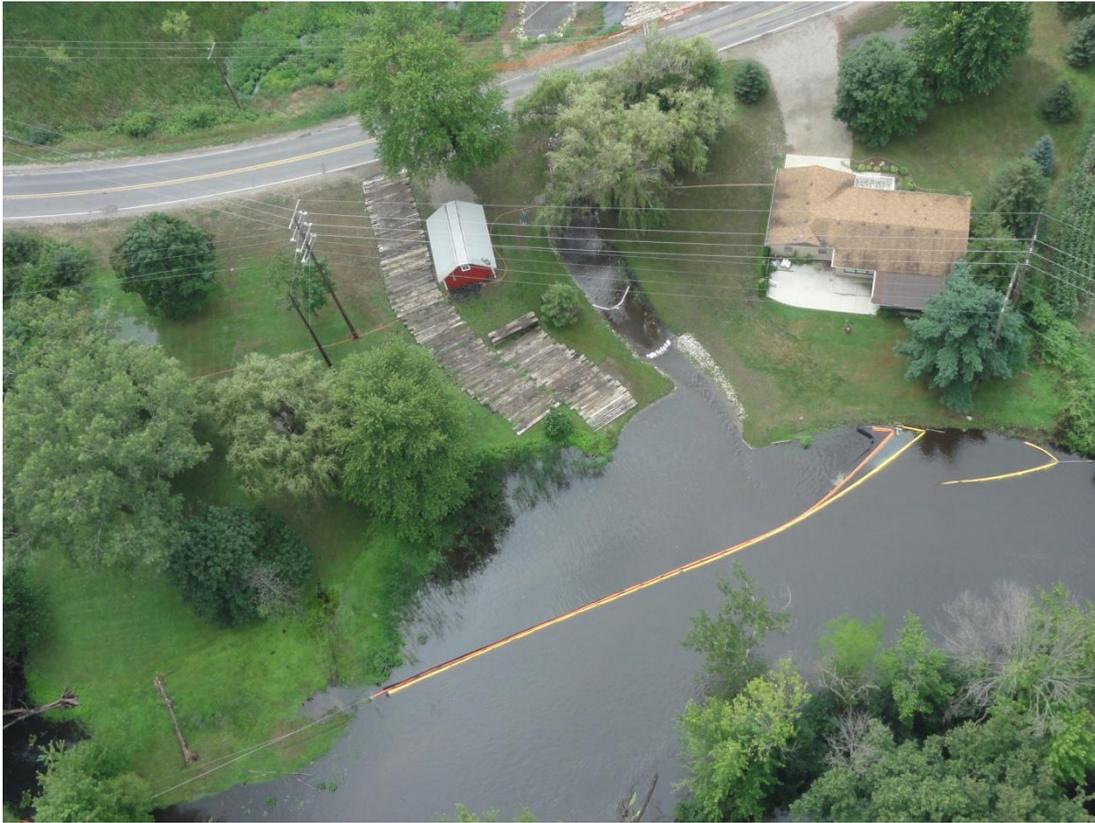
7. Confluence, no sheen observed.

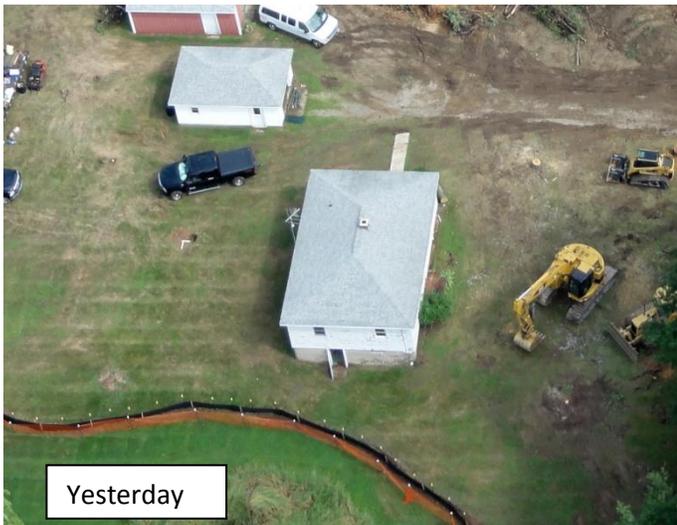
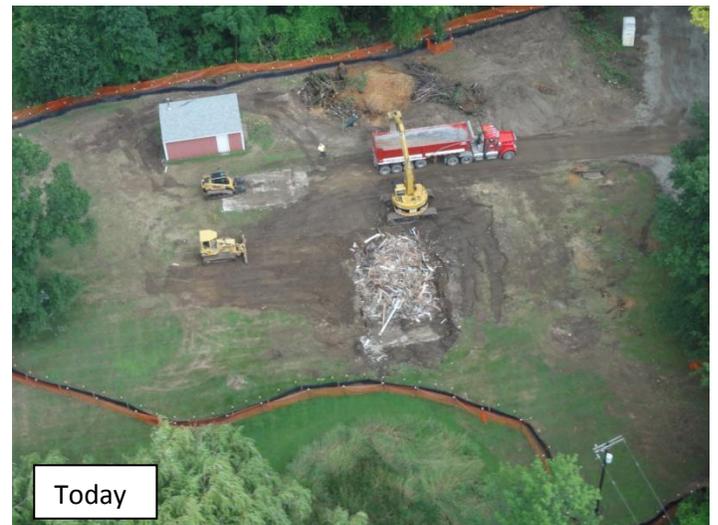
8. House Demolition/cleanup at MP2.25 for future river public access point.

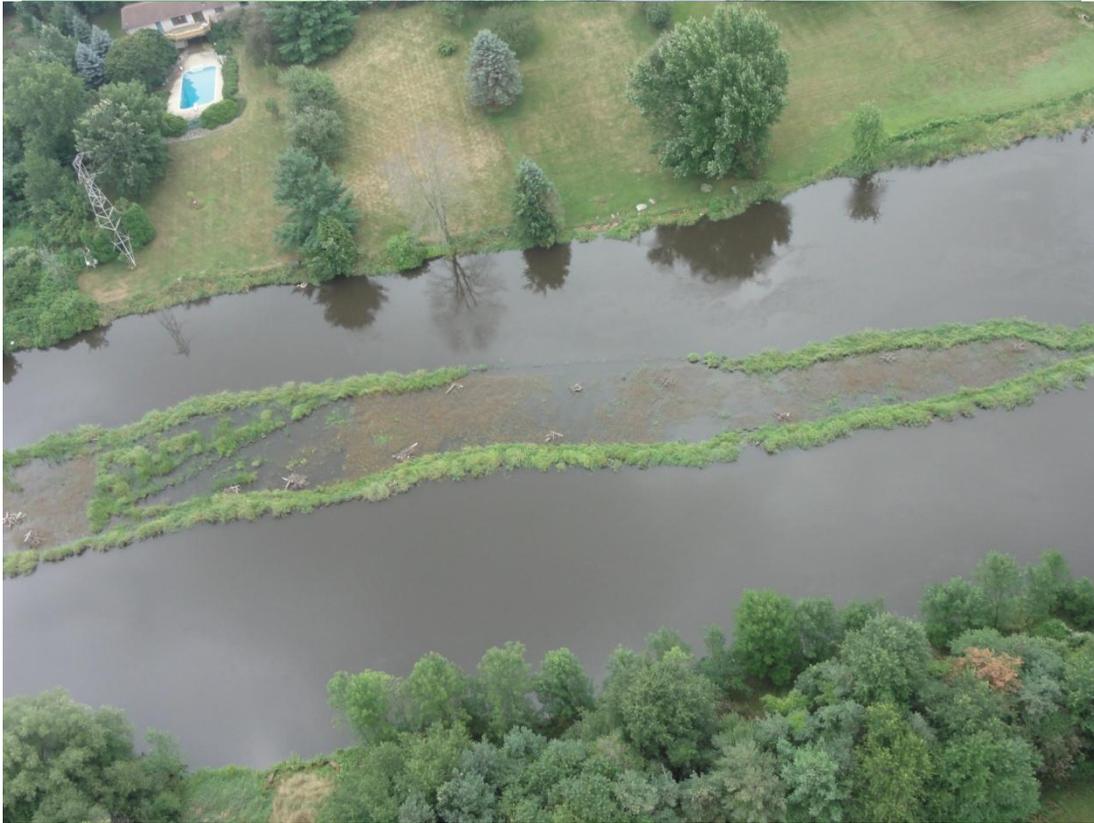
9. Island A, island is partially under water due to overnight rains.

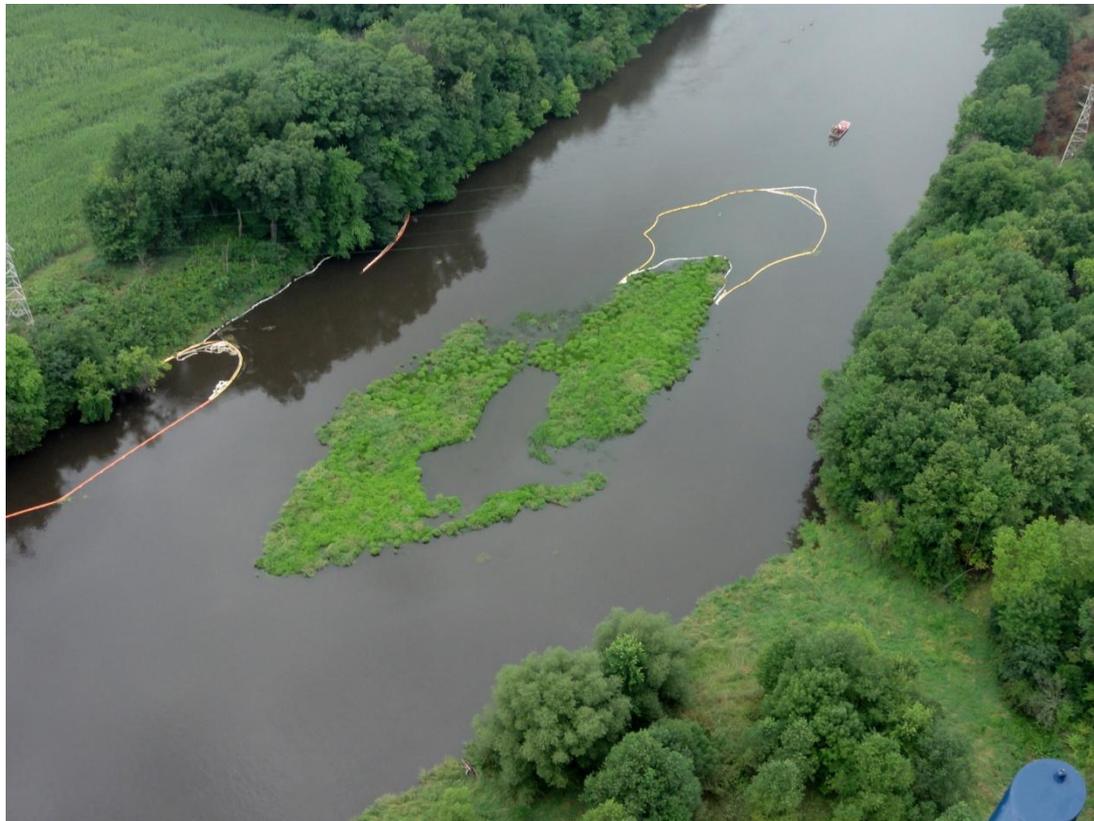
10. Island E, boom remains on downstream side of island.

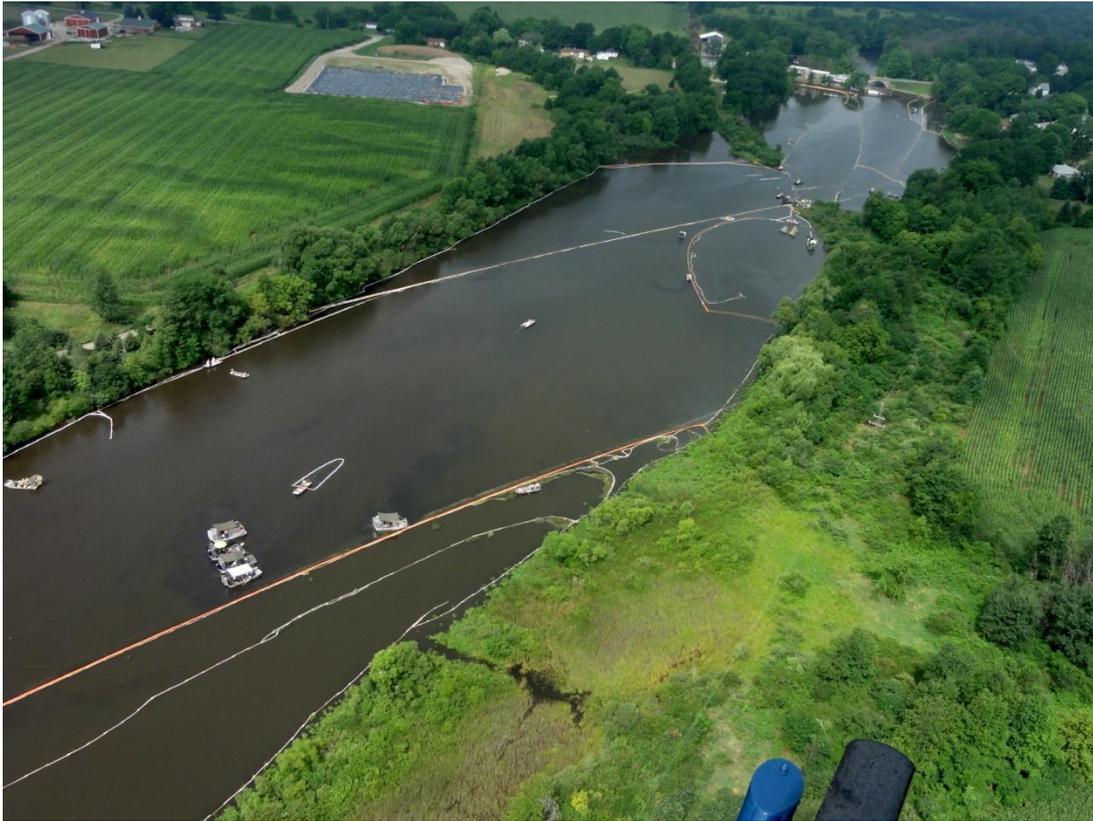
12. MP5.55 submerged oil activities above Ceresco Dam.

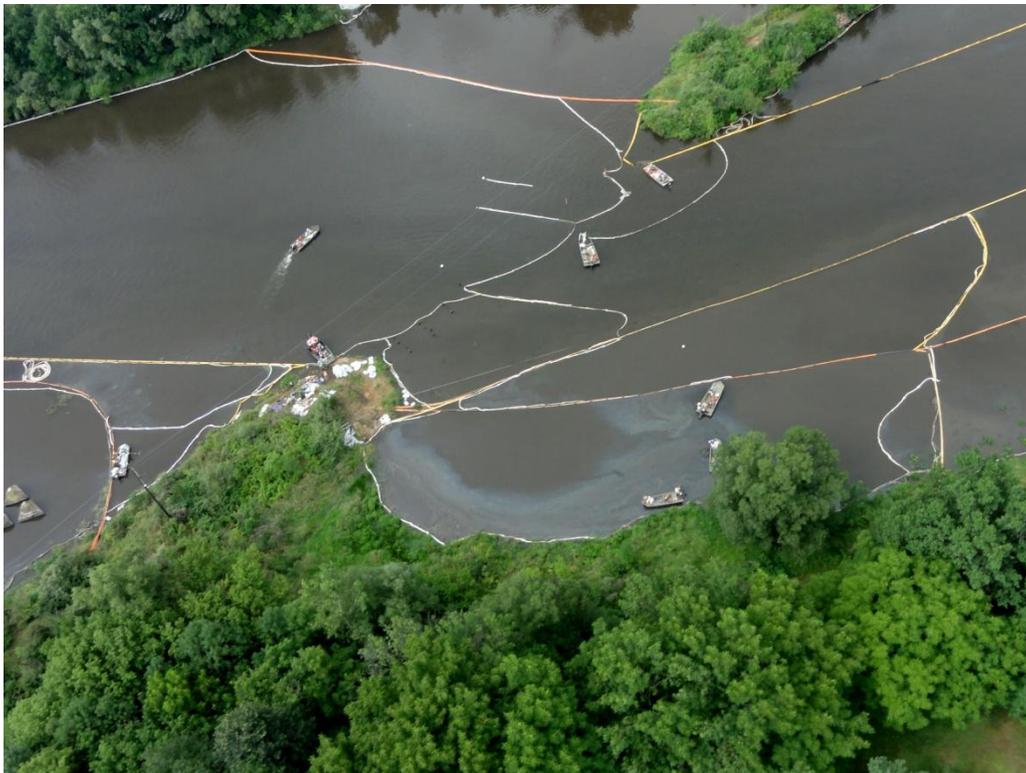
13. MP5.55 submerged oil recovery.

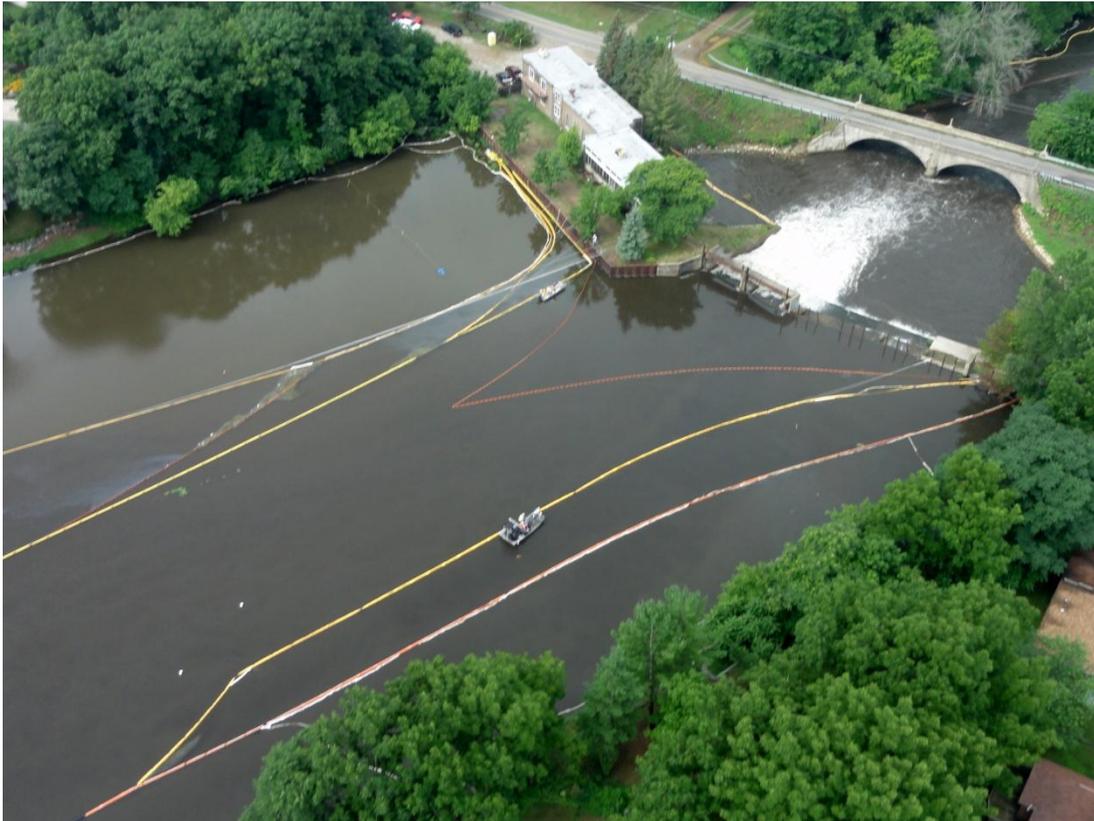
14. Ceresco Dam. Sheen observed within containment.

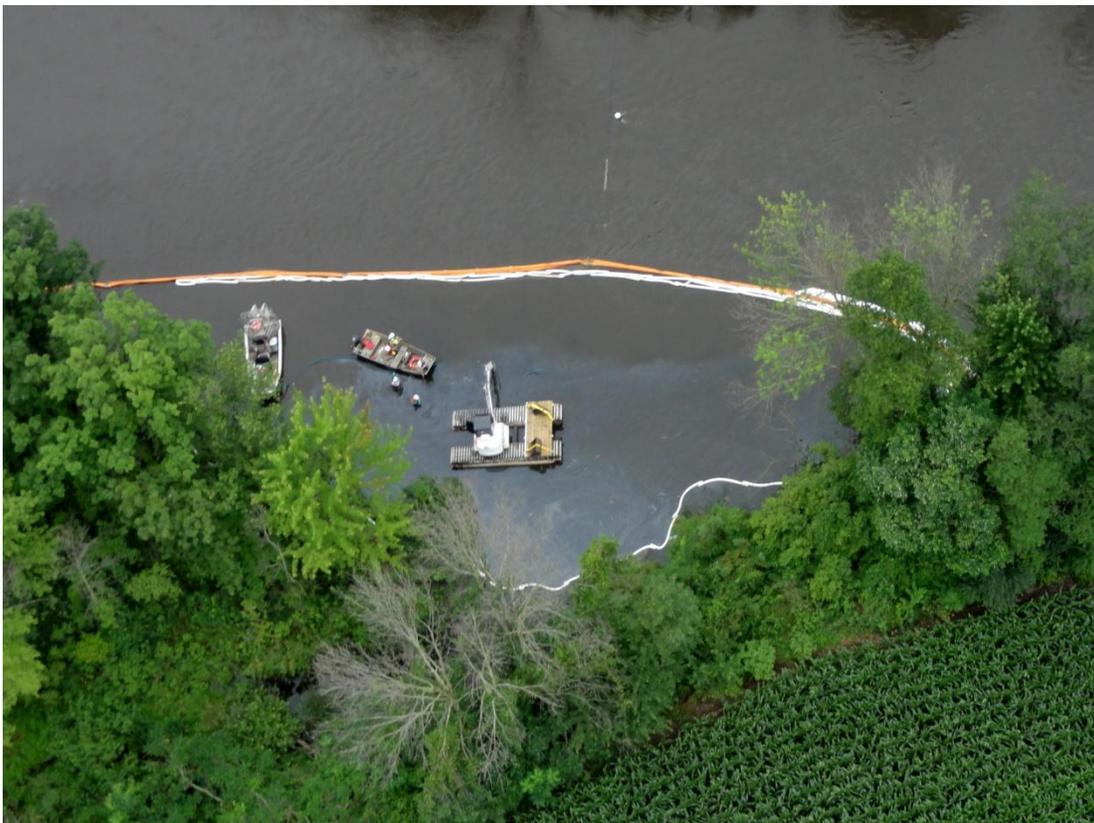
15. Swamp buggy working near MP8.0.

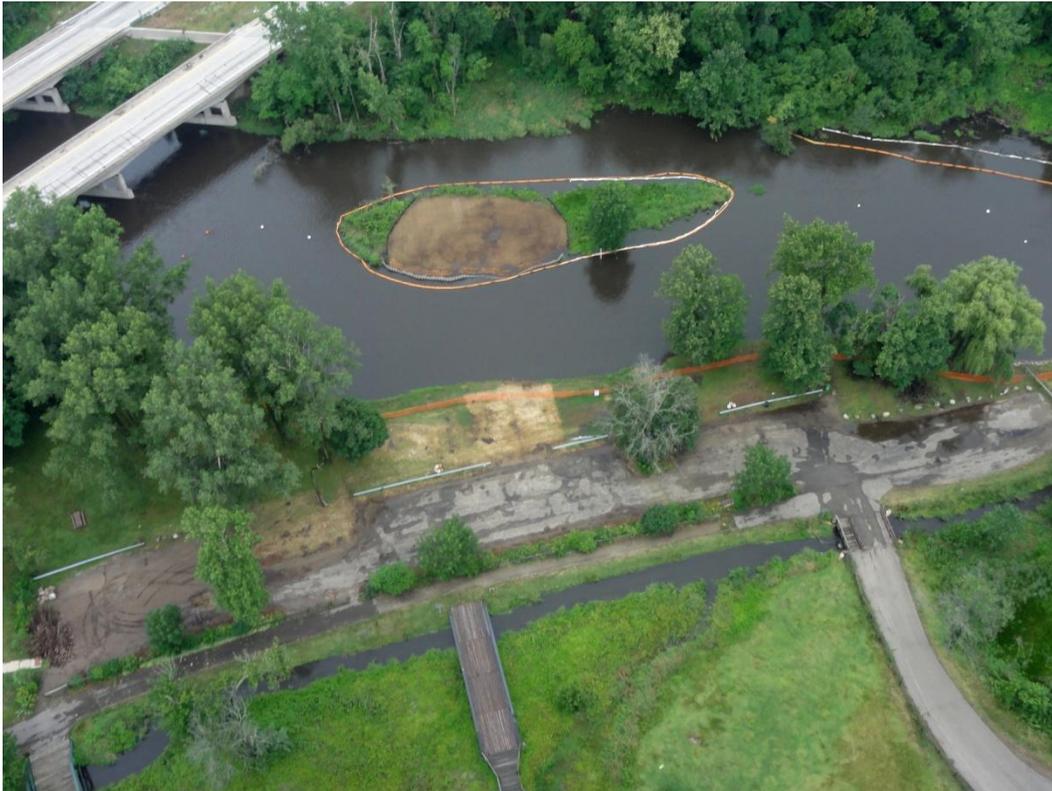
16. MP9.5 Island, work has been completed.

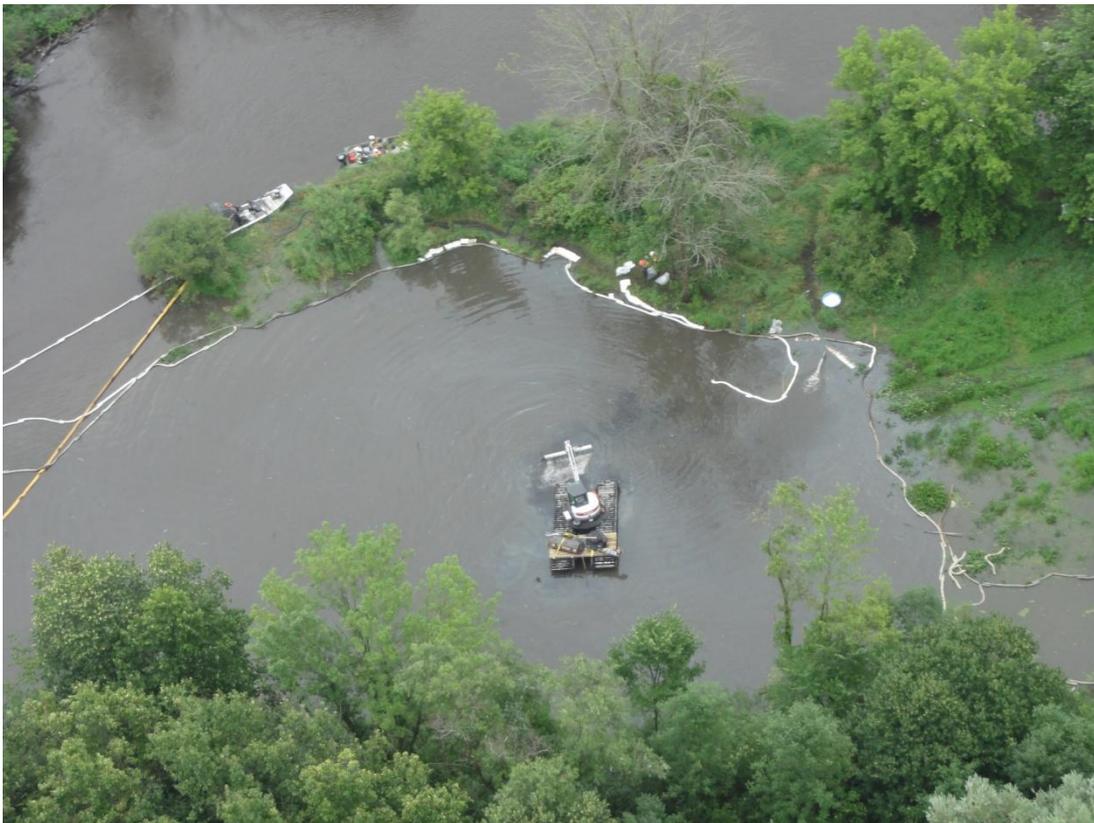
17. MP10.5. Swamp buggy conducting submerged oil work.

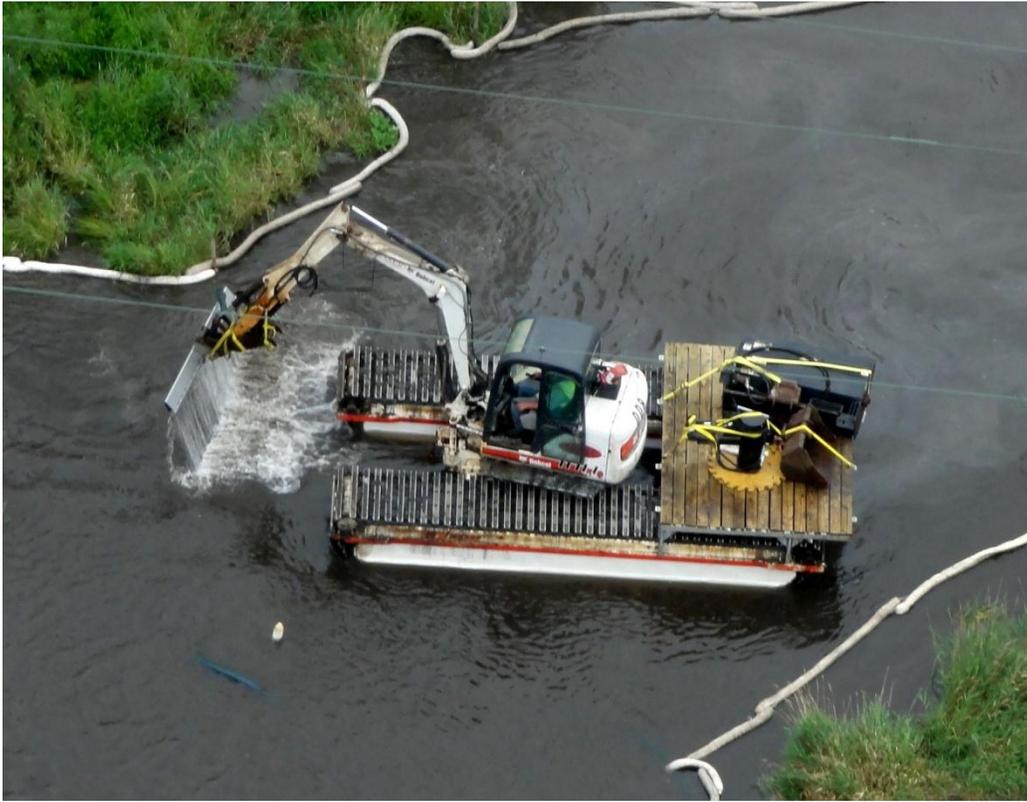
18. MP10.75, close up of swamp buggy with water jet attachment.

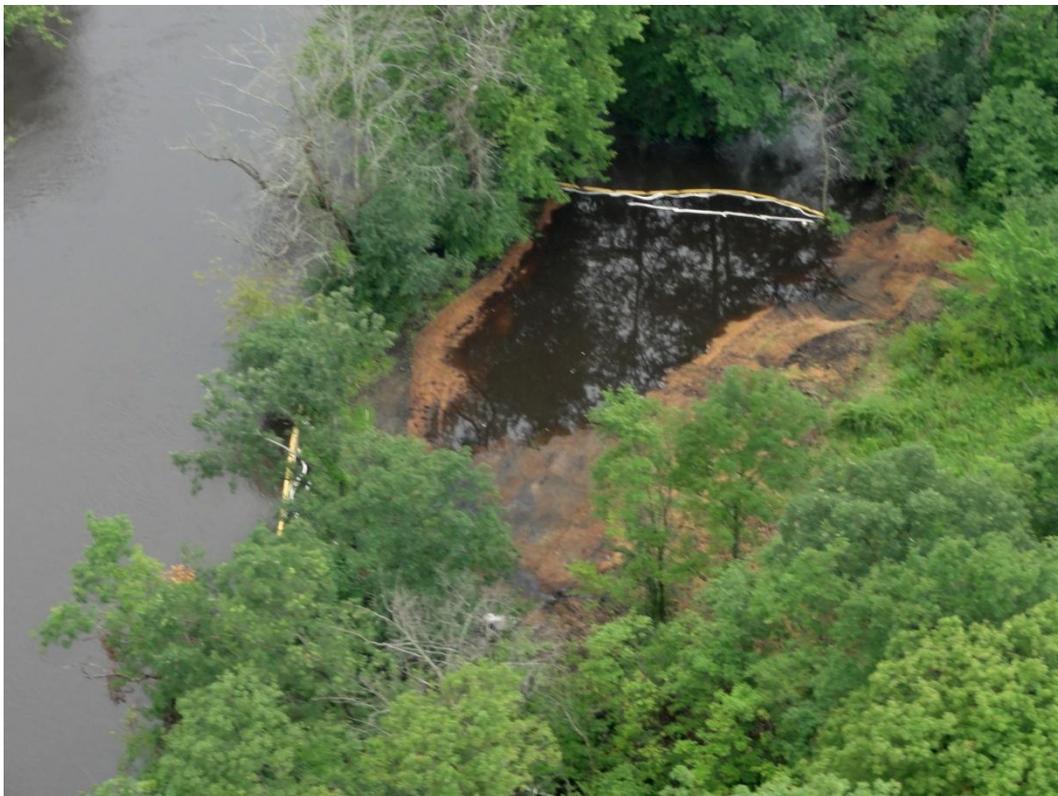
19. MP11.25R1, no activity noted.

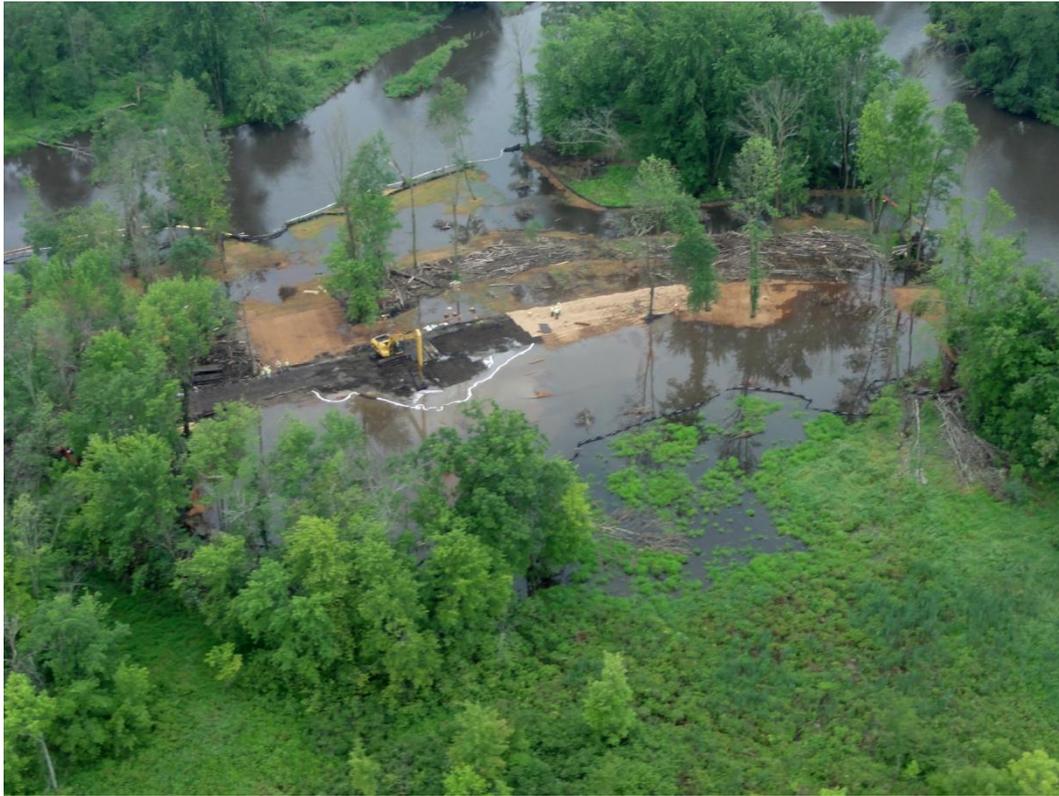
20. MP11.25R2, road mat removal continues. Much of area under water.

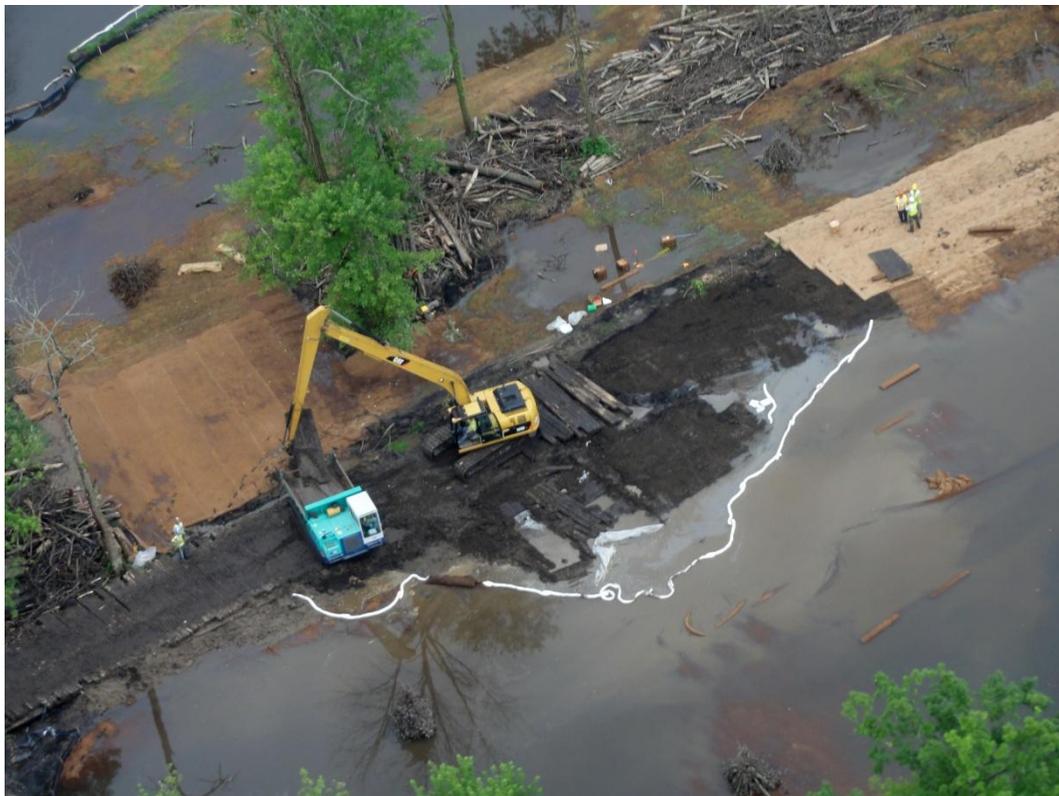
21. MP11.25R2, mat road removal.

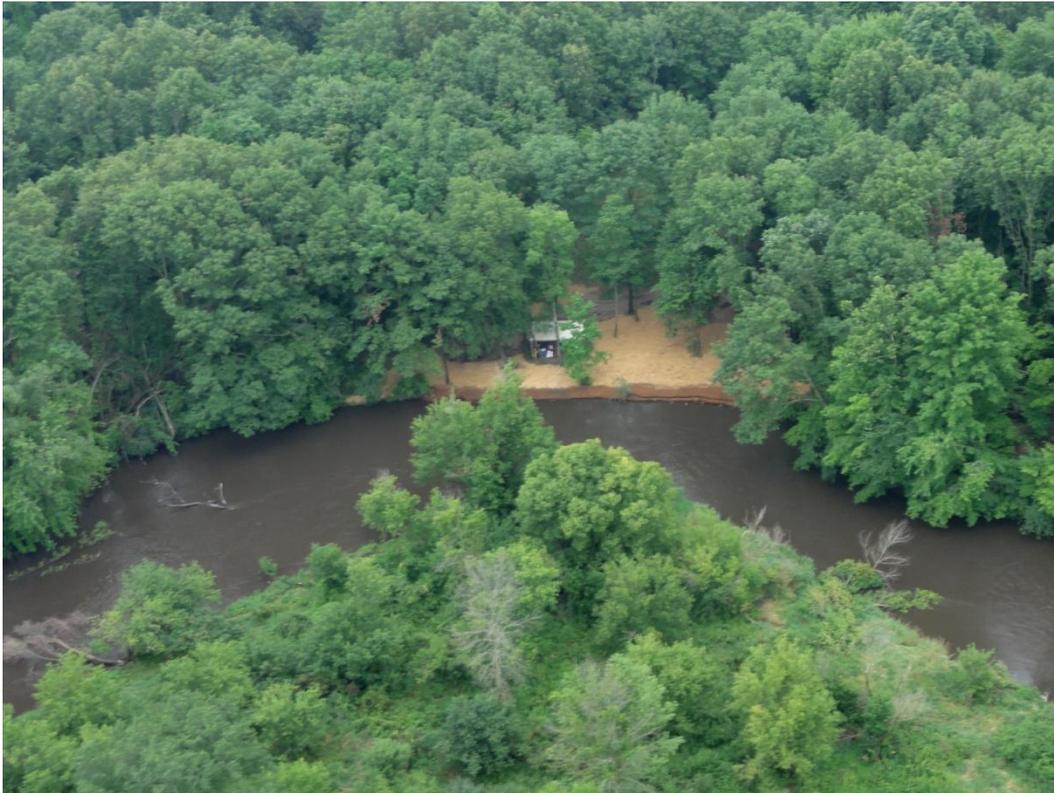
22. MP12.6, shoreline restoration work appears complete.

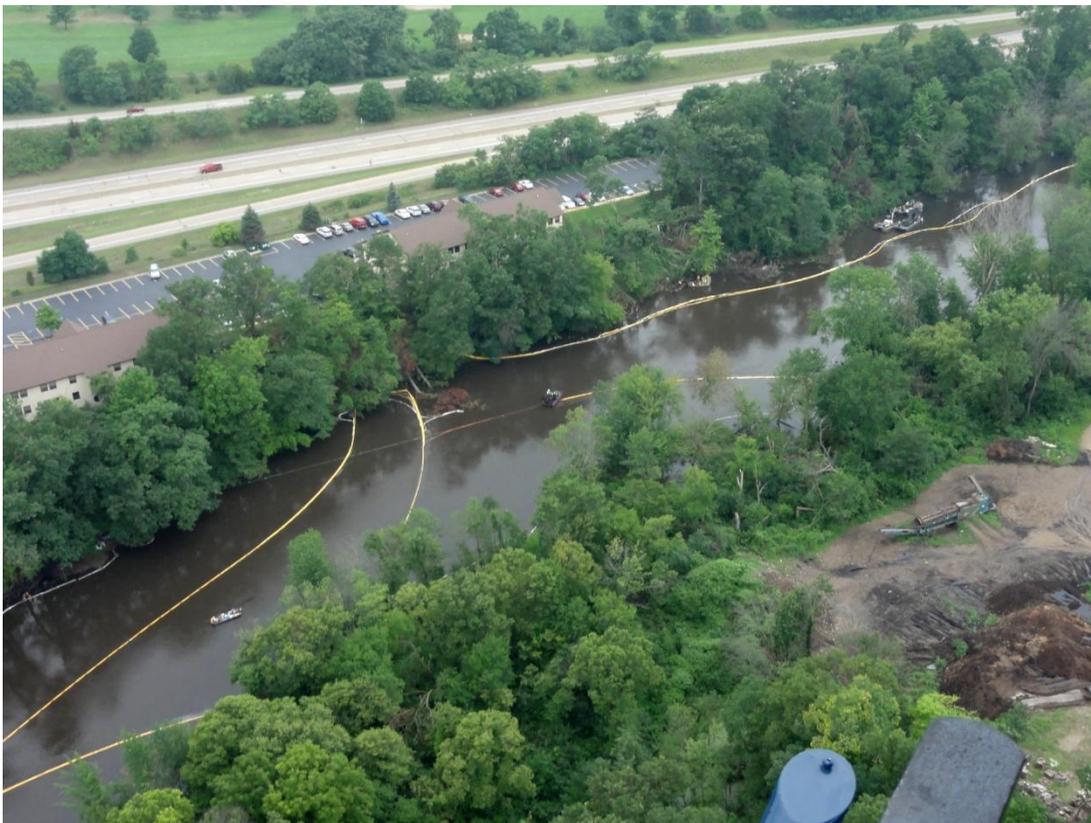
23. MP14.35, overview of boom configuration.

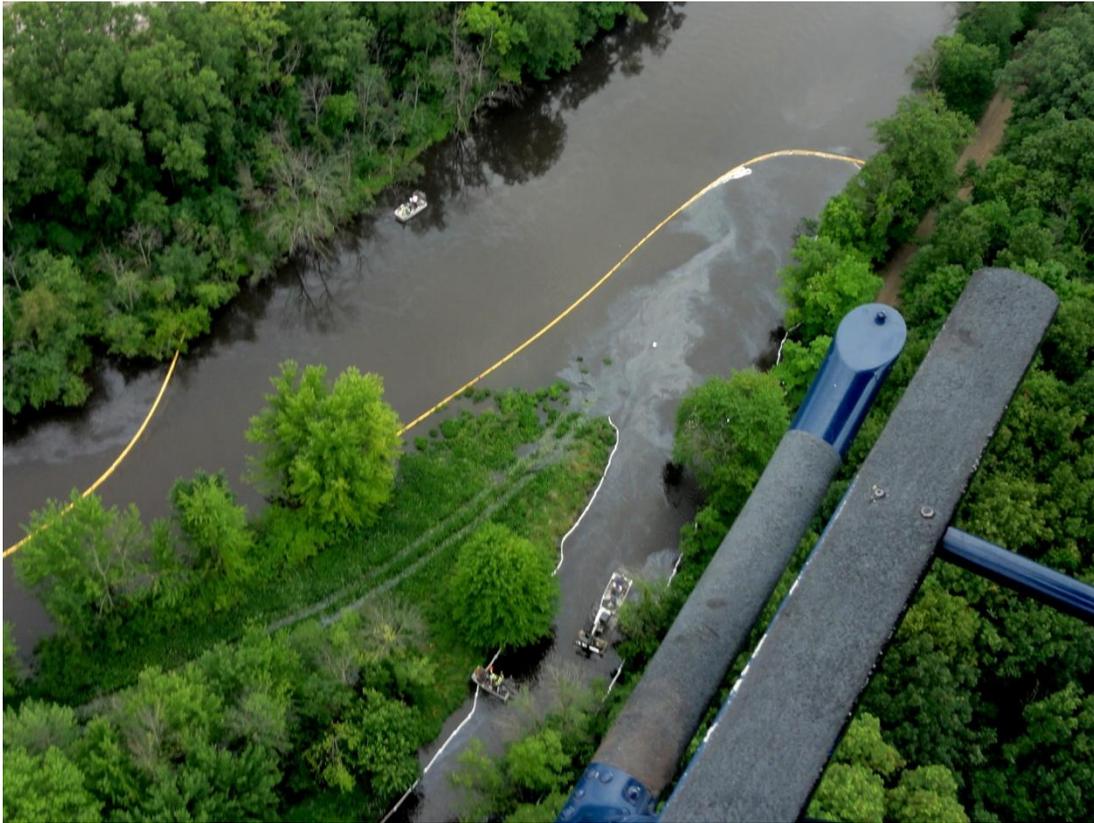
24. MP15.00, sheen observed within containment.

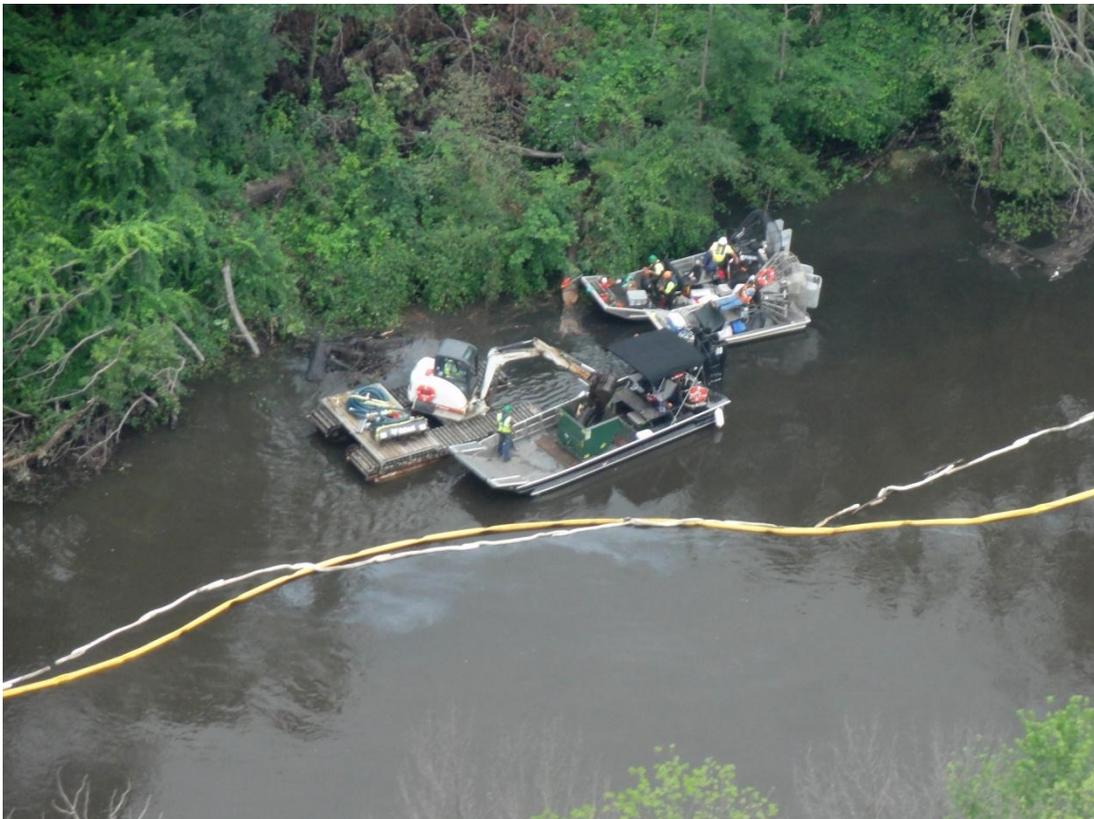
25. MP14.35, vegetation / debris removal.

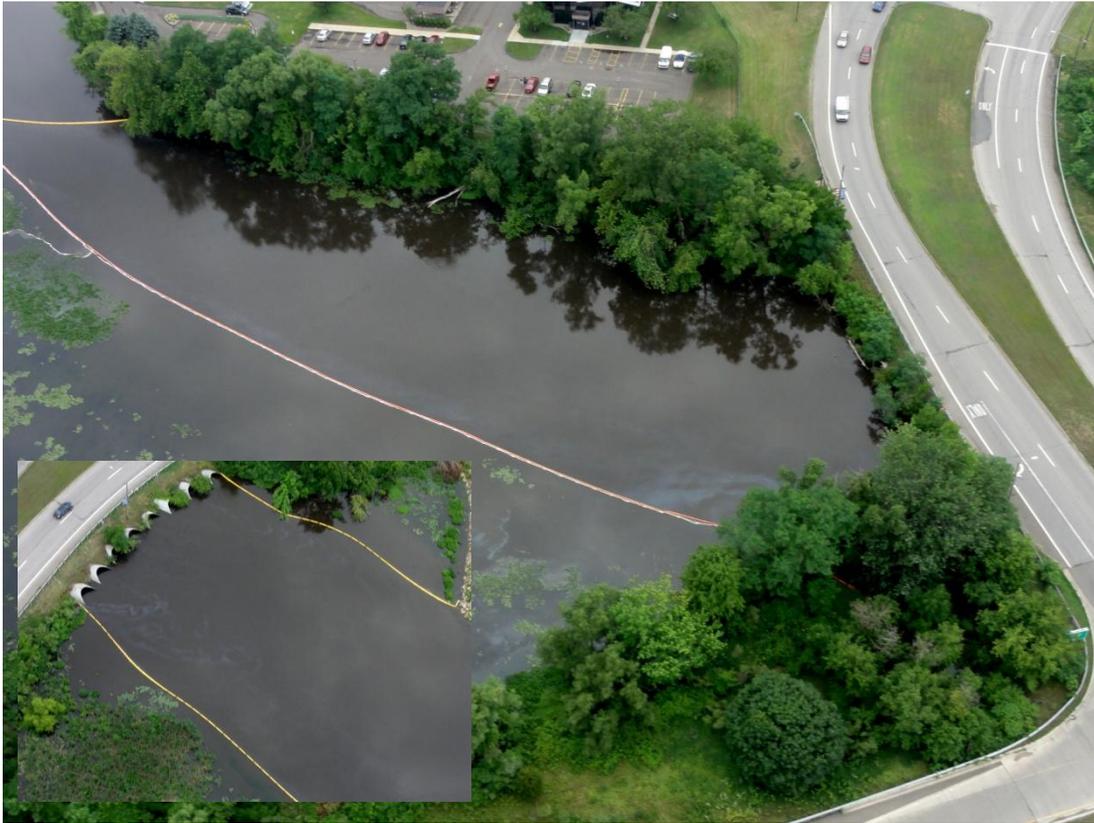
26. MP15.75, sheen from upstream activities observed going over spillway.

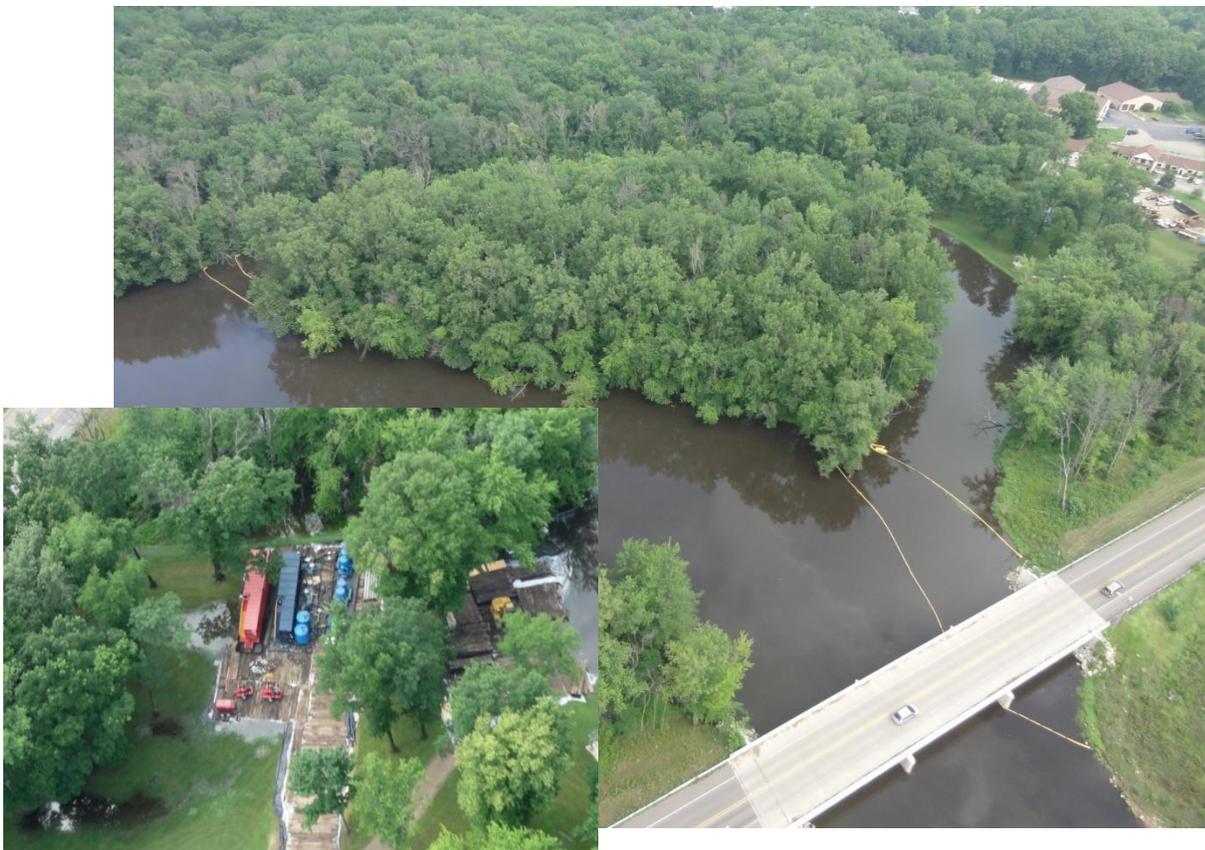
27. MP21.5 Oxbow, GAC system set up.
