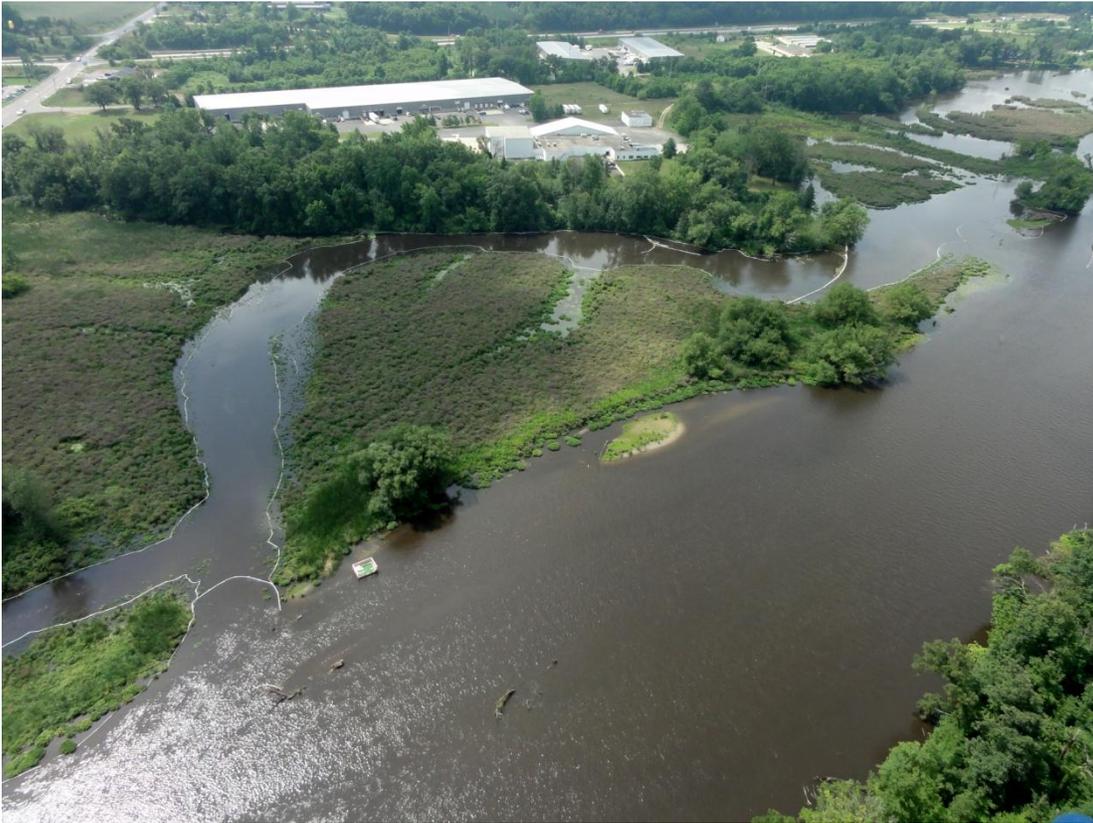
28. Morrow Lake Delta, no activity noted in Delta A.

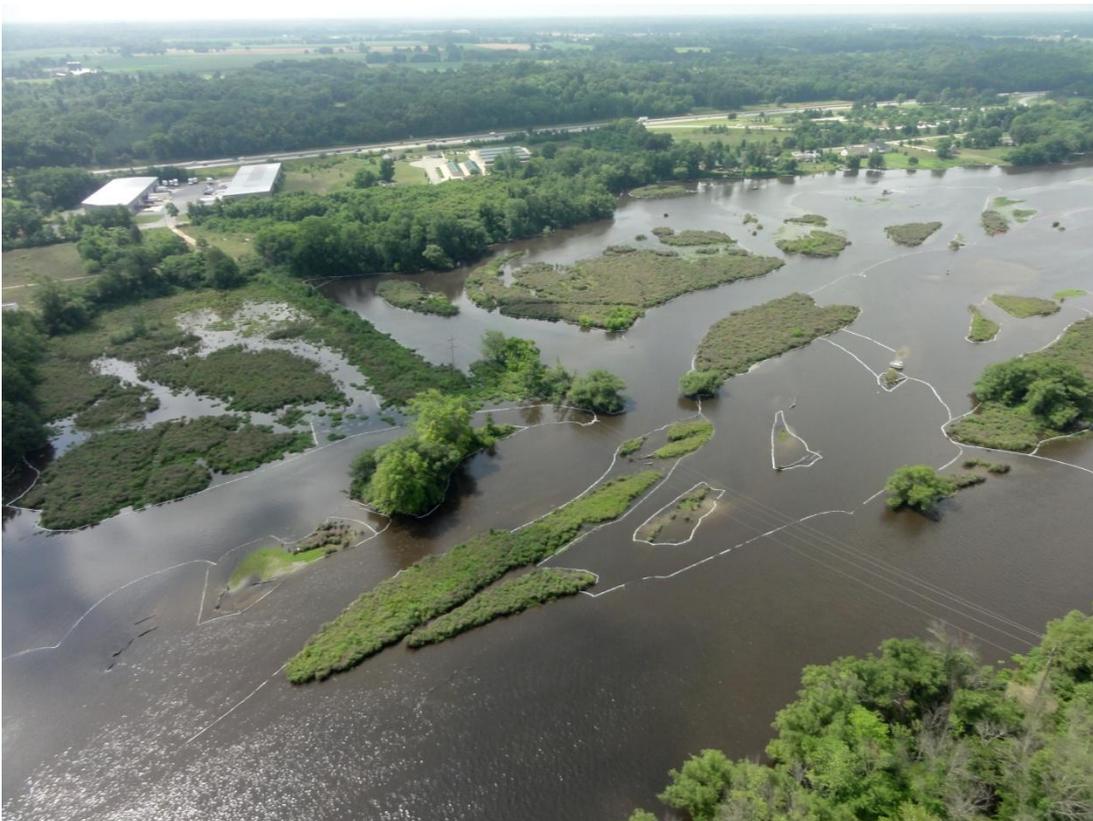
29. Central portion of Morrow Lake Delta.

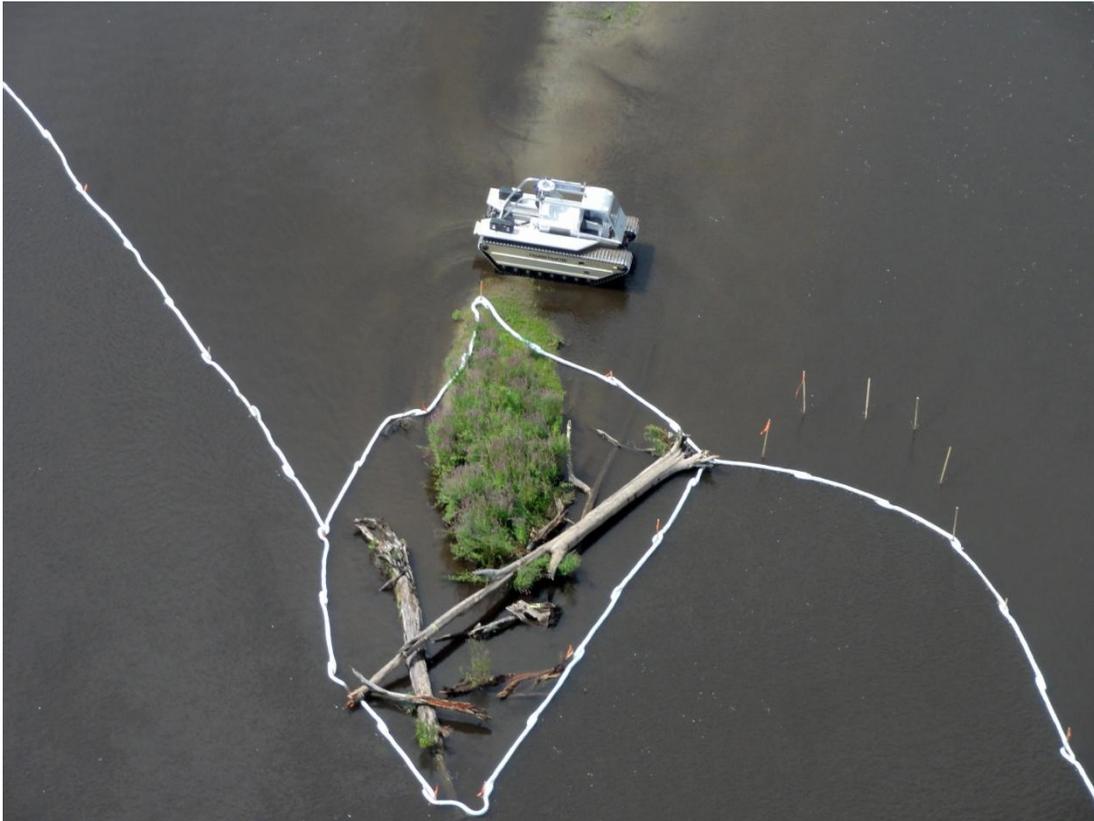
30. Marsh Master parked on sand bar in Morrow Lake Delta.

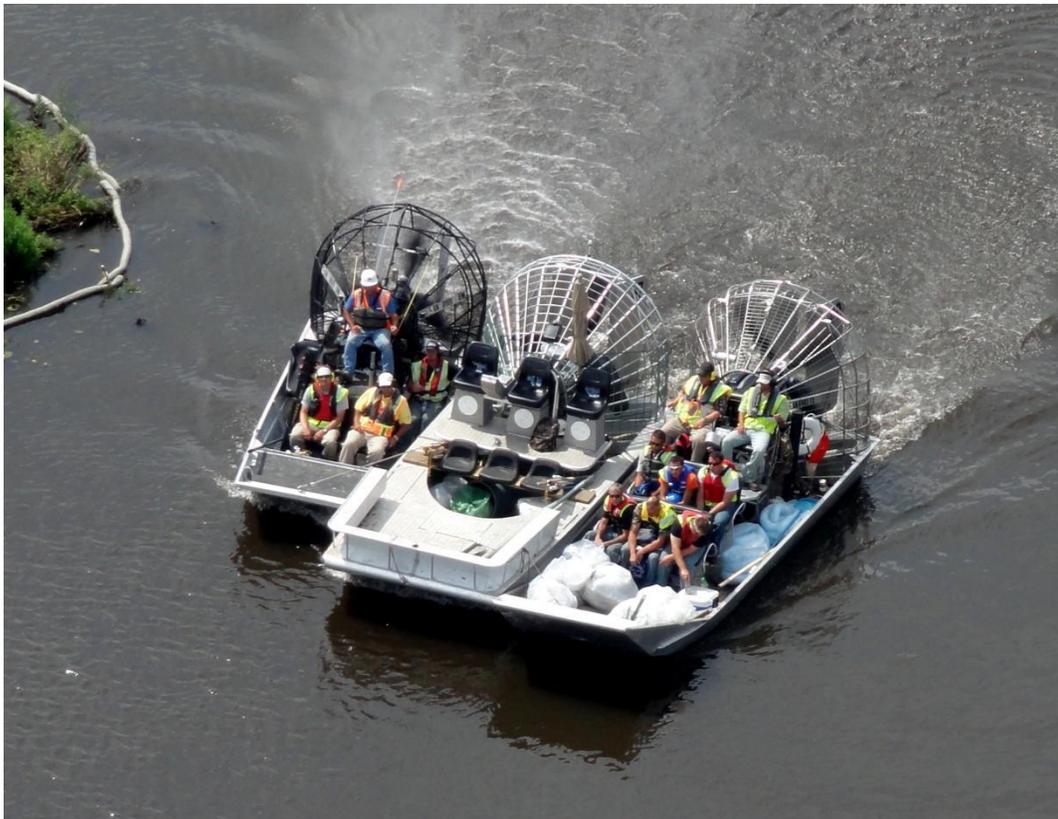
31. Towing in a broken airboat on Morrow Lake Delta.

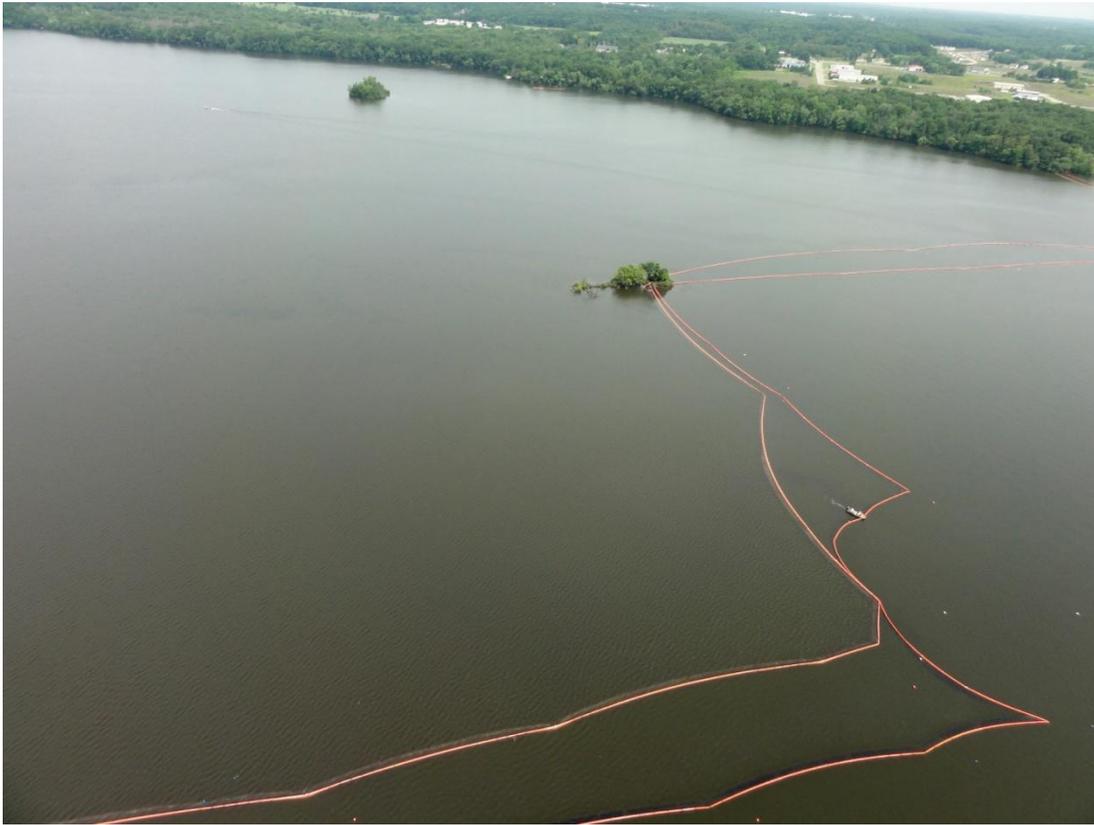
32. Control Point E4.5, boom maintenance.

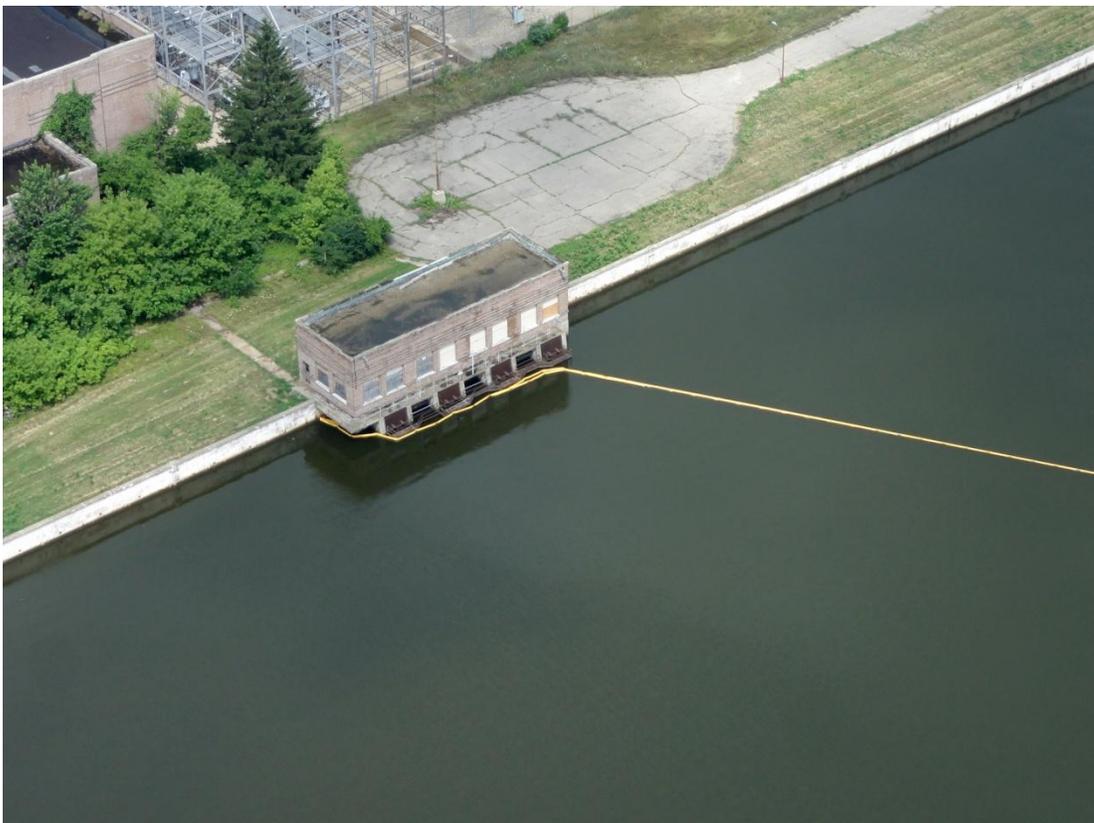
33. Control Point E6.0. No sheen or debris noted.

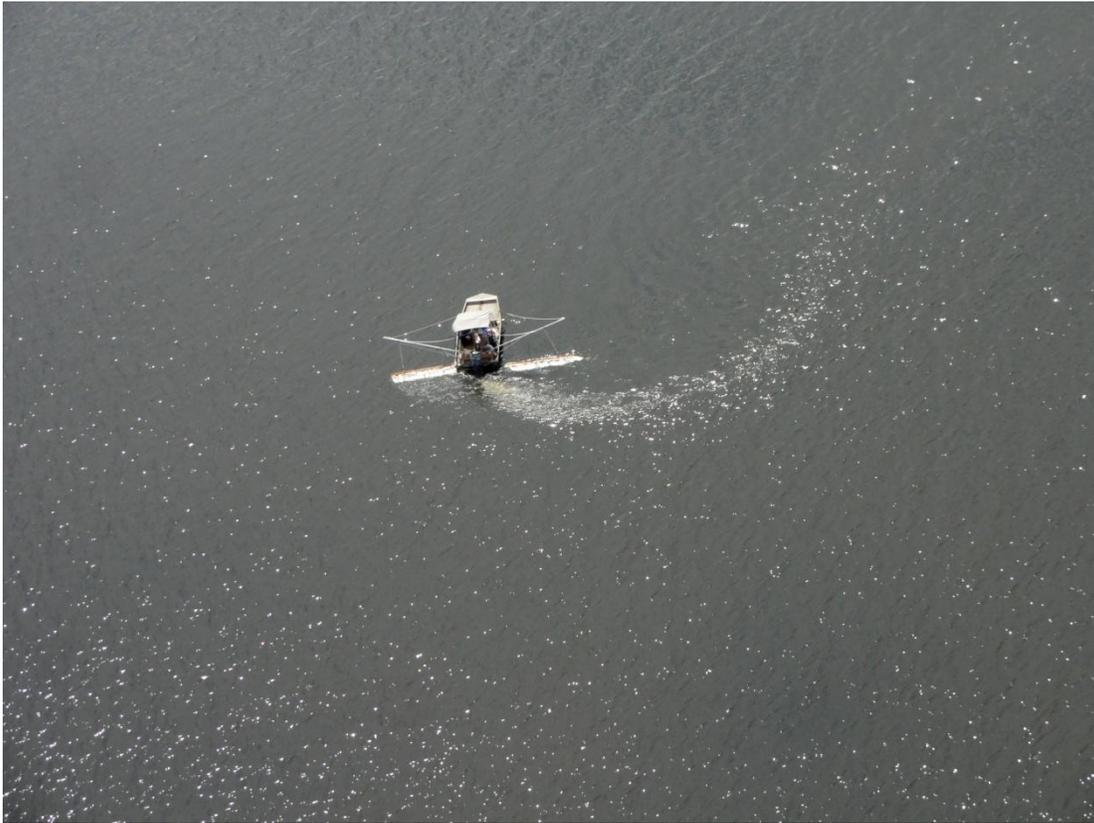
34. Skimmer boat in northeastern portion of Morrow Lake.

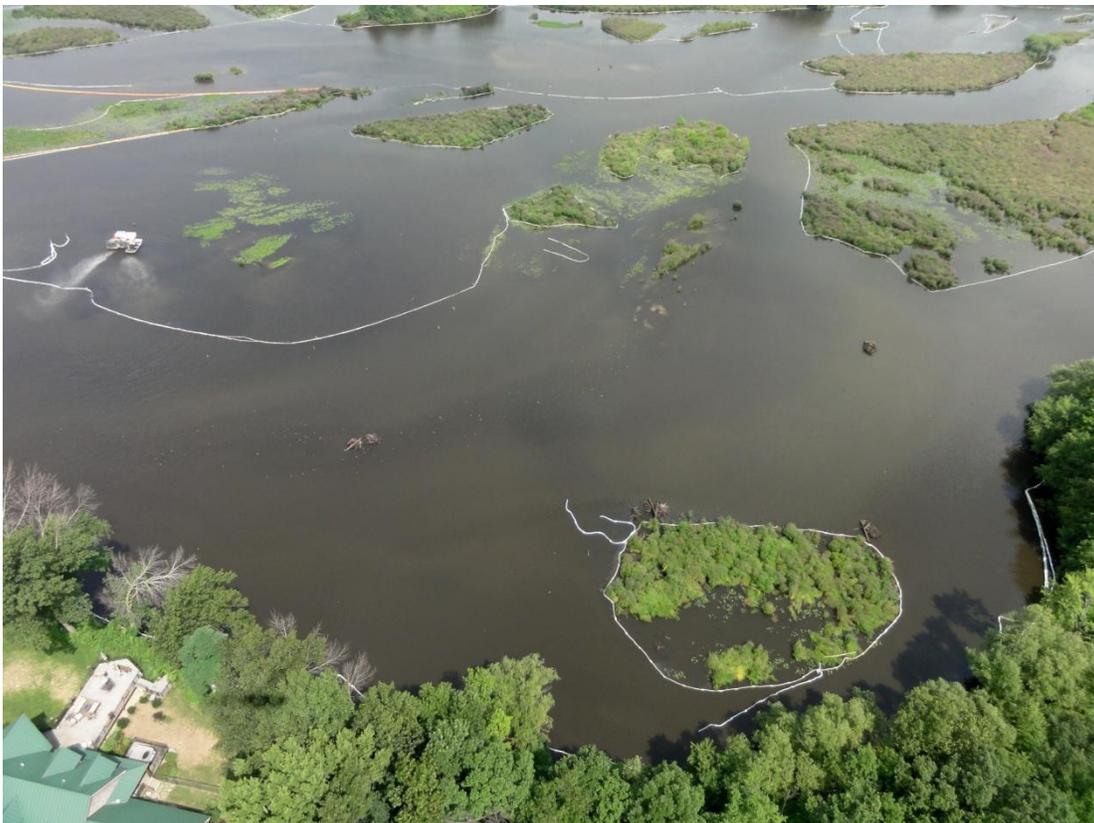
35. South shore of Morrow Lake Delta. No sheen observed.
