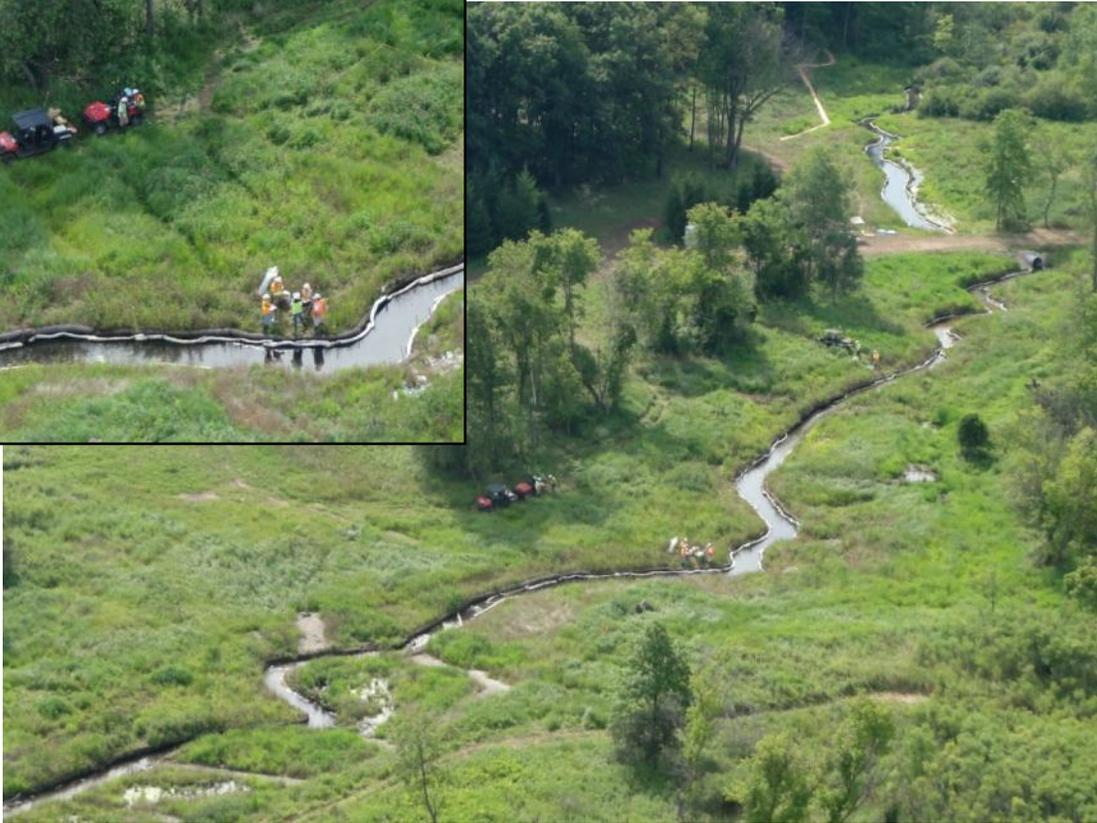
1. Talmadge Creek RI continued.

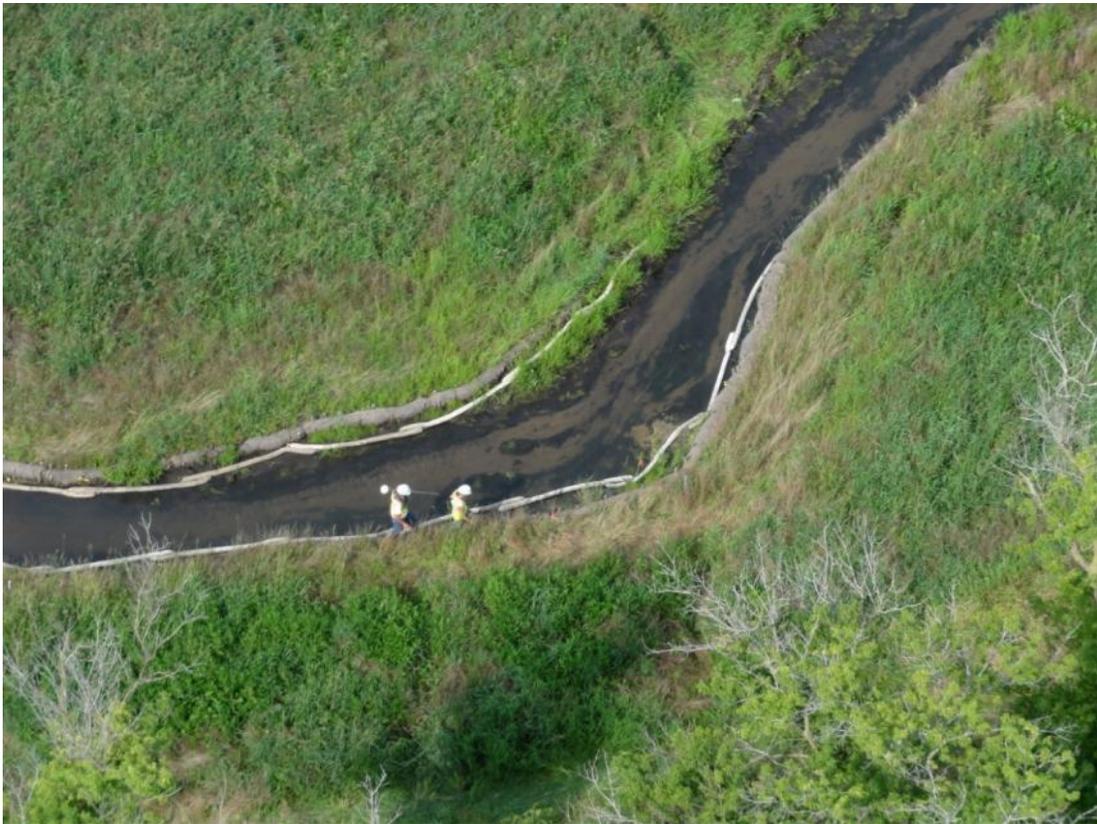
2. Talmadge Creek RI continued.

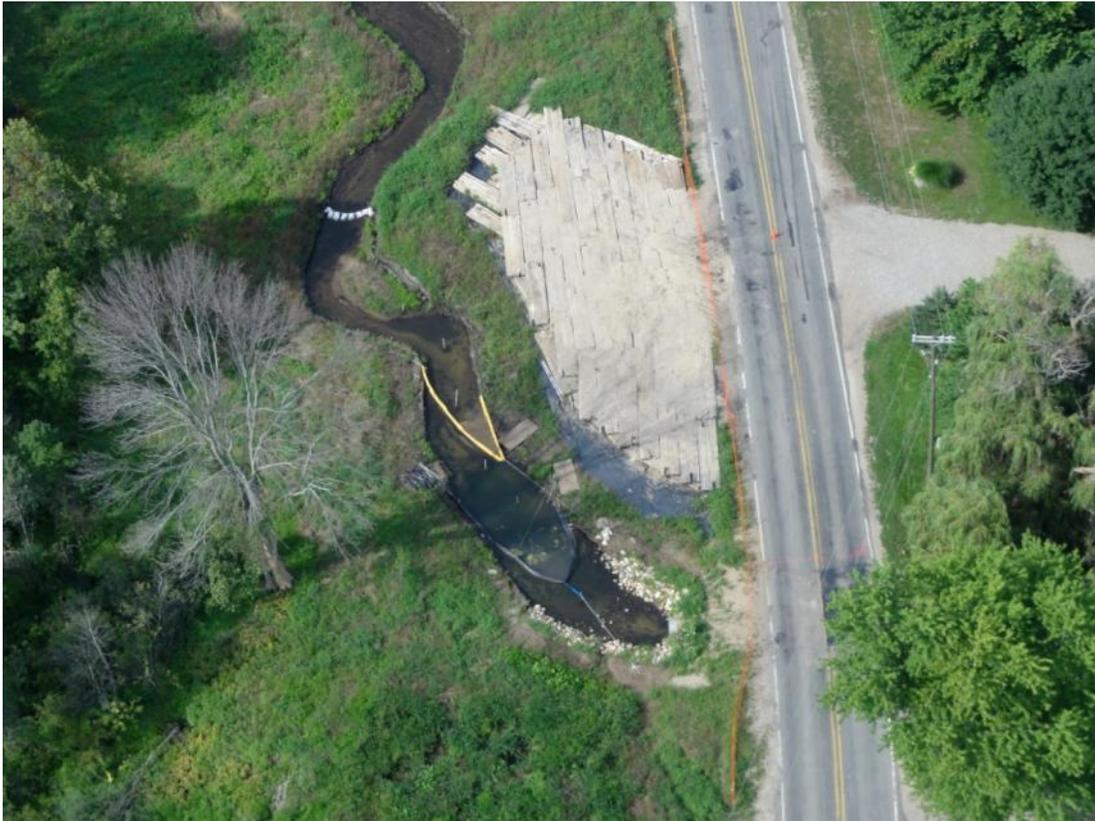
3. B5 Sediment Trap no activity or sheen observed.

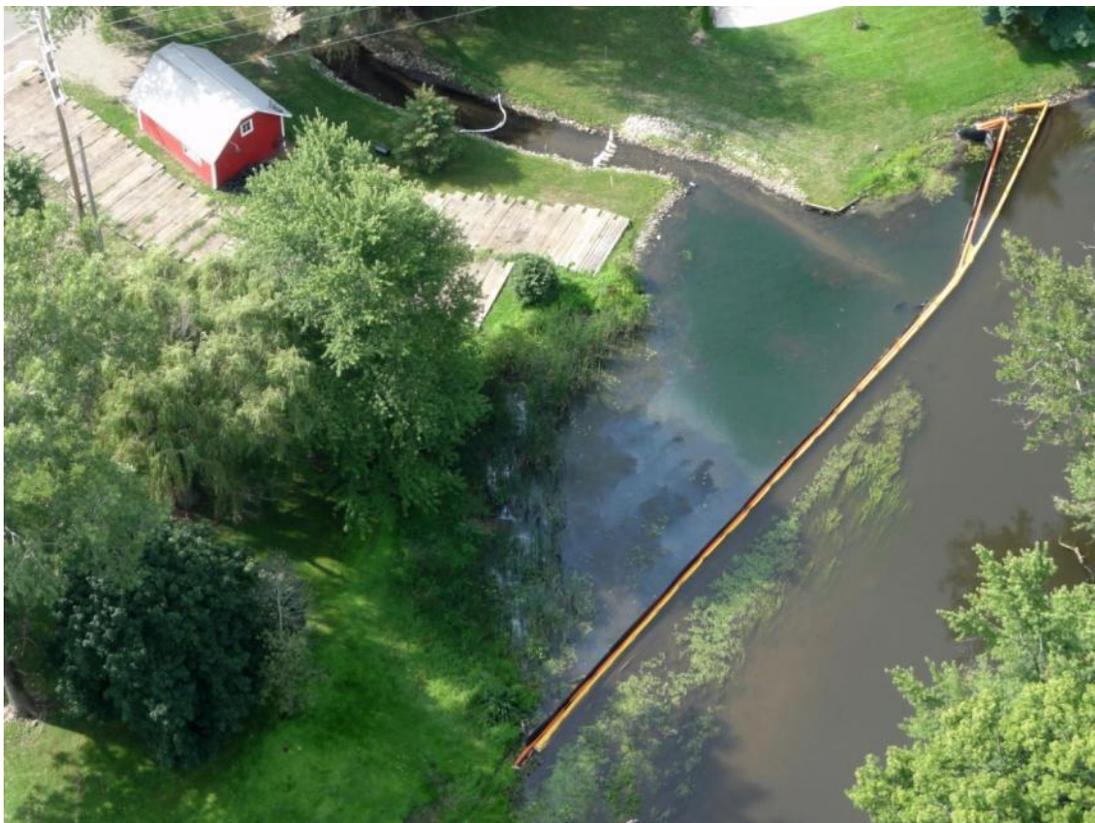
4. Confluence slight sheen observed.

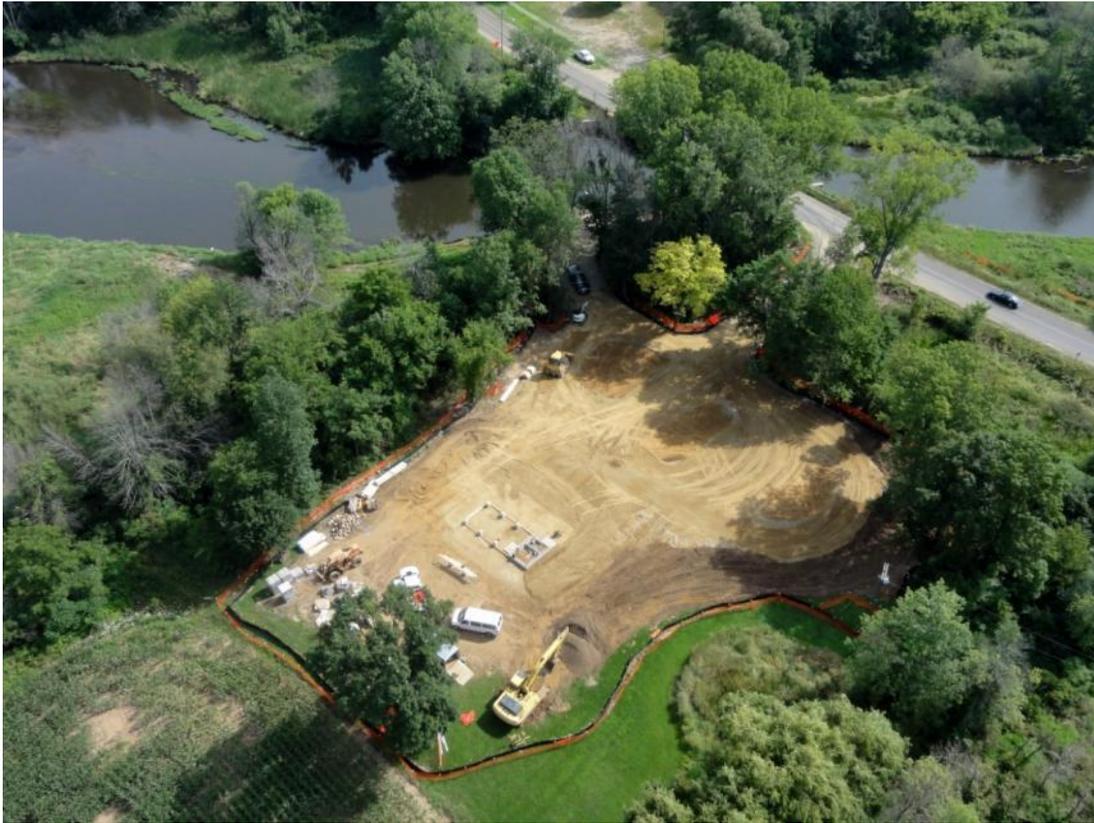
5. MP2.25 public river access progress.

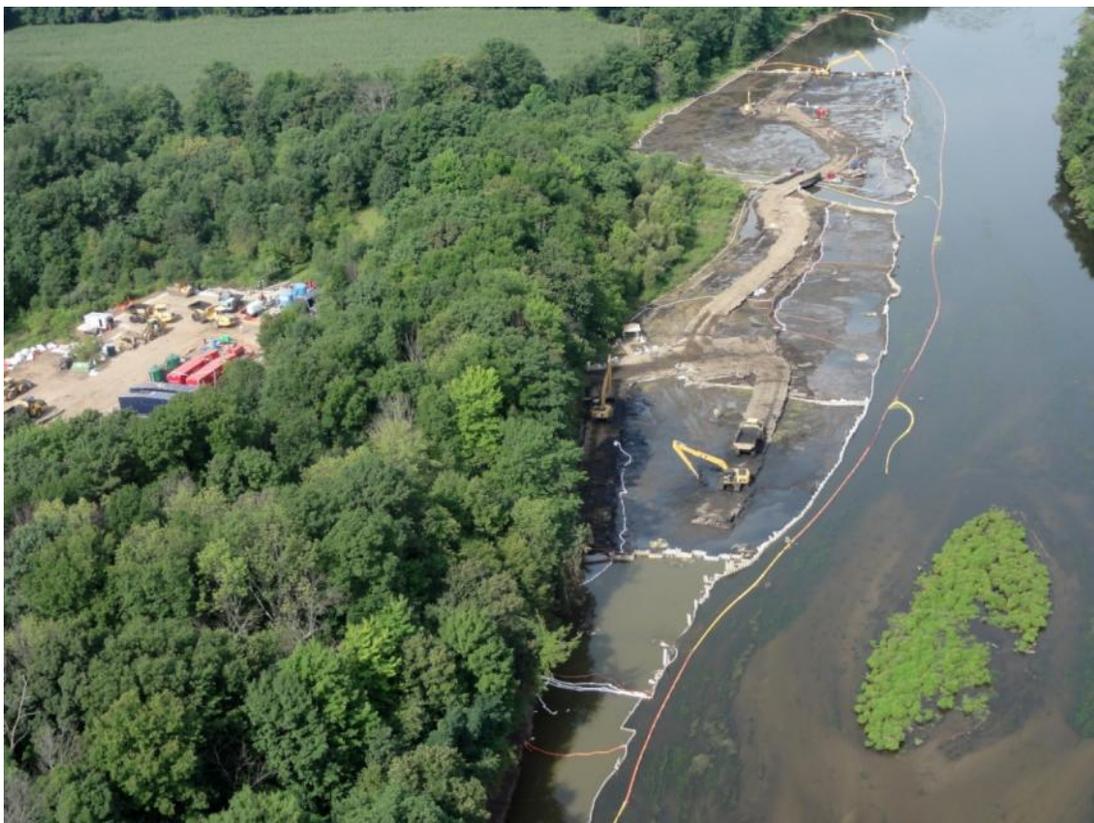
6. MP4.5 excavation work continued.

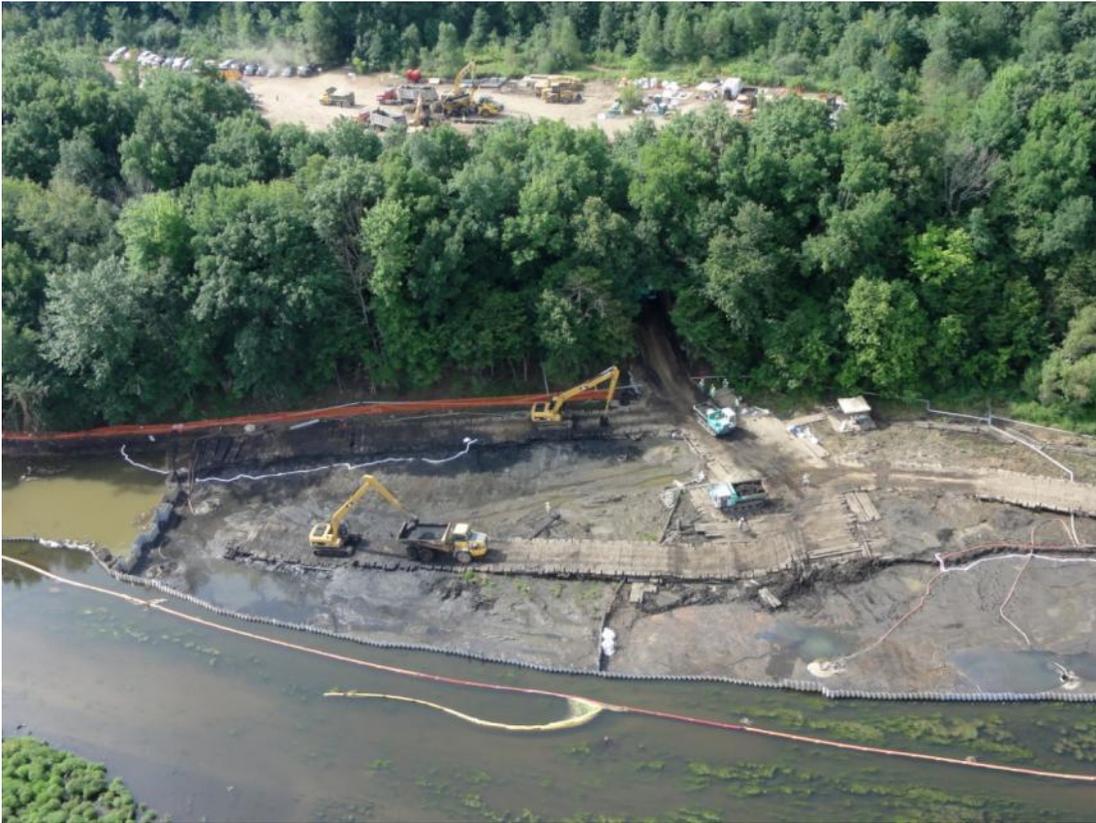
7. MP4.5 excavation work.

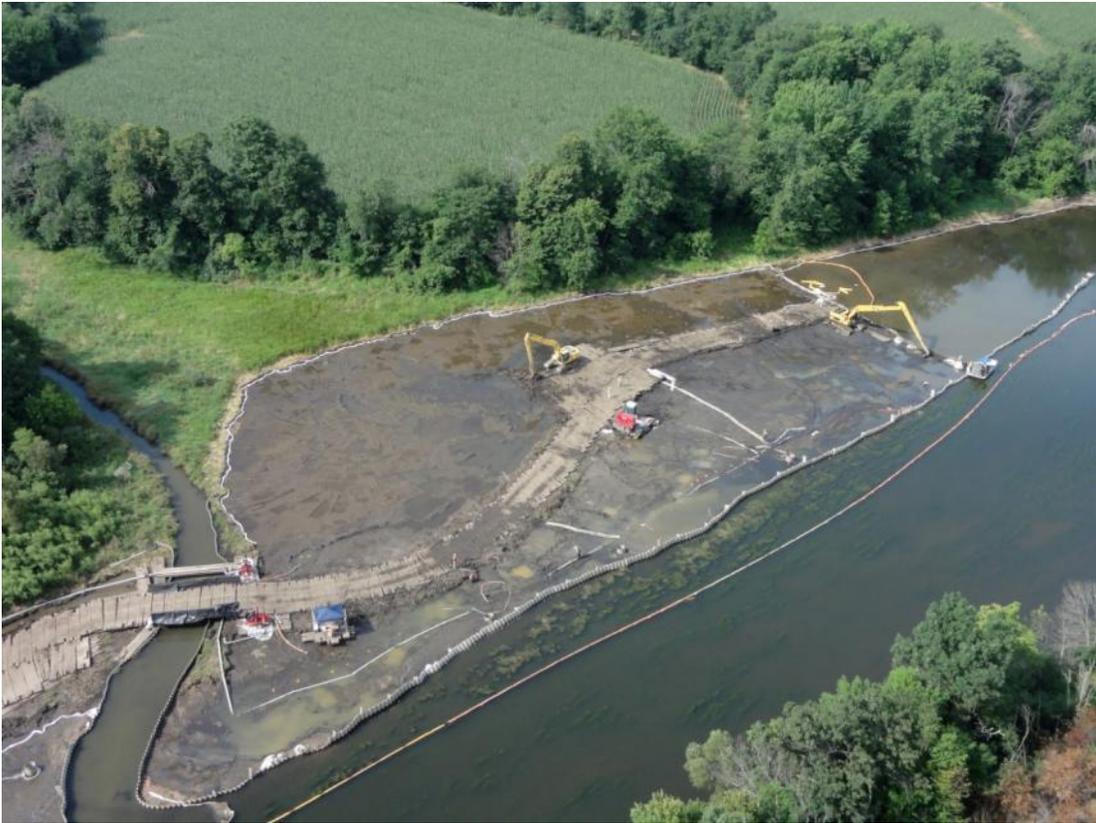
8. MP4.5 Excavation work.

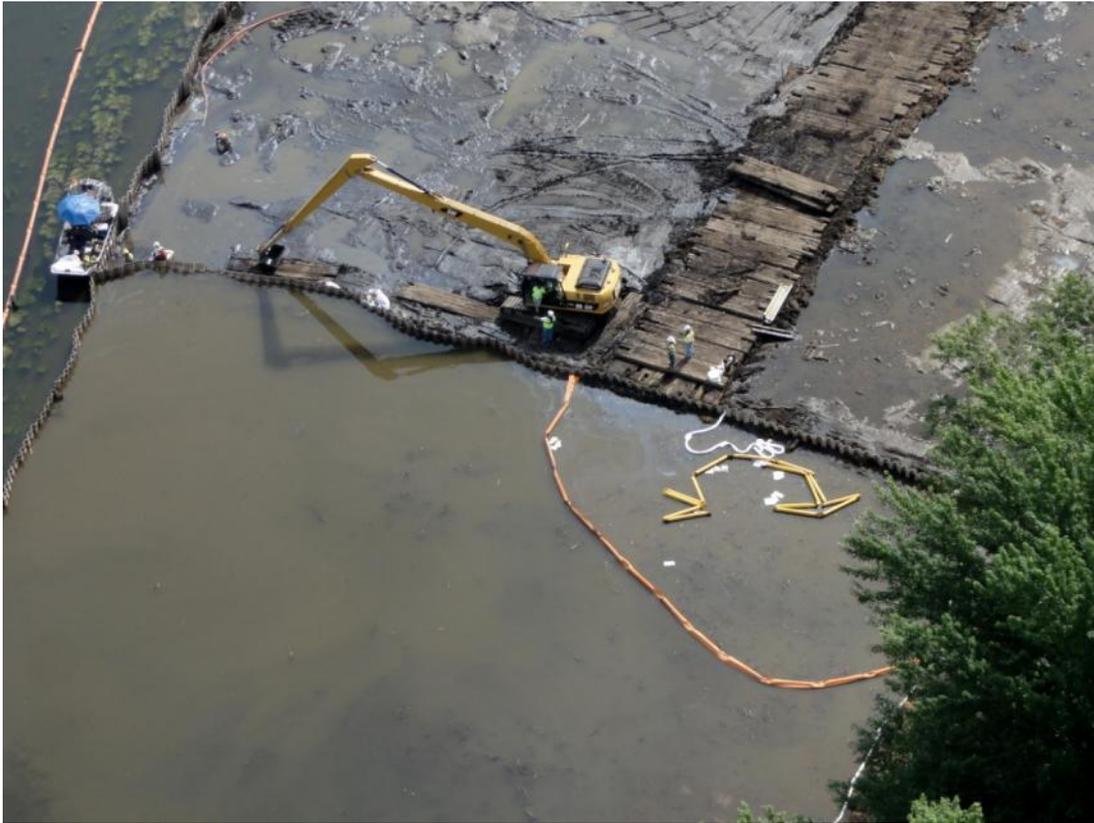
9. MP4.5 excavation work, boom deployed sheen observed.

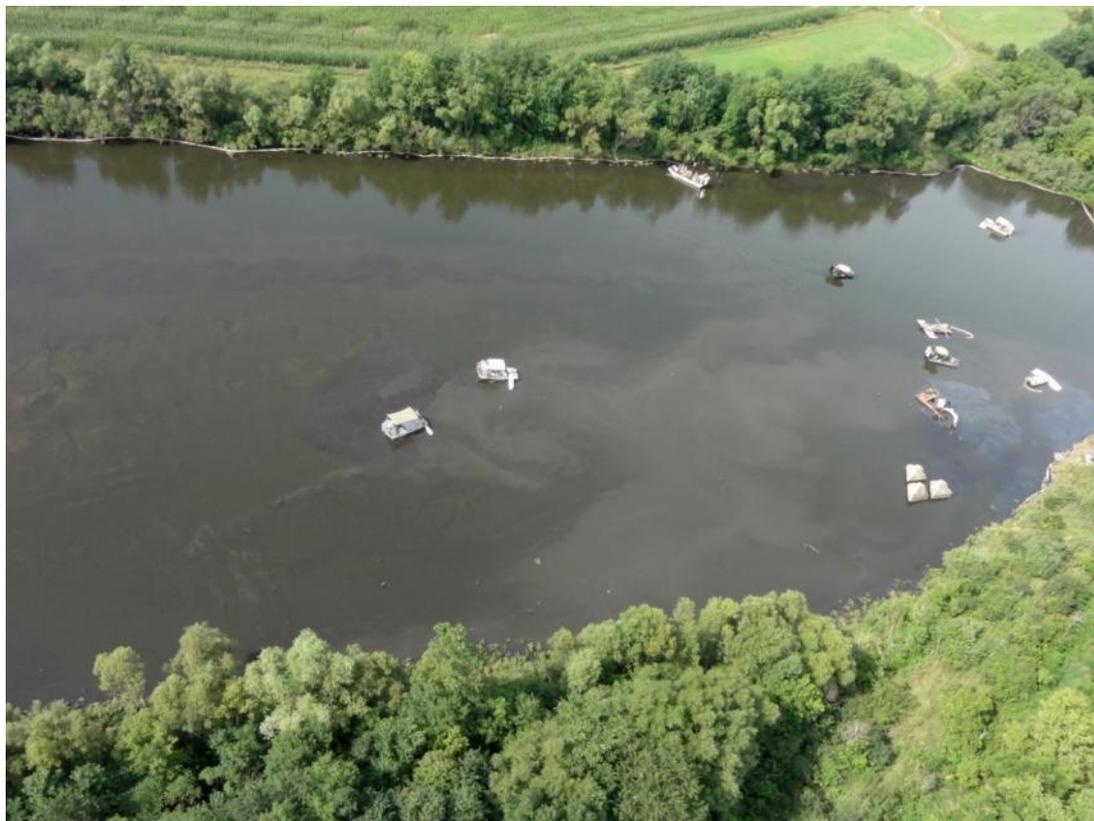
10. MP5.55 submerged oil work, boom at MP5.55N has been removed.

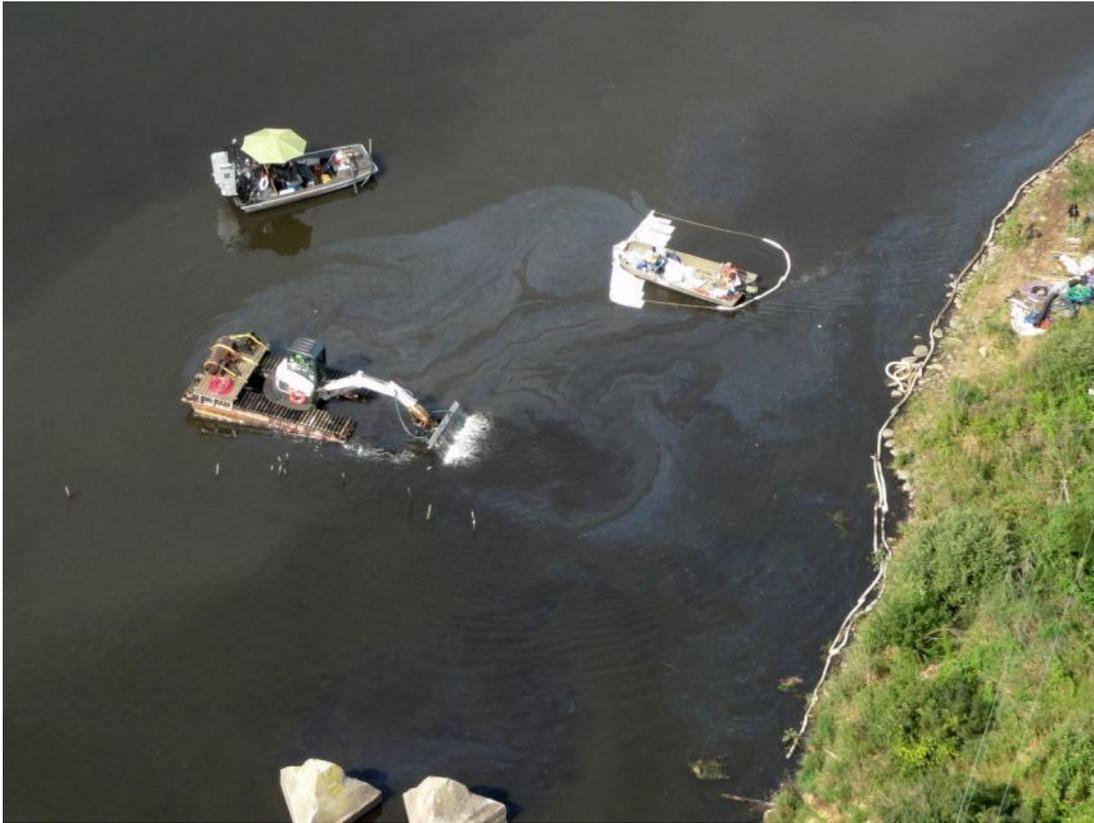
11. MP5.55 submerged oil recovery work.

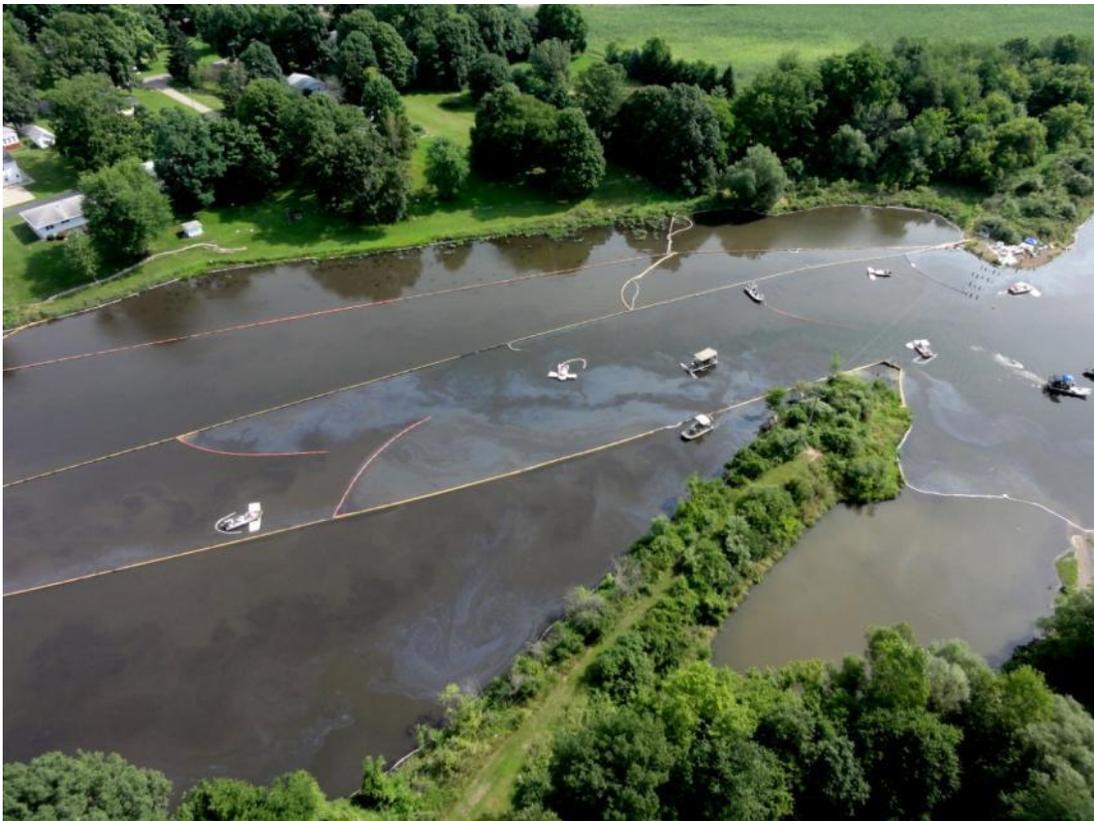
12. MP5.63 submerged oil recovery work.

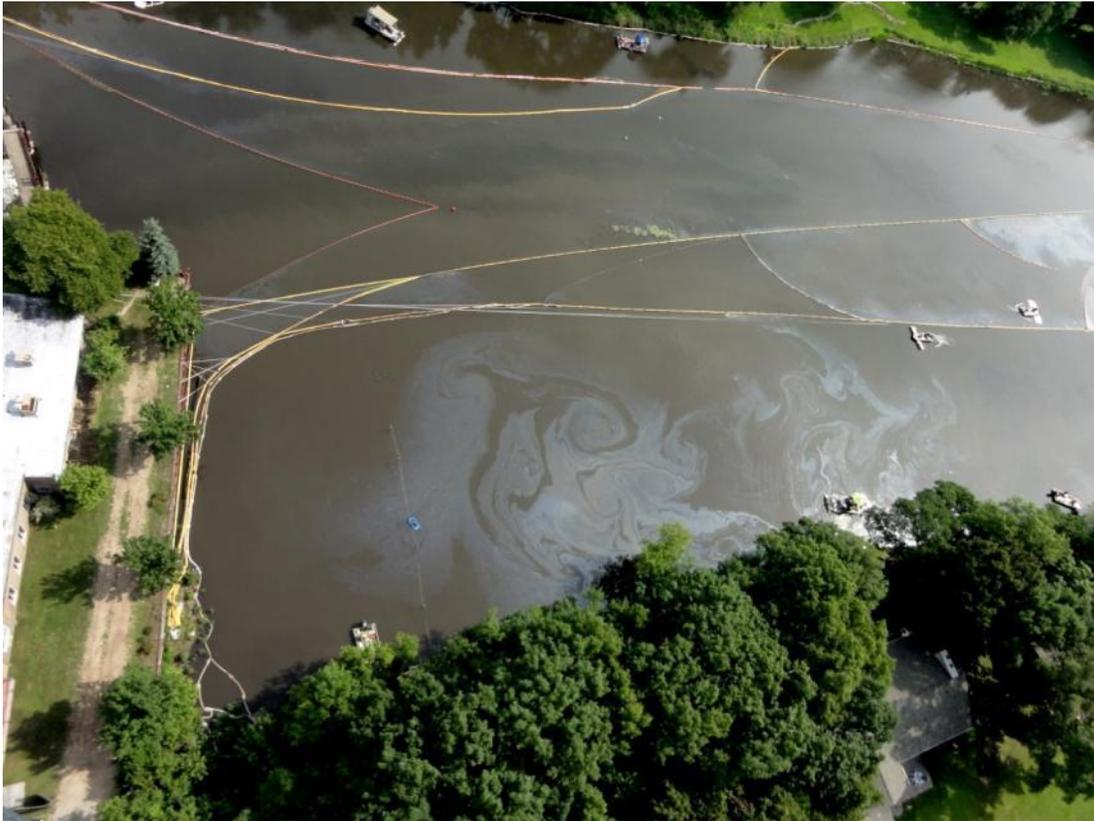
13. MP5.75 submerged recovery oil work.

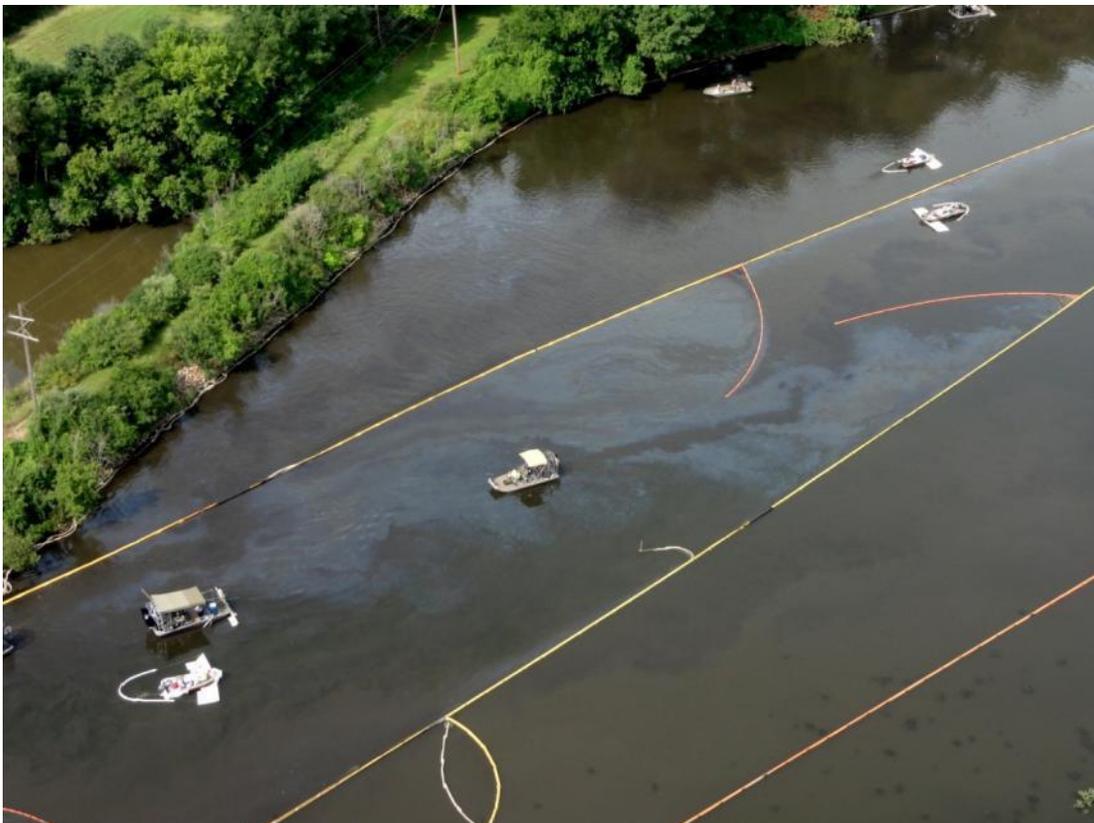
14. MP5.63 submerged oil recovery work.

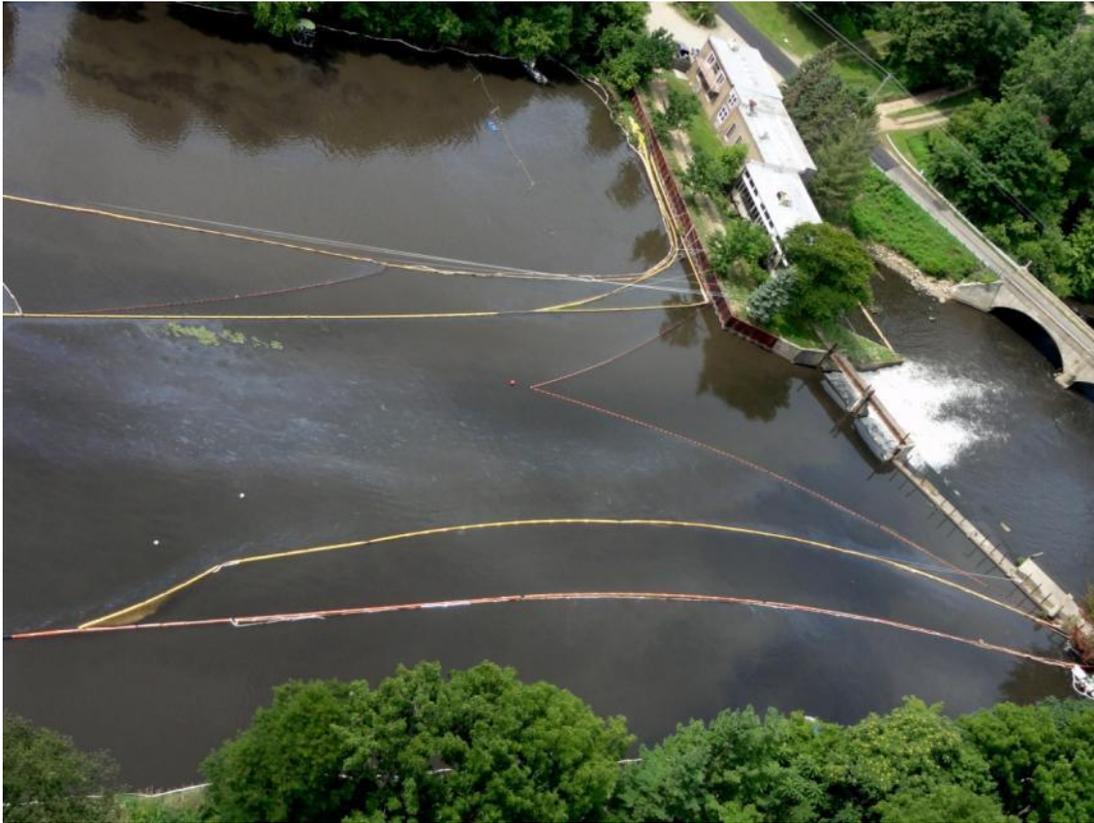
15. Ceresco Dam sheen heading to Chevron boom.

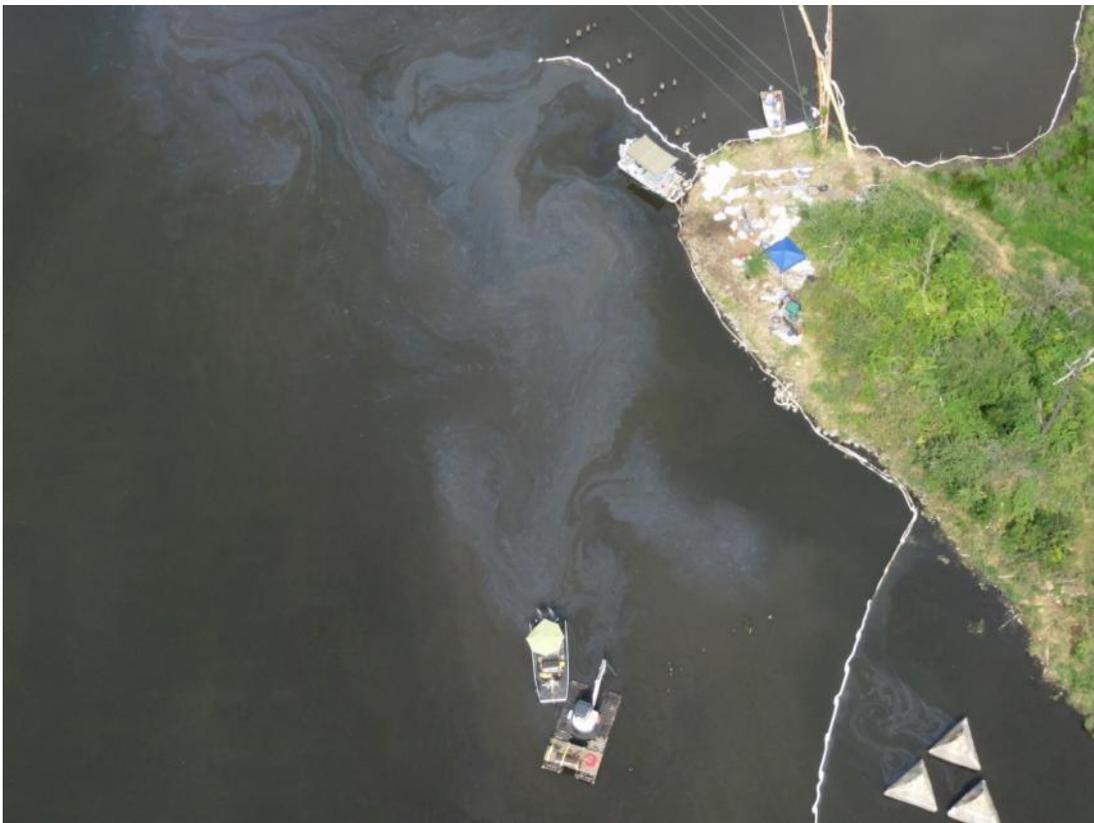
16. MP5.55N submerged oil recovery work.

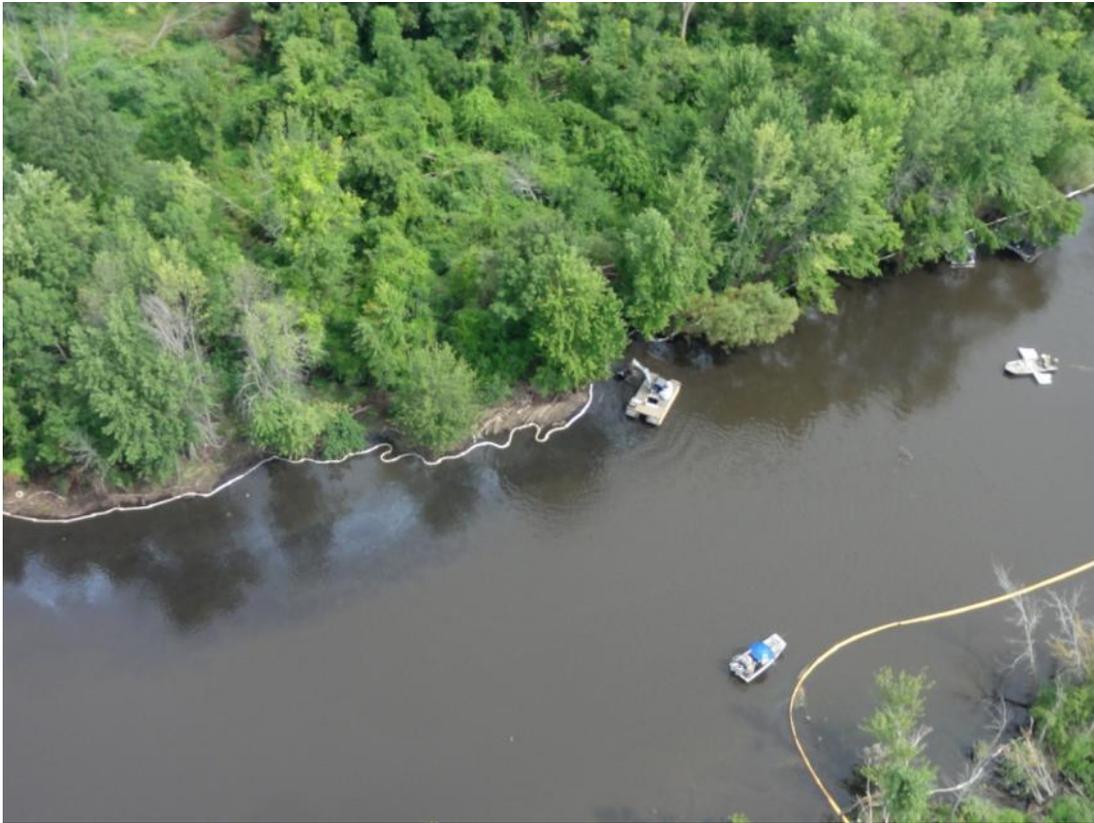
17. MP14.25 submerged oil recovery work.

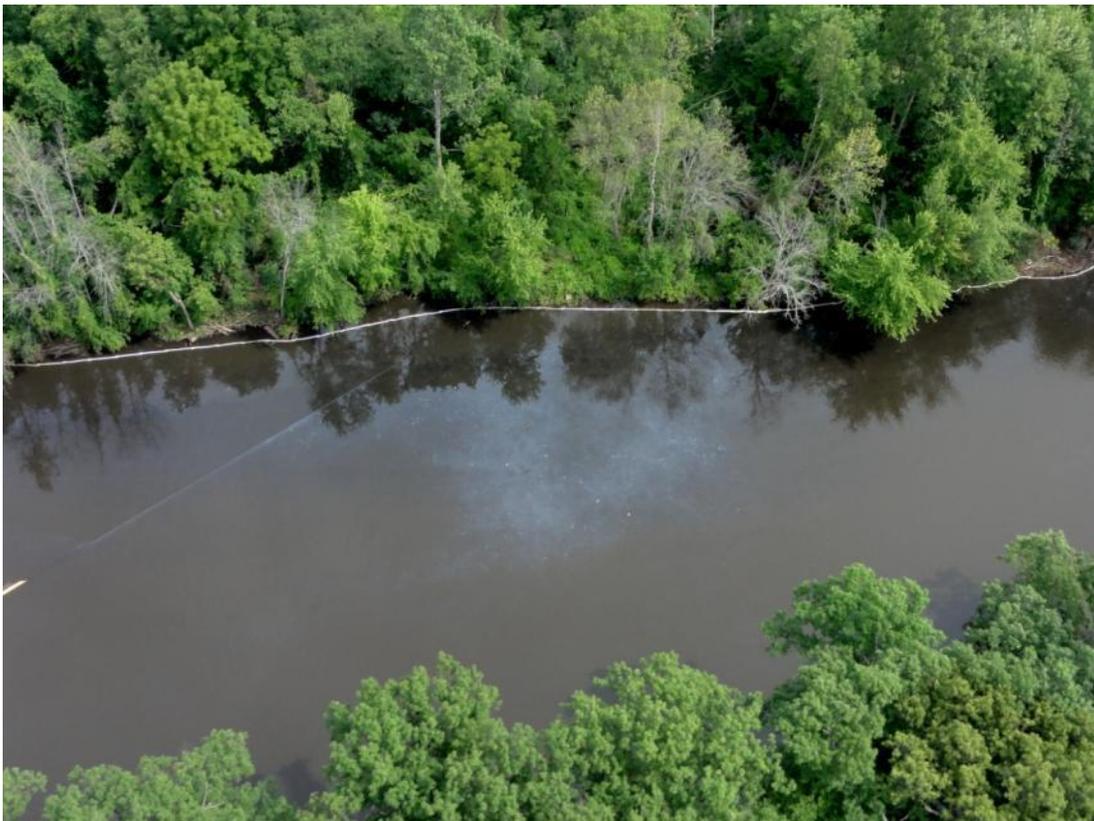
18. Sheen being generated by submerged oil recovery operations at MP14.25.

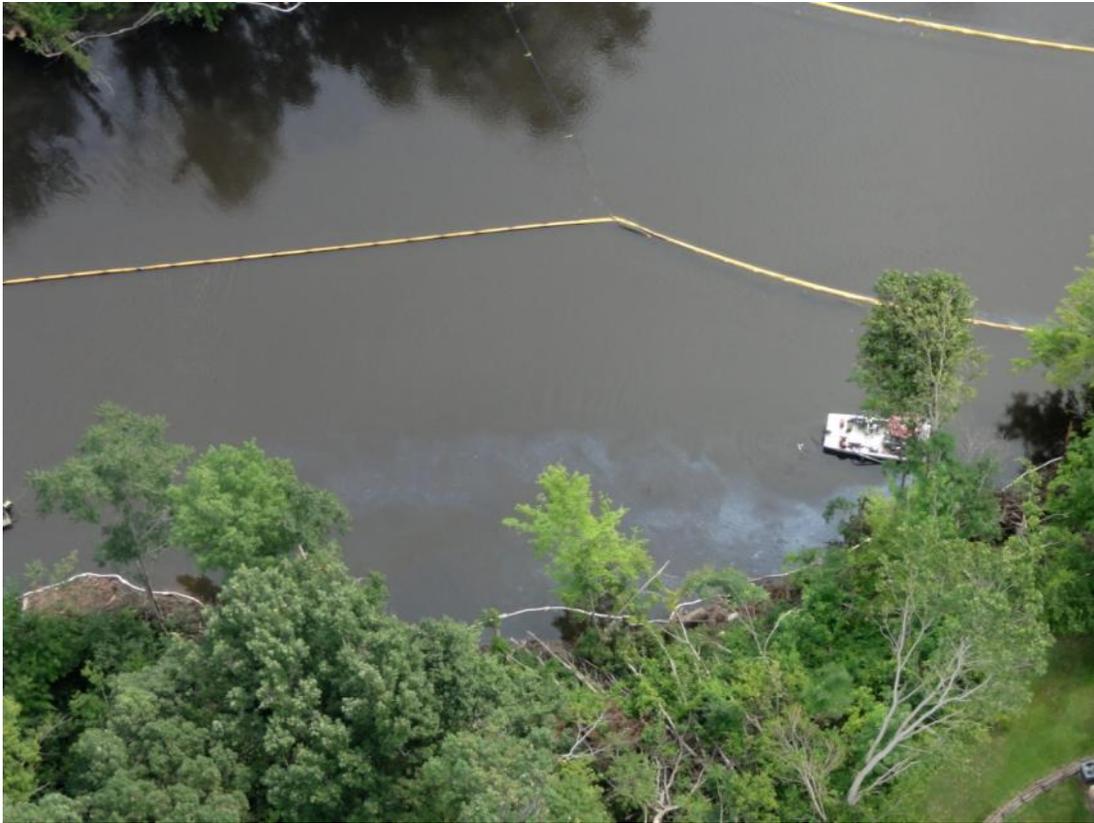
19. MP14.5 submerged oil recovery work.

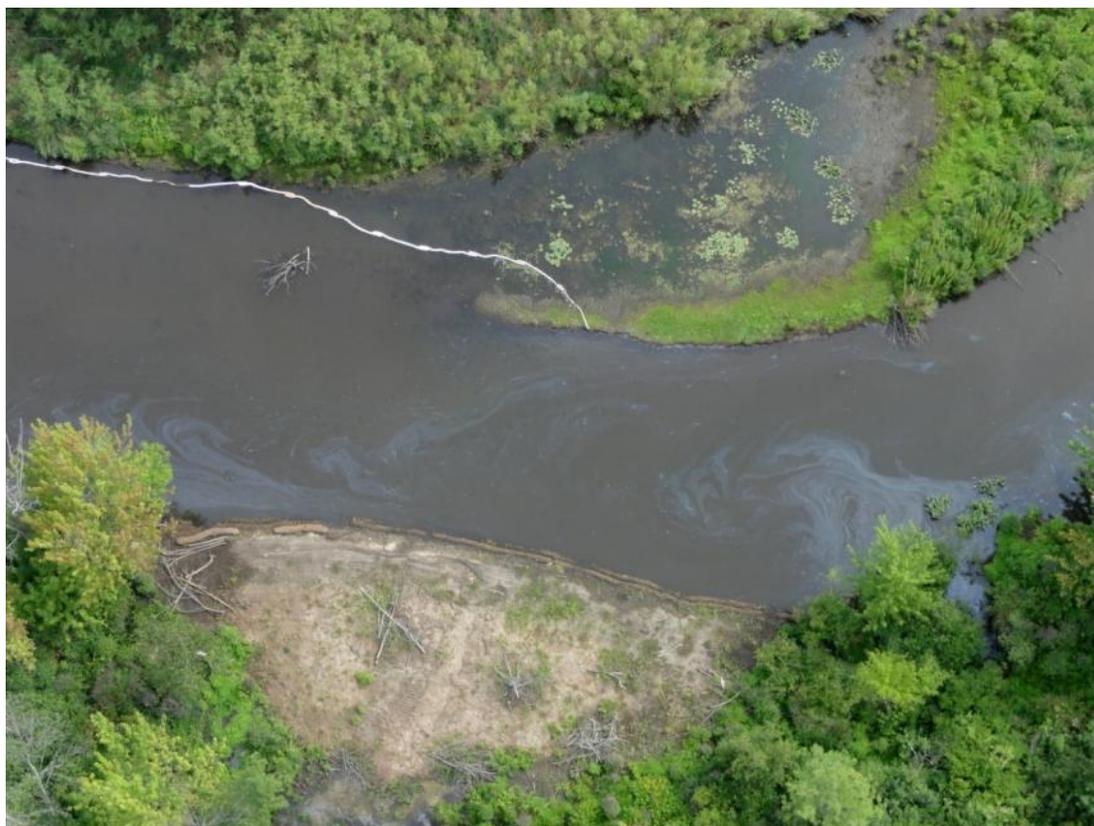
20. MP15.0 sheen observed within river channel.

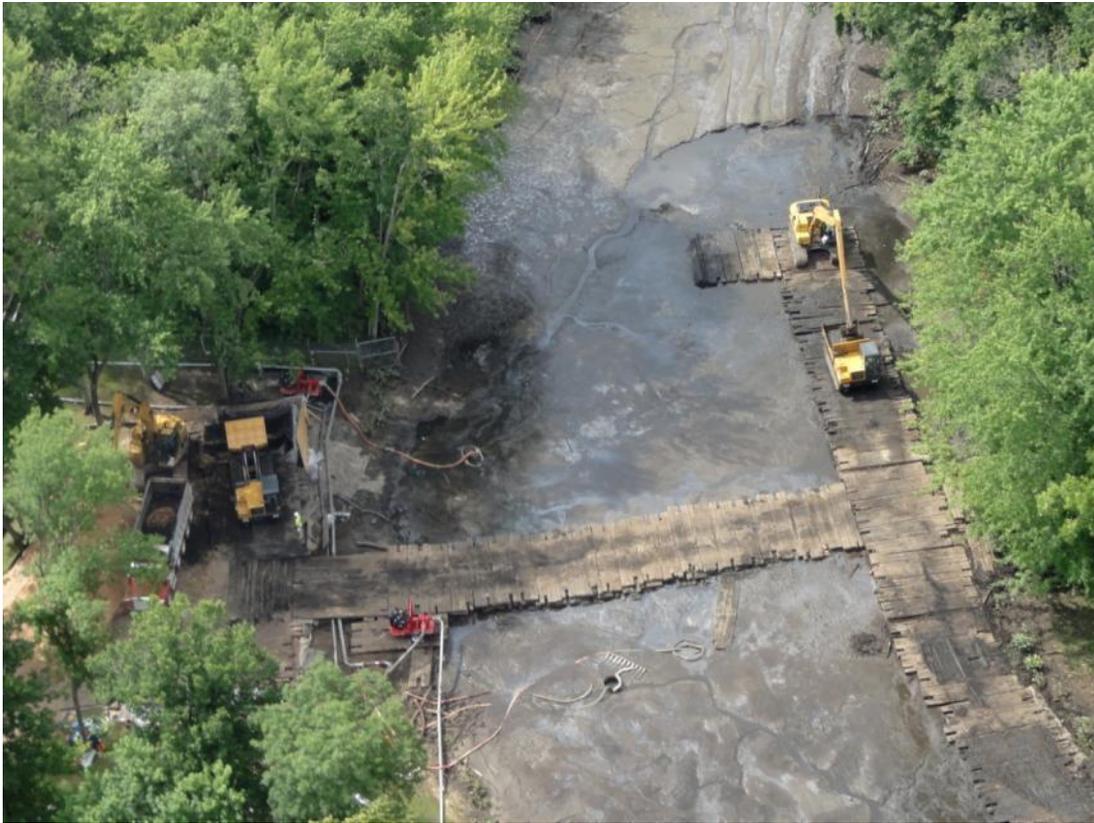
21. MP21.5 Oxbow excavation work.

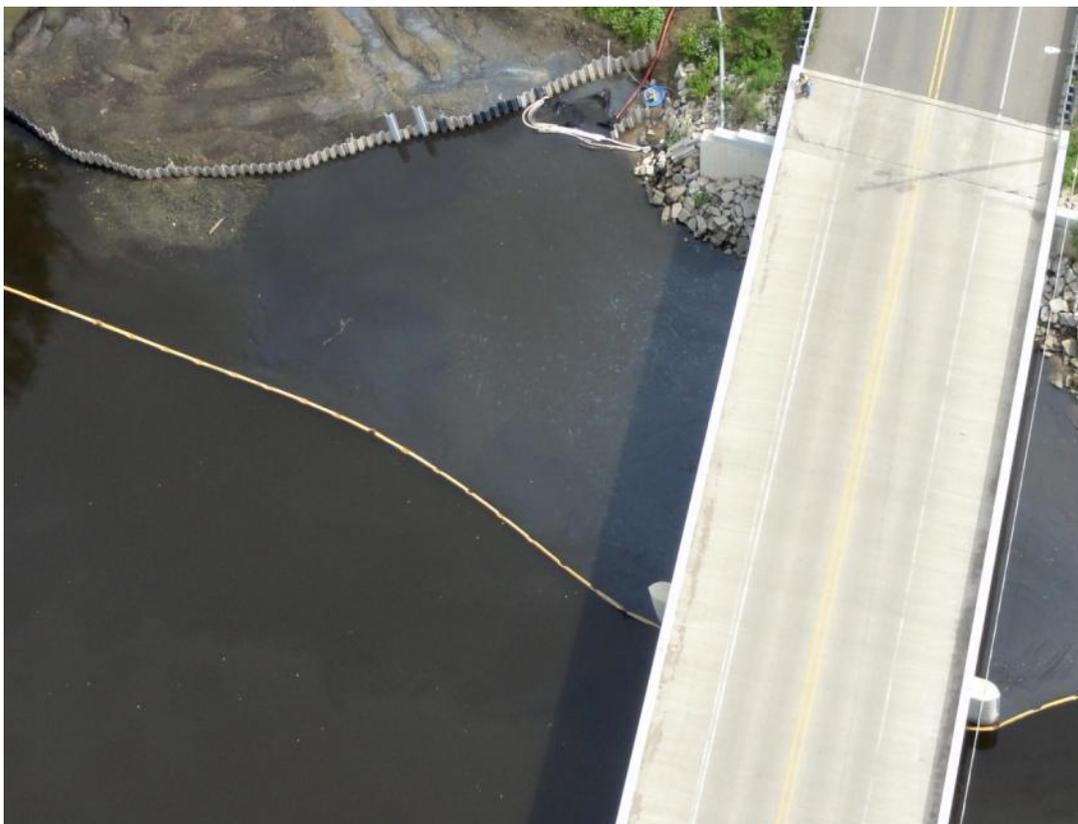
22. MP21.5 Oxbow sheen observed within boom.

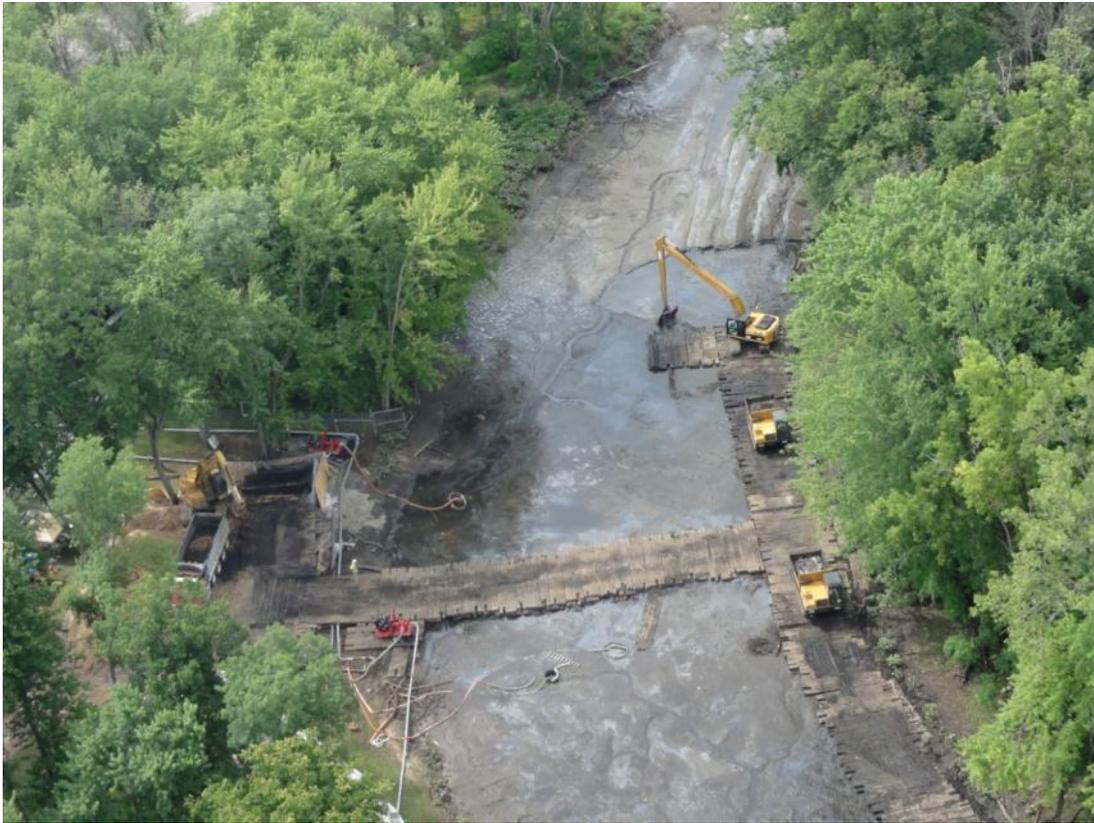
23. MP21.5 Oxbow excavation work.

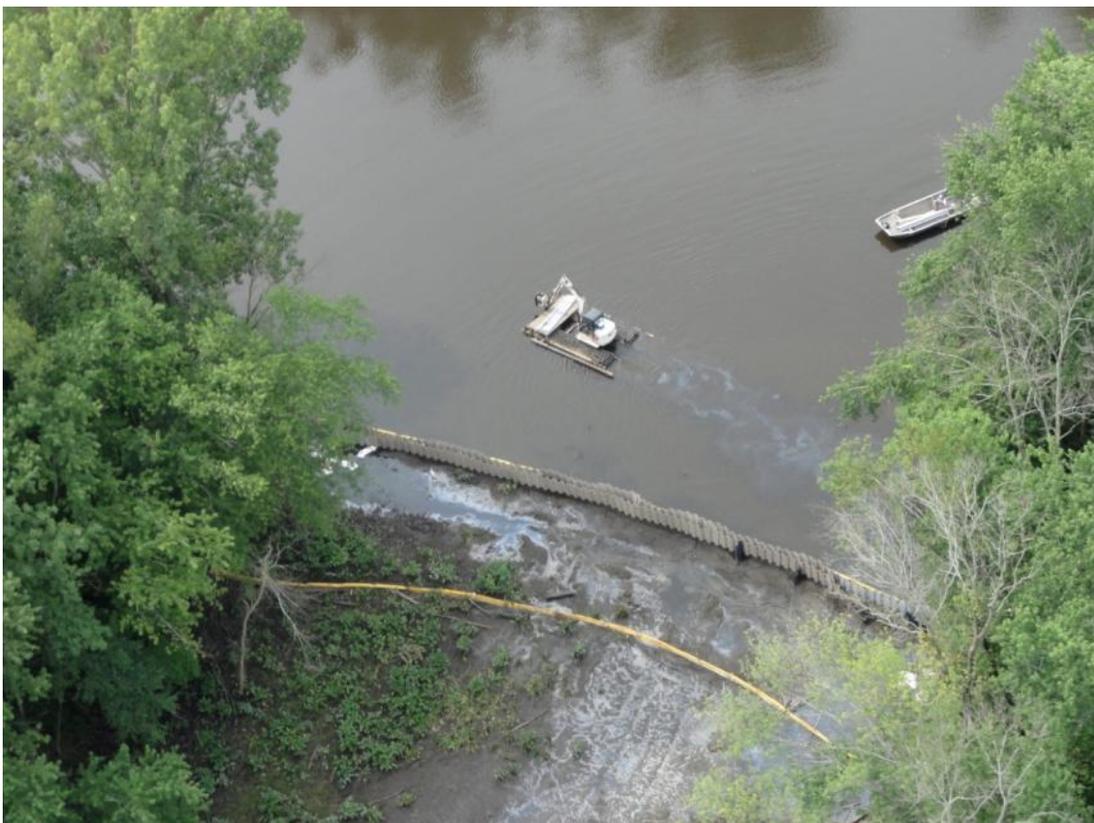
24. MP21.5 Oxbow sheen observed behind swamp excavator outside of sheet piling.

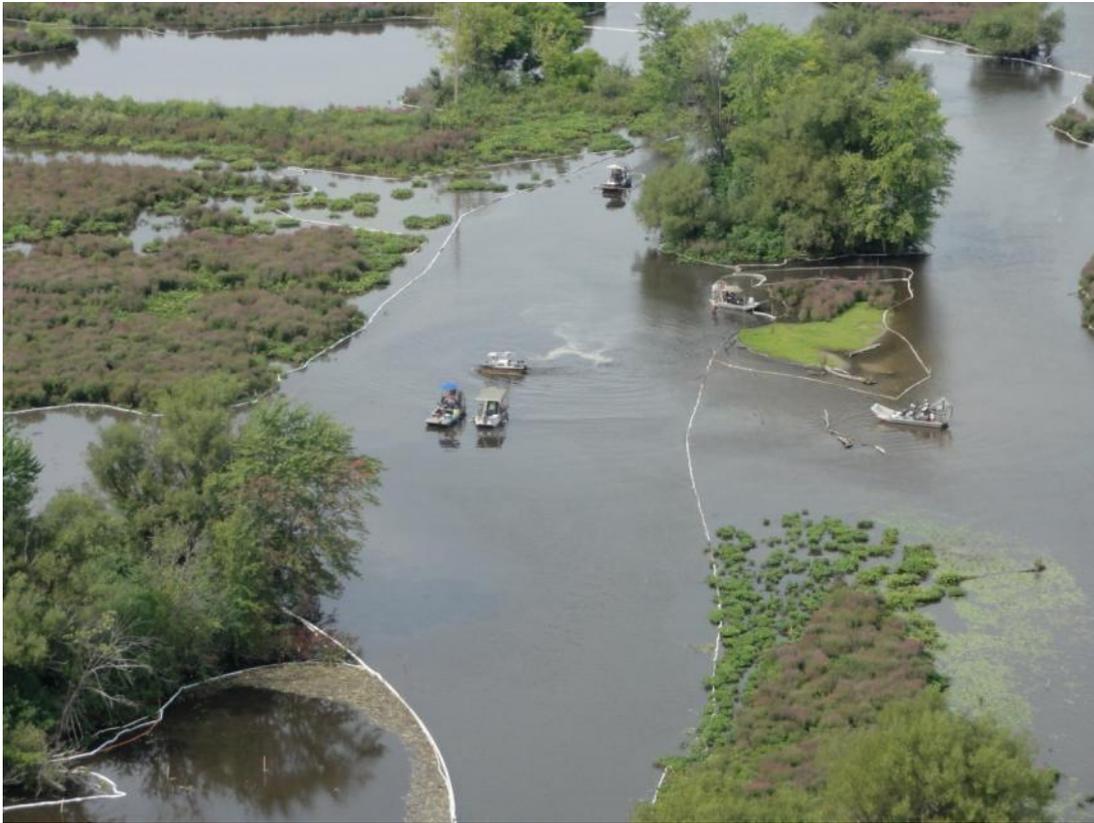
25. Morrow Lake Delta submerged oil recovery work.
