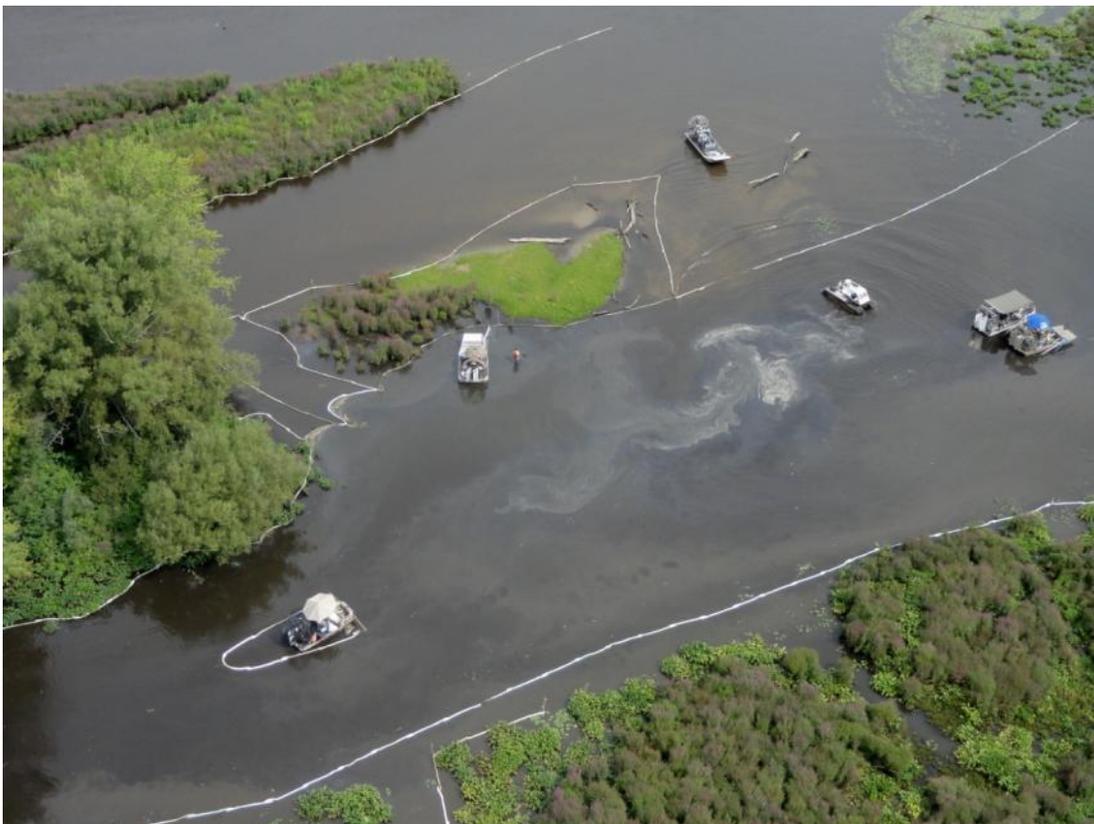
26. Morrow Lake Delta submerged oil recovery work.

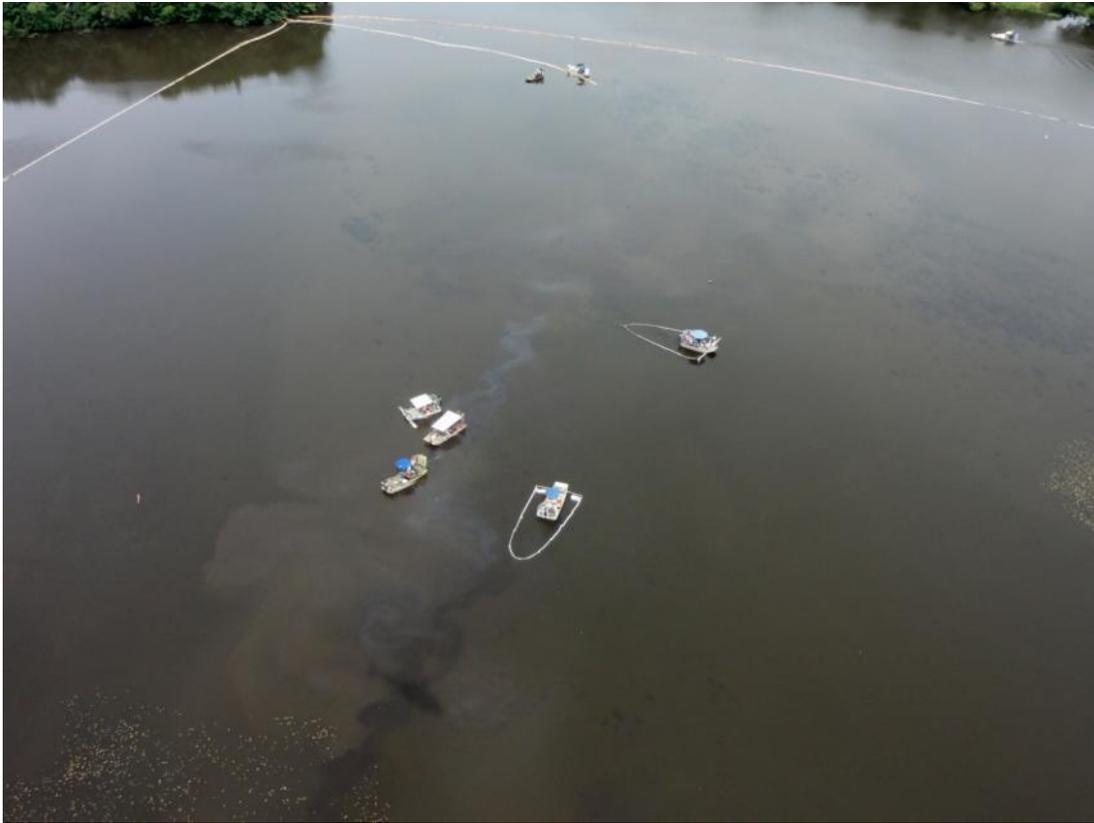
27. Morrow Lake Delta submerged oil recovery work.

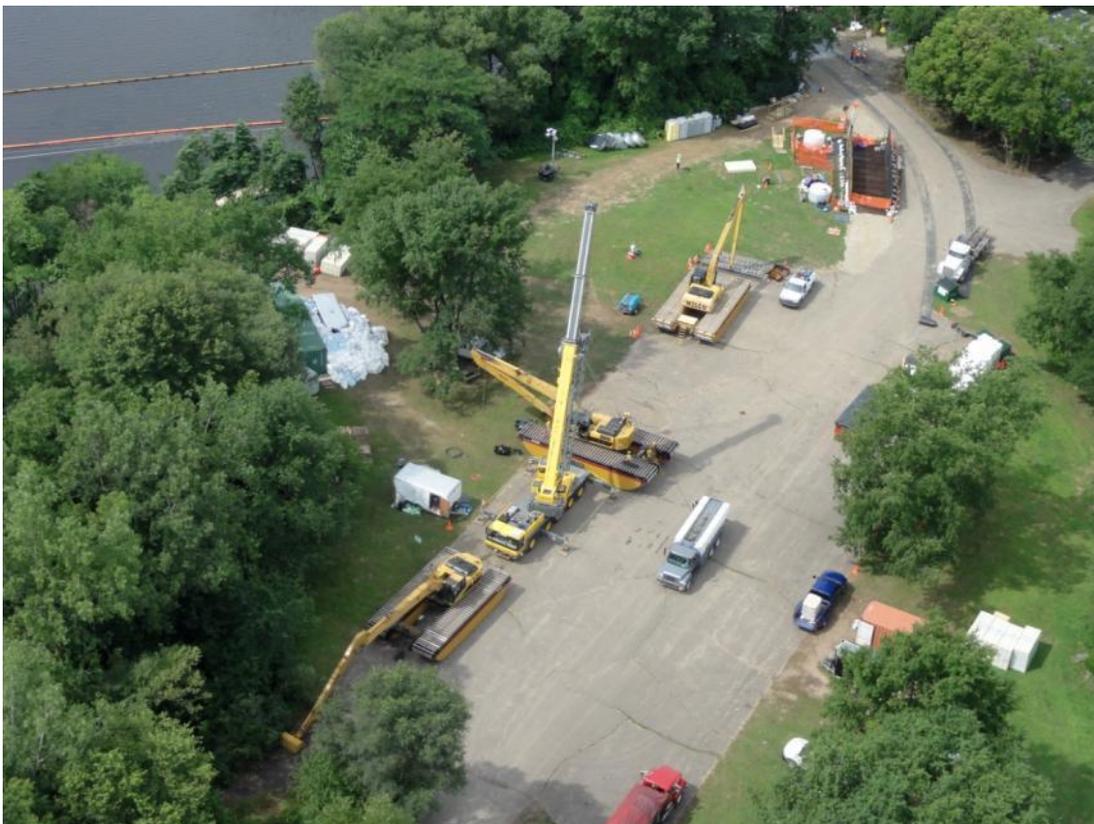
28. Continued assembly of the pontoon excavators.

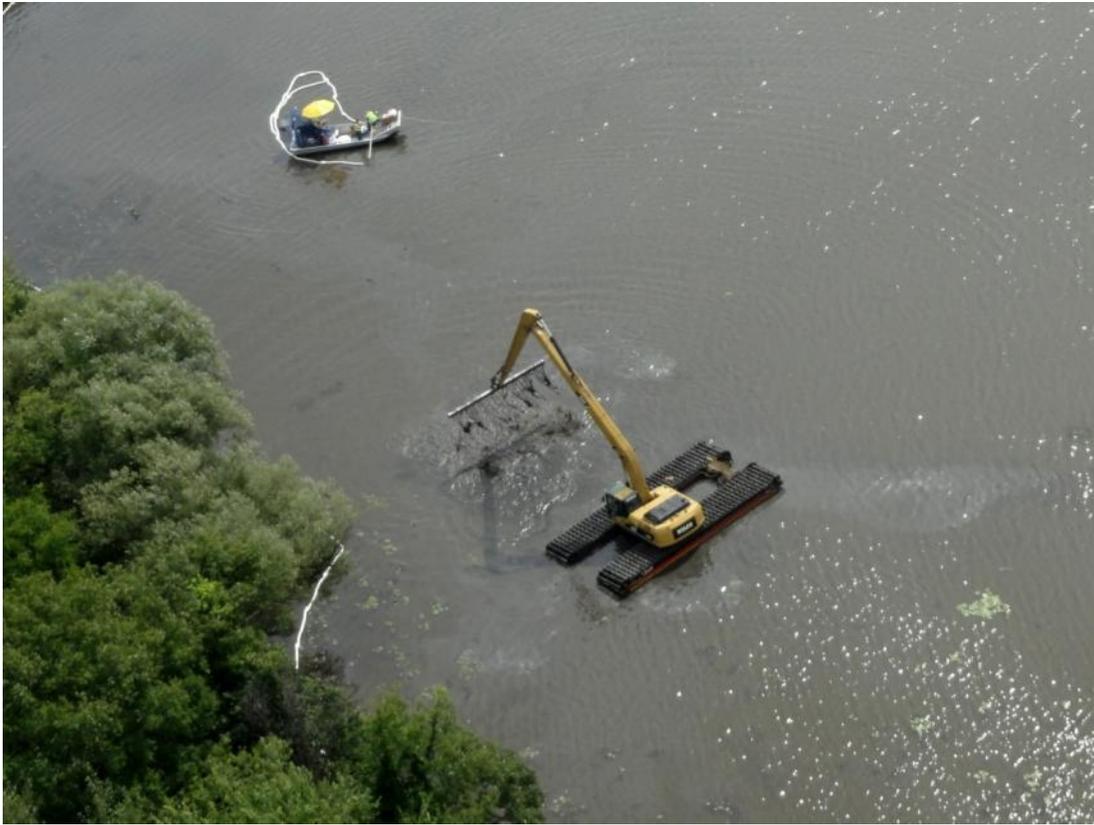
29. Morrow Lake submerged oil recovery work.

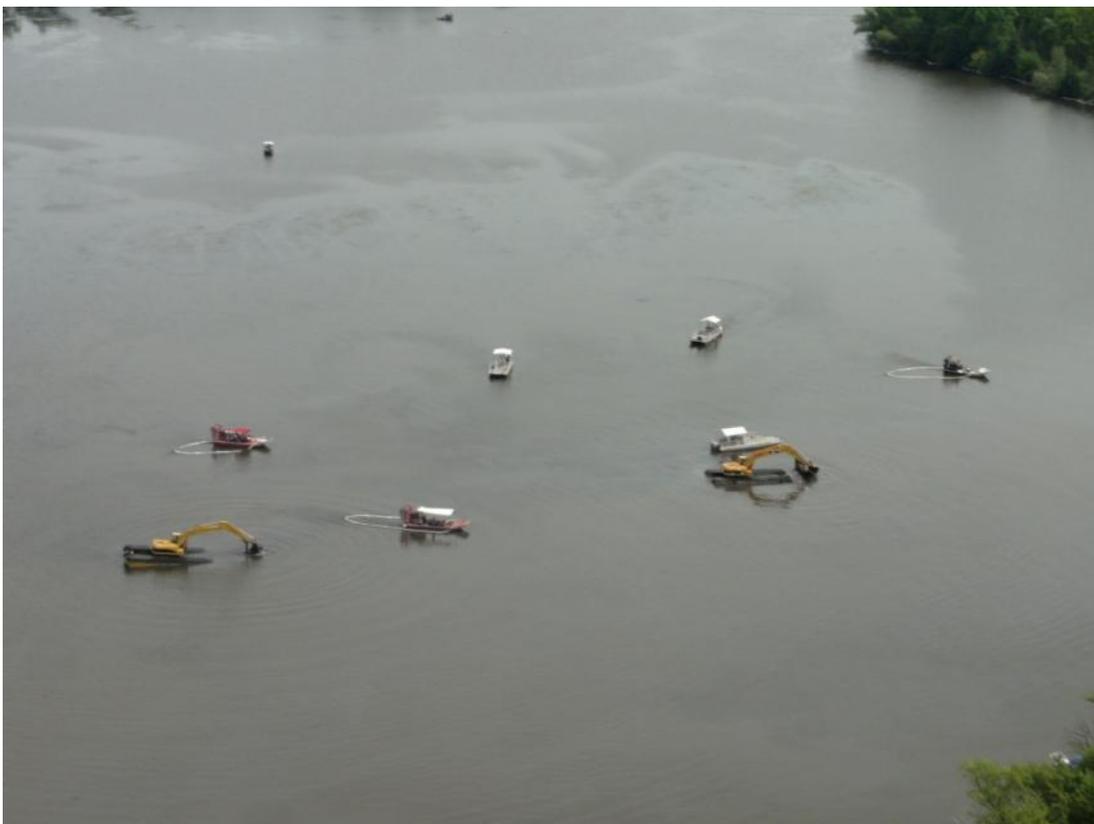
30. Morrow Lake submerged oil recovery work woody debris removal.

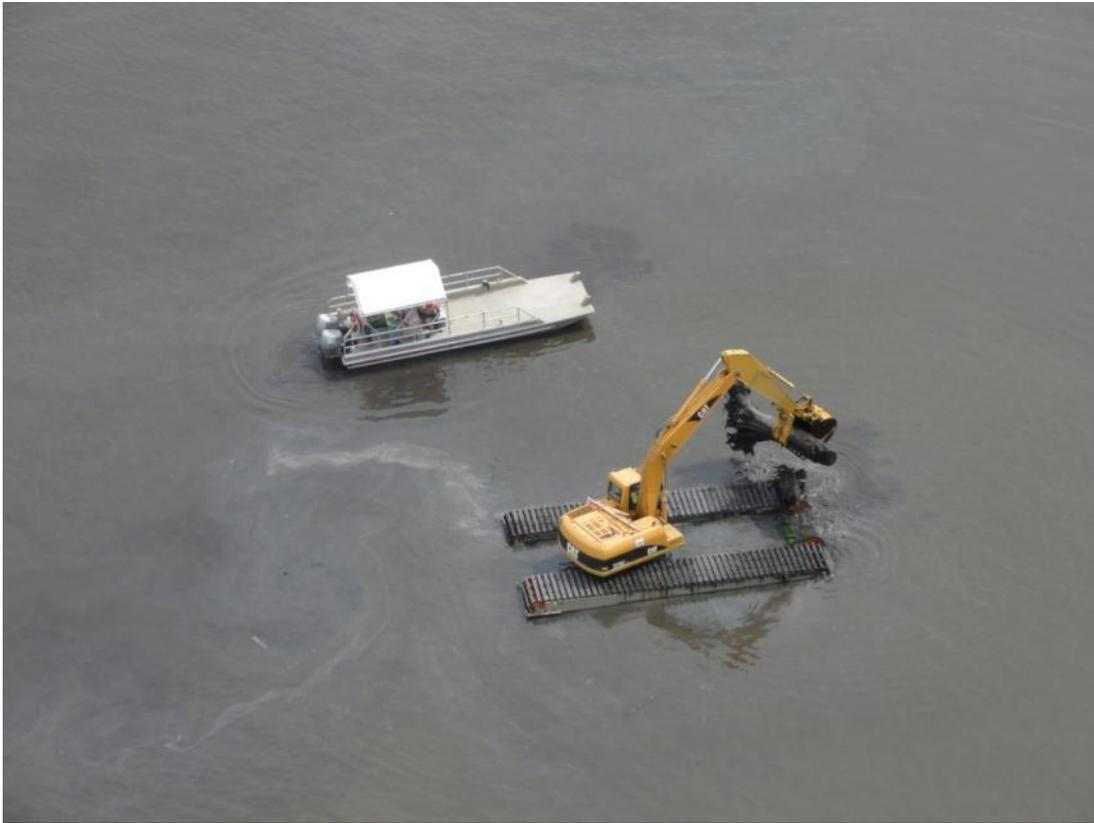
31. Morrow Lake submerged oil recovery work woody debris removal.

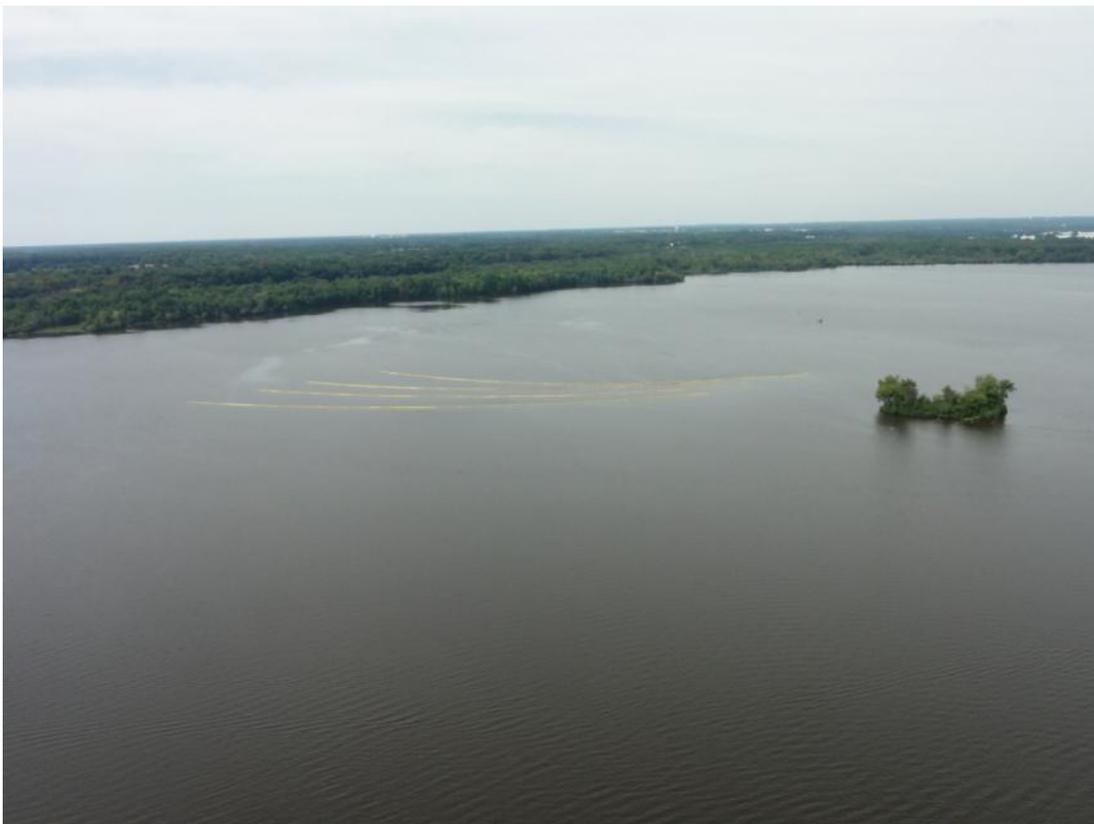
32. Morrow Lake boom staged out in lake.
