Situation Photo Log

Saturday, October 8, 2011

Kalamazoo River / Enbridge Spill

Prepared by:

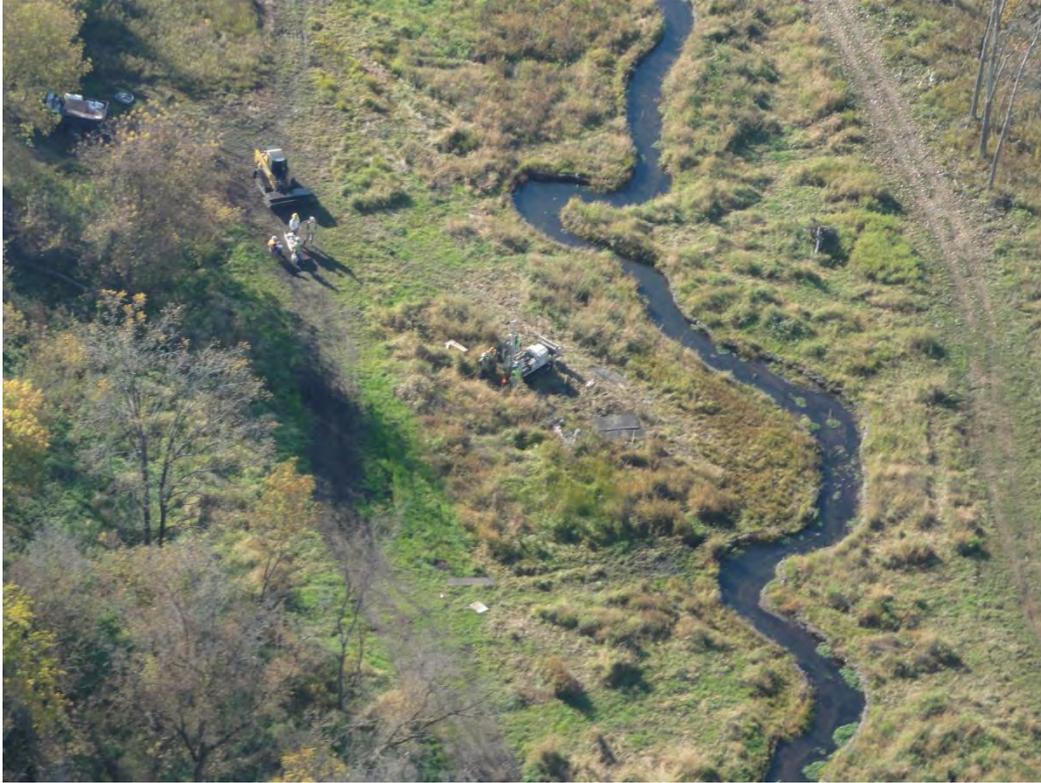
1. Talmadge Creek, Geoprobe crew sampling near MP0.25.

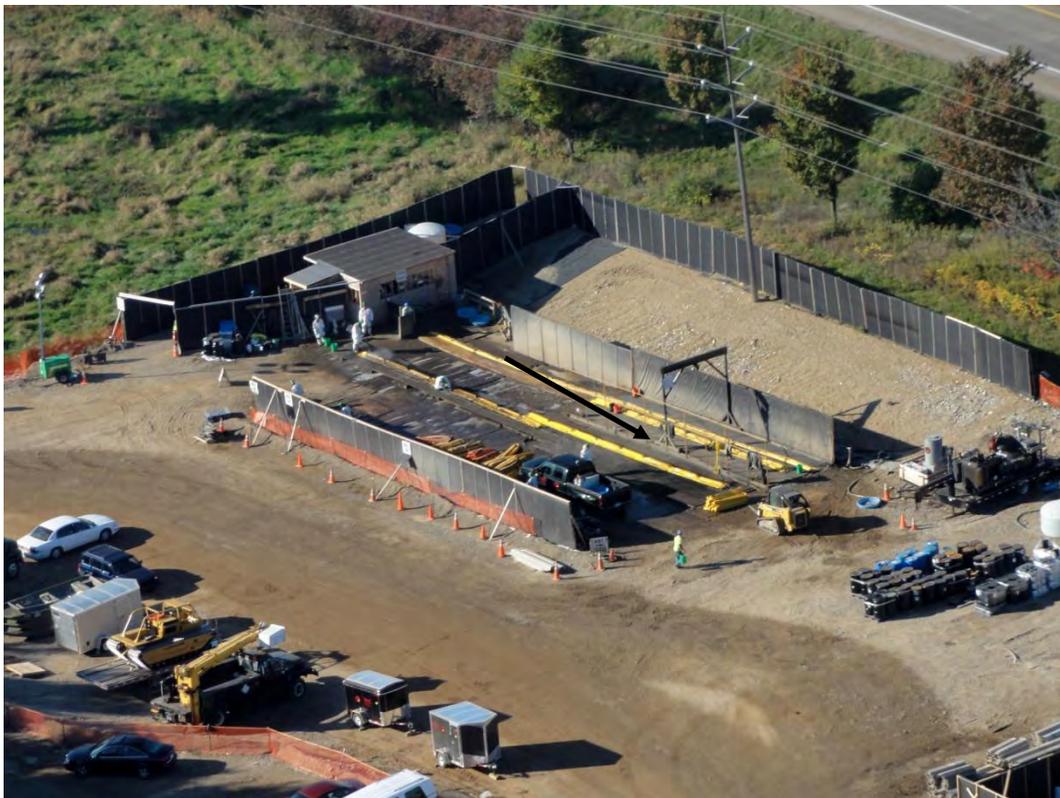
2. Frac tank city decon area. Boom decon.

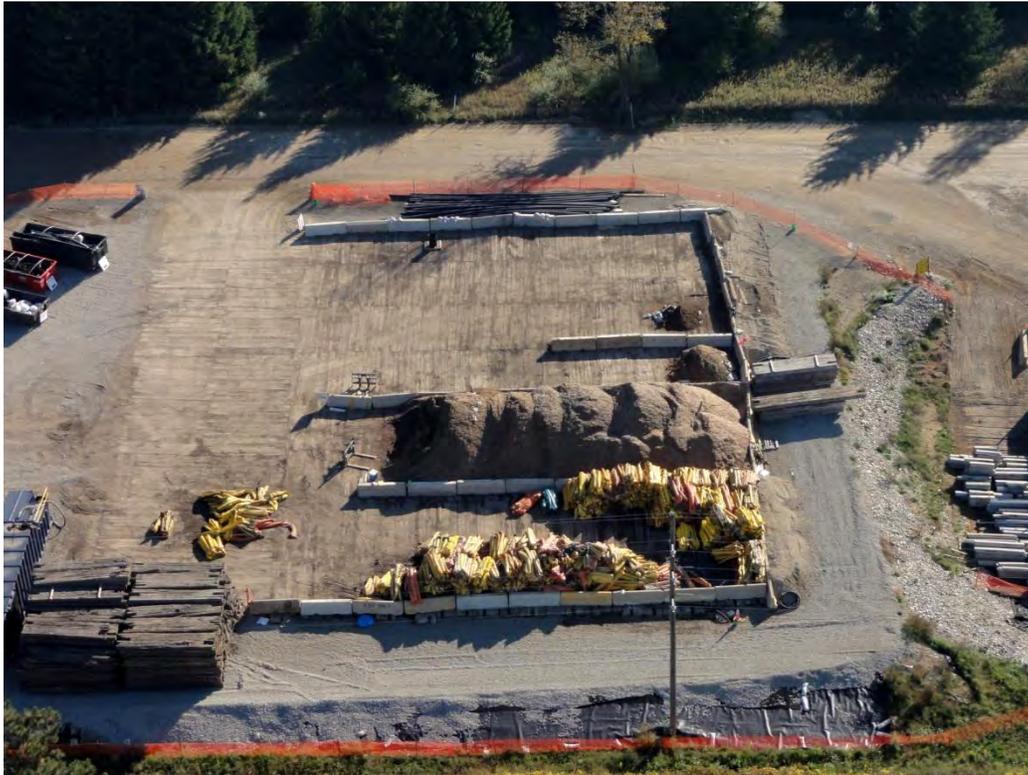
3. Soil staging area. Soils have been removed. Three roll-off boxes and boom observed.

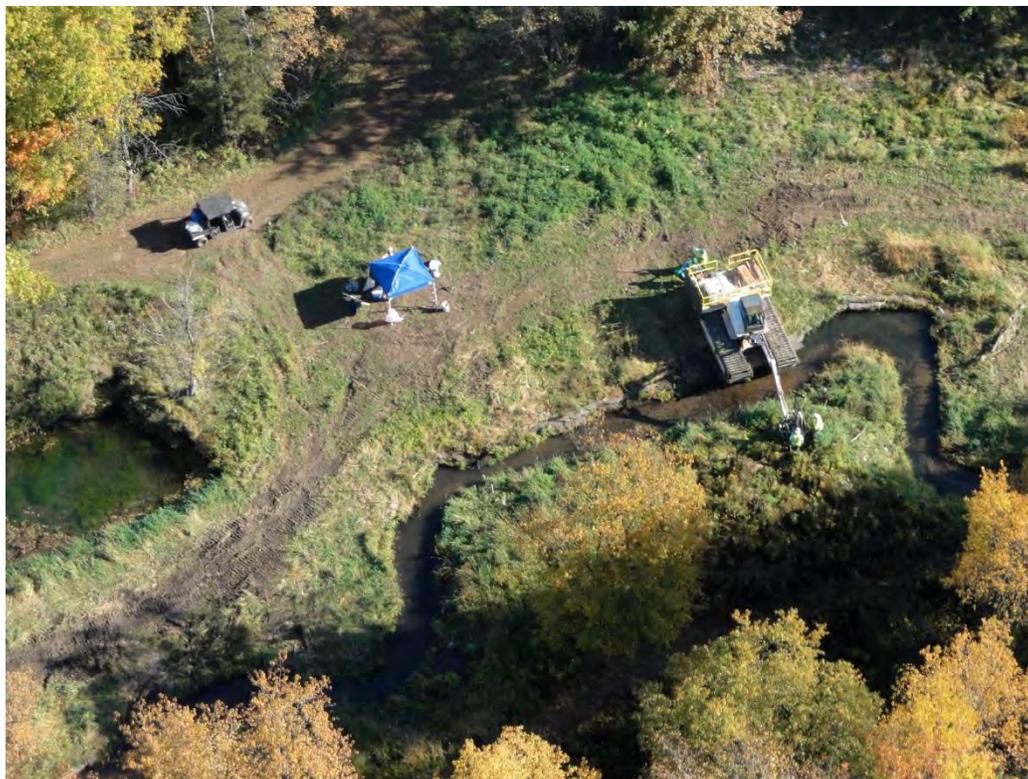
4. The first of two Talmadge Creek RI crews near MP1.5 collecting soil samples with Geoprobe rig.

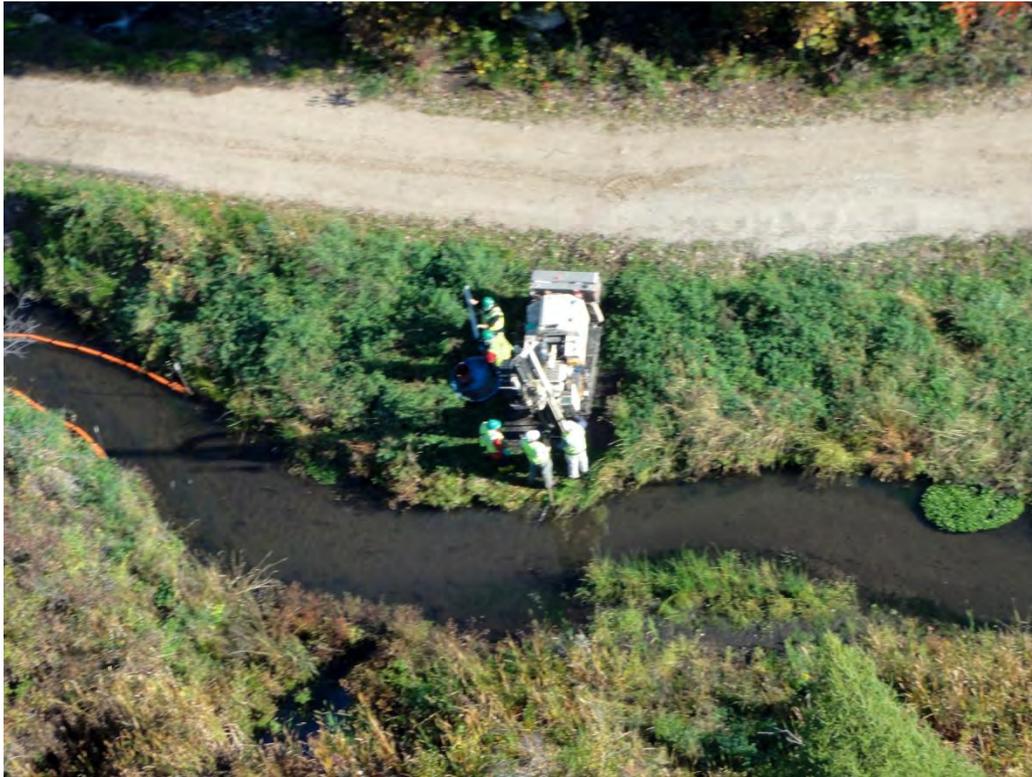
5. The second of two Talmadge Creek RI crews near MP1.5 collecting soil samples with Geoprobe rig.

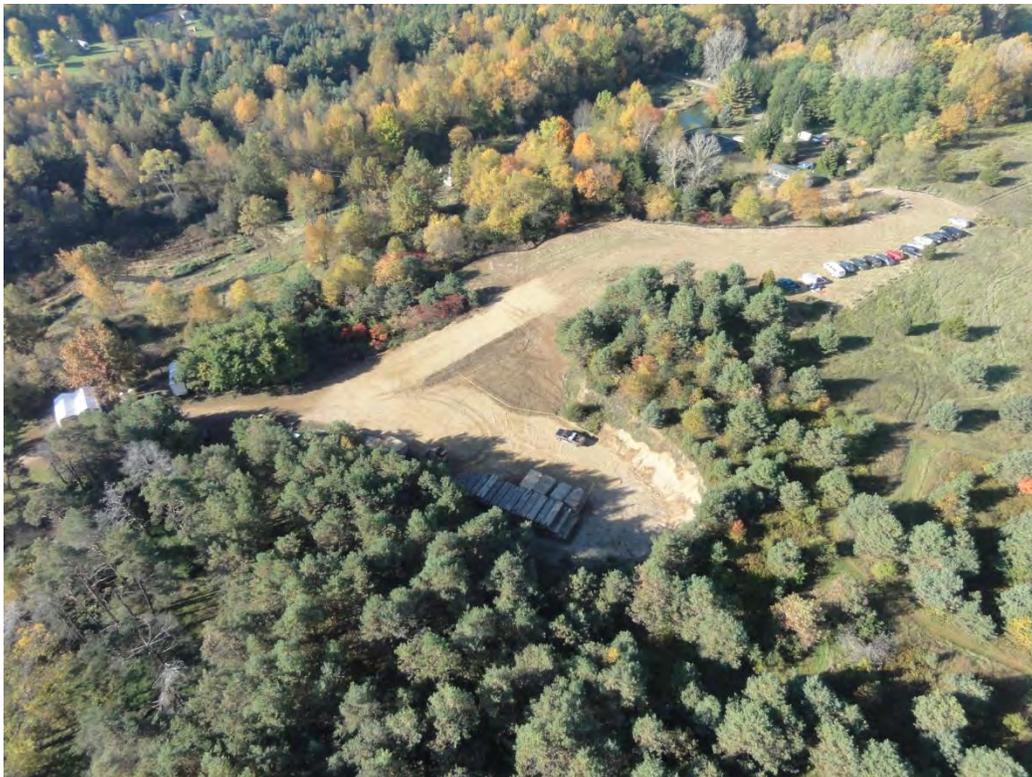
6. Talmadge Creek materials staging yard.

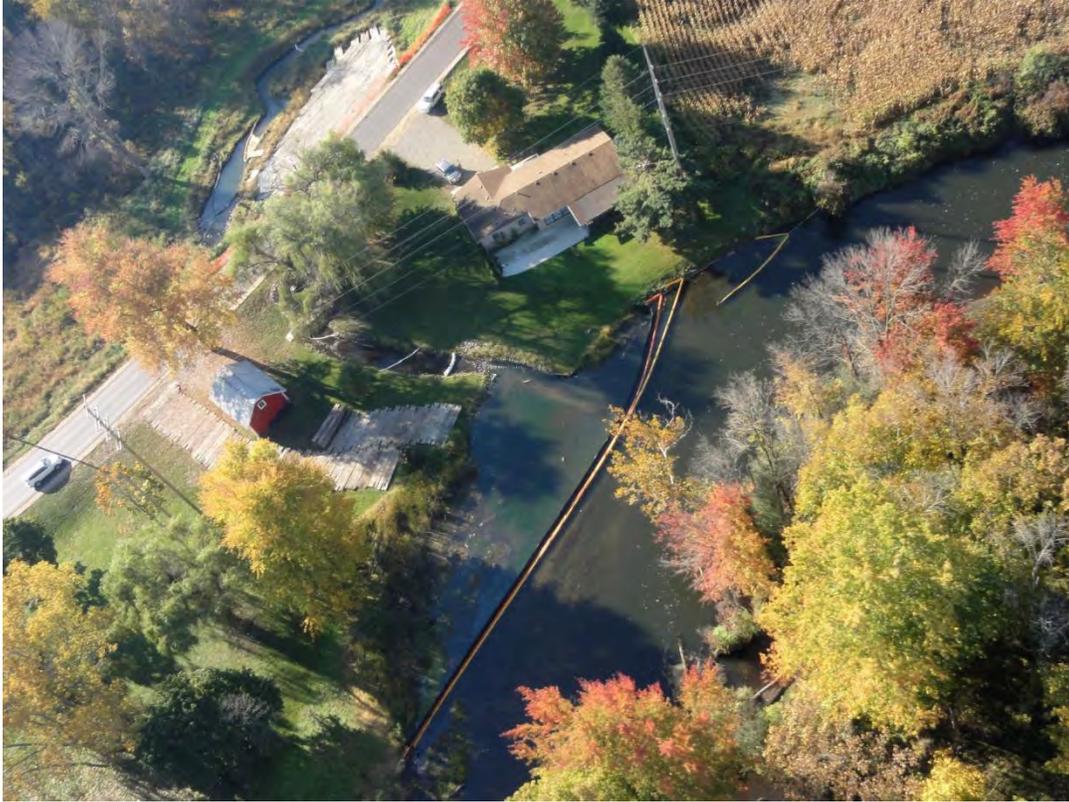
7. Confluence, no oil sheen or activity noted.

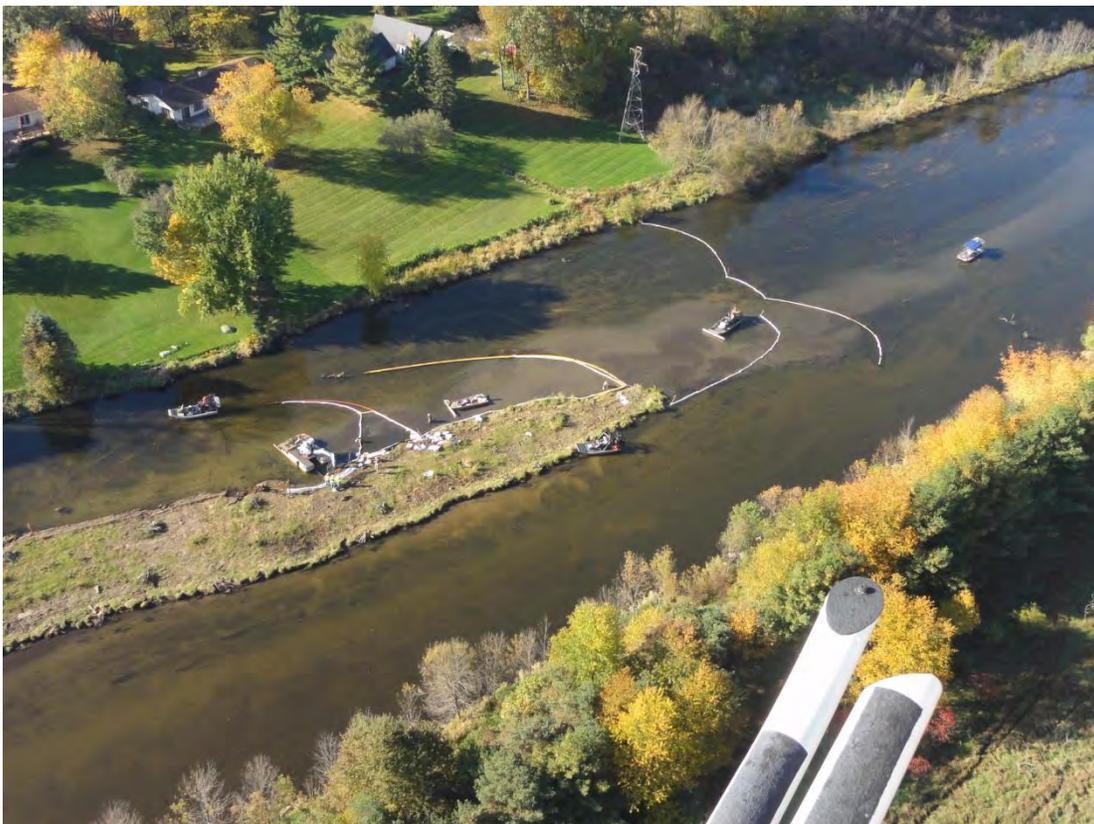
8. Island A, submerged oil recovery work in progress.

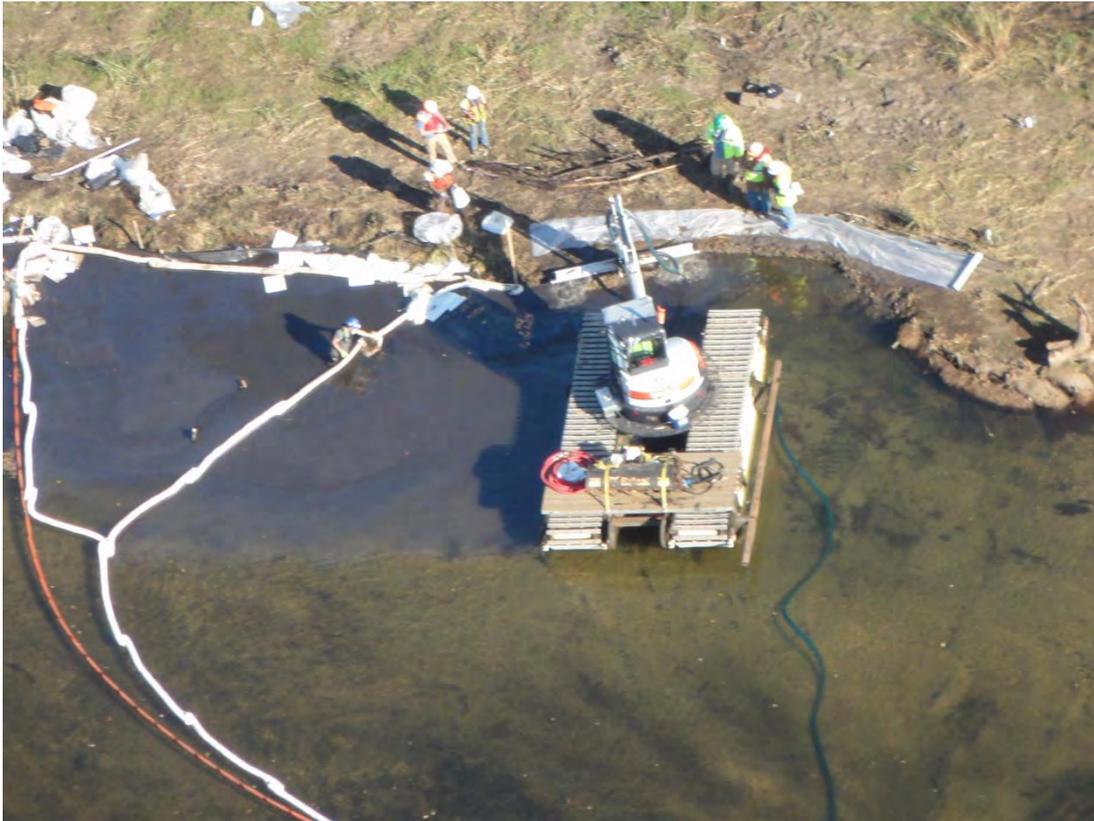
9. Close up of spray bar operating on shore of Island A.

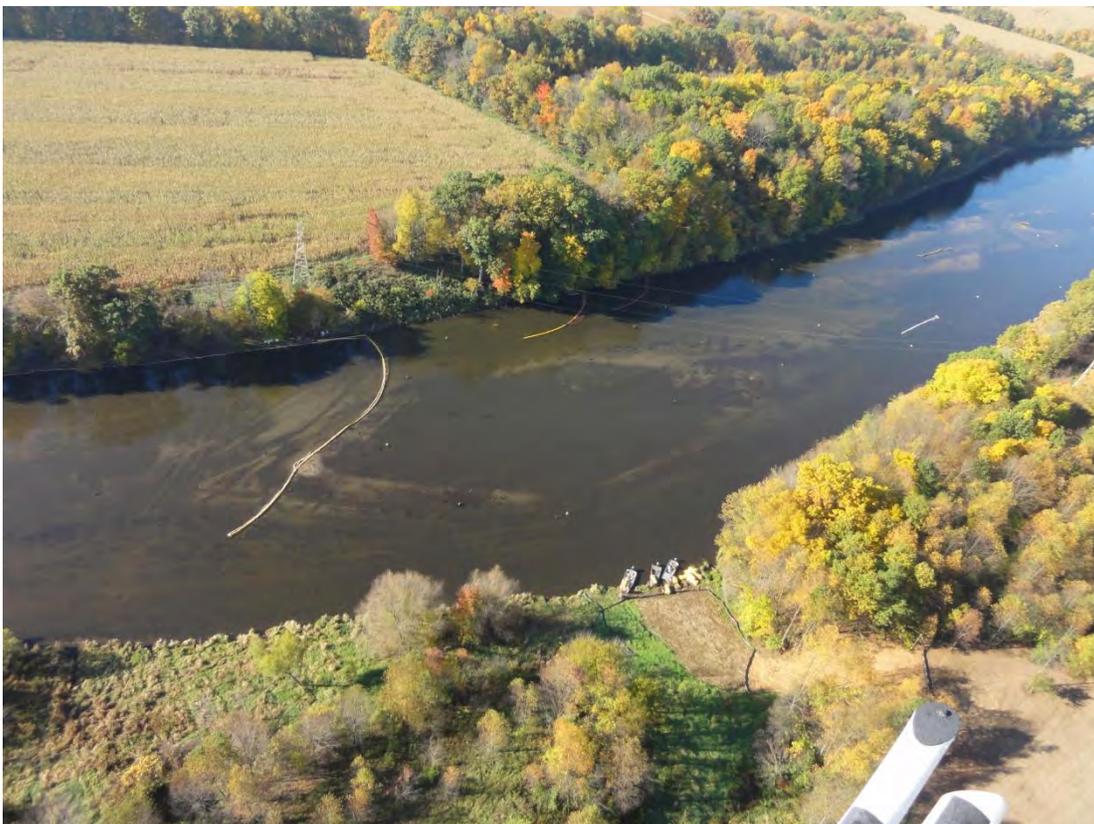
10. MP4.18 LDB, crews have demob'd from this location back to Island A.

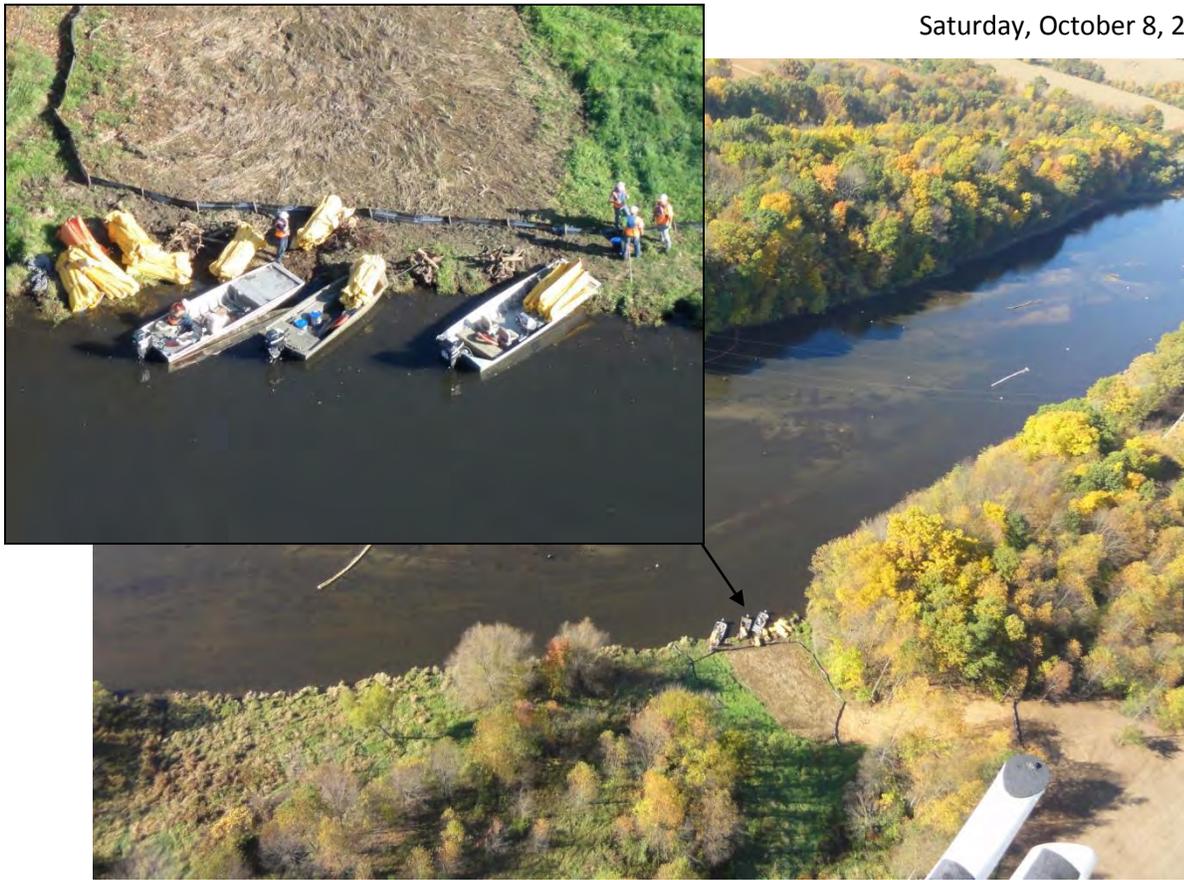
11. Crews conducting boom deployment across from MP4.18 LDB.

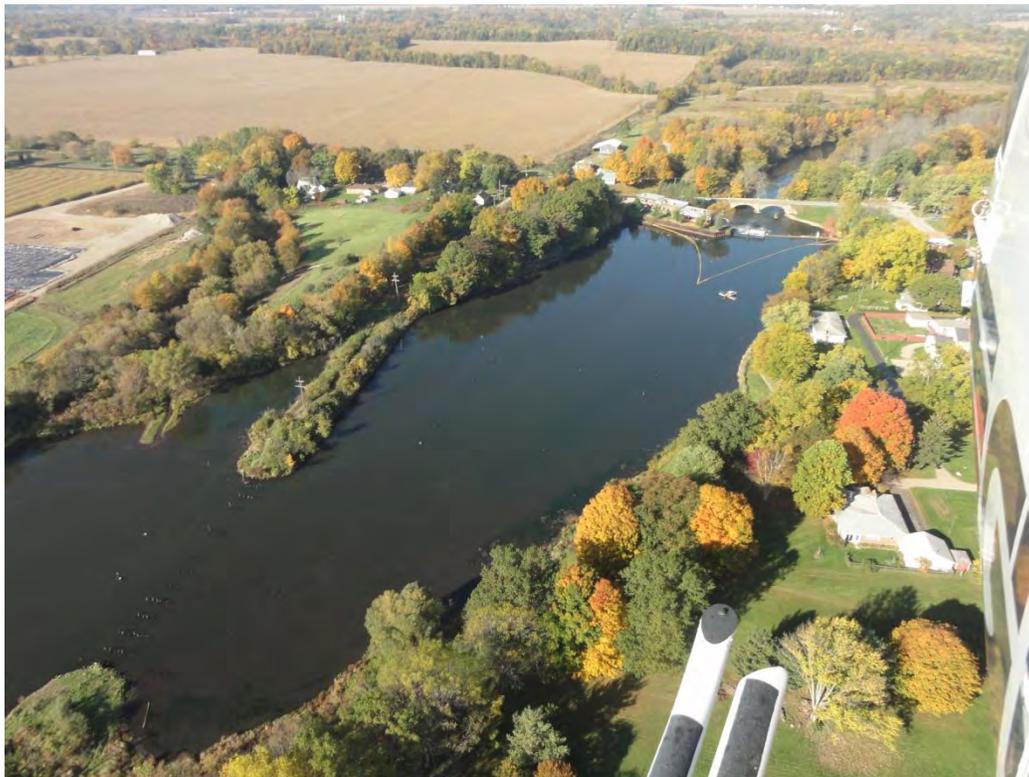
12. MP5.65 above Ceresco Dam, one sweeper boat continues to work above dam.

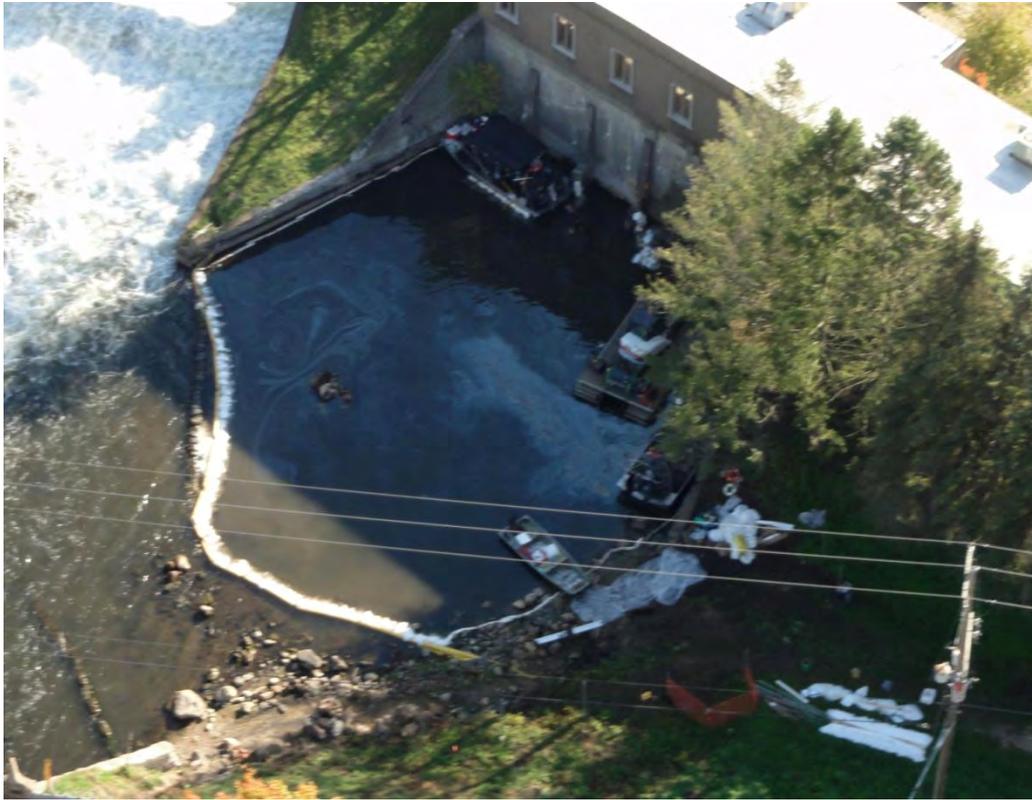
13. MP5.8, submerged oil recovery work below Ceresco Dam continues. Sheen observed within containment.

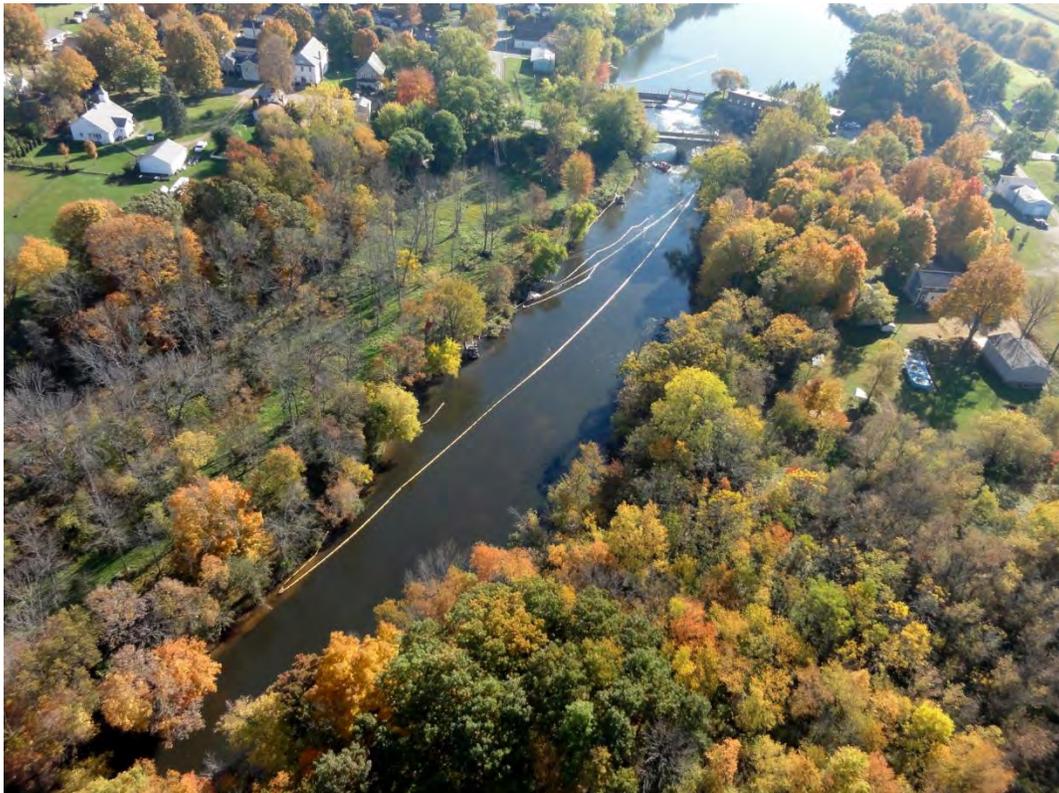
14. Boom configuration below Ceresco Dam.

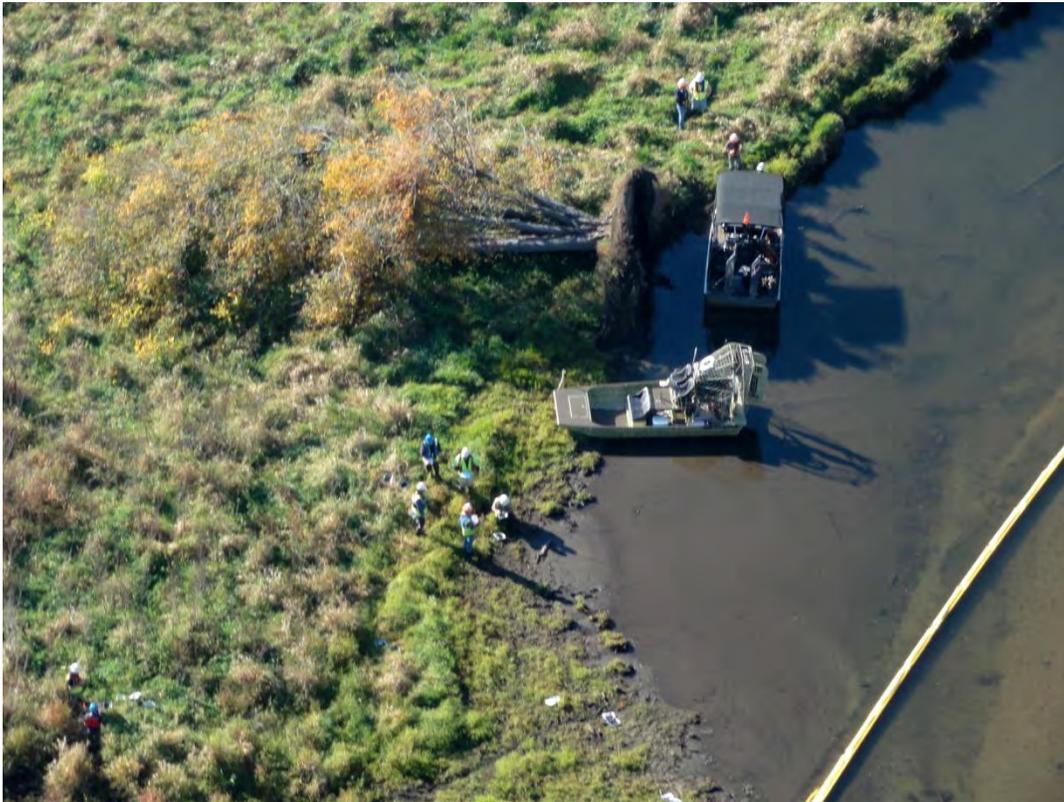
15. Overbank crews observed at Lonely Tree, MP11.75 LDB.

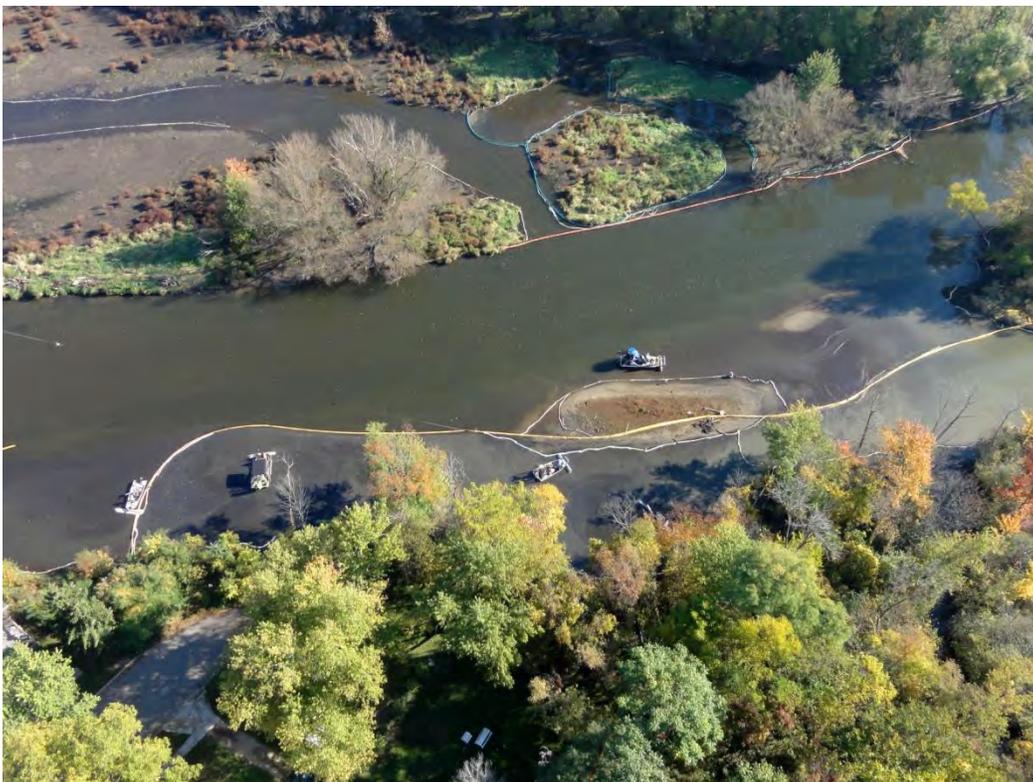
16. MP15.0, overview of submerged oil recovery work in southern end of Mill Pond. Some sheen observed within containment.

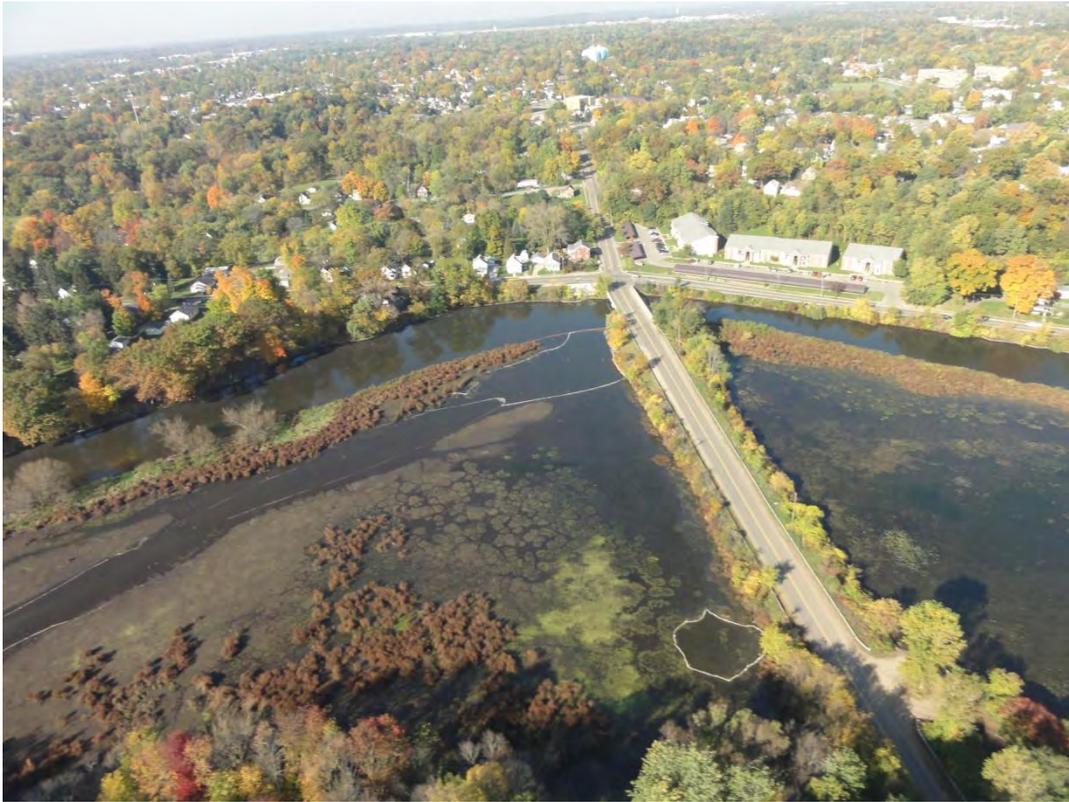
17. MP15.5, overview of south Mill Pond. No activity observed.

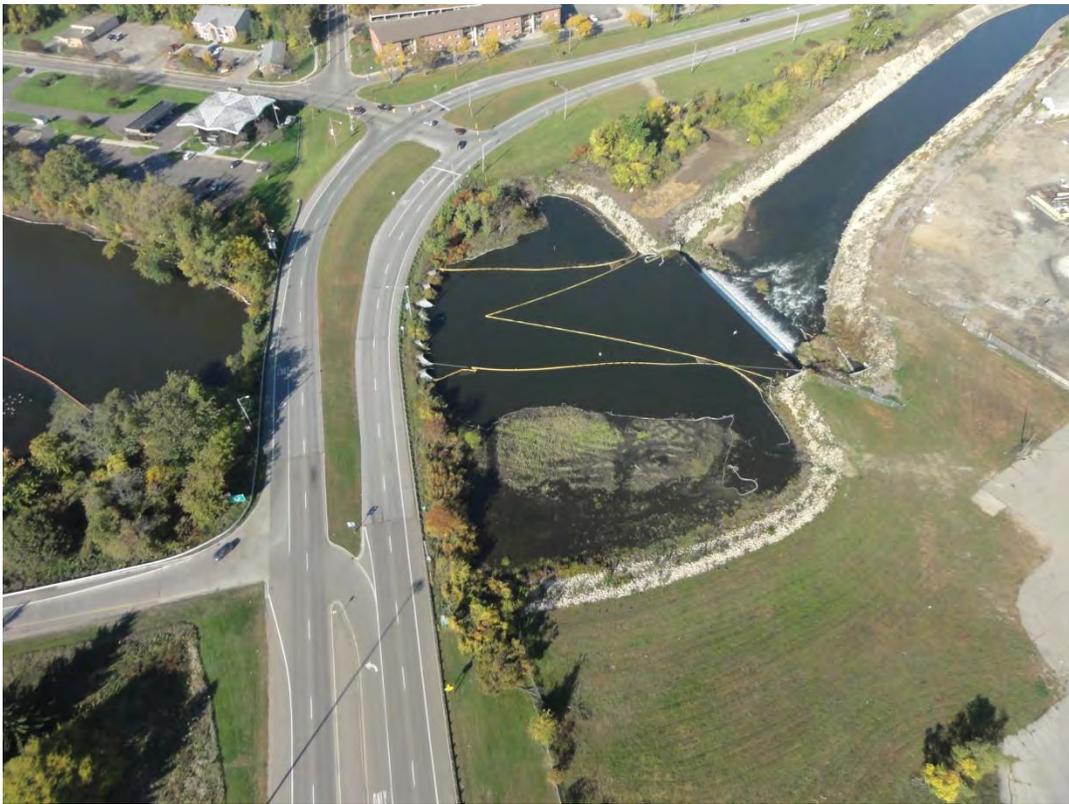
18. MP15.75, no activity observed.

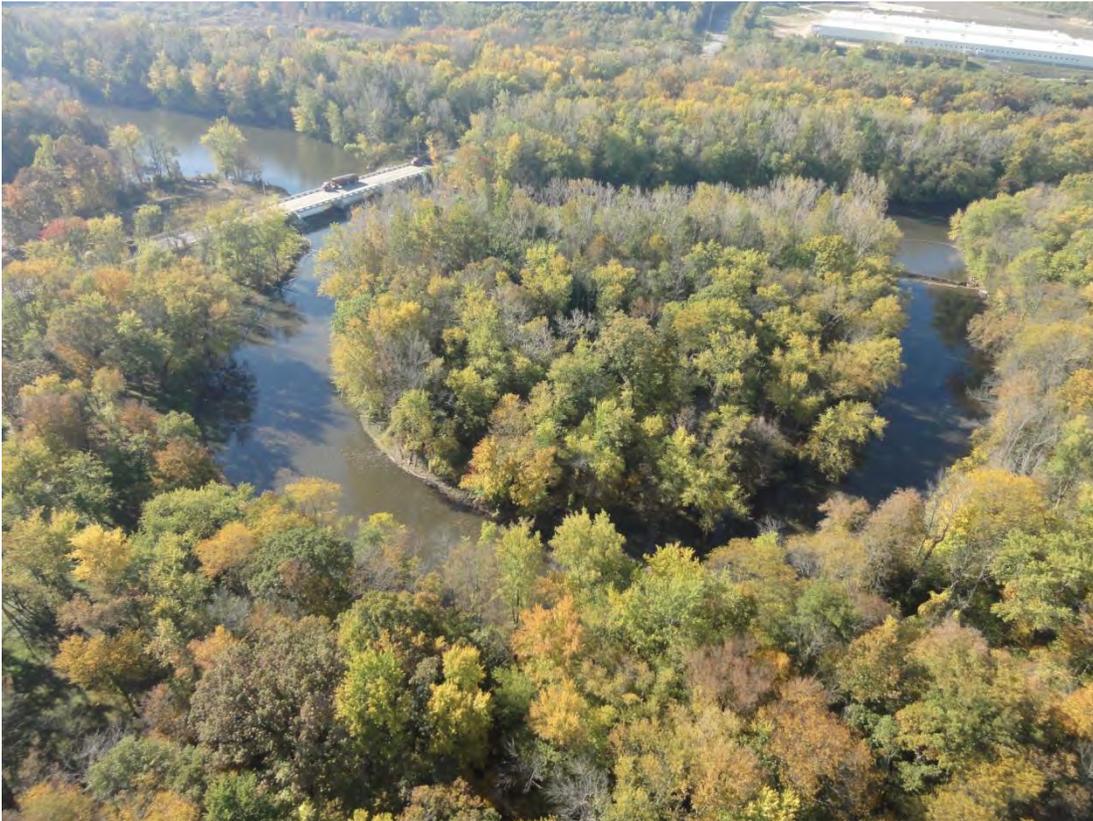
19. MP21.5, no sheen observed.

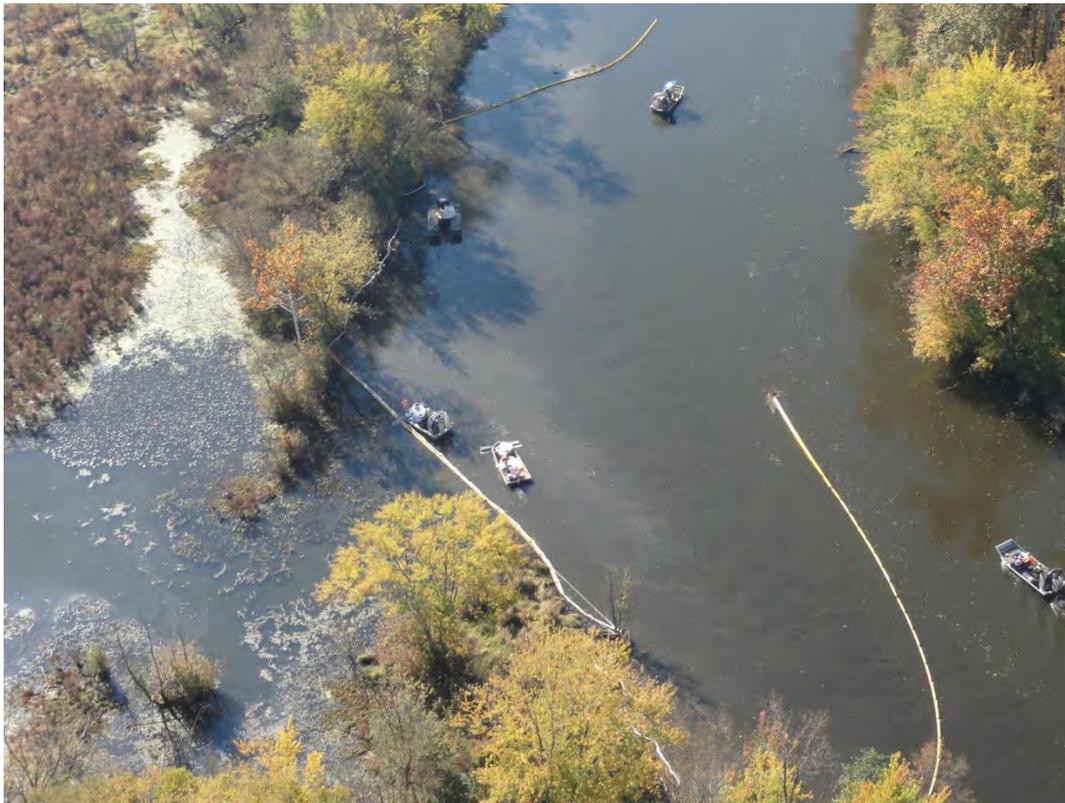
20. MP36.25, submerged oil recovery just east of 35th Street Bridge.

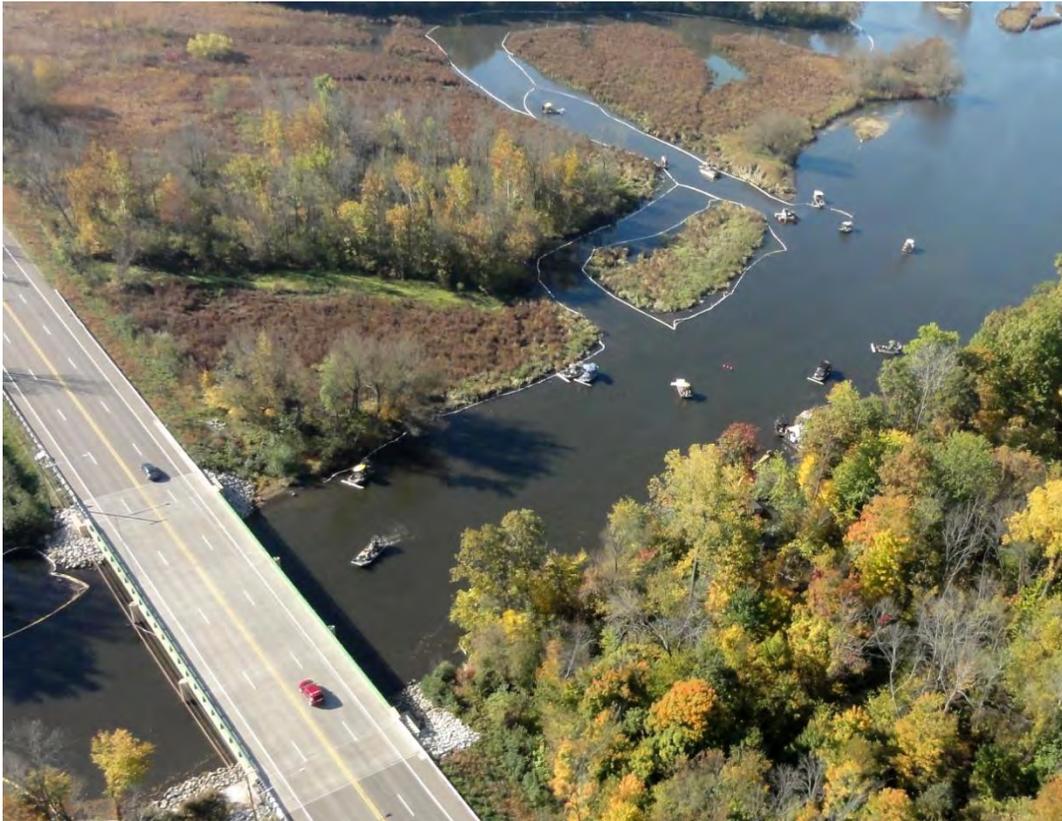
21. Overview of submerged oil recovery and vegetation removal west of 35th Street bridge.

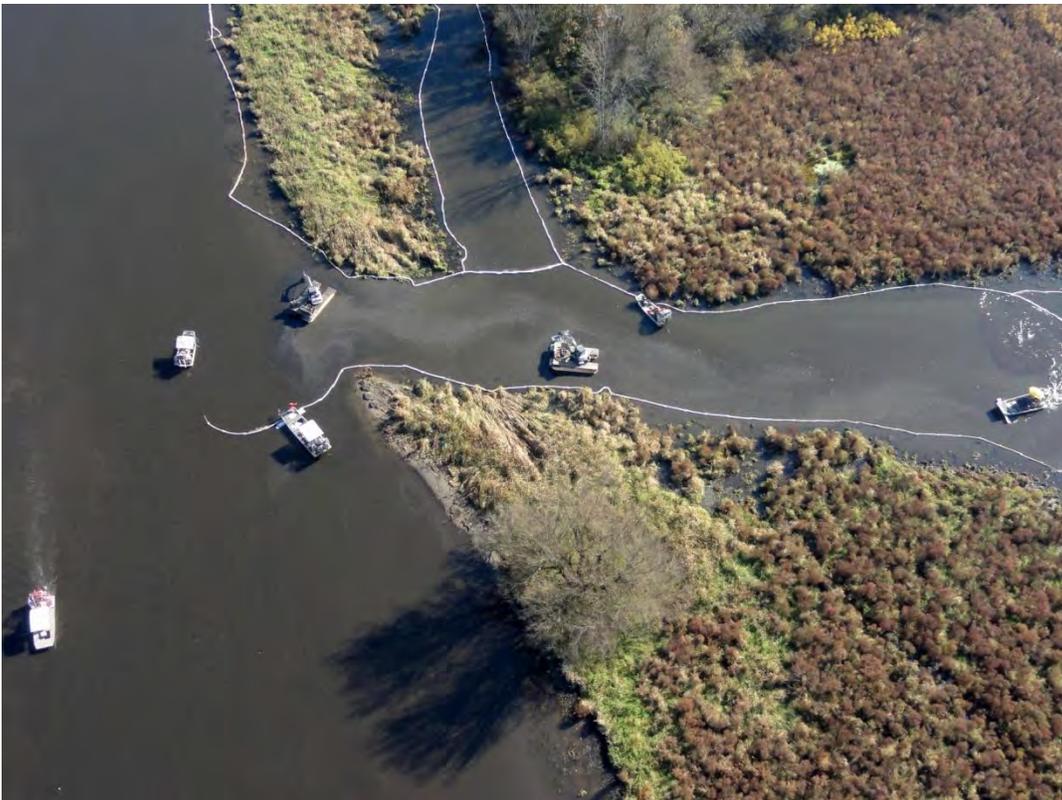
22. Excavators with spray bars and support boats in Channel 1 of Morrow Lake Delta.

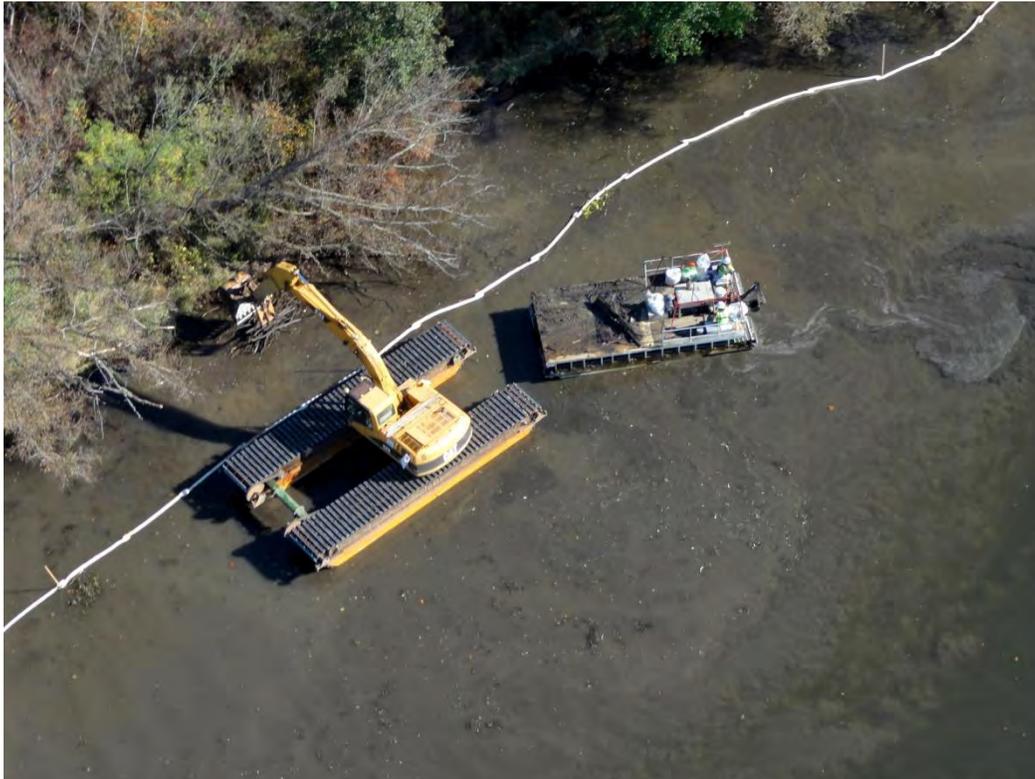
23. Woody debris removal along northern shore of Morrow Lake Delta.

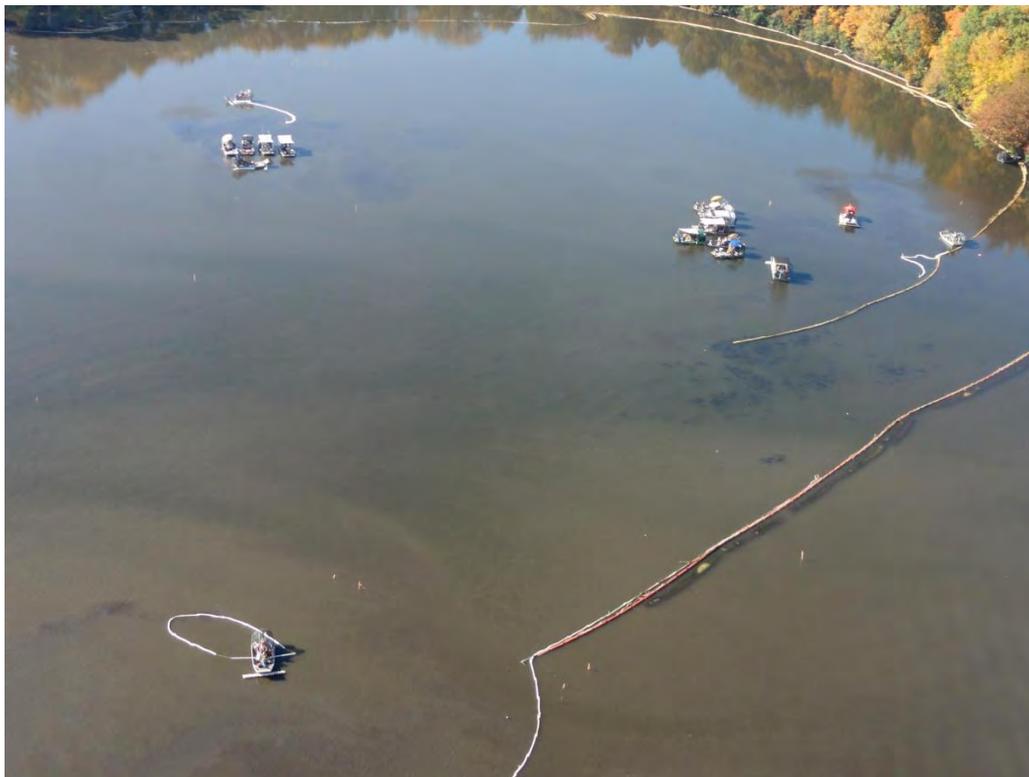
24. Southwest corner of Morrow Lake Delta, pumper boats continuing submerged oil recovery.

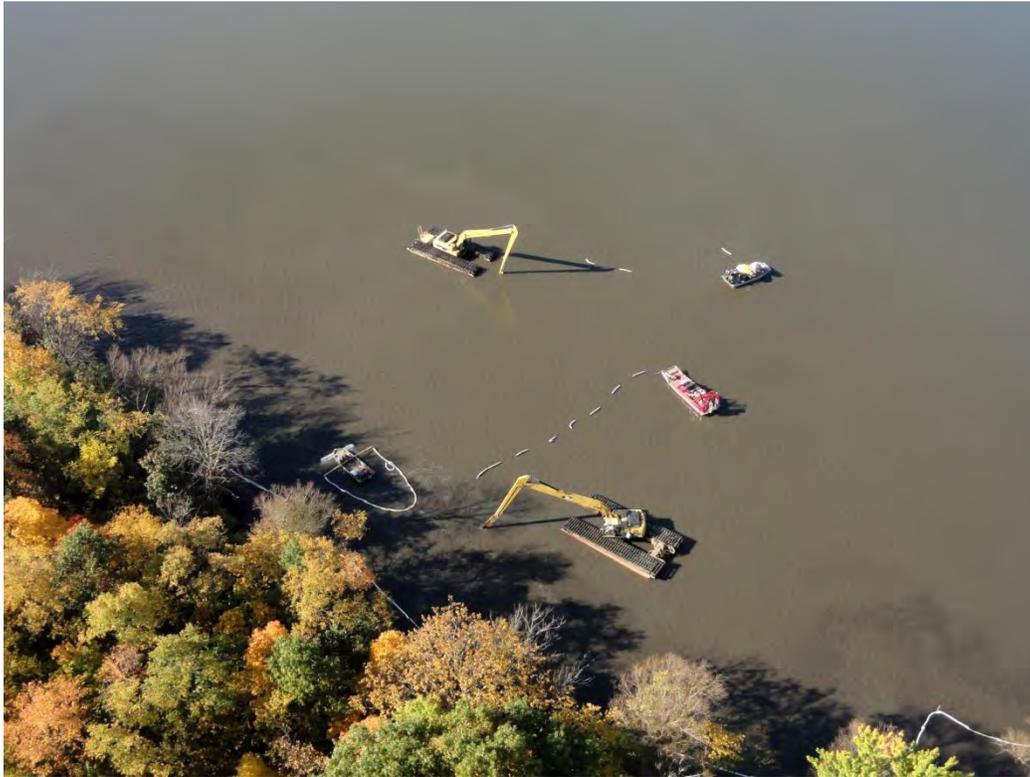
25. Northeast corner of Morrow Lake, pontoon excavators conducting submerged oil recovery.

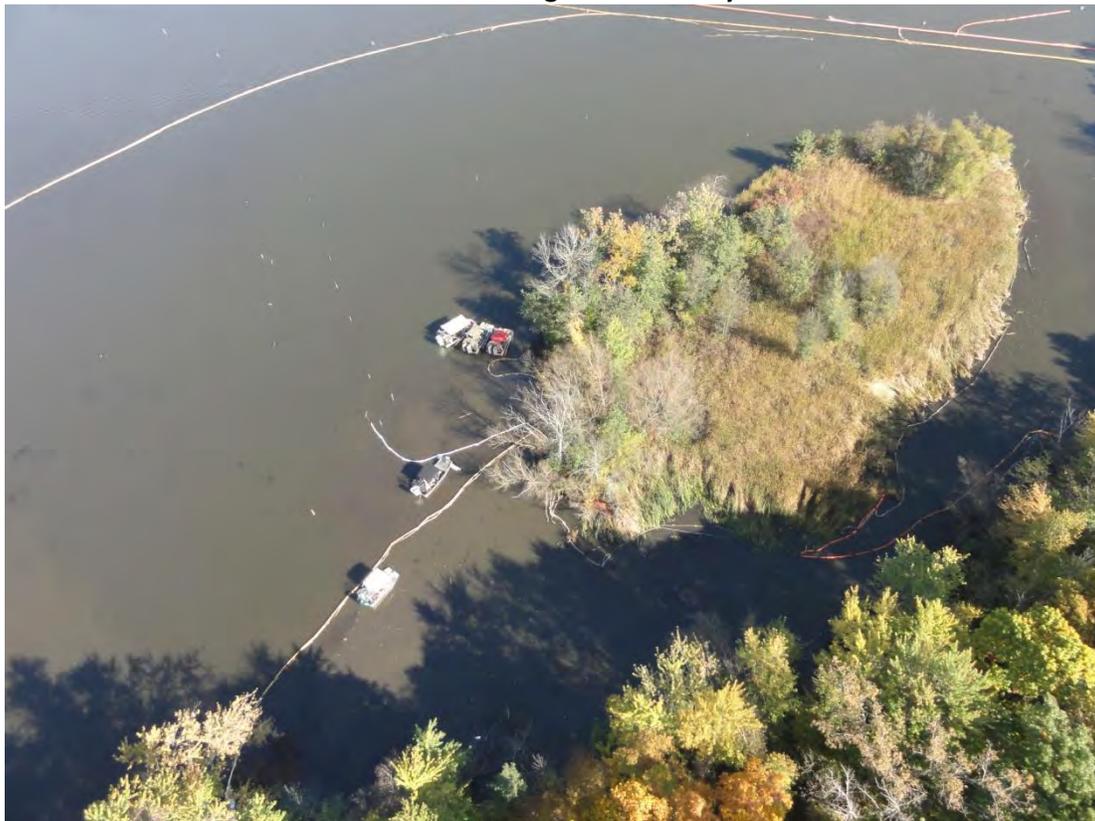
26. Pumper boats in Morrow Lake fan.
