City of Traverse City
400 Boardman Avenue
Traverse City, Michigan 49684

ADMINISTRATIVE CONSENT ORDER

BOARDMAN RIVER ASSESSMENT

Prepared By:
Will Harman, PG
March, 2015

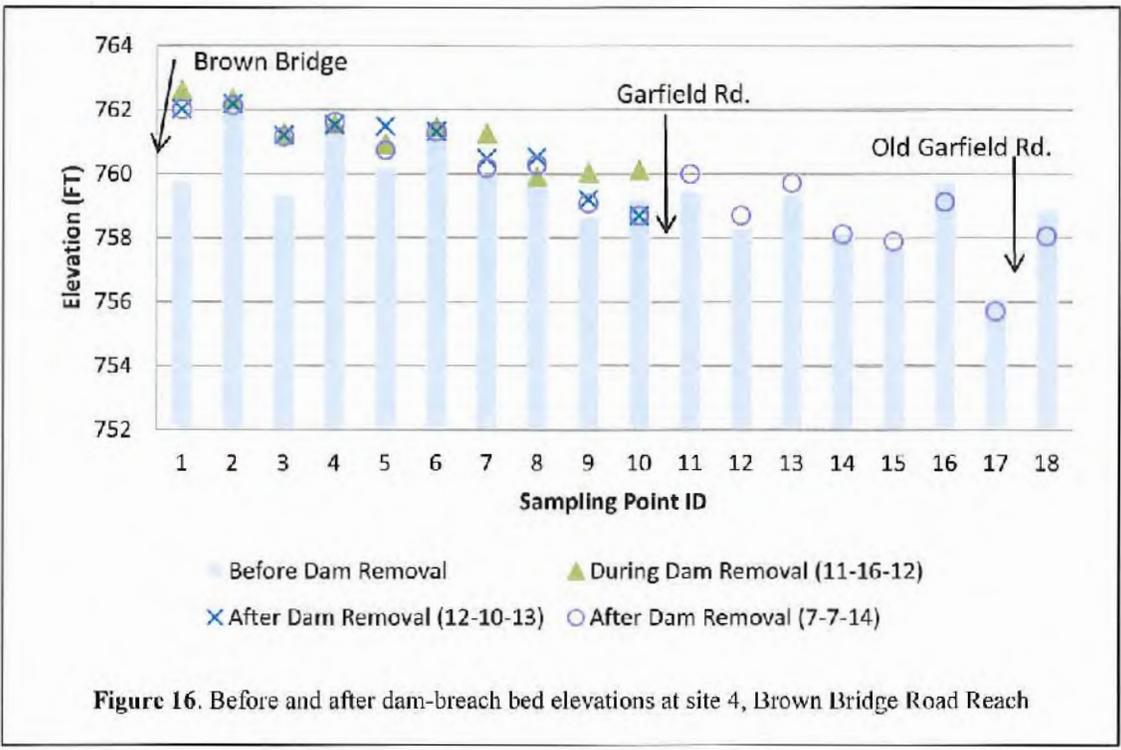
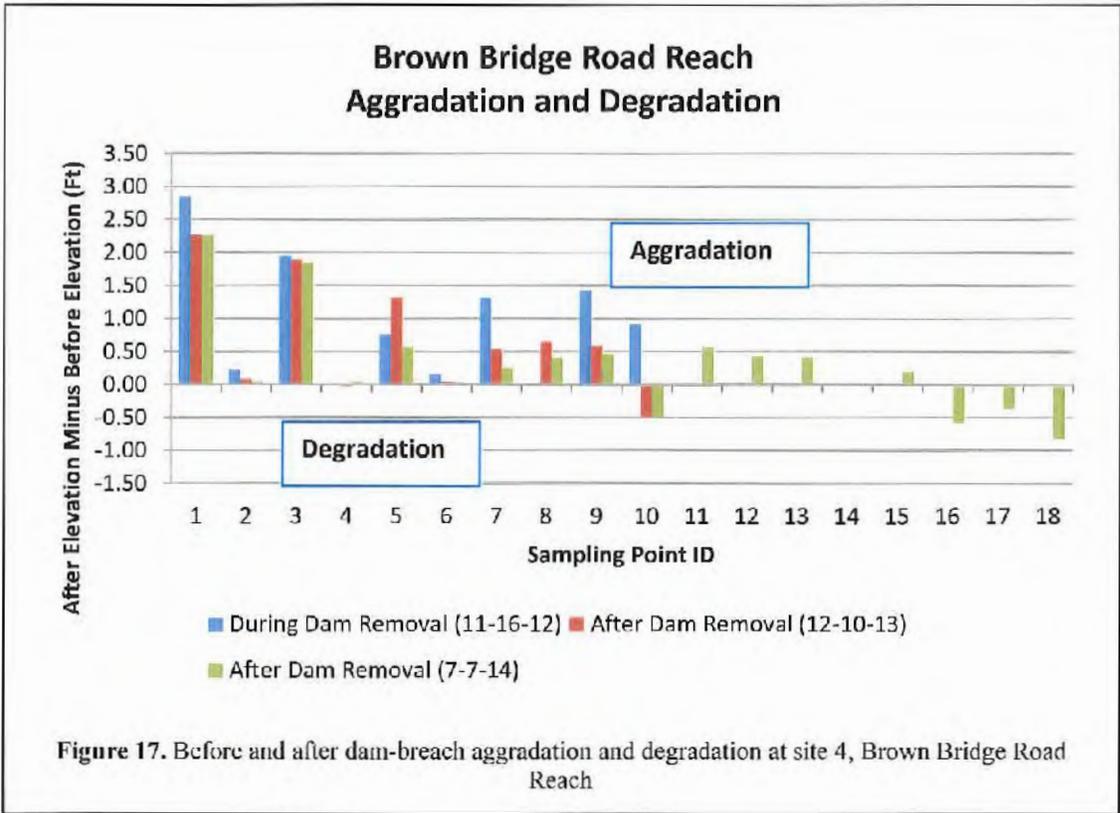
To better understand the magnitude of bed aggradation and degradation, a graph was created showing the post-TDS failure elevation minus the pre-TDS failure elevation for each site. The results are shown on **Figure 17** and clearly show a sediment wedge with maximum aggradation near the beginning of site 4, Brown Bridge Road and decreasing through Garfield Road. The aggradation wedge ends at point 14. The maximum aggradation was 2.9 feet at point number 1, surveyed approximately six weeks after the TDS failure (November 16, 2012). The max aggradation during the 2013 and 2014 survey was 2.3 feet.

Figure 18 shows the depth of refusal results for site 4, Brown Bridge Road. The zero depth on the graph represents the streambed elevation and the negative numbers show how far the steel/fiberglass graduated rod penetrated the bed sediments. Generally, the bar penetrated “soft” material like sand and small gravel that is scoured and filled during storm events. Coarse gravel is located below the refusal depth. The graph shows the depth of refusal generally decreasing in a downstream direction with the exception of points 9 and 10. These points are most likely influenced by scour and fill processes created by Garfield Road. Soft sediments are minimal downstream of Garfield Road with the exception of point 17, which is a deep pool near old Garfield Road.

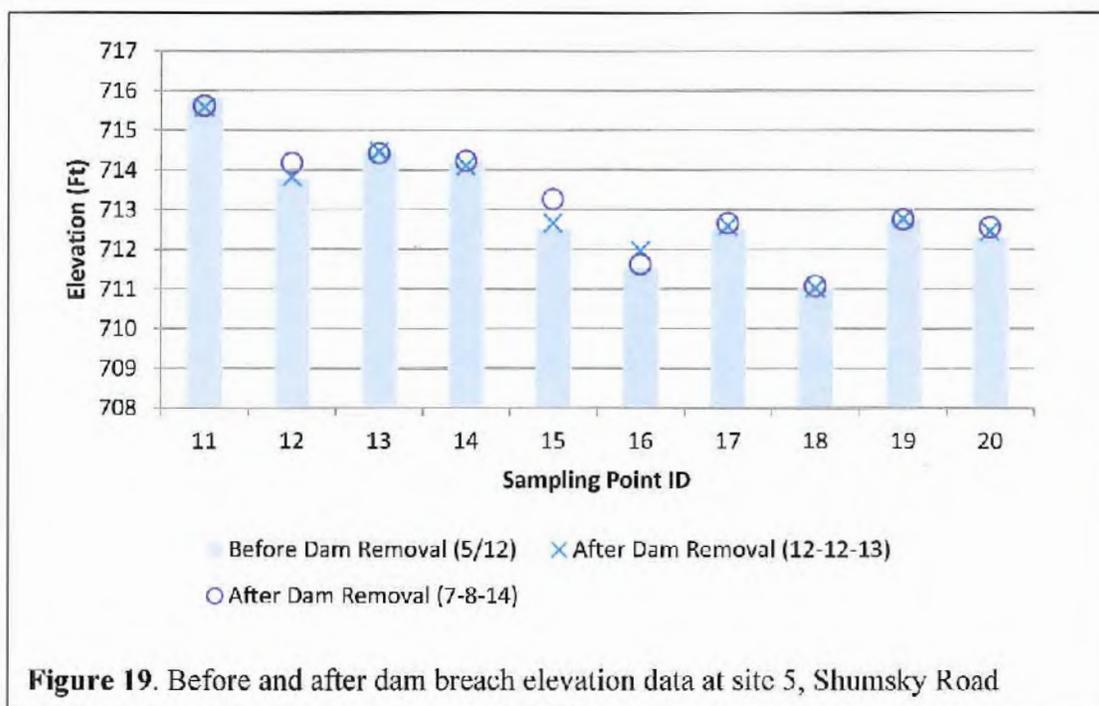
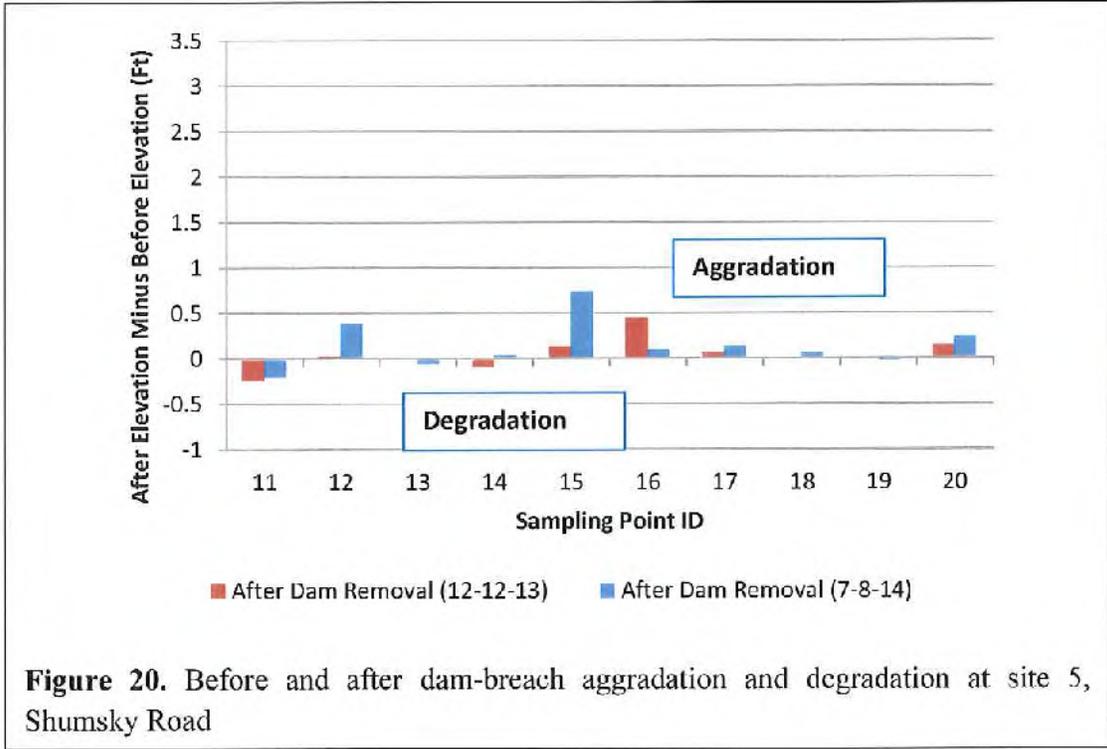
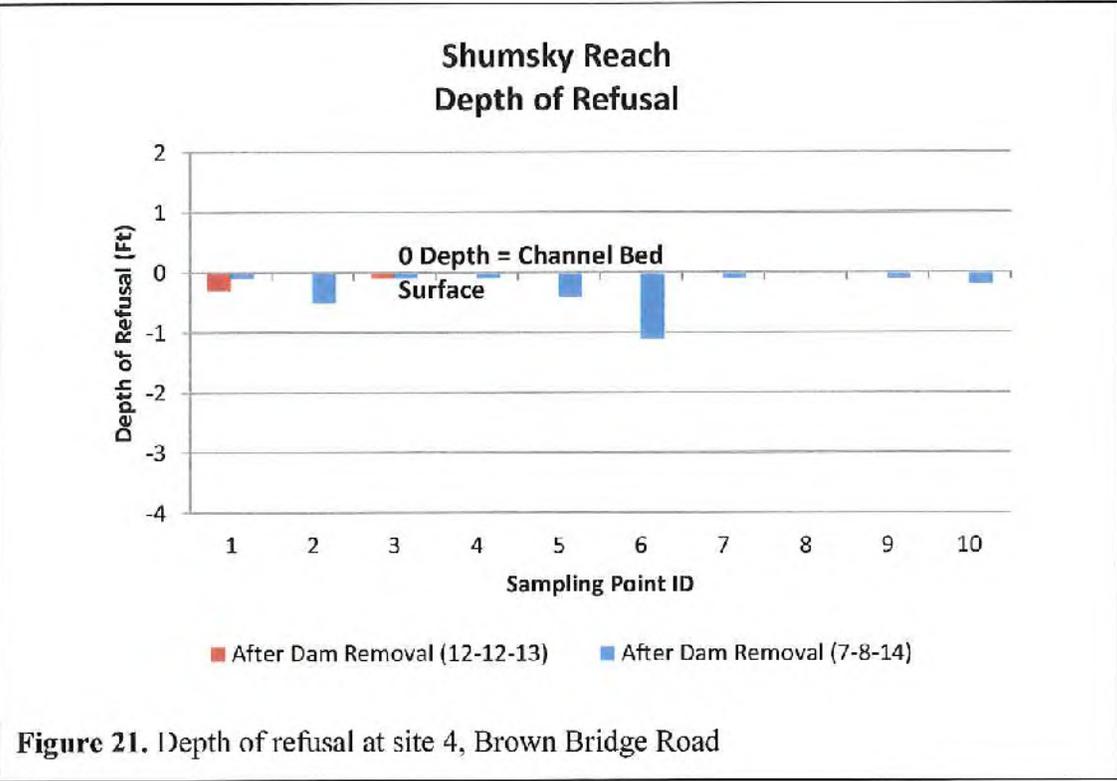
Figure 19 shows the bed elevation survey results for site 5, Shumsky Road. This graph shows very little bed elevation change from the pre-TDS failure condition to the post-TDS failure condition. There is no obvious sediment wedge; however, there are individual points that show minor increases and decreases in elevation. Points 15 and 16 show the largest elevation increases. The amount of aggradation and degradation is shown in **Figure 20**. Points 15 and 16 have aggradation rates ranging from 0.1 to 0.7 feet. The majority of the change is less than 0.4 feet, which is approximately the accuracy of the sampling method. Therefore, based on the sampling accuracy and lack of a sediment wedge, this reach is considered within the range of natural variability for streambed elevation fluctuation, i.e., it is vertically stable.

Figure 21 shows the depth refusal data and matches well with **Figure 20**. For most points, it was very difficult to drive the steel rod into the bed. Point number 6 was the only place where the rod could penetrate more than one foot. Points with apparently no data are locations where the depth of refusal was zero, i.e., no bed penetration. It was noted during sampling that the Shumsky streambed was much “harder” than the streambed at Brown Bridge Road.

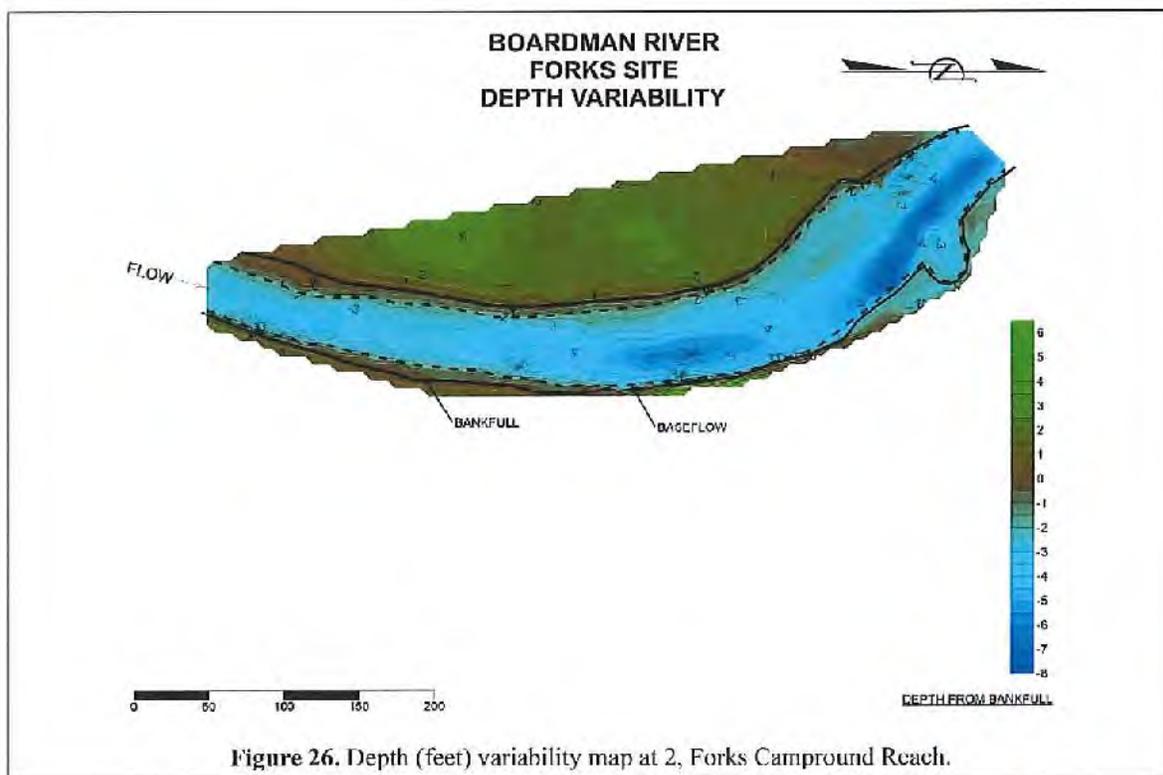
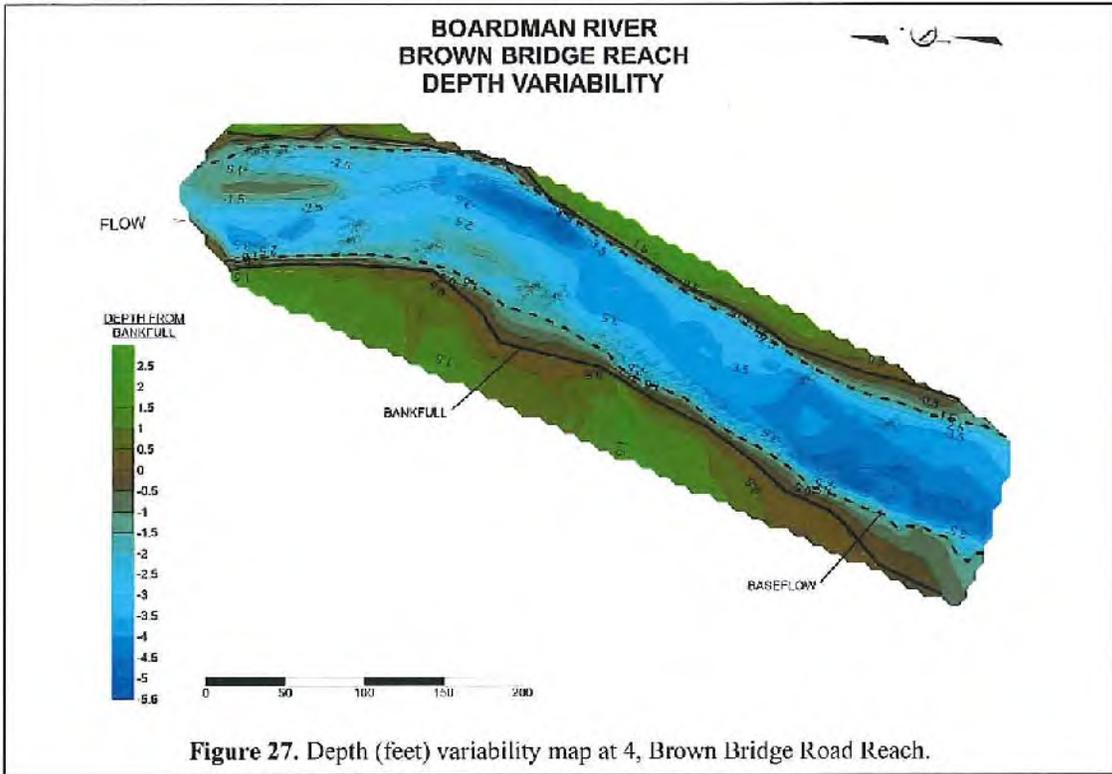
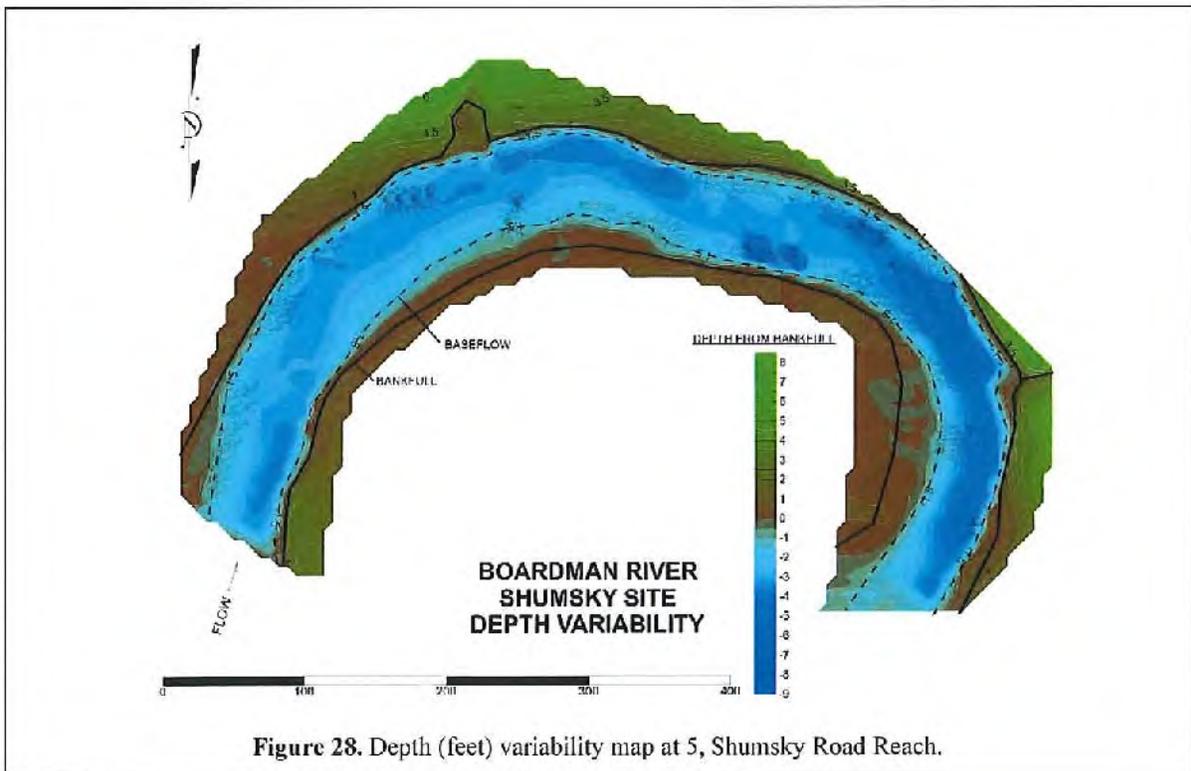
Site 4, Brown Bridge Road reach is particularly interesting. As discussed in the vertical stability assessment and stream mapping results, there are signs of aggradation in this reach. However, **Figure 267** shows that the aggradation is not having a negative impact on pool depth. There are deep pools along the outside meander bends and a thalweg has formed along the right side of the mid-channel bar. There are several pieces of LWD in this location, so a pool has formed as well.

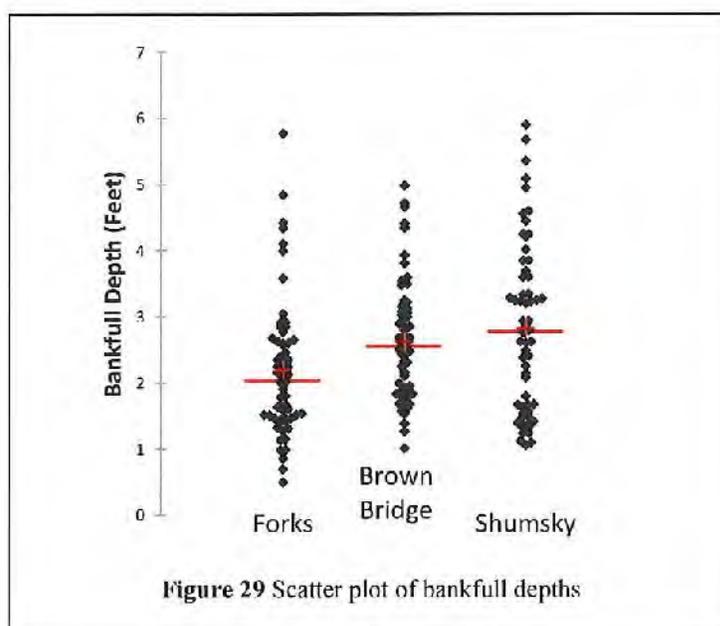
The final result from the bedform diversity assessment is the depth variability scatter plots. These plots are created from the same data set used to create the topographic maps. The result is shown in **Figure 29**. The black points are individual bankfull depths, the red line is the median, and the red plus sign is the mean. As expected, the mean/median and baseflow depth increase in a downstream direction due to increases in drainage area and flow. The max depth for site 2, Forks is almost the same as site 5, Shumsky, the farthest downstream reach. This is probably due to the flow contraction that occurs from the meander bend and LWD jam at 2, Forks. However, the distribution of depth is similar between the three sites. In other words, no site is mostly shallow or mostly deep.

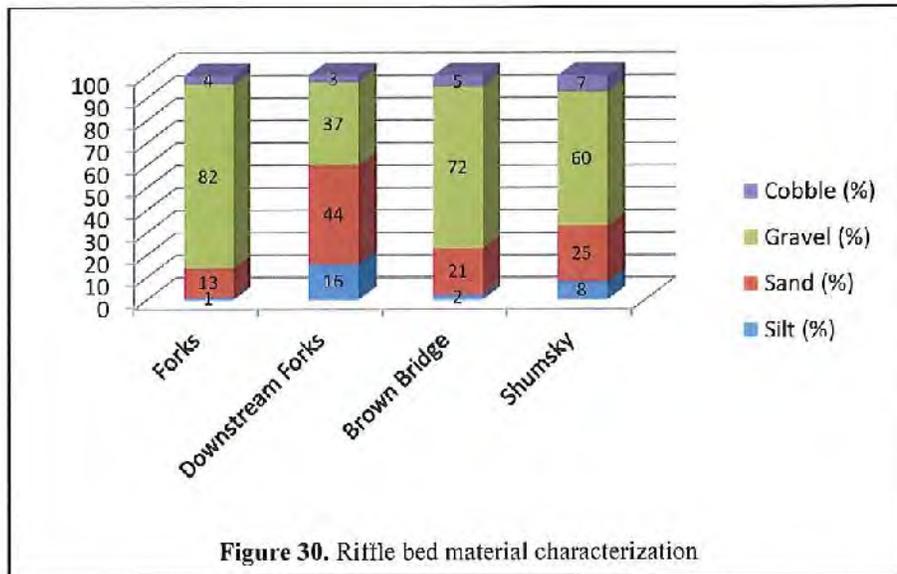
Results for the bed material data are divided by riffles, pool, and point bar bed features. The riffle results are shown on **Figure 30** and include sites 2, Forks; 3, Downstream of Forks; 4, Brown Bridge; and, 5, Shumsky. A full-page version of Figures 30 and 31 along with representative photos is included in Appendix 2. The riffles at sites 2, Forks, 4, Brown Bridge, and 5, Shumsky are mostly gravel at 82%, 72%, and 60%, respectively. It is typical that the percent gravel will decrease in a downstream direction (Knighton, 1998). There also is sand in the riffles, located along the channel margin as shown in the feature maps. The sand percentages for each site are: 2, Forks (13%); 4, Brown Bridge (21%); and, 5, Shumsky (25%). As discussed in the methodology section, the site 3, Downstream of Forks was selected because it appeared to be one of the sandiest reaches in the watershed. The pebble count data quantify this observation. The riffle here is 44% sand and 37% gravel, with 16% silt, this is twice as much as site 5, Shumsky. It is unknown why this site is so sandy, but this site along with visual observations, shows that there is a sand load throughout the Boardman River Watershed, not just downstream of the former Brown Bridge Pond.

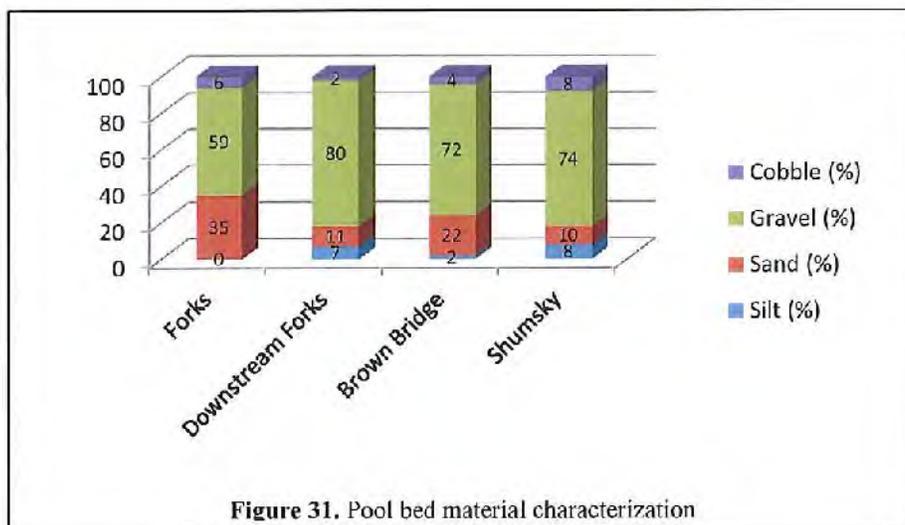
The pool bed material composition is shown in **Figure 31**. This graph shows that the pools also are dominated by gravel, both upstream and downstream of the former Brown Bridge Impoundment. Site 2, Forks Campground has the highest percentage of sand within the pool at 35%. Pools at sites 4, Brown Bridge and 5, Shumsky are 22% and 10% sand, respectively. If the TDS failure / dam removal were causing excessive sedimentation, the pools would likely have more sand than gravel. When comparing the pools to the riffles, the pools do have a higher percentage of sand, but it is not excessive. Combining this information with the depth data shows that the pools are well-formed. They are deep with coarse thalwegs; whereas, a reach impacted by sediment loading would have shallow pools filled with sand.

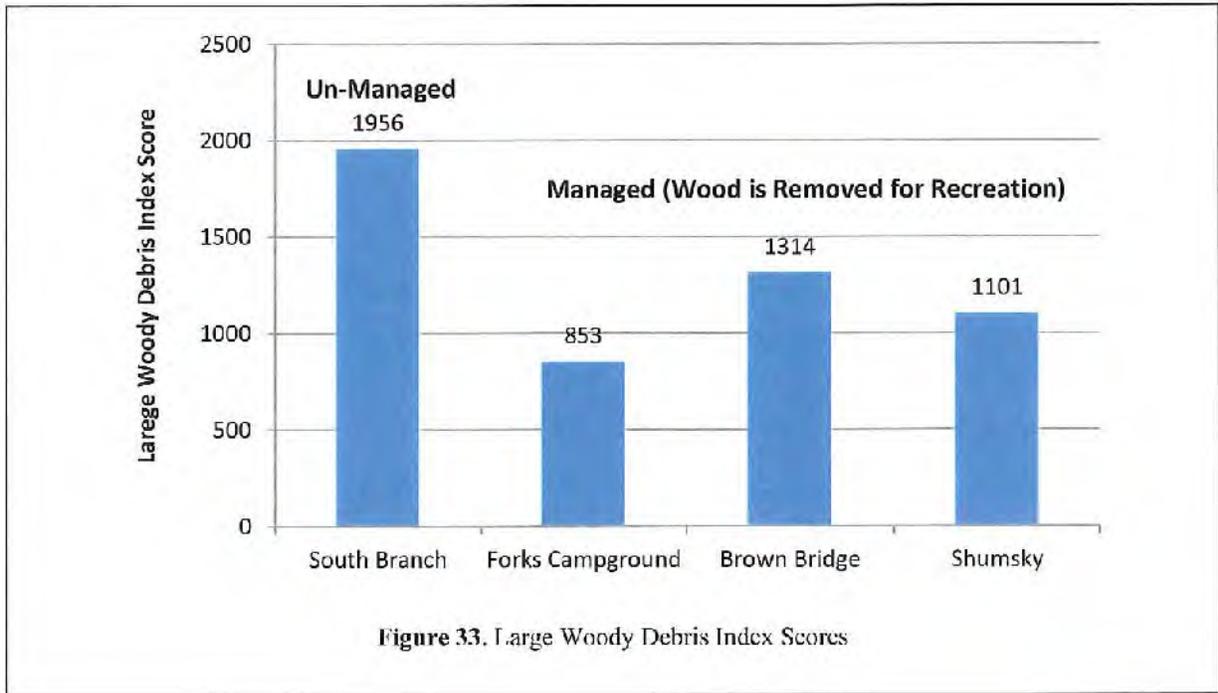
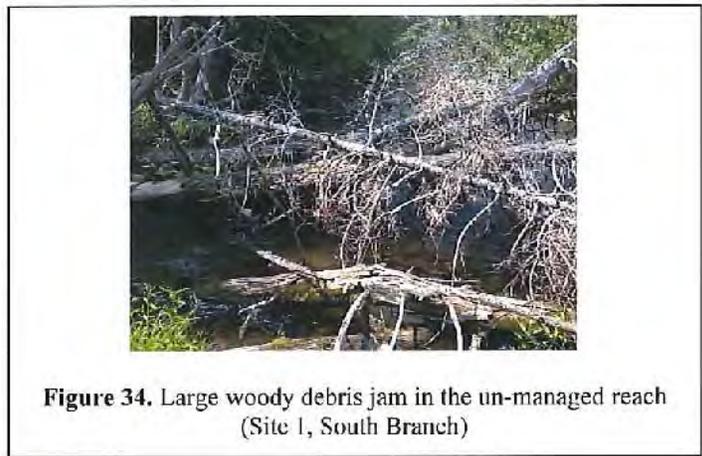
Results from the LWD assessment are provided in **Figure 33**. The LWDI was calculated at site 1, South Branch (un-managed) to represent a reach where wood is not routinely removed from the river. All other sites (2, Forks; 4, Brown Bridge; and, 5, Shumsky) have wood routinely removed to support water-based recreation like canoeing. Therefore, the comparison between managed and un-managed is more relevant than whether the site is upstream or downstream of the former Brown Bridge Pond. The difference is large. There is much more wood in the un-managed reach than the managed reaches, which is most of the main-stem of the Boardman River. The site closest to the un-managed LWDI is site 4, Brown Bridge, which is still 1,103 points less than the managed site (1, South Branch). A photo of the un-managed reach is provided below in **Figure 34**. This reach would be impossible to canoe, so it's understandable why wood removal is common.

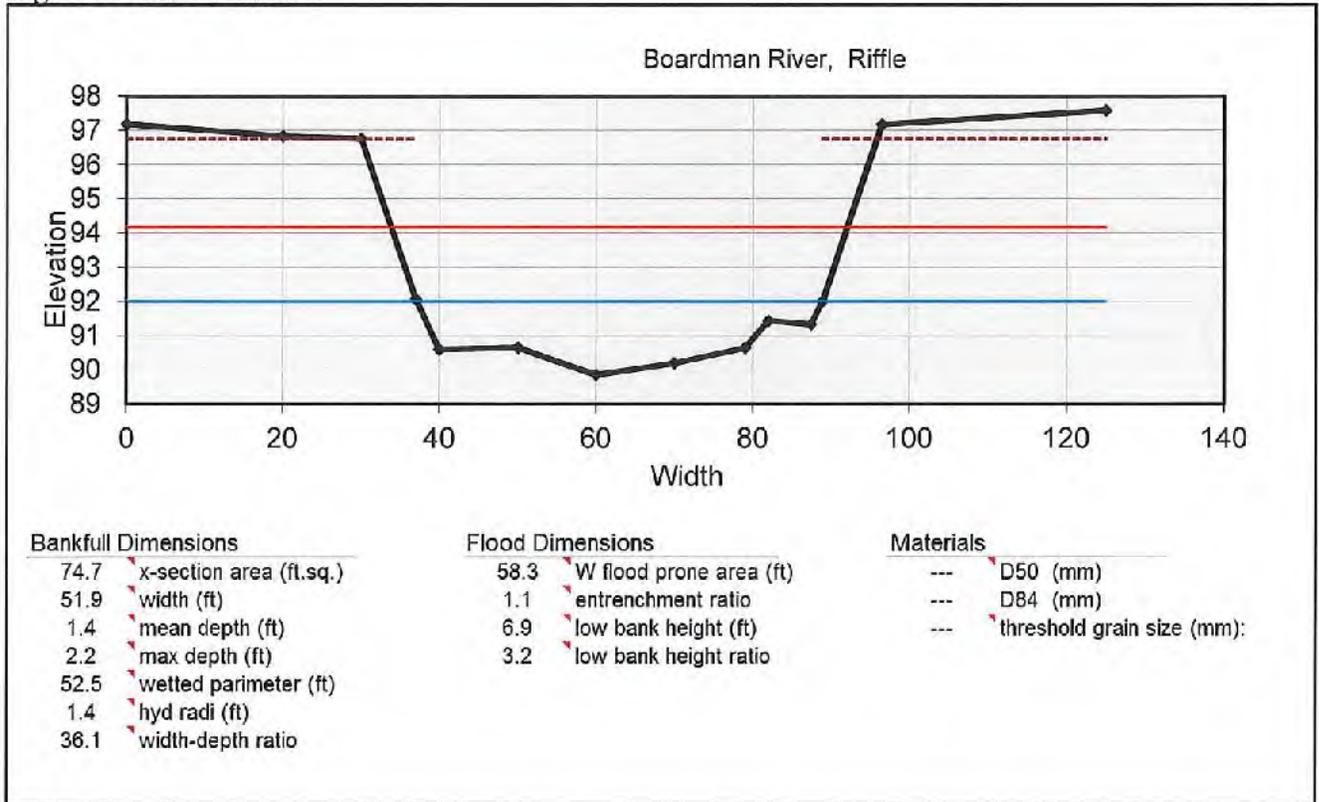
Figure 2: Cross Section 1

Cross sections 1 and 2 are provided below in Figures 2 and 3. The blue line represents the bankfull stage, the red line is the floodprone area width, and the dotted line is the low bank elevation. The bankfull and flood dimensions are shown below the graphs. The cross sections show that this reach is incised (bank height ratios of 3.2 and 2.7) and entrenched (entrenchment ratio of 1.1 for both cross sections). The Rosgen Stream Type is an unstable F4 channel. Using the Stream Functions Pyramid Framework, this reach would score a “Not Functioning” for floodplain connectivity.

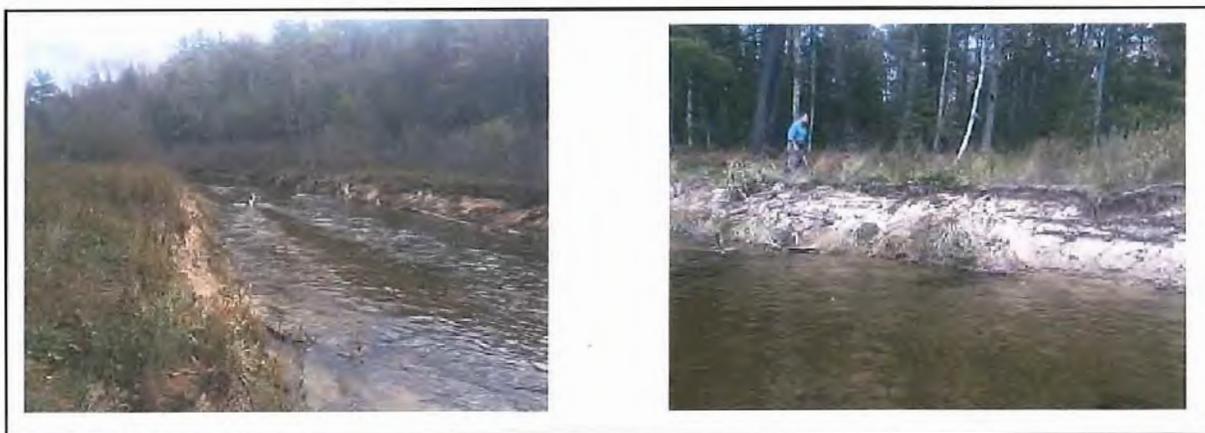
Figure 4: Photos of Project Reach

Photographs taken along the project reach are shown in Figure 4. Bank erosion is prevalent along both sides of the channel, which is very common when streams are disconnected from their floodplain, e.g., as shown with the high bank height ratio. This condition is prevalent throughout the project reach and it is unlikely that the banks will stabilize on their own in a short period of time.
