FIGURE 2  
SITE #29  
BANK EROSION STABILIZATION DESIGN  
ADDENDUM NO.1

Detail E - Brush Wattles and Woody Debris  
 Enbridge Line 6B Incident  
 Kalamazoo River Proposed Typical Restoration Techniques  
 Calhoun County, Michigan  
 JFNew 1008114.00 - Dec 16, 2010

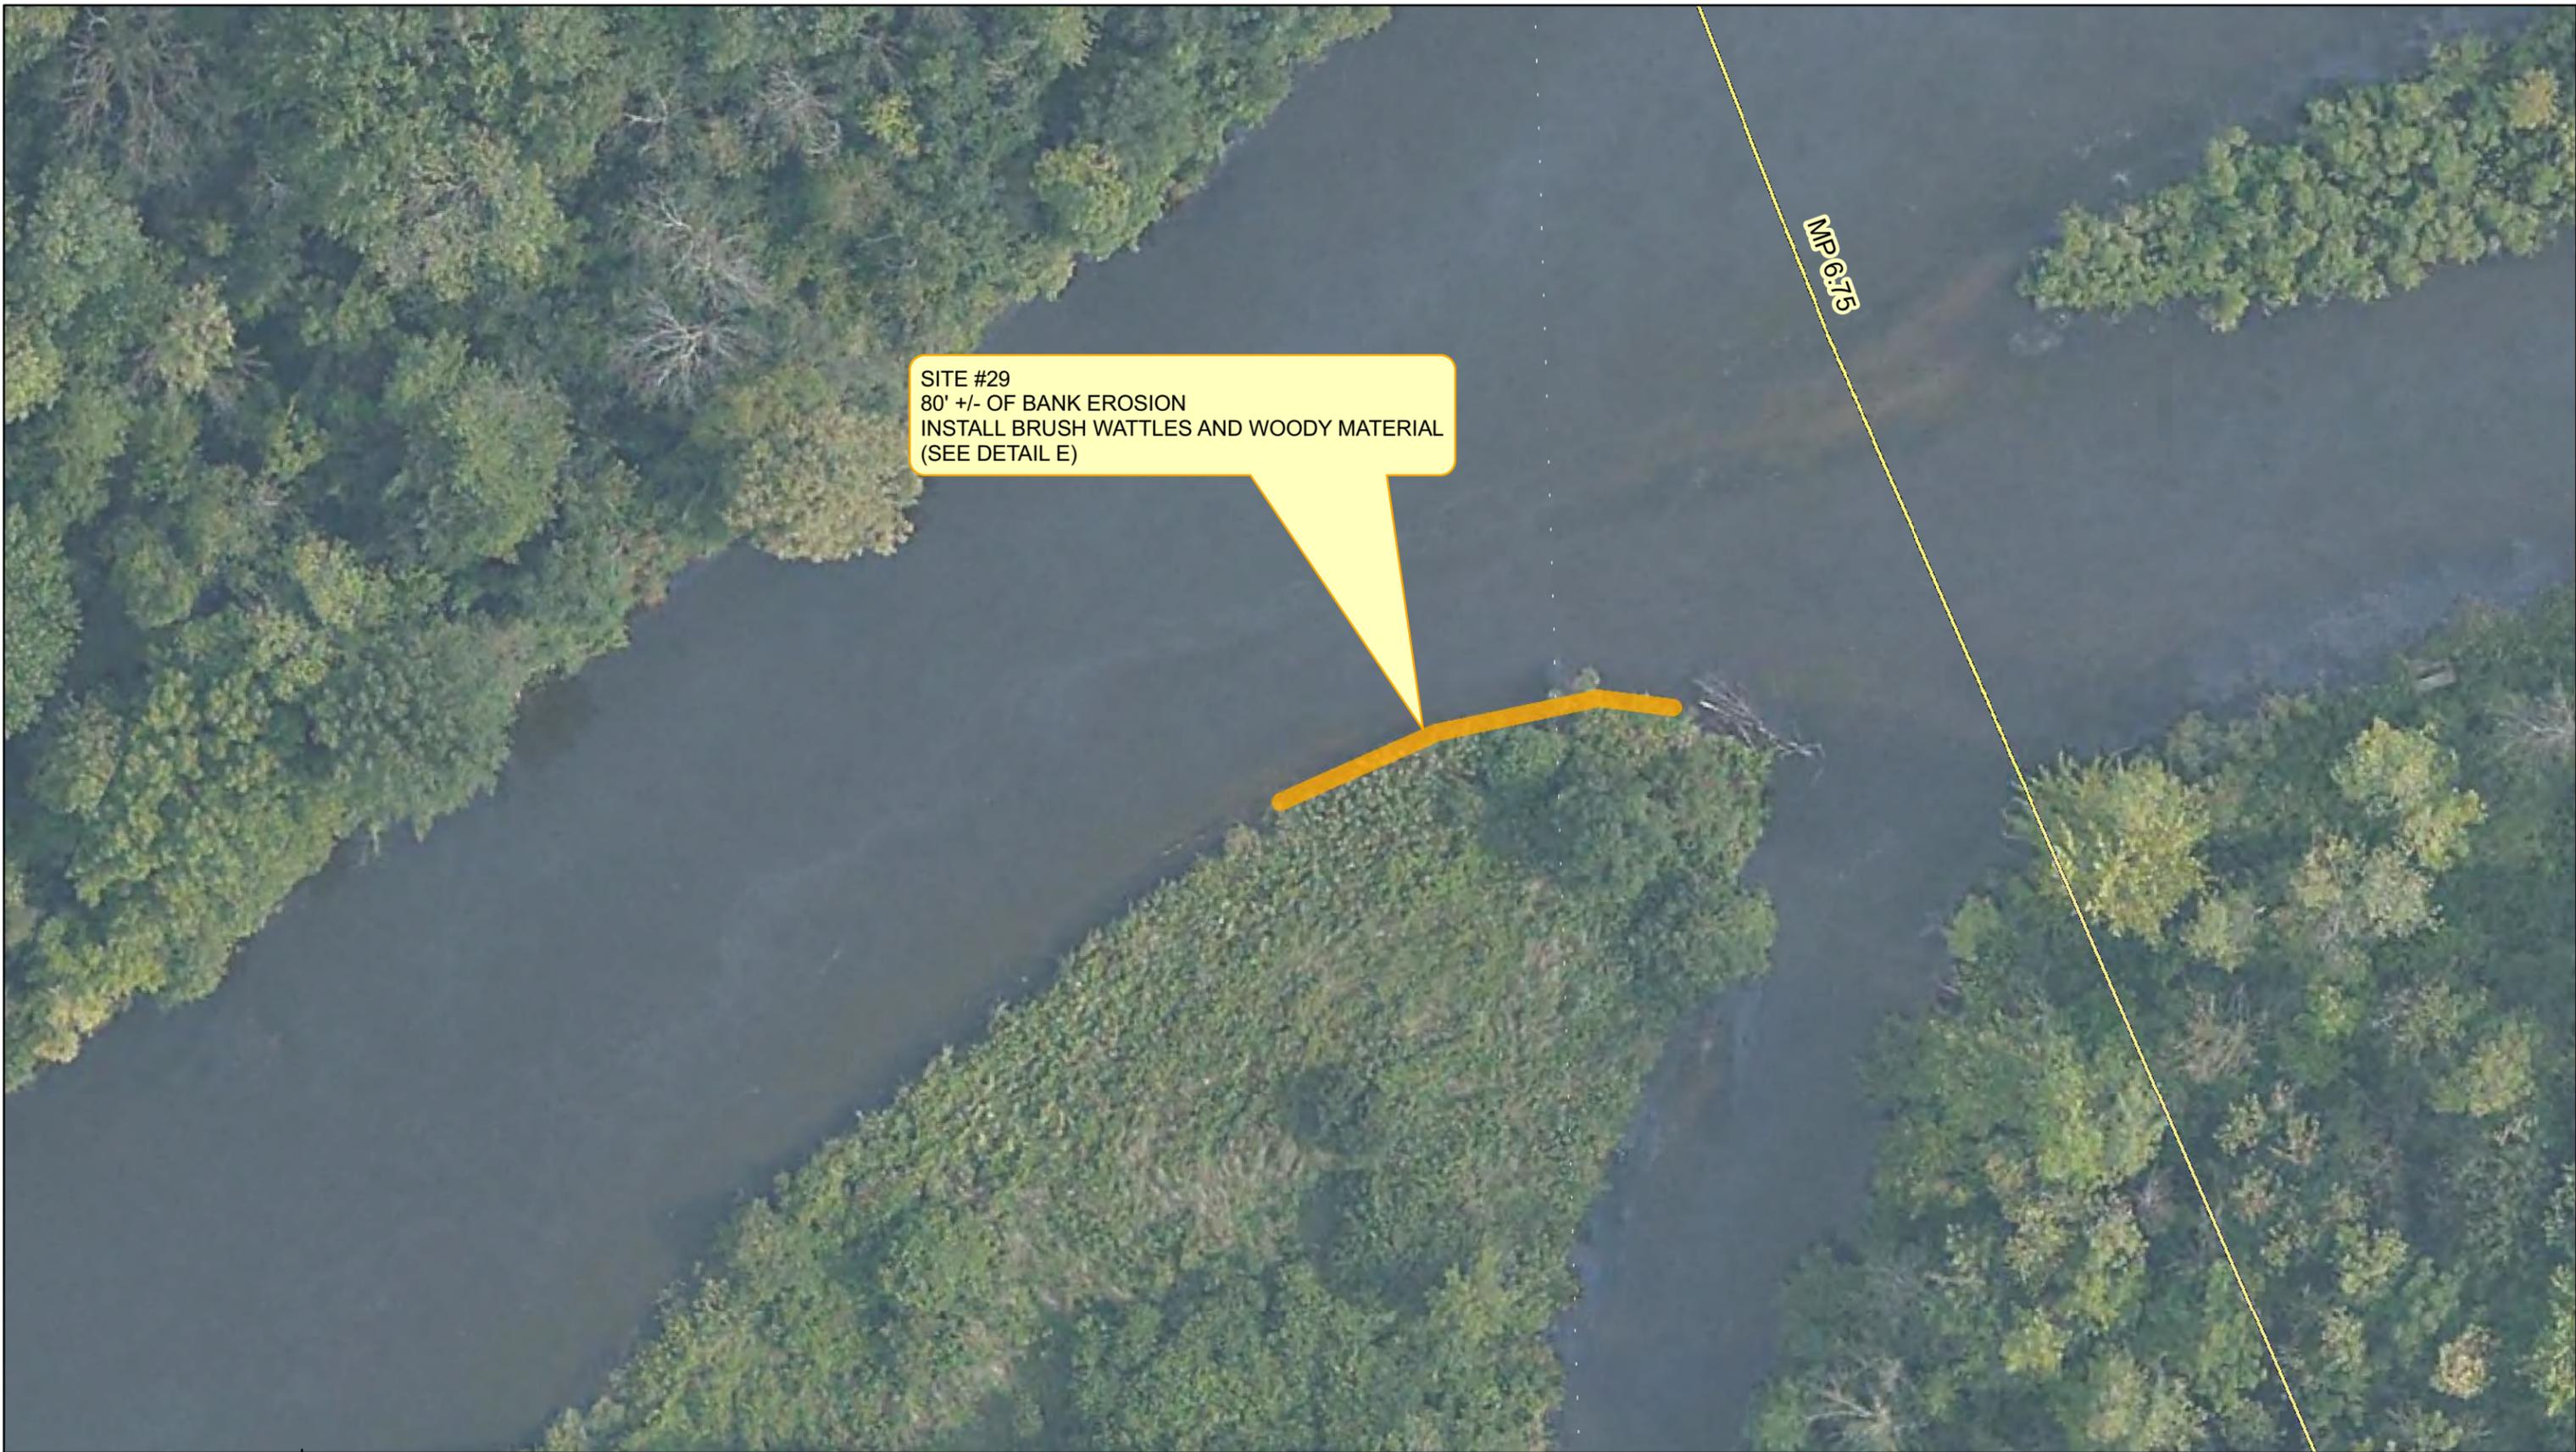
SITE #29  
80' +/- OF BANK EROSION  
INSTALL BRUSH WATTLES AND WOODY MATERIAL  
(SEE DETAIL E)

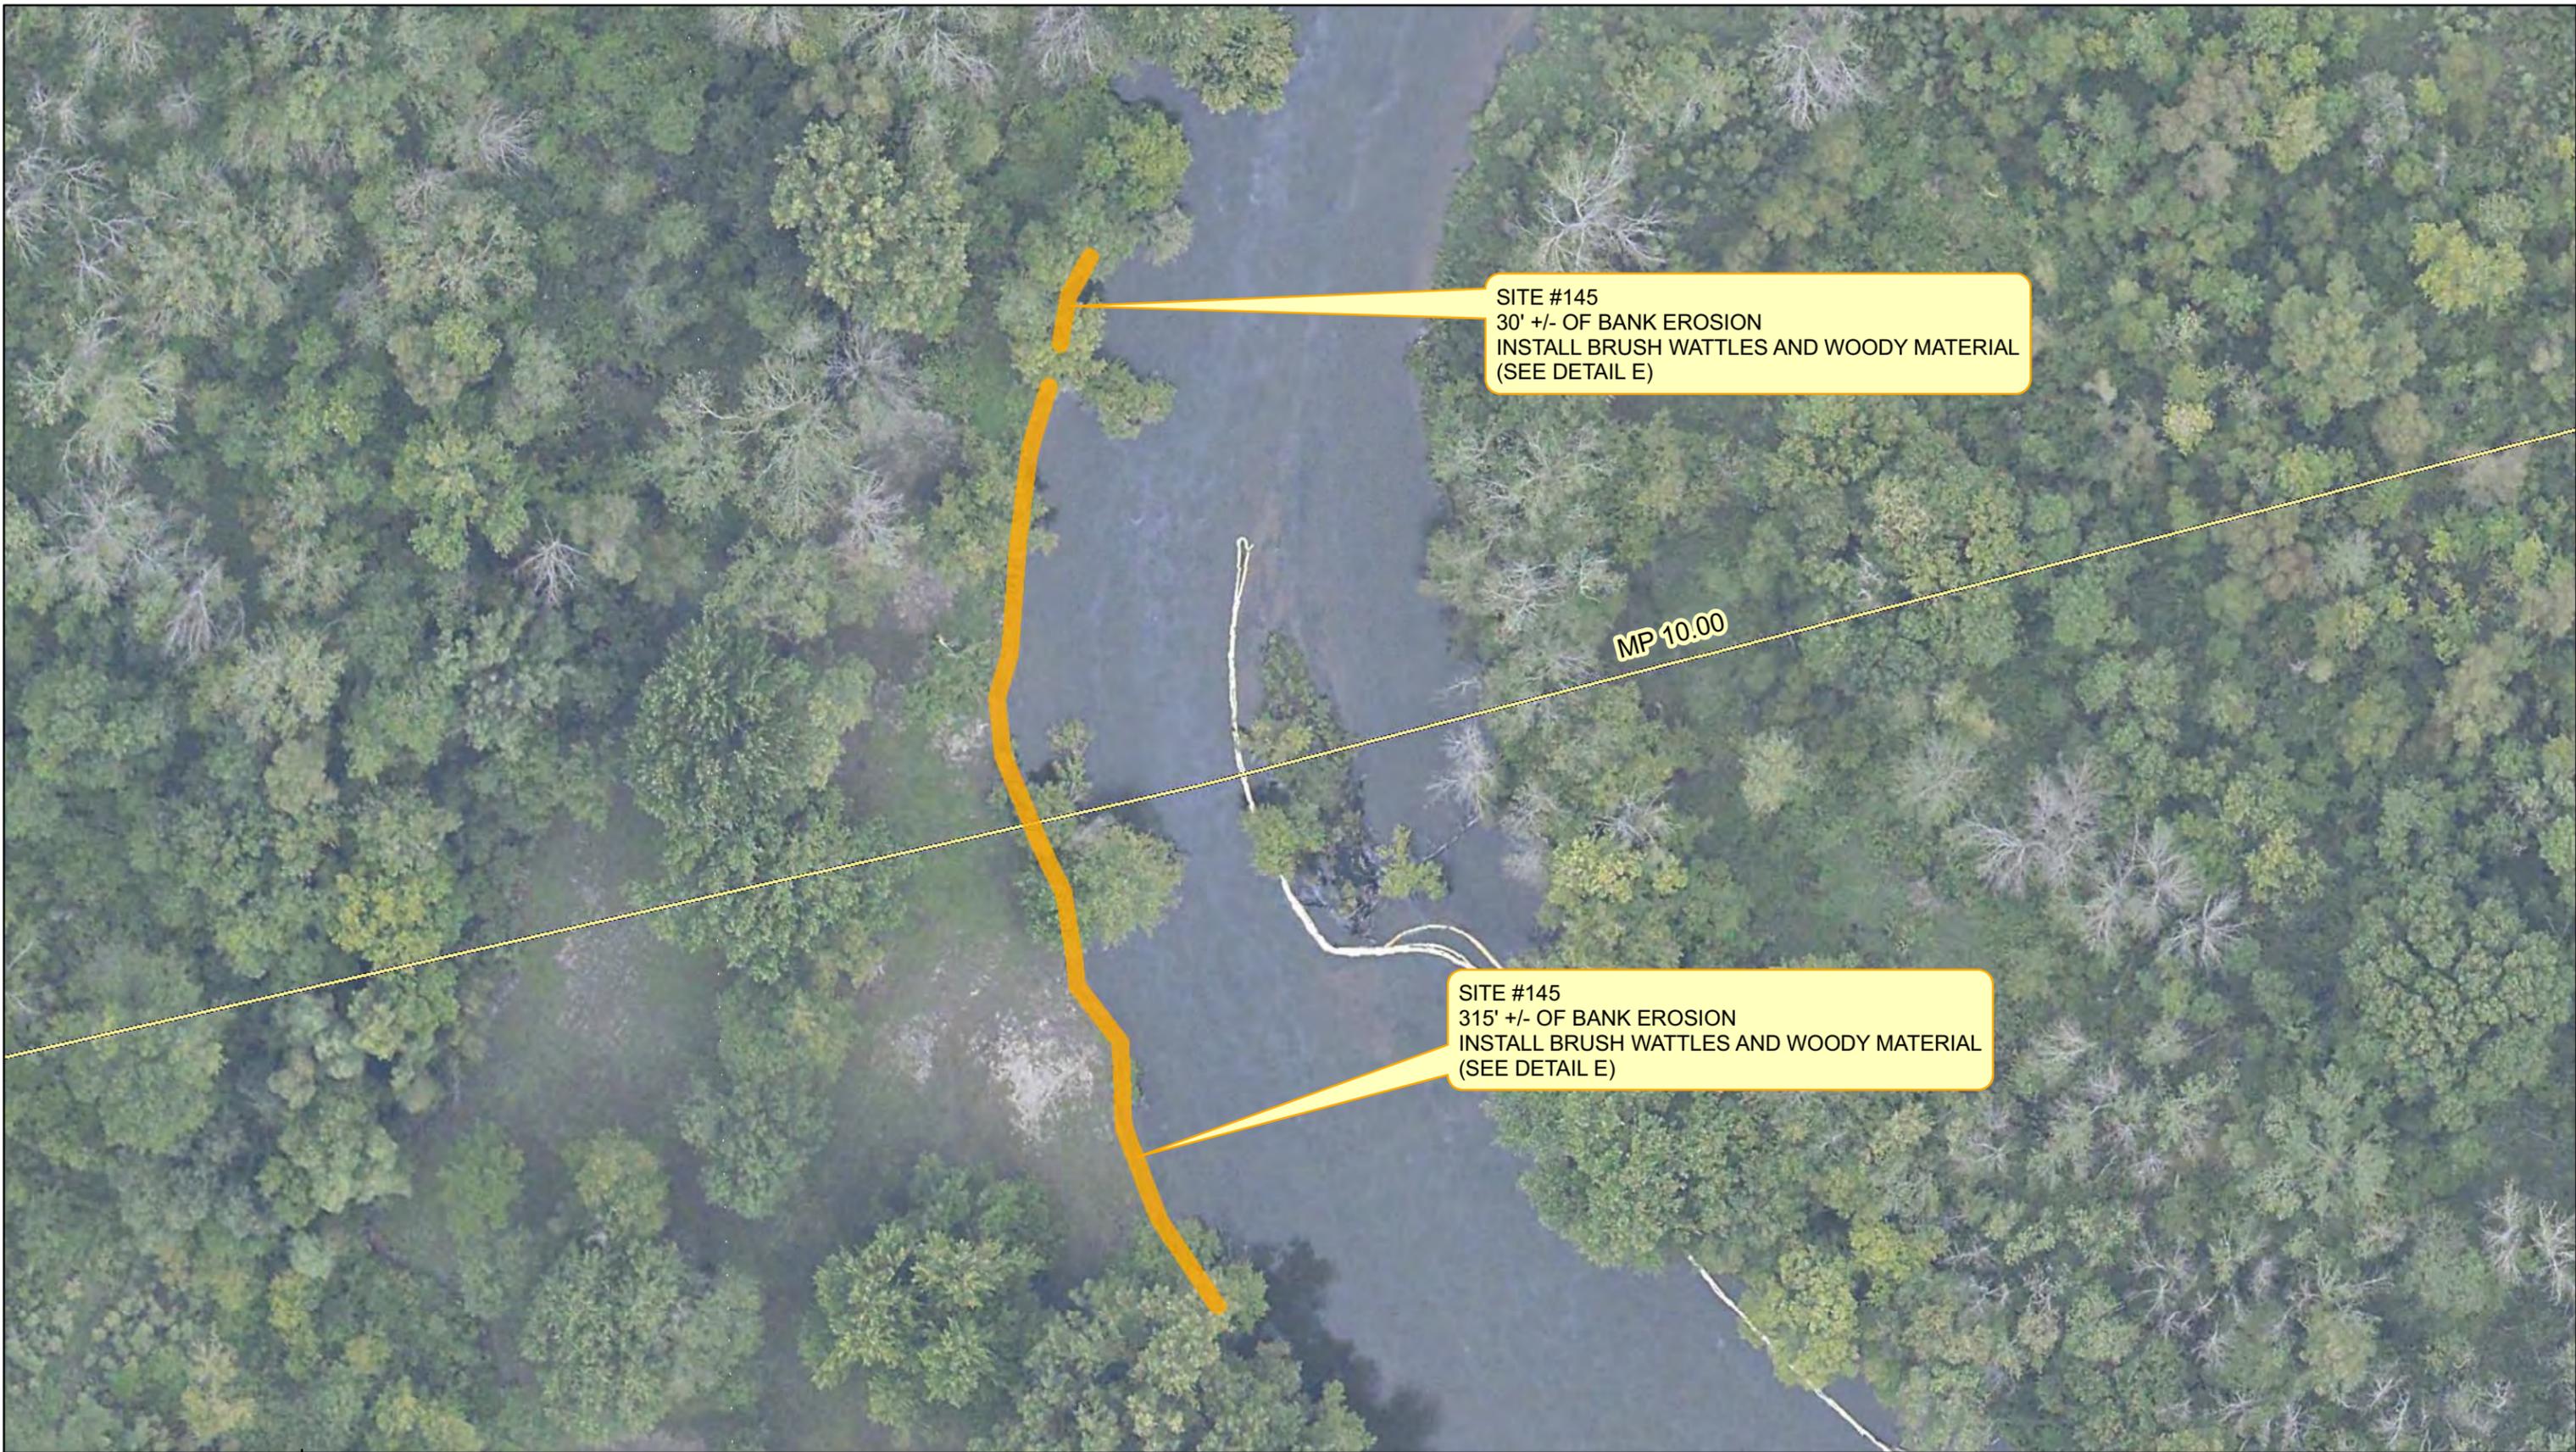
FIGURE 4  
SITE #145  
BANK EROSION STABILIZATION DESIGN  
ADDENDUM NO.1

SITE #145  
30' +/- OF BANK EROSION  
INSTALL BRUSH WATTLES AND WOODY MATERIAL  
(SEE DETAIL E)

SITE #145  
315' +/- OF BANK EROSION  
INSTALL BRUSH WATTLES AND WOODY MATERIAL  
(SEE DETAIL E)

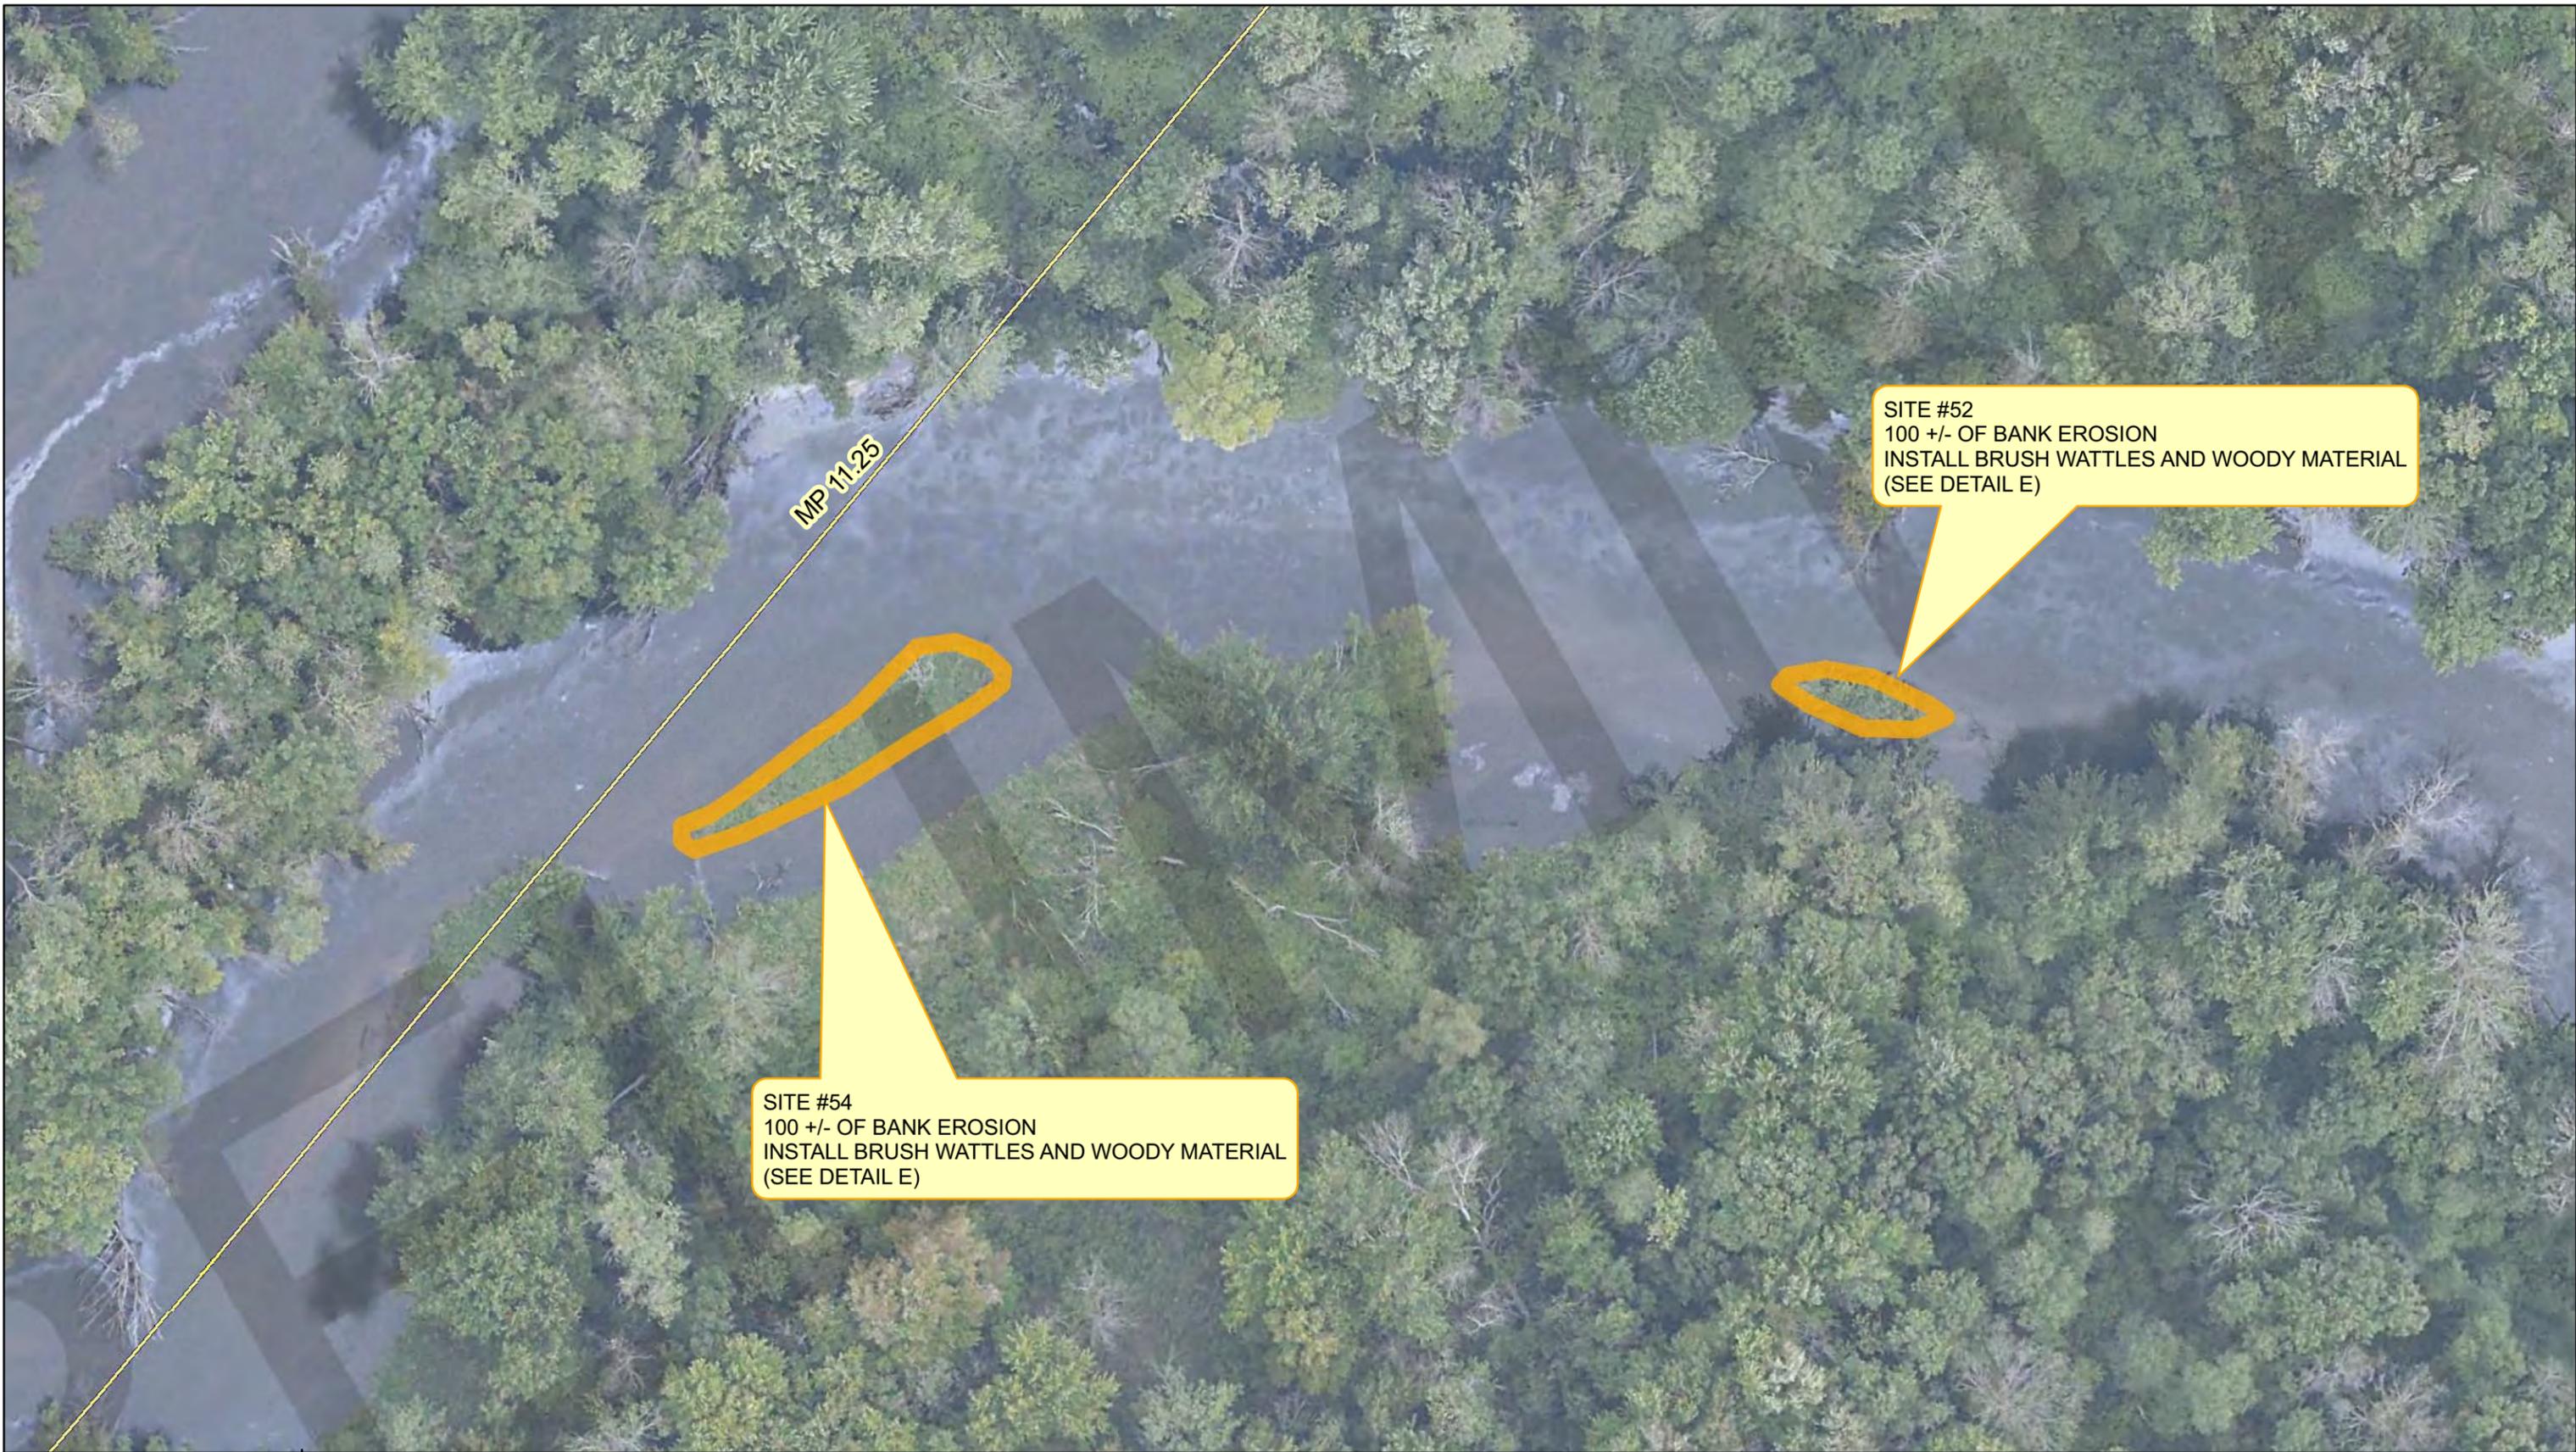
FIGURE 5  
SITES #52 & #54  
BANK EROSION STABILIZATION DESIGN  
ADDENDUM NO.1

SITE #52  
100 +/- OF BANK EROSION  
INSTALL BRUSH WATTLES AND WOODY MATERIAL  
(SEE DETAIL E)

SITE #54  
100 +/- OF BANK EROSION  
INSTALL BRUSH WATTLES AND WOODY MATERIAL  
(SEE DETAIL E)

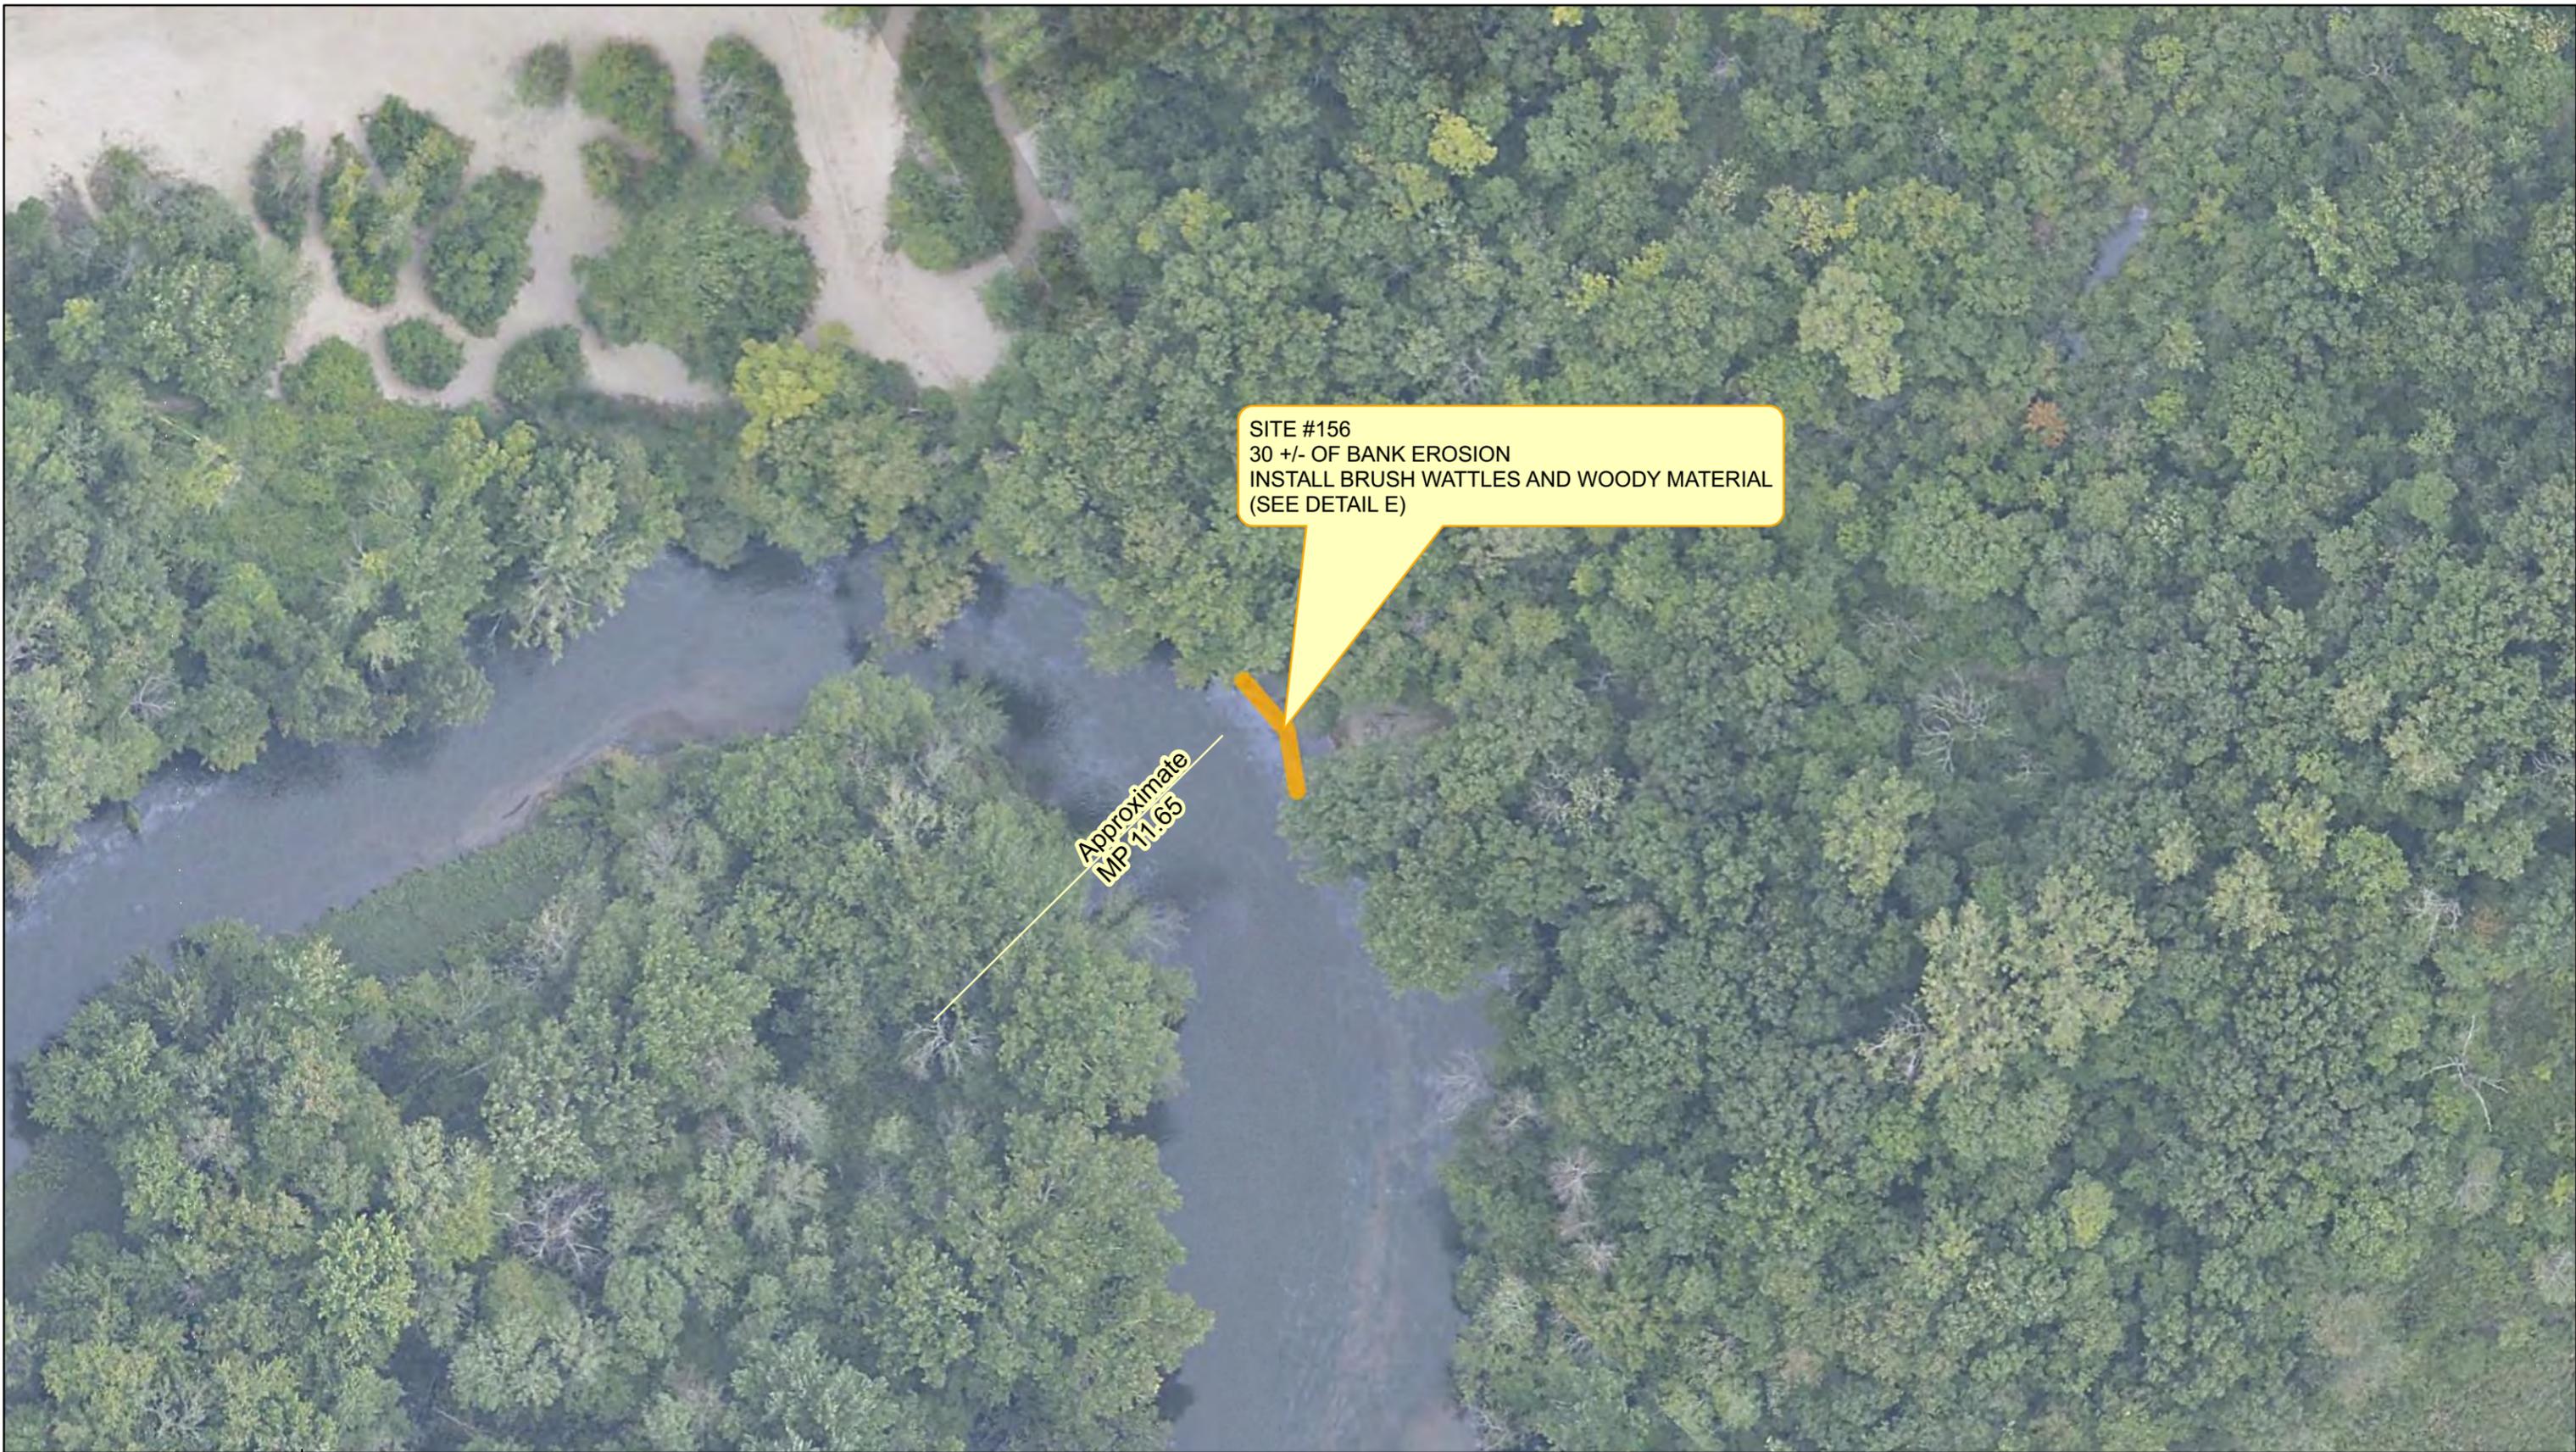
FIGURE 6  
SITE #156  
BANK EROSION STABILIZATION DESIGN  
ADDENDUM NO.1

SITE #156  
30 +/- OF BANK EROSION  
INSTALL BRUSH WATTLES AND WOODY MATERIAL  
(SEE DETAIL E)

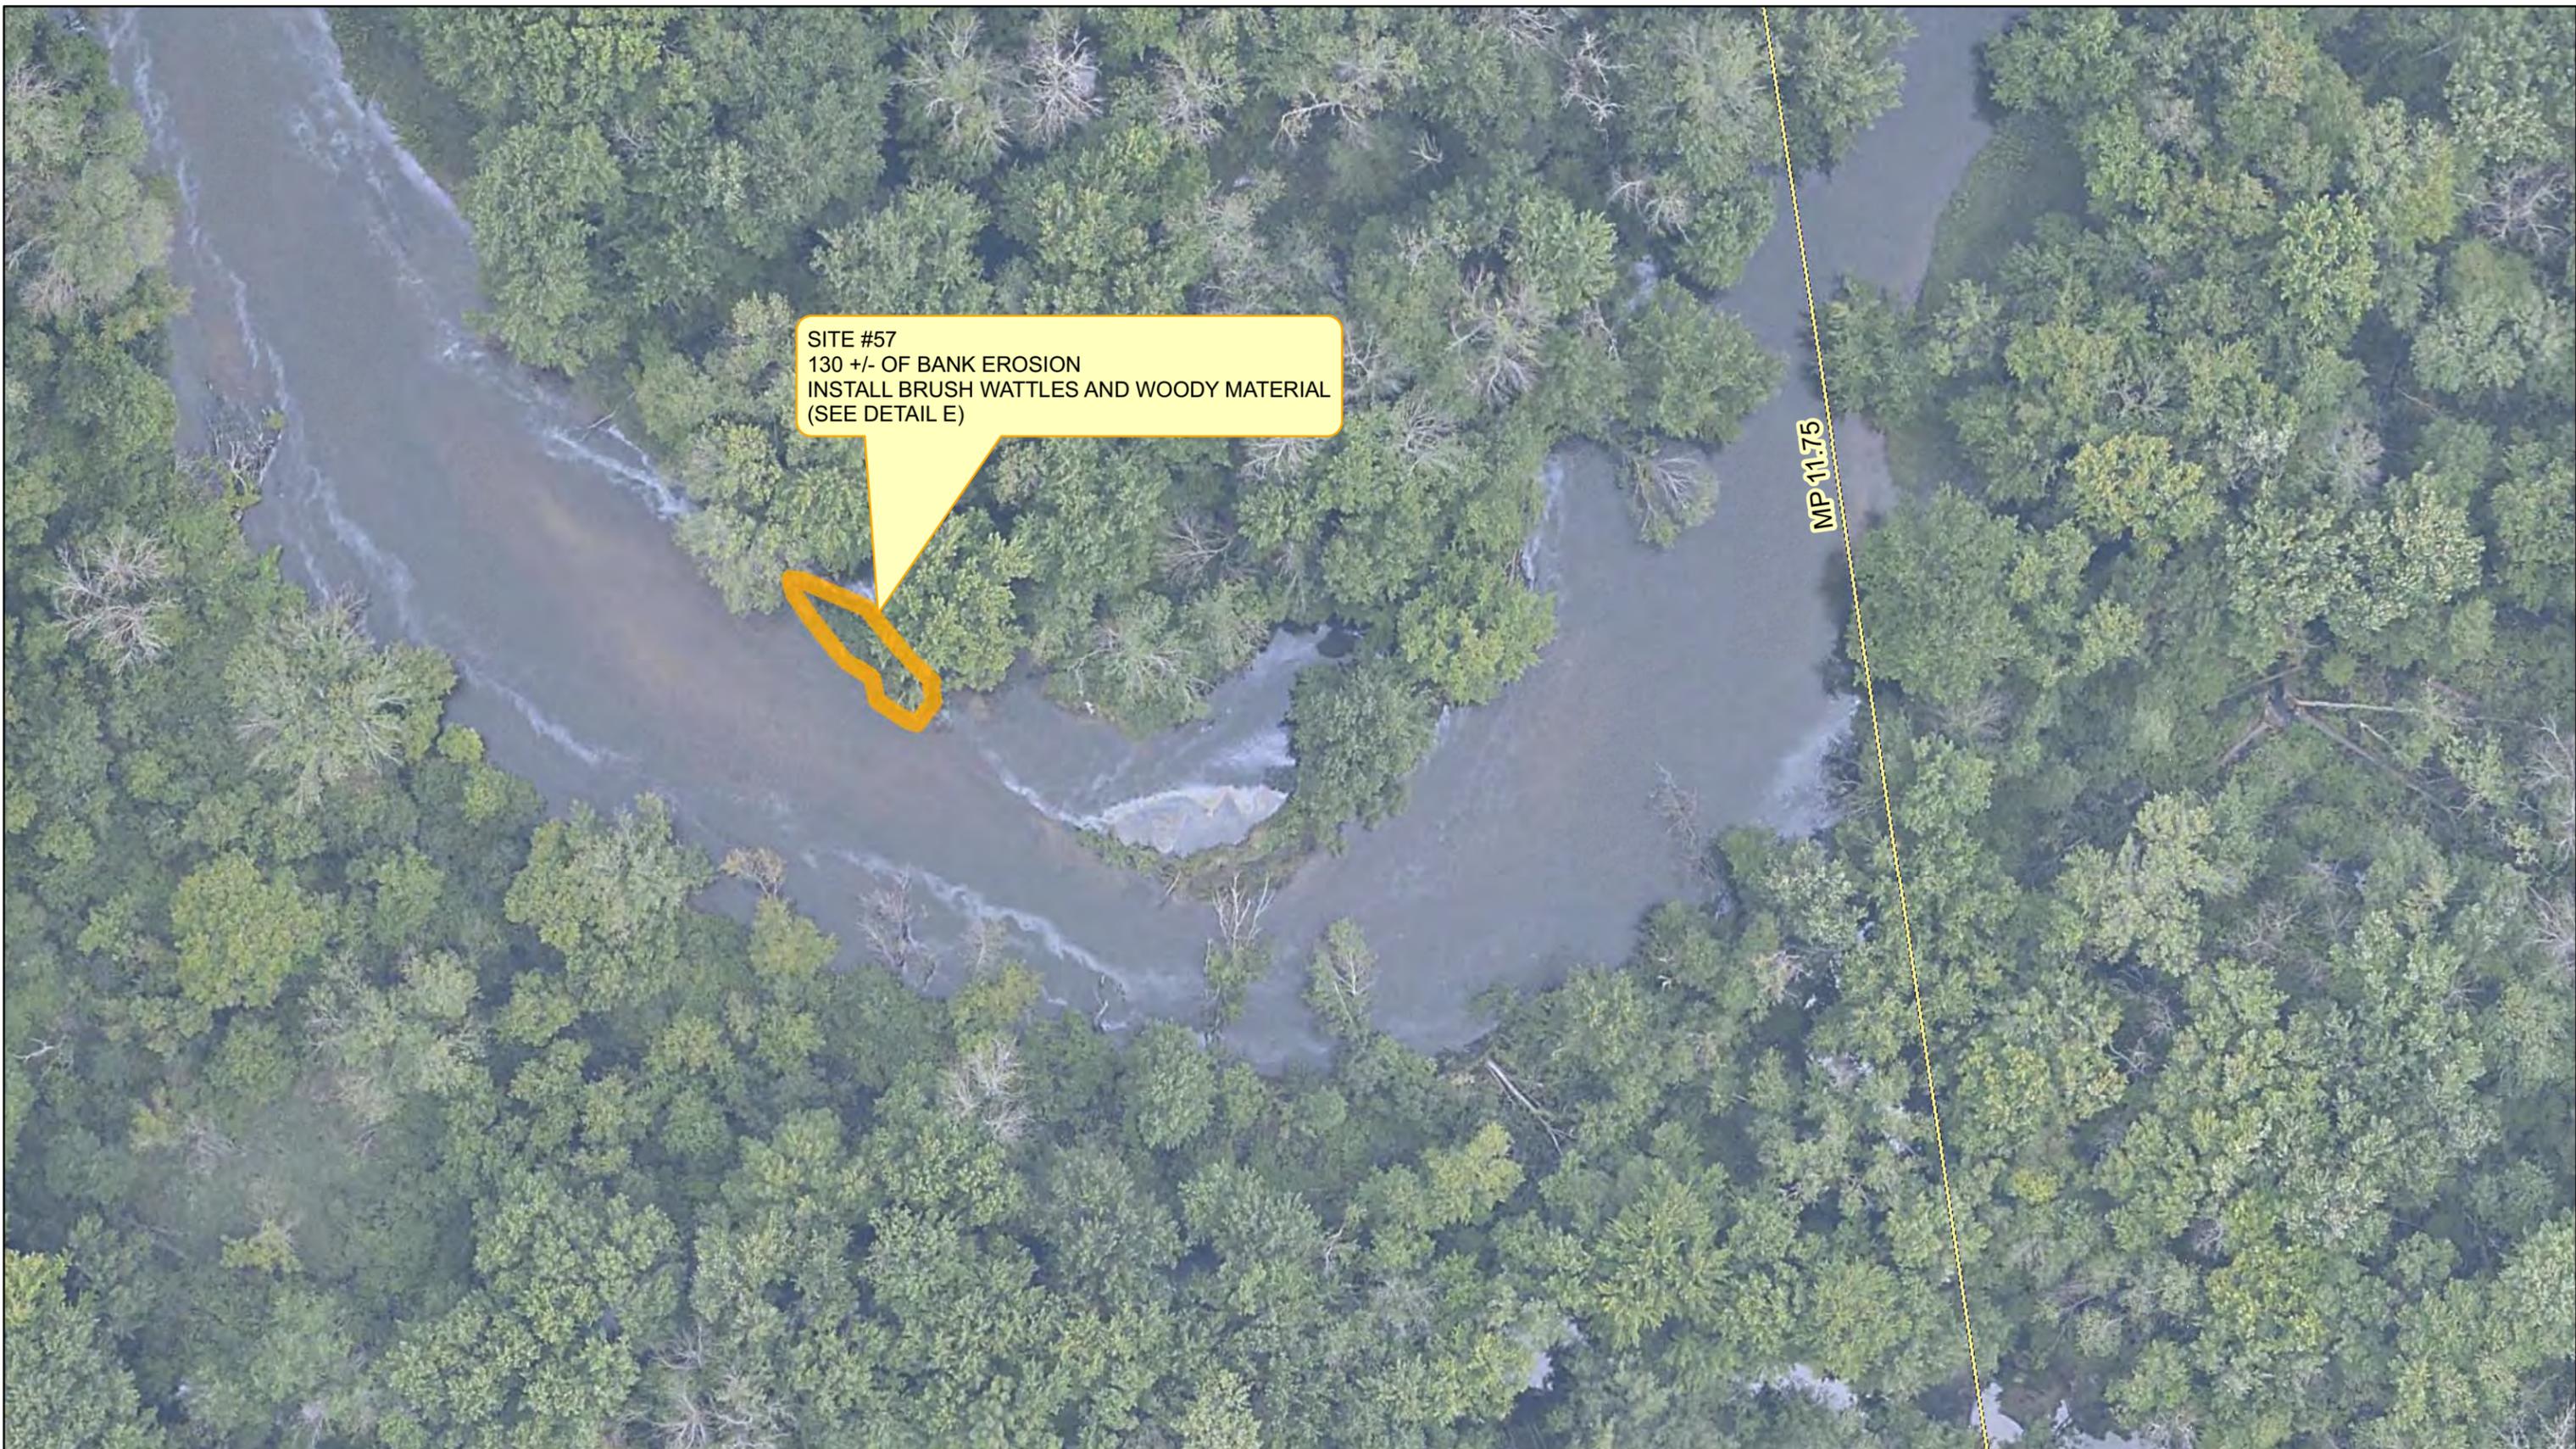
FIGURE 7  
SITE #57  
BANK EROSION STABILIZATION DESIGN  
ADDENDUM NO.1

SITE #57  
130 +/- OF BANK EROSION  
INSTALL BRUSH WATTLES AND WOODY MATERIAL  
(SEE DETAIL E)
