**Title: Culvert Replacement on Osborn Creek Improves Stream Channel Stability**

Waterbody Improved: Osborn Creek (AUID number 040601010803-02) in the White River watershed, in Oceana County, Michigan. Osborn Creek is not on the Clean Water Act section 303(d) list of impaired waters.

GRTS Numbers: 98502312-01 and 98502315-01 (pre and post monitoring support, respectively)

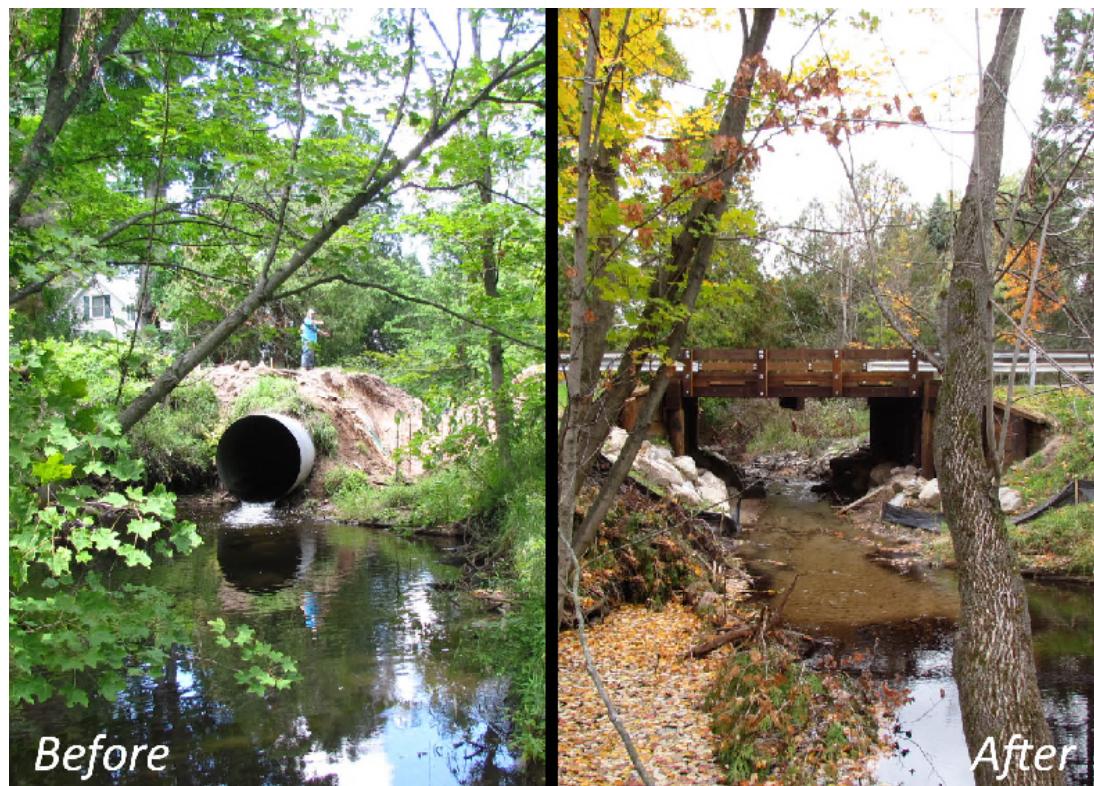
Problem: An undersized and perched culvert at Pierce Road caused upstream sediment deposition and downstream channel erosion, and prevented upstream migration of native fishes including brook trout and sculpin, as well as stocked salmonids. The plunge pool immediately downstream of the culvert eroded and destabilized the adjacent stream bank, causing sediment deposition in a riffle immediately downstream. Significant quantities of soil also eroded from the Pierce Road roadbed onto the Osborn Creek floodplain near the stream crossing.

Figure 1. Before and after photographs of the Pierce Road crossing.

Results: Since 2011, nine culverts on Osborn Creek have been replaced using a variety of funding sources. On Pierce Road, a 6 foot culvert was replaced with a 20 foot by 7 foot timber bridge (Figure 1). Prior to replacement the plunge pool immediately downstream of the culvert was 40 feet wide and 5.6 feet deep, compared to a normal channel width of 26 feet and depth of 2.7 feet at a nearby riffle. After replacement, sandy floodplain benches had formed in this reach, reducing channel dimensions to 32 feet wide and 1.8 feet deep (Figure 2).

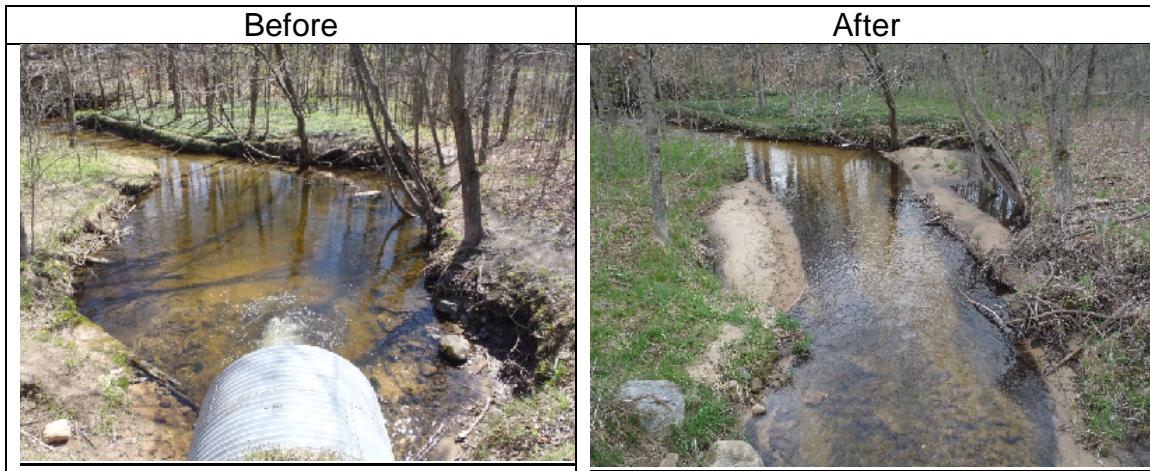
Channel stability in the plunge pool was assessed using EPA's stream function metric of bank height ratio (BHR), which is a measure of channel down-cutting, floodplain access, and bank erosion potential. Before the culvert was replaced the BHR of the deep plunge pool was 3.0 ("Not functioning"), and after construction of the bridge the BHR was 1.0 ("Functioning"; Table 1).

Figure 2. Before and after photographs of Osborn Creek downstream of the Pierce Road culvert, showing the plunge pool and destabilized stream channel (before) and the narrower, shallower channel and floodplain benches (after).

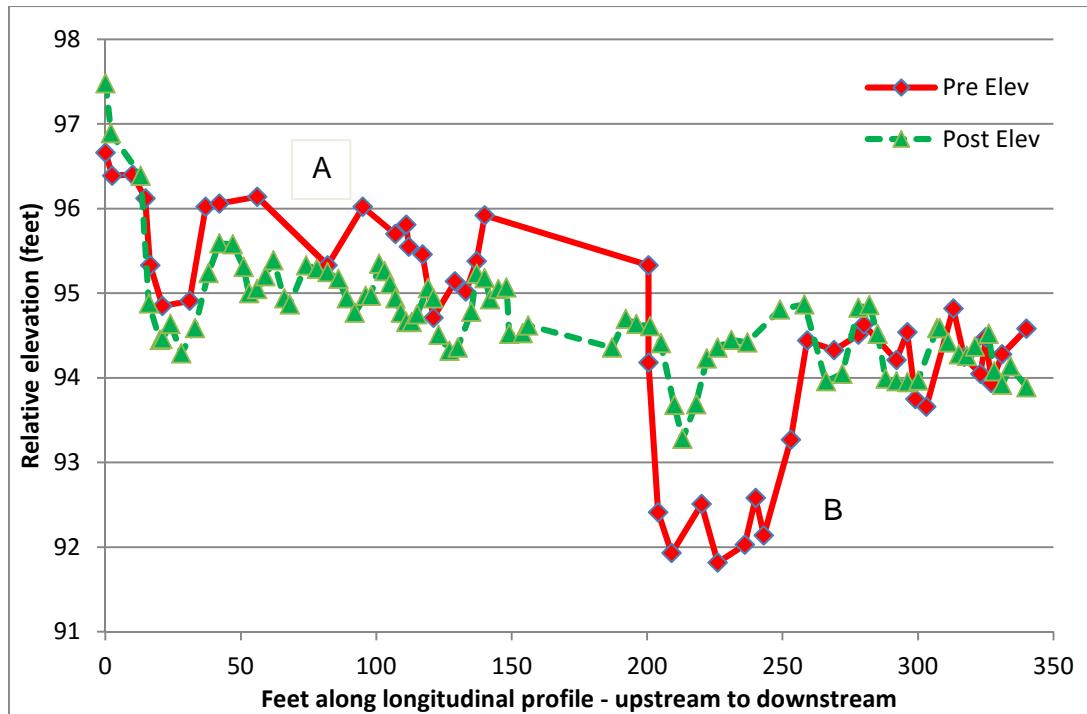
Prior to culvert replacement the streambed immediately upstream of the road crossing consisted entirely of fine sand. Although some sand still remains three years after replacement, much has been transported downstream, lowering the streambed about 0.5 feet (Figure 3) and exposing coarse gravel (Table 2). The median particle size ( $D_{50}$ ) and  $D_{84}$  (the particle diameter in the 84<sup>th</sup> percentile) in this reach are both substantially coarser after culvert replacement. Further riffle development is expected in this reach in the coming years.

Figure 3. Overlay graph of longitudinal profile data, before and after culvert replacement. A = lowered streambed elevation after sand transport; B = plunge pool mostly filled in.

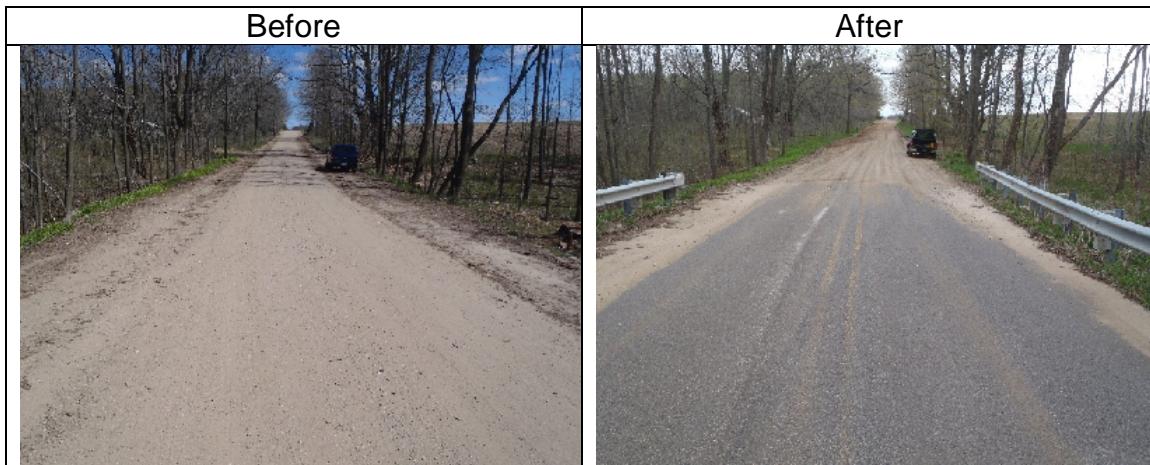
Figure 4. Before and after pictures of Pierce Road near the stream crossing, formerly a source of sediment to Osborn Creek.

Erosion control measures conducted in conjunction with the culvert replacement also reduced soil erosion from the Pierce Road roadbed (Figure 4).

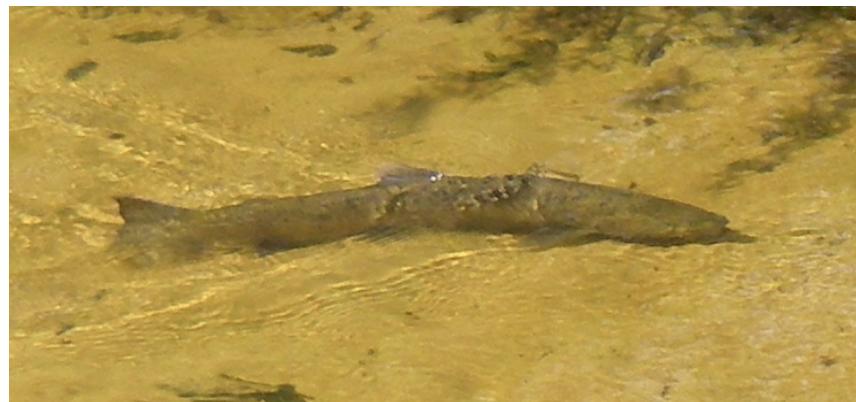
Finally, migratory salmon and steelhead were unable to pass through the culvert, but have been sighted by local residents and U.S. Forest Service personnel upstream of the Pierce Road crossing since the bridge was built (Figure 5).

Figure 5. Steelhead in Osborn Creek at Buchanan Road, 0.5 miles upstream of Pierce Road; May 2013. (Photo courtesy of Chris Riley, U.S. Forest Service)
