Title: Brown's Creek Habitat Restoration

<u>GRTS Number:</u> 975474030 - Project 02

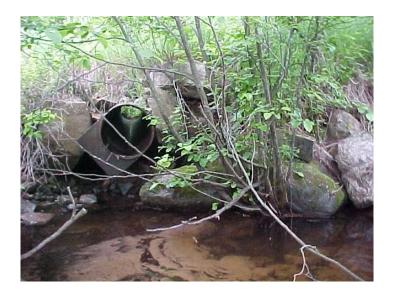
<u>Problem:</u> Brown's Creek is a tributary to Pine Creek in Dickinson County. The creek was obstructed due to a dilapidated, undersized and poorly positioned culvert on the Trepanier Farm, to the point that the majority of the creek's baseflow was passing through the porous road fill around the culverts rather than through the culverts. The stream bottom downstream of the culverts was dominated by fine sandy sediments, and instream habitat features were buried by sand. In 2002 the culverts were replaced by a modular steel bridge that spanned the width of the stream channel and allowed free passage of both baseflows and all but the most extreme storm flows.

Figure 1. Dilapidated Culvert on Brown's Creek, Prior to Replacement. (*Primary culvert is below water surface; visible culvert is for flood overflows*)

<u>Project Highlights:</u> In 2002 the Dickinson County Conservation District replaced the undersized culverts with a modular steel bridge that spanned the stream channel.

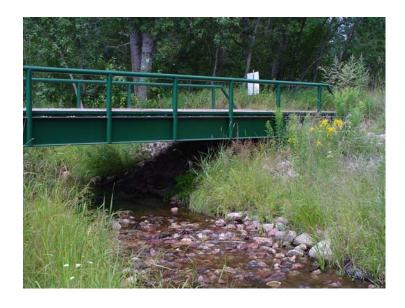
Figure 2. Replacement Bridge.

Results: In 2002 the culverts were replaced by a modular steel bridge (Figures 1 and 2) that spanned the width of the stream channel and allowed free passage of both baseflows and most storm flows. Stream geomorphology and biological surveys were conducted before and after culvert replacement, in 2002 and 2005, respectively, and showed substantial improvements in instream habitat conditions (Figure 3 and Table 1):

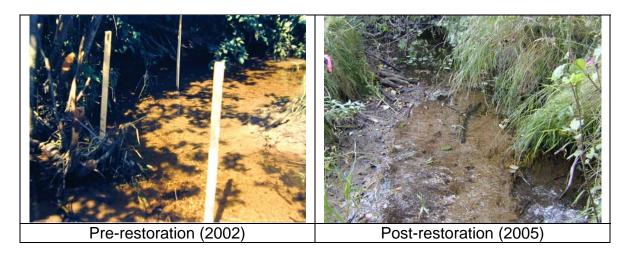
- Scores for instream habitat features related to sedimentation improved substantially.
- Improved water passage under the bridge transported or exposed coarser sediments downstream, as reflected by the D_{84} (the maximum particle size moved by bankfull discharges), which increased from 1.9 mm ("very coarse sand") in 2002 to 12.0 mm ("medium gravel") in 2005.
- Downstream thalweg depth increased 27 percent, from 0.56 feet to 0.71 feet.

Figure 3. Brown's Creek, 50 Feet Downstream of the Restoration Site.
