## **Title: Bruno Creek Culvert Replacement**

**Opening Paragraph:** Bruno Creek is a tributary to the West Branch of the Otter River in Houghton County, in Michigan's Upper Peninsula. Excessive soil erosion at a logging road crossing and stream blockage from a collapsing culvert altered the hydrology of the stream and aggraded the stream bottom.

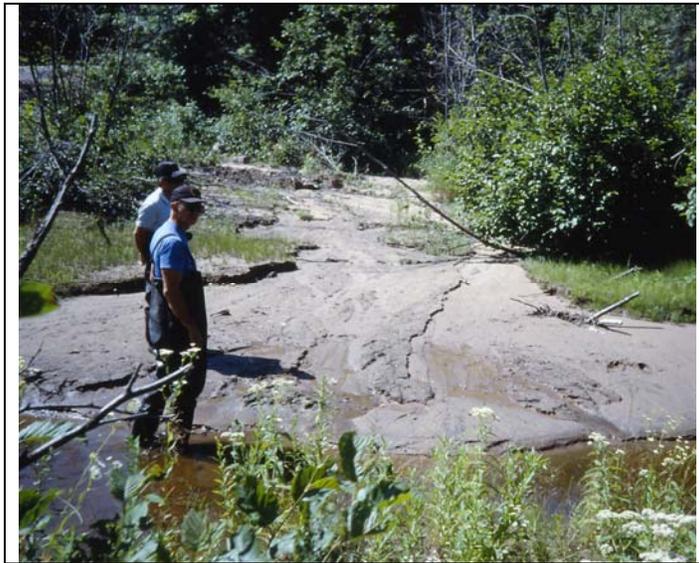
**1. Eroding soil entering stream from road; delta shown is along the left side of picture 4, below. A similar delta of soil eroding from the other side of the road is on the right side of picture 4.**

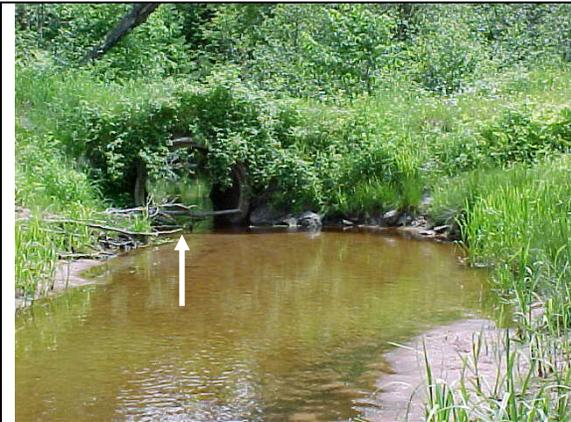
**2. Stream crossing when culvert was in place; note that culvert (arrow) is smaller than channel width.**

Partners and Funding: Conner Forest Industries voluntarily funded fixed the road crossing, and installed and maintained an instream sand trap during the 1990s. A subsequent owner of the property, Forestland Group, voluntarily replaced the culvert with a channel-spanning bridge in 2005, at a cost of approximately \$20,000.

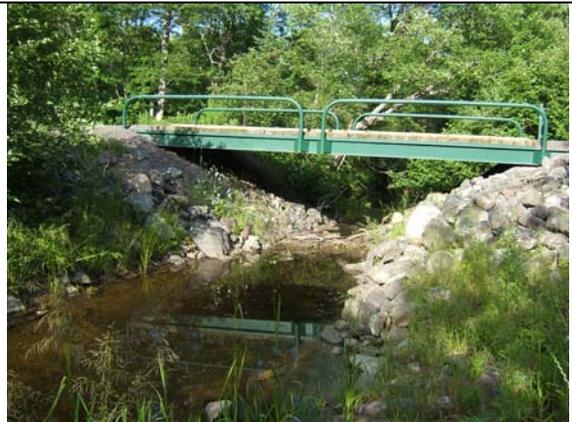
**3. Stream crossing after bridge was installed; note that bridge spans full channel width.**

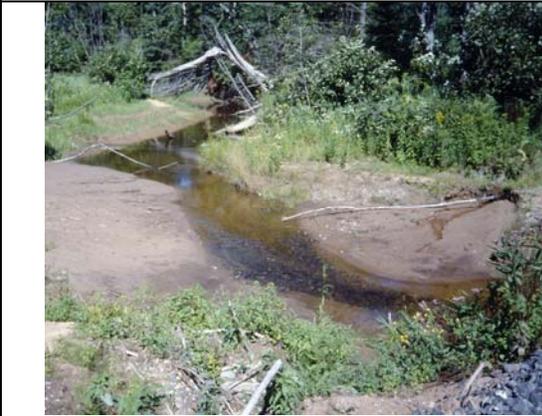
**4. Upstream of culvert; note soil delta on both banks, and the wide, shallow, sandy channel.**

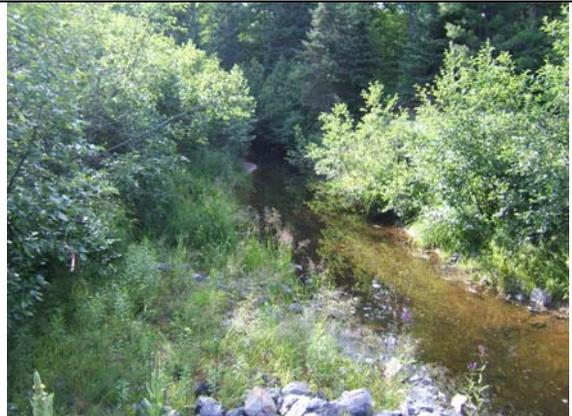
**5. Upstream of bridge; note vegetated bank on left, and the narrow, deeper, rockier channel.**
