INTERIM RESPONSE PLAN

5851 West Jefferson Avenue | Detroit, Michigan
PM Project Number 01-5303-3-0001

RE: Interim Response Plan
5851 West Jefferson Avenue, Detroit Michigan
Former Revere Copper and Brass
EGLE Site ID No. 82000136
PM Environmental Project No. 01-5303-3-0001

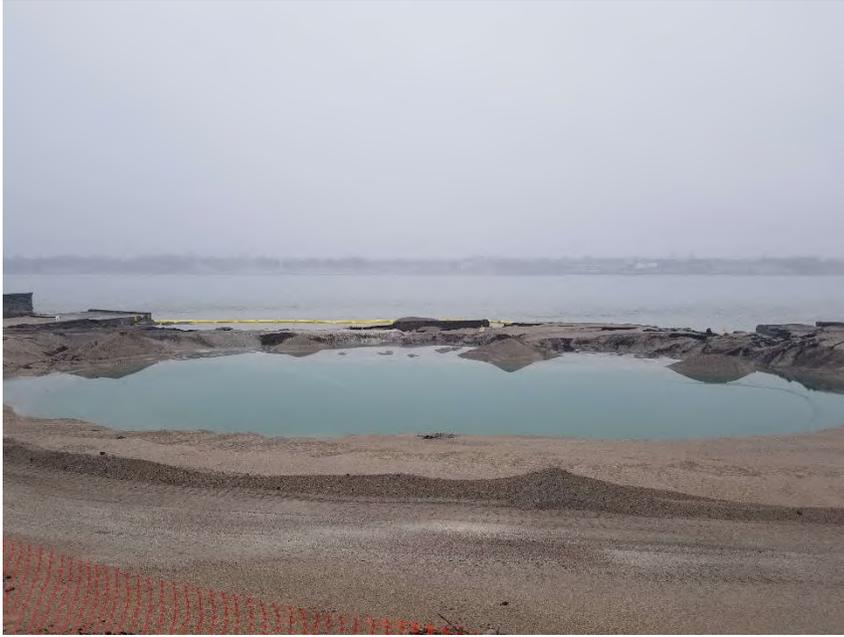
Photograph 1

View of gravel berm installed East of the Pond area; facing East.

Surface cover at the subject property consists of concrete driveway/approach/walkway areas to the north, an asphalt parking area to the west and areas of seeded topsoil and landscaping along the northern property boundary. The remainder of the subject property is covered with compacted gravel, including the majority of the area of the bank failure. Some areas along the southern area of the subject property where the bank failure occurred contain surface cracking that have not been filled with gravel due to geotechnical concerns associated with the added weight of a gravel blanket in that area. However, that area of the subject property has been isolated with temporary fencing to prevent access. An additional gravel berm was also installed along the southern boundary of the bank failure area where water has accumulated (i.e. south of the pond area), to further control erosion and provide sedimentation control (refer to Figure 2). Appendix C contains photos of the gravel berm.

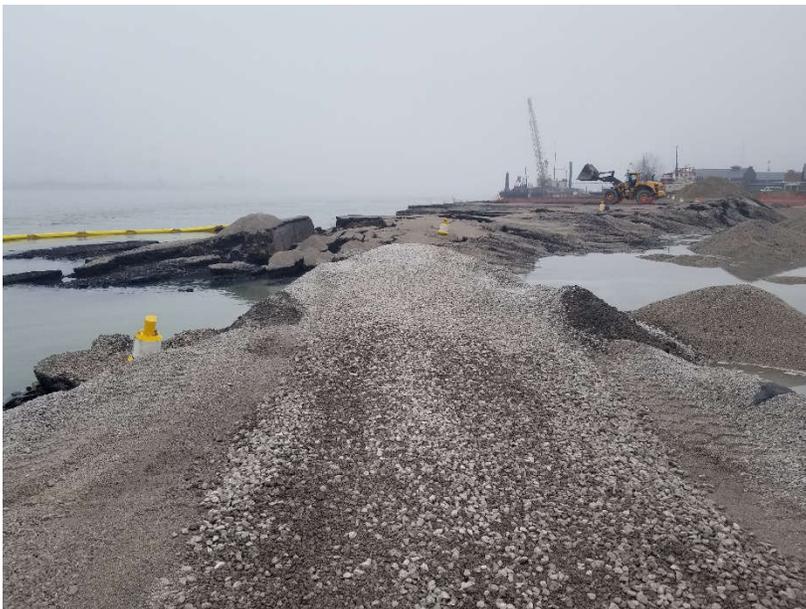
Photograph 2

View of gravel berm installed East of the Pond area; facing South.

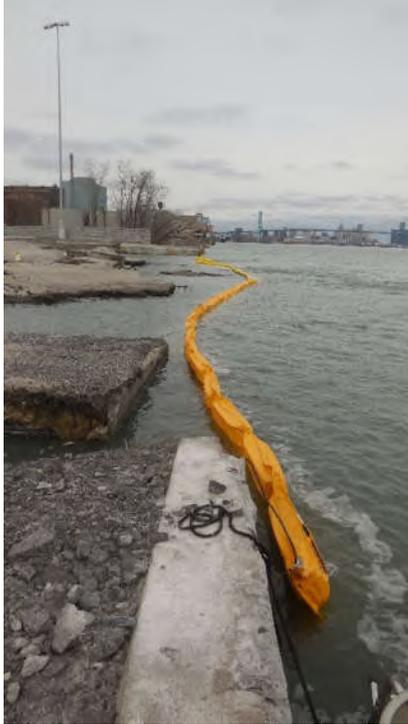
Photograph 3

View of the installed 5-foot turbidity curtains taken on 1/17/2020, facing North.

Approximately 300-linear feet of turbidity control curtains (five-foot curtain depth) with linked surface flotation elements/buoys are present in the water along the southern property boundary, which surround the bank failure area, and are anchored to the river bottom in accordance with manufacturer recommendations. The turbidity control curtains and associated linked surface flotation elements/buoys prevent access to the bank failure area via the water and also act to control and contain potential suspended sediments in addition to reducing wave action in the area. Appendix C contains photos of the installed turbidity control curtains.

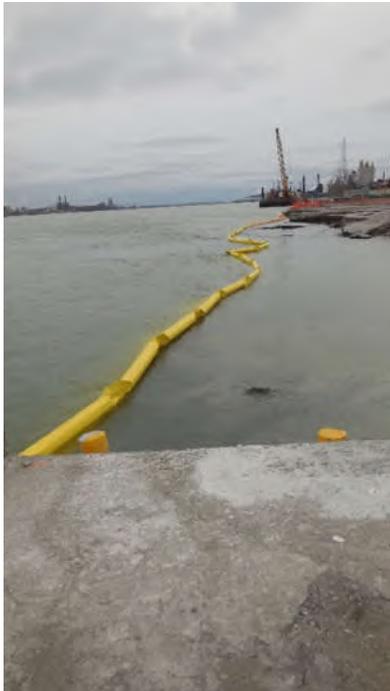
Photograph 4

View of the installed 5-foot turbidity curtains taken on 1/17/2020, facing South.
