# Edenville Dam Emergency Inspection Report

**June 19, 2020**

**Dam Name:** Edenville Dam

Re: Dam Emergency Inspection Report  
**Edenville Dam**  
**Edenville, Midland and Gladwin Counties, MI**  
**TRC Project No.: 398511**

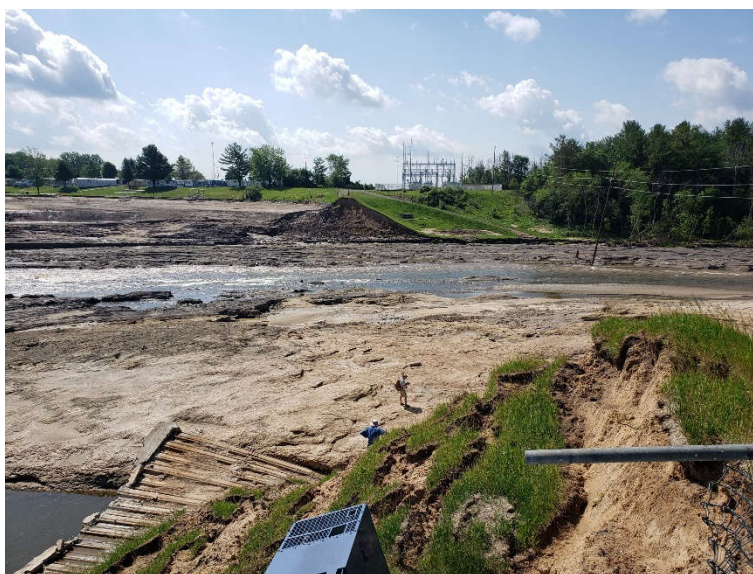
Photo 1: Breached section of the Left Embankment – Tittabawassee section looking left.

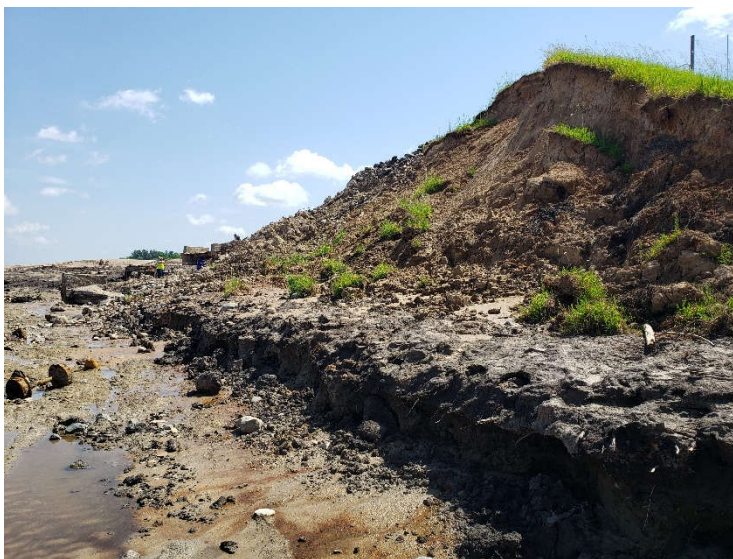
This portion of the embankment was 860 feet long and approximately 55 feet high at the deepest section. A majority of this section of embankment no longer exists as this was the section of dam that was breached on May 19, 2020, see Photo 1. An approximate 50-75 foot long section of embankment currently exists on both the right and left ends of this section. In our opinion, these sections of embankment are unsatisfactory as the structural integrity of these sections of embankment has been compromised and should be replaced when/if the embankment is reconstructed. The eroded edges of the embankment are currently steep and should be sloped to more stable 3H:1V slopes for safety and vegetated to minimize further erosion, see Photo 2.

*Photo 2: Left section of embankment that has eroded and requires stabilization.*

- R-1 Remove loose soil and regrade the edges of the remaining sections of the Left Embankment – Tittabawassee to maximum 3H:1V slopes. Establish vegetation along the disturbed portions of the embankment.

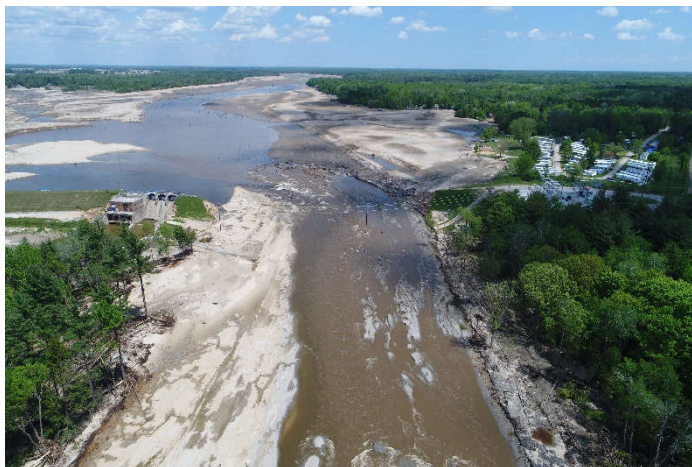
Flow from the Tittabawassee and Tobacco Rivers are currently cutting in a new channel within the failed section of the embankment within stiff blue clay. The stiff blue clay is noted as hardpan in historic boring logs, and appears to be the foundation material for the embankment, see Photo 3. ***It is highly recommended that the debris (e.g., trees, sediment, and other objects relocated from upstream areas from the flood) be removed and a new drainage channel be installed to properly control and pass drainage through this area. An extensive hydraulic model will need to be developed for the drainage basin so that a new river section, capacity, and alignment can be determined. This modeling should be completed as soon as possible so that future storm events can properly pass through the area and prevent flooding and damage to both upstream and downstream areas.***

*Photo 3: Breached section of embankment where drainage is currently cutting in a new alignment (drone photo provided by EGLE).*

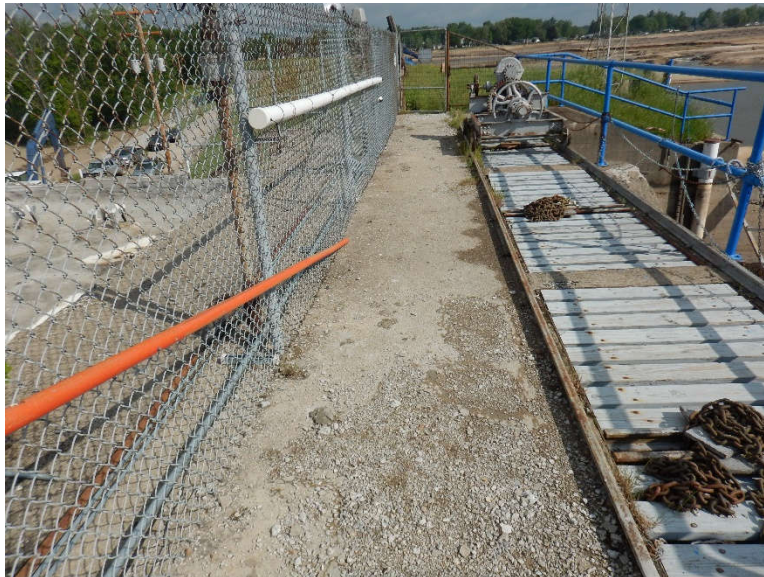
*Deck:* The deck was in poor condition with large areas of spalling and delamination, see Photo 4.

*Photo 4: Typical condition of deck looking east. Note recently painted safety railings and deterioration of concrete.*

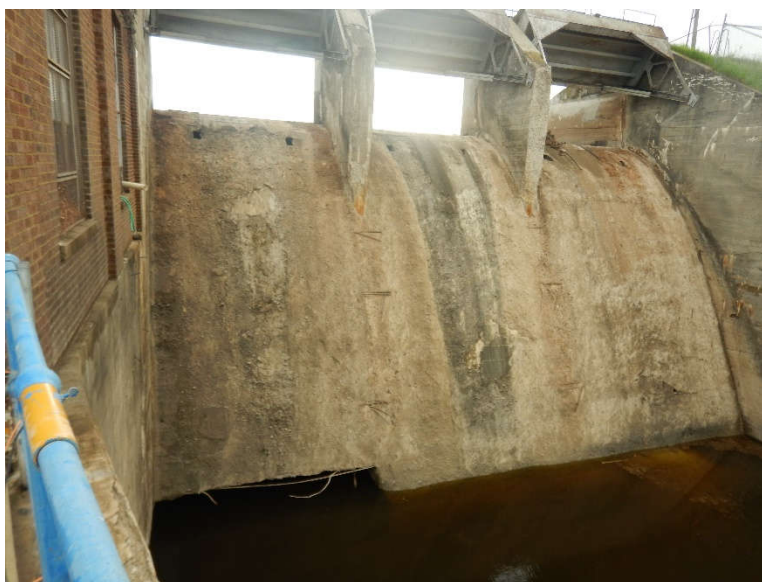
*Spillway:* The spillway was in poor condition. A visual inspection of the spillway facing and weir was performed from the embankments and deck. The spillway facing shows extensive spalling and delamination, see Photo 5. There is some cracking, concrete deterioration, and exposed rebar at the spillway crest. The depth severity of the deterioration was not able to be determined due to access constraints. The weir shows signs of extensive deterioration along the top with large areas of exposed reinforcing steel. A large sediment deposit was present approximately centered in the spillway adjacent to the downstream side of the weir. The bottom portions of the weir were not visible from the embankments due to standing water, see Photo 6.

*Photo 5: Spillway general elevation with extensive spalling, exposed reinforcing steel and likely delamination.*

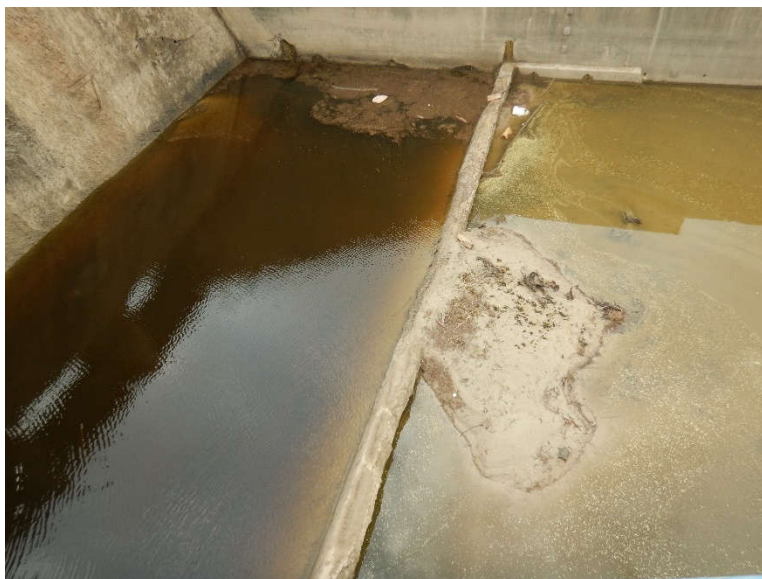
*Photo 6: Weir exhibiting large spalls with exposed reinforcing steel and sediment deposits.*

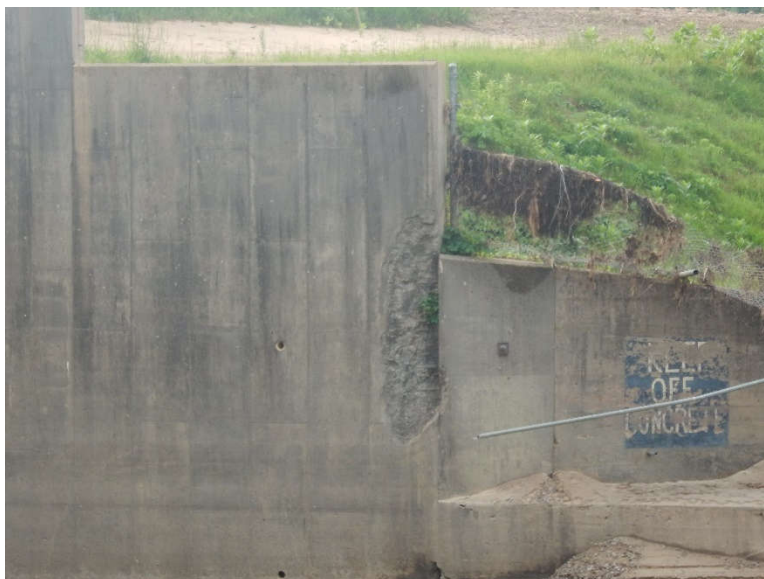
**Retaining Walls:** The retaining walls were generally in fair to poor condition. Near the middle of the left side (east) wall near the toe of the embankment, an isolated area with a large spall and exposed reinforcing steel was noted, see Photo 7. The downstream right side (west) exhibited large areas of cracking, efflorescence. The horizontal extension was separated from the main wall and rotated slightly towards the stream, likely due to an additional surcharge load as a result of the flooding, see Photo 8. Additionally, a portion of the right side (west) wall on the downstream end was broken off. This area also had areas of delamination and cracking with efflorescence, see Photo 9. Both retaining walls exhibited large areas of erosion of backfill at both upstream and downstream ends, see Photos 10 through 13.

Photo 7: Left (east) side retaining wall downstream general elevation including spall with exposed rebar (6'x2'x3").

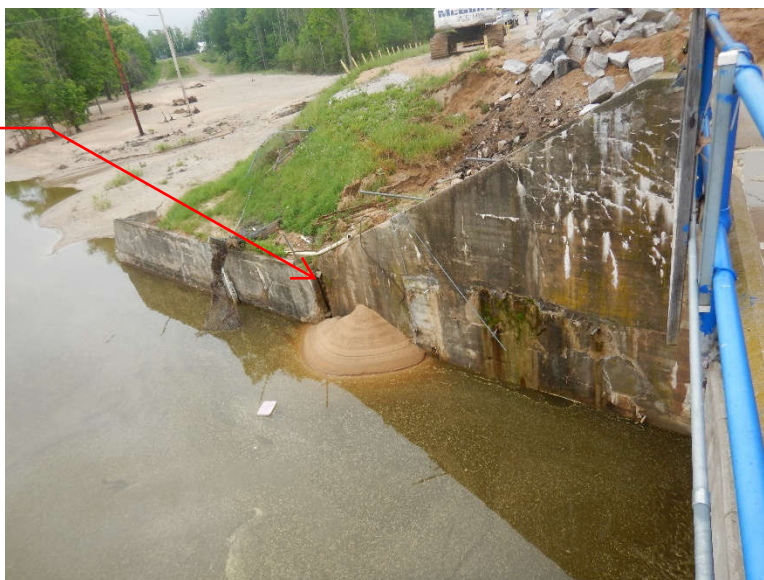
CRACK AND SEPARATION  
WITH LOWER PORTION  
ROTATING TOWARDS STREAM

Photo 8: Right side (west) downstream retaining wall showing cracks, efflorescence and leaking backfill. Note the horizontal extension is separated from the main wall at the toe of the slope and rotated towards the stream.

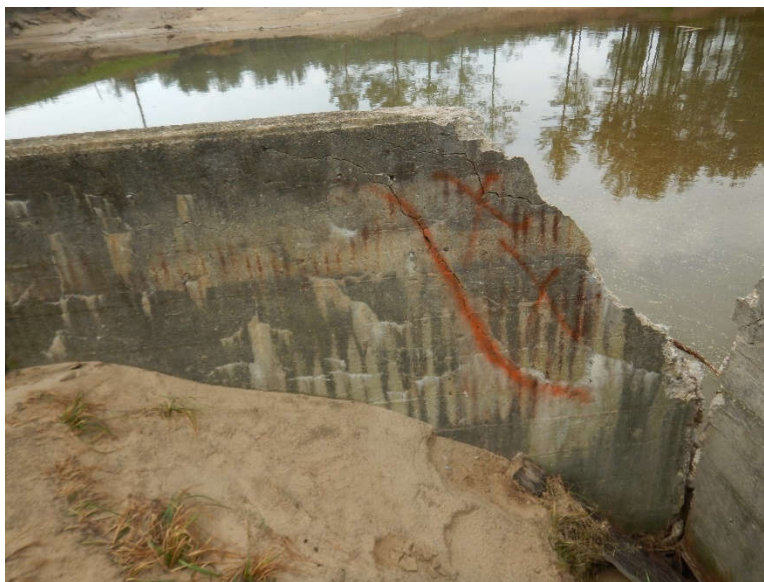
*Photo 9: Portion of right side (west) retaining wall missing with areas of delamination, cracking with efflorescence and erosion.*

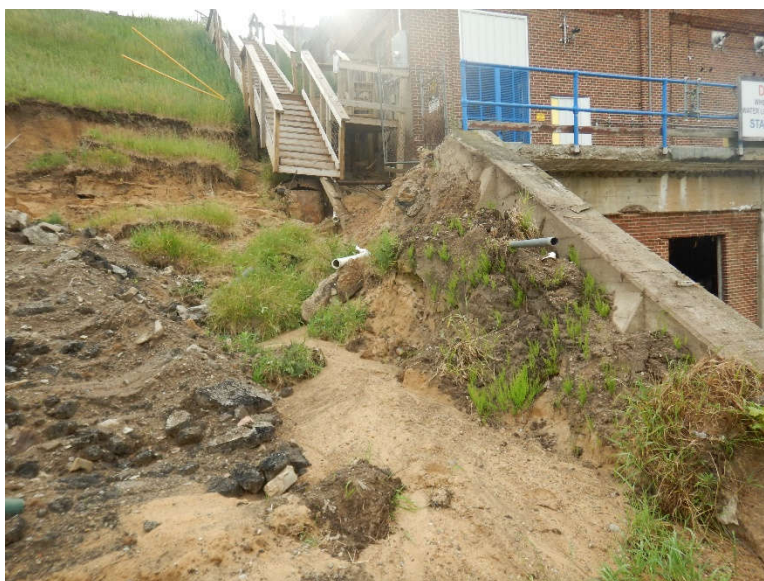
*Photo 10: Erosion behind right side (west) retaining wall at downstream end.*

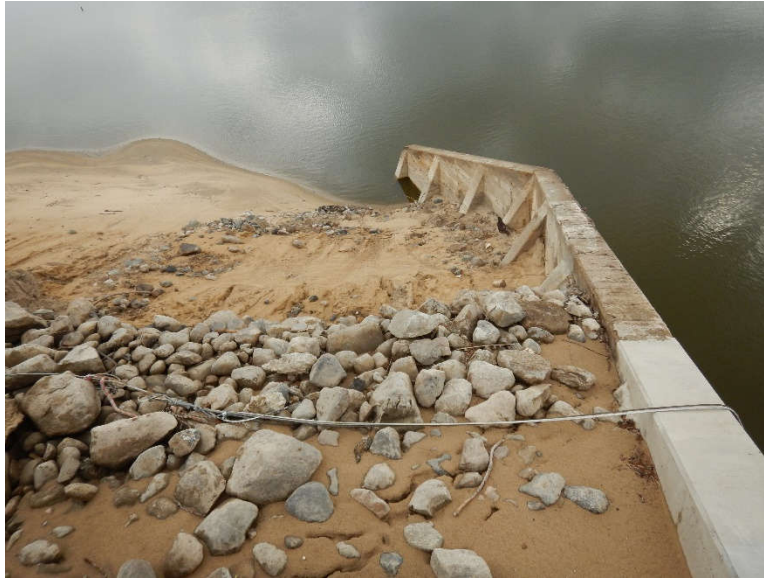
Photo 11: Erosion behind right side (west) retaining wall at upstream end.

- R-2 Shore and stabilize the access to the Powerhouse and perform an interior inspection.
- R-3 Backfill and repair the erosion washout immediately to the right of the retaining (side) walls on the upstream slope of the Tittabawassee Spillway to prevent progressive failure of the slope that could potentially impact the upper portion of the structure.

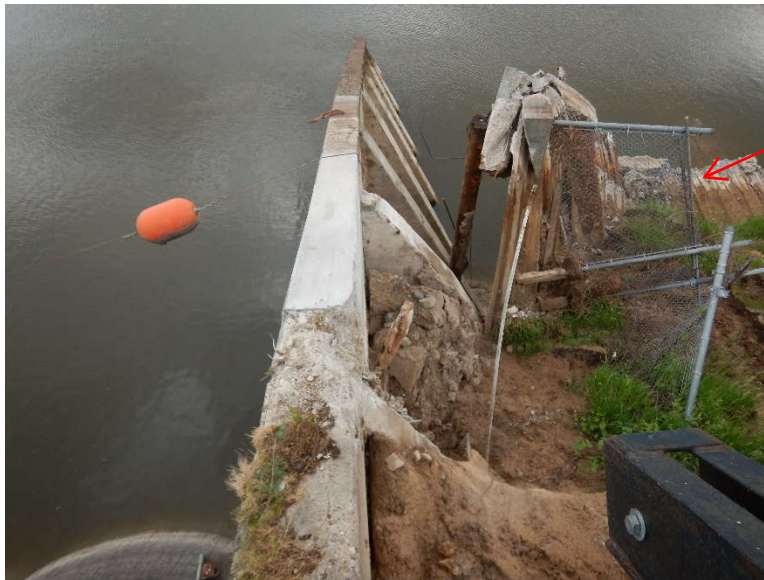
FAILED STEEL SHEET PILE WALL

Photo 12: Erosion behind left side (east) retaining wall at upstream end.

**Wingwall (Bulkheads) Upstream:** The west wingwall was not able to be inspected due to damage to the embankment from flooding. It is likely that the steel sheet piling is exposed below the concrete cap and will need repaired. There was an approximately 8' drop to the level of the sand as can be seen in Photo 11 (above). The east wingwall is gone due to the recent failure east of the spillway. It can be seen laid over in Photo 12 (above).

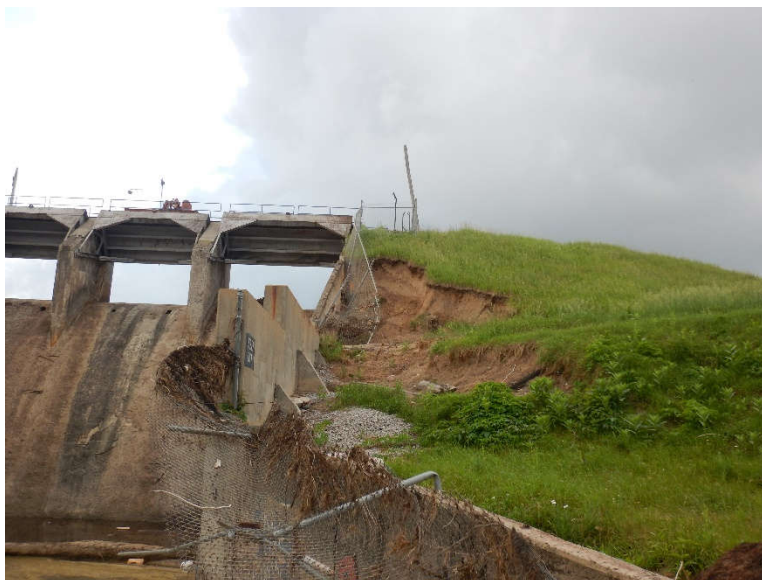
Photo 13: Erosion behind left side (east) retaining wall at downstream end.

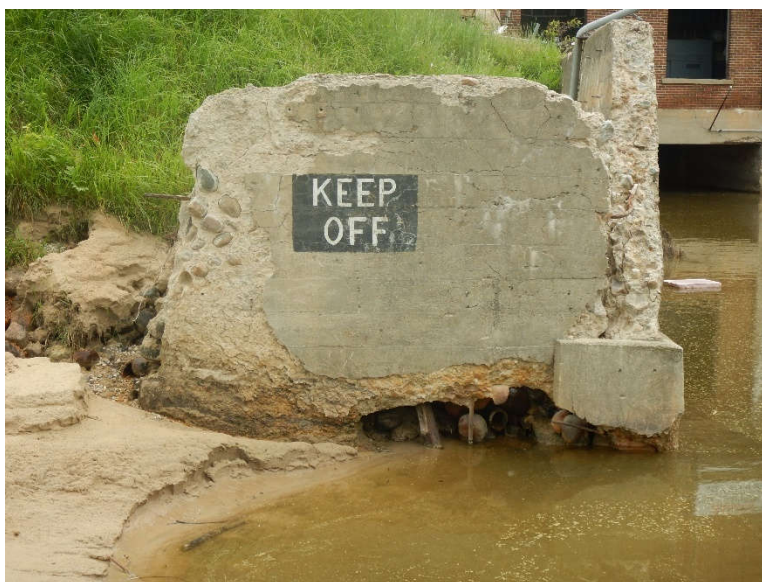
**Cutoff (Downstream) Walls:** The cutoff walls were in poor to unsatisfactory condition. The right side (west) cutoff wall has several large spalls and holes with exposed reinforcing steel. The connection to the retaining wall is non-existent, see Photos 9 (above) and 14. The left side (east) cutoff wall is buried under debris due to the adjacent failure of the dam and erosion from overtopping, see Photo 15.

*Photo 14: Right side (west) cutoff wall with large spalls/hole with exposed reinforcing steel.*

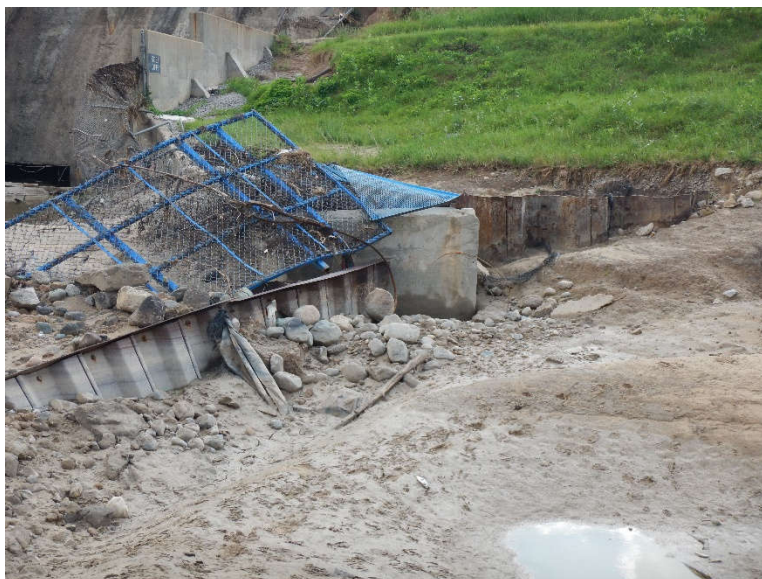
*Photo 15: Left side (east) cutoff buried under debris. Note failure of supporting sheet pile wall in the foreground.*

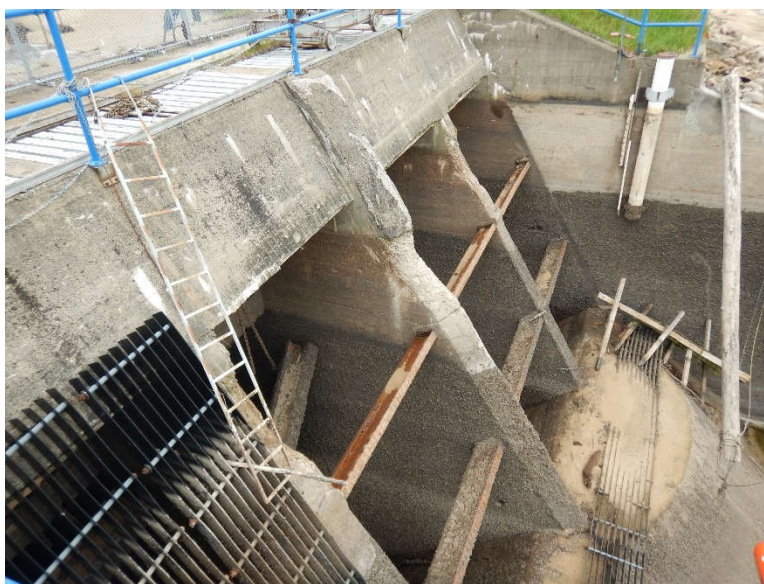
**Piers:** The piers were in fair condition, with typical cracking and efflorescence present. Spalls without exposed reinforcing steel were present on the intake nosing. Several of the intake trash racks have been displaced by the flooding. See Photos 5 (above), 13 (above) and 16.

Photo 16: Powerhouse intake piers with spalls and displaced or missing trash racks.

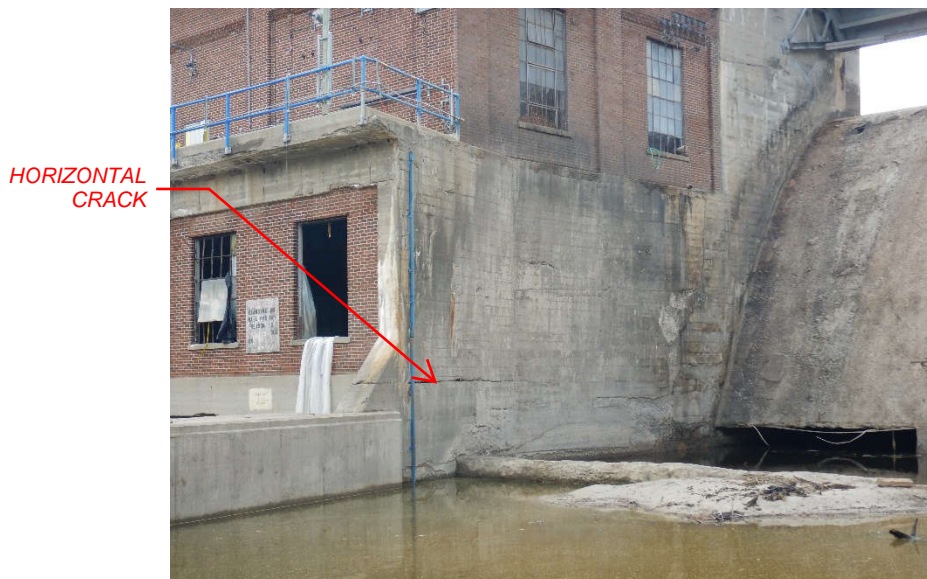
**Powerhouse:** The powerhouse has a concrete substructure and a brick superstructure that is approximately 50.6 feet wide. The powerhouse contains two vertical-shaft generating units. The interior of the powerhouse was not inspected. The exterior concrete foundations show significant cracking adjacent to the spillway. The lower windows at the back of the powerhouse were missing, likely due to the recent flooding, see Photo 17. The access stairway at the west side of the powerhouse was severely undermined due to erosion, see Photo 10 (above). The back porch of the powerhouse had significant areas of spalling along the edge near the safety railing supports, see Photo 18.

Photo 17: Powerhouse foundation with large crack and missing windows.

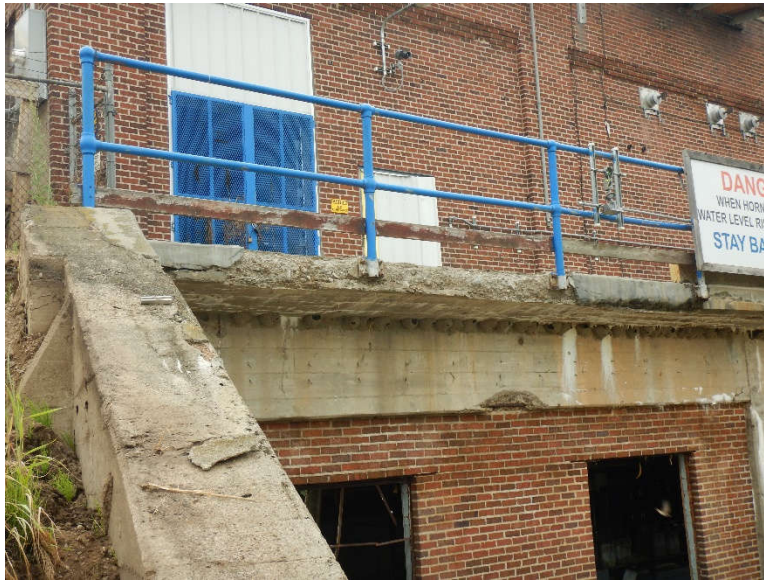
Photo 18: Powerhouse back porch with significant spalling on edge of slab.

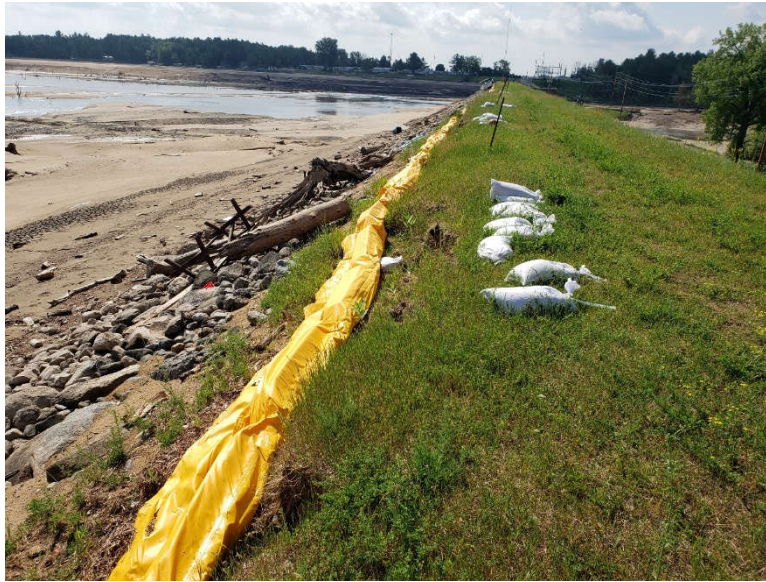
The upstream slope of the embankment is in poor condition as it appears that a portion of the toe has been eroded along a majority of the section. Tension cracks have developed at the crest of slope and the riprap appears to have eroded, both probably a result of wave action from the May 19<sup>th</sup> storm event and the loss of toe buttress, see Photo 19. Although the upstream side of the embankment will need to be repaired and the riprap replaced, based on visual observations only, this is not believed to threaten the overall stability of the embankment for the conditions observed at the time of TRC's site inspection. Under the conditions observed at the time of TRC's inspection, the edge of water was at a safe distance away from the dam.

*Photo 19: Upstream slope of Right Embankment – Tittabawassee. Note tension cracks that have developed at crest.*

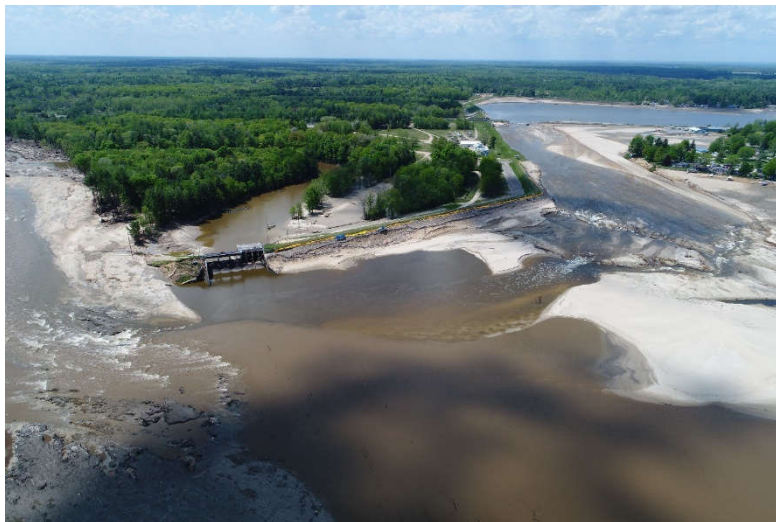
*Photo 20: Upstream slope of the Right Embankment – Tittabawassee (drone photo provided by EGLE).*

As part of the hydraulic modeling and reestablishing the river channel as previously discussed, ***the water should continue to be located away from the dam until the dam can be repaired to satisfactory conditions, see Photo 20.***

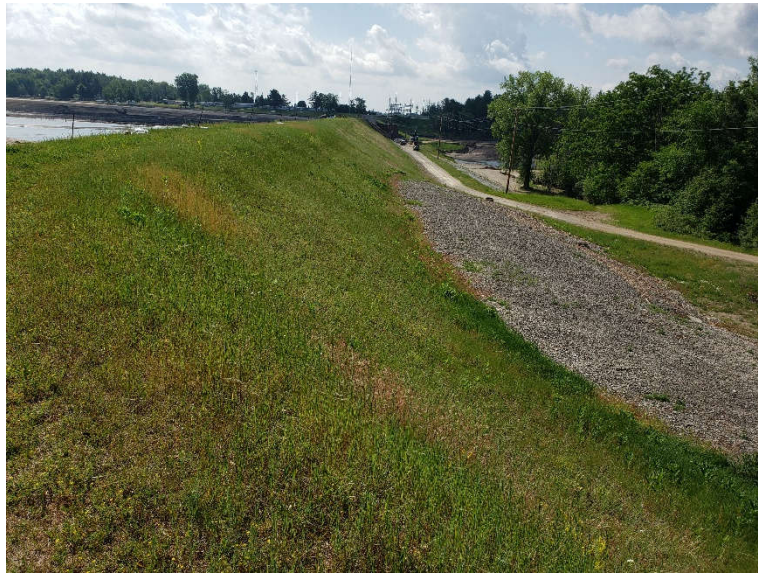
The toe drain system was not discharging at the time of TRC's inspection, however, some erosion has previously occurred at the drain outlets and should be repaired. Based on visual evidence at the time of TRC's inspection, the downstream slope appears to be in satisfactory condition and has established vegetation, see Photos 21 and 22.

*Photo 21: Downstream slope of Right Embankment – Tittabawassee.*

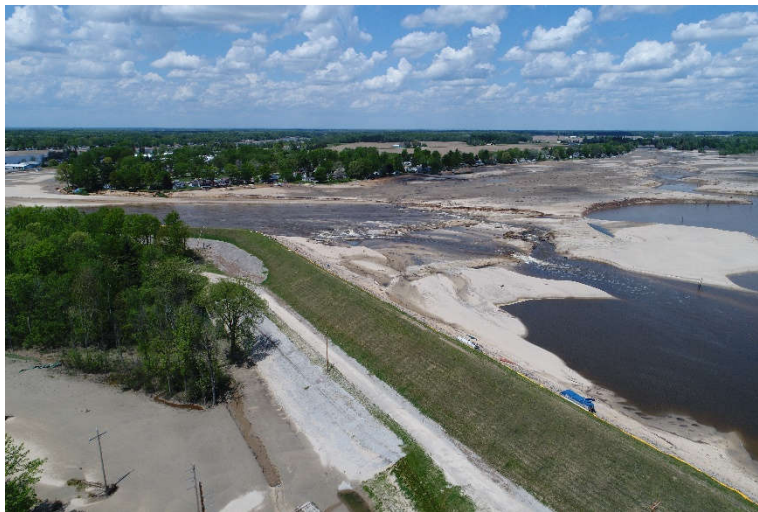
*Photo 22: Downstream slope of Right Embankment – Tittabawassee (drone photo provided by EGLE).*

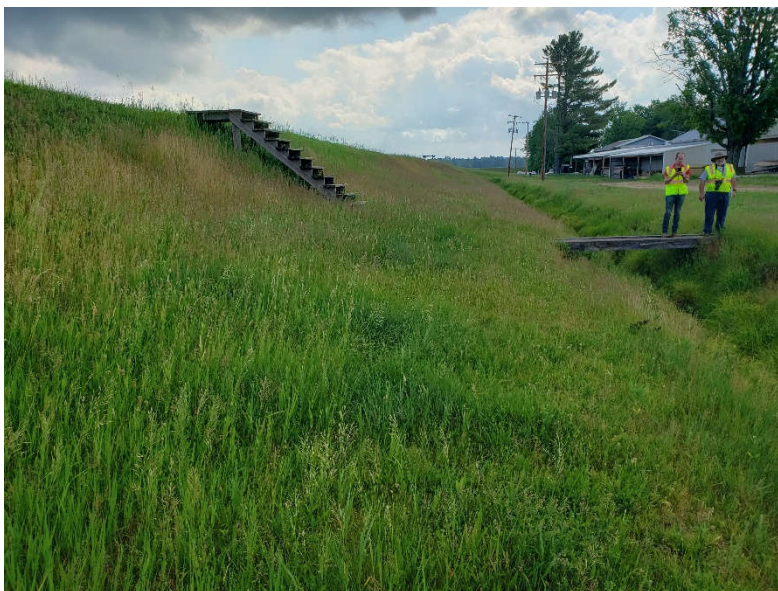
The left embankment of the Tobacco River is 520 feet long and approximately 55 feet high at the deepest section. The downstream slope appears to be in fair condition and has established vegetation, see Photo 23. Some localized sloughing and soft/wet spots were present on the downstream slope, however, this can be considered “normal” for an earthen embankment. Some animal borrows were also present along the downstream slope that will need to be backfilled. Boyce Hydro should continue to monitor the downstream slope on a weekly basis and following storm events for further movement or if the wet spots worsen. The embankment has a toe drain that has some vegetation growth and an accumulation of sandy sediment in the ditch, see Photo

*Photo 23: Downstream slope of Left Embankment – Tobacco.*

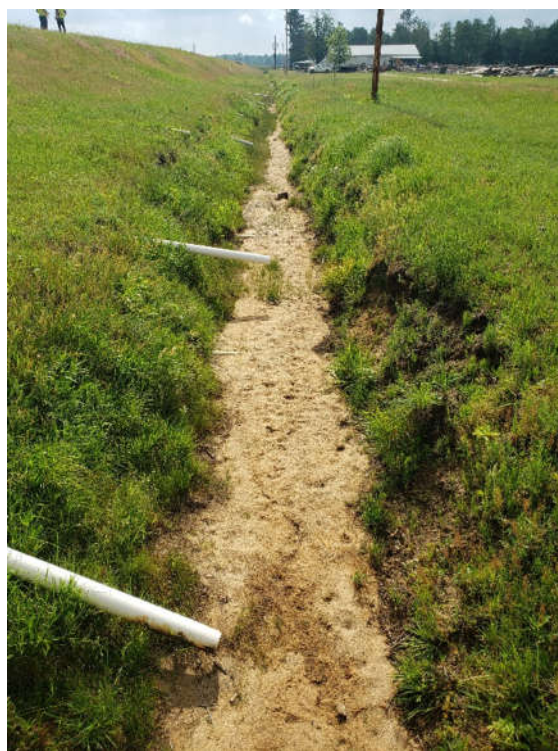
24. The toe drain outlets were not discharging at the time of the inspection. A nominal amount of sloughing of the ditch slopes was occurring and tension cracks were developing within localized sections of the ditch. ***The sediment should be removed and the ditch slopes repaired by removing the failed soil mass and replacing with well compacted clayey soil to the original ditch shape.***

*Photo 24: Toe drains of Left Embankment – Tobacco. Note accumulation of sediment in ditch.*

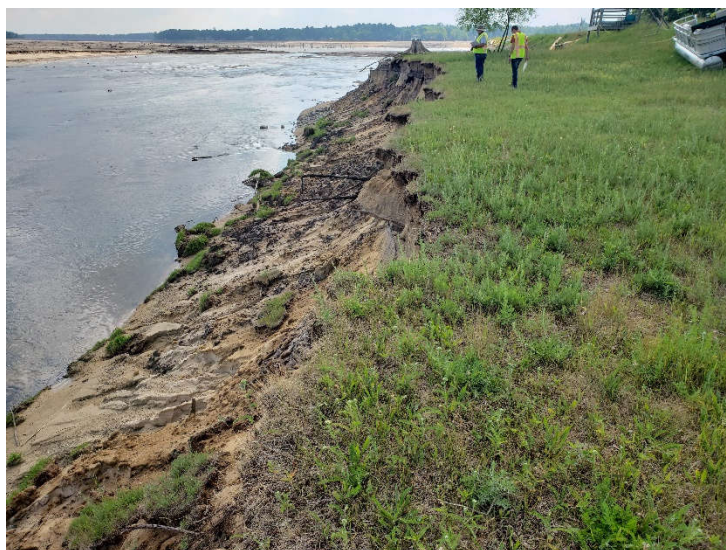
The upstream portion of the embankment is in unsatisfactory condition as a majority of the slope has been severely eroded. As a result, tension cracks are also developing at the crest of dam over a majority of the length of section. This section of embankment is at high risk for public safety as the structural integrity of this section of embankment will worsen and can be compromised as the embankment continues to be eroded. **Therefore, immediate action is recommended to protect the embankment from further erosion.** Until the dam can be repaired to satisfactory condition, as an interim measure it is recommended that a temporary sheet pile wall be installed from the existing fishing pier located approximately 275 feet east of M-30 to protect the dam from further erosion by moving the edge of the floodway away from the dam by reestablishing the original path of the stream, see Figure 2. There was debris and sediment build-up within the area of the former M-30 bridge. It is understood that MDOT will be removing the debris within the channel so that the river flow is no longer obstructed.

*Photo 25: Upstream slope of Left Embankment – Tobacco that has been severely eroded and requires immediate protection.*

- C-4 Until the Left Embankment – Tobacco can be repaired to satisfactory condition, as an interim measure it is recommended that a temporary sheet pile wall be installed from the existing fishing pier located approximately 275 feet east of M-30 to protect the embankment from further erosion by moving the floodway away from the dam by reestablishing the original path of the stream. Continue to monitor the rate of erosion of the embankment.

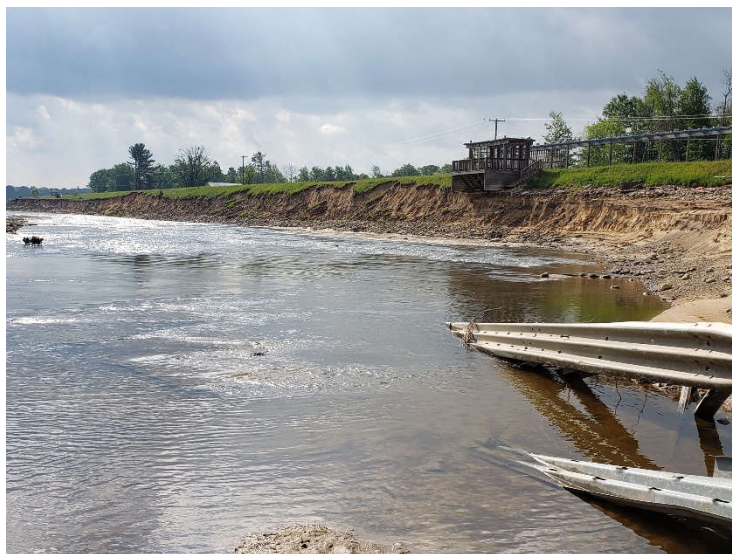
Photo 26: Upstream slope of Left Embankment – Tobacco that has been severely eroded and requires immediate protection.

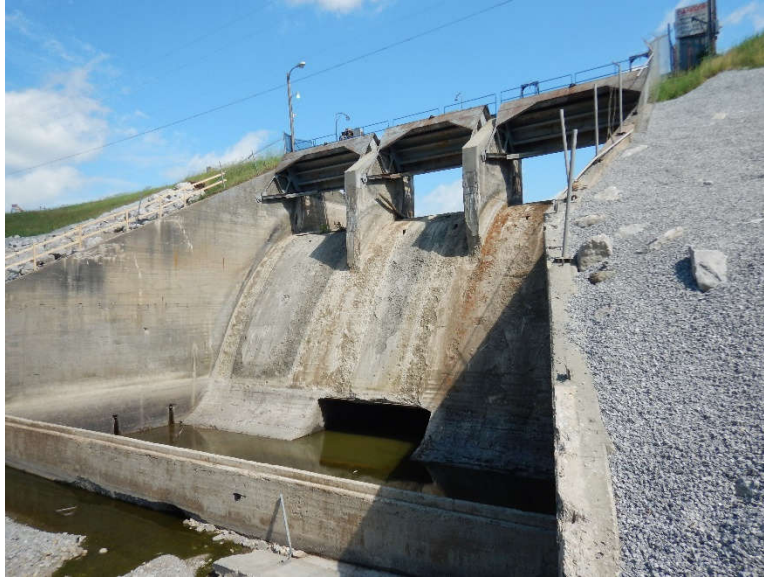
*Photo 27: Tobacco spillway with widespread spalling and likely delamination*

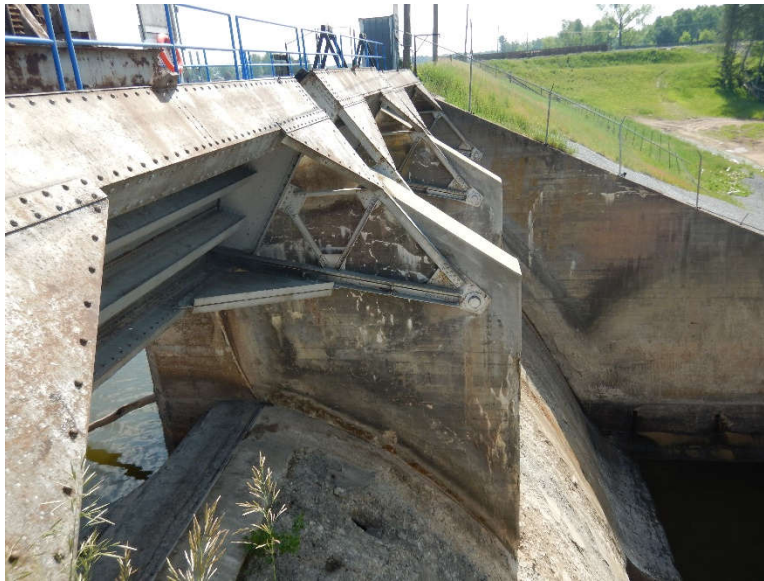
*Photo 28: Tobacco spillway pier with recent patch and still showing cracking with efflorescence.*

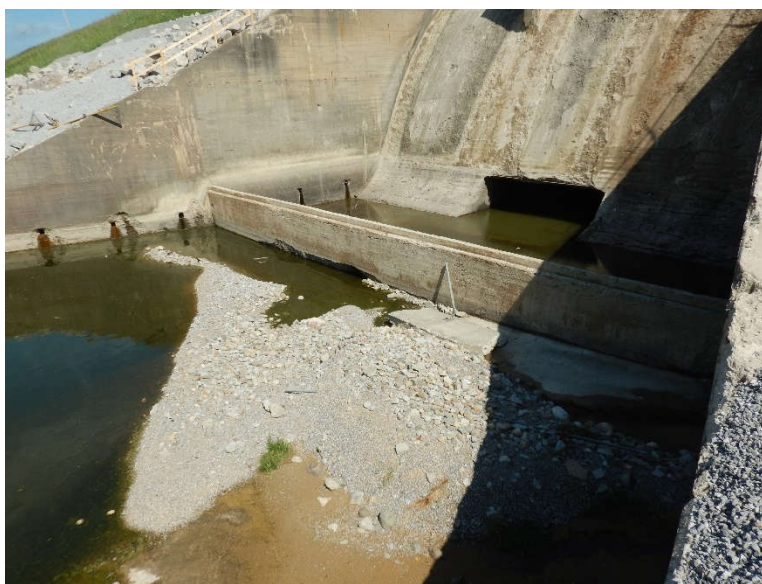
*Spillway:* The spillway was in fair condition. A visual inspection of the spillway facing and weir was performed from the embankments as the gates to access the deck were locked. The spillway facing showed widespread spalling and delamination, see Photo 27. The depth severity of the deterioration was not able to be determined due to access constraints. The spillway piers appear to have recently been rehabilitated, however areas for cracking with efflorescence were still present, see Photo 28. The weir had a large spall along the base of the downstream side. No exposed reinforcing steel was observed. A large sediment deposit was present across the spillway adjacent to the downstream side of the weir, see Photo 29. The spillway apron is being undermined.

*Photo 29: Tobacco spillway weir with large spall and sediment.*

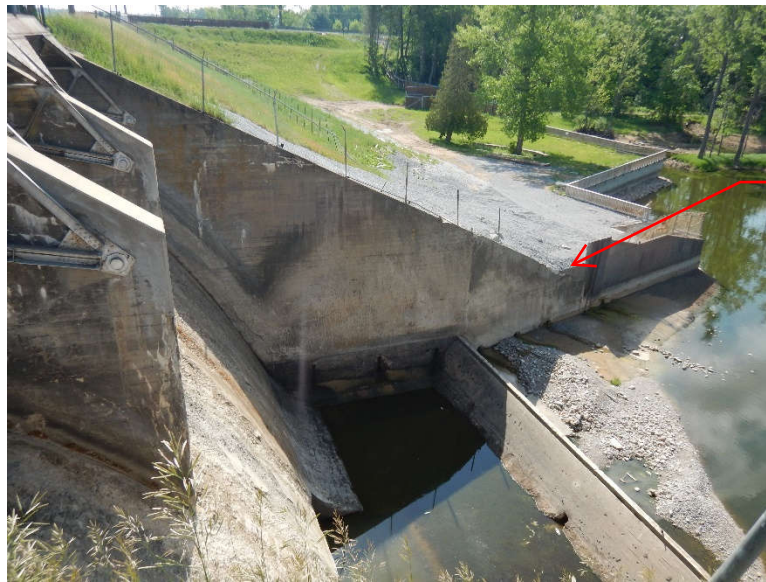
HORIZONTAL  
SAWCUT

*Photo 30: Left side (east) retaining wall exhibiting cracking with efflorescence, several large spalls near the bottom and a steel plate reinforcing an area under construction.*

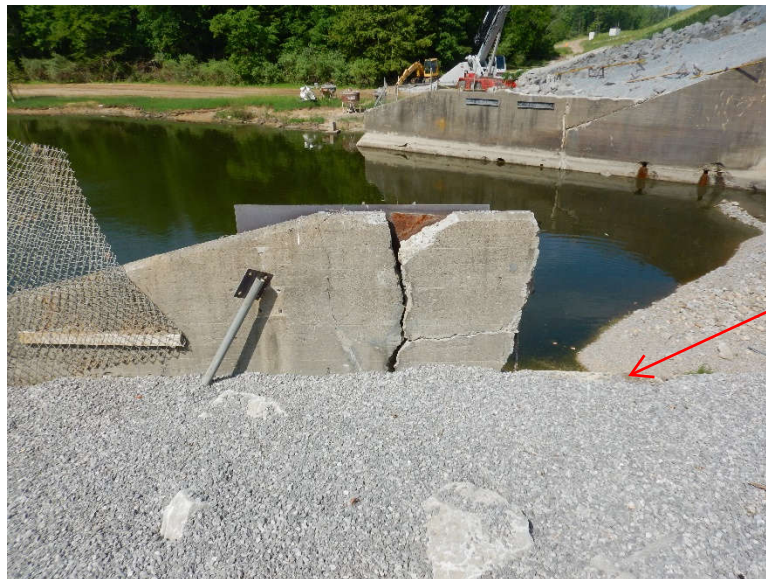
HORIZONTAL  
SAWCUT

*Photo 31: Back face of left side (east) retaining wall at steel reinforcing plate. Notice horizontal cut just right of plate.*

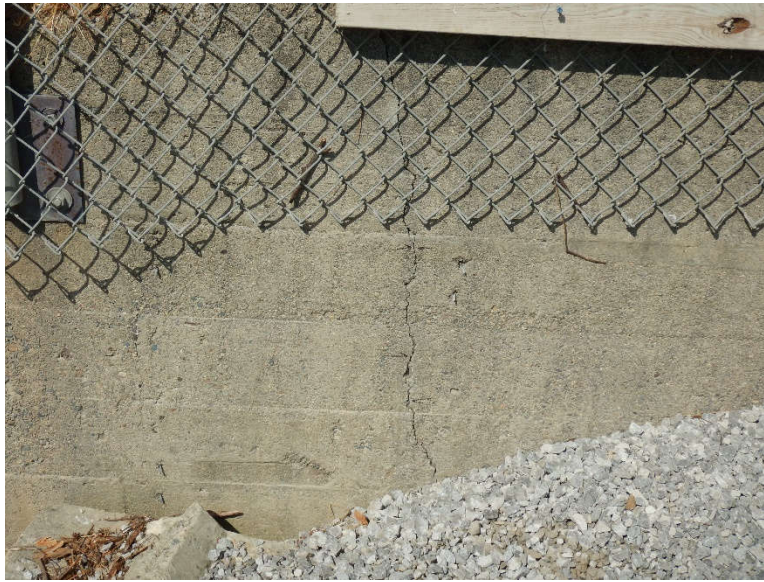
Photo 32: Vertical crack on back face of left side (east) retaining wall near downstream end.

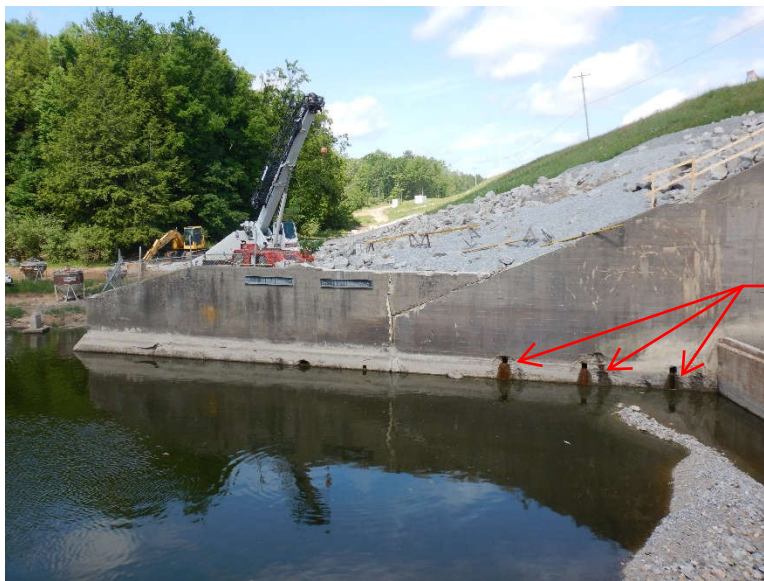
LARGE SPALL WITH  
EXPOSED REINFORCING  
STEEL

Photo 33: Right side (west) downstream retaining wall showing map cracking, large spall with exposed reinforcing steel and temporary construction railing.

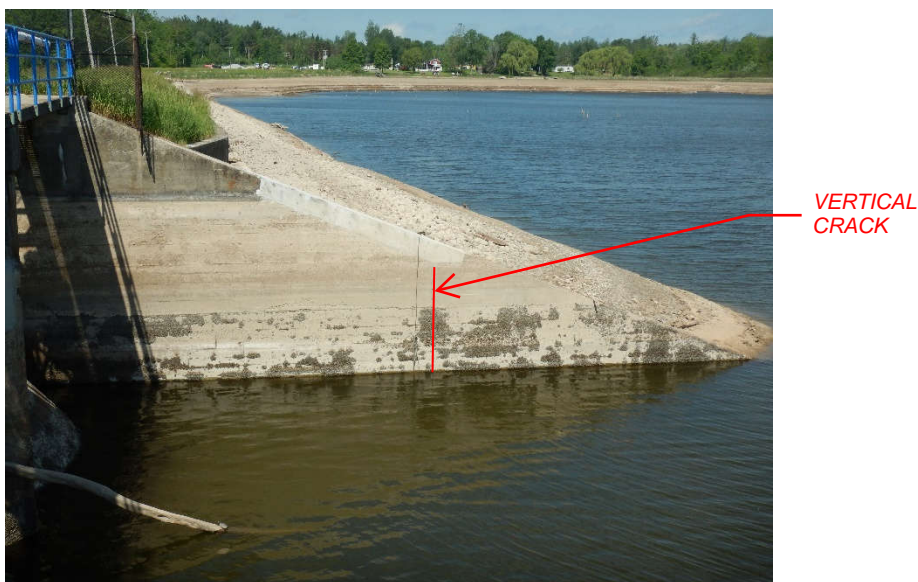
Photo 34: Upstream right side (west) retaining wall with a crack just right of the vertical line (cable hanging over edge).

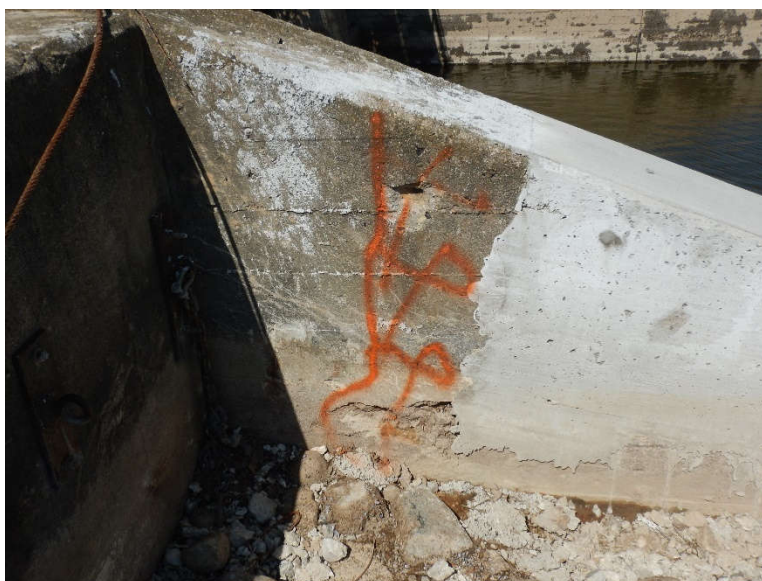
**Retaining Walls:** The retaining walls were generally in fair to poor condition. Large portions of the walls show minimal defects, however there are numerous isolated areas with large cracks and spalls. The retaining walls have tieback systems constructed but may not provide adequate support for the entire retaining wall systems, especially due to the recent erosion of the downstream slope. The left side (east) downstream retaining wall had an area of cracking with efflorescence near the top and several large spalls along the bottom. It appears that the retaining wall is currently undergoing a rehabilitation as a geometrically cut portion of the wall is missing near the toe of the slope and is reinforced with a stiffened steel plate, see Photos 30 and 31. Several vertical cracks approximately 0.125" wide were also noted near the downstream end, see Photo 32. The downstream right side (west) retaining wall had several large spalls along the bottom with exposed reinforcing steel and a large area of map cracking near the top. It also appeared to be under construction due to the presence of a temporary safety fence, see Photo 33. The upstream portions of the retaining walls were in better condition as compared to downstream. Isolated cracking was found on the right side (west) upstream wall and an area of delamination adjacent to a recent patch was located on the back face of the left (east) upstream wall, see Photos 34 and 35.

Photo 35: Upstream left side (east) retaining wall with delamination near recent patch (2'x4')

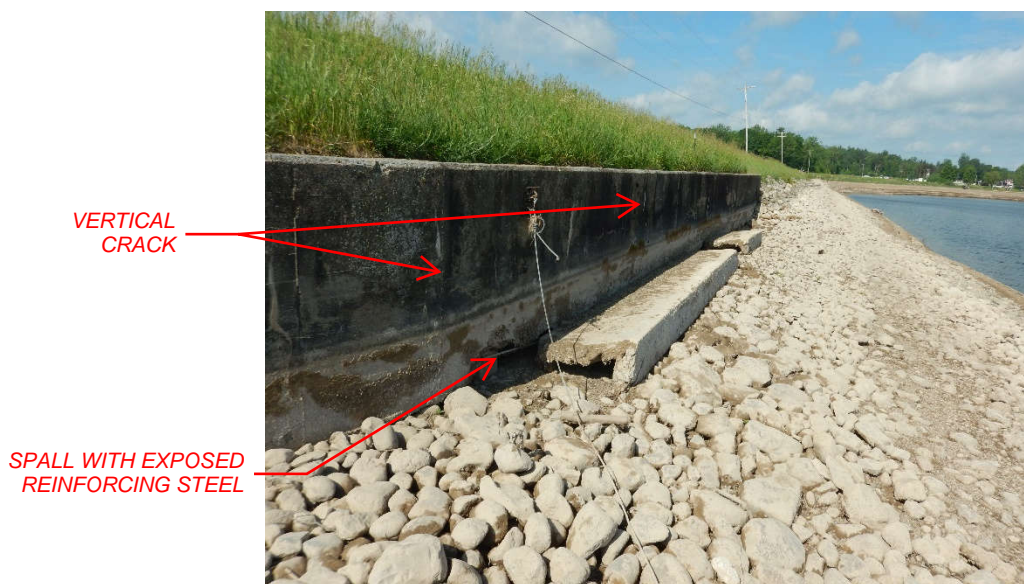
**Wingwall (Bulkheads) and Concrete Slope Protection Upstream:** The wingwalls (bulkheads) were in fair condition. The right side (west) wingwall (bulkhead) had a large area near the bottom where the sheet pile and reinforcing steel were exposed. There were also several vertical cracks in the concrete cap, see Photo 36. The left side wingwall (bulkhead) exhibited similar cracking, however spalling and exposed sheet piling and reinforcing steel were not present. At the east end of the wingwall (bulkhead), concrete slope protection had been installed. A couple of the panels showed signs of undermining and settling, see Photo 37.

Photo 36: Right side (west) wingwall (bulkhead) with vertical cracks and spalls exposing the sheet piling and reinforcing steel.

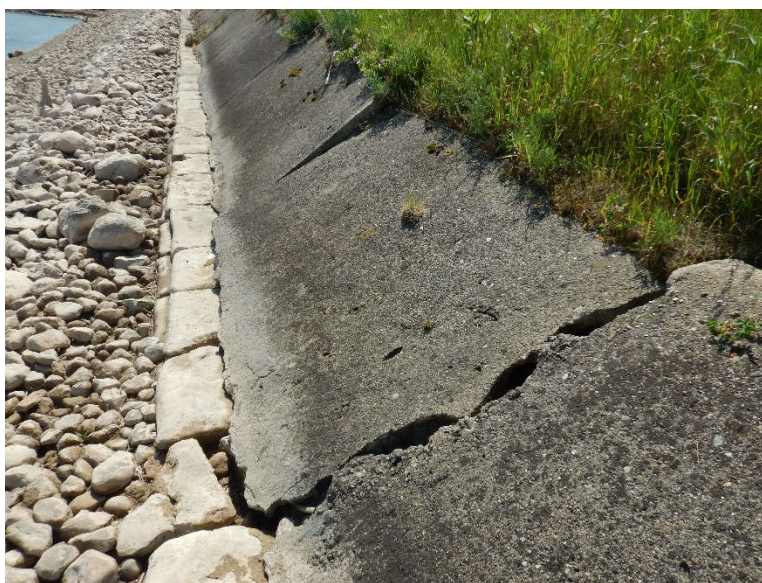
Photo 37: Concrete slope protection panel approximately 40' east of the wingwall (bulkhead) with undermining and settlement present.

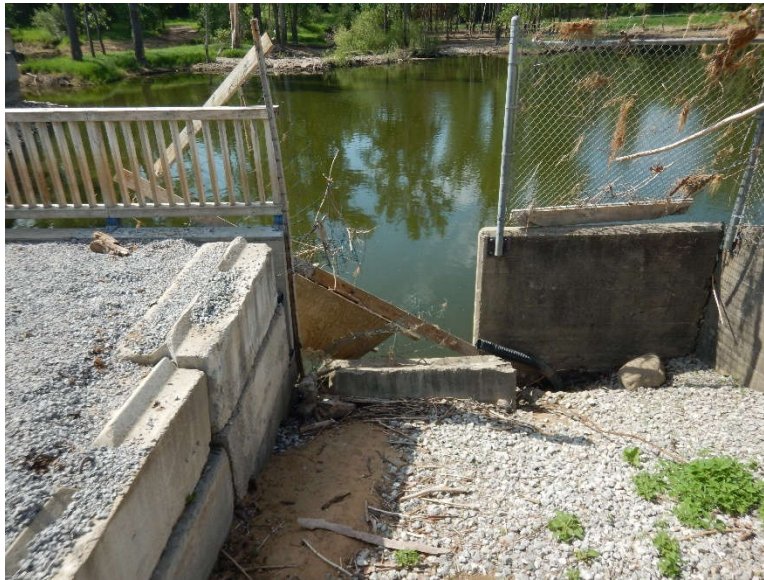
**Cutoff (Downstream) Walls:** The left side (east) cutoff wall is cracked and separated from the retaining wall. It also has a large spall near the bottom at the back face with exposed reinforcing steel. It is isolated and protected by concrete cribbing, see Photos 38 and 39. The right (west) side cutoff wall showed significant cracking near the top at the connection to the retaining wall, see Photo 40.

*Photo 38: Left (east) side cutoff wall isolated with concrete cribbing.*

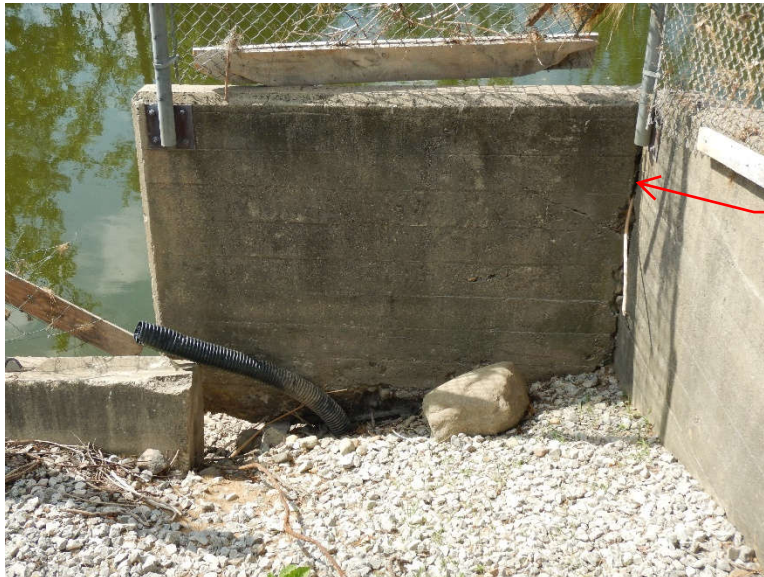
*Photo 39: Left (east) side cutoff wall with fully cracked connection to retaining wall and large spall with exposed reinforcing steel.*

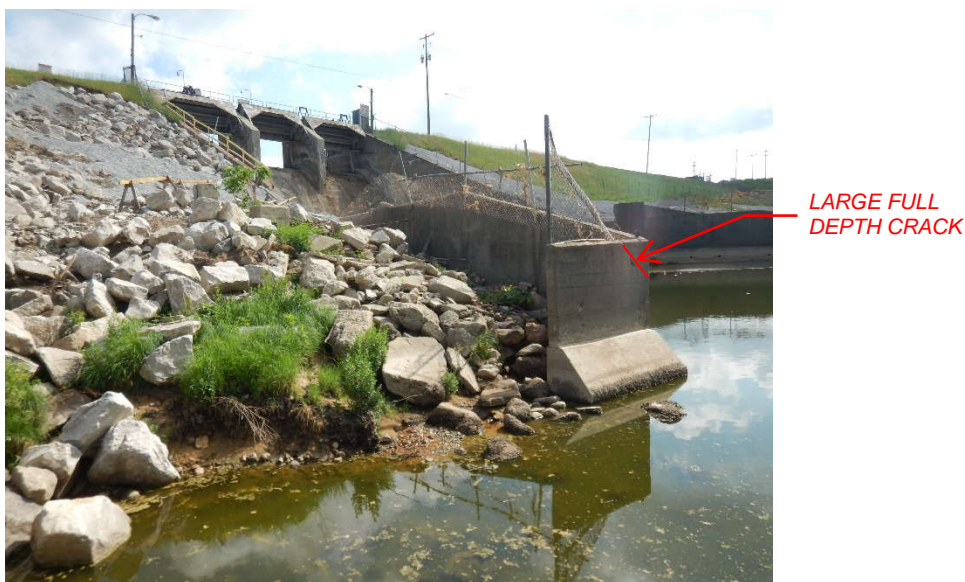
*Photo 40: Right (west) side cutoff wall with large crack near top at connection with retaining wall. Also note the lack of backfill*
