# Edenville Dam Emergency Inspection Report

**June 19, 2020**

**Dam Name:** Edenville Dam

Re: Dam Emergency Inspection Report  
**Edenville Dam**  
**Edenville, Midland and Gladwin Counties, MI**  
**TRC Project No.: 398511**

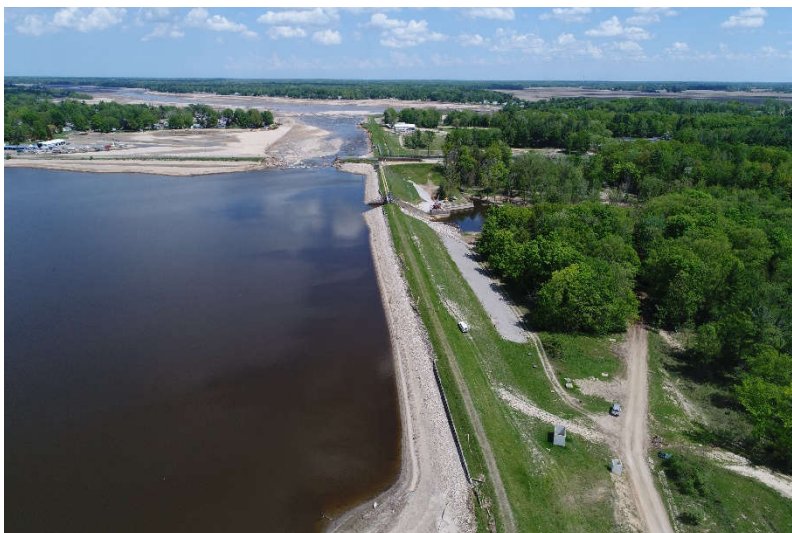
The right embankment of the Tittabawassee is 2,030 feet long and approximately 55 feet high at the deepest section. Except for the locations adjacent to the spillway as discussed below, a majority of the upstream and downstream slopes appear to be in fair to satisfactory condition, see Photos 41 to 43. There were no apparent signs of significant slope adjustment/movement, seeps, tension cracks, or rills present on the downslope slope, however, a few animal burrows were present that will need to be backfilled. The embankment has a toe drain system that has some vegetation growth in the ditch. The drain outlets were not discharging at the time of TRC's inspection. There were weeds accumulated along the pipe outlets that should be removed so the filter does not become clogged, see Photo 44. There were no signs of major erosion observed on the upstream slope; however, there are areas in which wave action has reduced the effectiveness of the riprap.

*Photo 41: Overall view of Right Embankment – Tittabawassee (drone photo provided by EGLE).*

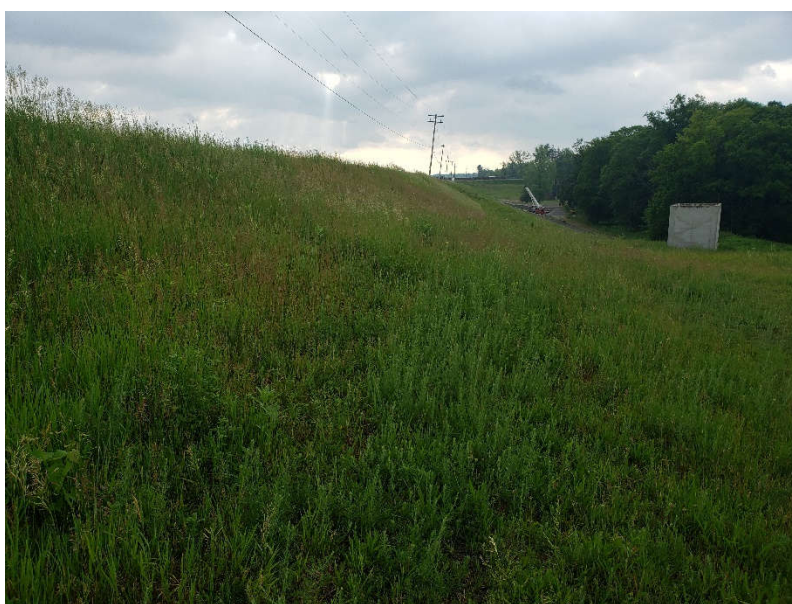
*Photo 42: Downstream slope of Right Embankment – Tittabawassee. Established vegetation and minimal slope adjustment/movement and seeps present.*

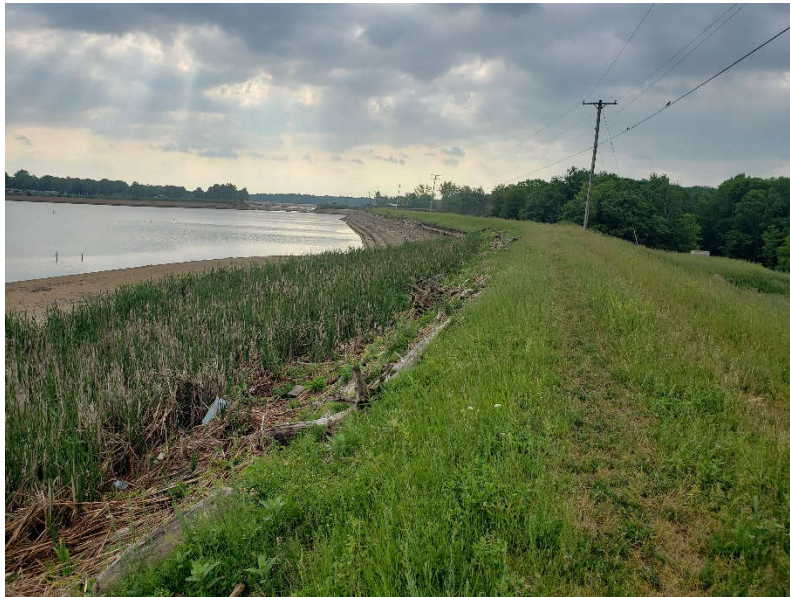
*Photo 43: Upstream slope of Right Embankment – Tittabawassee that will require slope protection to be reestablished (vegetation and riprap).*

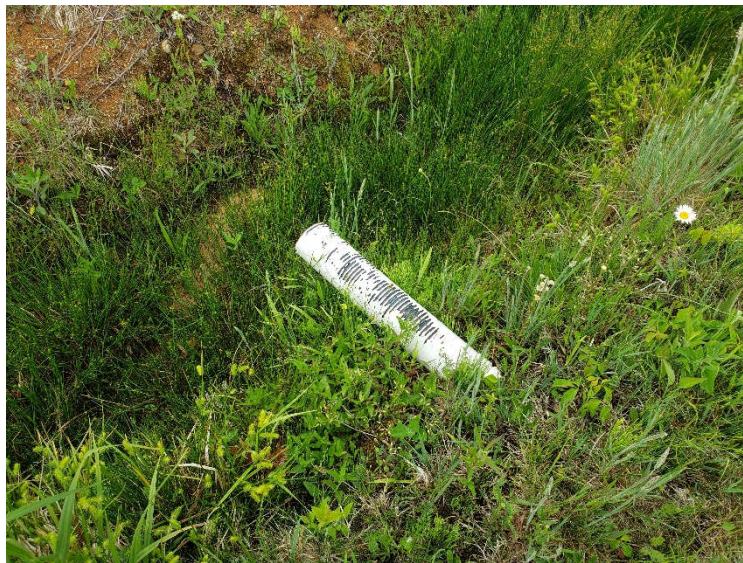
*Photo 44: Toe drain outlets not discharging at time of inspection.*

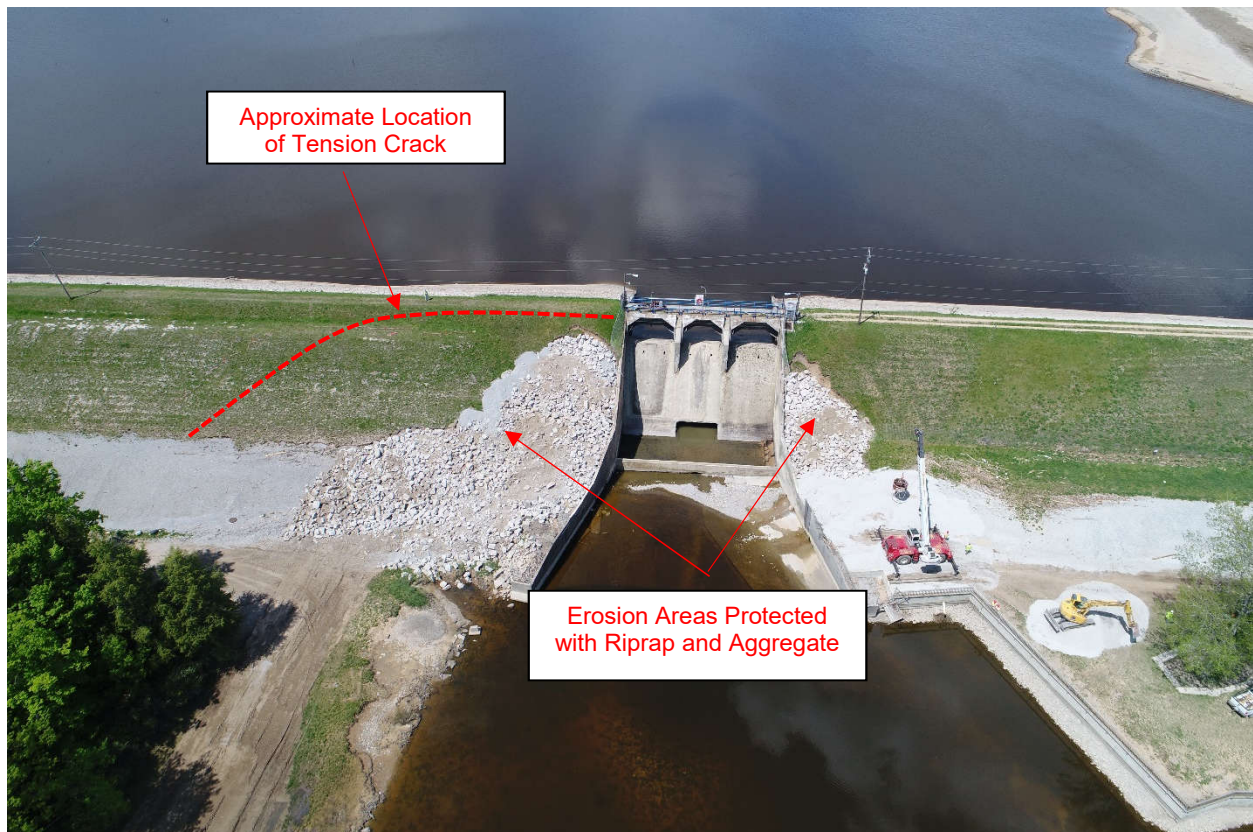
Tension cracks and surface sloughing was observed to the immediate right and left of the downstream slope of the Tobacco Spillway, see Photo 45. It is understood that tailwaters developed within the Tobacco River when the dam breached causing erosion damage to the bottom portion of the downstream slope where said cracks and surface sloughing was observed. The toe erosion created a loss of buttress support of the slope and the waves and precipitation during the storm inundated and softened the ground surface, thereby, weakening the slope causing the movement. It is anticipated that the sloughed material is a “sliver fill” overlay that was placed by Boyce Hydro at the request of FERC in 2014 and 2015 for the purpose of flattening the slope so that acceptable factors of safety could be achieved. As an

emergency effort, Boyce Hydro had the erosional areas backfilled with riprap and aggregate. Although it now may be more difficult to determine the location of a seep if one occurs, the riprap will protect the slope from erosion. Boyce Hydro also installed gauges around June 5, 2020 to monitor the tension cracks for additional movement, see Photo 46. Boyce Hydro indicated that since its installation the gauges have indicated the cracks are not increasing in size. These cracks should be backfilled with soil or bentonite to “seal the voids” to prevent water from entering the cracks and potentially weakening the embankment.

Under the conditions observed at the time of TRC’s inspection, the slope appears to be stable from a global perspective. Until repairs can be made to the Tobacco Spillway and adjacent slopes, it is recommended that the tension cracks be monitored by Boyce Hydro and that survey hubs be installed along the slope (at the crest, toe, and midslope) to monitor the slope for additional movement – the gauges and survey hubs should be monitored on a weekly basis. If the slope conditions worsen, the dam may need to be breached to the right of the spillway area so that the loading on the spillway and embankment is reduced by lowering the reservoir water level and passing the flow to the original Tobacco River alignment. Boyce Hydro will need to present this approach to EGLE for their review and concurrence if this is to be considered.

*Photo 45: Approximate location of tension cracks and eroded area previously remediated by Boyce Hydro.*

- C-5 Until a slope stability analysis can be performed and repairs made to the Tobacco Spillway and adjacent slopes to satisfactory conditions, it is recommended that survey monitoring hubs be installed along the downslope (at the crest, toe, and midslope) portion of Right Embankment – Tittabawassee to monitor the slope for additional movement. If

- C-6 The tension cracks that have developed to the right of the Tobacco Spillway should be backfilled with soil or bentonite to “seal the voids” to prevent water from entering the cracks and potentially weakening the embankment.

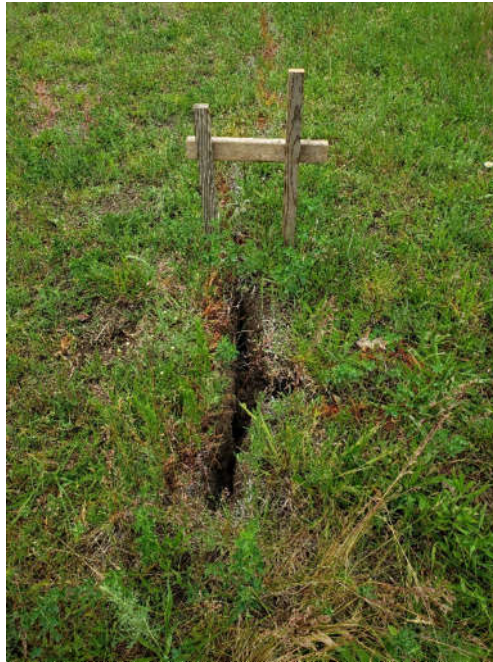
*Photo 46: Boyce Hydro installed crack gauges to monitor the tension cracks.*

- R-6 Continue to monitor the gauges previously installed along the tension crack observed to the right of the Tobacco Spillway to determine if the tension cracks are widening.
