## **Integrity Assessment – West Leg – Line 5 Straits**

June 20, 2020 (issued)  
June 21, 2020 (revised)

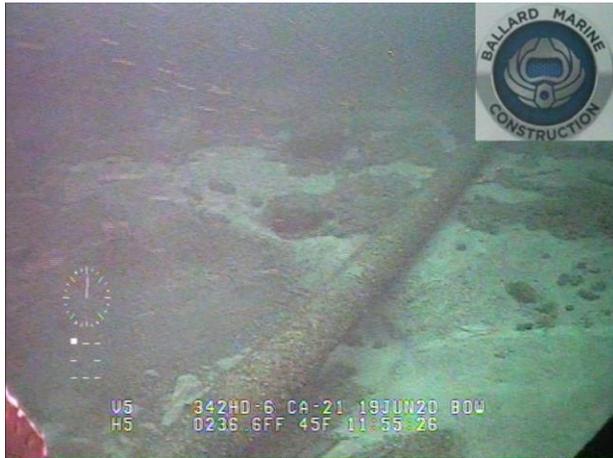
Figure 1: Location (overview)

The feature of interest identified by ROV on the West leg is comprised of an area of disturbed biota (quagga mussel encrustation is removed) with a small light-colored patch (approximately 50 square inches). The light-colored patch are calcareous deposits formed by the proper operation of the cathodic protection system. The images show there was no bare metal or mechanical damage and the pipe was protected by coating and cathodic protection. The follow up dive confirmed all ROV findings. The feature of interest did not require repair.

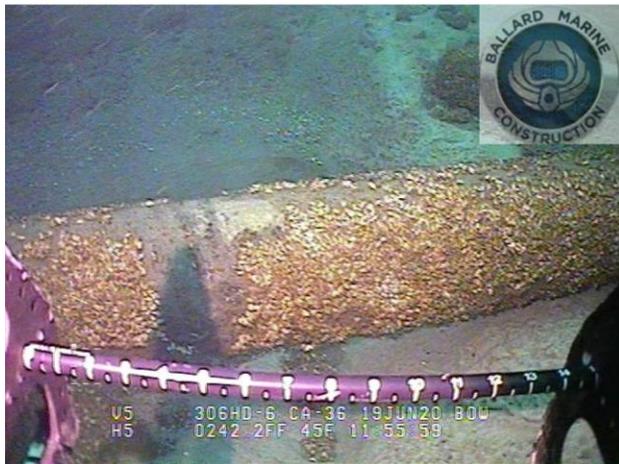
Figure 3: Feature of Interest (close)

A follow-up dive examination on the feature of interest was completed on June 21, 2020 and confirmed that there was no bare metal, no physical damage and that a coating repair was not required.

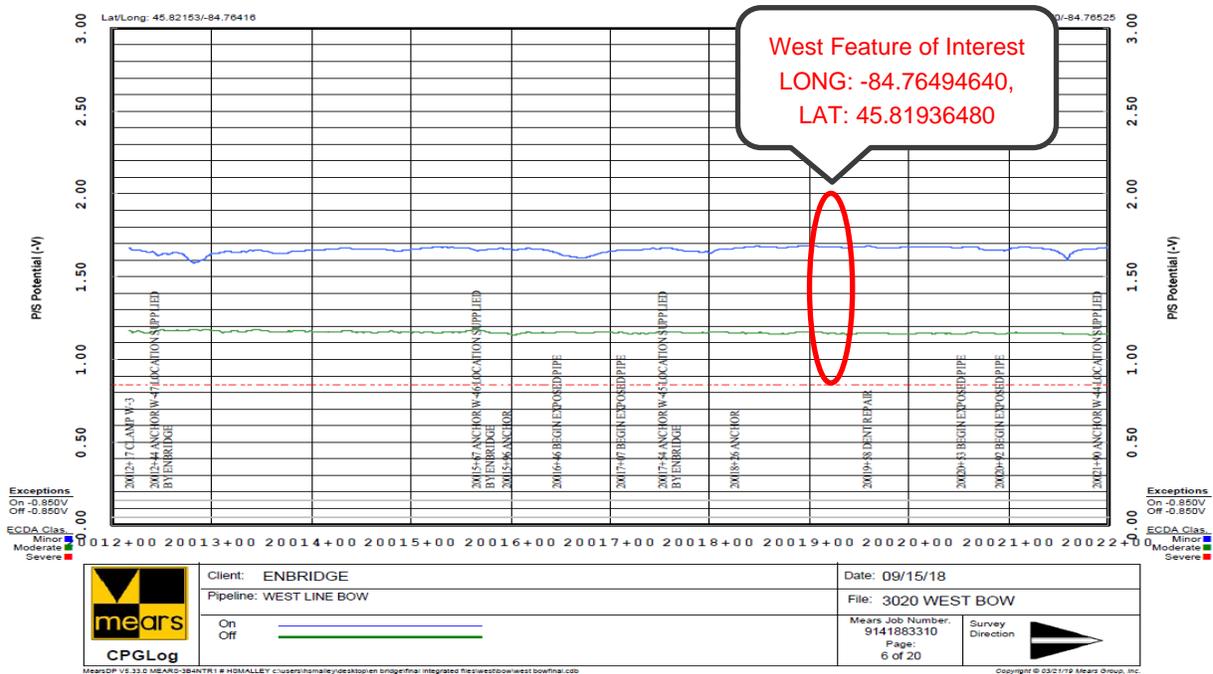
The area containing the feature of interest on the West pipeline was carefully examined for electrical variations to determine any signs of coating damage. No electrical anomalies were identified, indicating

that there was insufficient exposed metal to alter local protection levels at the time of the CIS. Figure 4 presents the segment of survey containing the feature of interest, with the location of the feature highlighted. An additional CIS survey is planned for 2020 during our ongoing maintenance and inspection activities.
