Integrity Assessment – West Leg – Line 5 Straits

June 20, 2020 (issued)

Summary

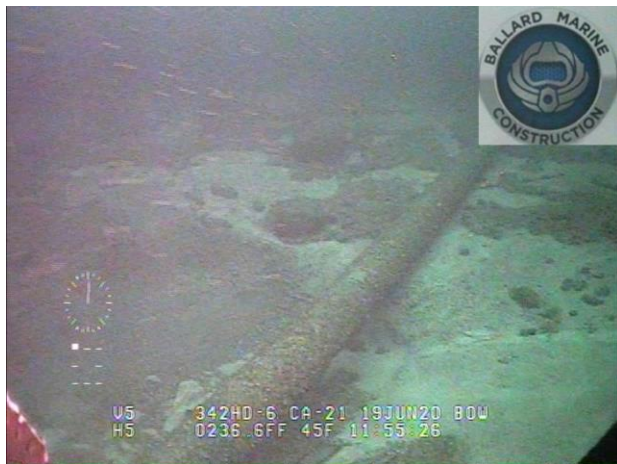
Figure 1: Location (overview)

The feature of interest identified by ROV on the West leg is comprised of an area of disturbed biota (quagga mussel encrustation is removed) with a small light-colored patch (approximately 50 square inches). The light-colored patch are calcareous deposits formed by the proper operation of the cathodic protection system. The images show there was no bare metal or mechanical damage and the pipe was protected by coating and cathodic protection. The follow up dives confirmed all ROV findings, and additional details were collected. The feature measurements from Diver was found to be slightly larger (~70 square inches) than the estimate previously provided based on ROV images. The feature of interest did not require repair.

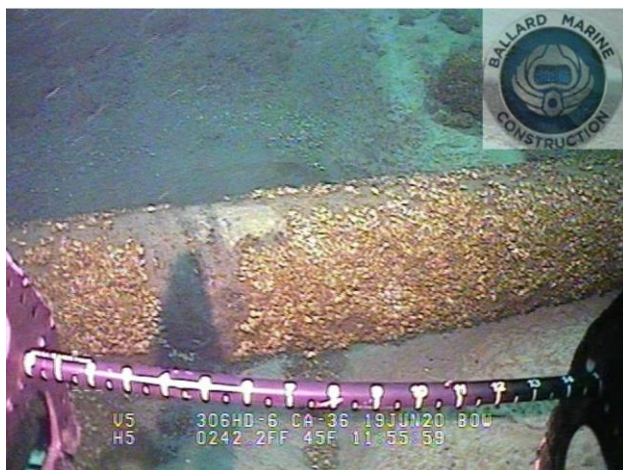
Figure 3: Feature of Interest (close)

Follow-up dive examinations were completed on June 21 and June 22, 2020 and confirmed that there was no bare metal, no physical damage and that a coating repair was not required.

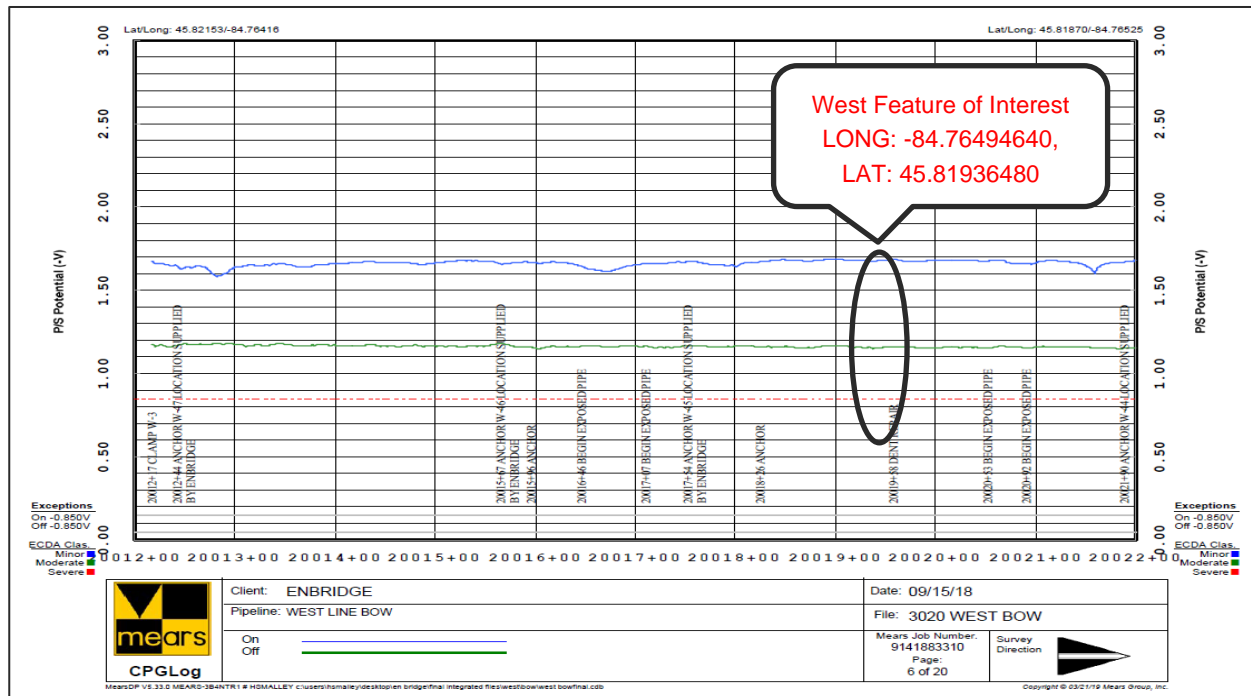
Figure 4: CIS of the Segment Containing Feature of Interest (Feature identified)

The area containing the feature of interest on the West pipeline was carefully examined for electrical variations to determine any signs of coating damage. No electrical anomalies were identified, indicating that there was insufficient exposed metal to alter local protection levels at the time of the CIS. Figure 4 presents the segment of survey containing the feature of interest, with the location of the feature highlighted.
