January 10, 2020

**December 11, 2019 Order to Restore
5851 West Jefferson Avenue, Detroit Michigan
Compliant Submission No.: HNV-Y8T9-CH85H6
Site Name: 82-5851 West Jefferson Avenue-Detroit**

**December 11, 2019 Compliance Communication: Notice of Section 20107a of Part
201 Obligations
Former Revere Copper and Brass
5851 West Jefferson, Detroit, Wayne County, Michigan
EGLE Site ID No. 82000136**

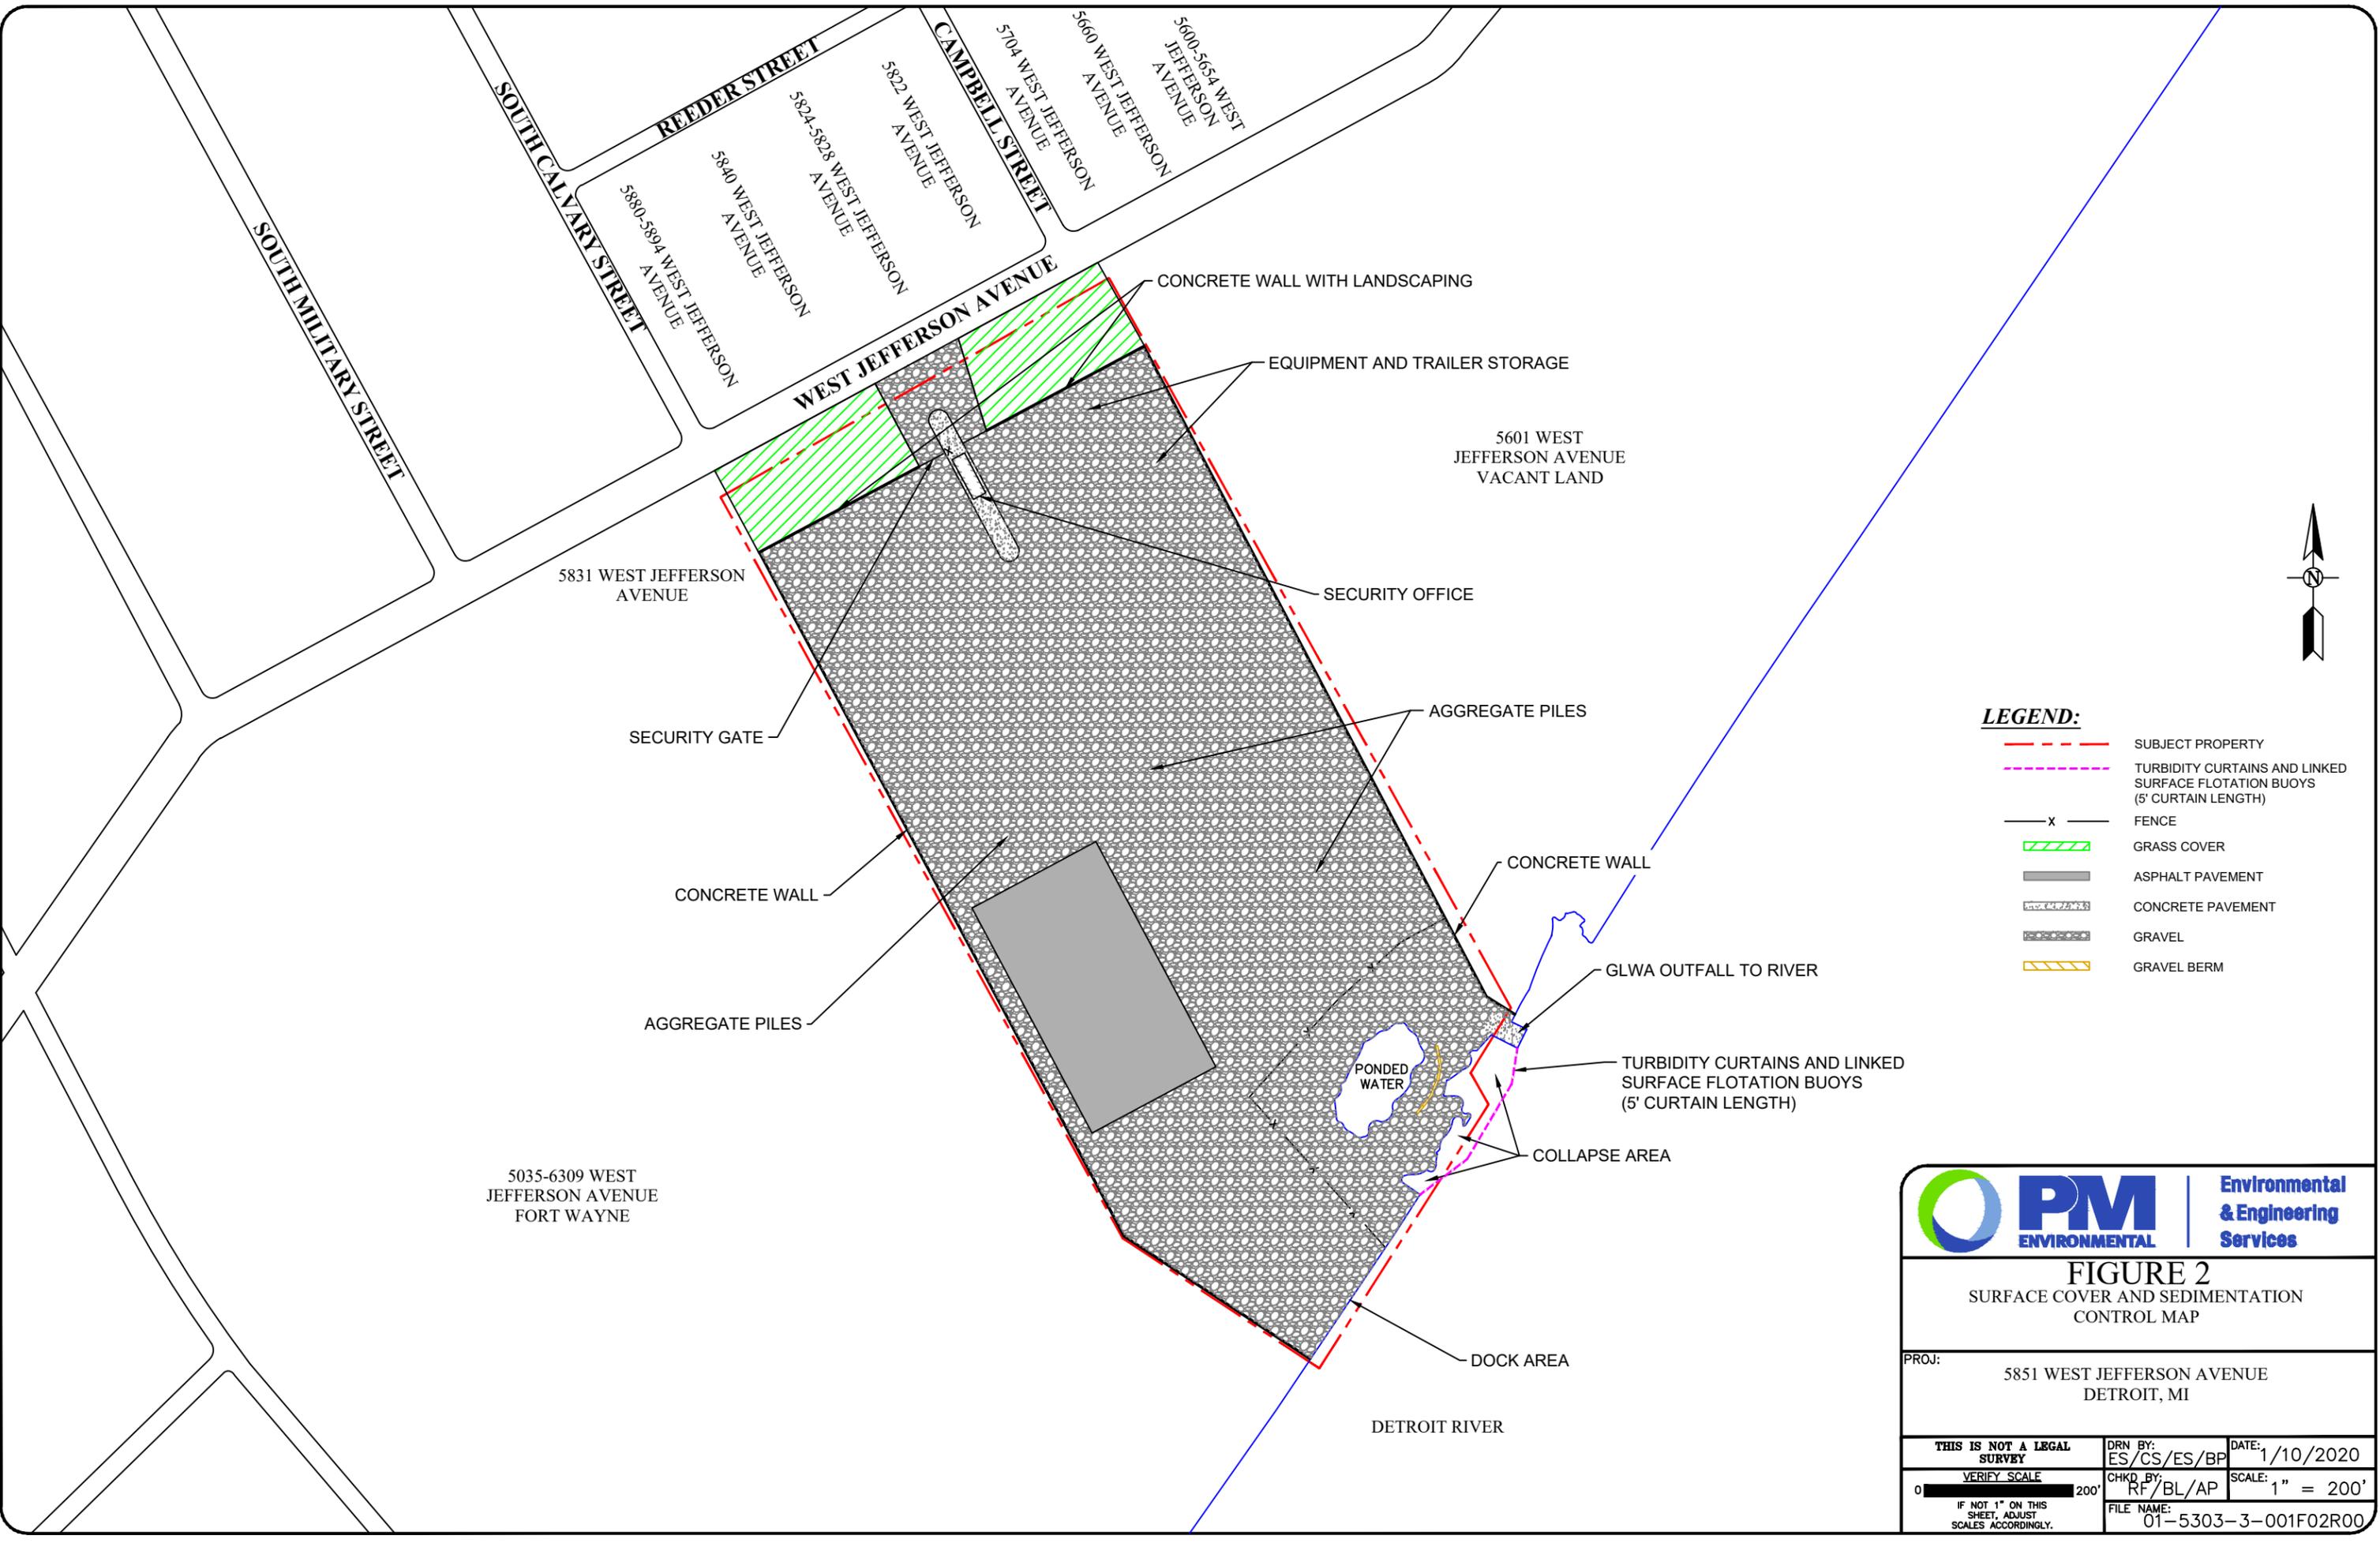
| FIGURE 2 SURFACE COVER AND SEDIMENTATION CONTROL MAP | | |

Surface cover at the subject property consists of concrete driveway/approach/walkway areas to the north, an asphalt parking area to the west and areas of seeded topsoil and landscaping along the northern property boundary. The remainder of the subject property is covered with compacted gravel, including the majority of the area of the bank failure. Some areas along the southern area

of the subject property where the bank failure occurred contain surface cracking that have not been filled with gravel due to geotechnical concerns associated with the added weight of a gravel blanket in that area. However, that area of the subject property has been isolated with temporary fencing to prevent access. An additional gravel berm was also installed along the southern boundary of the bank collapse area where water has accumulated, to further control erosion and provide sedimentation control (refer to Figure 2).

Approximately 200-linear feet of turbidity control curtains (five-foot curtain depth) with linked surface flotation elements/buoys are present in the water along the southern property boundary, which surround the bank failure area, and are anchored to the river bottom in accordance with manufacturer recommendations. The turbidity control curtains and associated linked surface flotation elements/buoys prevent access to the bank collapse area via the water and also act to control and contain potential suspended sediments in addition to reducing wave action in the area.

As indicated above, gravel surface cover, a gravel berm, and turbidity control curtains have been installed at the subject property as erosion and sedimentation control measures. The following additional actions will be undertaken to address the bank failure in compliance with Michigan Parts 31 and 301:

Up to 400-linear feet of additional turbidity control curtains with a 20-foot curtain depth will be installed in a secondary boundary beyond the existing turbidity curtains during the week of January 30, 2020. The 20-foot turbidity curtains will provide additional sediment and turbidity control, and will be anchored to the river bottom in accordance with manufacturer recommendations. The curtain depth will be maintained at least one-foot from the river bottom to prevent disturbing river sediments and the turbidity curtains will be maintained per manufacturer recommendations to ensure their effectiveness. Notice will be provided to EGLE, the United States Army Core of Engineers (USACE), and the United States Environmental Protection Agency (USEPA) prior to installing the 20-foot turbidity curtains.
