UNIDIRECTIONAL FLUSHING PILOT EVALUATION TECHNICAL MEMORANDUM

FINAL TECHNICAL MEMORANDUM

To: Chris Hill, Rebecca Slabaugh – ARCADIS Date: 31-August-2017
From: Andrew Hill, Melinda Friedman – Confluence Project: Flint Drinking Water Distribution System Optimization
cc: Jim Cooper – ARCADIS Subject: Unidirectional Flushing Pilot Evaluation

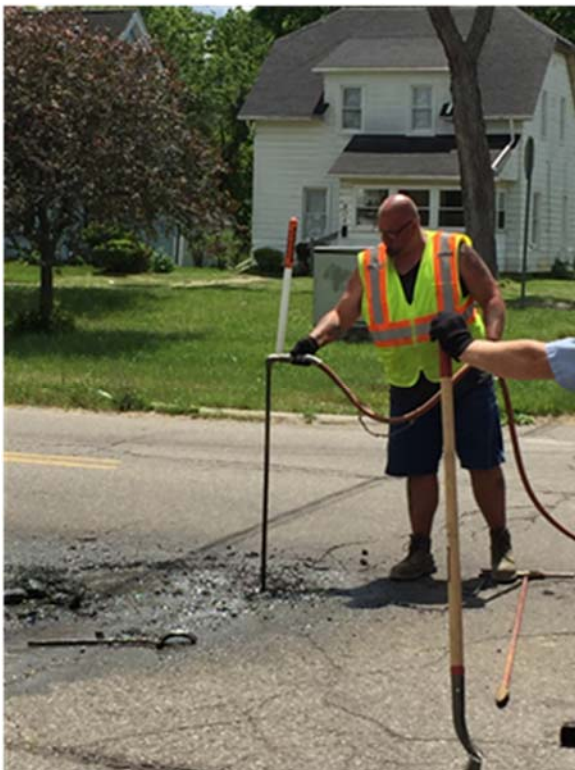
- There were a variety of infrastructure deficiencies that impeded effective UDF loop development and field progression (in addition to posing other challenges with system operation). For example:
 - Line valves are reportedly often paved over by streets department, even newly-installed and replacement valves. During the pilot, in the seven loops that were completed with Confluence, there were four valves (that needed to be turned to a closed position to ensure unidirectional flow) that were found to be paved over and thus could not be operated or closed.

In some cases, a nearby alternate valve was identified that served the intended need. However, in one case, a paved-over valve had to be jack-hammered open to support the loop – see **Figure 2**.

Figure 2. Jack-hammering needed to uncover paved valve on Loop #3.

- The City should develop and implement a routine asset inspection and maintenance program for its valves and hydrants. UDF cannot be reliably or cost-effectively implemented until an asset maintenance program is developed and applied. City maps should be updated in conjunction with asset inspection and maintenance activities to ensure that they reflect the status of system components.

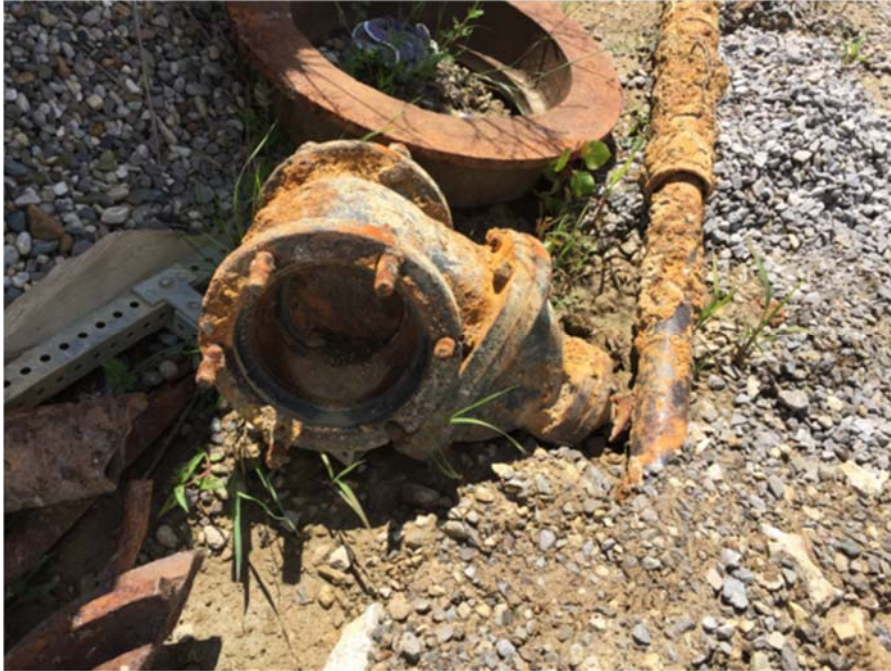
- Line valves often get stuck in a closed position – see **Figure 3**.
- Reportedly, fire hydrants are frequently damaged, in some cases due to vehicles driving into them. During the pilot, one hydrant could not be used because the bolts to the base flange were broken, allowing the hydrant to lift up and leak from the base – see **Figure 4**. Another hydrant could not be used due to damaged port threads.

Figure 3. Example gate valve stuck in closed position (located in City boneyard).

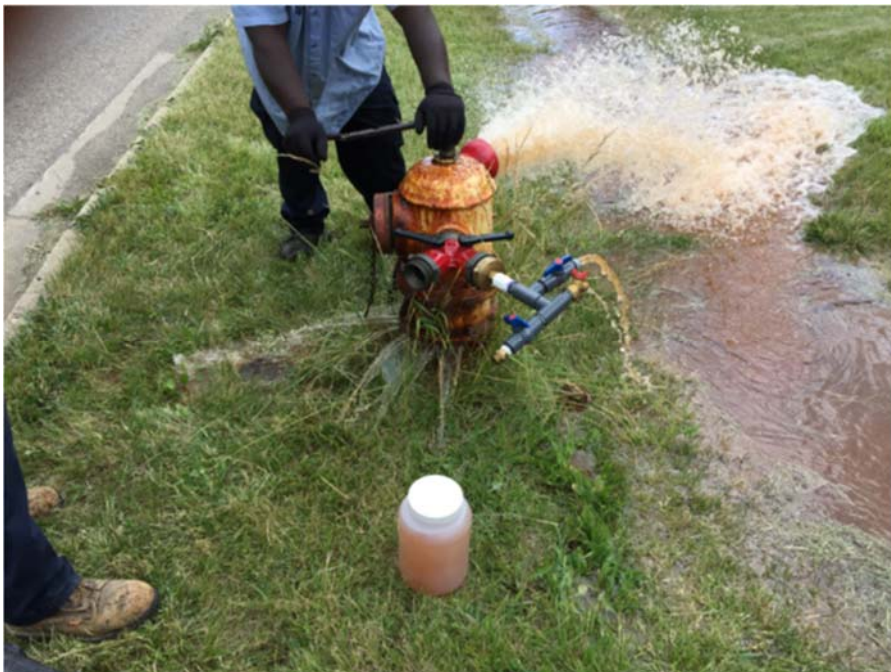
Figure 4. Hydrant for Loop #3 leaked due to broken bolts around the base flange.

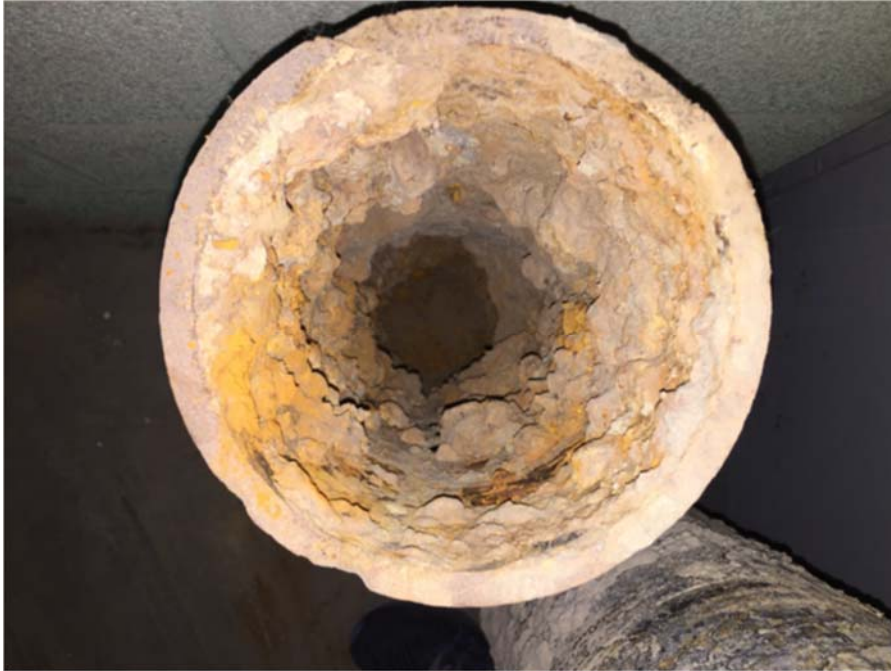
- The condition of the City’s old unlined cast iron pipe appears to be relatively fragile.
 - Crews reported hundreds of main breaks per year, with most attributed to pressure transients from WTP finished water pumping operations.

- There is moderate buildup of corrosion scale on UCI pipe, and the scale seems to be weakly-adhered and hydraulically-mobile. Regarding scale thickness, an 8-inch diameter unlined iron pipe specimen previously removed from the DS had an average scale thickness of one inch, with extreme roughness – see **Figure 5**. During flushing, tubercles were seen in the flush discharge stream when flushing at 450 gpm in an 8-inch diameter main (approximate velocity of 5 feet per second, or fps).

Figure 5. Tuberculation and scale thickness in an 8-inch cast iron pipe removed from Flint’s system.

- Given the fragile, aged condition of much of the City’s unlined cast iron pipe, efforts to replace this pipe type should be accelerated and prioritized as part of the City’s CIP. The replacement of these pipes will benefit hydraulic capacity, water quality, and reduce labor associated with dealing with frequent main breaks.

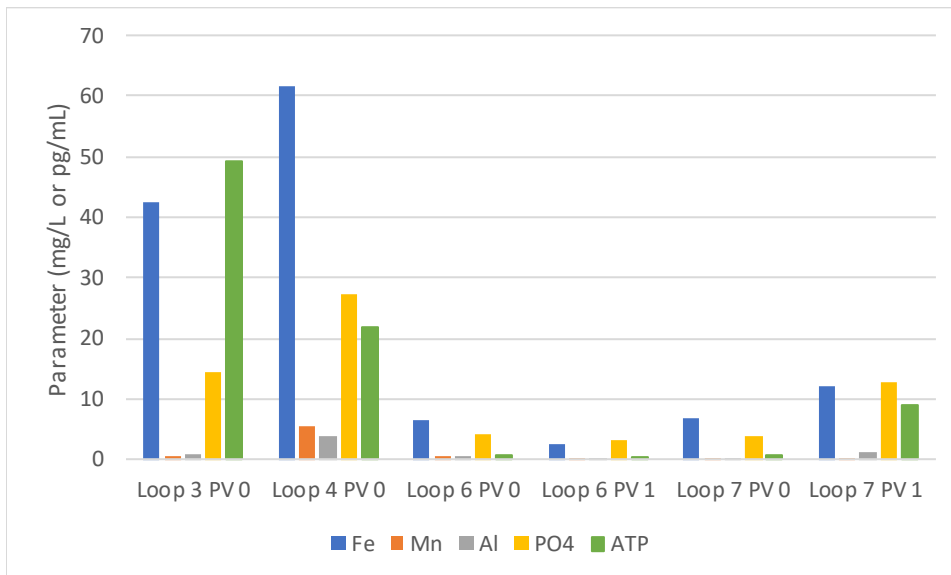
- **Table 2** provides a summary of flush water quality data obtained for pre-selected pilot area loops. These data represent the concentration of key constituents mobilized during the first pipe volume (PV) of flushing a given loop, i.e., *hydraulically-mobile accumulation*. They reflect a realistic release scenario associated with events such as main breaks, fire-fighting, construction activity, etc.
- Hydraulically-mobile deposit accumulation was highly variable between the loops. Order-of-magnitude concentration differences were observed between loops for several key constituents – see **Figure 6**.

Figure 6. Flush water quality variability observed between loops.

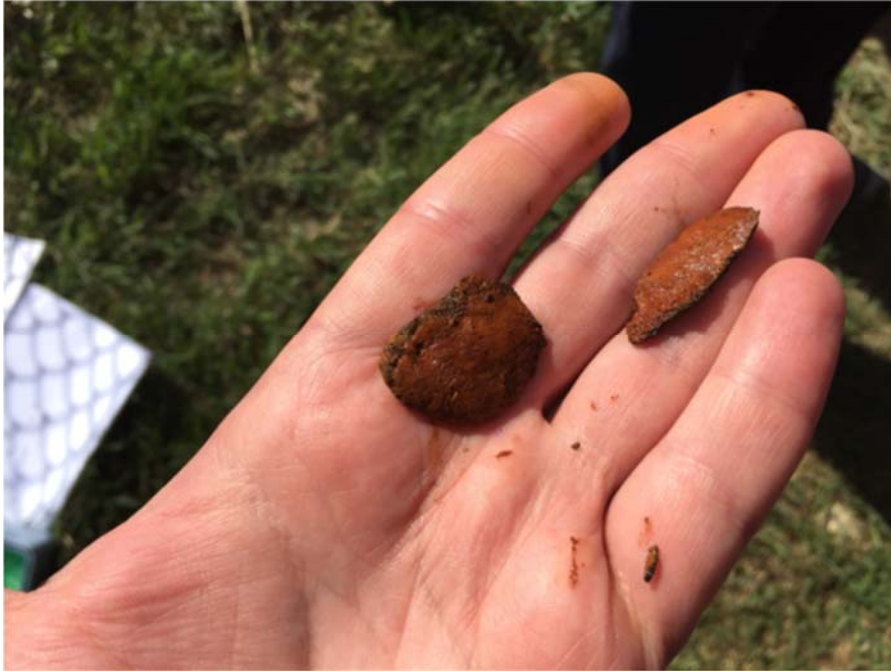
- The highest velocity tested (5 fps) sheared tubercles off from the pipe scale – see **Figure 7**. For all subsequent loops, the flushing flow rate was lowered such that the velocity was ≤ 5 fps. These lower velocities did not dislodge tubercles.
- Discolored (red/brown) discharge water was observed for all flushes. Turbidities reached as high as 375 NTU – see **Figure 8**.
- Turbidity gradually dropped to 10 NTU for each flushing loop, typically after about five PV – see **Figure 9**, which depicts the flush turbidity profile for Loop #2. The rate of turbidity decline slowed considerably as it neared 10 NTU, indicative of diminishing returns and suggesting that 10 NTU is an appropriate flush-terminating criterion to balance cleaning performance with resource utilization.

Figure 7. Tubercles removed on Loop #1 at 5 fps flushing velocity.

- Flushing velocity control and monitoring of discharge water quality should be applied during UDF activities to optimize scouring performance while avoiding tubercle removal. A flushing velocity of 4 ± 0.5 fps (based on effective pipe diameter) appears optimal for the City’s unlined cast iron pipe.

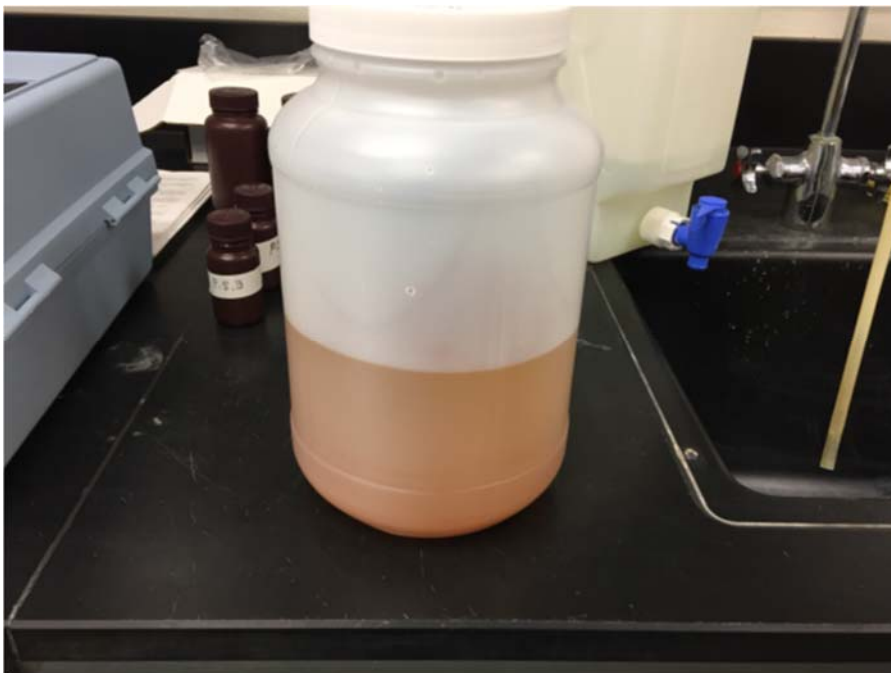
Figure 8. Flush turbidity of 375 NTU on Loop #4.

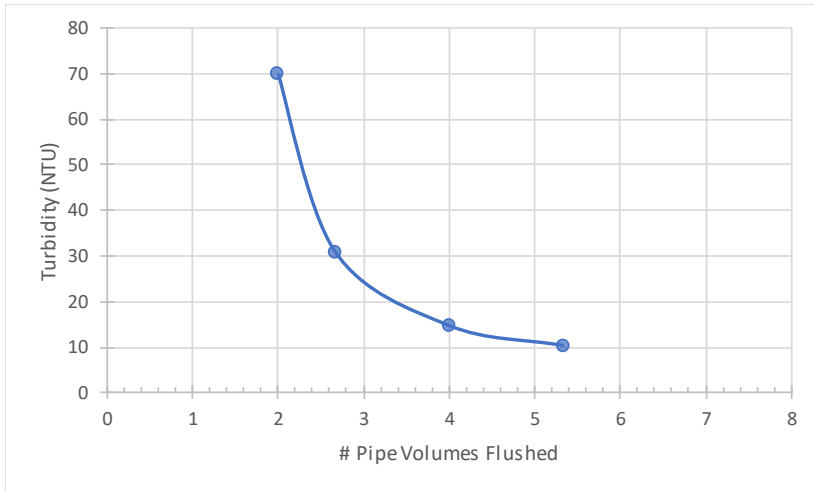
Figure 9. Turbidity profile for Loop #2.

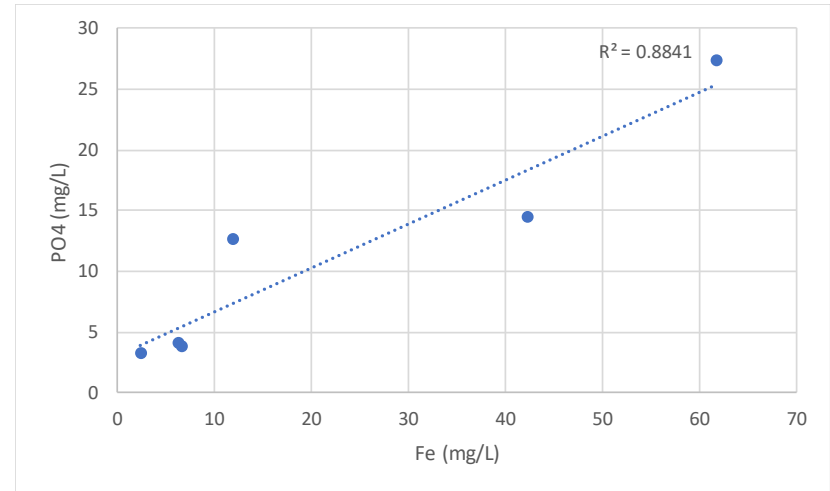
- High levels of orthophosphate buildup, i.e., in excess of 10 mg/L as PO₄, were observed in 3 of the 4 monitored loops. Orthophosphate strongly correlated to Fe (see **Figure 11**) and aluminum (Al), reflecting formation of Fe-PO₄ and Al-PO₄ precipitates on pipe surfaces, respectively. Orthophosphate also exhibited a strong correlation to turbidity – possibly via its association with Fe – further supporting the conclusion that turbidity serves as a good indicator parameter for multiple water quality constituents.

Figure 11. Correlation between orthophosphate and iron.

- The City should conduct water quality monitoring during flushing to ensure that cleaning objectives and water quality restoration goals are met. At a minimum, turbidity, free chlorine residual, and orthophosphate should be monitored during flushing.

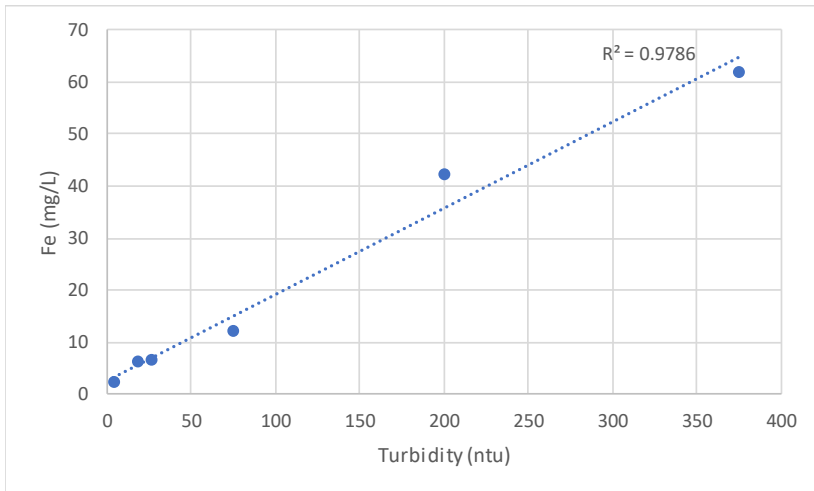
- Iron (Fe) represented the most concentrated (identified) element of total suspended solids (TSS) removed by flushing, averaging 33% of deposit mass. As a result, Fe exhibited a strong correlation to turbidity (which itself had a near-perfect correlation to TSS) – see **Figure 10**. Iron concentrations in the flush discharge ranged from 2.4 to 62 mg/L, indicative of significant accumulation of hydraulically-mobile iron particulate and destabilized scale particles.

Figure 10. Correlation between iron and turbidity.

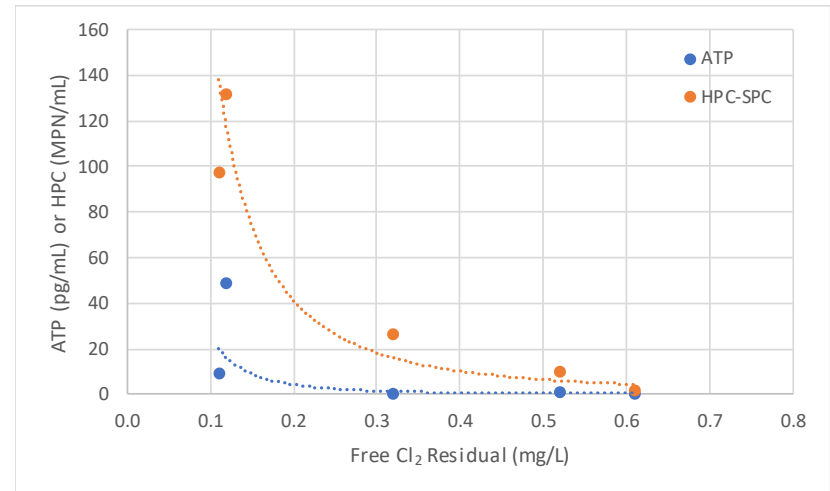
- Cellular ATP – representative of viable microbial activity – ranged from 0.2 pg/mL (typically considered good control) to 49 pg/mL (corrective action recommended), indicating large spatial variability in pipe wall biofilm presence and stability. Heterotrophic plate count (HPC), which represents less than 1% of viable bacterial activity, correlated to ATP and thus demonstrated similar spatial variability.
- Microbial activity was inversely related to free chlorine residual – see **Figure 12**. A free chlorine residual of approximately 0.3 mg/L appeared to represent an inflection point between regions of good and poor microbial control.

Figure 12. Correlation between microbial parameters and free chlorine residual.
