# DOYLE/RYDER ELEMENTARY SCHOOL

Outlet Sampling and Plumbing Assessment Recommendations

1040 Saginaw Street, Flint, Michigan 48503

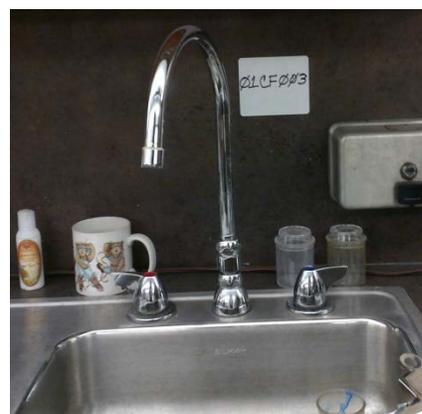
Location: Classroom 160

### Outlet: Sink Faucet (01CF003)

Results: P1=8 parts per billion, P2=26 parts per billion

F01=1 part per billion, F02=1 part per billion

These results suggest the highest contribution of lead may be from the faucet and its connecting plumbing. This appears to be a Chicago Specialty brand faucet. Faucet and operating handle connections on the underside of the sink contain brass fittings and a brass tee. Other connecting plumbing in the cabinet under the sink may contain additional brass components.

Replacement of this faucet and its connecting plumbing with lead-free materials will significantly reduce lead exposure at this location. If replacement is not currently feasible, sample results indicate that flushing this tap for three minutes following periods of stagnation is likely to reduce lead concentrations and lead exposure.

This faucet also has an aerator/screen at the outlet. If the faucet is not replaced, the aerator/screen should be removed, inspected for particulate accumulations, scrubbed clean, and reinstalled. If particulates are found, the aerator/screen should be periodically checked and cleaned.

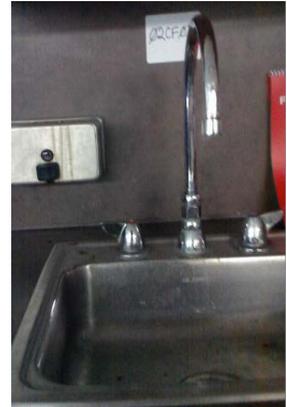
Location: Classroom 258

**Outlet: Sink Faucet (02CF019)**

Results: P1=10 parts per billion, P2=24 parts per billion

F01=2 parts per billion, F02=1 part per billion

These results suggest the highest contribution of lead may be from the faucet and its connecting plumbing. This appears to be a Chicago Specialty brand faucet. Faucet and operating handle connections on the underside of the sink contain brass fittings and a brass tee. Other connecting plumbing in the cabinet under the sink may contain additional brass components.

Replacement of this faucet and its connecting plumbing with lead-free materials will significantly reduce lead exposure at this location. If replacement is not currently feasible, sample results indicate that flushing this tap for three minutes following periods of stagnation is likely to reduce lead concentrations and lead exposure.

This faucet also has an aerator/screen at the outlet. If the faucet is not replaced, the aerator/screen should be removed, inspected for particulate accumulations, scrubbed clean, and reinstalled. If particulates are found, the aerator/screen should be periodically checked and cleaned.

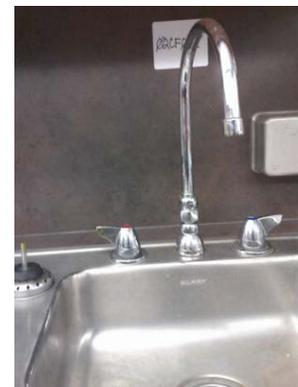
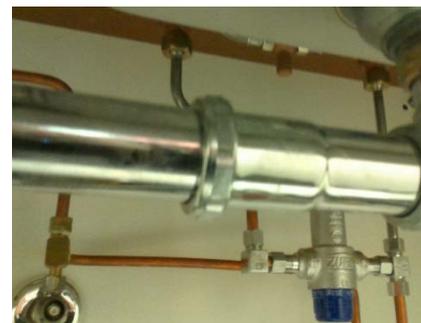
Location: Classroom 257

**Outlet: Sink Faucet (02CF021)**

Results: P1=17 parts per billion, P2=18 parts per billion

F01=2 parts per billion, F02=1 part per billion

These results suggest the highest contribution of lead may be from the faucet and its connecting plumbing. This appears to be a Chicago Specialty brand faucet. Faucet and operating handle connections on the underside of the sink contain brass fittings and a brass tee. Other connecting plumbing in the cabinet under the sink contains some additional brass components.

Replacement of this faucet and its connecting plumbing with lead-free materials will significantly reduce lead exposure at this location. If replacement is not currently feasible, sample results indicate that flushing this tap for three minutes following periods of stagnation is likely to reduce lead concentrations and lead exposure.

This faucet also has an aerator/screen at the outlet. If the faucet is not replaced, the aerator/screen should be removed, inspected for particulate accumulations, scrubbed clean, and reinstalled. If particulates are found, the aerator/screen should be periodically checked and cleaned.

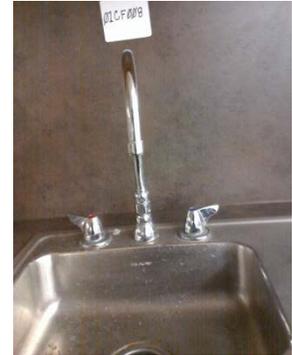
Location: Classroom 156

**Outlet: Sink Faucet (01CF008)**

Results: P1=11 parts per billion, P2=35 parts per billion

F01=4 parts per billion, F02=2 parts per billion

These results suggest the highest contribution of lead may be from the faucet and its connecting plumbing. This appears to be a Chicago Specialty brand faucet. Faucet and operating handle connections on the underside of the sink contain brass fittings and a brass tee. Other connecting plumbing in the cabinet under the sink may contain additional brass components.

Replacement of this faucet and its connecting plumbing with lead-free materials will significantly reduce lead exposure at this location. If replacement is not currently feasible, sample results indicate that flushing this tap for three minutes following periods of stagnation is likely to reduce lead concentrations and lead exposure.

This faucet also has an aerator/screen at the outlet. If the faucet is not replaced, the aerator/screen should be removed, inspected for particulate accumulations, scrubbed clean, and reinstalled. If particulates are found, the aerator/screen should be periodically checked and cleaned.

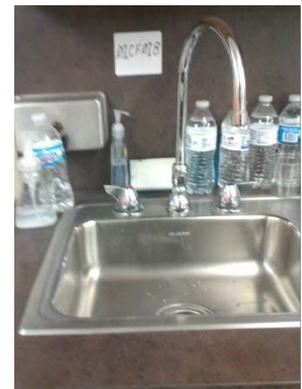
Location: Classroom 155

**Outlet: Sink Faucet (01CF018)**

Results: P1=9 parts per billion, P2=16 parts per billion,

F01=3 parts per billion, F02=3 parts per billion

These results suggest the highest contribution of lead may be from the faucet and its connecting plumbing. This appears to be a Chicago Specialty brand faucet. Faucet and operating handle connections on the underside of the sink contain brass fittings and a brass tee. Other connecting plumbing in the cabinet under the sink contains some additional brass components.

Replacement of this faucet and its connecting plumbing with lead-free materials will significantly reduce lead and exposure at this location. If replacement is not currently feasible, sample results indicate that flushing this tap for three minutes following periods of stagnation is likely to reduce lead concentrations and lead exposure.

This faucet also has an aerator/screen at the outlet. If the faucet is not replaced, the aerator/screen should be removed, inspected for particulate accumulations, scrubbed clean, and reinstalled. If particulates are found, the aerator/screen should be periodically checked and cleaned.

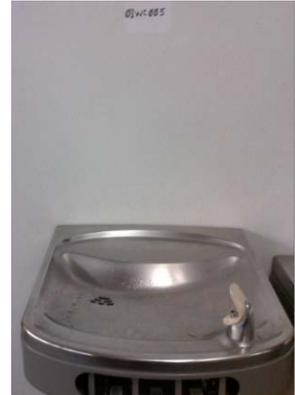
Location: Hallway, Outside Bathroom

### Outlet: Water Cooler Fountain (01WC005)

Results: P1=12 parts per billion, P2=15 parts per billion  
F01=16 parts per billion, F02=4 parts per billion

These results suggest the highest contribution of lead may be from the water cooler unit. The water cooler is an Elkay brand. This cooler contains some brass components. Connecting plumbing to the cooler unit may also contain brass components.

Replacement of the entire unit is recommended and will significantly reduce lead exposure at this location. If replacement is not currently feasible, sample results indicate that flushing this tap for three minutes following periods of stagnation is likely to reduce lead concentrations and lead exposure.

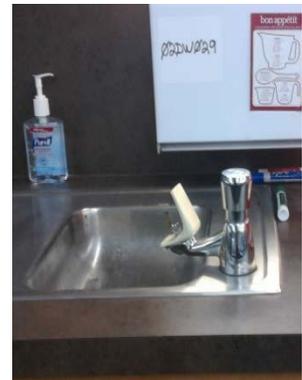
Location: Classroom 254

### Outlet: Bubbler Fountain (02DW029)

Results: P1=23 parts per billion, P2=52 parts per billion  
F01=2 parts per billion, F02=1 part per billion

These results suggest the highest contribution of lead may be from the bubbler and its connecting plumbing. This bubbler fixture is made of chrome-plated brass and has a brass connector on the underside of the sink. Connecting plumbing in the cabinet under the sink should be checked for brass components and copper piping with lead solder.

Replacement of this bubbler tap and its connecting plumbing with lead-free materials will significantly reduce lead exposure at this location. If replacement is not currently feasible, sample results indicate that flushing this tap for three minutes following periods of stagnation is likely to reduce lead concentrations and lead exposure.

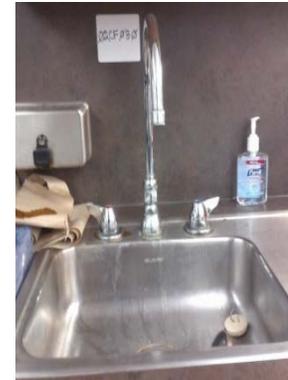
Location: Classroom 254

**Outlet: Sink Faucet (02CF030)**

Results: P1=13 parts per billion, P2=17 parts per billion,  
F01=2 parts per billion, F02=2 parts per billion

These results suggest the highest contribution of lead may be from the faucet and its connecting plumbing. This appears to be a Chicago Specialty brand faucet. Faucet and operating handle connections on the underside of the sink contain brass fittings and a brass tee. Other connecting plumbing in the cabinet under the sink contains some additional brass components.

Replacement of this faucet and its connecting plumbing with lead-free materials will significantly reduce lead exposure at this location. If replacement is not currently feasible, sample results indicate that flushing this tap for three minutes following periods of stagnation is likely to reduce lead concentrations and lead exposure.

This faucet also has an aerator/screen at the outlet. If the faucet is not replaced, the aerator/screen should be removed, inspected for particulate accumulations, scrubbed clean, and reinstalled. If particulates are found, the aerator/screen should be periodically checked and cleaned.

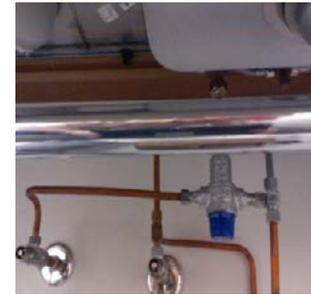
Location: Classroom 253

### Outlet: Sink Faucet Right (02CF032)

Results: P1=15 parts per billion, P2=20 parts per billion

F01=3 parts per billion, F02=2 parts per billion

These results suggest the highest contribution of lead may be from the faucet and its connecting plumbing. This appears to be a Chicago Specialty brand faucet. Faucet and operating handle connections on the underside of the sink contain brass fittings and a brass tee. Other connecting plumbing in the cabinet under the sink contains some additional brass components.

Replacement of this faucet and its connecting plumbing with lead-free materials will significantly reduce lead exposure at this location. If replacement is not currently feasible, sample results indicate that flushing this tap for three minutes following periods of stagnation is likely to reduce lead concentrations and lead exposure.

This faucet also has an aerator/screen at the outlet. If the faucet is not replaced, the aerator/screen should be removed, inspected for particulate accumulations, scrubbed clean, and reinstalled. If particulates are found, the aerator/screen should be periodically checked and cleaned.

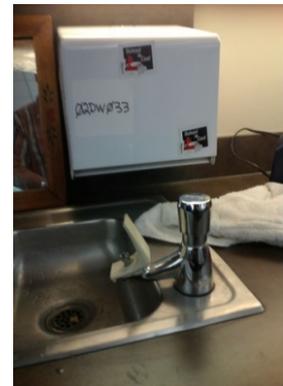
Location: Classroom 252

### Outlet: Bubbler Fountain (02DW033)

Results: P1=11 parts per billion, P2=16 parts per billion

F01=2 parts per billion, F02=2 parts per billion

These results suggest the highest contribution of lead may be from the bubbler and its connecting plumbing. Parts of this bubbler fixture are made of brass, with a brass connector on the underside of the sink. Connecting plumbing in the cabinet under the sink is partly made up of brass connectors, copper piping with lead solder, and a brass shut-off valve.

Replacement of this bubbler tap and its connecting plumbing with lead-free materials will significantly reduce lead exposure at this location. If replacement is not currently feasible, sample results indicate that flushing this tap for three minutes following periods of stagnation is likely to reduce lead concentrations and lead exposure.

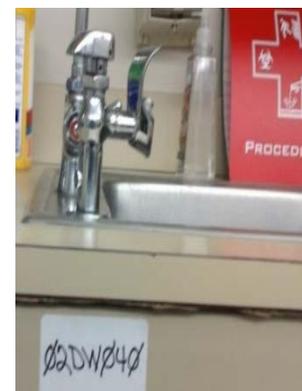
Location: Classroom 260

### Outlet: Bubbler Fountain (02DW040)

Results: P1=85 parts per billion, P2=29 parts per billion

F01=18 parts per billion, F02=15 parts per billion

These results suggest the highest contribution of lead may be from the bubbler and its connecting plumbing. This bubbler fixture is made of chrome-plated brass, with a brass connector on the underside of the sink. Connecting plumbing in the cabinet under the sink is made up of brass connectors, copper piping with lead solder, and a brass shut-off valve.

Replacement of this bubbler tap and its connecting plumbing with lead-free materials will significantly reduce lead exposure at this location. If replacement is not currently feasible, sample results indicate that flushing this tap for three minutes following periods of stagnation is likely to reduce lead concentrations and lead exposure.

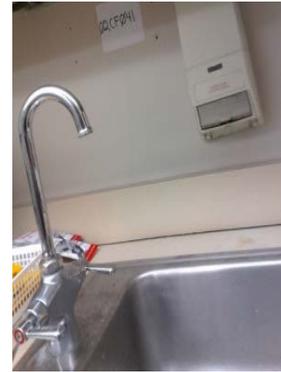
Location: Classroom 262

**Outlet: Sink Faucet (02CF041)**

Results: P1=340 parts per billion, P2=132 parts per billion  
F01=16 parts per billion, F02=8 parts per billion

These results suggest the highest contribution of lead may be from the faucet and its connecting plumbing. This appears to be a Chicago Specialty brand faucet. The base of this faucet is chrome-plated brass, with a brass connection on the underside of the sink. Hot and cold water lines connect to this faucet with a brass mixer fitting under the sink. Connecting plumbing in the cabinet under the sink also contains additional brass connectors, copper plumbing with lead solder, and brass shut-off valves.

Replacement of this faucet and its connecting plumbing with lead-free materials will significantly reduce lead exposure at this location. If replacement is not currently feasible, sample results indicate that flushing this tap for three minutes following periods of stagnation is likely to reduce lead concentrations and lead exposure.

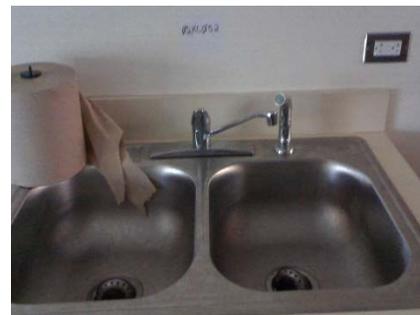
Location: Teachers' Lounge

**Outlet: Kitchen Sink Faucet (02KC052)**

Results: P1=11 parts per billion, P2=20 parts per billion

F01=6 parts per billion, F02=1 part per billion

These results suggest the highest contribution of lead may be from the faucet and its connecting plumbing. This appears to be a Delta 350 model faucet. This style faucet has a single-handle mixing valve that may allow mixing of hot and cold water. Connecting plumbing for this faucet should be checked for additional lead-containing components, including brass fittings and brass valves.

Replacement of this faucet and its connecting plumbing with lead-free materials will significantly reduce lead exposure at this location. If replacement is not currently feasible, sample results indicate that flushing this tap for three minutes following periods of stagnation is likely to reduce lead concentrations and lead exposure.

This faucet also has an aerator/screen at the outlet. If the faucet is not replaced, the aerator/screen should be removed, inspected for particulate accumulations, scrubbed clean, and reinstalled. If particulates are found, the aerator/screen should be periodically checked and cleaned.

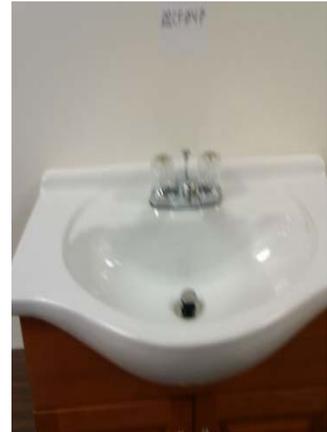
Location: Classroom 111

**Outlet: Sink Faucet (01CF047)**

Results: P1=22 parts per billion, P2=3 parts per billion

F01=2 parts per billion, F02=non-detect

These results suggest the highest contribution of lead may be from the faucet and its connecting plumbing. This faucet may contain brass components. Connecting plumbing for this faucet should be checked for additional lead-containing components, including brass fittings and brass valves.

Replacement of this faucet and its connecting plumbing with lead-free materials will significantly reduce lead exposure at this location. If replacement is not currently feasible, sample results indicate that flushing this tap for three minutes following periods of stagnation is likely to reduce lead concentrations and lead exposure.

This faucet also has an aerator/screen at the outlet. If the faucet is not replaced, the aerator/screen should be removed, inspected for particulate accumulations, scrubbed clean, and reinstalled. If particulates are found, the aerator/screen should be periodically checked and cleaned.

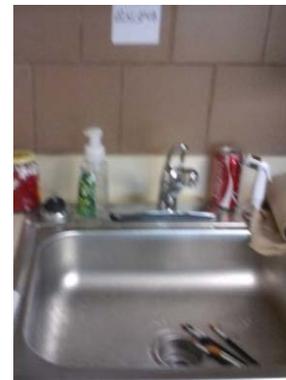
Location: Classroom 110, North Wall

**Outlet: Sink Faucet Left (01KC048)**

Results: P1=21 parts per billion, P2=23 parts per billion

F01=5 parts per billion, F02=5 parts per billion

These results suggest the highest contribution of lead may be from the faucet and its connecting plumbing. This appears to be a Moen brand faucet. The base deck of this faucet contains brass components. This style faucet also has a single-handle mixing valve that may allow mixing of hot and cold water. Connecting plumbing for this faucet should be checked for additional lead-containing components, including brass fittings and brass valves.

Replacement of this faucet and its connecting plumbing with lead-free materials will significantly reduce lead exposure at this location. If replacement is not currently feasible, sample results indicate that flushing this tap for three minutes following periods of stagnation is likely to reduce lead concentrations and lead exposure.

This faucet also has an aerator/screen at the outlet. If the faucet is not replaced, the aerator/screen should be removed, inspected for particulate accumulations, scrubbed clean, and reinstalled. If particulates are found, the aerator/screen should be periodically checked and cleaned.

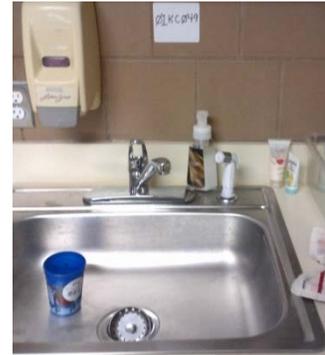
Location: Classroom 110, North Wall

### Outlet: Sink Faucet Right (01KC049)

Results: P1=11 parts per billion, P2=21 parts per billion  
F01=4 parts per billion, F02=10 parts per billion

These results suggest the highest contribution of lead may be from the faucet and its connecting plumbing. This appears to be a Moen brand faucet. The base deck of this faucet contains brass components. This style faucet also has a single-handle mixing valve that may allow mixing of hot and cold water. Connecting plumbing for this faucet should be checked for additional lead-containing components, including brass fittings and brass valves.

Replacement of this faucet and its connecting plumbing with lead-free materials will significantly reduce lead exposure at this location. If replacement is not currently feasible, sample results indicate that flushing this tap for three minutes following periods of stagnation is likely to reduce lead concentrations and lead exposure.

This faucet also has an aerator/screen at the outlet. If the faucet is not replaced, the aerator/screen should be removed, inspected for particulate accumulations, scrubbed clean, and reinstalled. If particulates are found, the aerator/screen should be periodically checked and cleaned.
