STATE OF MICHIGAN
DEPARTMENT OF HEALTH AND HUMAN SERVICES
LANSING

April 4, 2018

This letter is in response to your request for a public health evaluation of the asbestos in the area surrounding the C&H Mineral Building, located at 52986 Highway M-26 in Hubbell, Houghton County, Michigan.

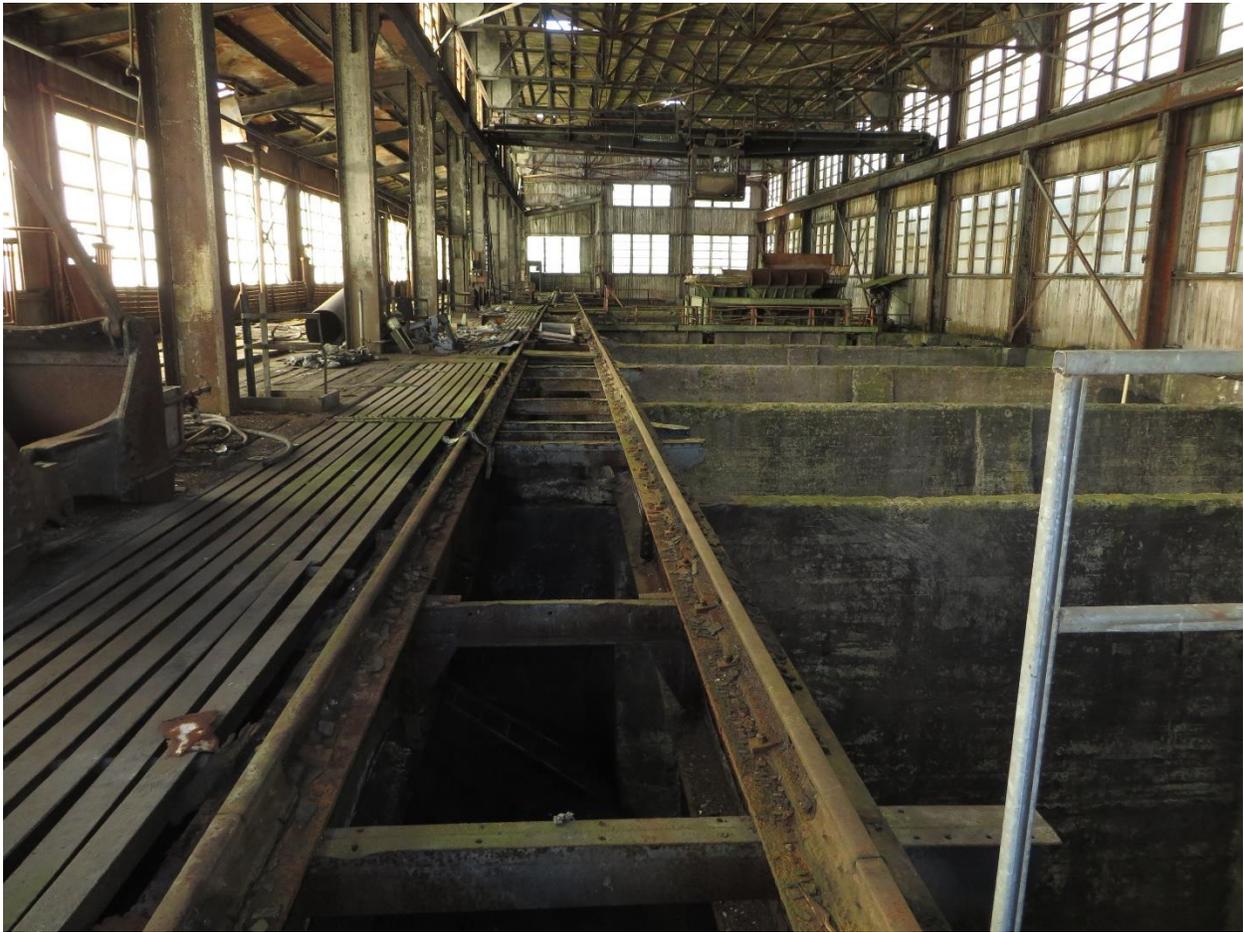
- The Mineral Building itself has pits (former mineral storage bins) that are 20 feet below the floor. The floor also appears uneven and has debris and material from former uses. See photo 1 and 2.

Photo 1: Mineral Building interior, looking southwest, with the bins (pits) on the right (MDEQ 2014)

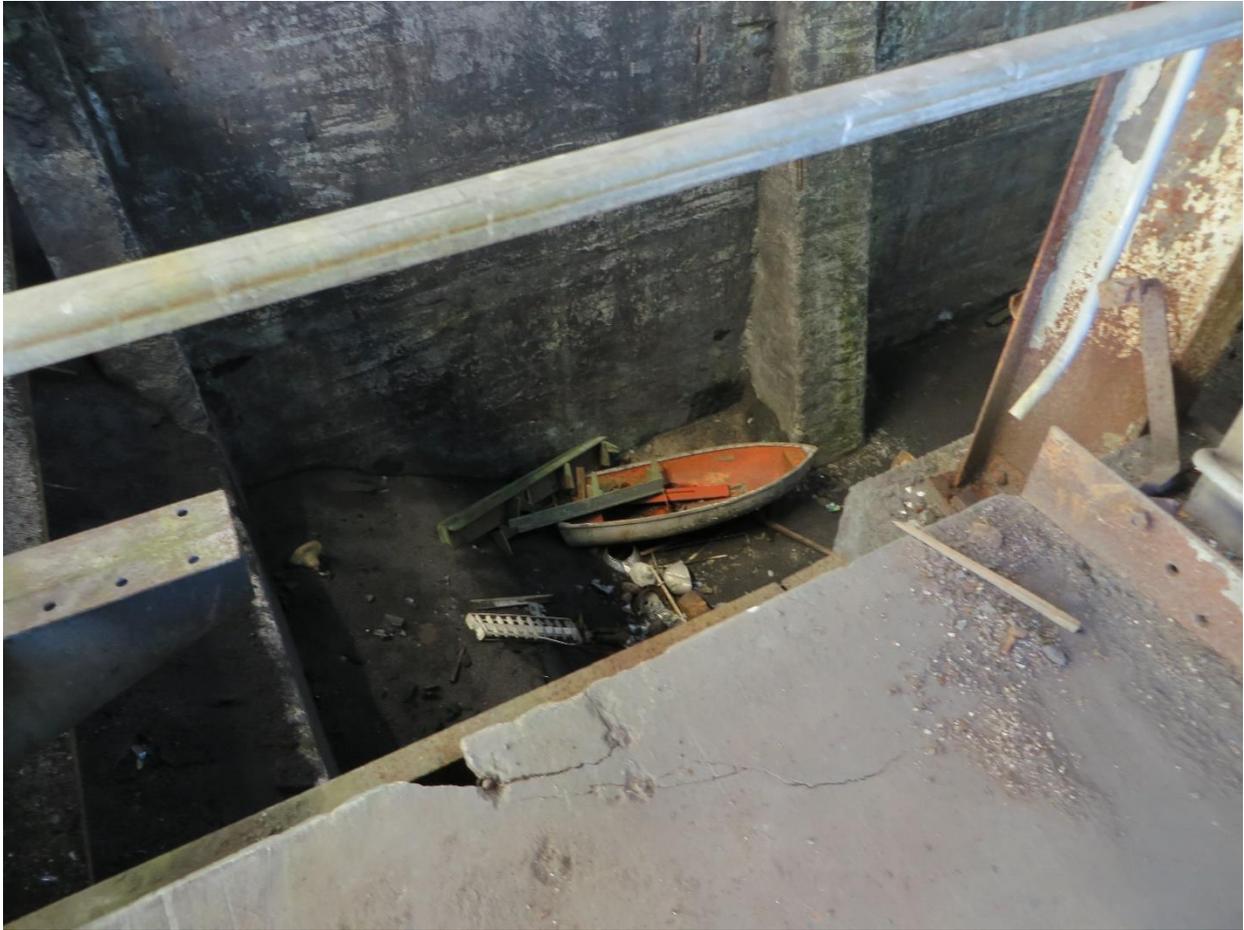
Photo 2: Mineral Building interior, boat in bin (pit) (MDEQ 2014)
