Appendix F – Road Safety Audit

**Downtown Kalamazoo – Stadium Drive, Michigan
Avenue, Kalamazoo Avenue and Michikal Street (I-94
BL/US-131 BR/M-43)
(Southwest Region)**

Road Safety Audit (JN 127117)

FINAL REPORT

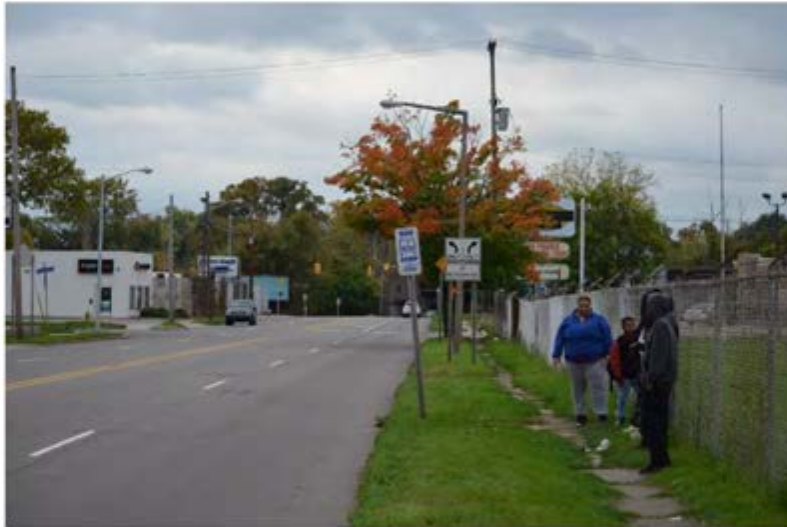
- The bus stop on Riverview Drive near Hotop Avenue suffers from a wide variety of safety deficiencies, as represented in the image below taken on foot during the field review. Immediately apparent is the poor condition of the sidewalk. Additionally, missing entirely is a marked crosswalk, there are no ADA-compliant ramps in the vicinity of the area, and most of the area is unlighted.

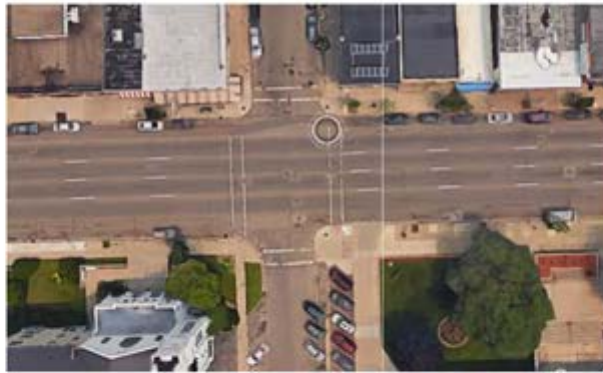
- At the intersection of West Michigan Avenue and Church Street, a number of issues were observed which were detrimental to pedestrian safety. The sidewalk was in very poor condition, the sidewalk ramps were not ADA compliant, and there were no pedestrian crossing signs. These issues are exacerbated by the nature of the location of the unsignalized intersection on a high-speed multi-lane corridor.

- Install curb extensions as seen in the image below to reduce the current crossing distance from approximately 73' to 50' or less. The less time pedestrians spend in uncontrolled vehicle travel lanes greatly improves the probability of a safe crossing maneuver.
- Create a high visibility crossing fit with special emphasis "ladder-style" pavement markings and W11-2 "Pedestrian Traffic" signs to increase driver awareness that pedestrians may attempt to cross at the location.

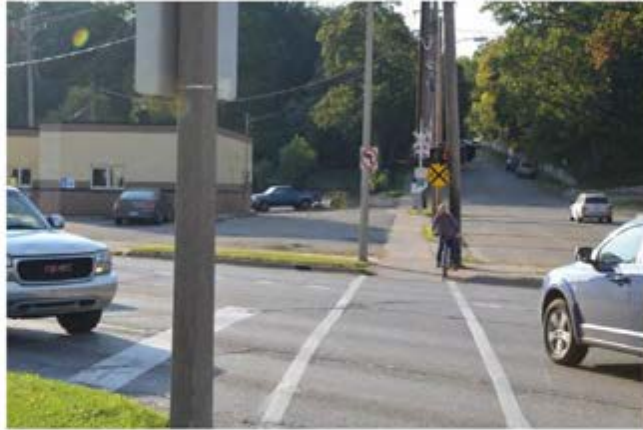
5.1C Crash Potential #1 (Risk Category E) – Pedestrian Safety
West Michigan Avenue at Lovell Street Pedestrian Crossing

- Due to the geometric configuration and traffic operation of the intersection, pedestrians crossing east-west on the south leg of the intersection may find it difficult to find a gap to cross against westbound left-turning vehicle traffic.

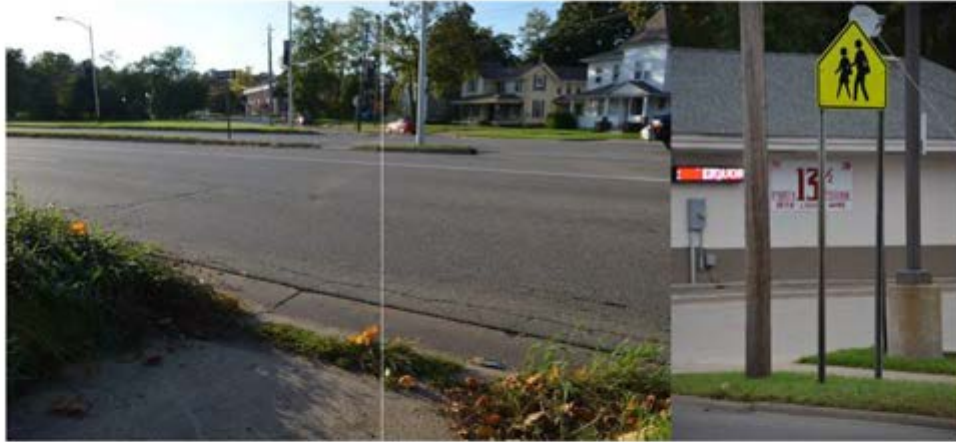
- At intersections and midblock crossing locations in the vicinity of the campuses of Western Michigan University and Kalamazoo College, as well as other schools, the crossing locations are either completely unmarked or striped with only the standard 6"-width longitudinal lines.

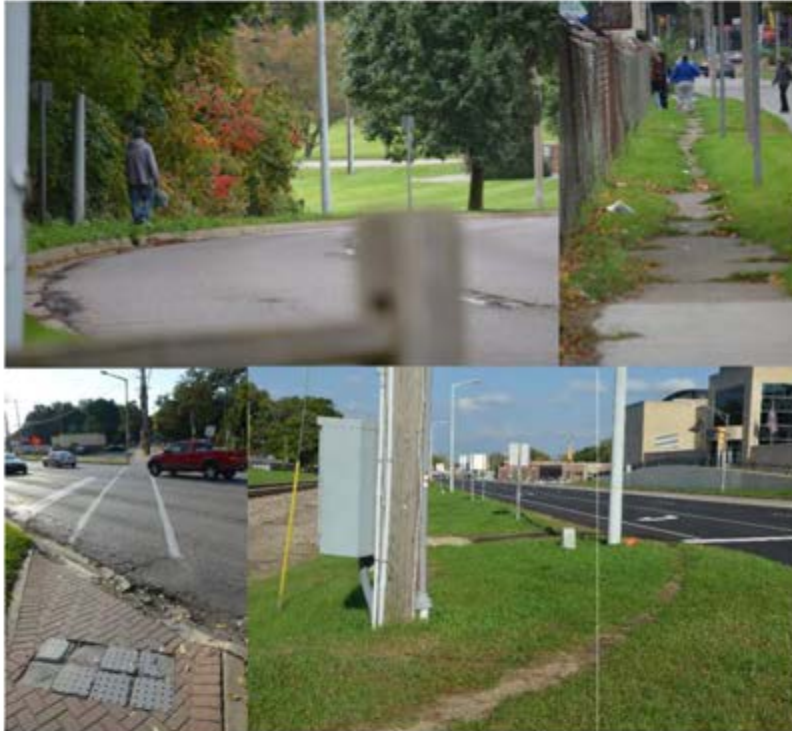
- Throughout the study region, the RSA team observed and noted numerous instances of missing, substandard, disconnected or deteriorated pedestrian facilities, with some notable examples shown below.

- Create an asset management program to take inventory of all pedestrian facilities and assess the condition of such features. Maintain compliant existing pedestrian facilities, upgrade those which don't meet ADA standards and install missing components.
- Ensure that existing or planned pedestrian facilities are connected in a safe and consistent manner.

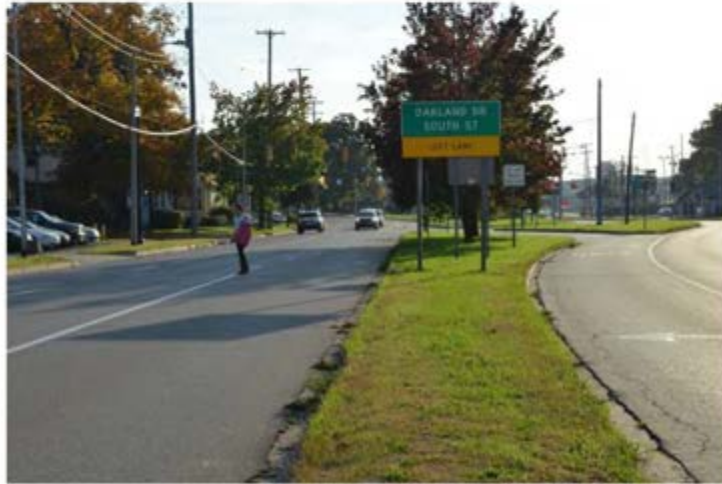
- The RSA team observed a number of occurrences of jaywalking. Particularly on Riverview Drive near Hotop Avenue and in the “Spaghetti Bowl” area near Oliver Street, South Street and Stadium Drive/West Michigan Avenue (which was an area pinpointed during the pre-RSA meeting by a member in attendance).

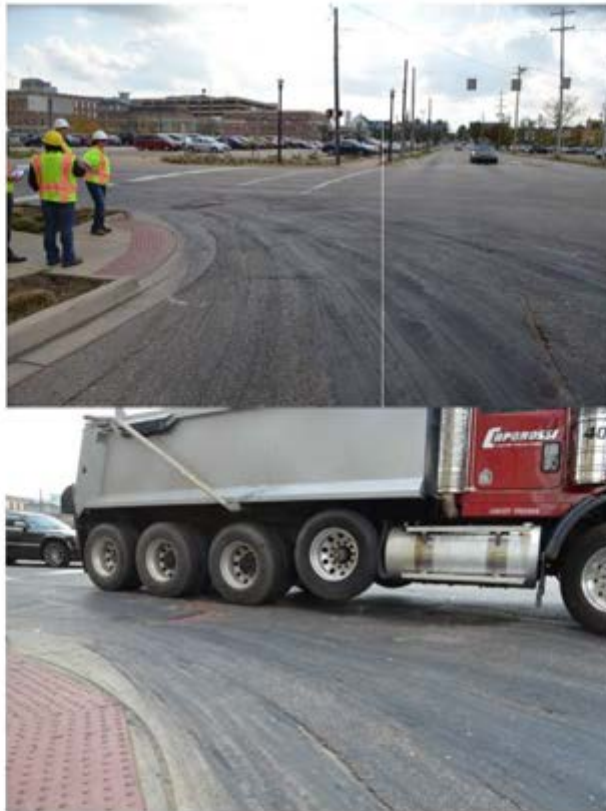
5.1G Crash Potential #1 (Risk Category E) – Pedestrian Safety
Pavement Condition at Kalamazoo Avenue at Parks Street

- The RSA team observed pronounced pavement rutting on the northeast corner of the intersection of Kalamazoo Avenue at Park Street. This is an undesirable situation as it makes navigating the crossing difficult for pedestrians with physical disabilities. Even those without a physical impairment may find the road difficult to traverse if the rutted pavement holds water and/or ice during inclement weather.

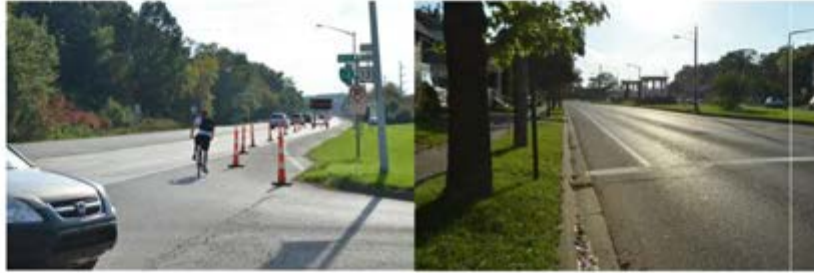
5.2A Crash Potential #2 (Risk Category E) – Bikes
Lack of Bicycle Facilities

- There does not exist a dedicated non-motorized path that connects Howard Street to Riverview Drive. The current non-motorized features are sporadic with variations between pathways, sidewalk or no features.

- Create a Non-Motorized Master Plan which performs a thorough origin-destination study and ultimately produces a recommendation for a fully-connected, non-motorized path from Howard Street, through Downtown, and across to the neighborhoods near Riverview Drive.

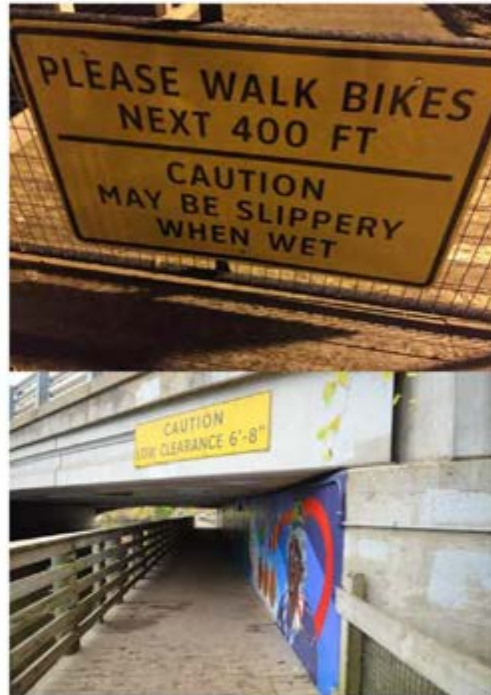
- Low clearance underneath the bridge over the Kalamazoo River on East Michigan Avenue creates an unsafe situation for cyclists utilizing the pedestrian bridge, especially considering the lack of lighting and inadequate advance warning.

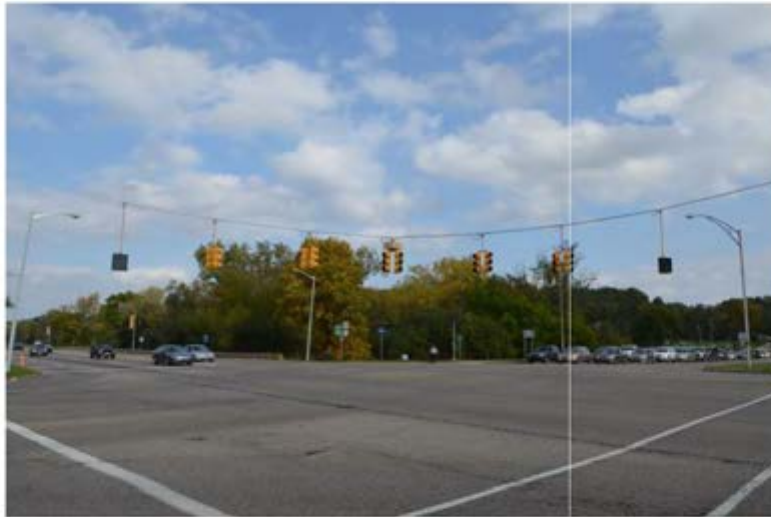
- Numerous signalized intersections were constructed as diagonal span and/or lacked countdown pedestrian signals.

- Modernize all signals which are deficient to a box span design with countdown pedestrian signals, ADA ramps, and pushbuttons. The box span design has been shown to reduce the frequency of red-light running by making the signals easier to see. The box span design also improves the safety of maintenance workers by moving the maintenance operation out of the middle of the intersection.
- Consult with a Mobility Specialist to determine if audible pushbuttons are needed.
- If the funding is available, consider incorporating mast arms with lighted street names in the box span design. The mast arms are an aesthetic improvement, while the lighted street names will enhance navigation of the study region.

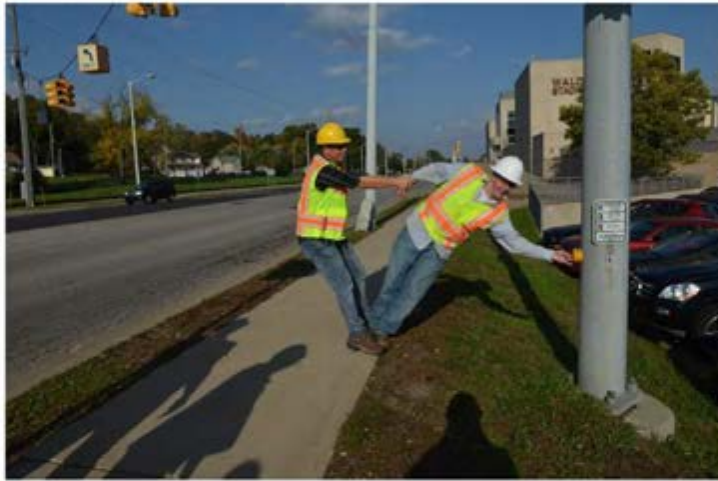
- At many signalized intersections, pedestrian pushbuttons are not ADA compliant, either due to lateral distance from ramps or vertical distance from grade.

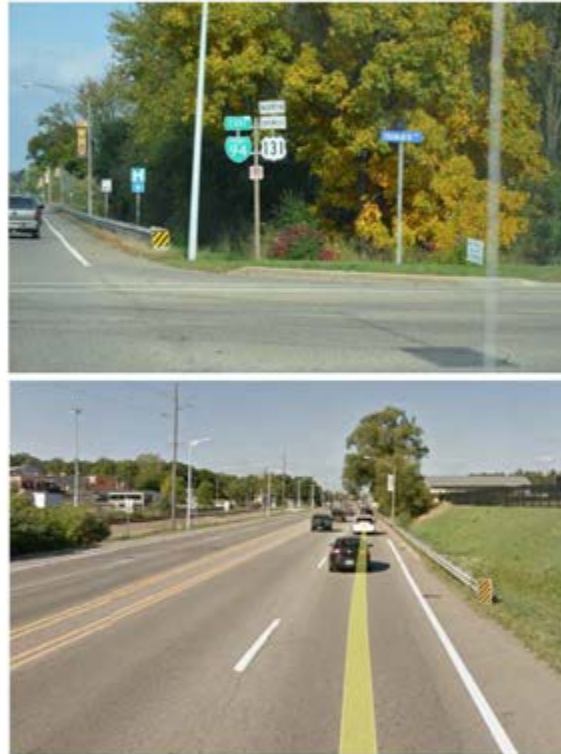
- Along Stadium Drive, the edge of pavement varies between paved shoulder and curb, and guardrail or no guardrail. This creates a situation where cyclists riding on the shoulder may run out of space to ride on the shoulder, which may cause them to ride on the wrong side of the road.

- Provide a consistent shoulder treatment along Stadium Drive to accommodate travel expectations of cyclists utilizing the road. This recommendation coincides with an earlier suggestion to produce a city-wide Non-Motorized Master Plan.

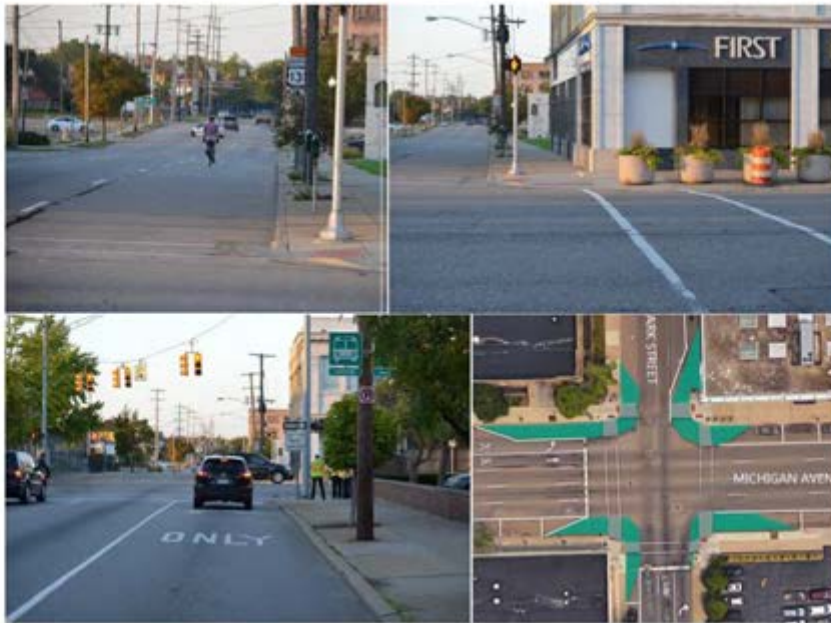
- According to city officials as noted at the pre-RSA meeting, there is a crash pattern regarding vehicles striking the building at the northeast quadrant of the intersection of West Michigan Avenue at Park Street. As seen in the images below, this crash pattern may be attributed to the lane alignment on Park Street heading northbound. The northbound rightmost lane is marked as "RIGHT ONLY"; however, looking ahead, the rightmost lane is striped as a through travel lane. Vehicles are likely attempting to travel through from the right turn lane and conflicting with vehicles attempting to change lanes from the adjacent through lane, causing them to swerve and hit the building.

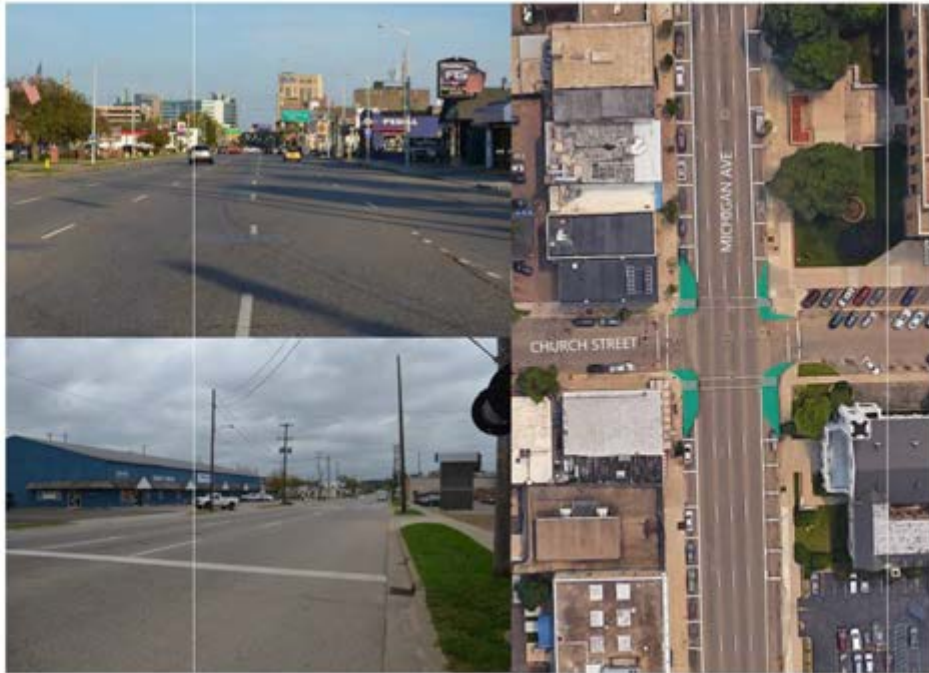
- At many locations, particularly along Kalamazoo Avenue between Walbridge Street and Pitcher Street, along East Michigan Avenue between Pitcher Street and Walbridge Street, and along West Michigan Avenue between Westnedge Avenue and Kalamazoo Mall, extra wide lane widths and lack of delineation between travel lanes and parking spaces creates a confusing situation for motorists as to the desired travel path. This is likely a major contributing factor to the high frequency of sideswipe crashes in the study region.

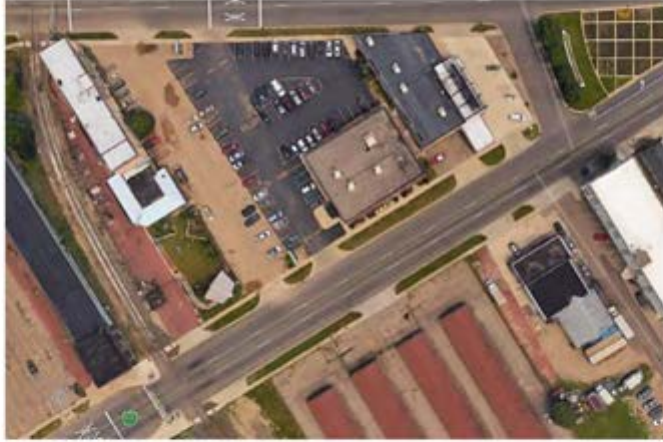
- An excessive amount of pavement on East Michigan Avenue east of Pitcher Street and past both sets of railroad crossings creates a situation where motorists may drift out of position and sideswipe adjacent vehicles.

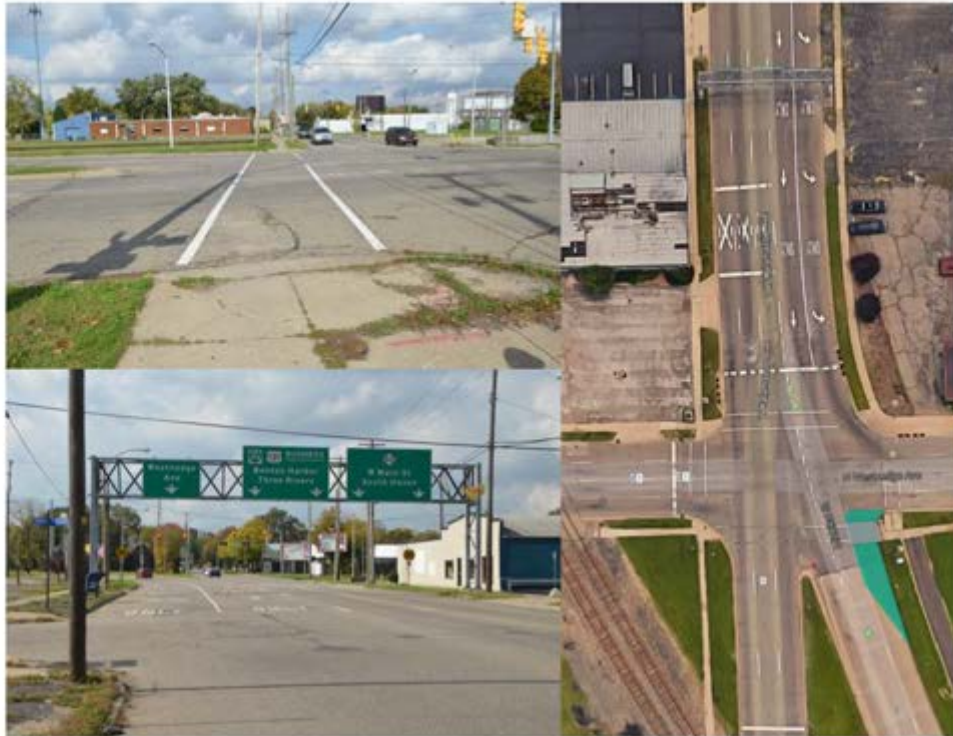
- At the intersection of Kalamazoo Avenue and Westnedge Avenue and Michikal Street, the geometric configuration and overhead lane assignment signs create a situation where it is unclear to the motorist which is the desired travel lane. Lane assignment confusion can result in sideswipe and/or fixed object collisions.
- The geometry of the intersection on the west leg is such that a pedestrian must traverse approximately 90' of pavement to cross the road. As noted earlier in the report, long crossing distances increase the likelihood of a potentially severe vehicle-pedestrian collision.

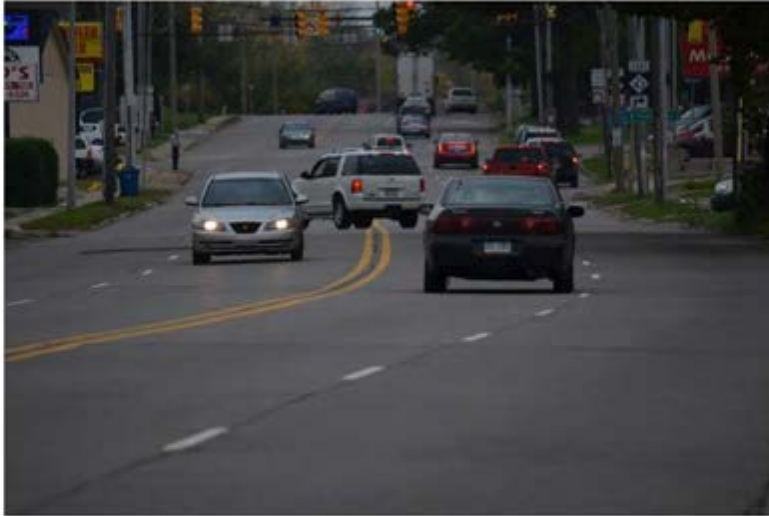
- Riverview Drive is presently a four-lane, undivided urban roadway. These types of roads commonly exhibit higher than expected crash rates due to the high number of conflict points and poor sight distances for turning and crossing vehicles along the street.

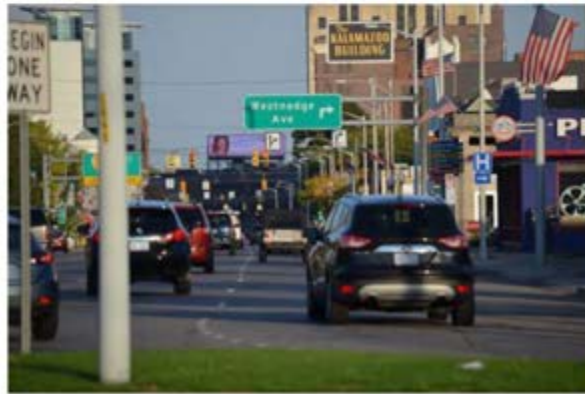
- The current geometric configuration of the intersection of West Michigan Avenue/West Main Street and Michikal Street promotes the weaving of vehicles as motorists heading westbound from West Main Street attempt to position themselves to turn right onto Westnedge Avenue (the next major intersection and M-route) conflict with motorists heading west from the south leg who try to leave the right turn lanes. Weaving vehicles are symptomatic of sideswipe collisions.

- Construct a curb extension on the south side of West Michigan Avenue just past the intersection to separate the parking spaces from the travel lane and stripe the parking spaces.
- Study traffic patterns to modify the geometry and striping of the intersection such that vehicles turning right from the south leg of the intersection are routed to the middle through lanes rather than the option lane and right turn lane.

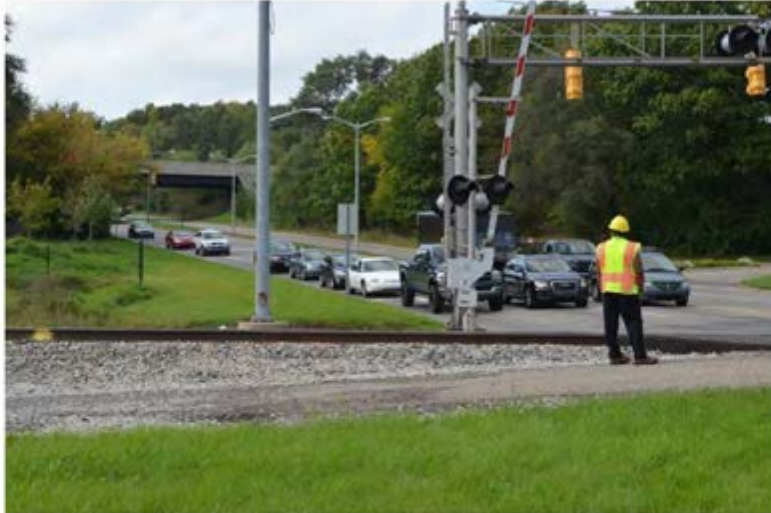
**5.5A Crash Potential #5 (Risk Category D) – Railroad and Fencing
Howard Street Bus Stop**

- Near the intersection of Stadium Drive and Howard Street, the fencing protecting pedestrians from crossing the railroad tracks is located too far west of the tracks, so as to be ineffective.

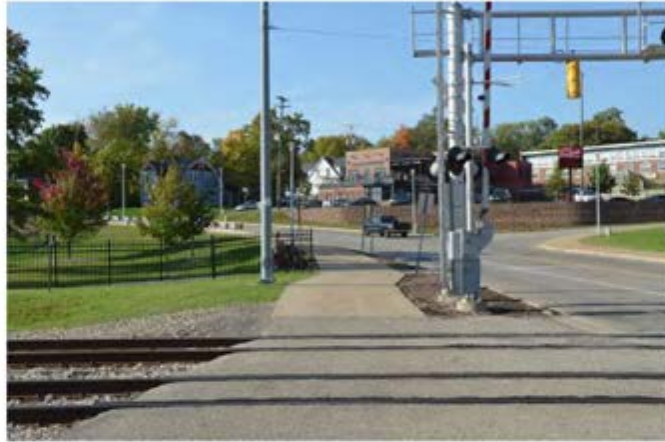
- None of the railroad crossing on West Michigan Avenue and Kalamazoo Avenue are protected by pedestrian crossing arms. This is especially concerning as these rails carry high-speed passenger trains.

- Add pedestrian crossing arms similar to those on Rose Street near Kalamazoo Avenue, as shown in the image below:

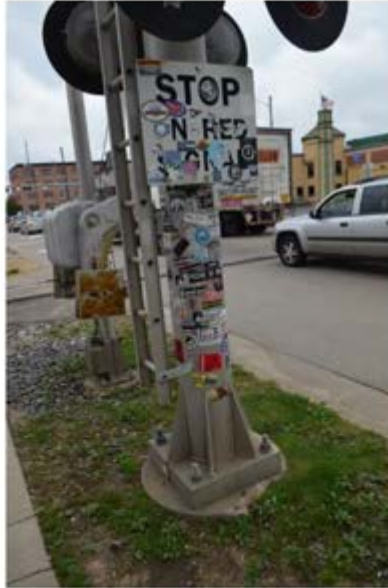
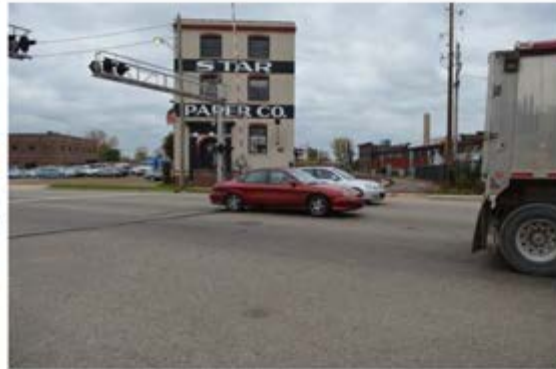
**5.5C Crash Potential #5 (Risk Category D) – Railroad and Fencing
Vehicles Stopping on Tracks**

- The RSA team observed a number of vehicles stopping on the railroad tracks crossing Kalamazoo Avenue just adjacent to Porter Street. Vehicles stopping on the tracks is a potentially dangerous situation in the case of a signal or vehicle malfunction.

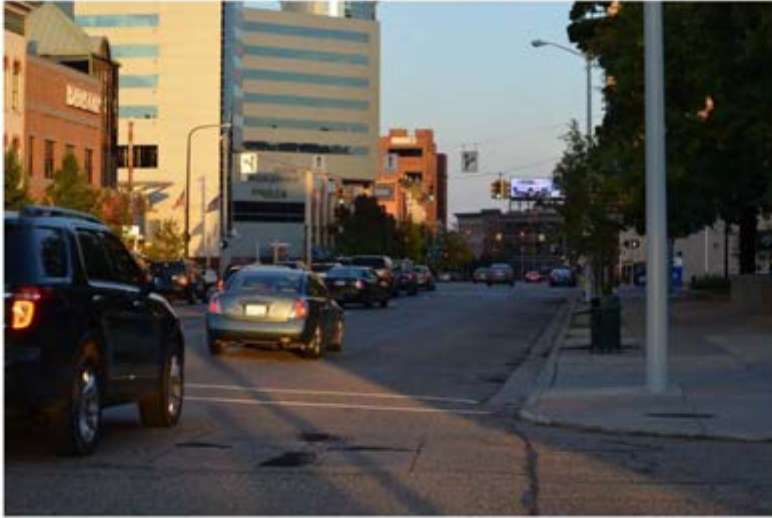
- Throughout the study region, the RSA team observed a widespread lack of parking space delineation and edge lines, which can induce sideswipe collisions as motorists are unaware of the proper travel path.

- For a short term solution, add pavement markings to delineate parking spaces and edge lines.
- In the long term, construct curb extensions (bump-outs) throughout parking areas (as depicted below) with marked parking stalls, for reasons described earlier in the report.

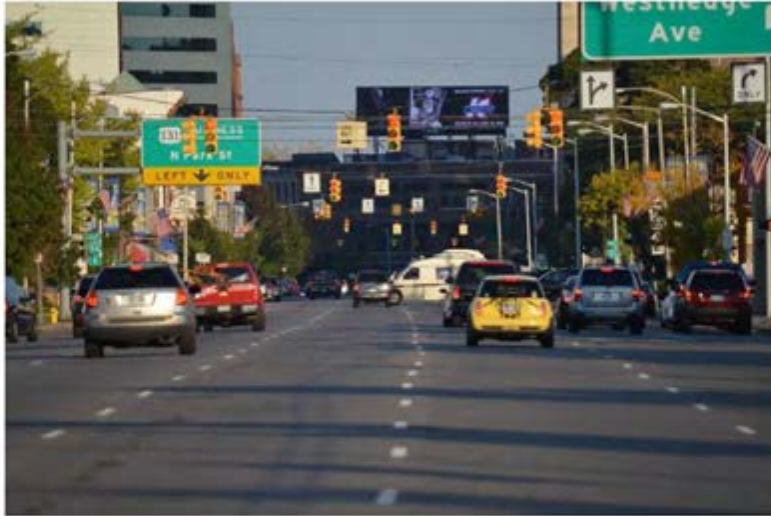
5.6B Crash Potential #6 (Risk Category D) – Pavement Markings
Unaligned Pavement Joints and Lane Lines

- At various locations along West Michigan Avenue, the pavement joints do not align with the lane lines, which can contribute to sideswipe collisions as motorists tend to follow the pavement joints, especially on wet or snow-covered pavement.

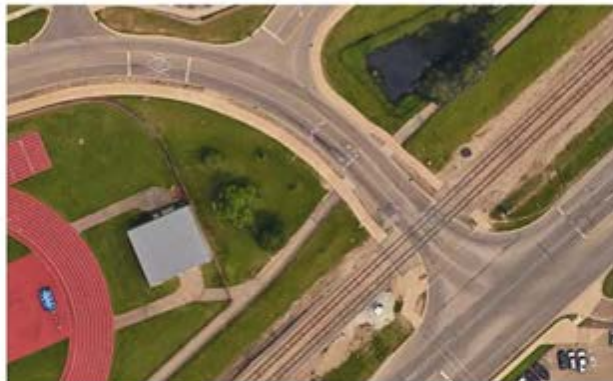
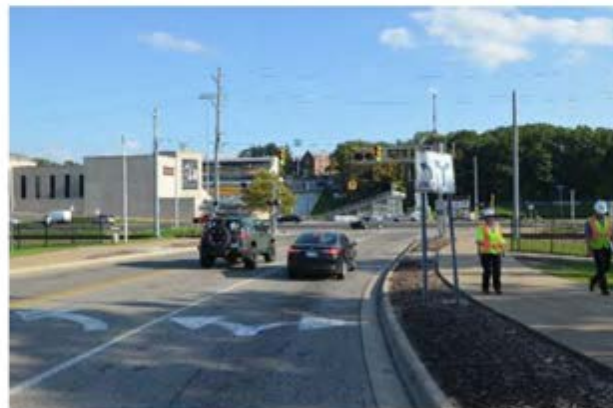
- On the West Michigan Avenue approach to the intersection, the turn symbol pavement markings are only located west of the railroad crossing, as shown in the image below. This could lead to lane assignment confusion and thus a sideswipe collision if the markings went unnoticed and the motorist made an incorrect turn at the intersection.

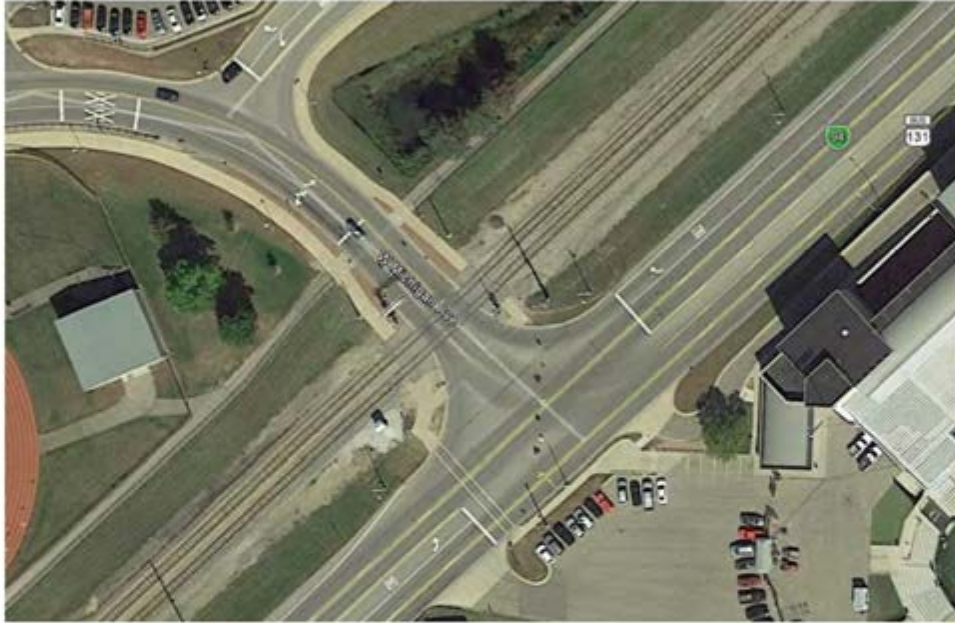
- Some of the study intersections have dual-left and dual-right turns without turning guide markings. Without these markings, motorists may have a tendency to drift into the adjacent lane, causing a sideswipe collision.

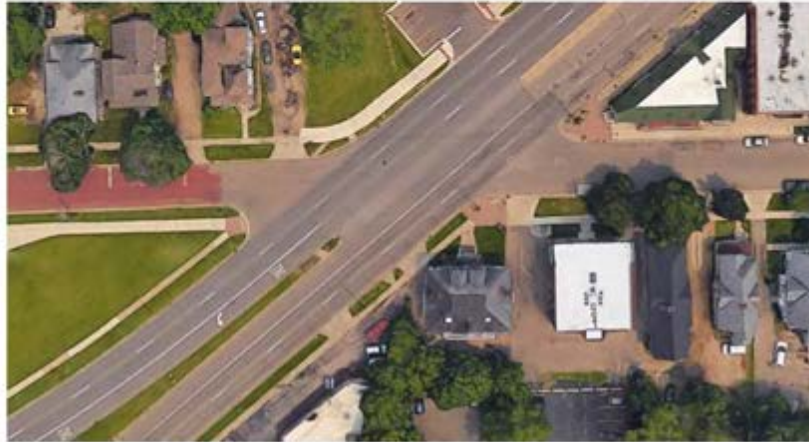
- At the intersection of West Michigan Avenue at Academy Street, the inside West Michigan Avenue approach lanes are unmarked and undivided and it is unclear where a motorist should position his or her vehicle to perform a left-turn to Academy Street from either direction. This situation likely increases the likelihood of both sideswipe and head-on collisions.

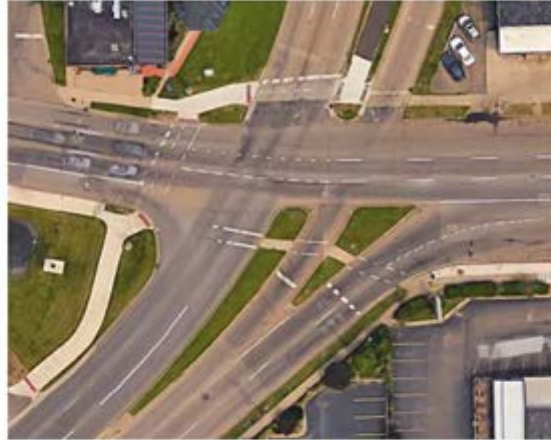
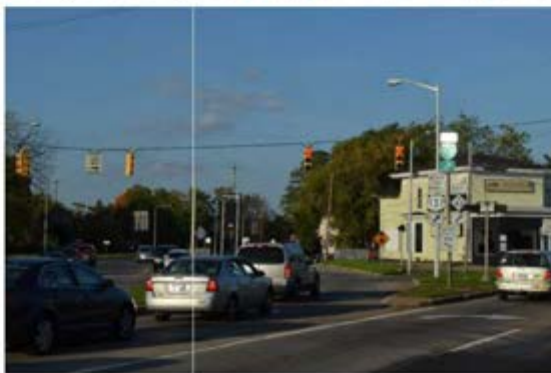
- At the intersection of West Michigan Avenue/West Main Street and Michikal Street, the correct travel path for northbound vehicles is unclear, which may lead to sideswipe or fixed object collisions. The lack of pavement markings may exacerbate the weaving traffic issue described in Section 5.4G.

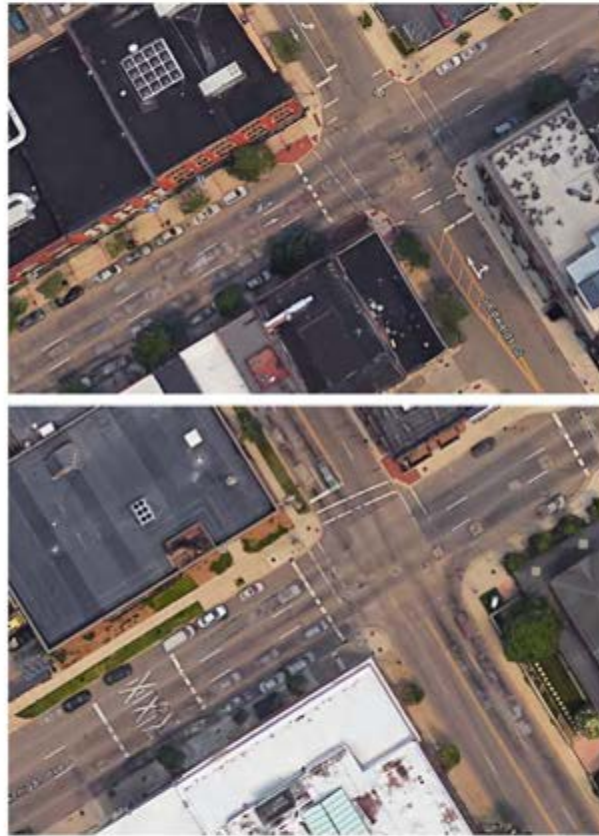
- Along West Michigan Avenue, the arrow symbol pavement markings are not consistent throughout the corridor. Some intersections have the arrow symbols, while others do not. This variation violates driver expectancy which can cause rear-end collisions due to speed variability, sideswipe collisions due to abrupt lane changes, or head-on collisions due to wrong-way travel.

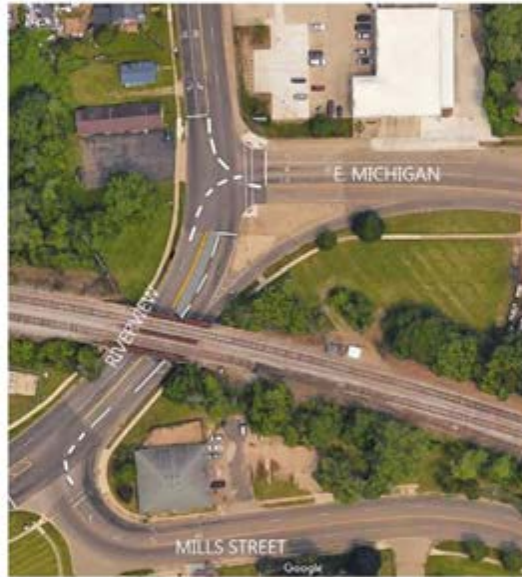
- A number of issues were observed on Riverview Drive between Mills Street and East Michigan Avenue, which include the following:
 - No turning guide markings for southbound Riverview Drive left turns at East Michigan Avenue, for westbound East Michigan Avenue left turns at Riverview Drive, and for westbound Mills Street right turns at Riverview Drive
 - Missing center skip lines on northbound Riverview Drive just north of Mills Street and below the railroad bridge
 - Lack of channelizing striping for the northbound Riverview Drive right turn to East Michigan Avenue
 - Narrow lanes around the curve underneath the railroad bridge

- Add turning guide pavement markings to keep vehicles in lane and further reduce the likelihood of a sideswipe collision.
- Restripe missing center skip lines with resilient pavement marking material to prolong the life of the markings against high heavy vehicle traffic volumes.
- Add channelizing striping for the northbound right turn movement onto East Michigan Avenue to improve lane decisions.
- Narrow the hatched median on the northbound approach to provide wider lanes through the curve and enhance driver comfort.

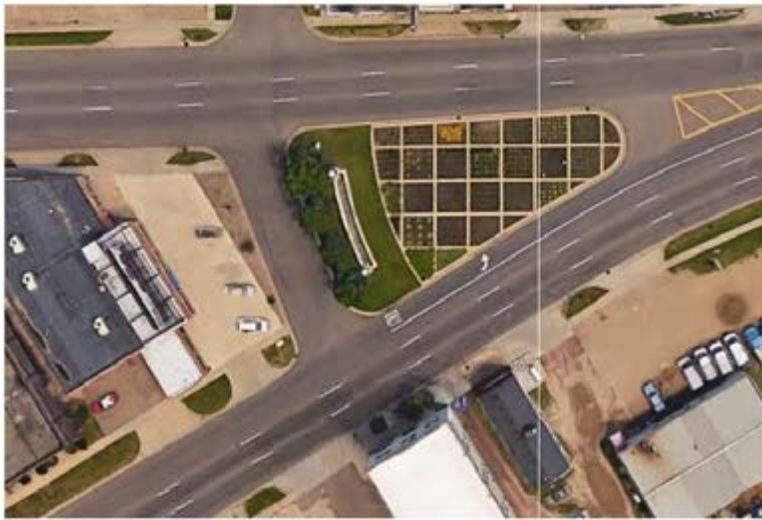
- The short roadway segment of Walbridge Street between East Michigan Avenue and Kalamazoo Avenue allows two-way traffic, however the center double-yellow centerline is missing. This is problematic given that both East Michigan Avenue and Kalamazoo Avenue are one-way, which might lead a motorist to incorrectly believe that Walbridge Street is also one-way, possibly resulting in head-on collisions.

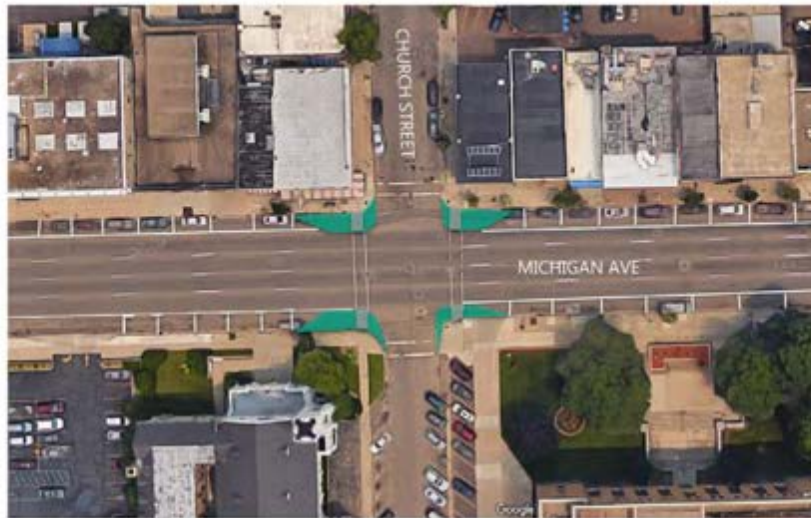
- At the intersection of West Michigan Avenue at Church Street, there are unsignalized pedestrian crossings of Michigan Avenue which are lacking pedestrian warning signs. This is an intersection that was highlighted as potentially detrimental to pedestrian safety by local stakeholders at the pre-RSA meeting.

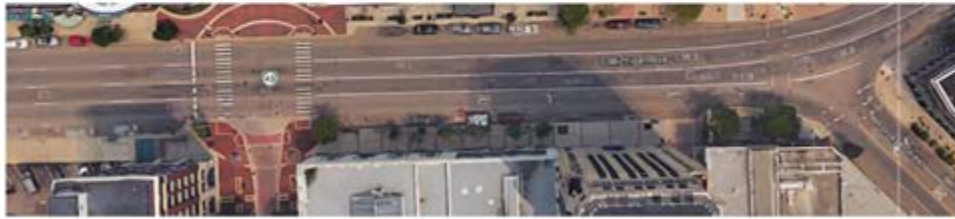
- At the intersection of West Michigan Avenue and Portage Street, the right turn movement conflicts with pedestrians crossing Portage Street without notice, placing pedestrians at risk of being struck by an unsuspecting vehicle turning right onto Portage Street
- The W4-2R “Lane Ends” sign is missing, thus vehicles may perform a late lane switch and sideswipe a vehicle in the adjacent through lane.

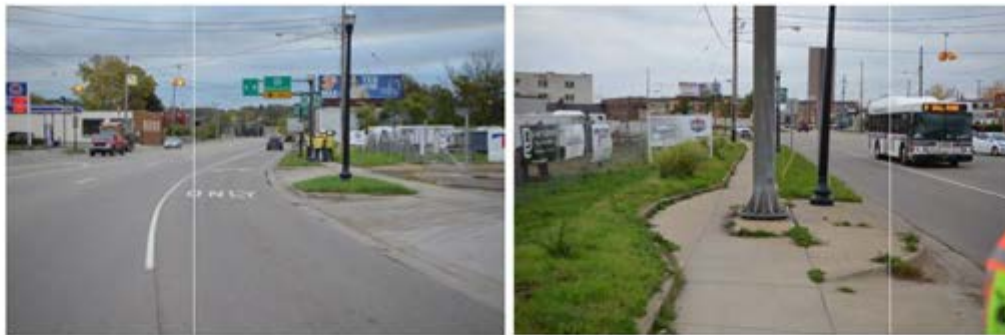
- The RSA team noticed a number of signing issues near the intersection of East Michigan Avenue at Harrison Street, which include:
 - Missing W4-2R “Lane Ends” sign on East Michigan Avenue for the right turn lane to Kings Highway
 - The eastbound I-94 and eastbound M-43 Junction sign cluster assembly has the route signs in the wrong order
 - The cantilever structure for the overhead guide signs is located in the sidewalk

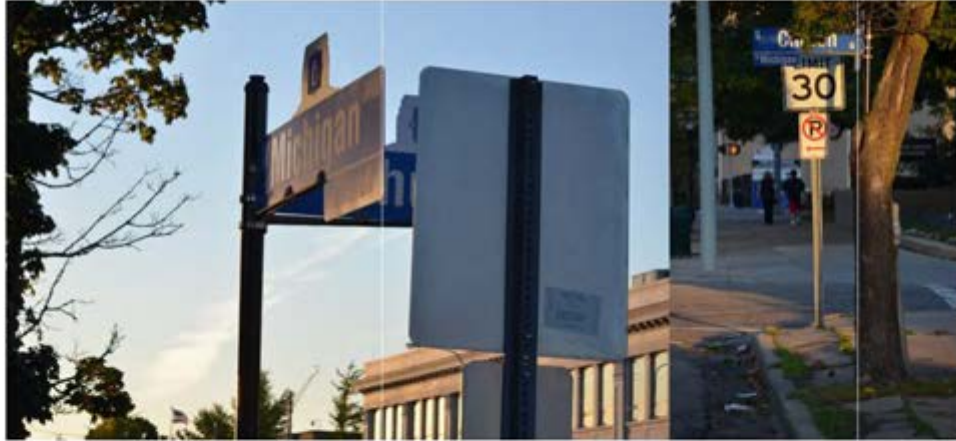
- At various locations, the RSA team noticed signs which were blocked by other signs, signal heads or vegetation. Signs which are not visible cannot serve their intended purpose, possibly leading to unsafe driver behavior.

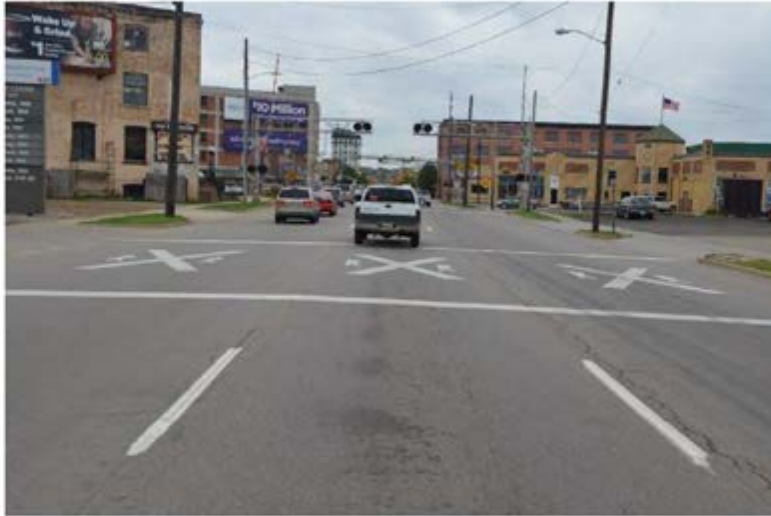
5.8F Crash Potential #8 (Risk Category C) – Signs (Specific)
Missing “DO NOT STOP ON TRACKS” Signs

- The RSA team noticed missing R8-8 “DO NOT STOP ON TRACKS” signs on westbound Kalamazoo Avenue on approach to the railroad crossing adjacent to Porter Street. Vehicles stopping on the tracks is a potentially dangerous situation in the case of a signal or vehicle malfunction.

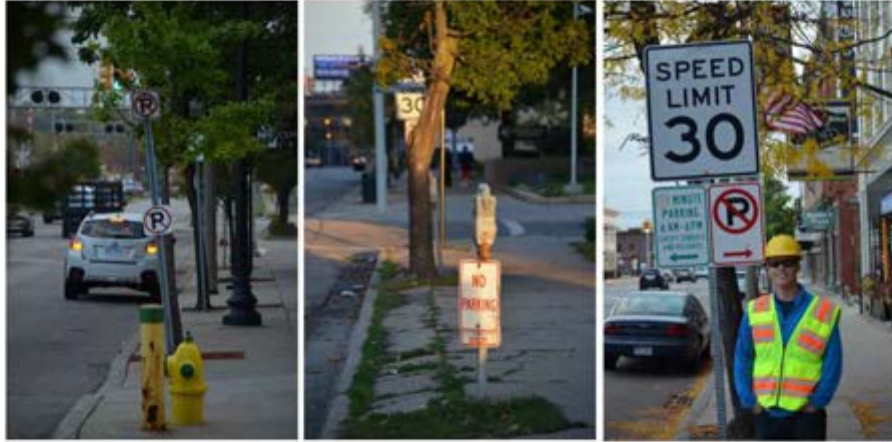
5.9A Crash Potential #9 (Risk Category C) – Signs (Upgrade)
General Sign Deficiencies

- Throughout the study regions, the RSA team observed signs which were outdated, don't meet current standard, have poor or no reflectivity, incorrect bottom height, and with conflicting messages on the same sign assembly.

- The information relayed to motorists on signs is imperative to traffic safety. It is recommended that a sign upgrade project is performed on all stretches of road under investigation in the RSA to ensure that signs are readable, consistent and correct.

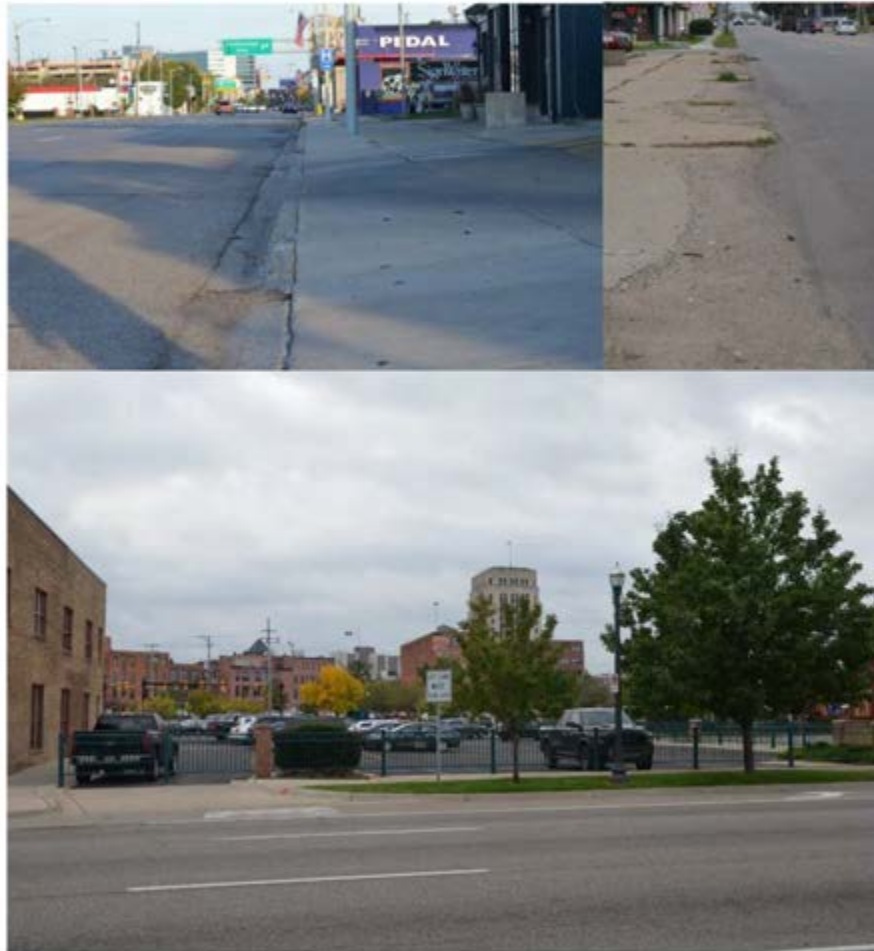
- The RSA team observed many locations where a property had in excess of two access points to West Michigan Avenue, particularly between Michikal Street and Westnedge Avenue. Every additional access point increases the number of conflict points which raises the probability of an accident occurring.

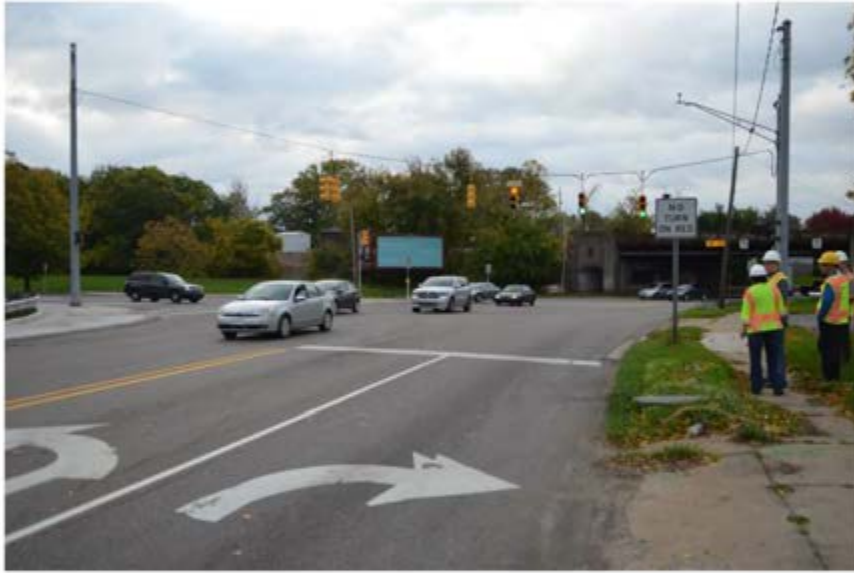
- During one of the nighttime field reviews, the RSA team observed low lighting conditions on the west side of the intersection on Riverview Drive at East Michigan Avenue. Poor lighting conditions can increase the likelihood of a vehicle striking a pedestrian wishing to cross East Michigan Avenue at night.

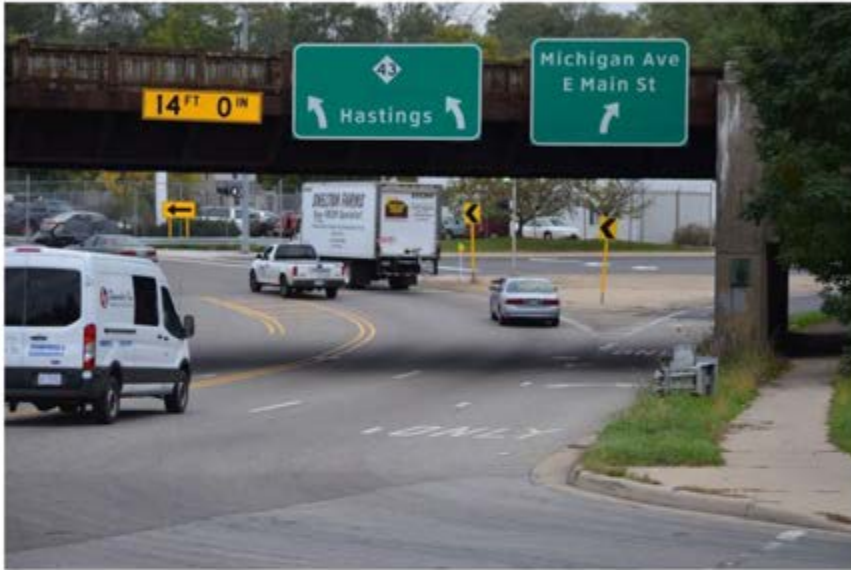
- The guardrail approach terminal is missing on Riverview Drive, just north of Mills Street. The guardrail at this location is intended to protect vehicles from striking the bridge columns.

- Replace the guardrail approach terminal.
