Michigan's Deteriorating Roads and Bridges

November 2014

Southwest Region

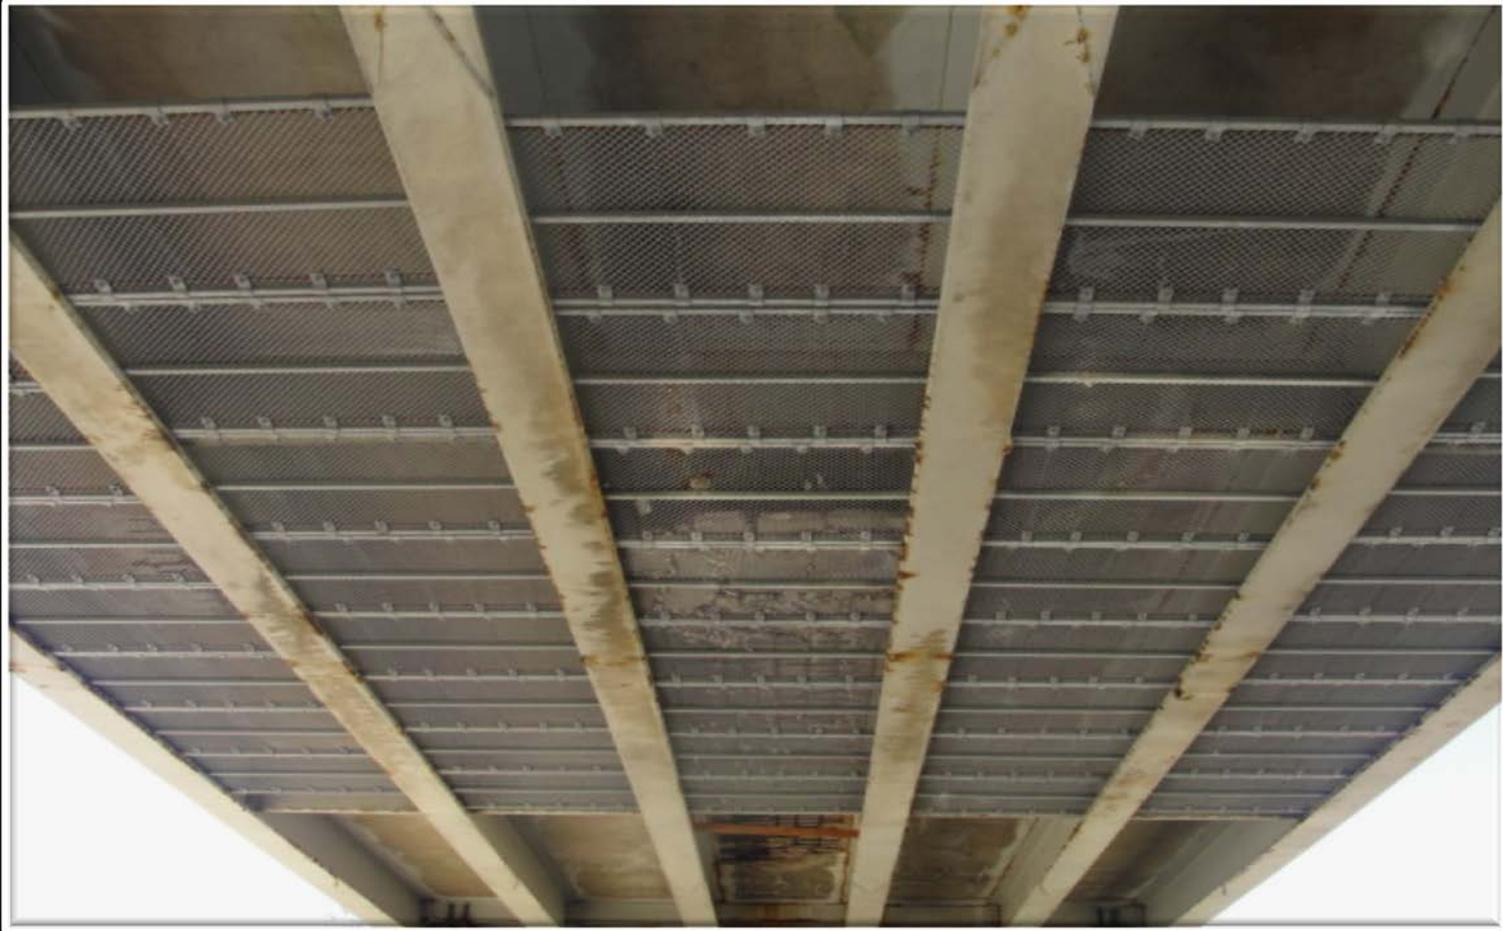
**I-196 under M-63 (Hager Shore Road), Berrien County
Fallen Concrete from Deck on Top of the Mesh False Decking**

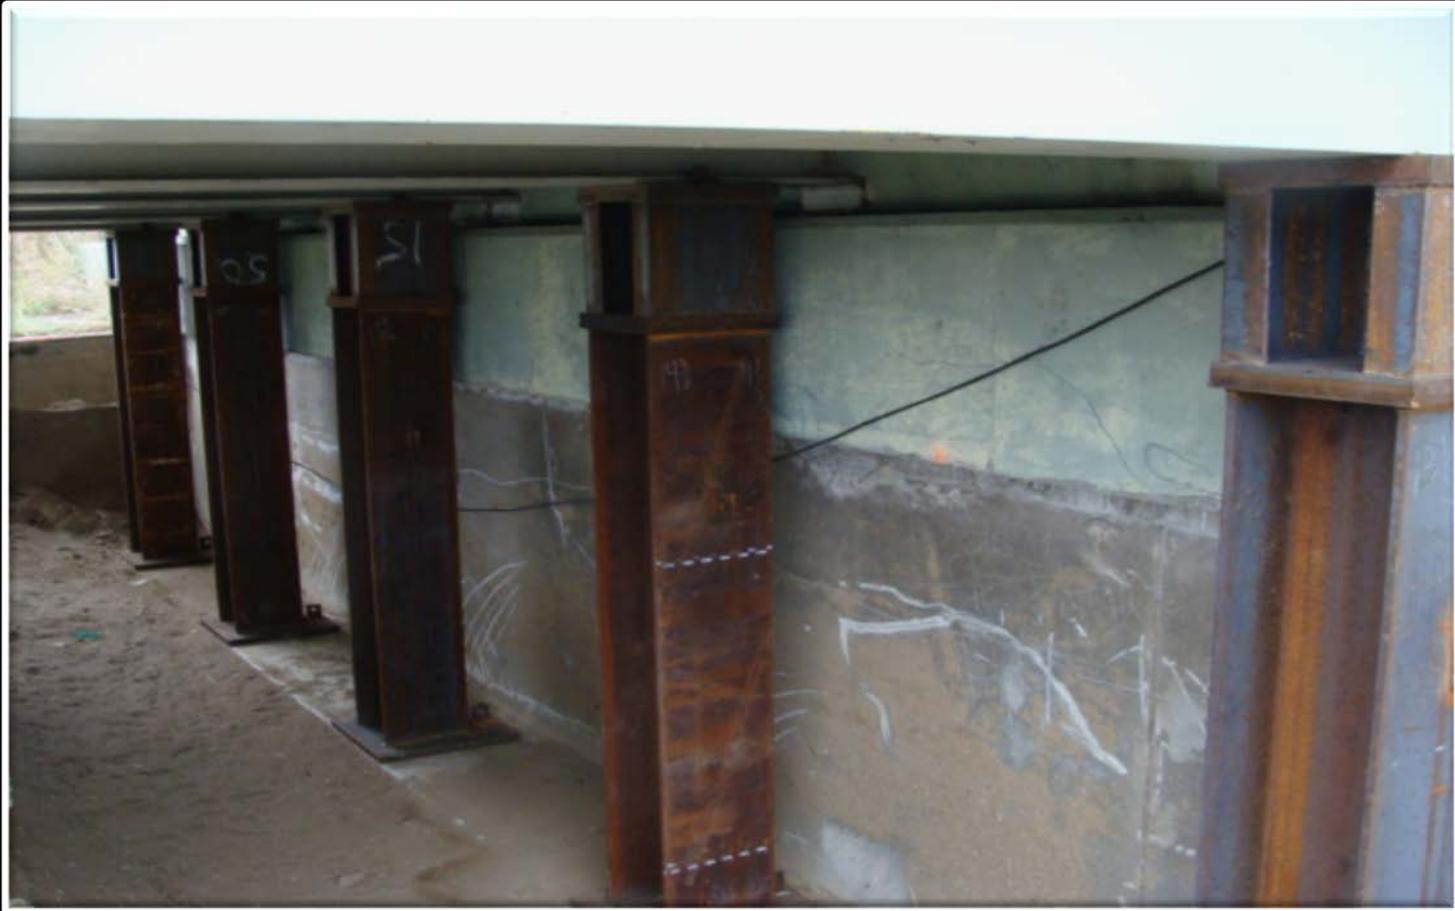
**I-94 BL Eastbound over I-69, Marshall Township, Calhoun County
Temporary supports to support beams**

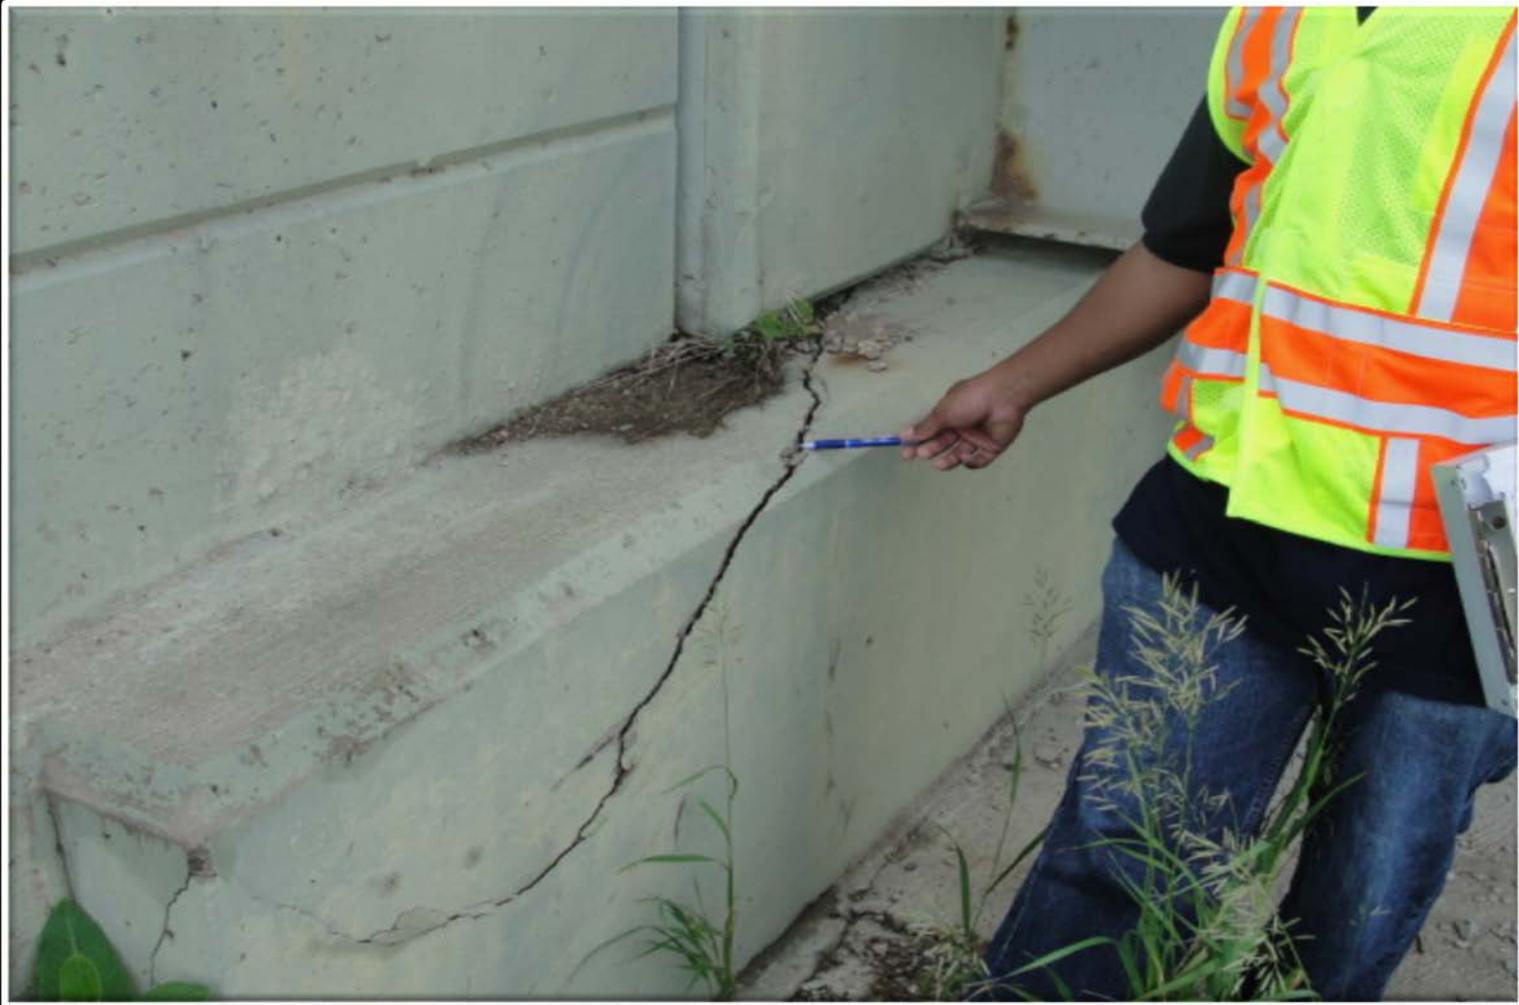
**I-94 BL Eastbound over I-69, Marshall Township, Calhoun County
Crack in abutment requiring temporary supports**

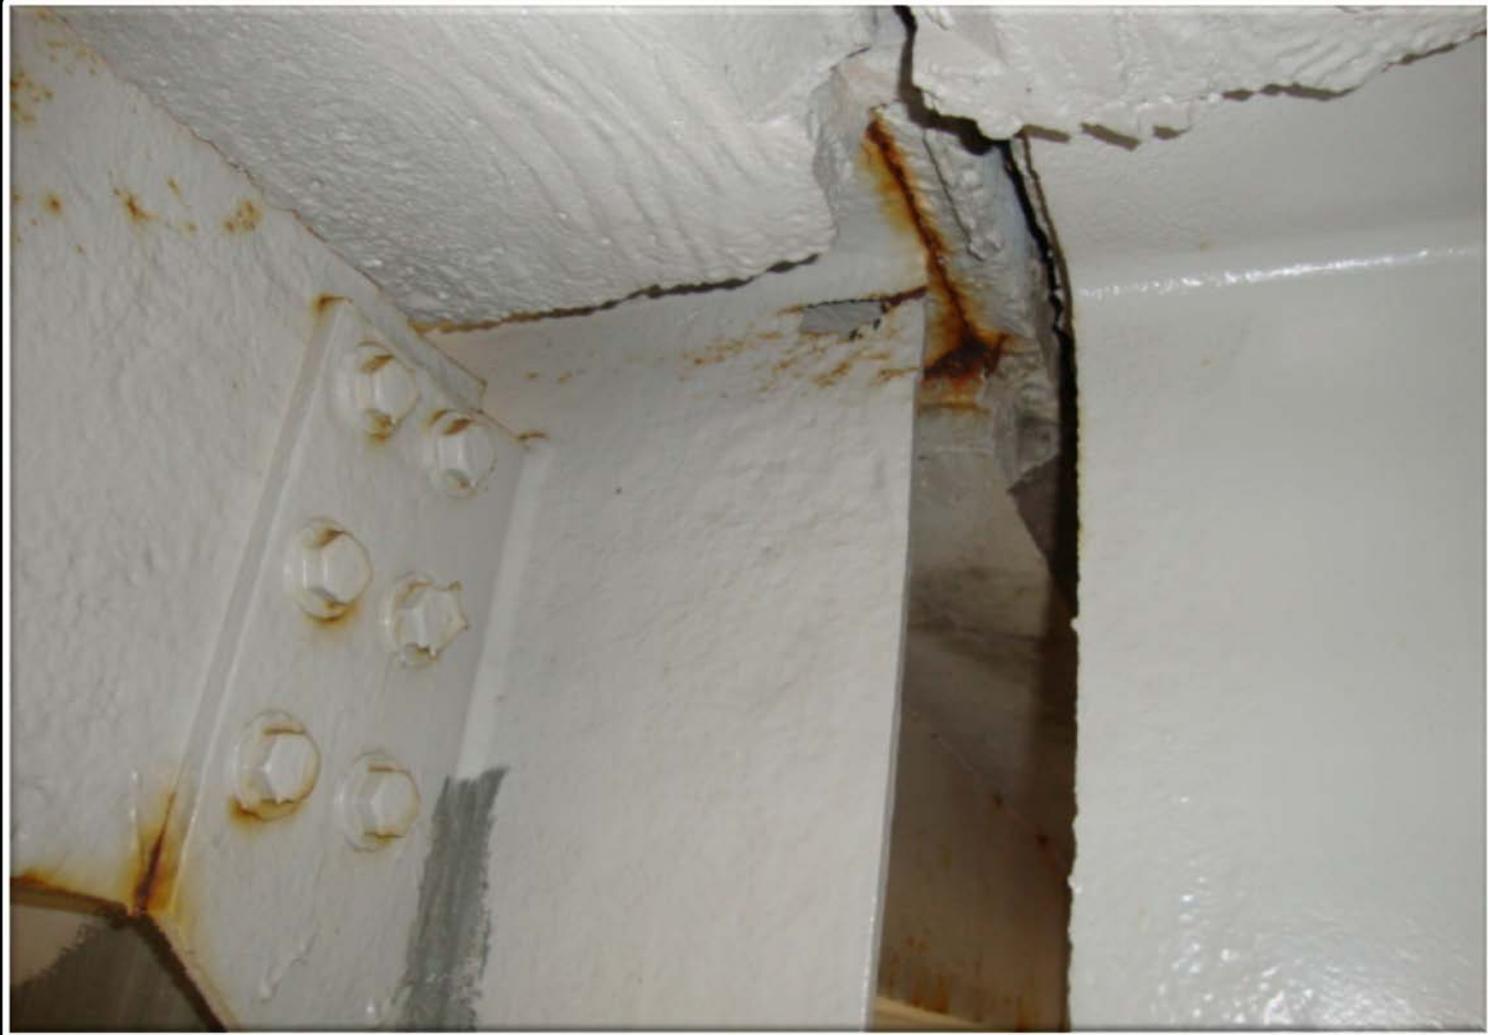
**I-196 under M-63 (Hager Shore Road), Berrien County
Hole in Beam / Section Loss of Beam**

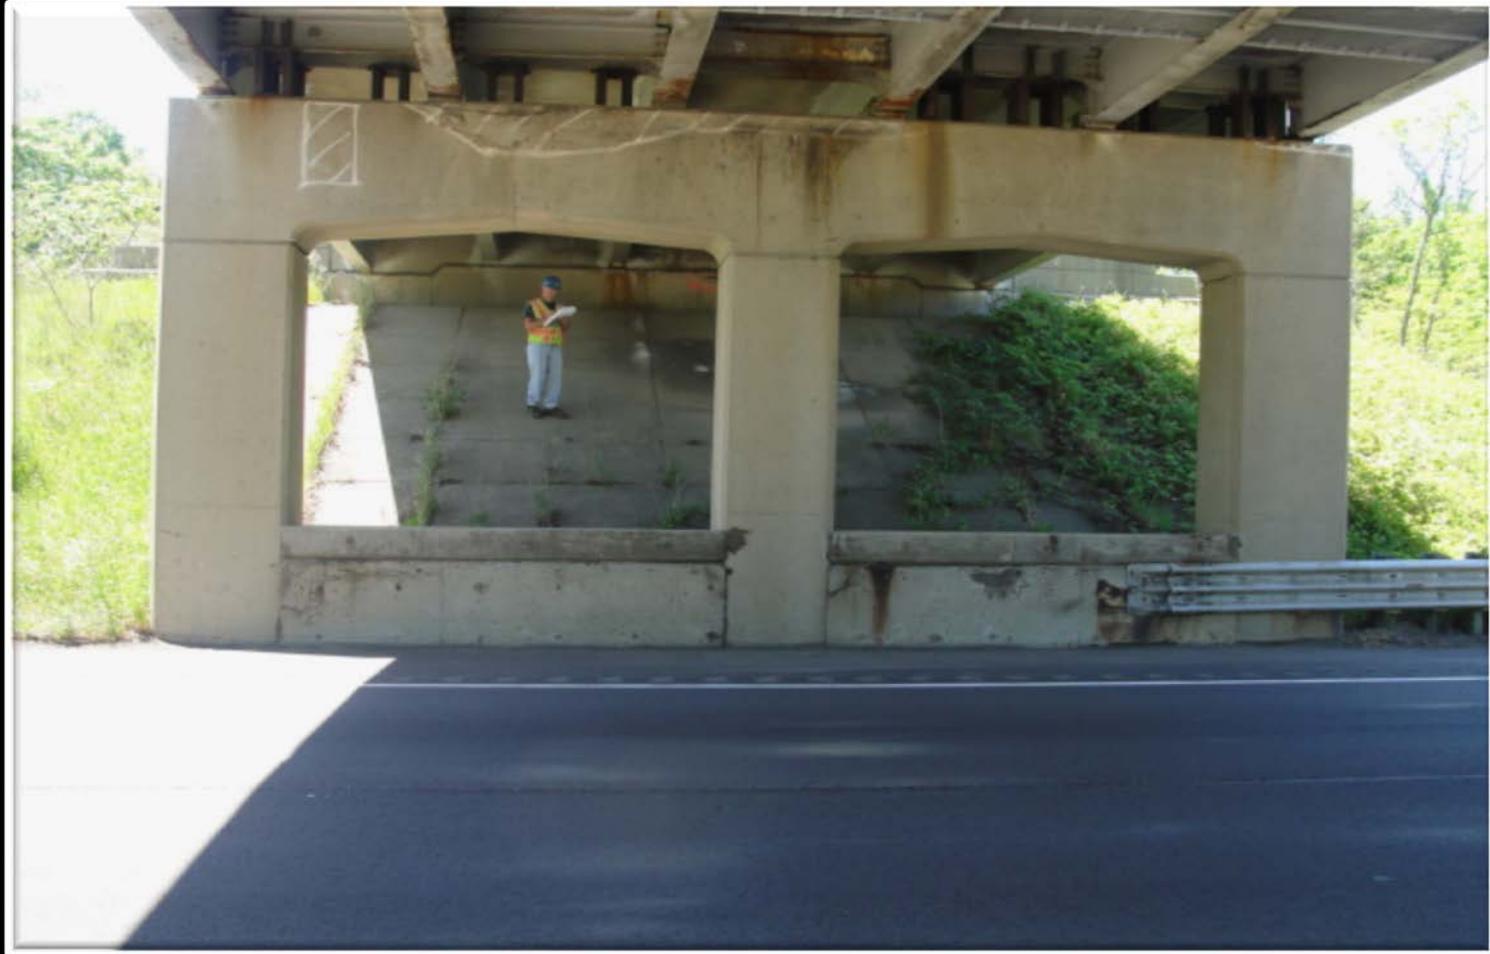
**I-196 under M-63 (Hager Shore Road), Berrien County
Beams with Temporary Supports at Piers Due to Severe Section
Loss on Beam Ends**

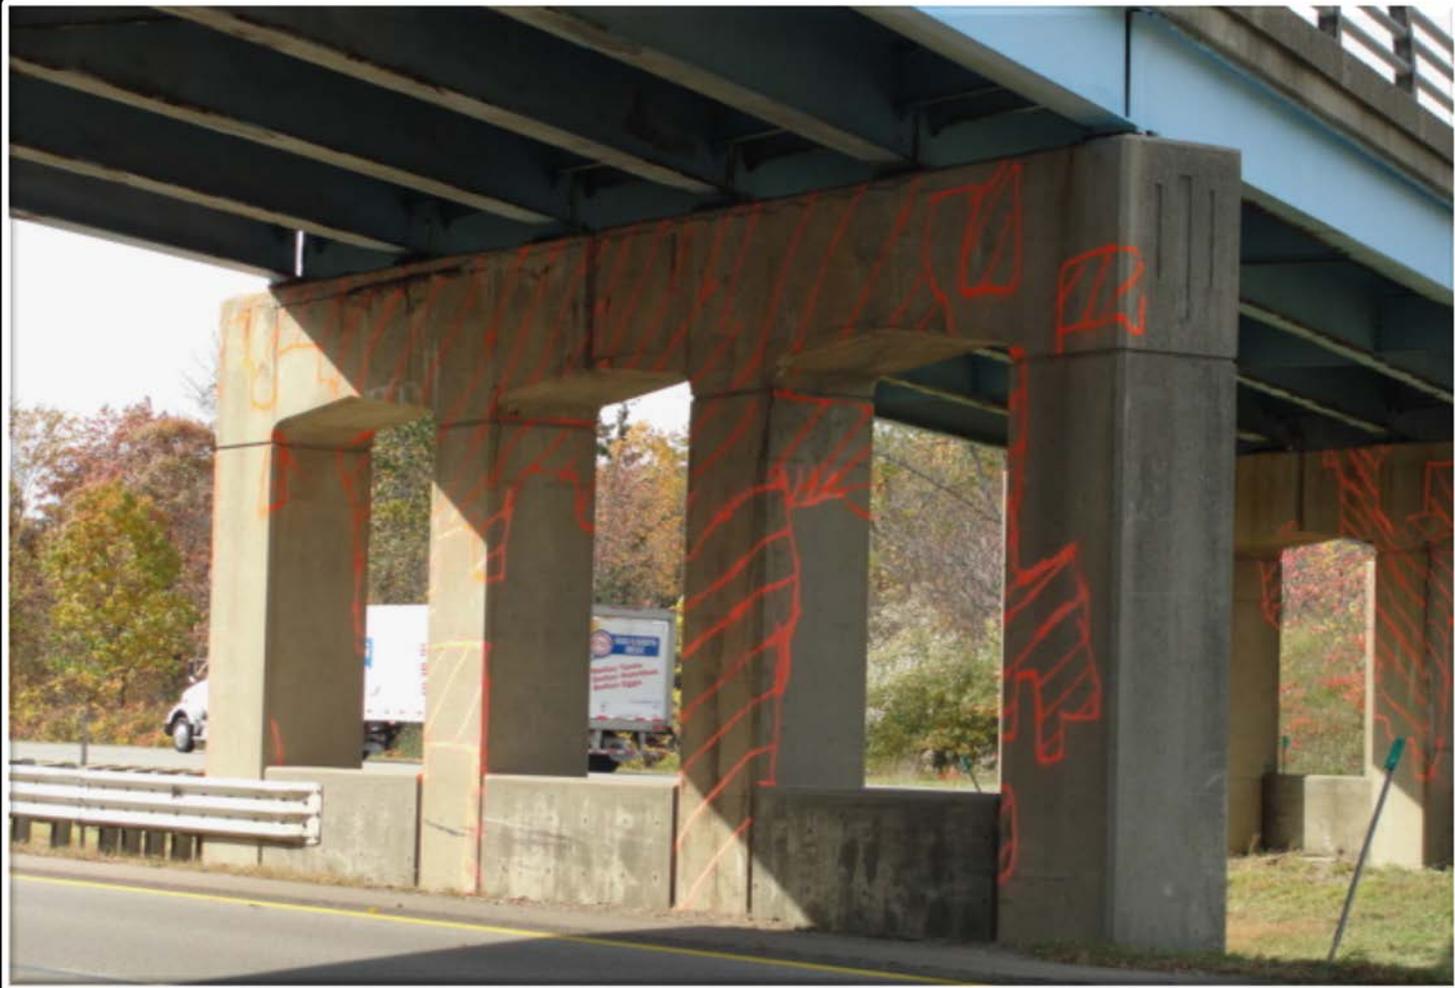
**Kruger Road over I-94, near New Buffalo, Berrien County
Painted Orange Lines Delineate Delamination of Concrete**

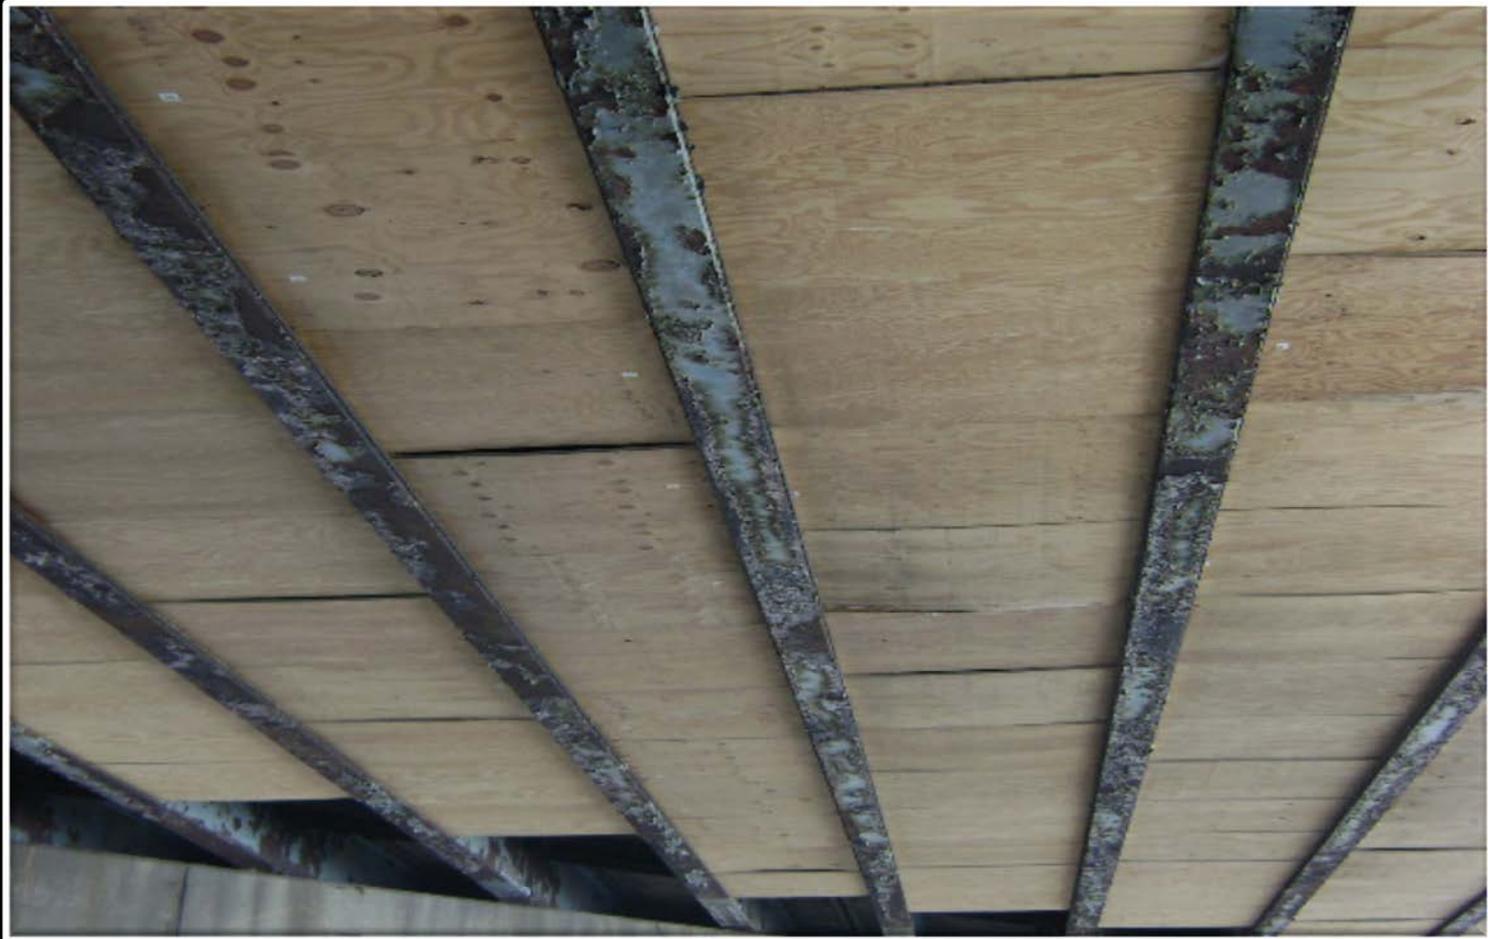
**Sprinkle Road over I-94, Kalamazoo, Kalamazoo County
Wood False Decking over Traffic under Poor Deck**

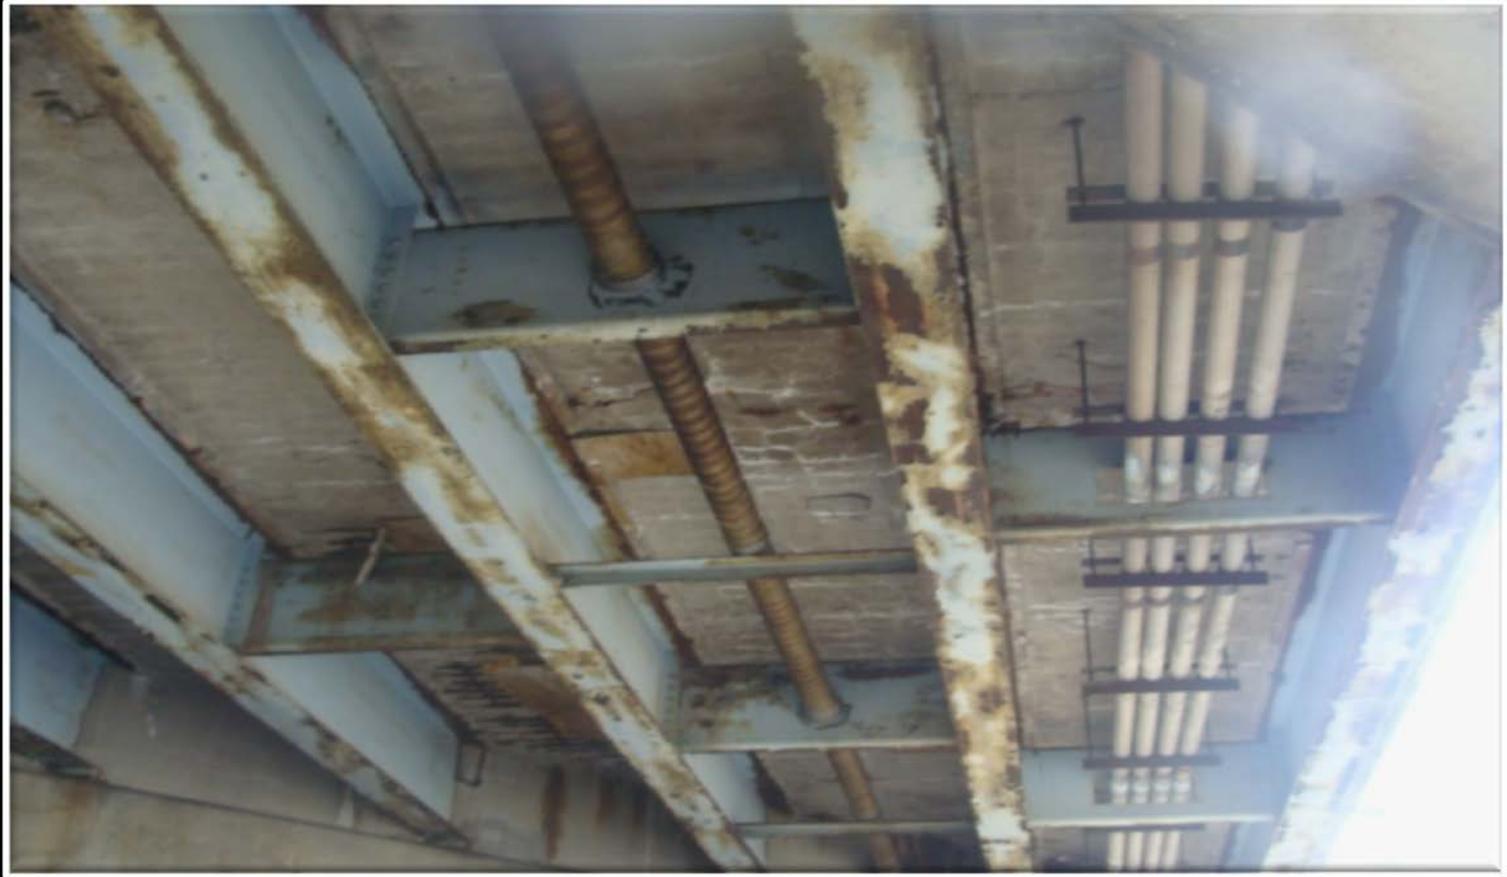
**Sprinkle Road over I-94, Kalamazoo, Kalamazoo County
Poor Bridge Deck Bottom in Tail Span**

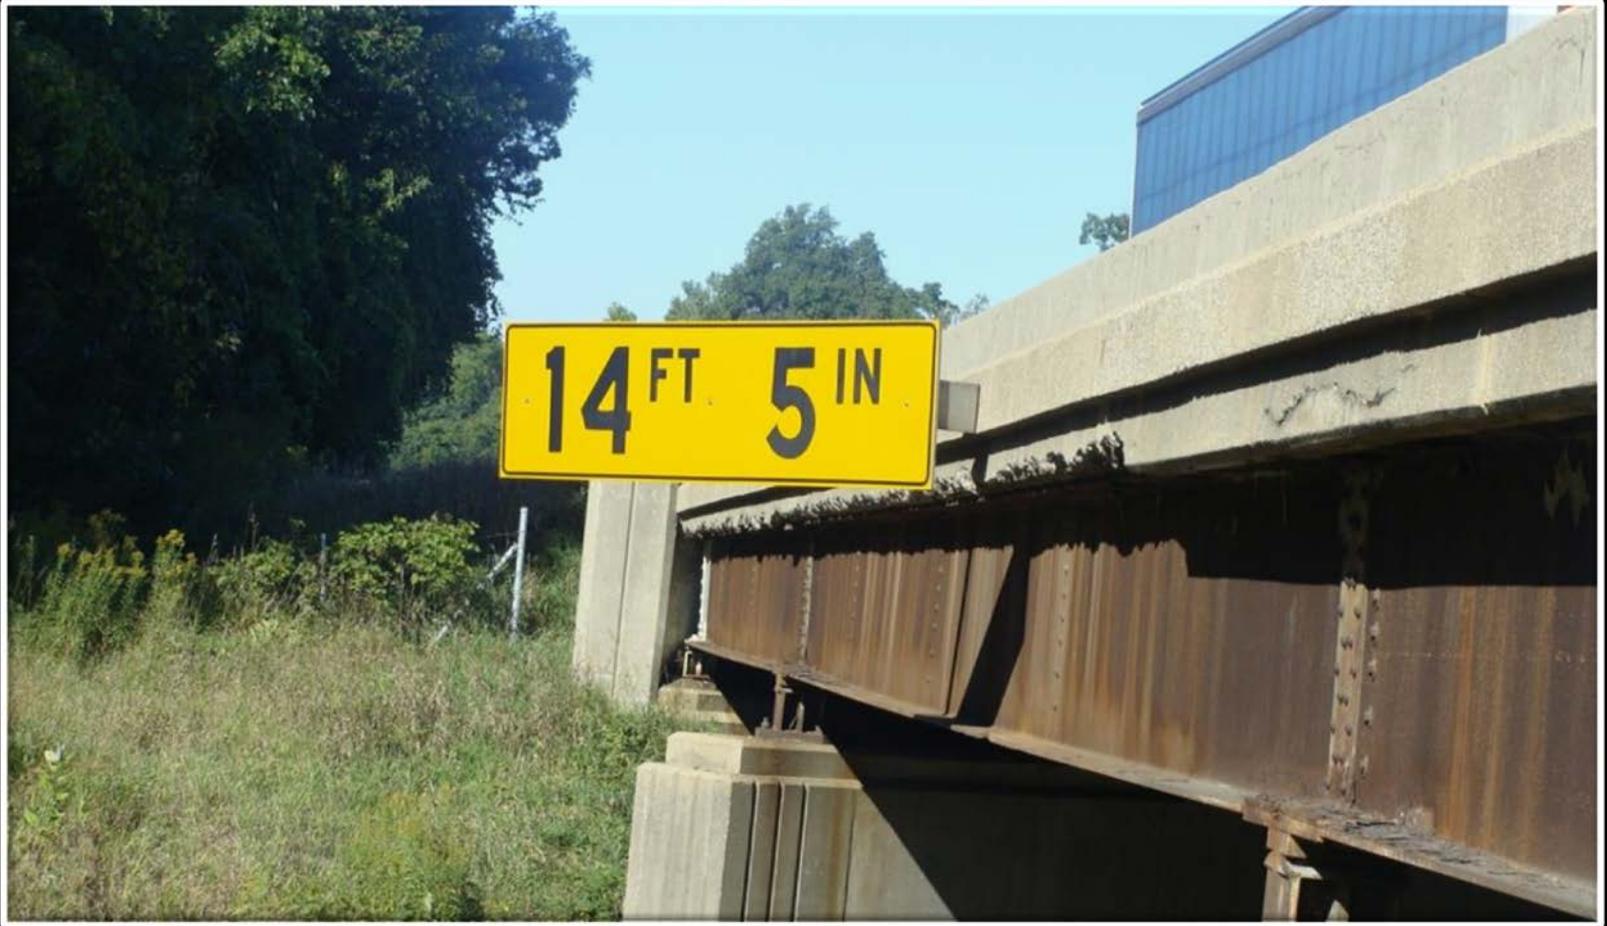
**I-94 over East Michigan(40th Street), Charleston Township, Kalamazoo County
Deck Fascia with Severe Spalling to Rebar**

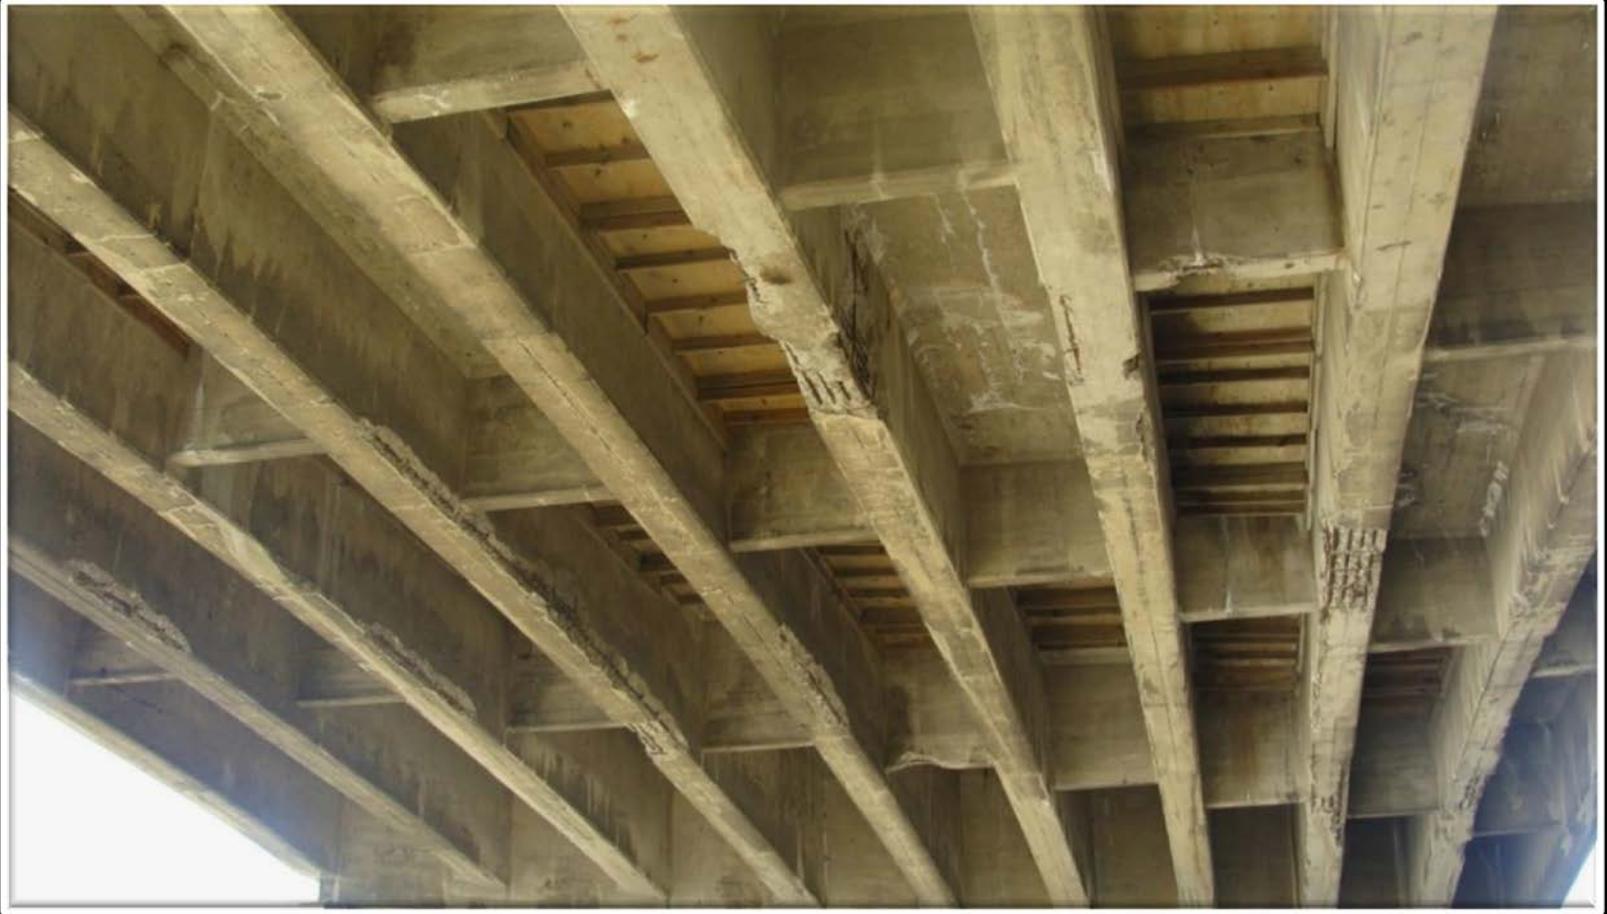
**I-94 BL (MLK Drive) over I-94, City of Battle Creek, Calhoun County
Poor Bridge Deck with Wood False Decking**

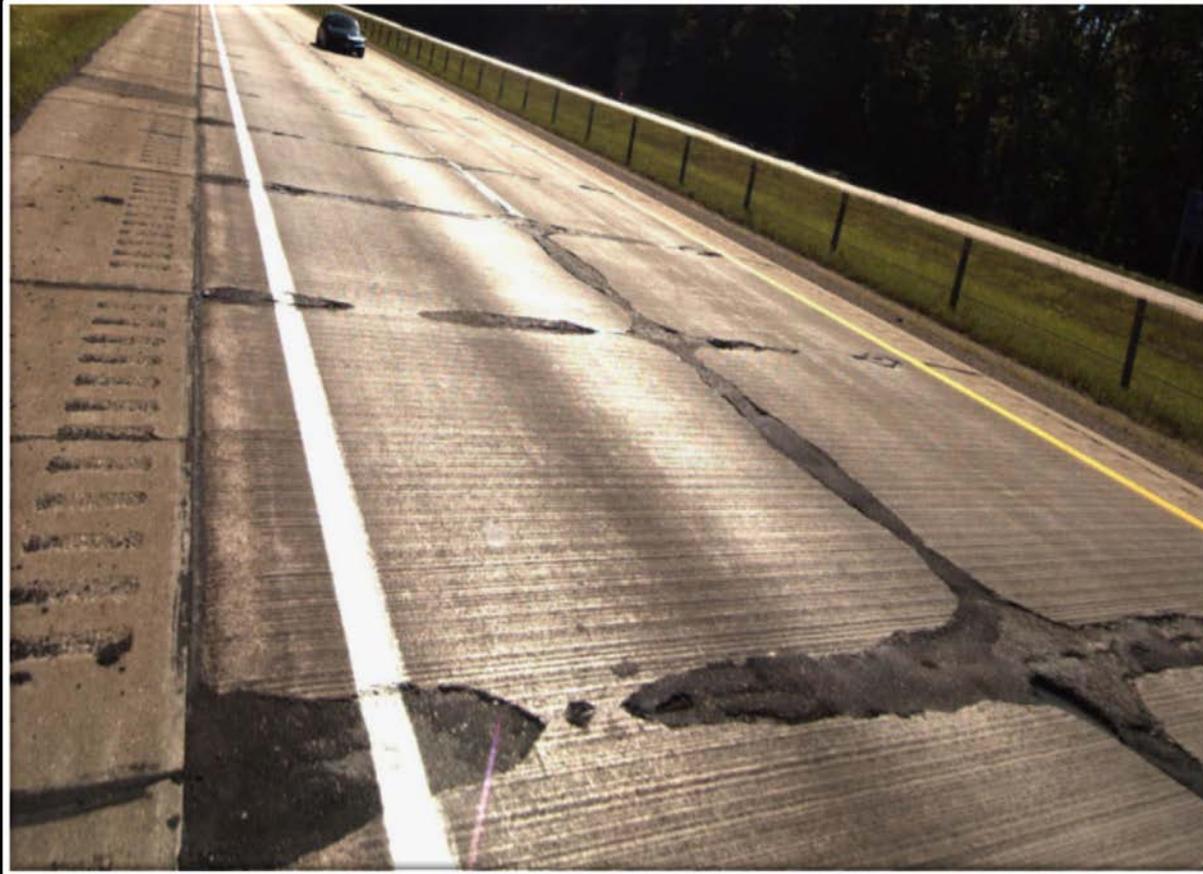
**I-94 WB Hartford to Lawrence Township, Van Buren County
Excessive Joint Deterioration/Failure & Patching**

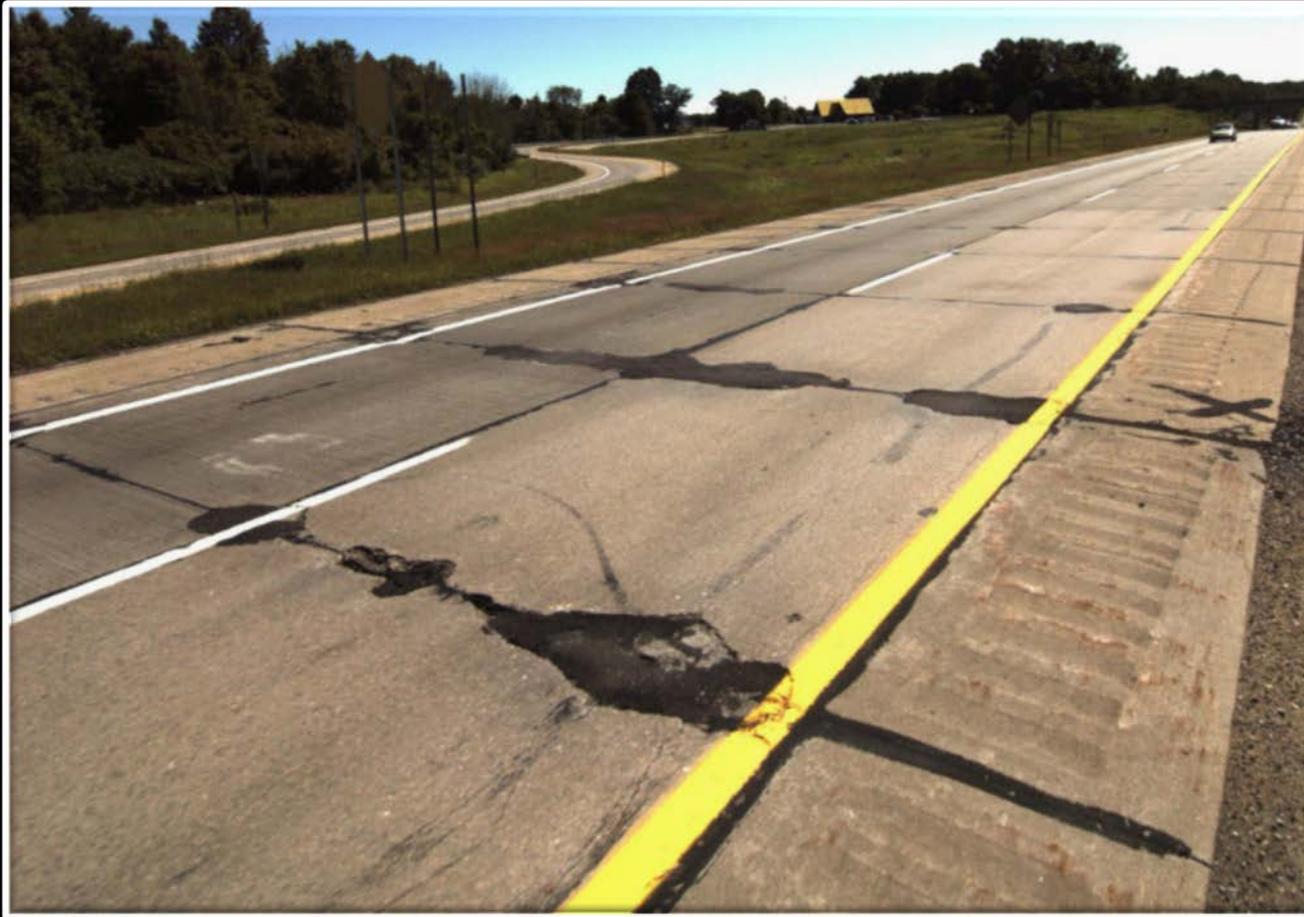
**I-94 WB Lawrence Township, Van Buren County
Excessive Joint Deterioration/Failure & Patching**

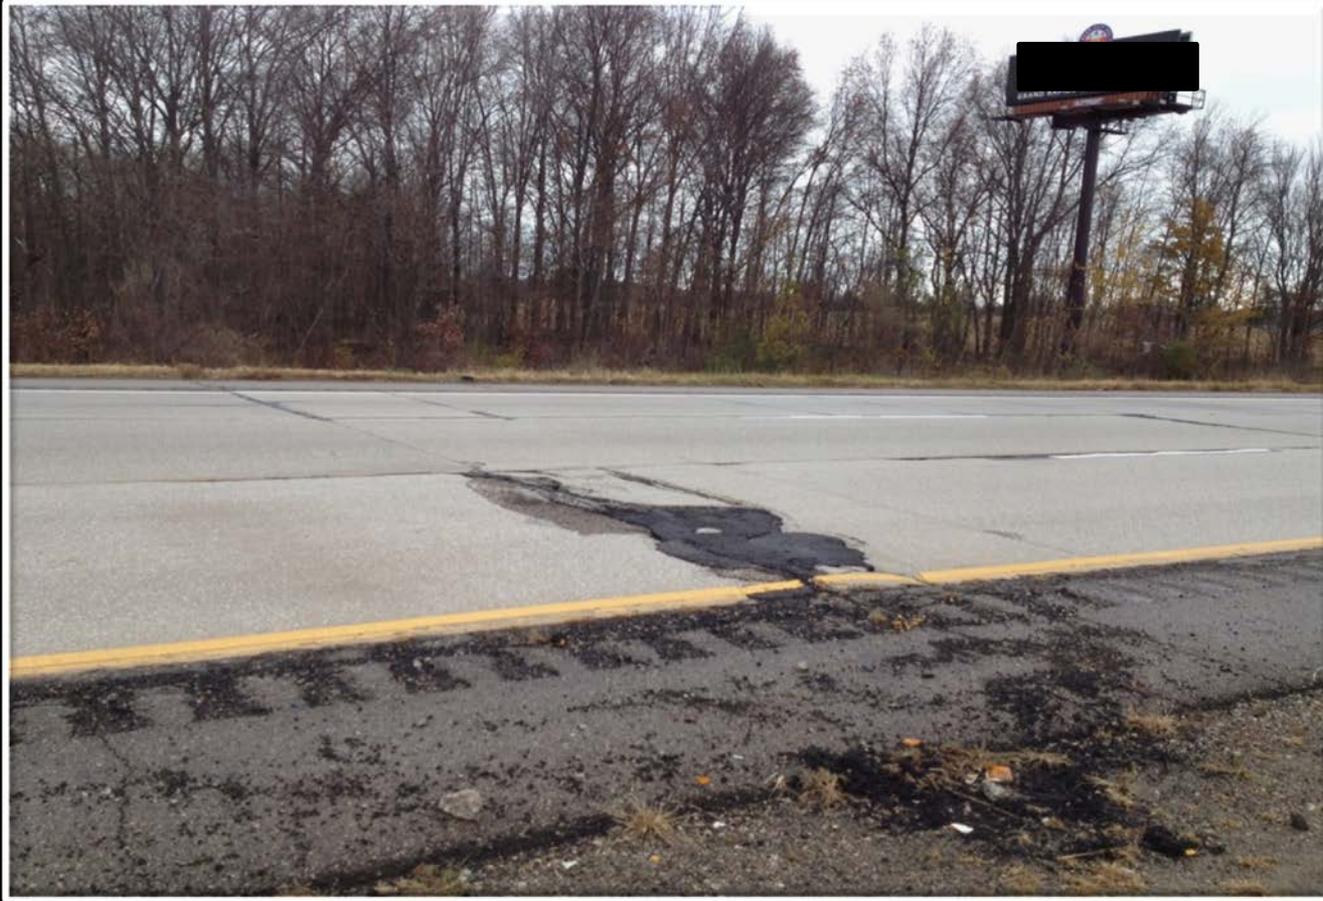
**I-94 WB inside lane, south of New Buffalo near mile marker 1, Berrien County
Concrete Pavement Failure (Poor Ride Quality)**
