MICHIGAN
DEPARTMENT OF STATE HIGHWAYS

July 14, 1972

Subject: Corrugated Metal Pipe Culvert Disintegration, I 75, Mackinac County
Research Project 72 TI-106, Research Report No. R-824.

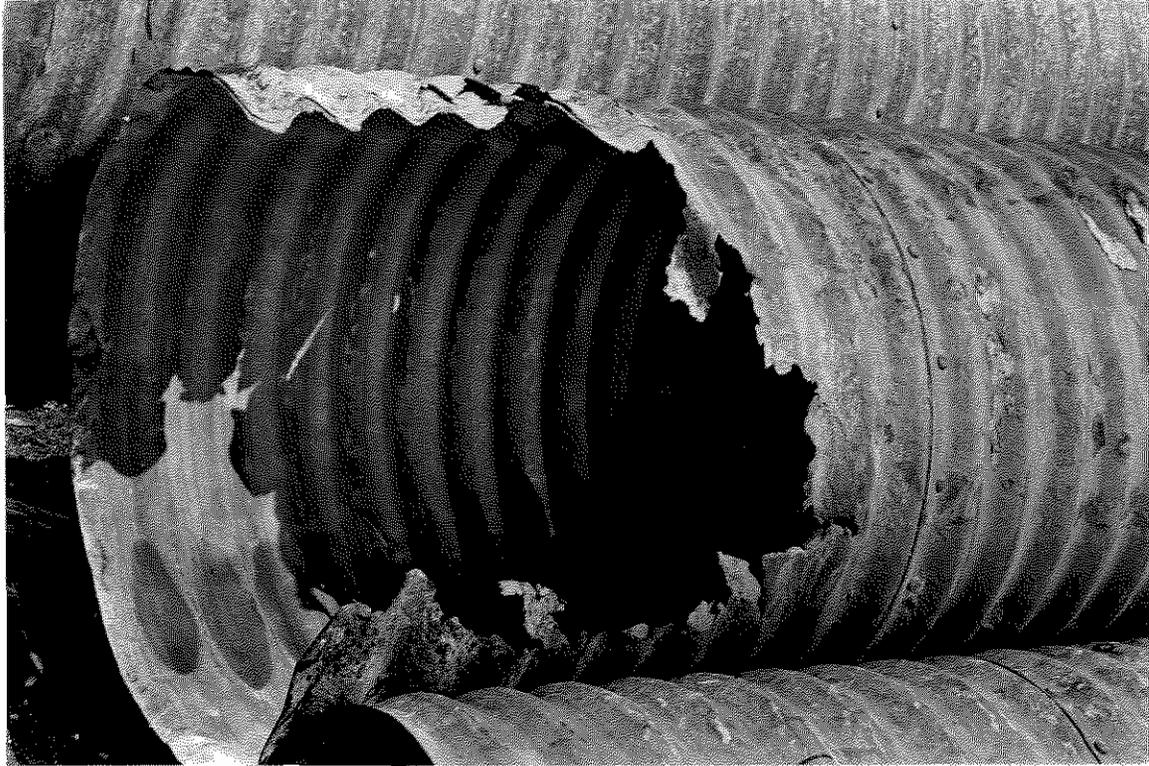
1) On June 13, 1972, along with C. V. Iansiti of this Laboratory, I met with Mr. Sweeney of the St. Ignace Maintenance Garage to see the removed section of the badly corroded CMP culvert from Sta. 616+75. As noted in O. F. Eichen's letter of June 6, 1972 to P. J. Marek, several square feet from the bottom of one end and from the top of the opposite end of the culvert were disintegrated (Fig. 1). The remainder of the culvert section was very rusty and quite thin in spots. Mr. Sweeney showed us the site (Sta. 616+75) where the culvert section had been removed and replaced with a section of 15-in. diameter CMP culvert. During the balance of June 13 and on the morning of June 14, we inspected the remaining culvert sections at Sta. 616+75 and all other culverts in the immediate vicinity starting with the culvert at Sta. 603 and continuing north to Sta. 775. Also, several other culverts as far north as Sta. 898 about four miles south of M 28, were inspected. In addition to the CMP culverts, several concrete culverts immediately south of the damaged culvert area were inspected. The inspection consisted of crawling into the culverts as far as possible, probing the bottom with a sharp geologist hammer, observing the visible area with a strong flashlight, photographing damaged areas, and performing on-site pH measurements of the water traversing many of the culverts.

Figure 1. Section of culvert removed at Sta. 616+75.

- (a) Inserting a bituminous coated CMP or a reinforced, sulfate-resistant concrete pipe inside the damaged culvert and grouting the space between the old and new pipes.
 - (b) Installing a new culvert using reinforced, sulfate-resistant concrete pipe.
- 4) Install magnesium anodes on CMP culverts where the need is indicated by the soil resistivity measurements.

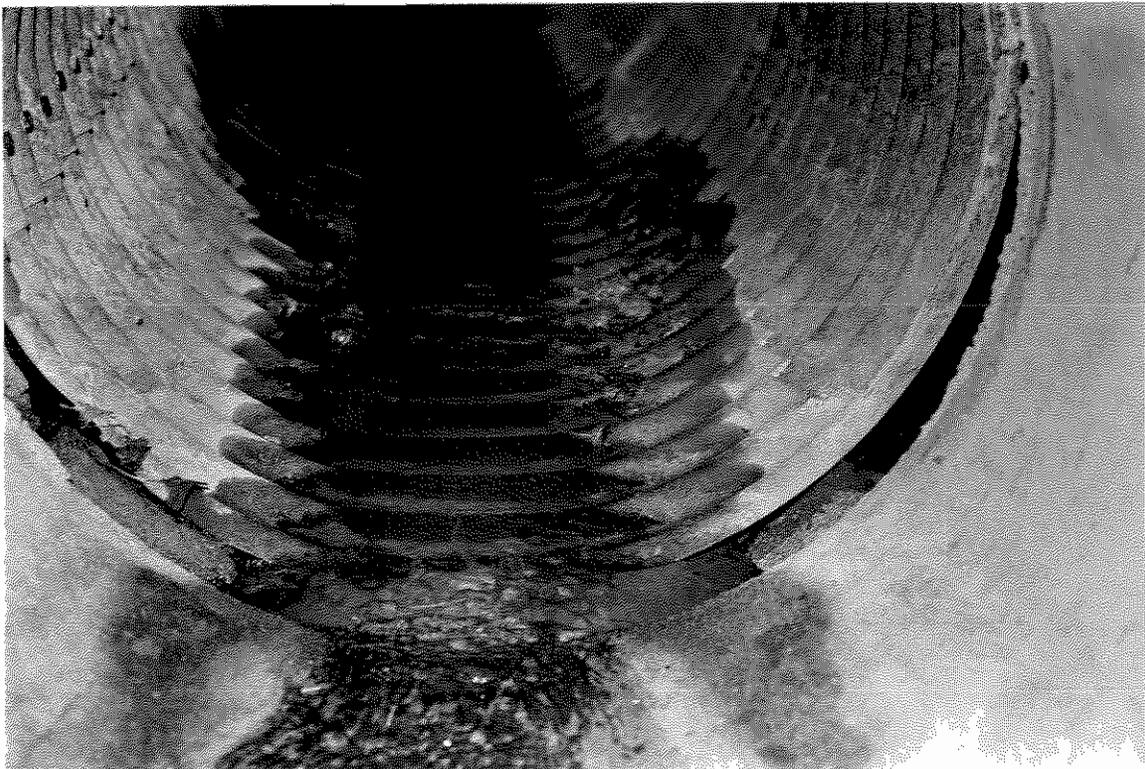
Sta. 603+00 - The east end of the culvert under the northbound I 75 lanes had one large hole approximately 12 by 6 in. and several smaller holes up to about 1 in. in diameter (Fig. 2). The remainder was quite rusty with much of the galvanizing removed. The culvert under the southbound lanes appeared to be solid, without serious attack, but much of the bottom was obscured under about 12 in. of muck and water.

Figure 2. Perforated culvert still in-place at Sta. 603+00.

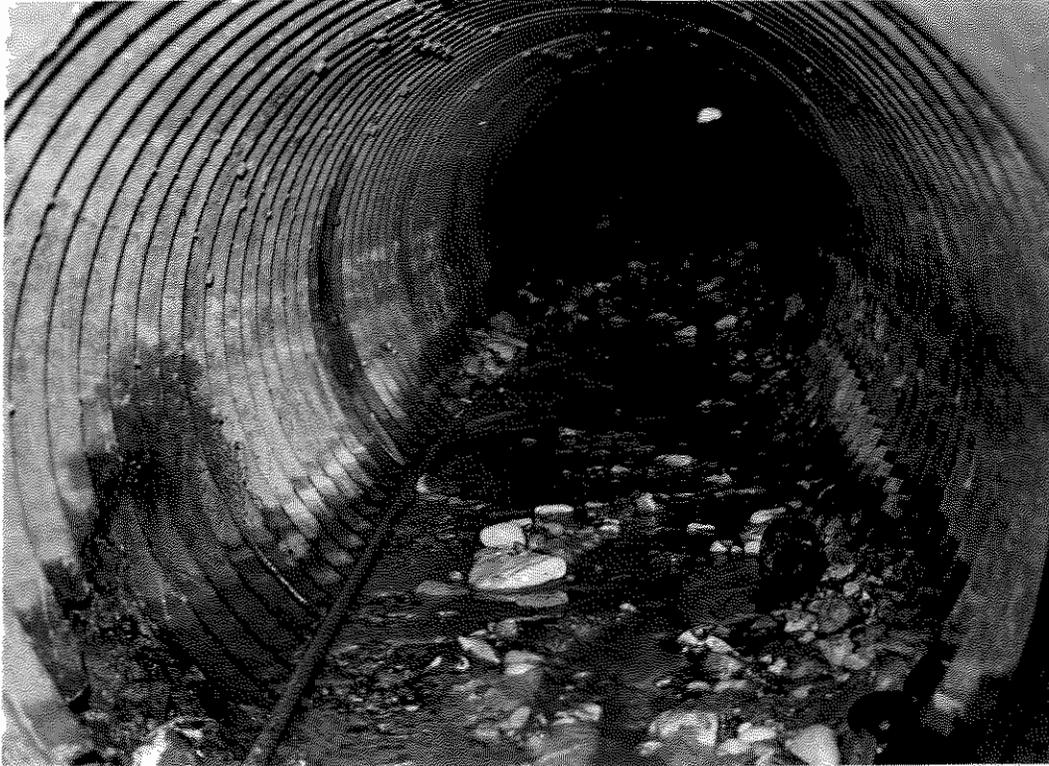
Sta. 616+75 - The east end section under the northbound lanes had been replaced with a 15-in. diameter CMP. The west end section under the northbound lanes (Fig. 3) and the east end section under the southbound lanes had several holes ranging up to about 5 in. in diameter. The remaining sections under both the northbound and southbound lanes were quite rusty with much of the galvanizing removed.

Figure 3. Perforated culvert section still in-place at Sta. 616+75.

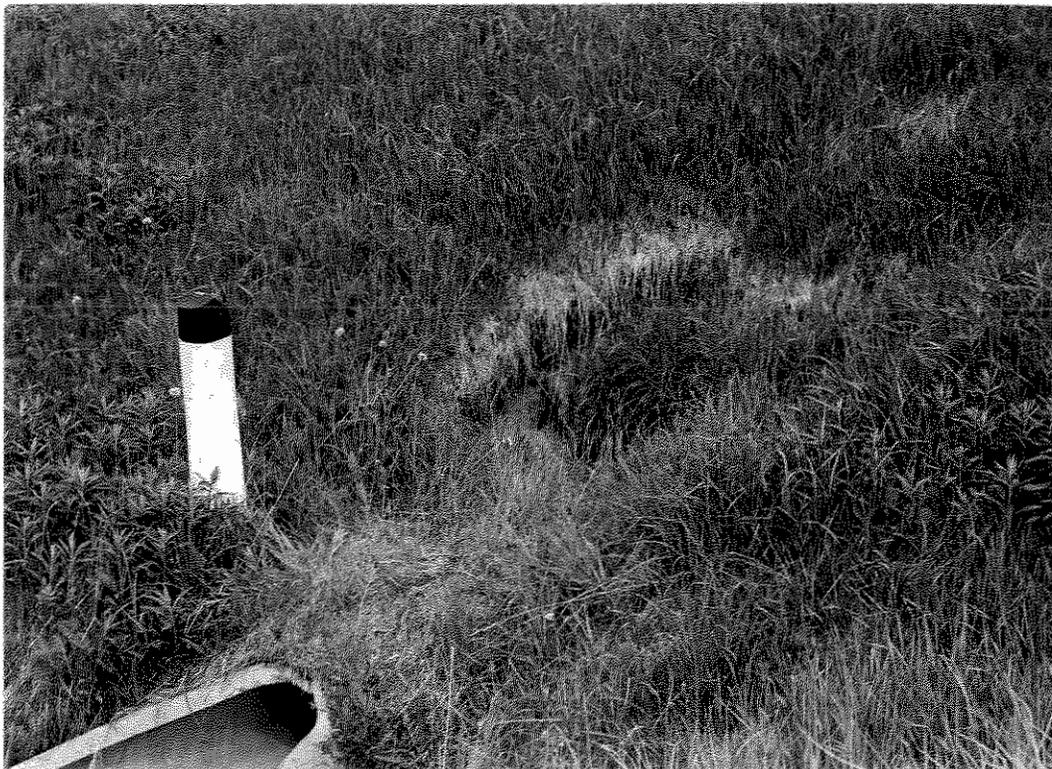
Sta. 626+00 - The east end section under the northbound lanes had two holes about 6 by 3 in. in the bottom and lower side. The east end under the southbound lanes had one 3-in. diameter hole in the side. At the west end of the culvert under the southbound lanes, backfill soil had settled several feet forcing the culvert down about 3 in. below the headwall, causing partial collapse of the culvert so that about 2/3 of the original opening remains (Fig. 4).

Figure 4. Settled embankment over culvert at Sta. 626+00.
