# **Region Bridge Support Unit Bridge Field Services**

## ***Alleviating the Effects of Pavement Growth on Structures***

**January 2012**

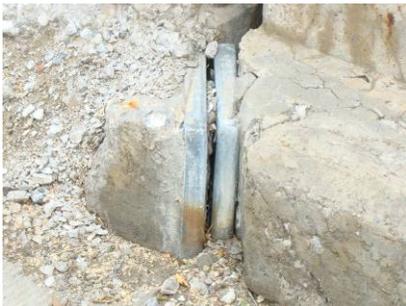
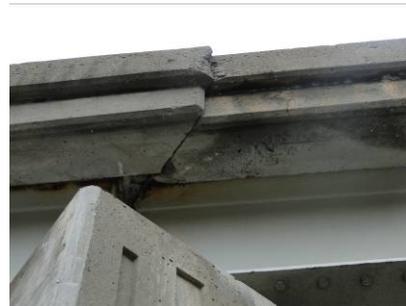
Expansion joints are often the first vital component to be affected by PG. They allow the bridge to freely expand and contract during temperature cycles, and if there is no space available for expansion damage will occur to the deck and beams beneath.

*Figures 11 & 12. Expansion joints permanently closed*

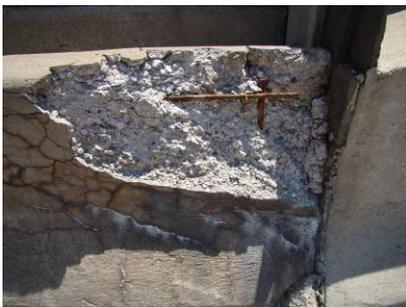
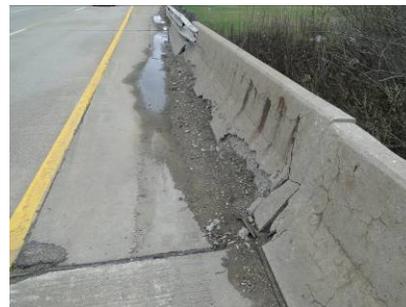
Damaged railing is often readily noticeable and may be the first element damaged. If the space separating two sections of railing at an expansion joint is less than the joint throat the railing will be tight or crushed first. The damage may also occur along the approach if the expansion joints are not on the bridge.

*Figures 13 & 14. Crushed concrete railings*

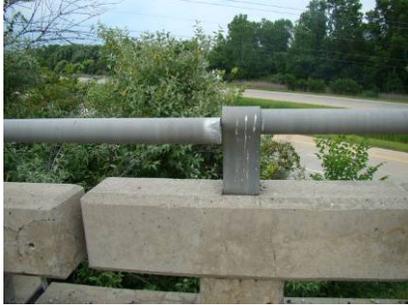
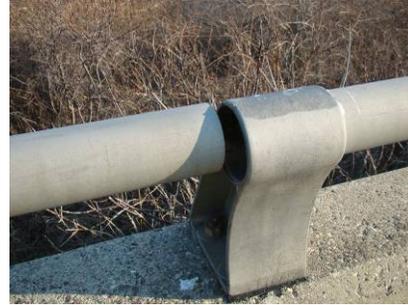
Many older structures have single and double tube railing, and tube separation is a visual sign pressure from the roadway is being applied. Look for separated sections near each end of the deck where tube railing attached to a wing wall meets railing joined to the tailspan.

*Figures 15 & 16. Aluminum tube rail separation*

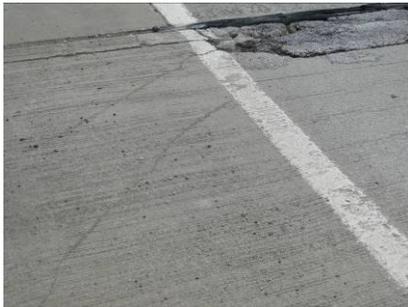
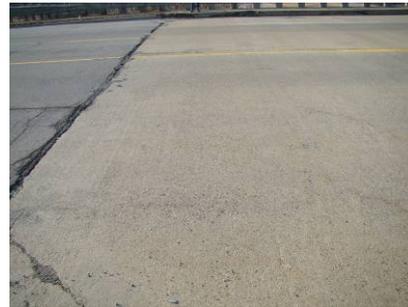
A series of cracks that propagate near the approach end of a tailspan are a feature of pavement pressure. The cracks are measurable in some cases, but are most often hairline. If more than two cracks at a forty-five degree angle to the reference line can be seen, look for other symptoms beneath the deck.

*Figures 17 & 18. Diagonal deck cracks in tailspans*

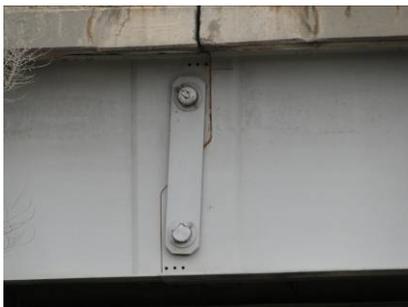
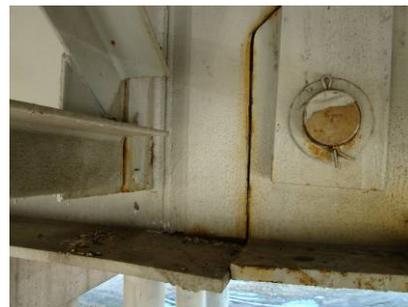
Pin and hangers are easy to see while driving, and closed ones during winter months should be investigated. Although corrosion is often blamed, a closer examination should be conducted.

*Figures 19 & 20. Pin & Hangers closed during cold weather*

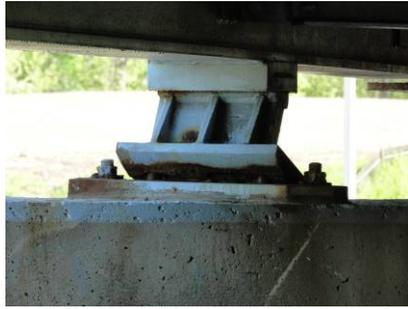
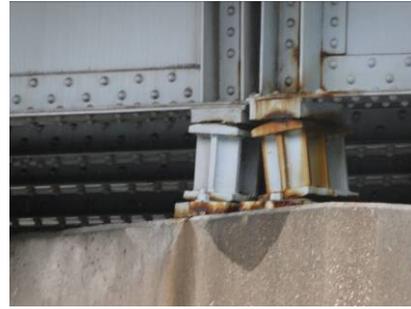
Severely tilted rockers may be an indication of PG. Taking action by only realigning the tilted rocker bearings to accommodate for thermal expansion is not a remedy. Installing a PRJ prior to beam end contact will eliminate damage to beam ends.

*Figures 21 & 22. Tilted rocker bearings during cold weather*

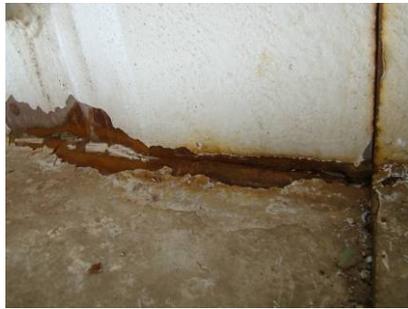
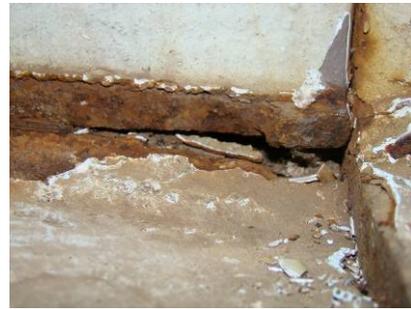
Beam end contact occurs when the effects of PG have gone untreated and the resulting damage will lead to stress cracks near the bottom flange and web interface. A hands-on inspection should be performed to determine if a crack is present that will require a bolted repair.

*Figures 23 & 24. Examples of damage from beam end contact*

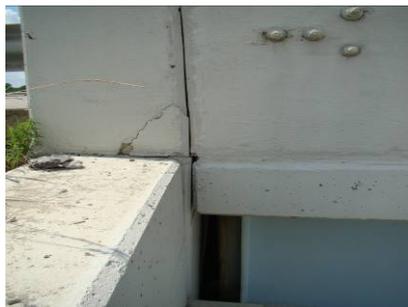
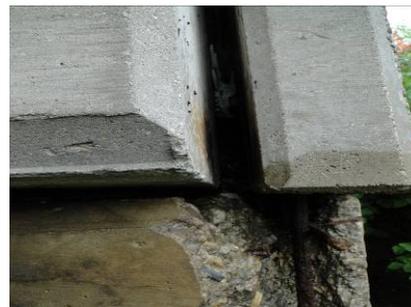
An independent backwall that is not vertically plumb may have been constructed correctly, but has since been pushed by PG. This action results in a void forming behind it causing the approach to crack. In many cases both vertical construction joints between the backwall and wing walls will open and a significant amount of subbase material may be lost.

*Figures 25 & 26. Tilted independent backwalls*

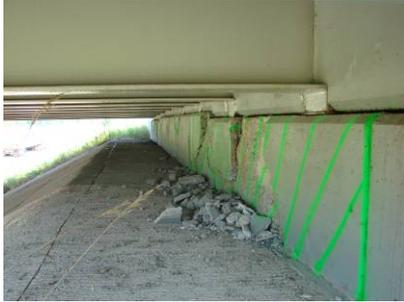
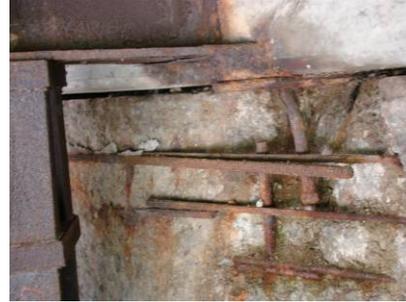
When sounding of the abutment stub reveals delaminations beneath the beams PG is present and corrective action through the installation of a PRJ must be performed. Significant spalling or exposed positioning dowels are signs of reduced bearing and will require substructure repair and temporary supports.

*Figures 27 & 28. Dependent backwall delamination and spalling*

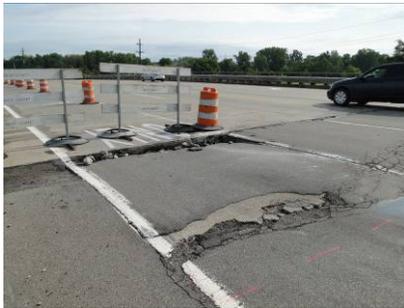
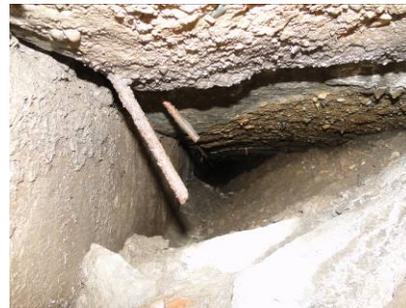
A bridge approach that has settled or been raised by PG creates additional impact force on the deck. A void beneath the pavement presents an unneeded hazard and further inspection is required to determine if it is a result of PG or poor construction.

*Figures 29 & 30. Approach settlement and void behind backwall*

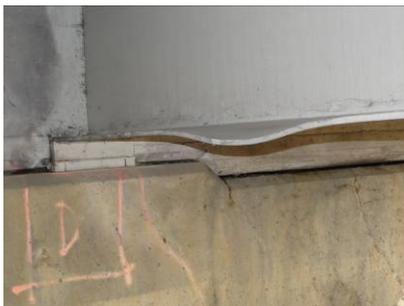
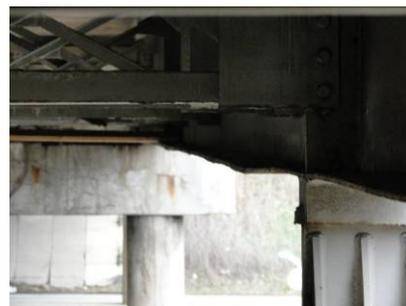
If the previous signs are ignored tailspan beams may buckle from longitudinal pavement stress. A buckled beam could possibly be heatstraightened. Retrofitting a heatstraightened beam with a bolted repair is a temporary fix, and would require attentive monitoring until replacement.

*Figure 31. Buckling tailspan beam*

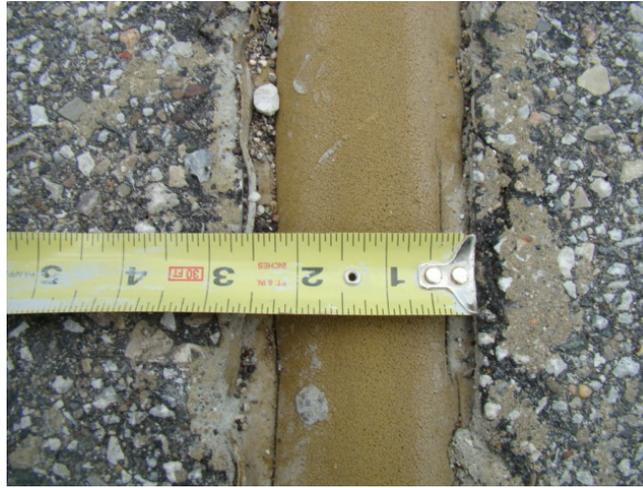
*Figure 36.* Inspectors should measure the joint to prevent future damage

Once a PRJ has been installed work is not finished. It is very important for bridge inspectors to monitor the width of the joint and communicate to maintenance staff when a replacement is required. If the joint measures 1" to 2" a replacement should be added to the list of annual maintenance work crew recommendations. When a PRJ measures less than 1" it should be replaced immediately to eliminate the opportunity for damage.
