THIRD CONDITION SURVEY OF EXPERIMENTAL CONTRACT  
RESEALING AND PATCHING

US-16 Nunica to Fruitport  
Project Mc 70-28, C3

(Research Project 53 G-68)

Progress Report No. 5

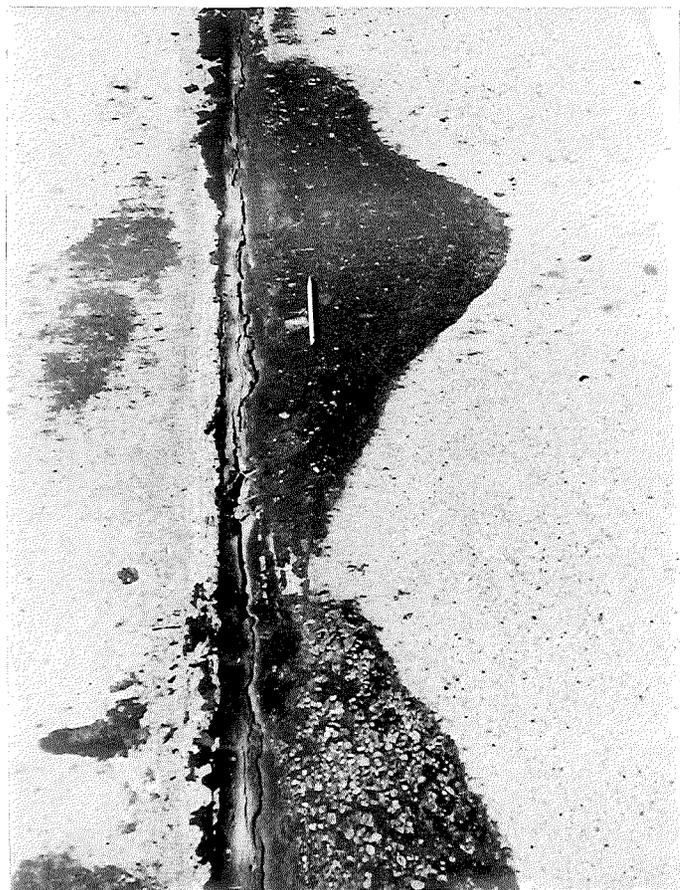
In the current survey it was found that the only major changes since the previous survey had occurred with Brands A and C sealer in transverse joints. With the exception of a few adhesion failures, Fig. 1-A, all the Brand A failure is now manifested as cohesion failure, Fig. 1-B. The deterioration of Brand B sealer has continued to the point where all transverse joints containing this sealer have failed in adhesion, Fig. 2.

A. Station 655+50 N. Failure mainly in adhesion.

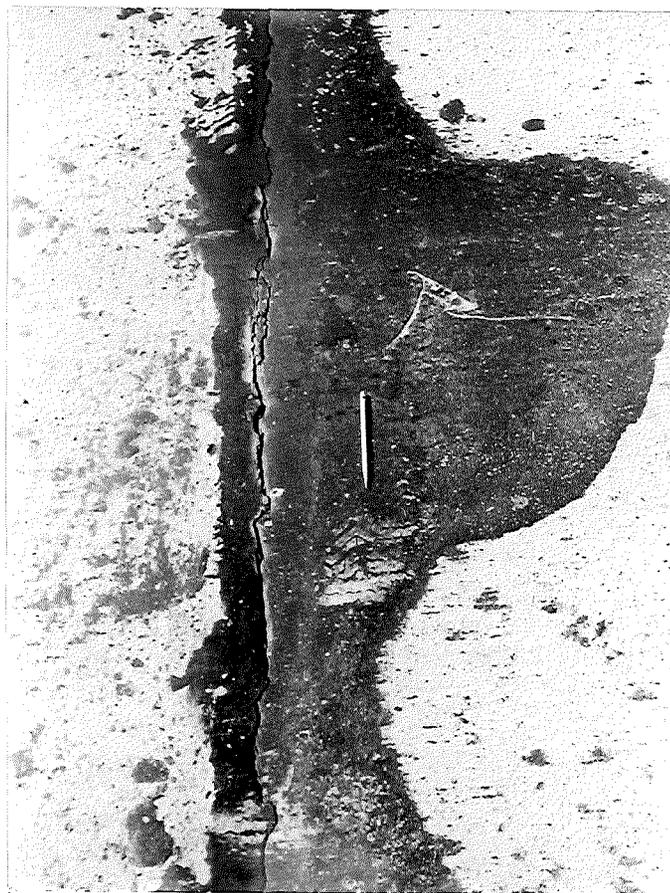
B. Station 629+30 N. Failure mainly in cohesion - Typical of Brand A failures.

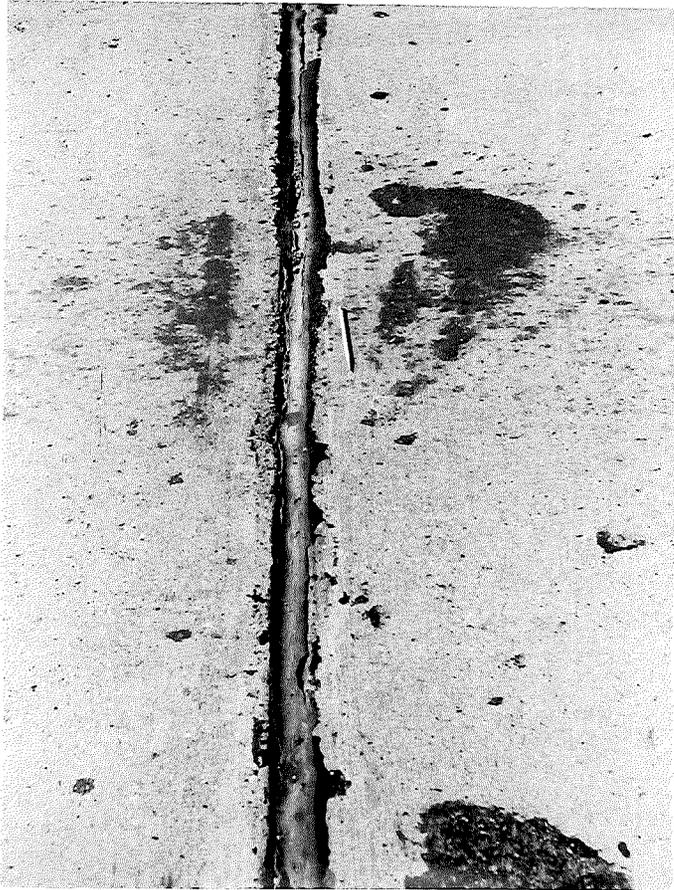
A. Station 645+50 N. Adhesion failure - Typical of joints resealed with Brand B.

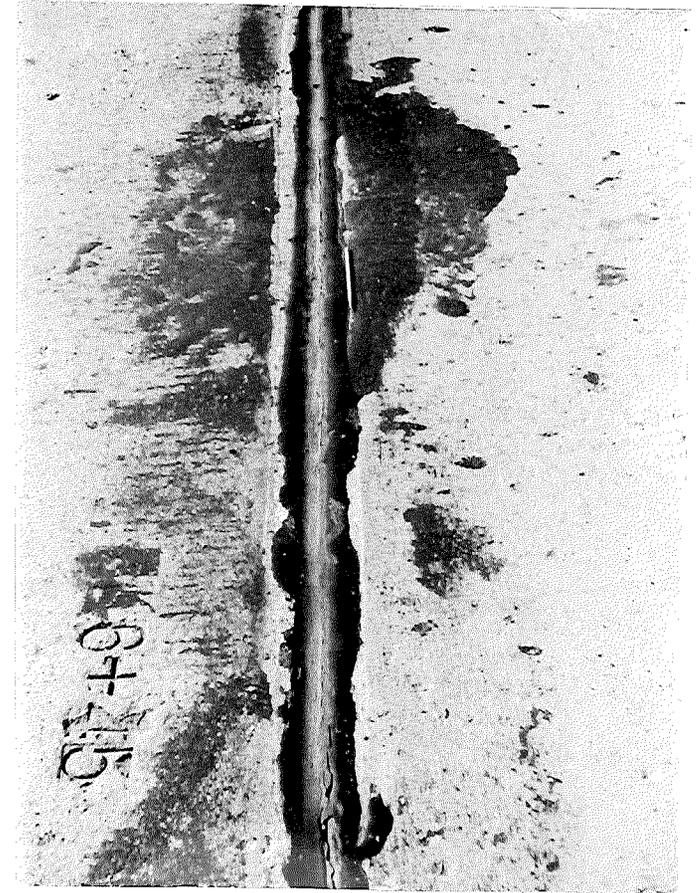
B. Station 646+45 N. Best joint containing Brand B. Adhesion failure only near pavement edge.

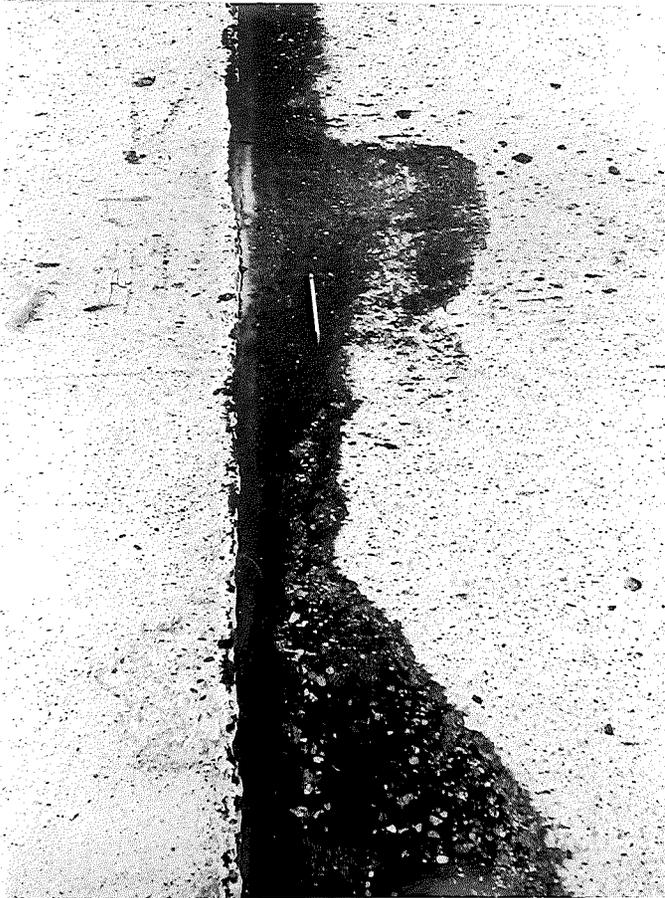
The remainder of the maintenance repairs appear to be in exactly the same condition that they were a year ago. The Brand C sealer still shows adhesion failure in only a few transverse joints with most of them in good condition, Fig. 3. Transverse joints containing Brands D, E and F are still well sealed with no apparent failures of any kind, Fig. 4.

A. Station 514+97 S. The sealer in this joint has lost adhesion to the joint face.

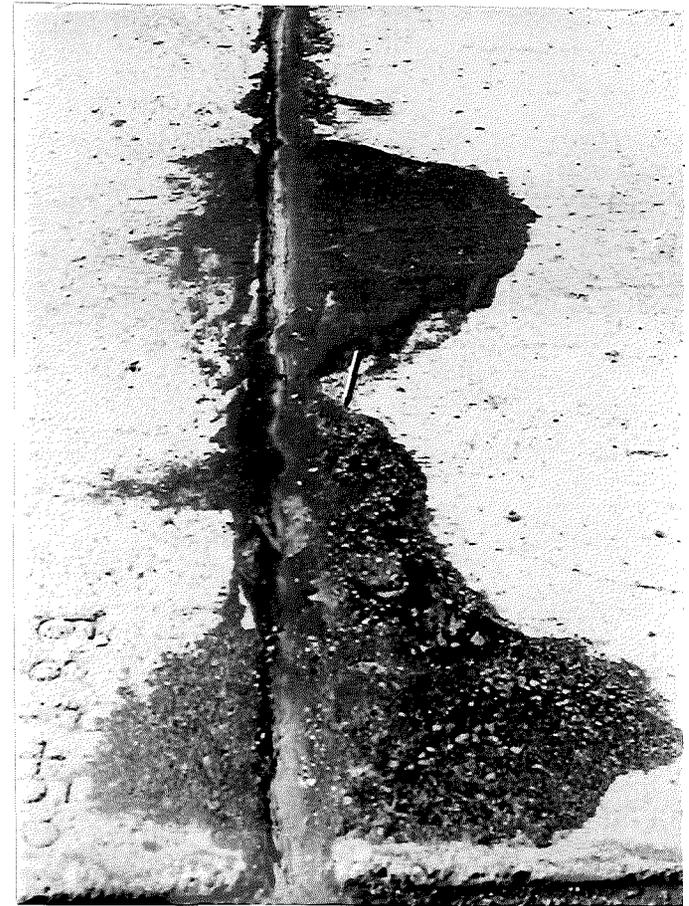
B. Station 587+52 N. This joint has no failures and is typical of joints containing Brand C.

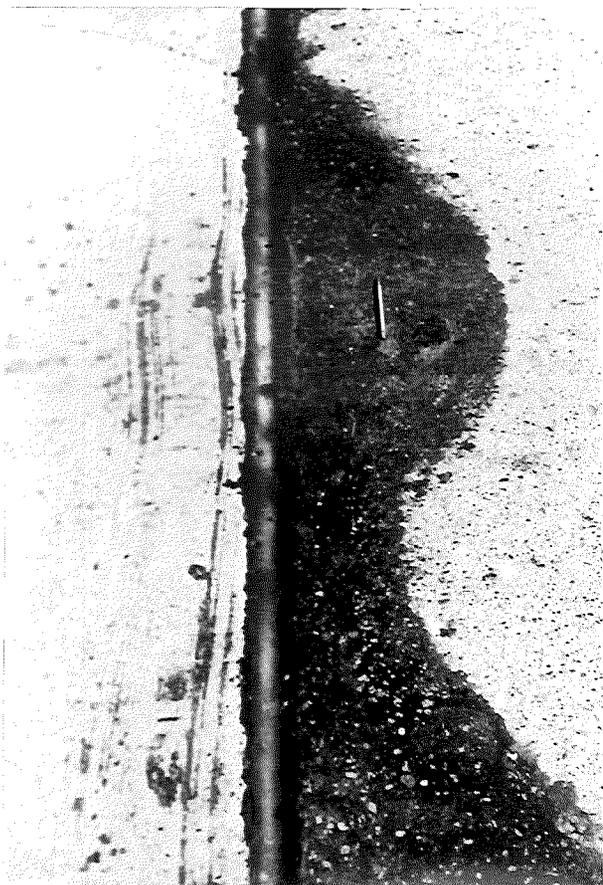
A. Station 482+50 S. Brand D  
in good condition.

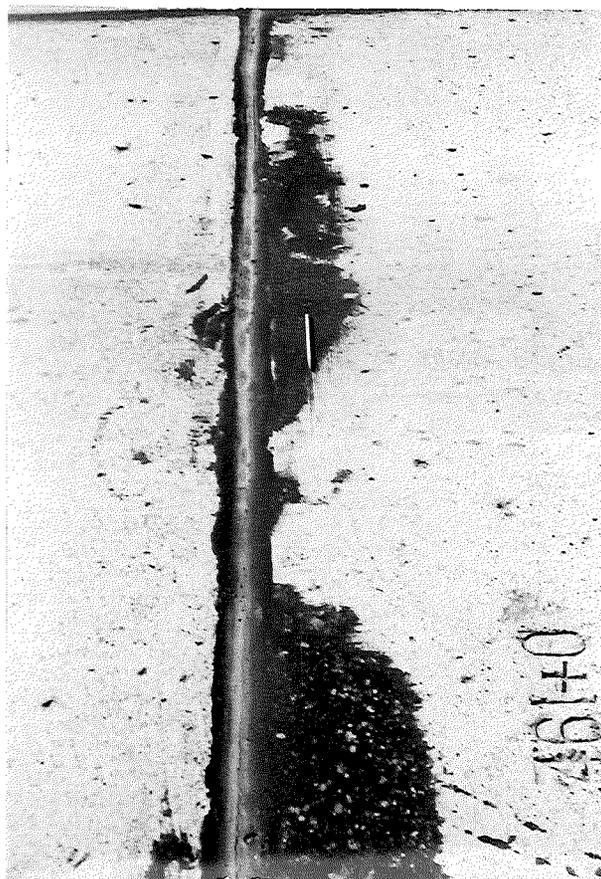
B. Station 461+00 N. Brand E  
in good condition.

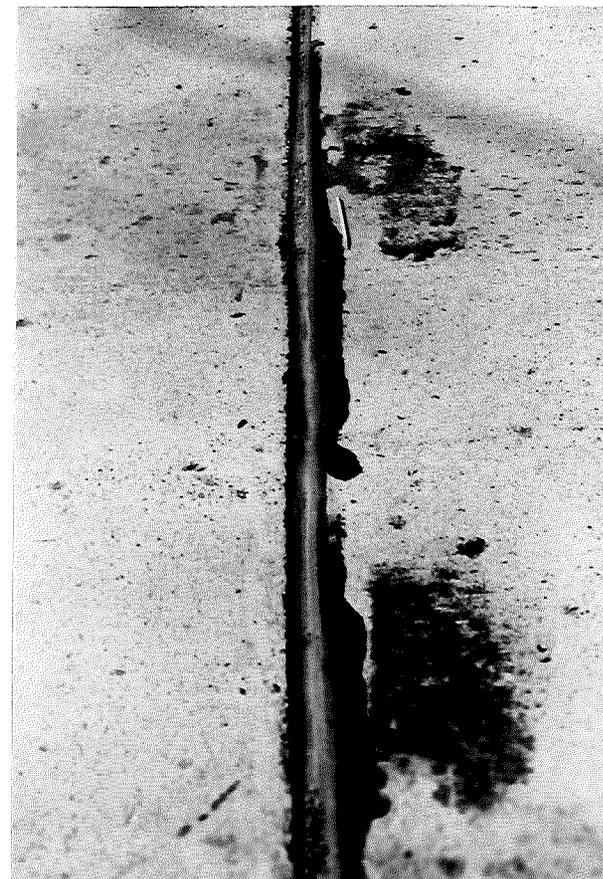
C. Station 430+20 N. Brand F  
in good condition.

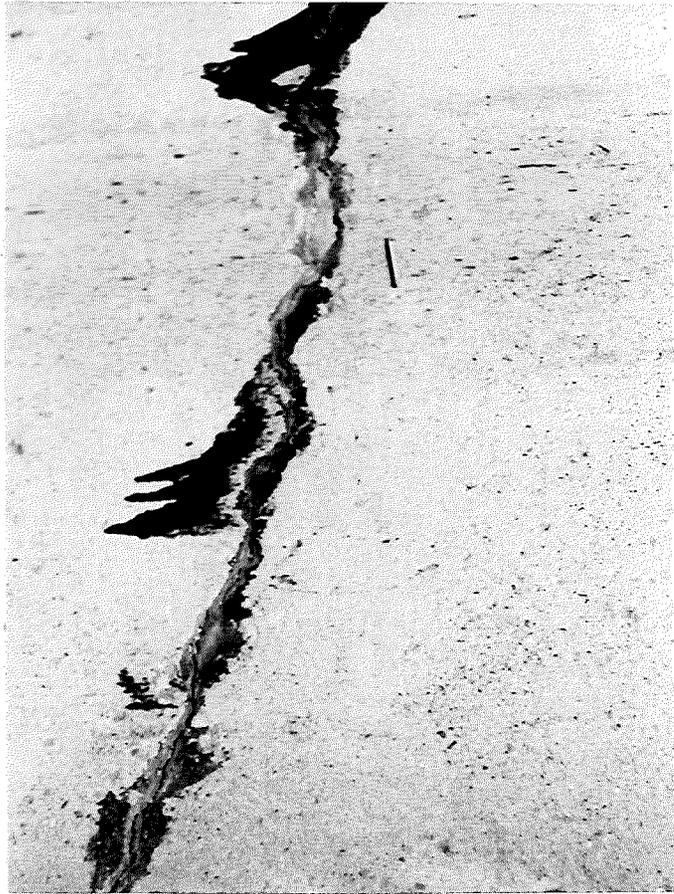
Open cracks sealed with Brands A and C still show cohesion failures, Fig. 5, while the longitudinal joint and fine cracks are still completely sealed, regardless of the brand of sealer used.

A. Station 582+60 S. Sealed with Brand A. Failed in cohesion.

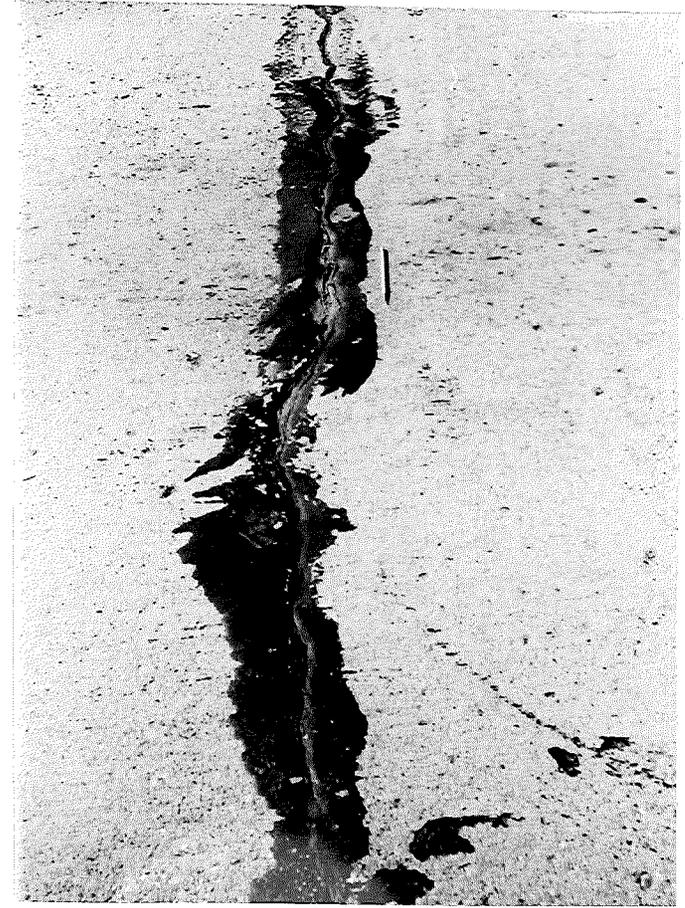
B. Station 582+60 N. Sealed with Brand C. Failed in Cohesion.

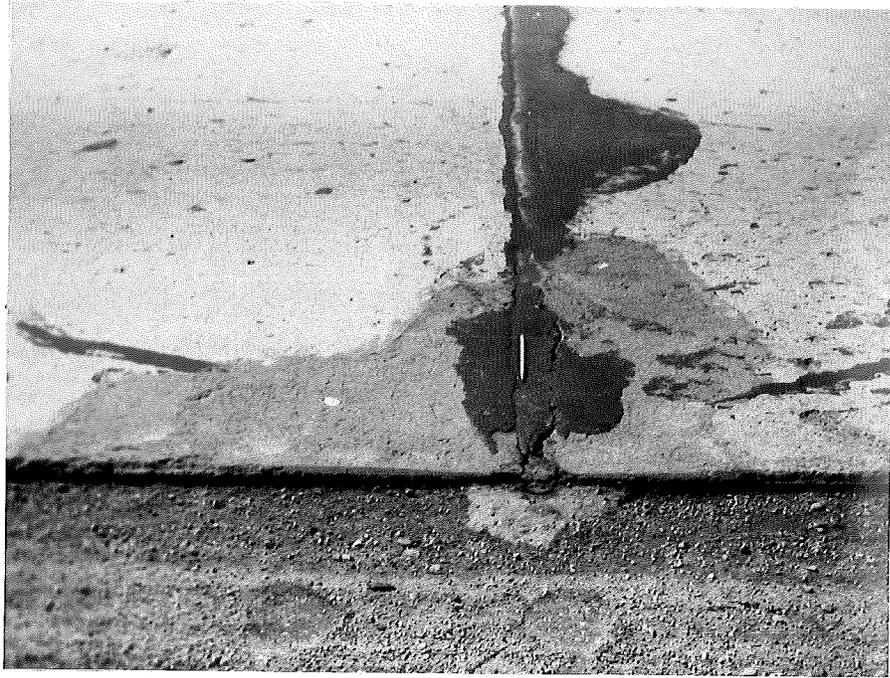
The concrete patches are still remaining bonded to the old concrete and are intact, although some scaling of their surfaces is now apparent, Fig. 6.

Figure 6. Station 451+00 N. Typical Appearance of Repaired Corner Breaks on March 19, 1956. After 2-1/2 Years of Service.
