OFFICE MEMORANDUM

MICHIGAN
STATE HIGHWAY DEPARTMENT

Subject: Investigation of Deck Cracking. EBI-96 Over the Grand River in
Grand Rapids. B02 of 41027A, C2. Research Project 63 B-72.
Research Report No. R-442.

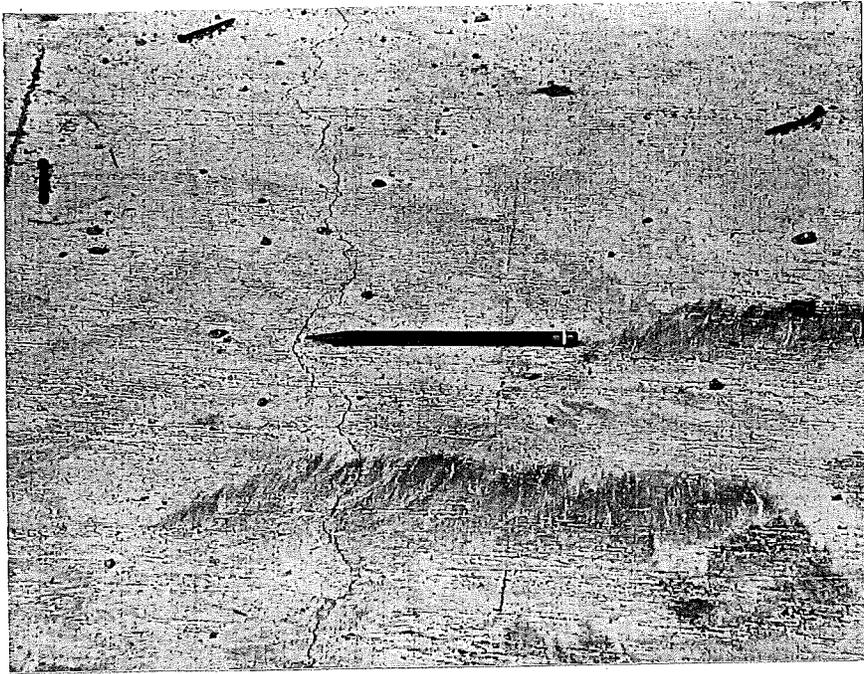
In all probability, the deck cracking is primarily due to plastic shrinkage caused by an excessive rapid evaporation of water from the concrete surface. Only one outside pour, FJM, had a low number of cracks and this was poured on the only cloudy and overcast day. Because the greatest amount of cracking occurred in the exterior lane pours, it is quite likely that a good deal of the cracking was also the result of induced tensile forces in the exterior lane pours brought about by an elongation of the structure as the temperature increased from early morning till late afternoon. The 24 foot central slab area which was poured first would greatly add to the heat absorption volume of the structure surface being heated, and the slab reinforcing would exert tensile forces on the freshly placed exterior segments as the structure elongated.

Figure 1. Typical fine transverse crack mainly in outer pours.

These corrective measures would include the following:

1. Utilization of cold mixing water.
2. Keep the aggregate ^{7. cool} ~~cool~~ by intermittent sprinkling of the stockpile or sprinkling successive layers as the stockpile is built up.
3. Shading the aggregate stockpile from the direct rays of the sun.
4. Keep the forms and reinforcing steel protected from the direct rays of the sun and cool by sprinkling.

5. Start curing the concrete as soon as possible after placing and finishing. Particular attention should be paid to having all facilities ready for prompt initiation of curing.

6. After placing, and before application of curing compound, keep surface moist with fog sprays.

7. Erect wind breaks to reduce wind velocity over the concrete surface.

8. Provide sun shades to control surface temperatures.

In addition, all exterior pours should begin in mid-afternoon, so that the structure would be in the process of cooling off and contracting during the time interval these sections were being placed. This would tend to put the fresh concrete in compression rather than tension as it cured.

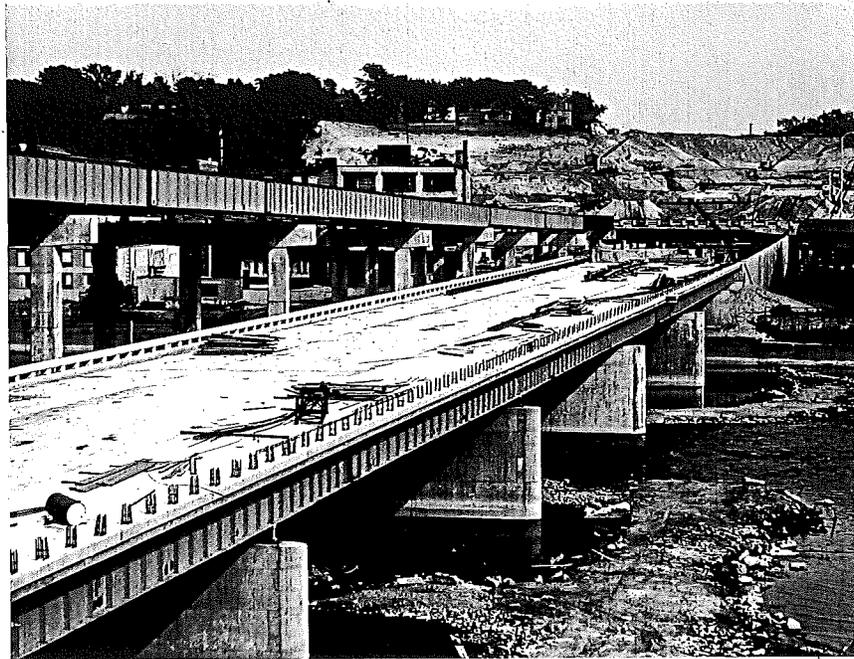
Figure 2. General view of eastbound deck looking east. Higher westbound deck in background.
