APPLICATION AND PERFORMANCE OF
EPOXY SEALANTS ON BRIDGE DECK AND WALKS
Houghton-Hancock Lift Bridge (B01 of 31012)

Research Laboratory Division
Office of Testing and Research
Research Project R-62 B-66
Research Report No. R-466

Michigan State Highway Department
John C. Mackie, Commissioner
Lansing, August 1964

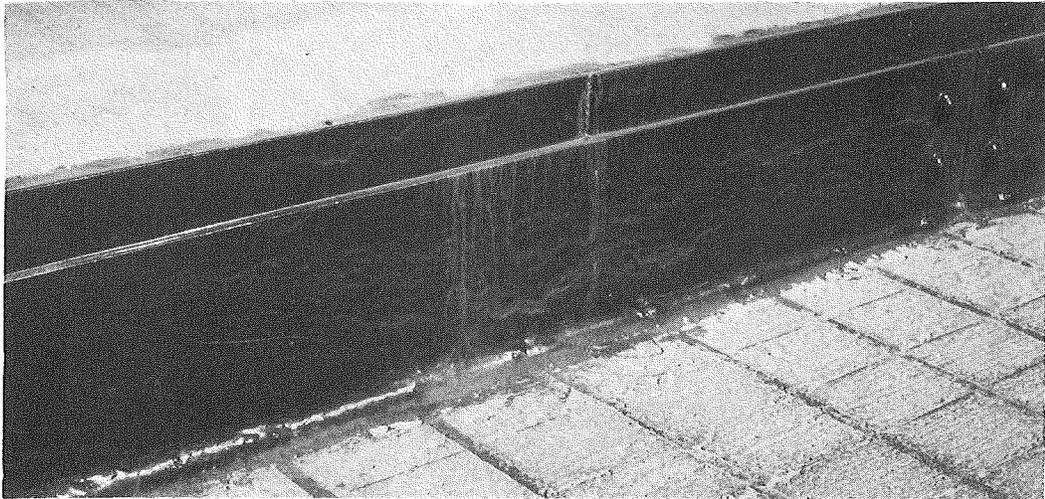
The steel curbs on the upper deck were sandblasted to remove all paint and rust, with care taken not to damage the epoxy fillet that had been placed at the junction of the curb and the deck in 1962. After sandblasting they were coated by roller with flow-resistant Guardkote 140 FR using about 75 sq ft per gal (Fig. 2).

Figure 2. Steel curb just after coating with flowing resistant coal tar epoxy (Guardkote 140 FR). Coving (Resiweld 633) visible at curb-deck joint was done in 1962 (photo: 8-30-63).

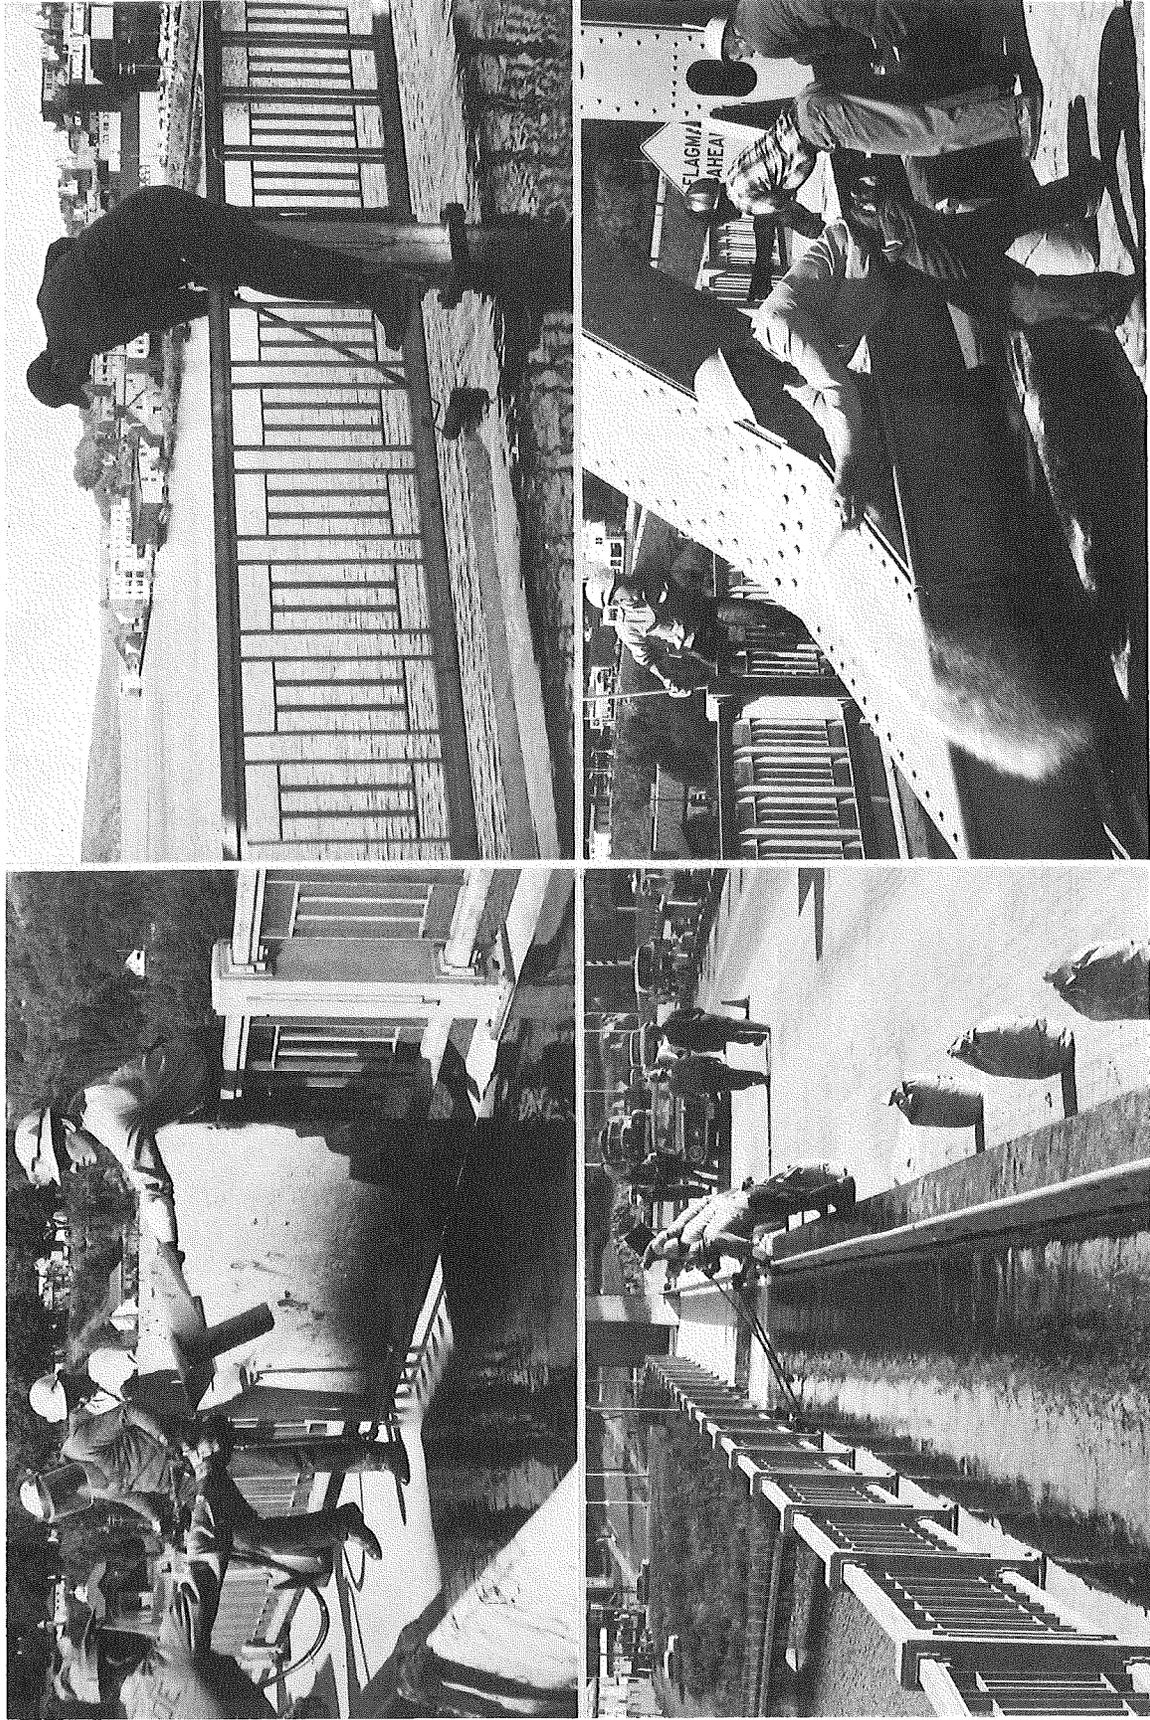
The Guardkote 140 was applied using a hand spray bar attached to the Broyhill Resinous Paver. This provided a positive measurement of the two components as they came from the Paver and assured a 1:1 mixture, by volume, in the spray bar. Areas that could not be reached with the bar (such as under railing and splash guards) were coated with mohair rollers. Immediately after epoxy application, quartz was broadcast by hand into the epoxy until no wet areas were visible. After the epoxy had cured the excess quartz was swept off for re-use on the deck. Stages of walk repair are illustrated in Fig. 3.

Figure 3. Application of epoxy sealer to walks included use of hand-held spraybar on accessible areas (upper left), and mohar rollers under railings (upper right and lower left). After epoxy was applied, quartz aggregate was spread over the fresh surface (lower right).

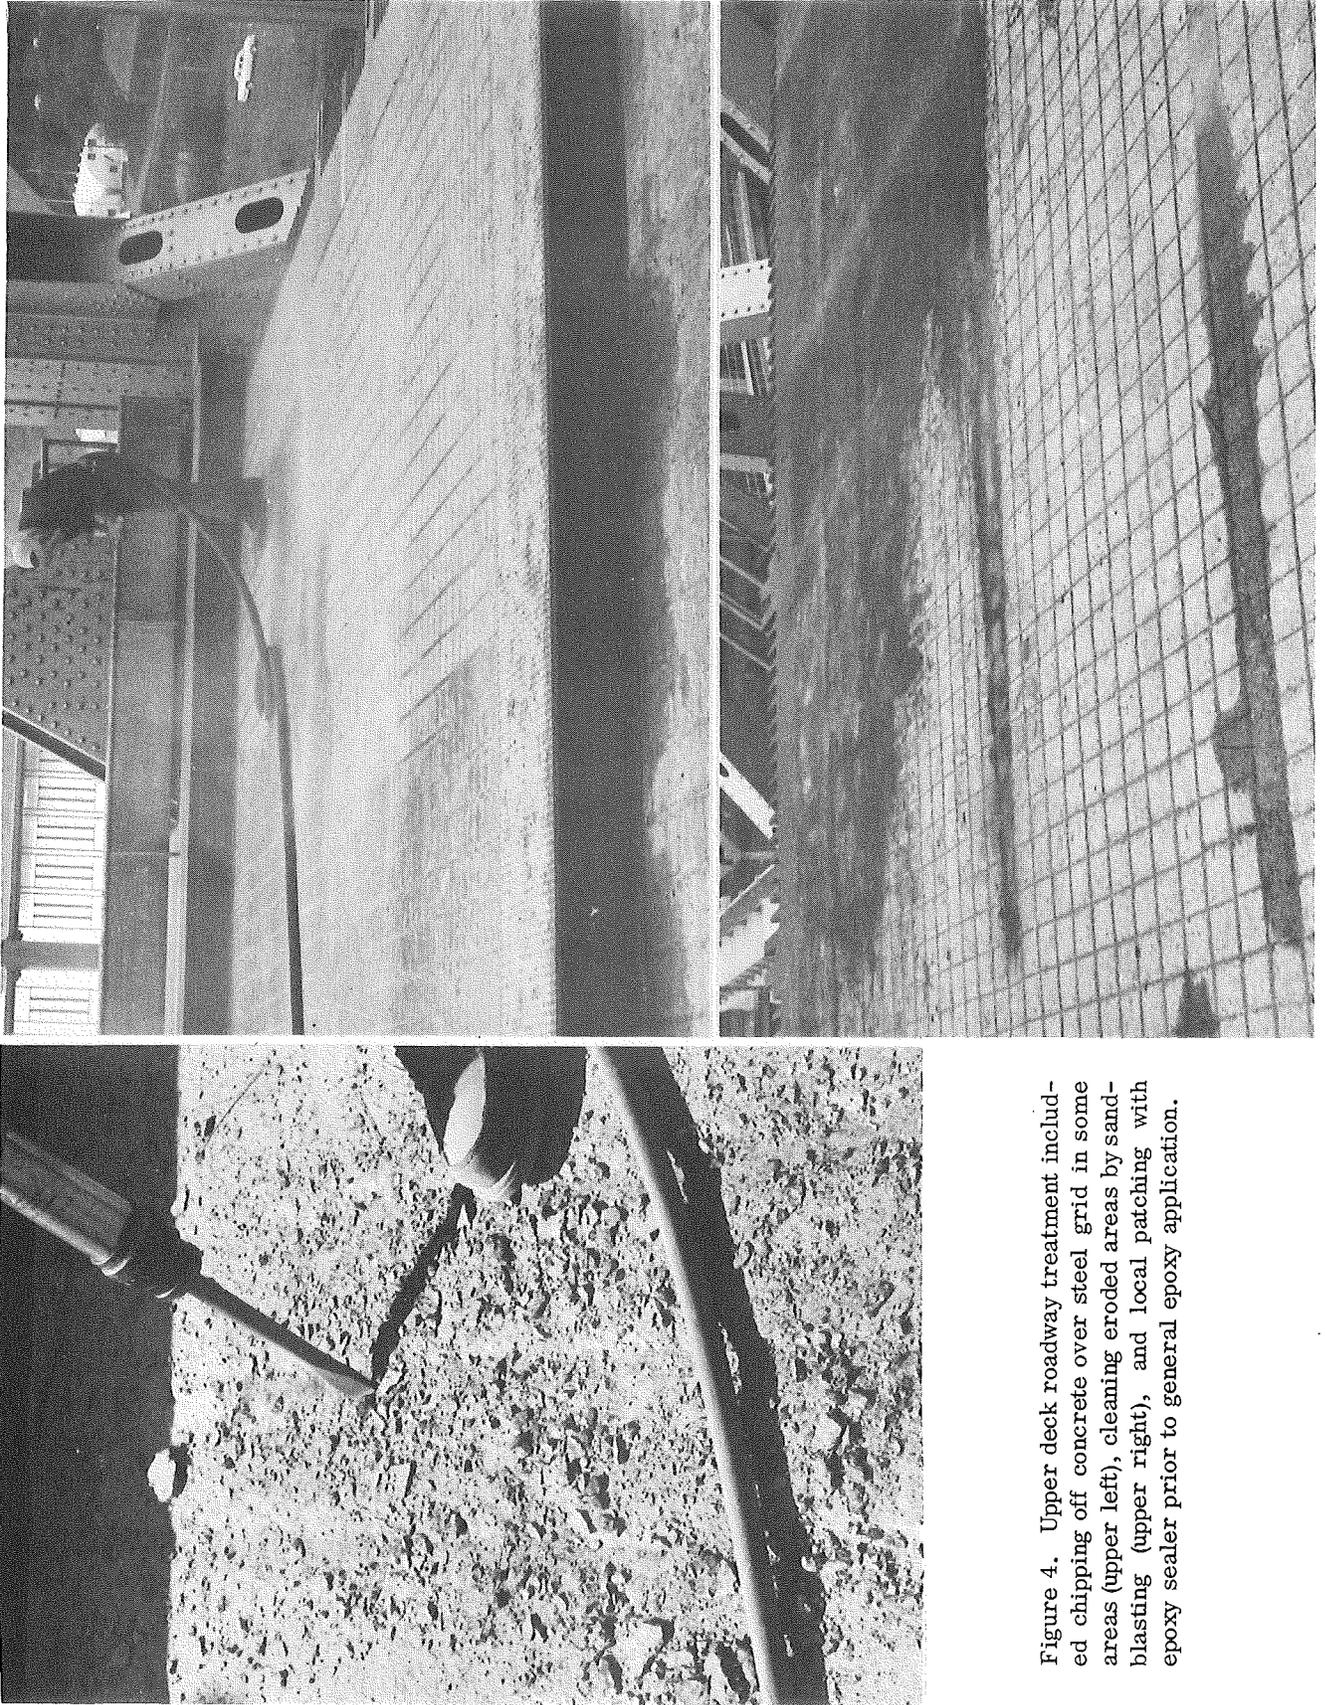
Considerable preliminary preparation of the upper deck was required prior to its sealing. An area of about 69 sq yd on the south end was badly scaled and required patching. Other areas were found where the steel grid was covered by only a thin layer of concrete. To prevent these areas from breaking loose after the deck was sealed, it was decided to chip them off and patch the resulting depression. Patching was accomplished 1) by chipping out all unsound concrete, 2) by brushing on a tack coat of Guardkote 140, and 3) by patching with a fairly stiff Guardkote 140 mortar which was screeded off level with the top of the steel grid. Sand was sprinkled on the patches to provide a better bond with the subsequent seal coat. Some difficulty was encountered in removing spots of cable lubricant that had been tracked across the deck, since they could not be removed by sandblasting; the same method of removal that had been used on the walks proved successful although time-consuming. Steps in deck preparation are illustrated in Fig. 4.

Figure 4. Upper deck roadway treatment including chipping off concrete over steel grid in some areas (upper left), cleaning eroded areas by sandblasting (upper right), and local patching with epoxy sealer prior to general epoxy application.

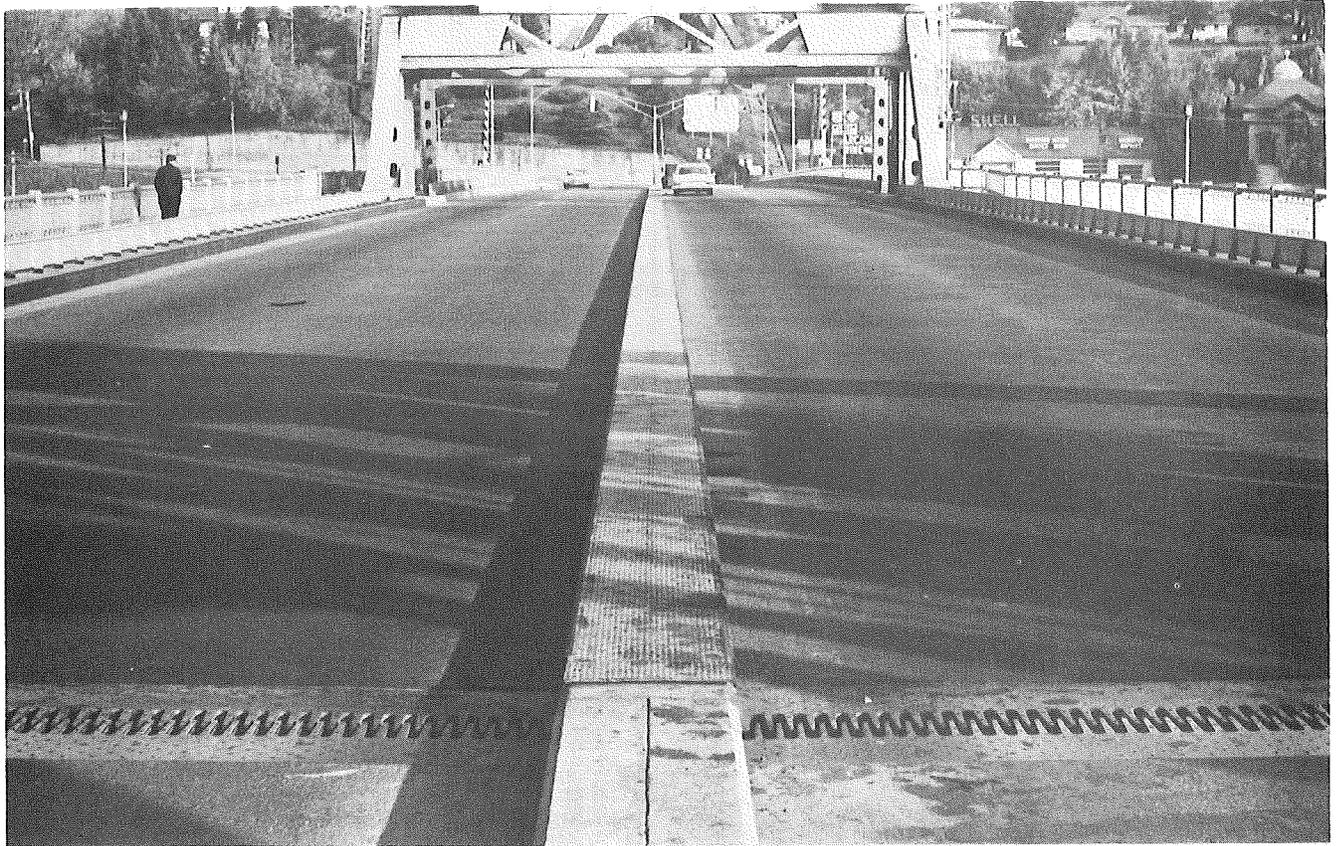
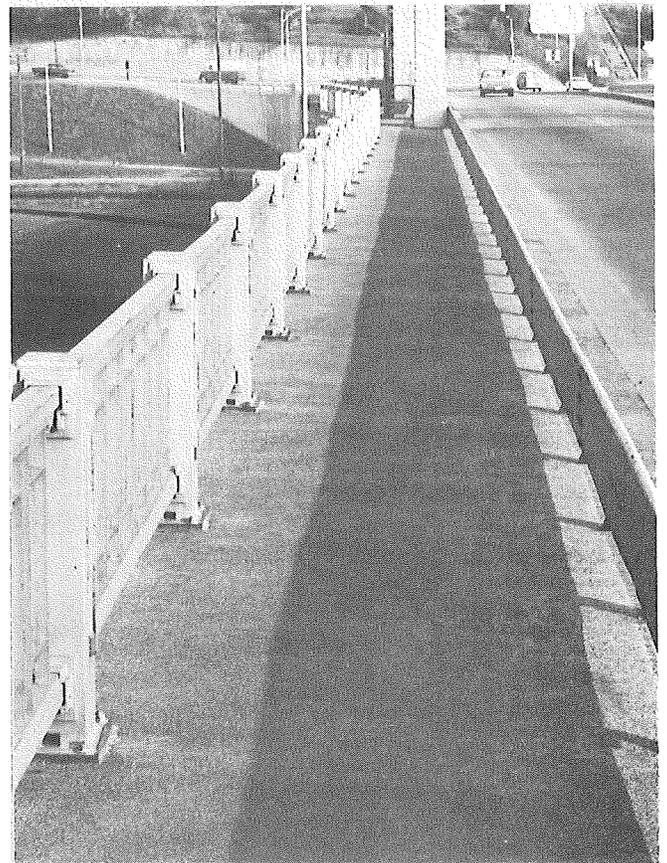
The Highway Bridge Deck Committee inspected the newly applied sealers on October 16, 1963 and found the deck, walks, and curbs in good condition (Fig. 5).

Figure 5. General views after sealing of lift span upper deck (top: sealed 9-11 and 12-63, photographed 10-16-63), and west walk (bottom: sealed 9-4-63, photographed 10-16-63), both looking north.

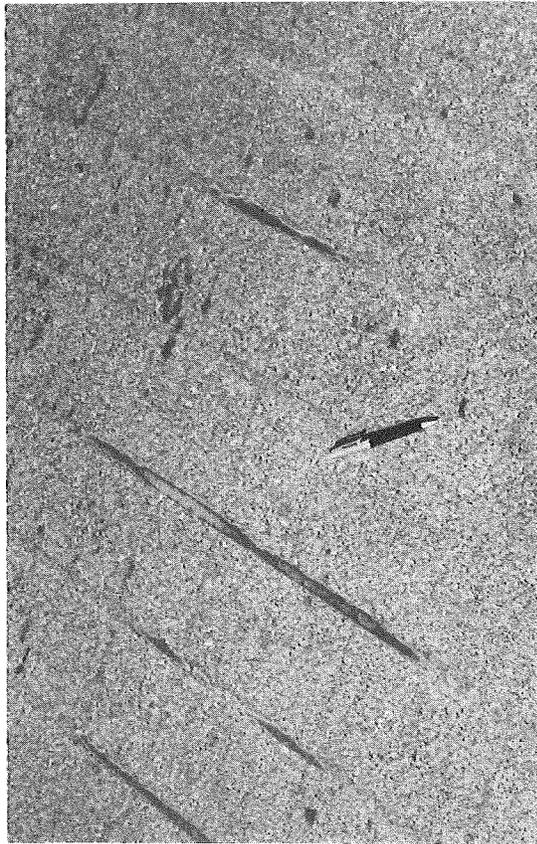
Upper Deck Roadway. In the northbound lanes, about 70 spots were found where the transverse steel grid was exposed, primarily in wheel-track areas (Fig. 6). As yet, no loss of epoxy bond to concrete was apparent surrounding spalls over the steel grid. In the northbound traffic lane, grid exposure at about 15 locations varied in length from 6 in. to 3 ft, mostly in the outer wheelpath and in the central third of the span. In the northbound passing lane, the situation was more serious and the grid was exposed to varying degrees at about 50 locations, mostly in the outside wheel track. By contrast, both southbound lanes were in good condition with the grid visible at only three points in the traffic lane. At the time of inspection, the steel grid pattern beneath the sealant was visible, reflected as discoloration on the deck epoxy surface (Fig. 7). It appears that rust is coming through the coating, which suggests that the epoxy seal is less waterproof than expected.

Figure 6. Typical area where transverse steel bars have become exposed through the epoxy seal coat (photo: 5-20-64).

The probable causes for the differences in coal tar epoxy durability between the northbound and southbound deck lanes could include: 1) dampness, 2) inadequate cure, or 3) high steel.

1. Soon after the epoxy had been sprayed on the northbound lanes and before all the quartz aggregate had been applied, it rained. The water probably did not seep through to the concrete and steel, but undoubtedly would cause poor bond of epoxy to the quartz. This would tend to weaken the composite seal coat.

2. The weather turned cooler after the northbound lanes had been coated, and since the curing rate for this type of epoxy depends on temperature it is possible that the deck was opened to traffic before curing adequately. If this was the case, the coating could have been rolled thin by traffic in the wheel track areas.

3. It was noticed at the time of repair that some of the steel grid protruded above the level of the concrete in the northbound lanes. This would tend to leave a thin coating over the steel. It should be noted that although high steel was observed at the time of repair, it was not in sufficient evidence to cause this much damage to the seal coat.

Although no indication of leaking has been noted under the upper bridge deck, which was the primary reason for having the bridge sealed, steps should be taken for immediate repair of the defective areas before they cause loosening of the epoxy seal coat in adjacent areas. The supplier of the coal-tar-modified epoxy materials should be consulted, to obtain his views on the noted failures and his recommendations for corrective treatment.

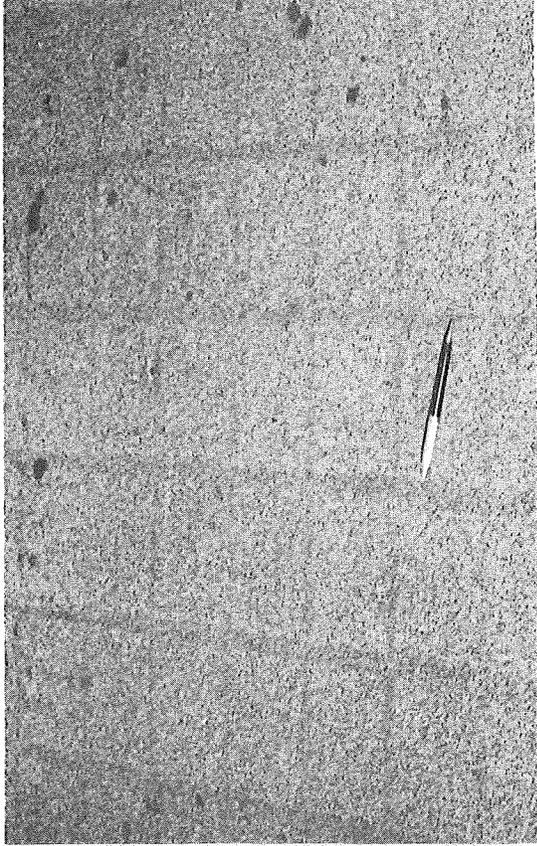
Figure 7. Discoloration in coal tar epoxy sealant coating above the steel grid (photo: 5-20-64).

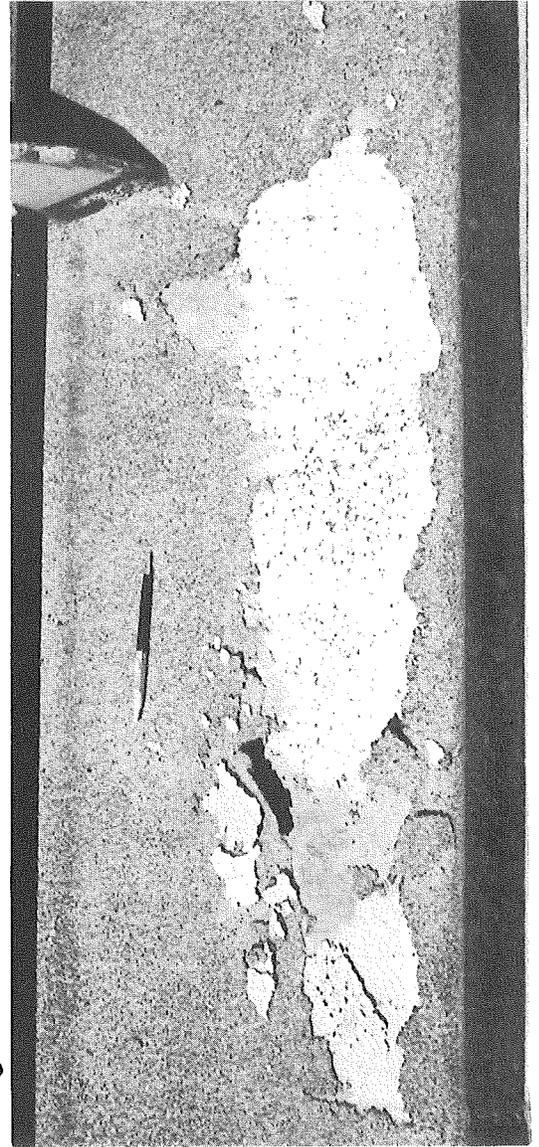
Figure 8. Epoxy flaked off of upper deck west walk between curb and splash guard; poor adhesion surrounds flaked area (photo: 5-20-64).

Upper and Lower Deck Walks. The upper deck walks were generally in good condition, with one small hole near the splash guard at the north end of the east walk where a worker apparently had stepped into the epoxy before it had hardened, and another larger hole about 90 ft from the south end of the upper deck west walk. Here, epoxy in an area about 2 ft square between the curb and splash guard had lost bond with the concrete (Fig. 8), and material around this hole was losing bond and will probably flake off. It appears that this material was sprayed on over a thin laitance film which sandblasting did not remove. The lower deck walks were both in good condition with only a few small holes visible on the east walk (Fig. 9).

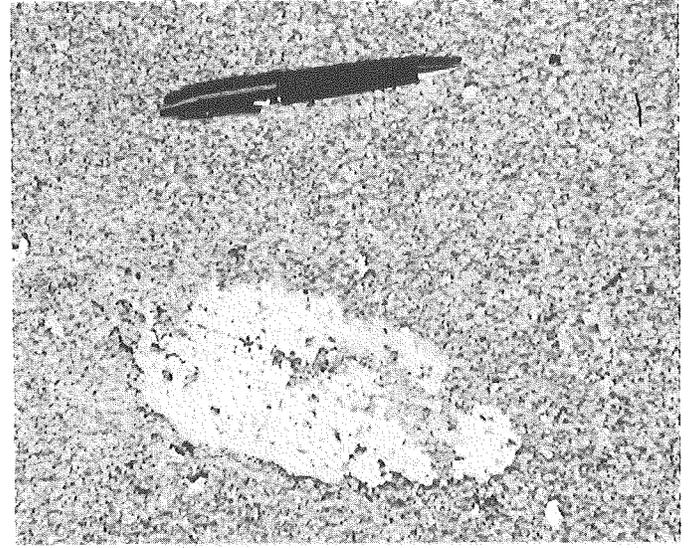
Figure 9. Small adhesion loss found in the lower deck east walk seal coating (photo: 5-20-64).
