EVALUATION OF HOOK BOLTS  
FOR LONGITUDINAL BULKHEAD CONSTRUCTION JOINTS

Research Laboratory Division  
Office of Testing and Research  
Research Project R-58 F-50  
Research Report No. R-485R

Michigan State Highway Department  
Lansing, January 1965

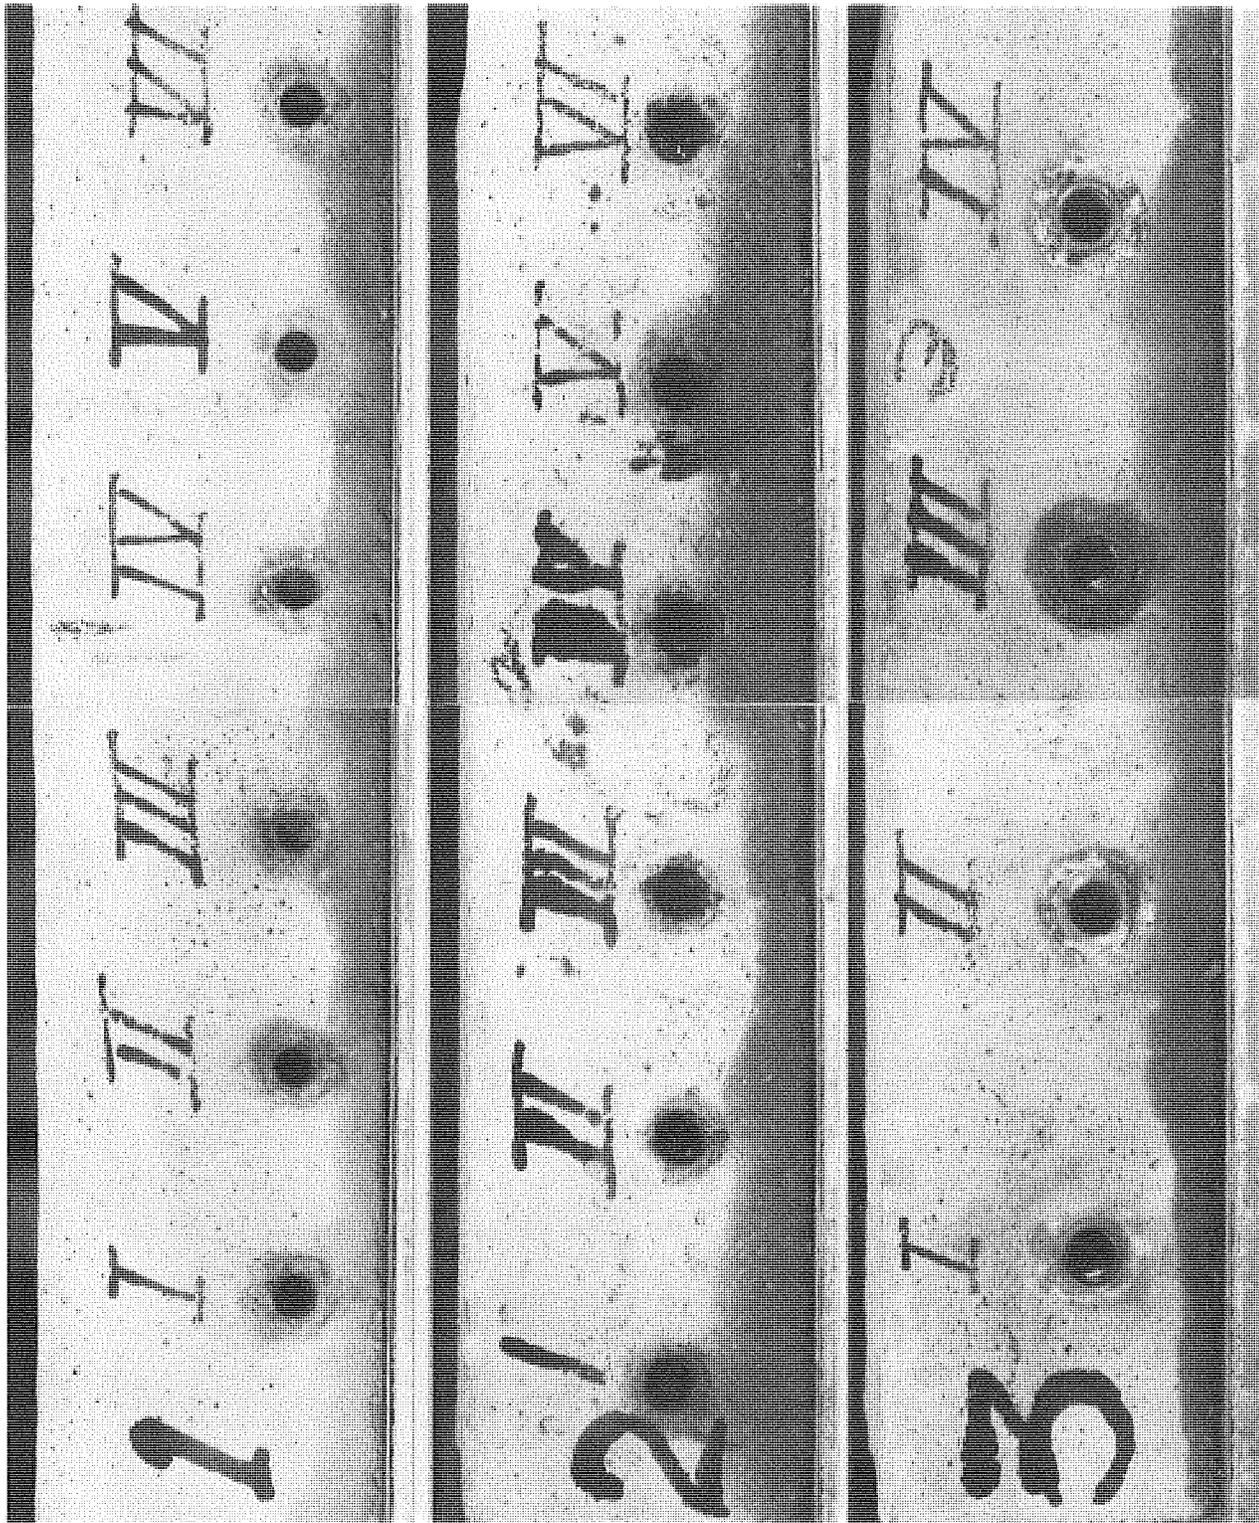
Block No. 1. The coupling faces showed heavy corrosion to a depth ranging from 1/32 to 1/8 in. , and the first thread in each was corroded. In addition, all threads were corroded in Couplings III and IV, which had received no treatment whatever. The rust inhibitors had provided good protection and the couplings received the hook bolts with ease, again with the exception of Couplings III and IV which required retapping to the same thread size before hook bolts could be screwed into the sleeves.

Block No. 2. All couplings in this block showed corrosion on the end faces to a depth of approximately 1/16 in. and the first thread in each was also corroded. The hook bolts screwed into the couplings with ease, although in Couplings III, IV and VI a small force exerted on a wrench was required, possibly because of pigment from the rust inhibitors having collected in the thread grooves.

Block No. 3. No corrosion was noted on the end faces nor on the internal threads of the couplings and they all received the hook bolt with ease. However, the head on each bolt used to seal the sleeves was heavily corroded, and cleaning was required before a wrench could be applied to remove the bolts.

The condition of the couplings after the six-month inspection is shown in Fig. 1. The experiment failed to show any appreciable difference in the corrosion preventive properties of various rust inhibitors used. With respect to sealing characteristics, the bolt-and-washer systems proved superior. To supplement the information obtained from the experiment it was decided that a section of a regular construction project would be selected in which the hook bolt couplings would be prepared against corrosion with various types of rust inhibitors and plugs.

Figure 1. Condition of hook bolt couplings after six months of embedment in corrosive environment Block No. 1 (top), Block No. 2 (center), Block No. 3 (bottom).

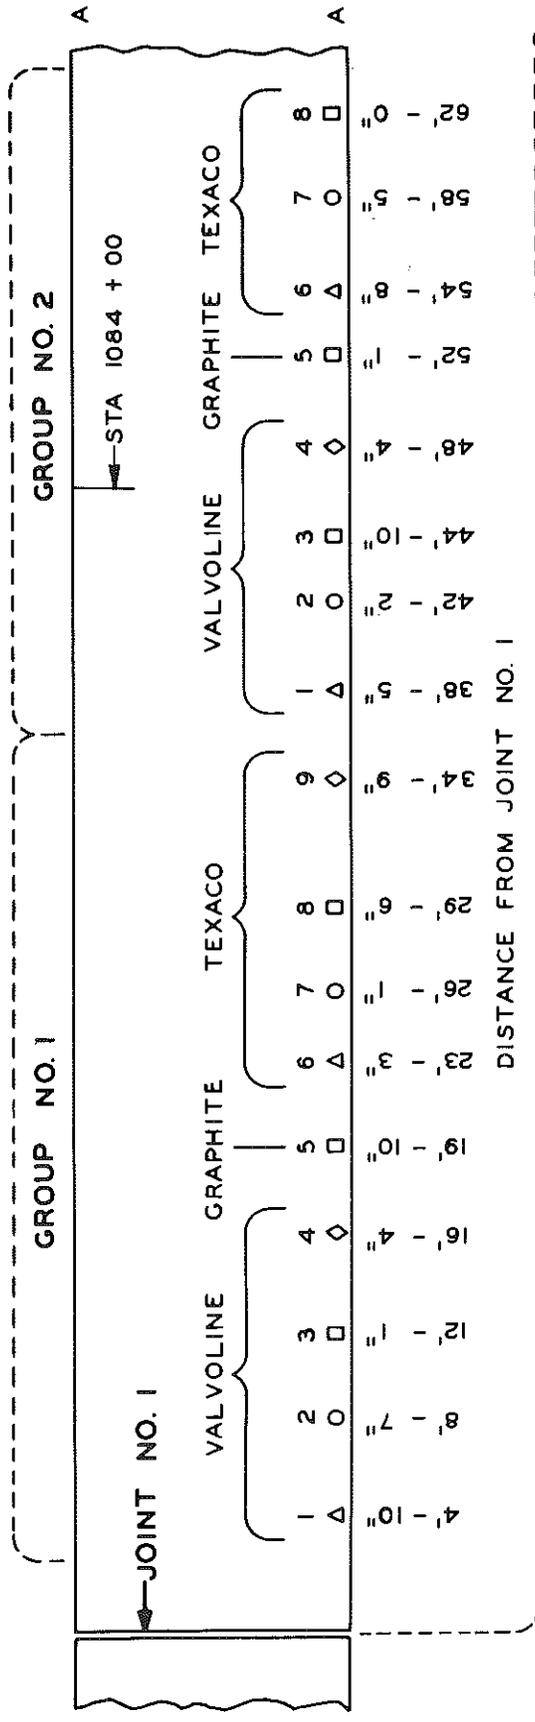
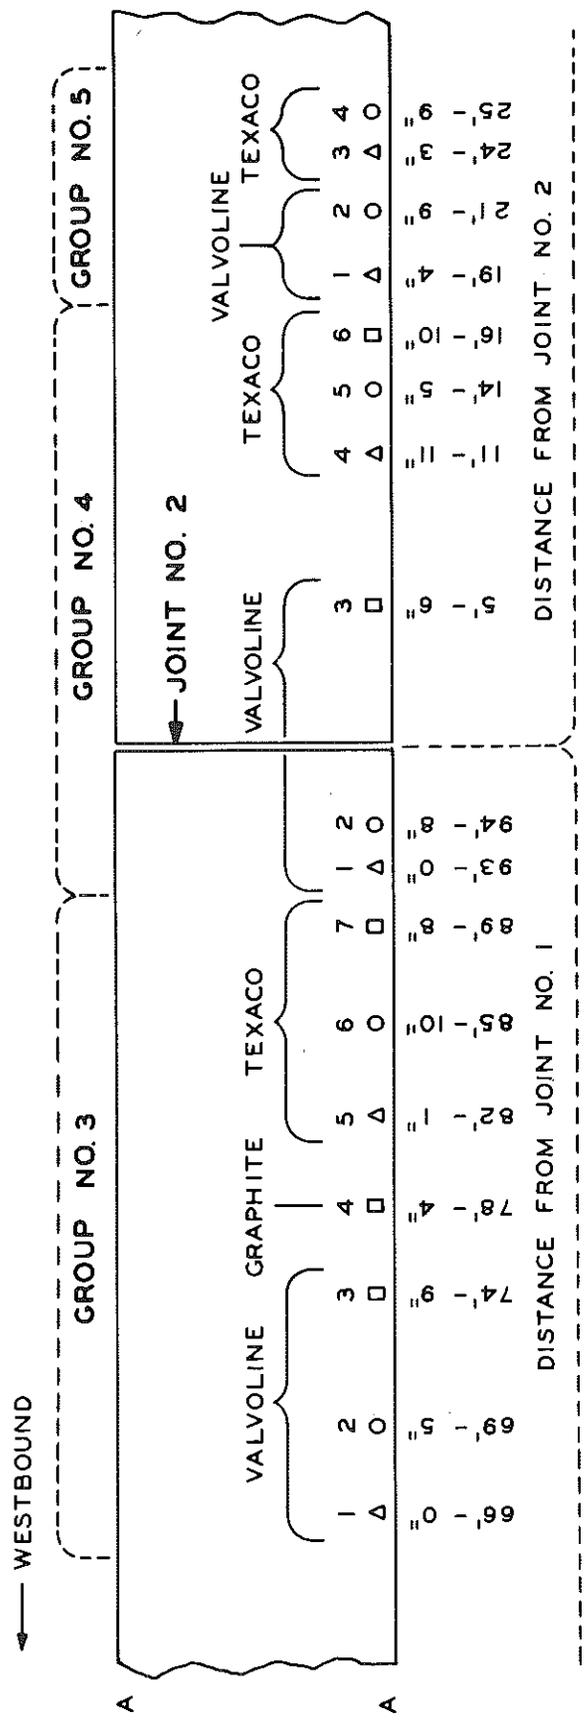
On July 15, 1960, nine months after installation, the nine couplings in Group No. 1 were exposed for examination and at this time it was discovered that the contractor, in the process of placing shoulder material, had allowed a scraper blade or similar piece of equipment to ride along the edge of the pavement damaging the plugs. The plastic cap screws and the corks were broken off flush with the pavement edge, the neoprene plugs were missing, and the hollow, tapered plastic plugs which protrude about 3/64 in. from the pavement edge had been damaged. Thus, it was not possible to evaluate the ability of the plastic cap screws to prevent corrosion of the coupling face. Examination of Group No. 2 on June 6, 1961, and Groups No. 3 and 4 on September 1, 1964, revealed that the plugs in these groups had also been damaged, in the same manner as Group No. 1.

Figure 2. Layout of I 94 experimental installation.

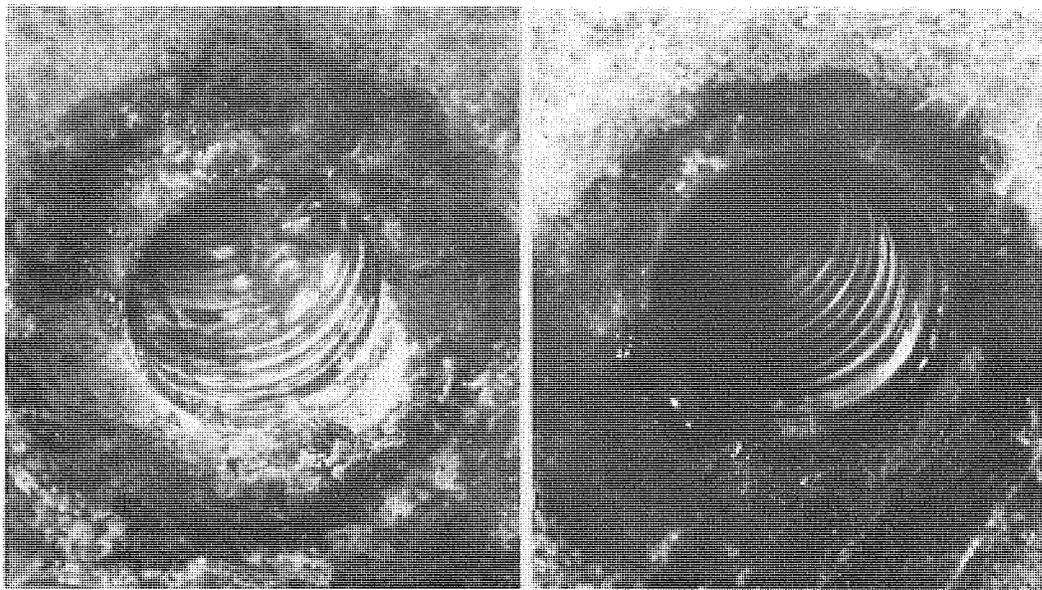
of the ability of the rust inhibitors to protect against corrosion indicated that the Valvoline oil during the five-year test period had retained its protective properties in all couplings. The Texaco oil appeared effective in the 1960 inspection, but in the couplings inspected in 1961 the oil had dried up. This was also the case for the couplings checked in 1964, except for one which still appeared to retain some protection. Of the three couplings protected with graphite grease, the one examined in 1960 showed that the graphite had dried up. The graphite in the coupling inspected in 1961 appeared intact, but had dried up in the one checked in 1964. As shown in Table 2 the threads in most couplings were rust free. Where rust is indicated, it was confined to the first few threads of the coupling. A check of the ease with which the couplings received the hook bolt during the 1964 survey indicated that the hook bolts could be classed as finger free fit. Typical condition of the Valvoline oil and coupling threads is shown in Fig. 3; although these photographs were taken during the 1961 survey, the condition illustrated is also representative of that observed in 1964.

**Figure 3.** Condition of couplings treated with Valvoline oil. Sealed with hollow plastic plug (right) and cork (left).

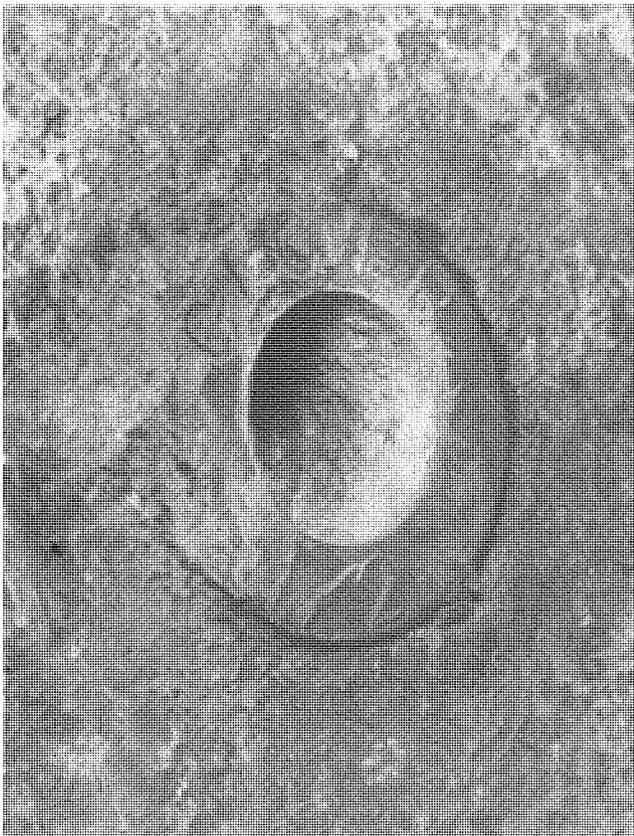
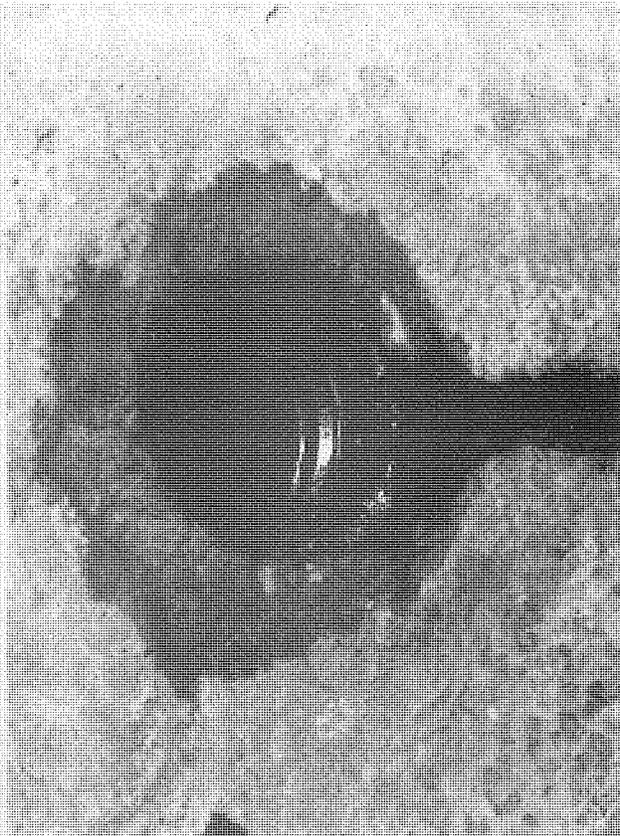
As soon as the plug was removed an attempt was made to screw the proper size hook bolt into the coupling without further cleaning of any kind. In general, all couplings except those where the plug was missing received the hook bolt with ease for the first three to four threads, but then became extremely tight so that full length engagement of the hook bolt threads could not be obtained even by use of a wrench. The rating of the couplings shows that this condition existed in 26 couplings, and only four could be used without retapping to same size. Moisture accumulation was noted in the bottom of the couplings, probably caused by condensation or seepage around the plugs. However, the dried-up graphite apparently had retained enough of its protective properties after four years to prevent corrosion of the threads, because very little rust damage was found. Typical condition of a properly sealed coupling and its threads after retapping to same size is illustrated in Fig. 4.

Figure 4. Typical condition of properly sealed coupling, showing sealing plug (top) and threads after retapping (bottom).

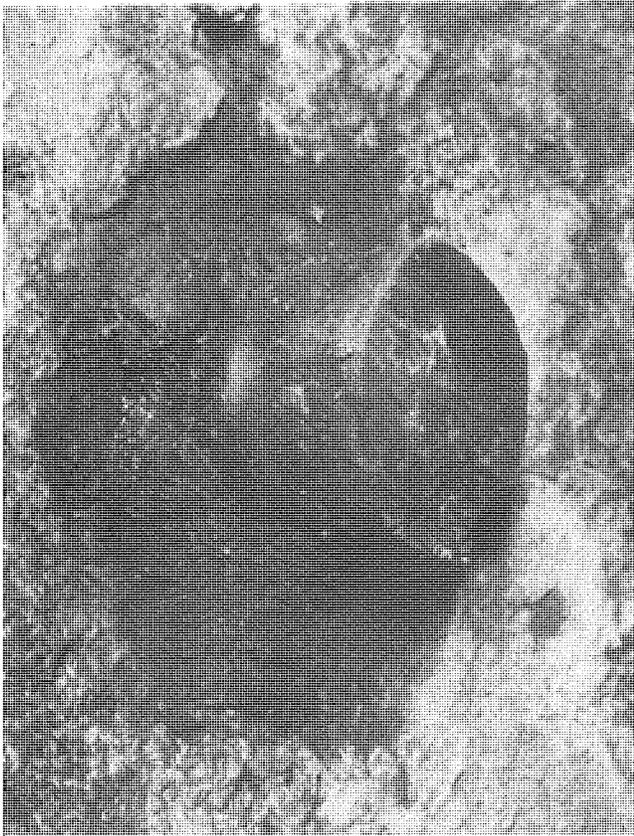
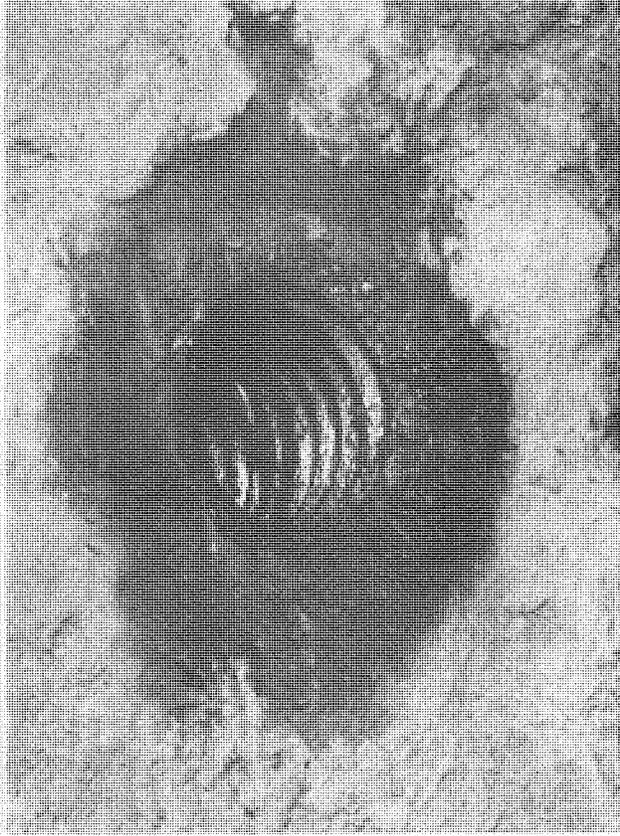
Construction Projects 11017, C3 and 11016, C1. The survey was confined to the portion of the project west of the I 94-I 196 interchange. In sealing the 9/16 NC couplings two types of plugs had been used--hollow, tapered plastic plugs and corks. The group of 10 couplings where the plastic plug was used had 30-percent damaged plugs. The remaining two groups of 10 each were sealed with corks, with the corks that were found to be intact protruding as much as 1/2 in. from the pavement edge. This condition permitted heavy damage (60 percent), probably inflicted by shoulder construction equipment having broken the corks off flush with the coupling face or pulling them out entirely. An unidentified grease material had been used in treating the couplings. This material appeared to have retained its lubricating properties, as well as protecting the threads from corrosion. It was exceptionally clean and free of sand, except in one case where the plug was missing. As a result 29 of the 30 couplings inspected received the hook bolt without cleaning in a finger free manner, and the remaining one was usable after retapping to the same thread size. Moisture accumulation was most pronounced in the couplings sealed with plastic plugs, probably because the corks (which were noted to be moisture saturated) absorb moisture accumulated in the coupling as well as moisture from the shoulder material. No serious rust damage was noted in any of the couplings after four years. Figs. 5 and 6 illustrate coupling conditions before and after removal of a cork and a plastic plug, respectively.

Figure 5. Typical condition of properly sealed coupling, showing sealing plug (top) and exposed threads (bottom).

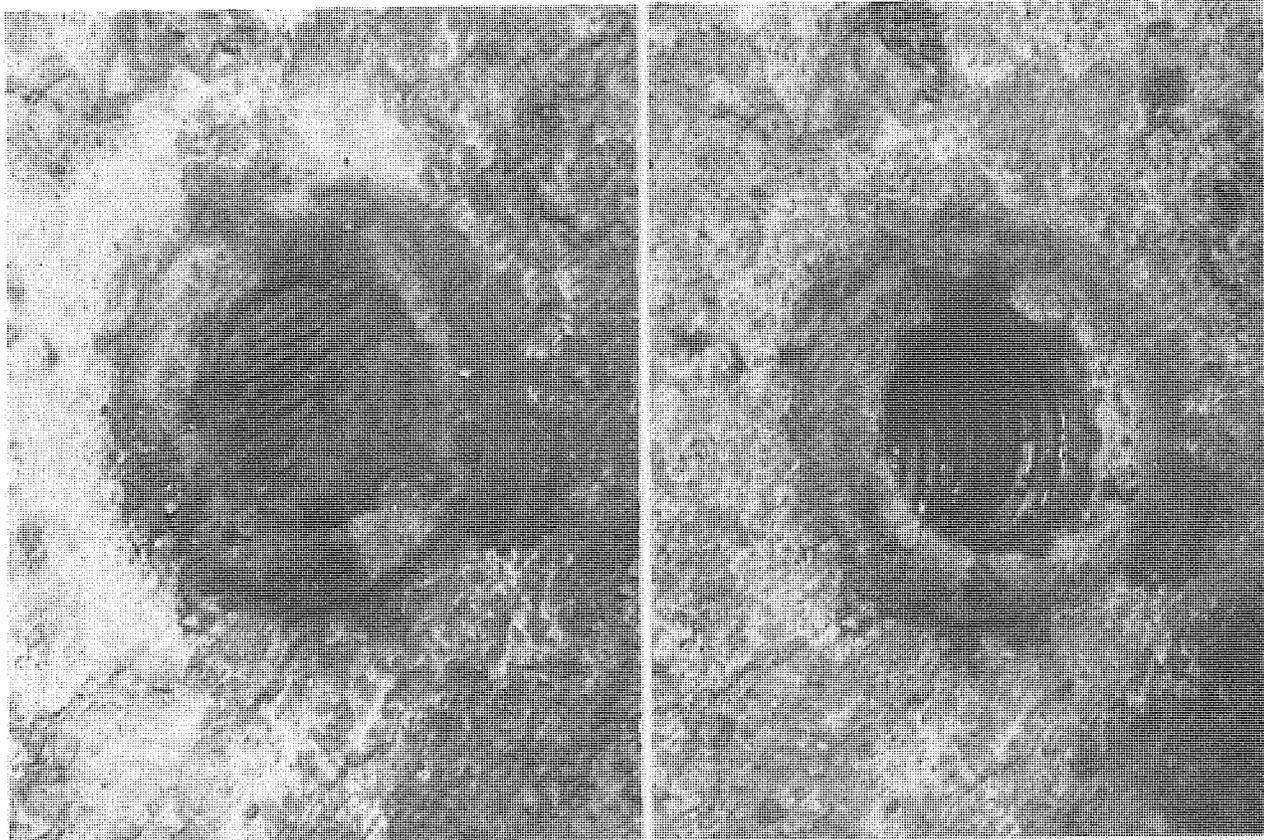
Figure 7. Typical condition of properly sealed coupling, showing sealing plug (top) and exposed threads (bottom).

used instead of graphite. The corks used for sealing the 5/8 in. couplings were the same size used for 9/16 in. couplings, thus permitting their insertion flush with the pavement edge. Therefore, all plugs except one which was missing were intact and showed no damage whatever. The graphite in the group located at Sta. 318+00 had dried up but was free of sand, and all couplings in this group received the hook bolt without cleaning. In the group at Sta. 238+00 the graphite was in the same condition. However, five of ten couplings, including the one where the plug was missing, required cleaning by retapping to the same thread size before the hook bolt could be engaged for the full thread length. The remaining five couplings needed no cleaning. The last group had been treated with Lubriplate, which was clean and still retained its lubricating properties, and all ten couplings were rated in the Condition 1 class. Very little moisture had accumulated in the couplings, but the corks in most cases were saturated with moisture. No serious rust was noted although these couplings had been embedded for approximately seven years. Plug and thread condition of a coupling treated with Lubriplate are shown in Fig. 7.

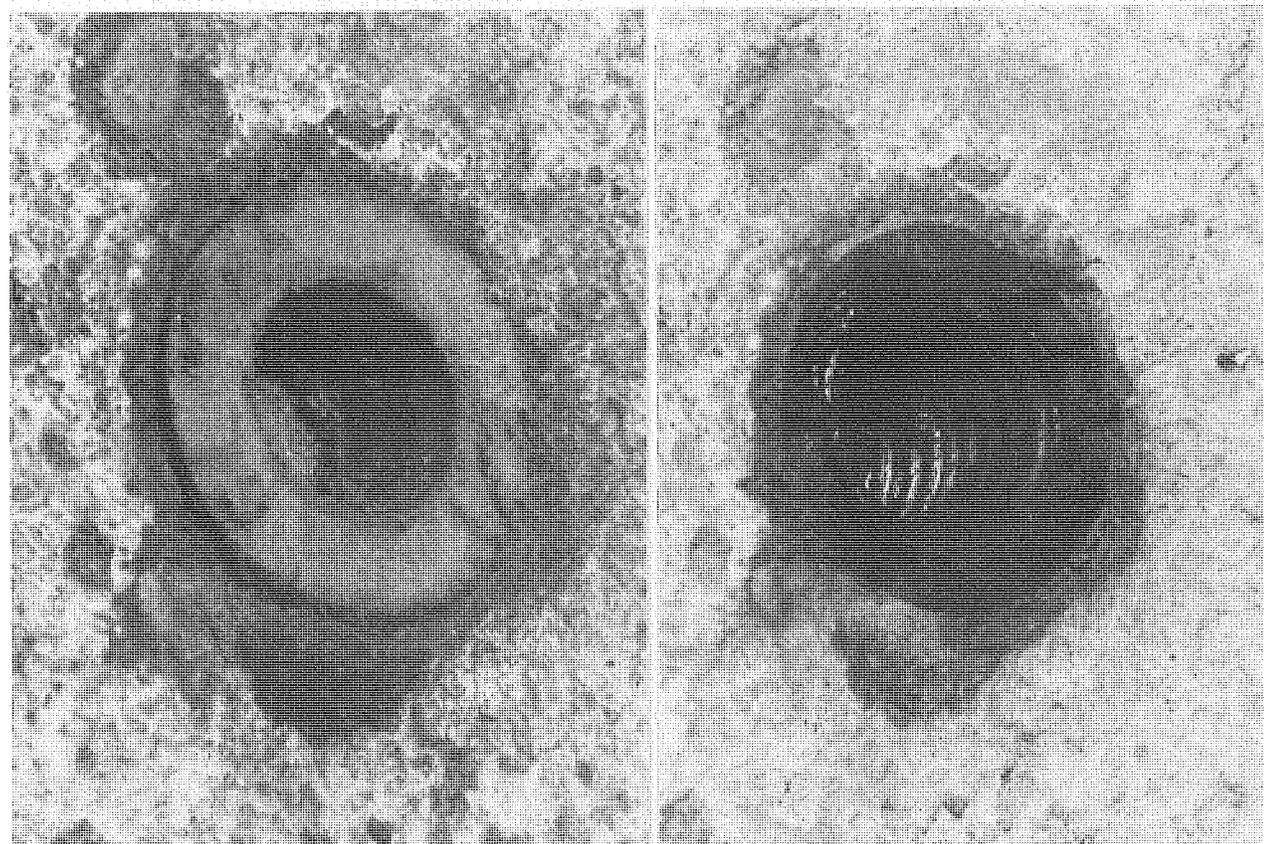
Figure 6. Typical condition of properly sealed coupling, showing sealing plug (top) and exposed threads (bottom).
