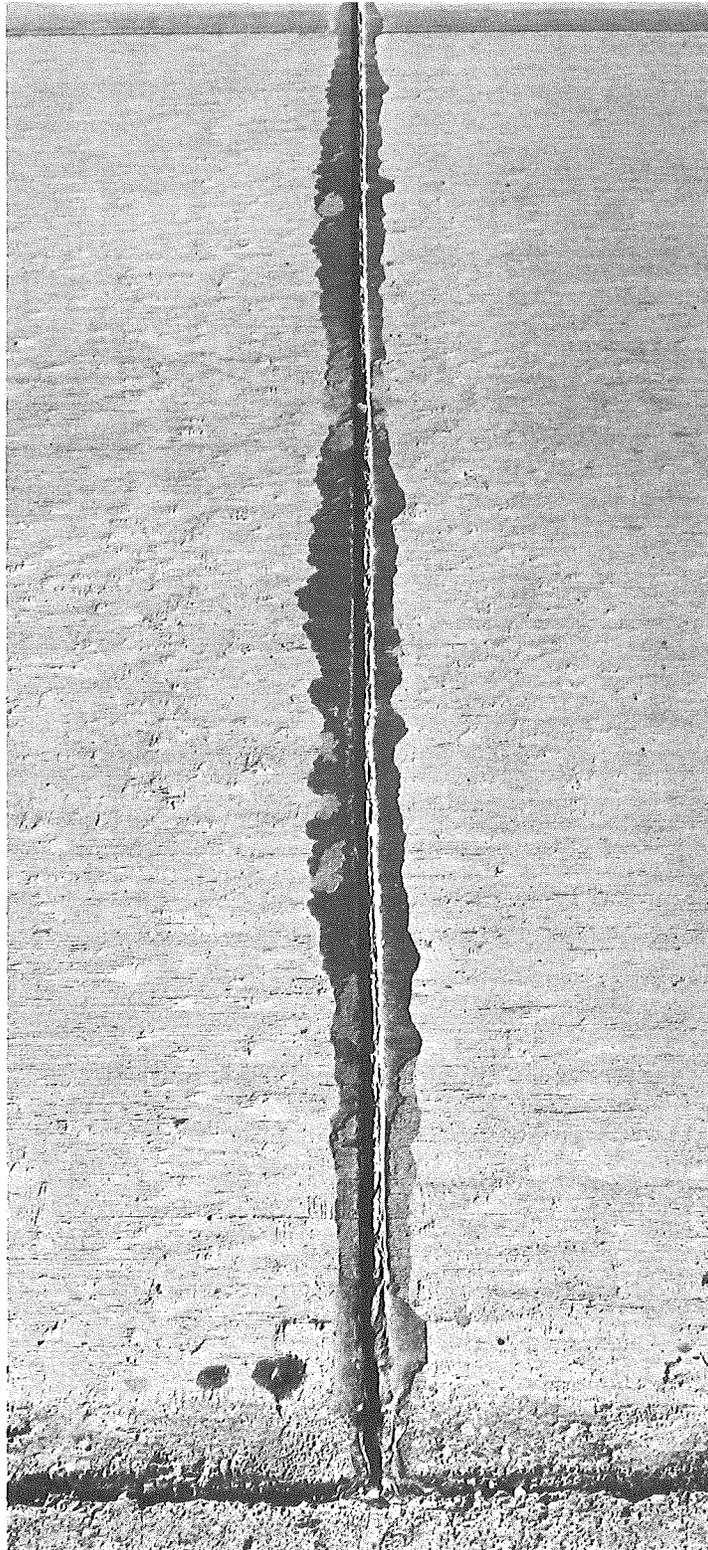
Figure 21. Typical failure in adhesion, cohesion, and resilience after one year of service: Permiteco regular (SS-S-164) hot-pour, rubber-asphalt sealer (north-bound I 496 between Cavanaugh Rd and Forest Rd).

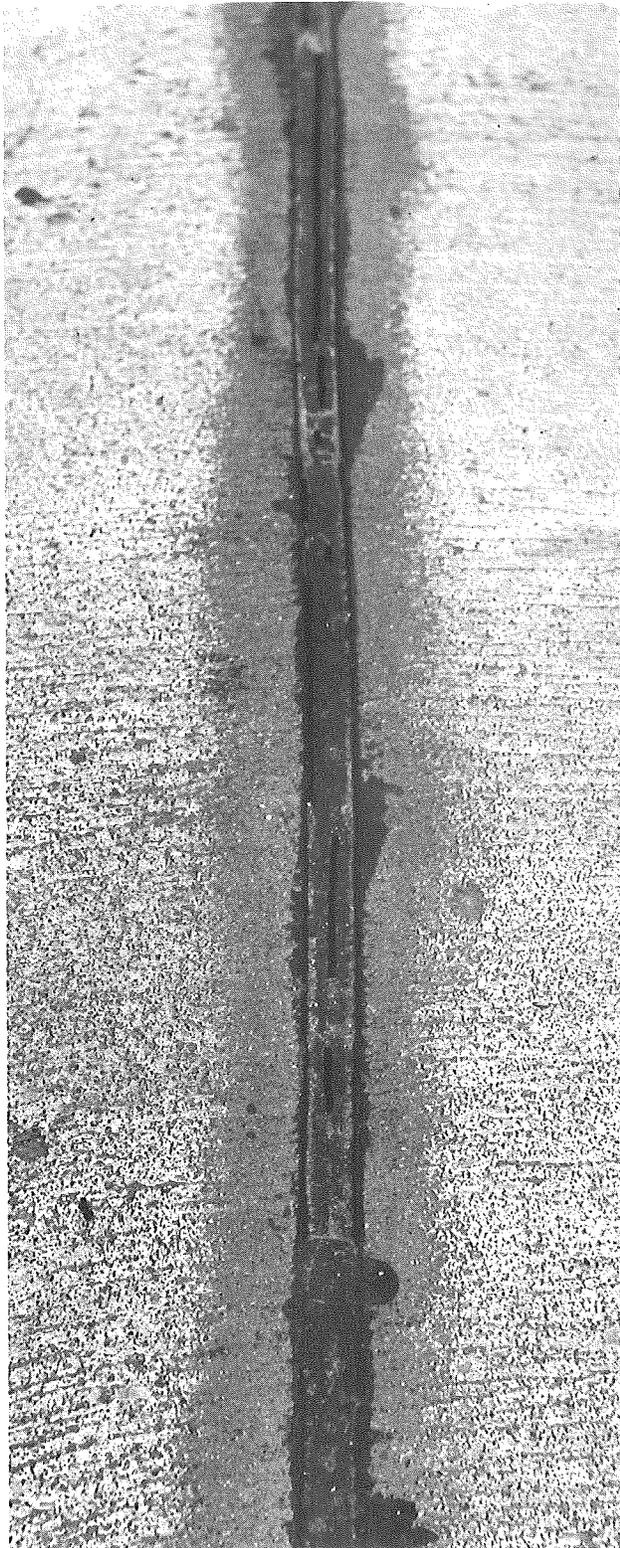
Figure 22. Cohesive failure typical of about 70 percent of this project's joints, after about four months of service: Peterson two-component, cold-applied sealer (I 75 Rest Area).

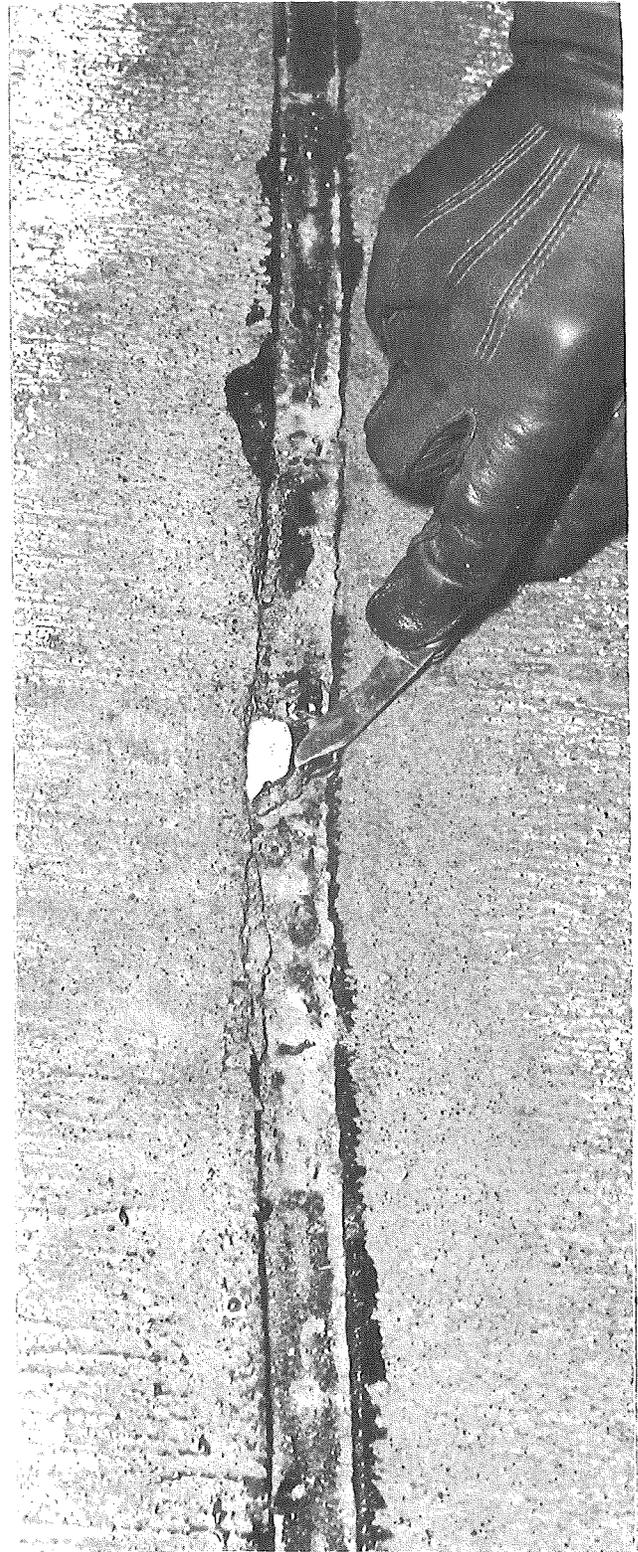
Figure 23. Effect of Ethafoam filler placed too high in joint, after about four months of service: Peterson two-component, cold-applied sealer (I 75 Rest Area).

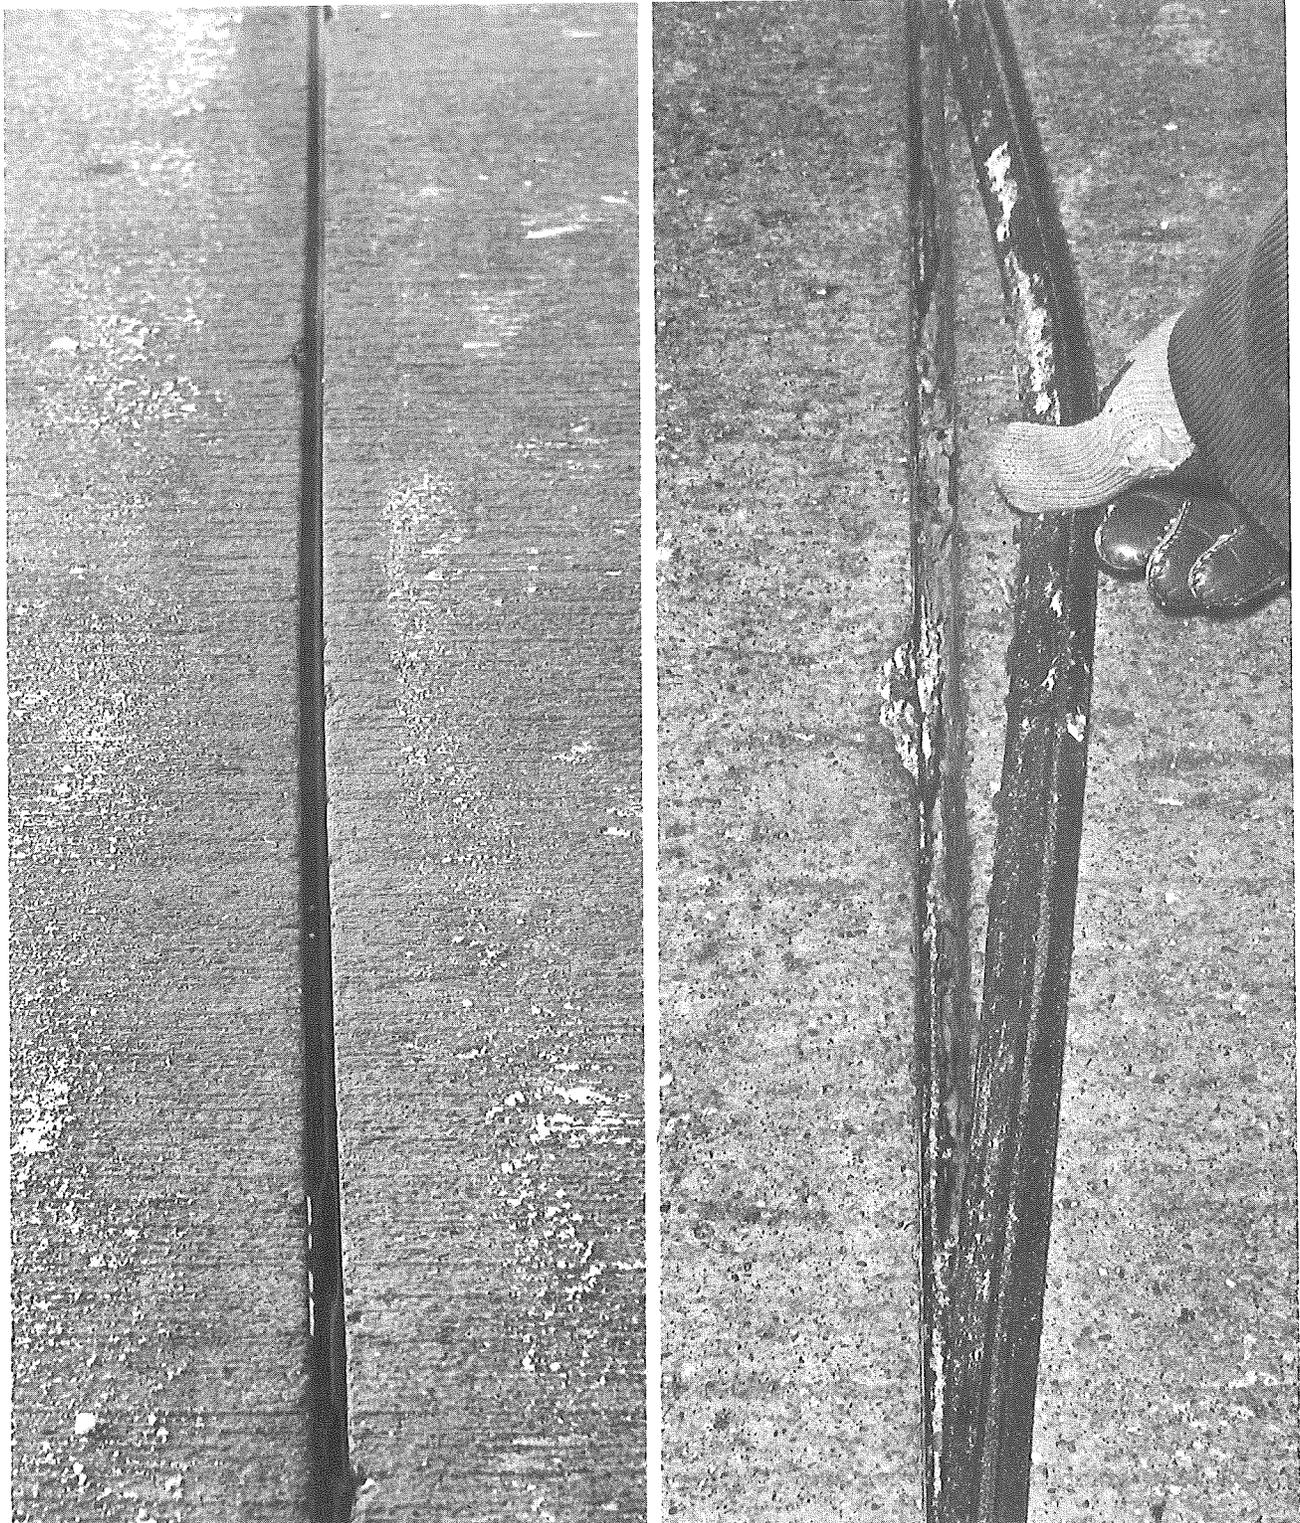
Figure 24. General and detailed views of neoprene sealed joint, showing clean joint groove beneath sealant. Joint was formed by 3/8-in. wide plastic insert, and width when photographed was 0.65 in. (Sta. 662+40, westbound traffic lane, Project EBACI 33083B, C3).

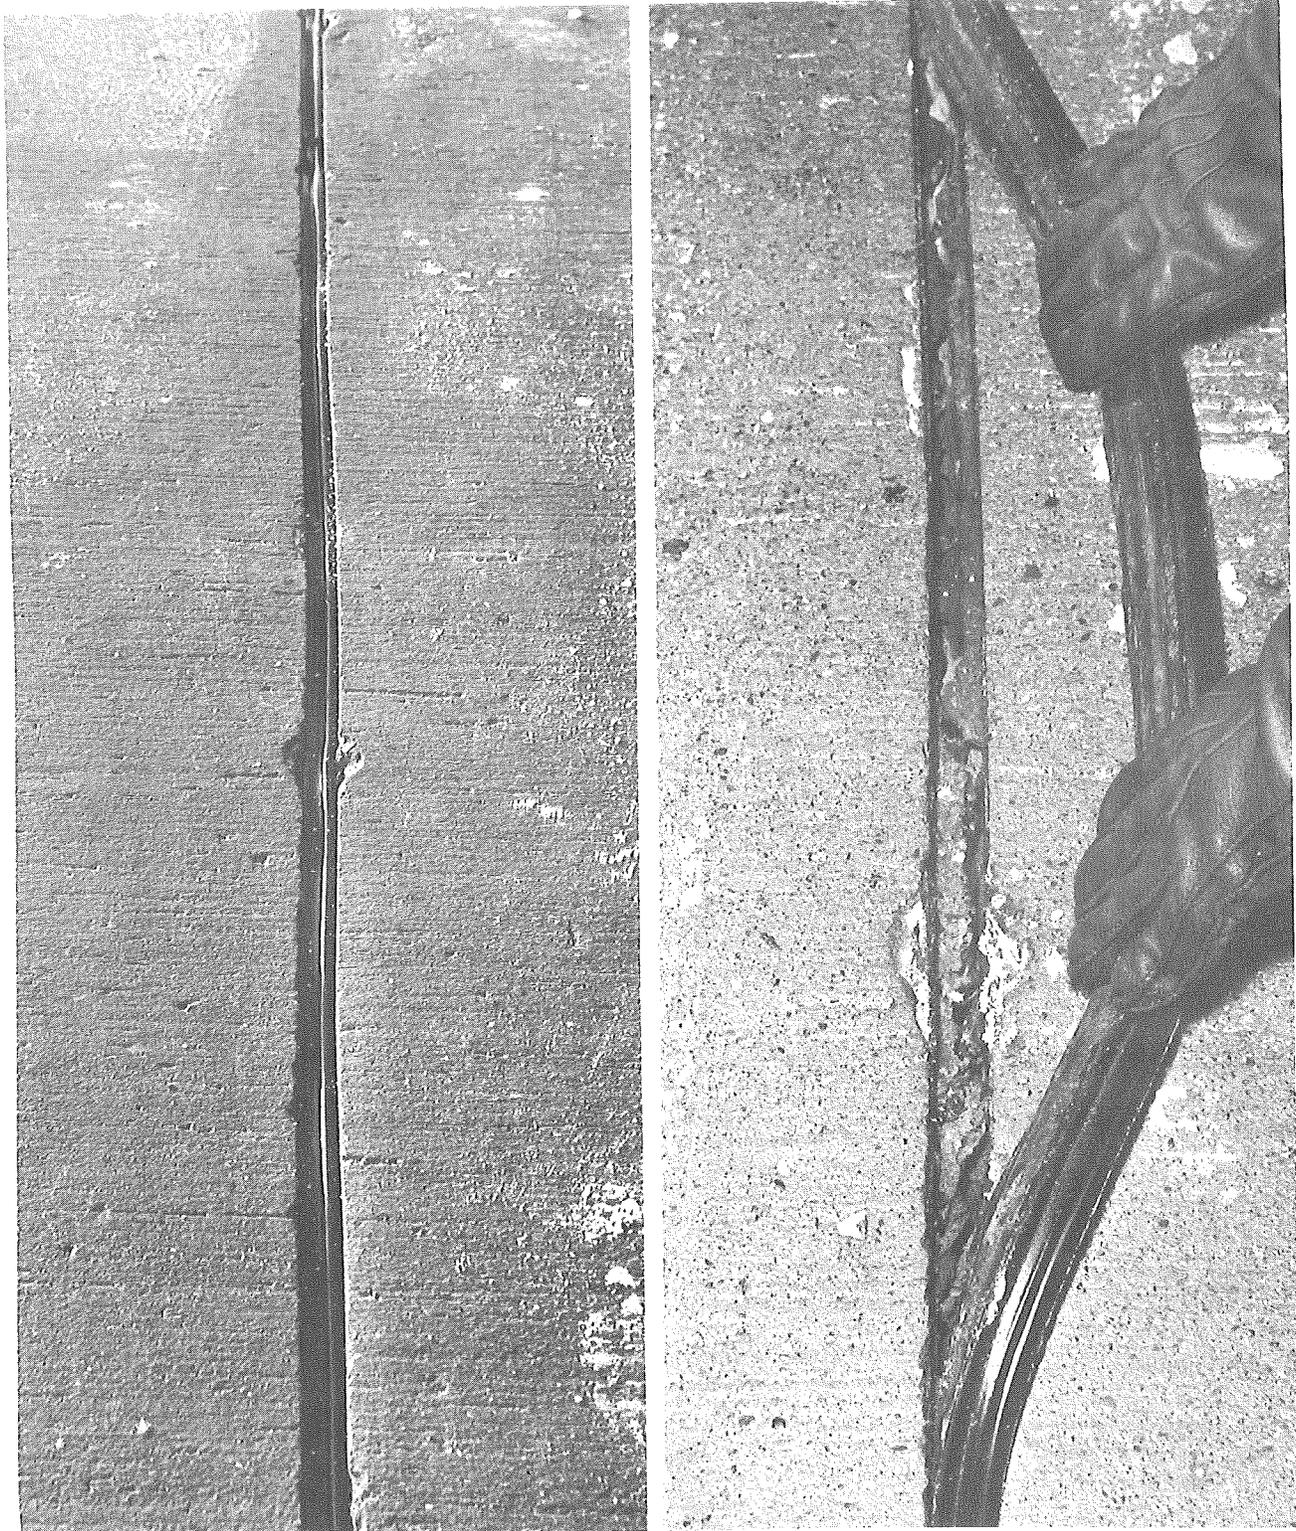
Figure 25. General and detailed views of neoprene sealed joint, showing clean joint groove beneath sealant. Joint was formed by 1/2-in. wide styrofoam, and width when photographed was 0.96 in. (Sta. 600+70, westbound traffic lane, Project EBACI 33083A, C1).

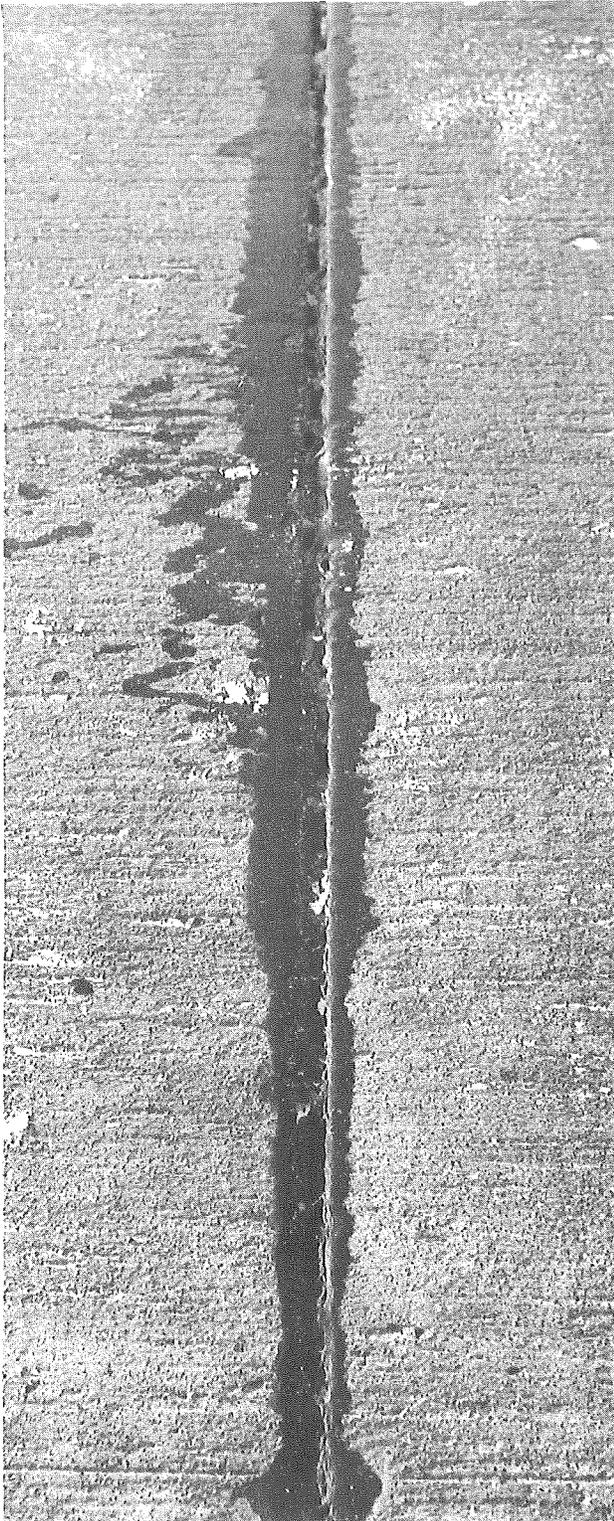
Figure 26. Pronounced adhesion and cohesion failure of hot-pour joint seal (westbound traffic lane, Sta. 649+00, Project EBACI 33083A, C1).

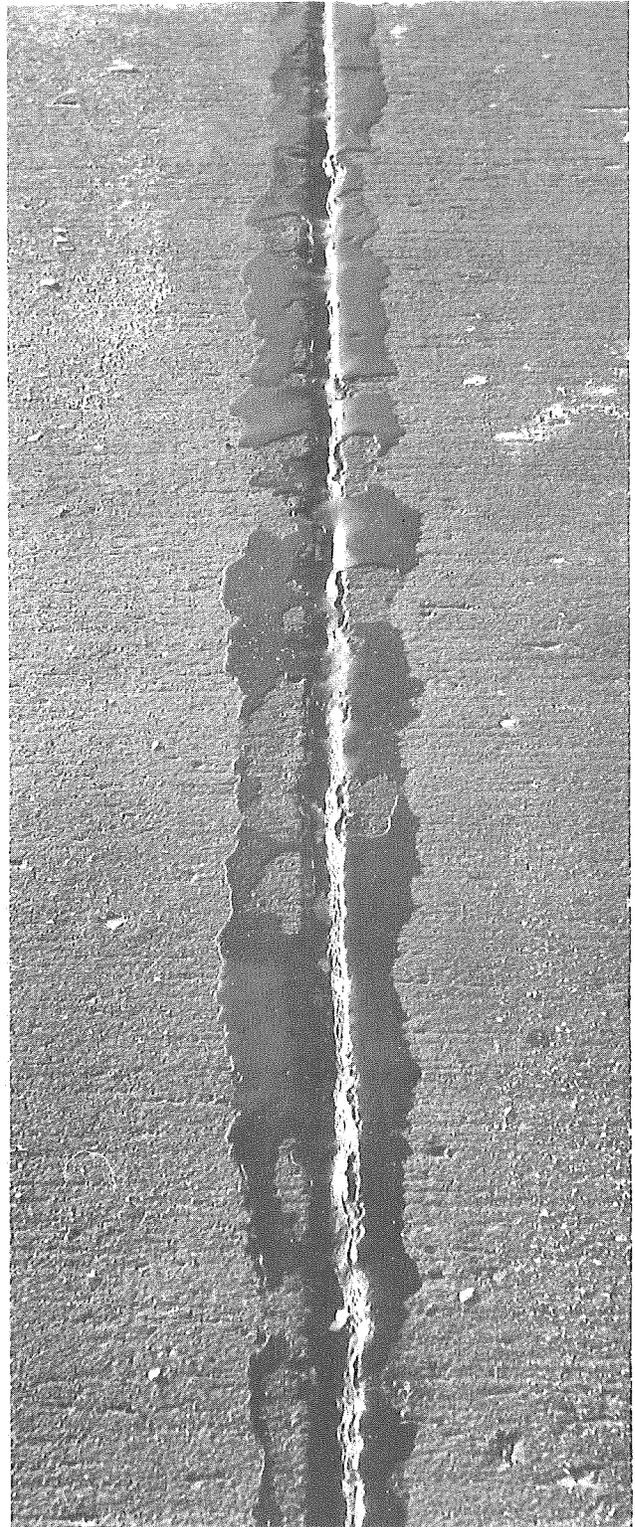
Figure 27. Some cohesion failure of hot-pour joint seal (westbound traffic lane, Sta. 553+08, Project EBACI 23151A, C1).

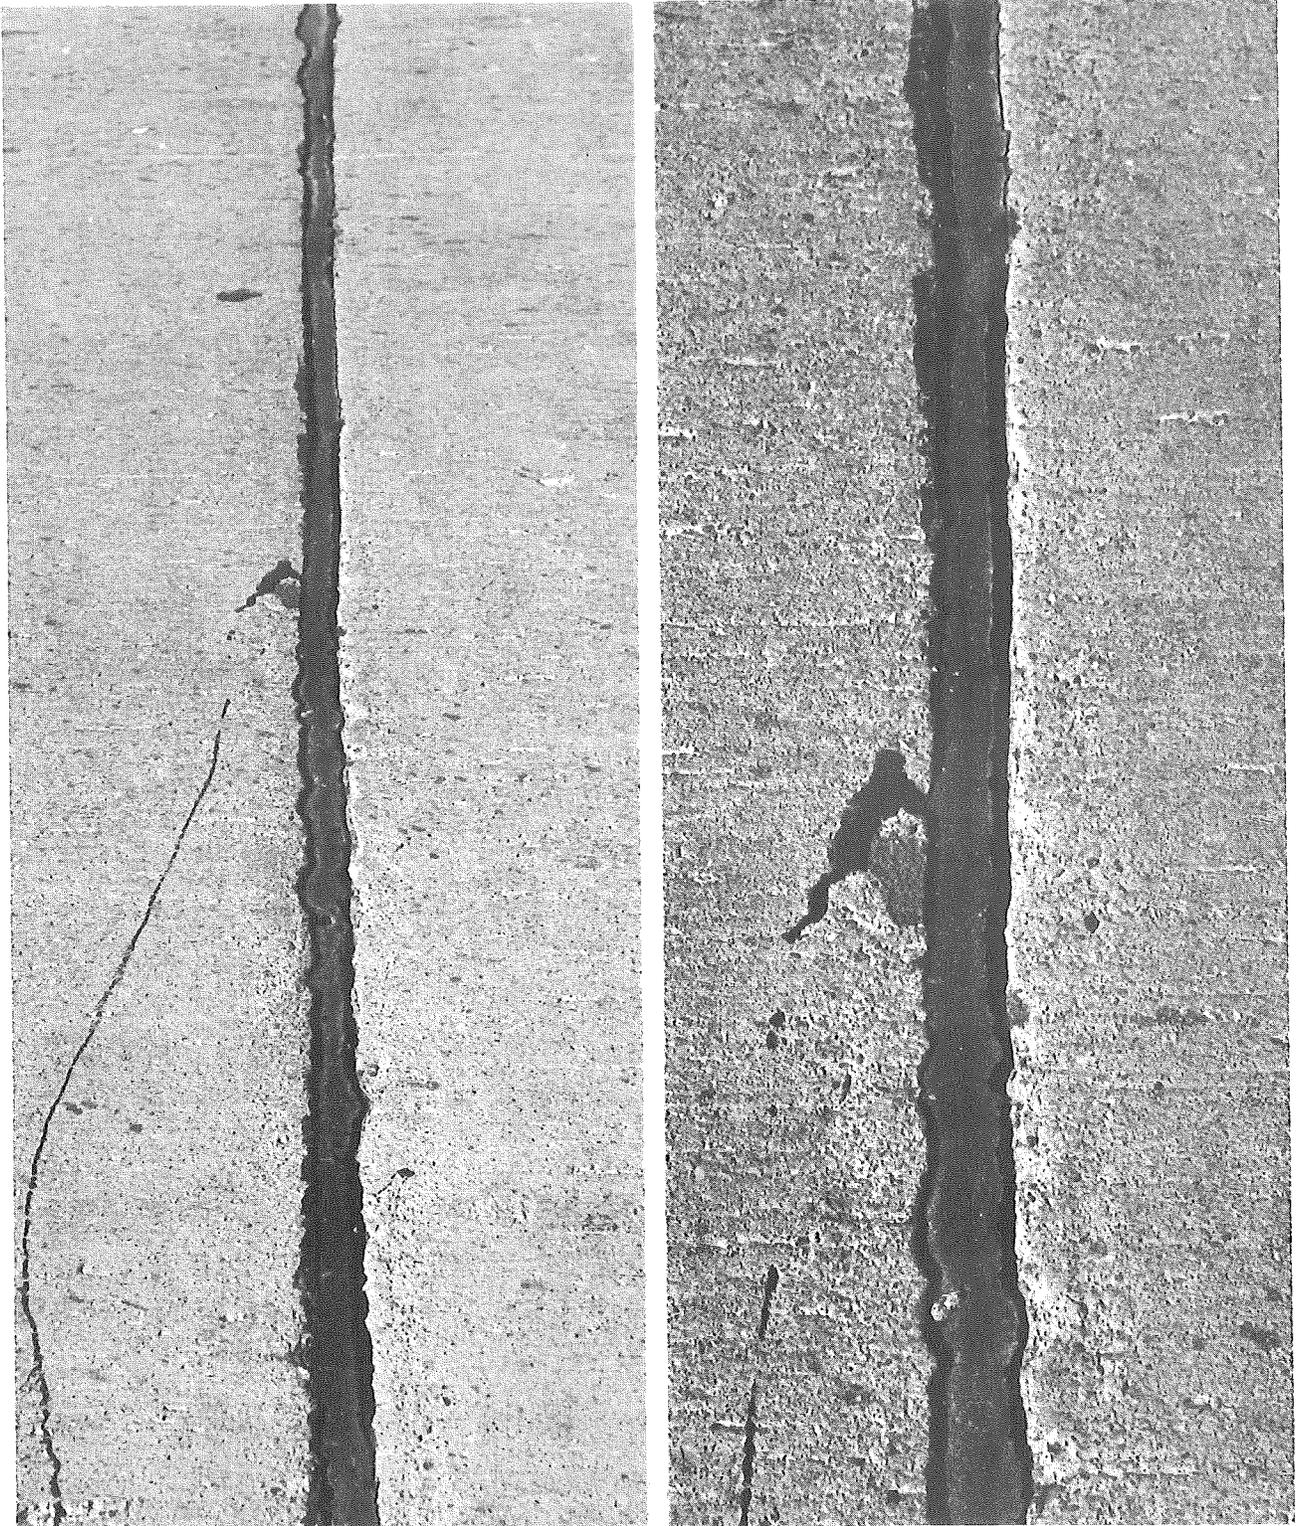
Figure 28. General and detailed views of the same joint shown in Fig. 19, indicating complete lack of cohesion of cold-applied, two-component sealer (Sta. 668+52, northbound traffic lane, Project I 53045D, C1).
