MICHIGAN
STATE HIGHWAY DEPARTMENT

Subject: Skidproofing Treatments at South Cedar Street (US 127) Intersections with Holmes Rd. and Baker St. in Lansing. Research Project 54 G-74. Research Report No. R-521.

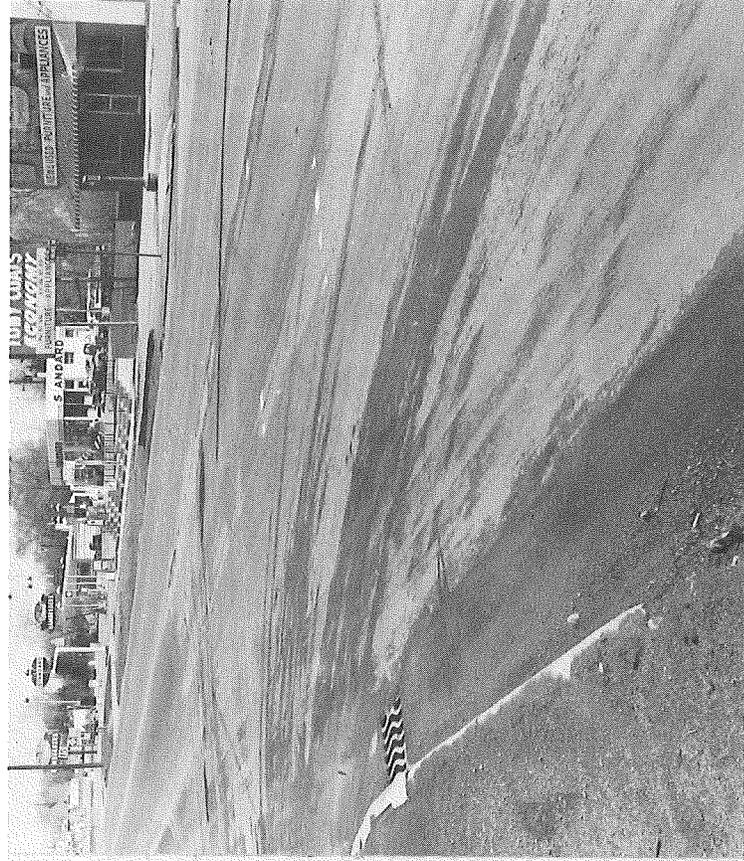
Looking northeast

South Cedar Street (US 127) at Holmes Rd. The 2NS sand-asphalt emulsion hot mix was applied over a polished and rutted bituminous pavement containing limestone aggregate. As can be seen in Fig. 1, fairly large areas of the treatment have failed. About 30 percent of the treatment within the intersection proper has been removed by traffic. The stopping areas approaching the intersection, however, seem at this time to be relatively unaffected by traffic. Skidometer data obtained in the stopping areas on May 25, 1965, indicate the surface friction properties have decreased slightly since the tests last November.

Figure 1. Holmes Rd. intersection with Cedar St., showing rough appearance and areas where surface treatment is missing.

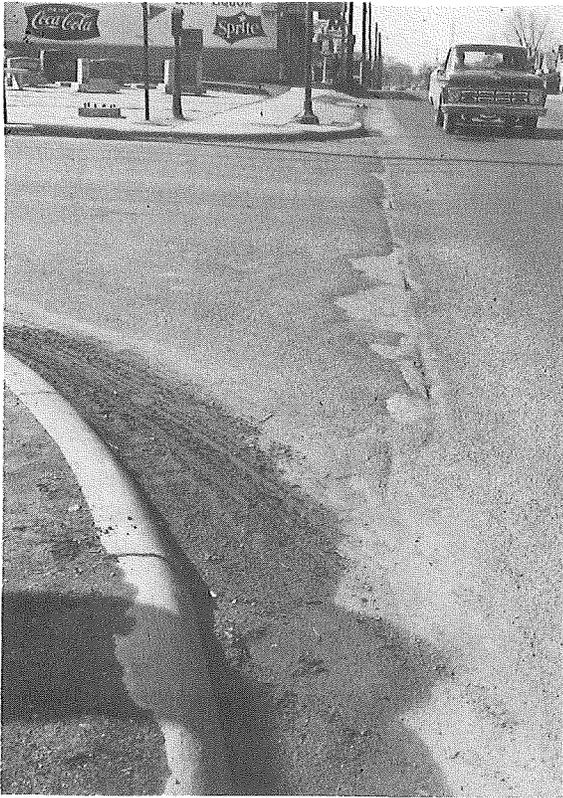
Looking south

South Cedar (US 127) at Baker St. The 31A bituminous concrete-emulsified asphalt hot mix was applied over a polished concrete surface containing gravel aggregate. Fig. 2 indicates that the same problem encountered at Holmes Rd. was found here, although not to as great a degree. Possibly 5 to 10 percent of the treatment has been removed within the boundaries of the intersection. The stopping lanes are in excellent condition, although skid resistance has dropped 0.12 from 0.52 in November 1964, to 0.40 when tested in April 1965. Some cracking and spalling can be found at most joints and around manholes, but this is probably due to movement of the underlying concrete.

Figure 2. Baker St. intersection with Cedar St. showing damaged areas in surface treatment.

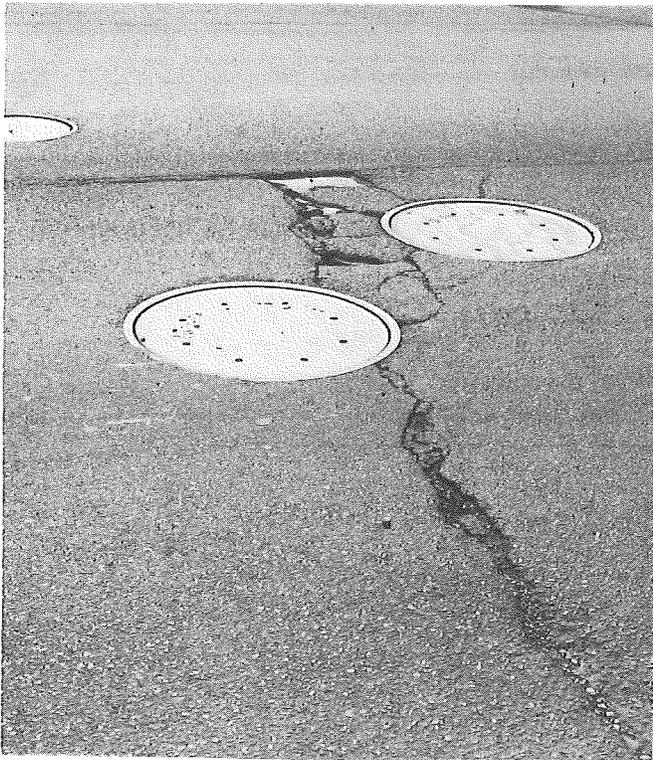
Manholes in intersection

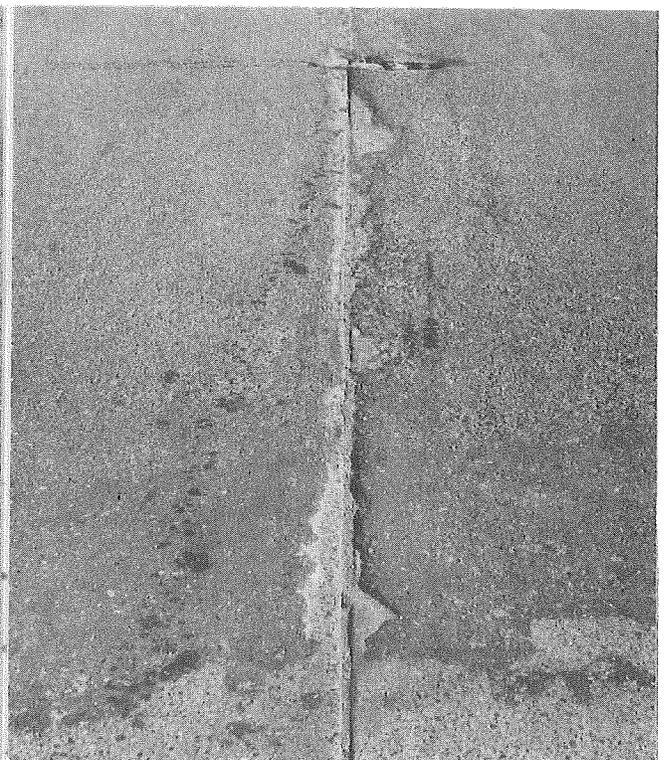
Southbound centerline at south end of treatment
