MICHIGAN
STATE HIGHWAY DEPARTMENT

September 3, 1965

Subject: US 127 Blowup South of Jackson (Construction Project 38-7, C5).
Research Project 39 F-7(14). Research Report No. R-541.

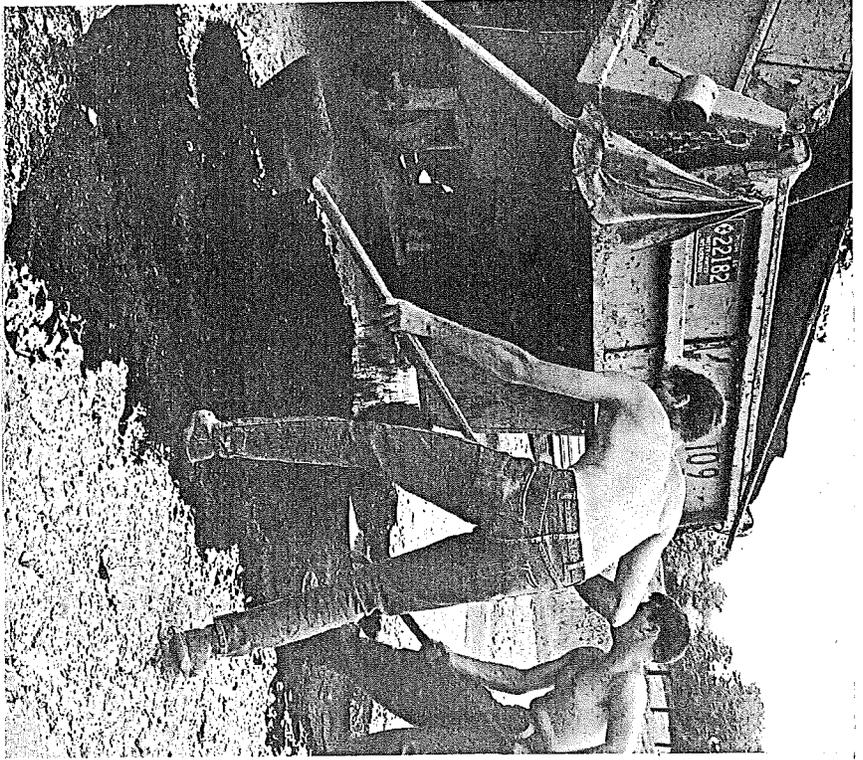
At your request prompted by a telephone call from the District 8 Office, a US 127 joint blowup located at Sta. 460+20 near Loomis Road was inspected on June 23, 1965. This 1955 project has 22-ft wide roadways, with 99-ft transverse joint spacing. In the summer of 1964, the gravel shoulders were bituminous surface-treated for a 3-ft width. The blowup occurred across both lanes in the late afternoon of June 22, and was temporarily patched at that time. More permanent repairs were performed on June 23, and were nearing completion at the time of the inspection (Fig. 1).

Figure 1. Blowup repair in progress during inspection of joint at Sta. 460+20.

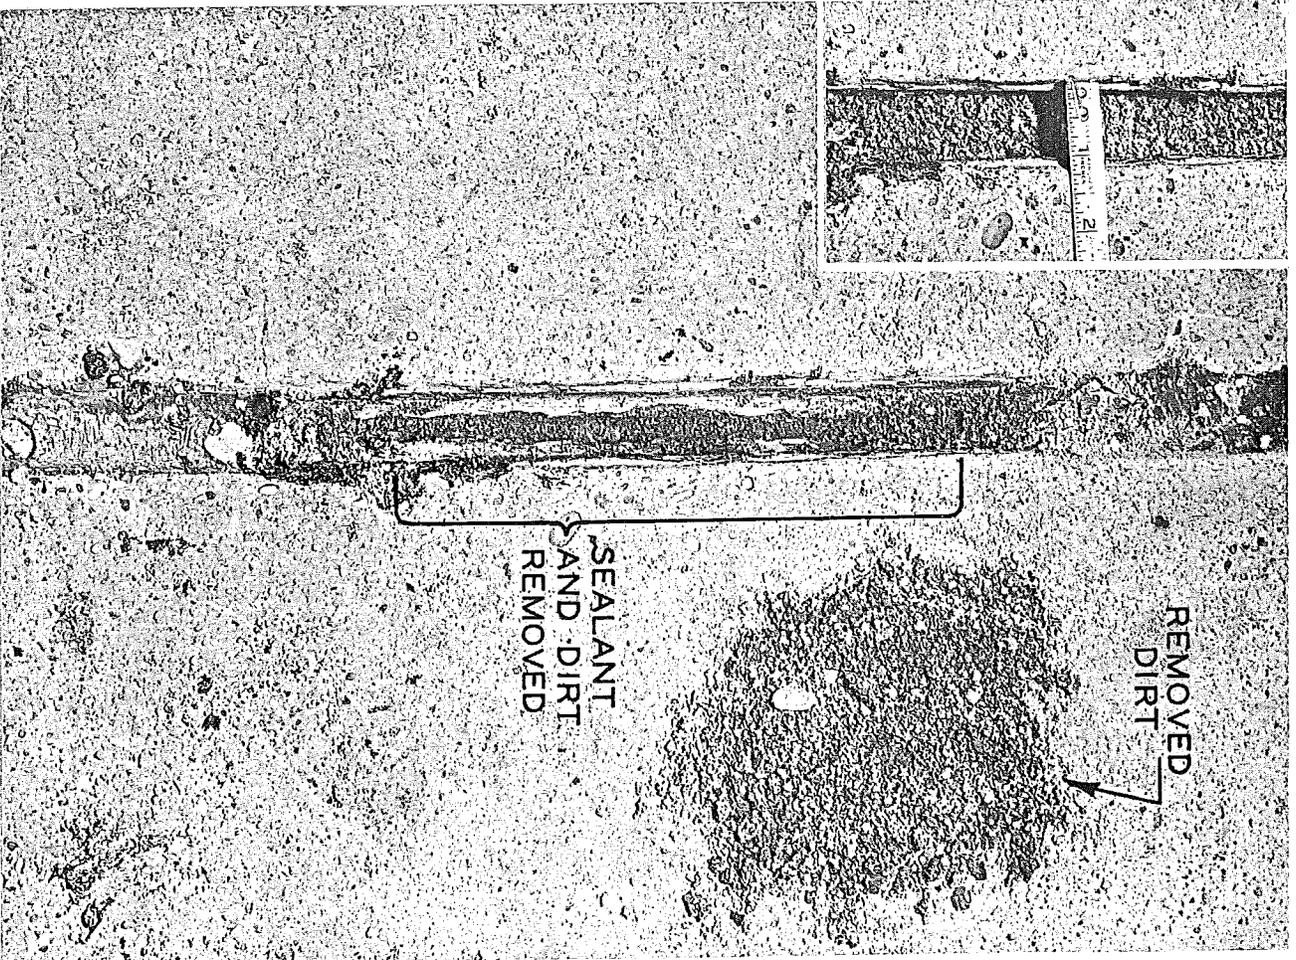
General inspection of pavement near the failed joint revealed that contraction joint grooves were about 1-in. wide (i. e., open about 1/2-in.) in spite of an air temperature over 80 F. To determine the reason for this, sealant in the second joint south of the failure (Sta. 458+22) was removed, and the groove and plane of weakness crack were inspected for dirt infiltration. The bottom of the joint groove was found to be filled with sand and small stones, and the crack completely filled with similar material (Fig. 2).

Figure 2. Joint width (upper left), and appearance of groove with infiltrated dirt and sealant removed (center), exposing plane of weakness crack, at Sta. 458+22.
