MICHIGAN
STATE HIGHWAY DEPARTMENT

Subject: Joint Blowup, I 94 East of US 127 Bypass, Jackson County.
Research Project 39 F-7(14). Research Report No. R-545.

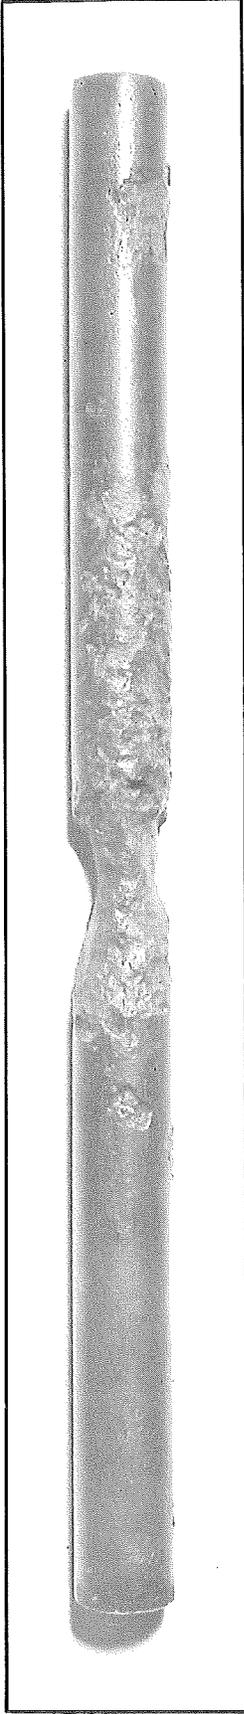
The repair crew supervisor said that no dowel bar misalignment had been noticed. Fig. 1 shows a load transfer bar removed from the joint on August 16, 1965. The cross-section was reduced by corrosion to 9/16-in. diam, a reduction of almost 50 percent of the original size.

Figure 1. Load transfer bar from I 94, EB, Sta. 1033+55.

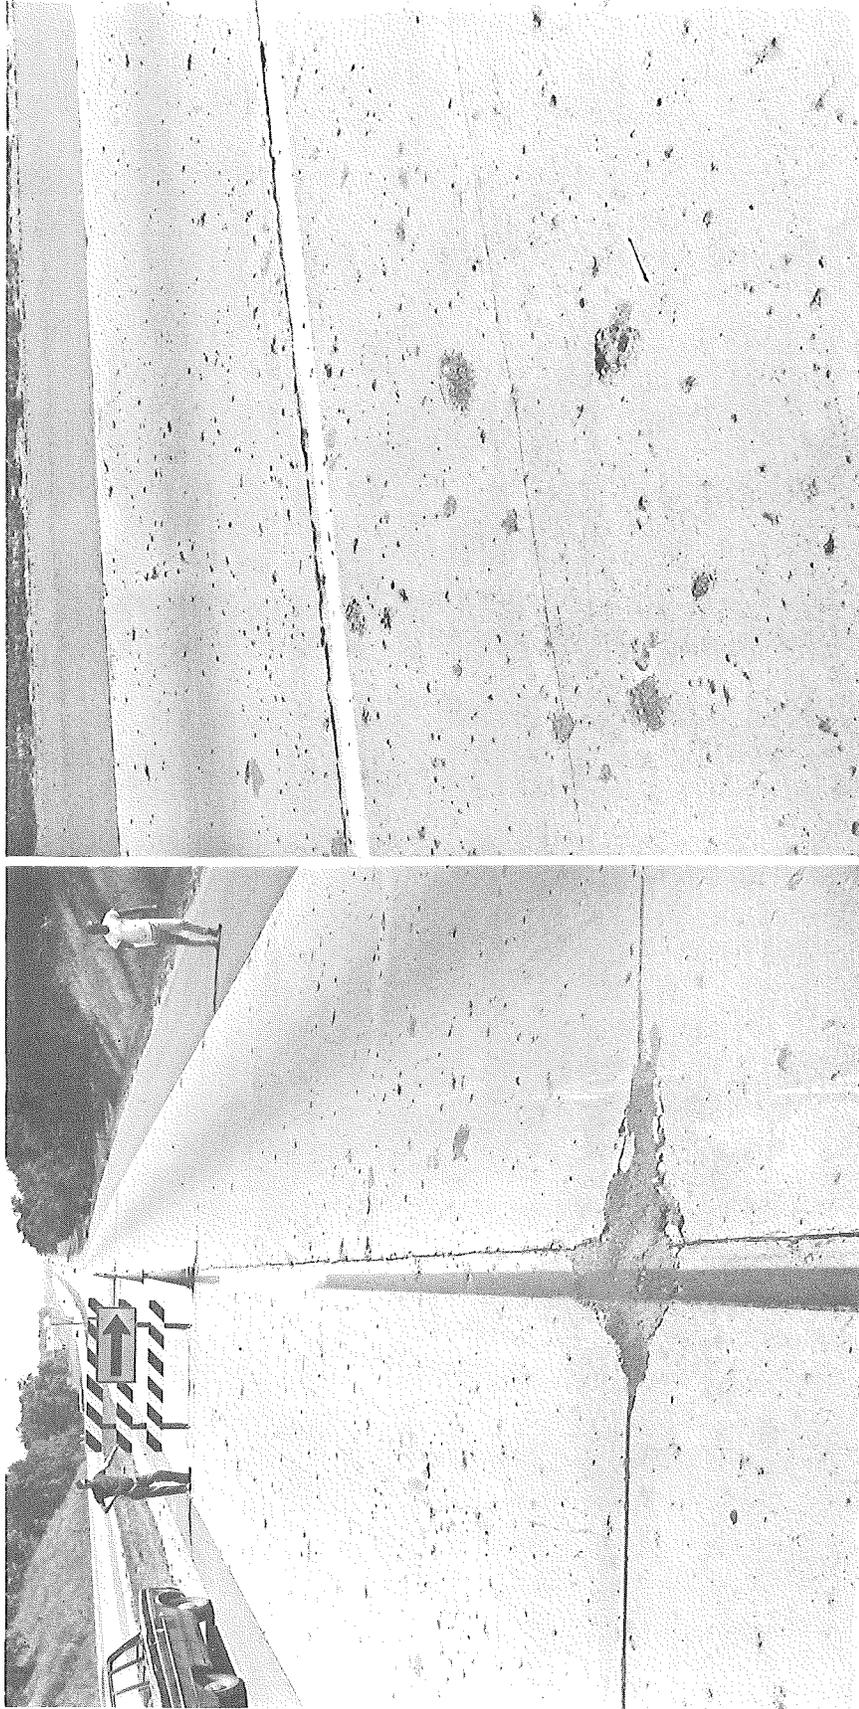
Fig. 2 shows the large number of popouts evident in the pavement near the joint blowup. The Klumpp Bros. aggregate used in the concrete contained a large proportion of deleterious material and its poor quality was the subject of Research Project 51 A-11, reported on in Research Report No. R-176.

Figure 2. Typical surface condition of Construction Project 34-48, C2.
