OFFICE MEMORANDUM

MICHIGAN
STATE HIGHWAY DEPARTMENT

Subject: Progress Report on Thermoplastic Pavement Markings on W. P. Chrysler Freeway (Projects BI 82111C, C24; BI 82251C, C34). Research Project 47 G-36 (17a). Research Report No. R-560.

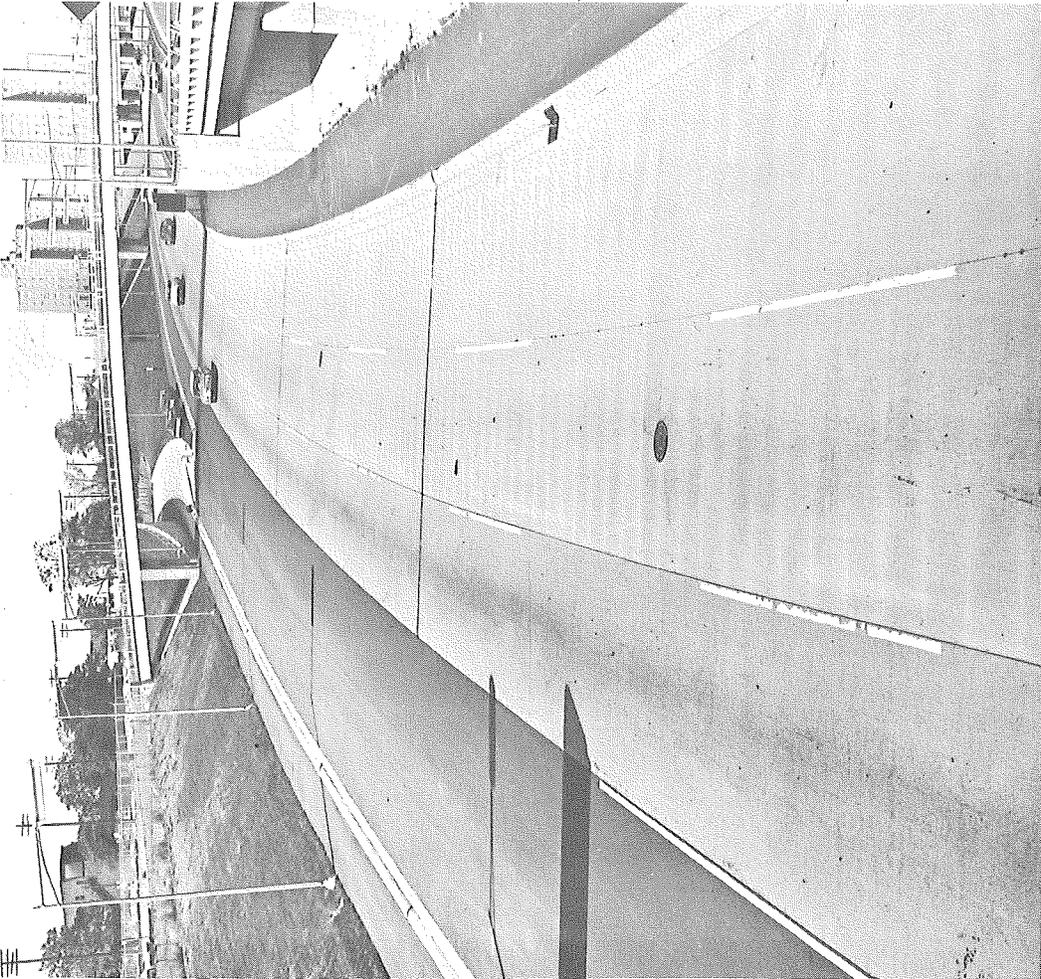
Figure 1. Appearance of 15-month-old striping on southbound Chrysler in the Gratiot-Elizabeth area. Left lane line shows minor fraying, and the right lane line shows less fraying. Edge line is in very good condition.

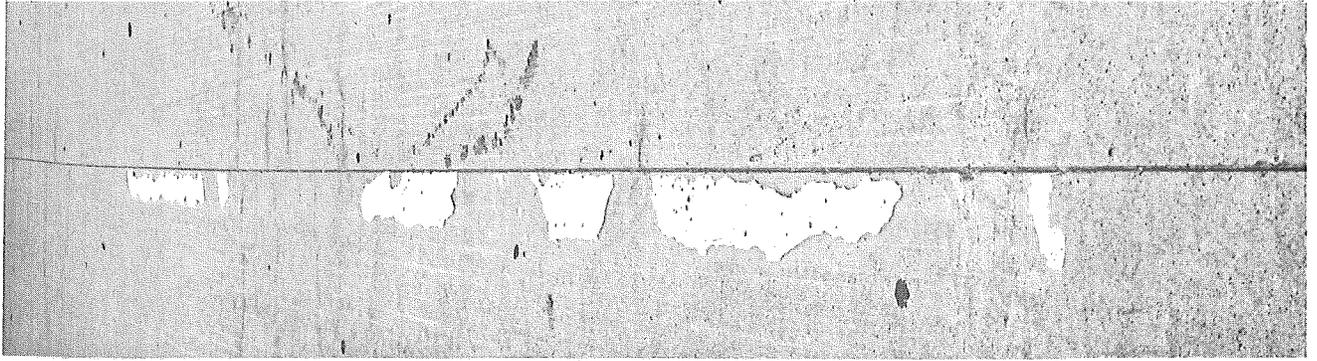
1. Ramps from westbound Ford to southbound Chrysler, and from eastbound Ford to southbound Chrysler, show very little loss of striping. The existing loss generally occurred as several inches of fraying on the leading length of striping facing traffic.
2. Lane striping on the Chrysler showed occasional slow, progressive loss of some striping (Figure 1), confined mostly to the Gratiot-Mack area. The most extensively deteriorated area (Figure 2) showed about 50-percent loss of striping. It is estimated that less than 5 percent of the total striping has been lost by fraying.
3. Supplementary edge striping was generally in very good condition, although occasional shrinkage cracking is now appearing.

Figure 2 (right). Badly frayed length of striping after 15 months of service on southbound Chrysler in Division Street area.

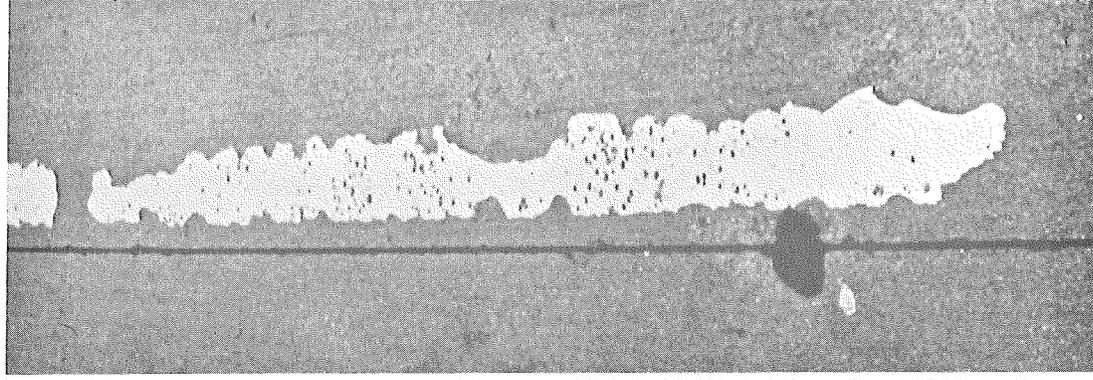
After 15 months of service the striping was rated as generally having a satisfactory appearance despite an increasing loss of some lane striping by a fraying mechanism, and a perforated appearance (Figure 3) resulting from expansion of original gas inclusions. Eventually, the lost striping may require replacement under the guarantee provisions of the specifications. A night examination of the striping was not made. Continuing inspections will be conducted and reported.

Figure 3. Original gas inclusions expanded into pores after 15 months of service, in striping on northbound Chrysler near Elizabeth Street.
