OFFICE MEMORANDUM

MICHIGAN
DEPARTMENT OF STATE HIGHWAYS

August 30, 1967

Subject: Investigation of Foreign Material Embedded in the Continuously Reinforced Concrete Pavement of the Seaway Freeway (I 75); Construction Project I 82194A. Research Project 61 F-64 (1). Research Report No. R-651.

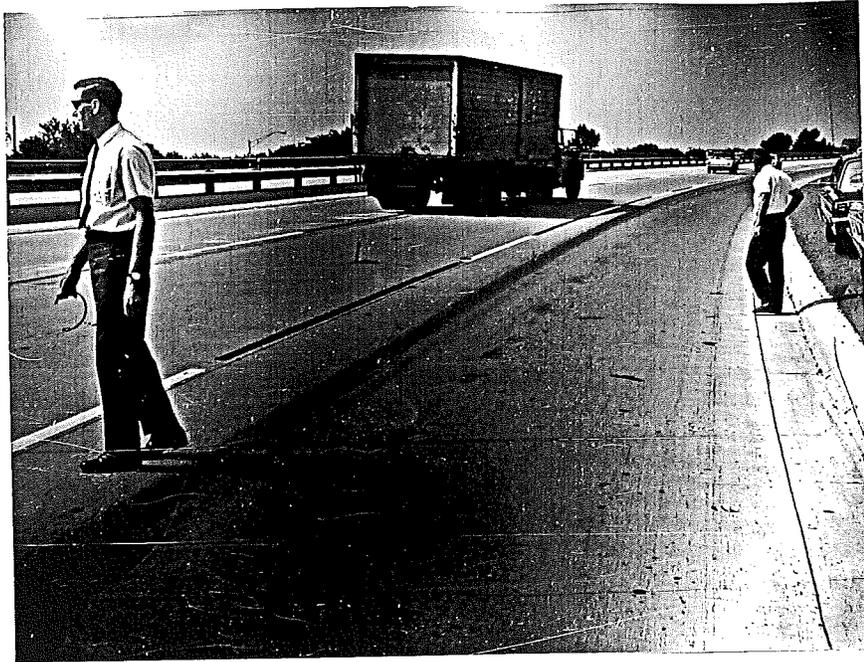
Figure 1. Several claypockets in area of Sta. 914+70 in center lane of SB roadway. Note hammer protruding from the largest hole that was dug out and close-up (below).

The cavities and pockets of cohesive soil and other material should be repaired one lane at a time in the following manner: Remove all clay and foreign material from the pockets and clean thoroughly with a stream of water under pressure. Examine the edge of the hole and break back to sound concrete of 3/4 in. minimum thickness. Remove all the loose concrete either with another water flushing or an air blast. Blow all standing water from the pocket, leaving the surface wet. Fill with a stiff portland cement-Embeco shrink-resistant mortar, tamped and finished to match the adjoining pavement surface. Mix the mortar in the following proportions (as prescribed in Specifications for Shrink-Resistant Mortar for Patching Concrete, dated July 8, 1963):

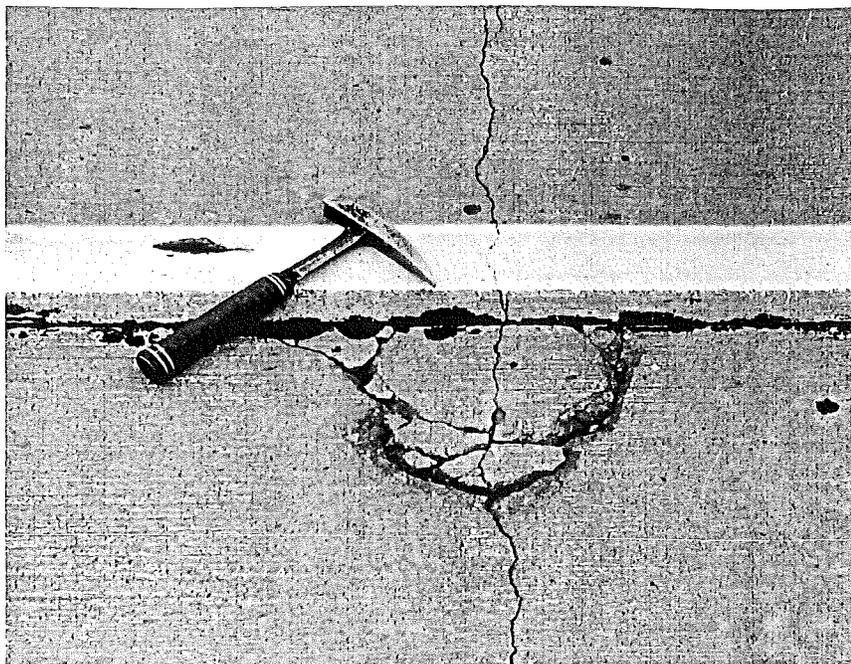
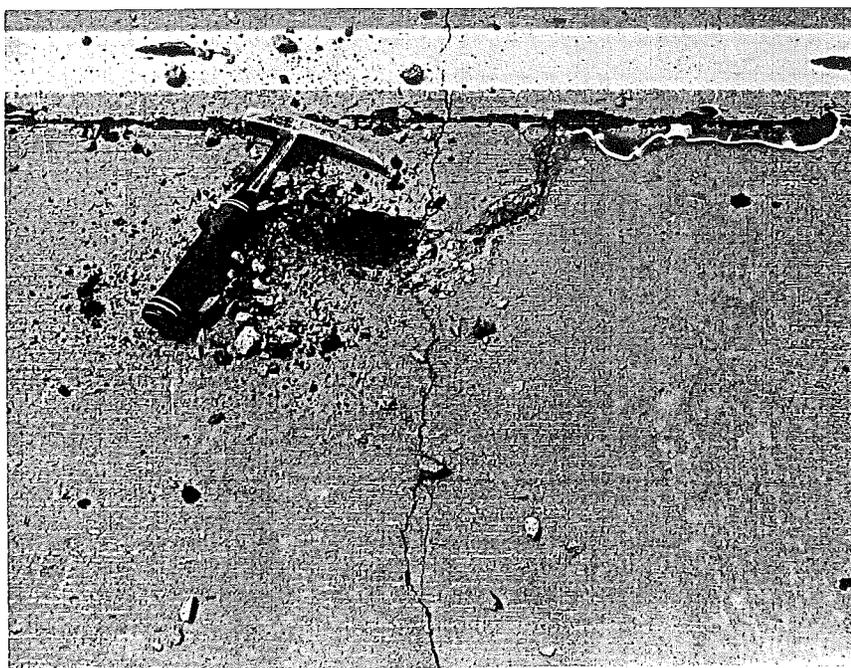
Figure 3. Pavement condition at suspected clay pocket (Sta. 940+20) in NB roadway. Lower photograph reveals clay pocket after partial opening.

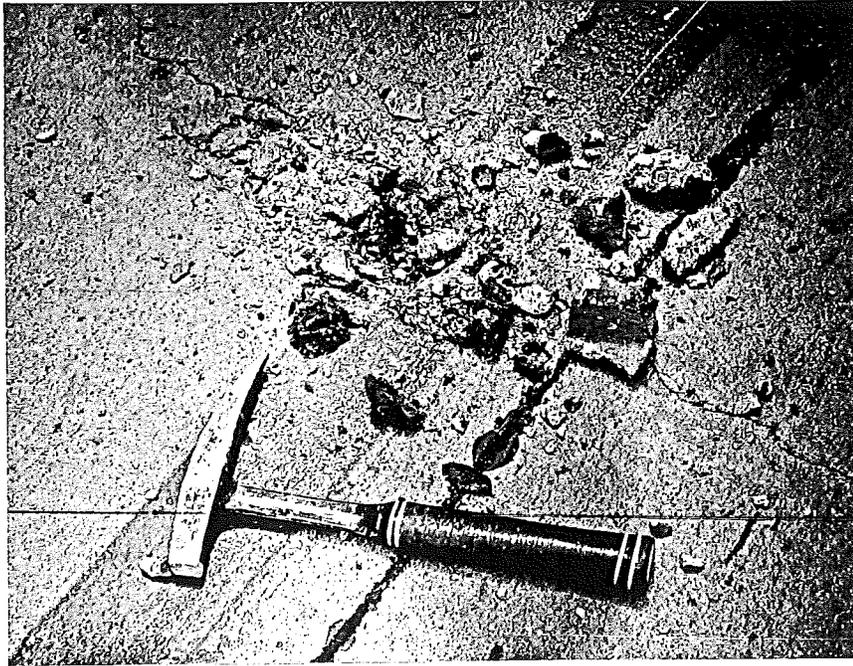
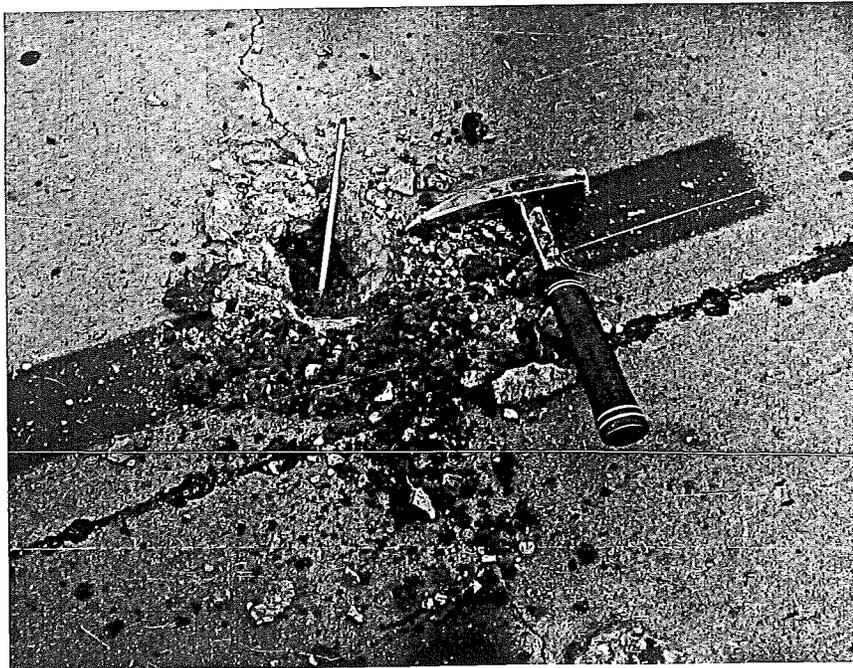
Figure 4. Close-up of unusual crack pattern (Sta. 872+15) of the SB roadway before and after exposing clay pocket.

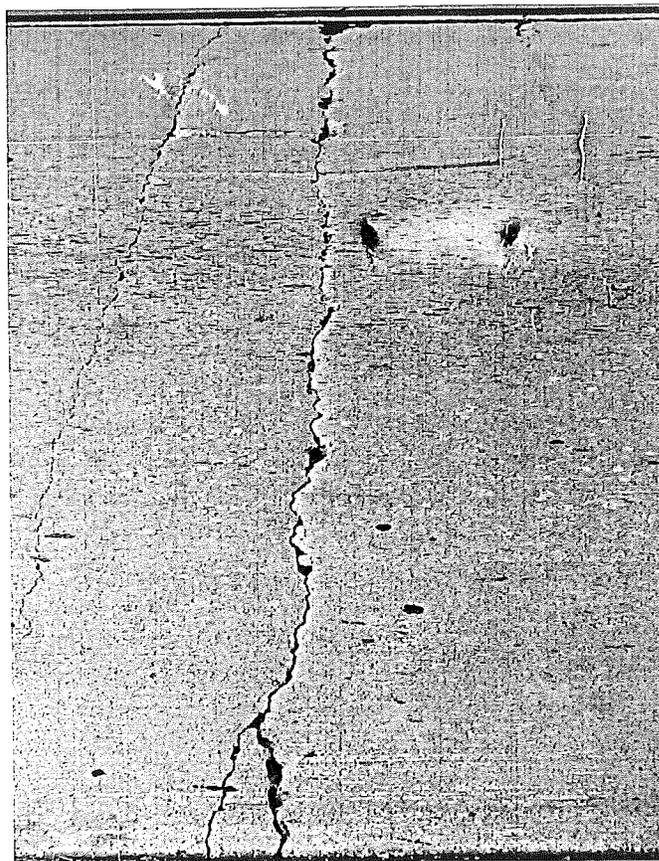
At NB Stations 925+00 to 925+15, a series of transverse cracks, spaced about a foot apart had formed in the center and right hand lanes with only two extending into the left hand lane. Cores taken subsequently revealed a stratum of soil that had become sandwiched between the two concrete courses. Figure 6 shows the most prominent crack and others adjacent to it.

Figure 6. General view of distressed area (Sta. 925+00) of the NB roadway.

It was decided that the defective areas in the north bound roadway near stations 888+50 and 925+00 would have to be replaced.
