OFFICE MEMORANDUM
MICHIGAN
DEPARTMENT OF STATE HIGHWAYS

Subject: U. S. Rubber "UNIROYAL" Advertising Sign, I 94, Detroit. Research Project 54 G-73. Research Report No. R-655A. An addendum to Research Report No. R-655, October 2, 1967.

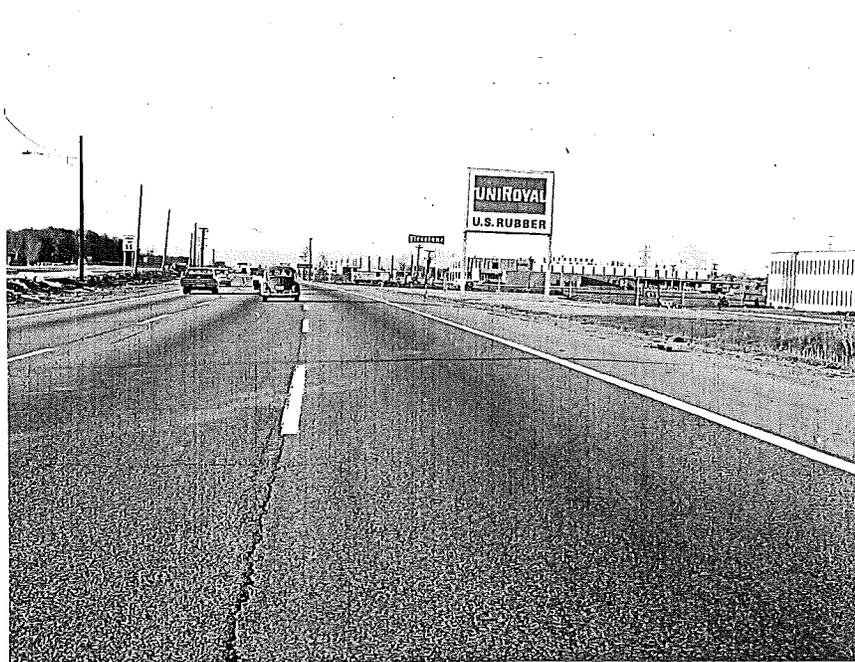
The delineators, which had been rendered nearly invisible by weathering, have been replaced by new ones and the roadway paint striping has been renewed. It must be noted, however, that the delineator post--which should be approximately 200 ft in front of the sign--is missing.

The delineation of roadway edge is now more evident at night (Fig. 1). This, coupled with the lower luminance of the sign, with further reductions of around 20 percent as the lamps age will result in a satisfactory level of roadway visibility.

Figure 1. Day and night views of sign taken at 400 ft (May 2, 1968).
