SEVENTH PROGRESS REPORT ON SPECIAL TEST PAINTING  
ON M 78 BRIDGE STRUCTURAL STEEL

Research Laboratory Section  
Testing and Research Division  
Research Project 49 G-50(4)  
Research Report No. R-661

State of Michigan  
Department of State Highways  
Lansing, December 1967

**Subject:** Seventh Progress Report on Special Test Painting on M 78 Bridge Structural Steel under Research Project 49 G-50(4); Research Report No. R-661.

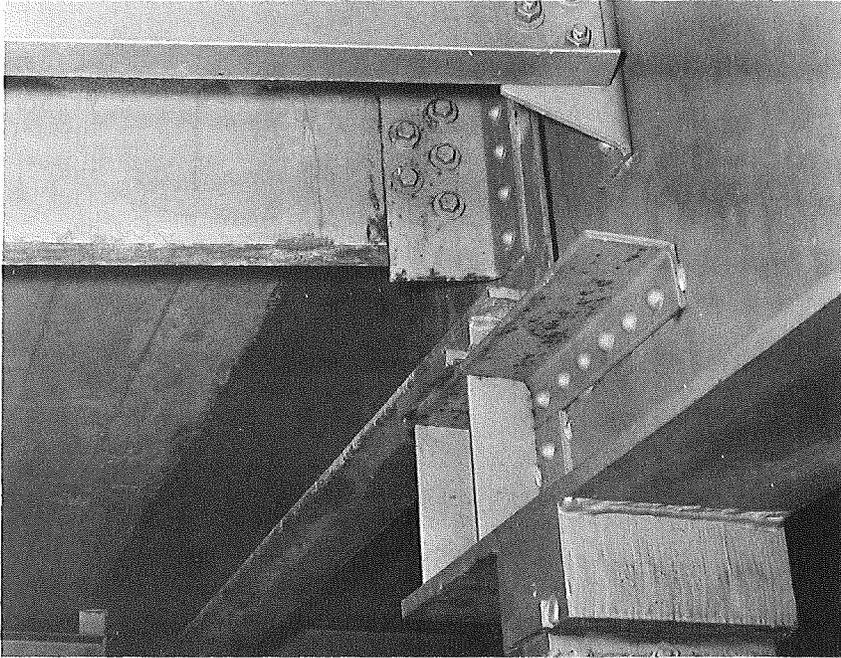
1. All have deteriorated in the joint area, to an extent that is probably dependent on the leakage in the area, Figures 1 and 2: The paint coatings exhibit red rusting while the galvanized coating shows white rusting.

Figure 1. (left) Progressive coatings' failure in joint area after 6 years service. Photo over N pier, shows 2 package epoxy primed system in foreground and zinc rich primed system in background.

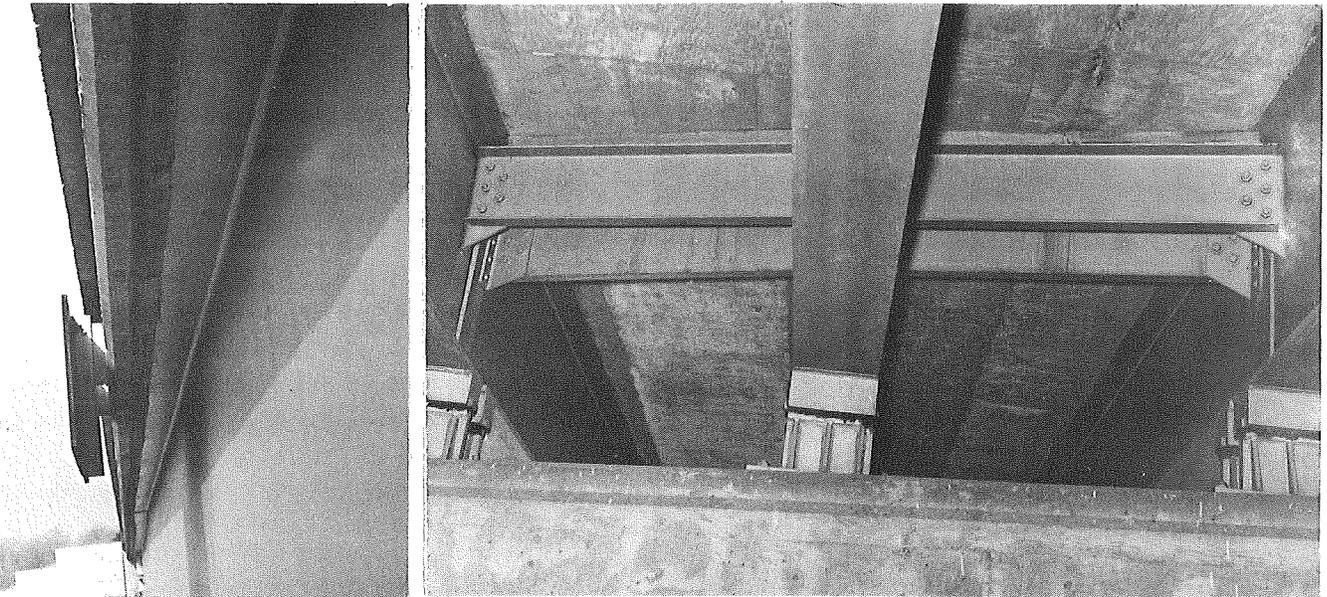
Figure 2. (below) Very minor coatings' deterioration is just beginning to appear in joint area (construction joint, non-opening) over center pier. Photo shows systems 3 and 4 in foreground and systems 5 and 6 in background.

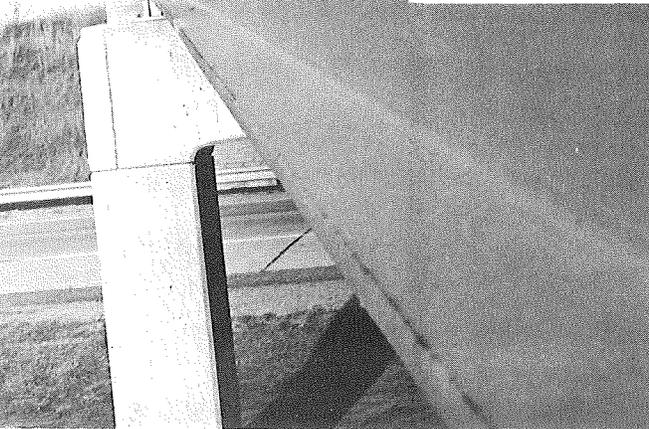
2. All, except the galvanizing, now show minor, spotty rusting on edges of lower flanges of beams, Figure 3.

Figure 3. (left) Minor and spotty coatings' failure on sharp edges of lower flanges is present, but has progressed only moderately. Remainder of surface is in good condition. Photo shows facia of system 4 based on a SSPC primer containing red lead and fractionated linseed oil.
