OFFICE MEMORANDUM

DEPARTMENT OF STATE HIGHWAYS

Subject: Pavement Damage Related to Tire Studs. Research Report R-680.
Research Project 65 F-82.

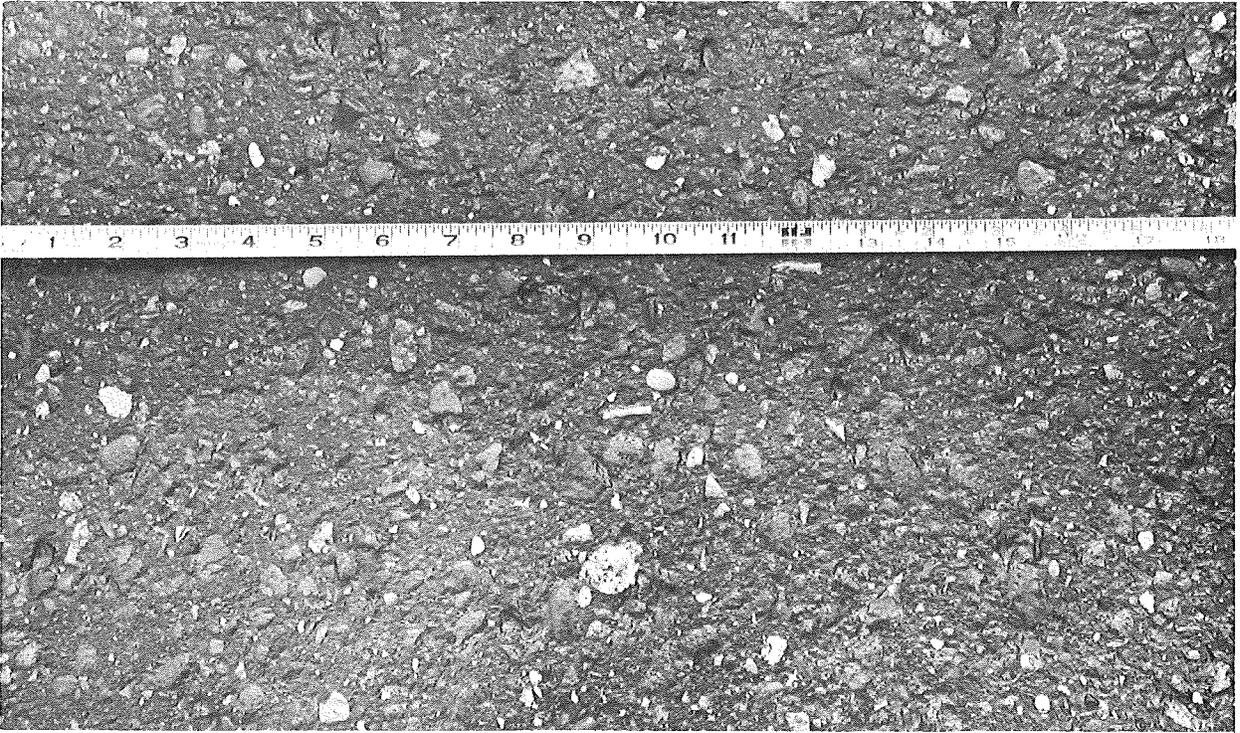
Figure 1 shows a comparison of pavement wear in two areas located within ten feet of each other. However, one photo shows a badly worn area in the wheeltracks and the other an undamaged area near the curb subject to relatively little traffic. The pavement shown in Figure 1 is located in Hancock on M 203, Quincy St. near Elevation St. (Construction Project M 31031-004). This 85-100 penetration bituminous aggregate surface, constructed to Michigan 4.11 specifications, was placed in the fall of 1967 and has carried traffic for less than one year.

Condition of pavement in wheel tracks.

Figure 1. Comparison of surface condition on M 203, Hancock (construction project M 31031-004).

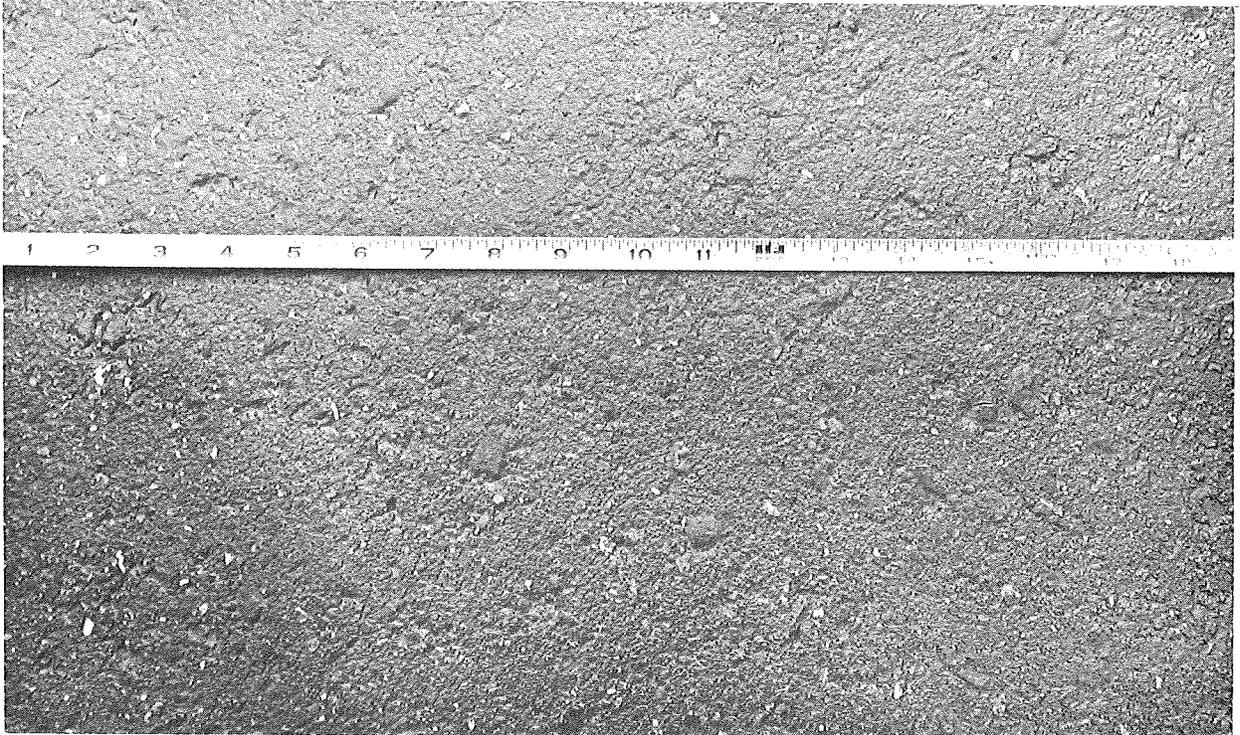
Condition of pavement in low intensity traffic area.

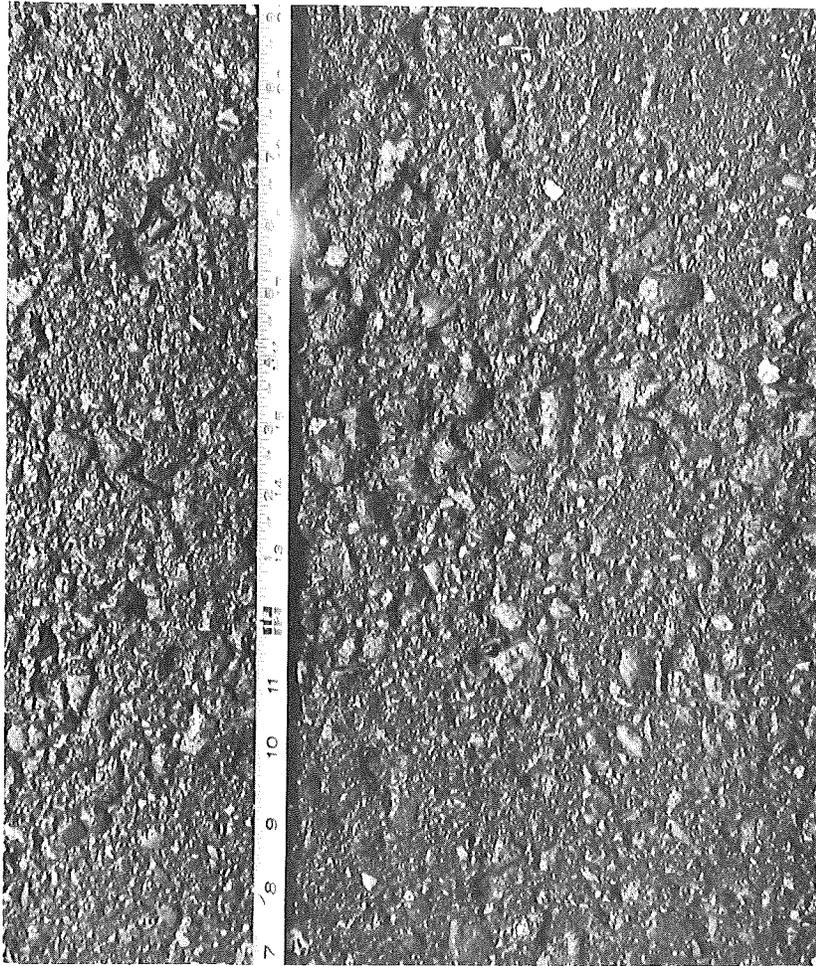
Figure 2 shows another badly worn area of pavement on the same M 203 project, but located on a horizontal curve. Figure 3 is another view of the same M 203 pavement project but in an area outside of town where traffic volume is lower. This surface shows no visible wear.

Figure 2 (above). Pavement surface on horizontal curve on M 203, Hancock (construction project M 31031-004).

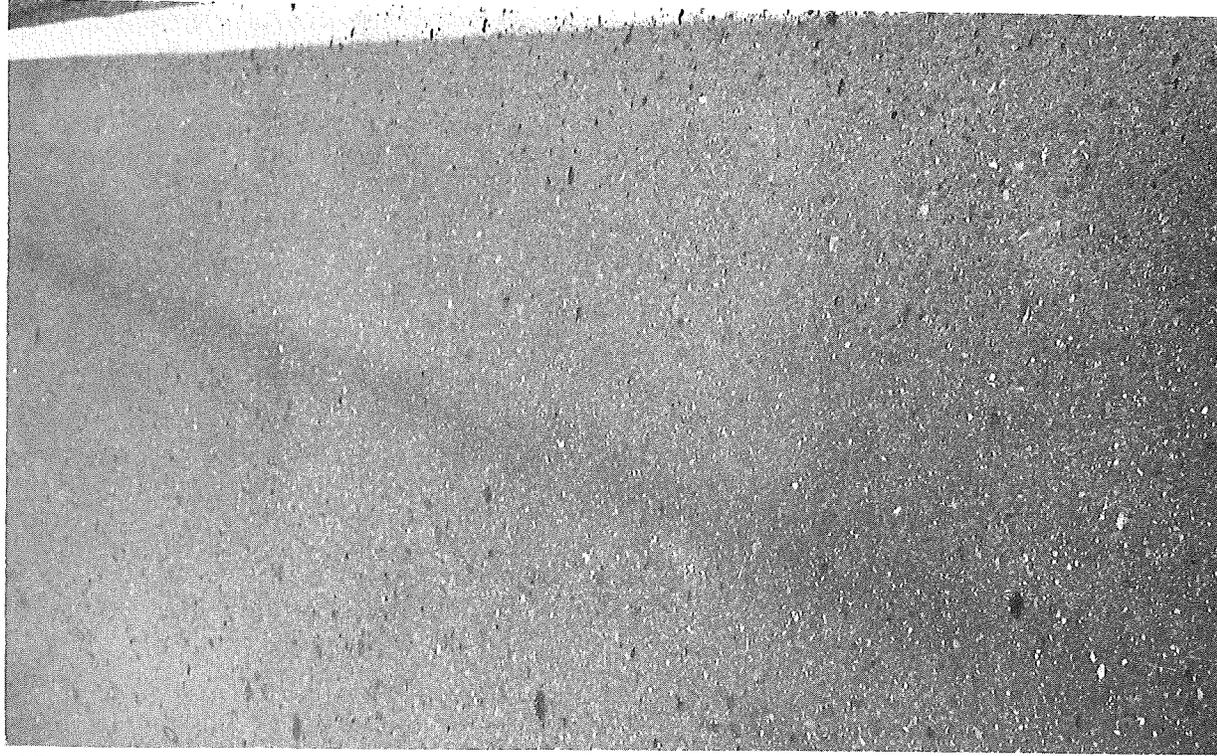
Figure 3 (right). Pavement surface on M 203, Hancock (construction project M 31031-004). Relatively low traffic volume area.

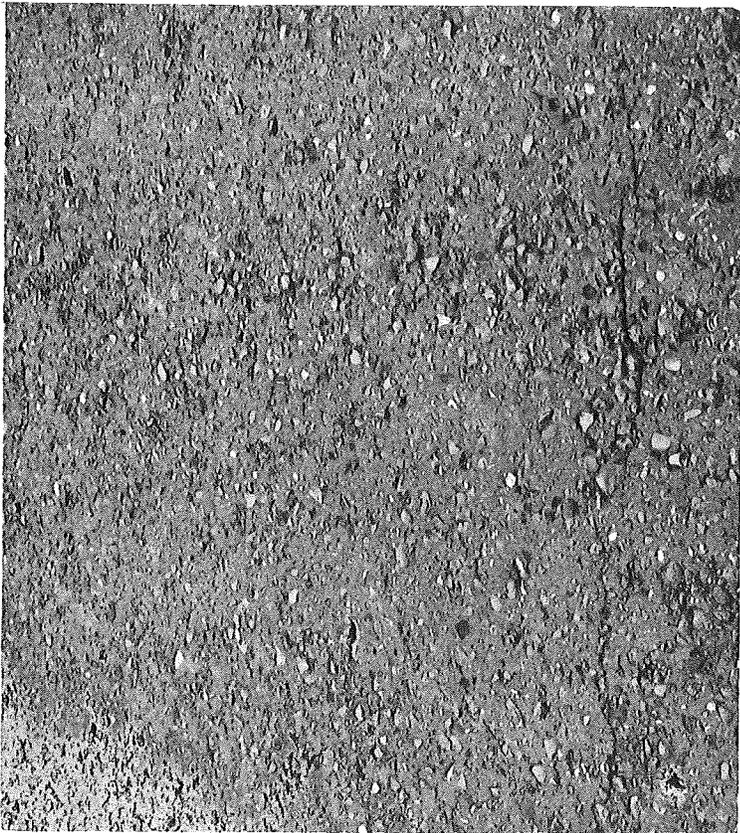
A worn portion of US 41 SB also located in Hancock is shown in Figure 4. For this construction project, Hancock St. (U 31052-011), constructed in late fall of 1967, 4.11 bituminous aggregate surface was specified which had a penetration of 200-250. The high-penetration asphalt may have been a factor in the rapid surface wear.

On each of the bituminous aggregate construction projects, much of the sand-asphalt had apparently been removed by traffic leaving only coarse aggregate exposed.

Figure 4 (left). Typical view of Southbound US 41, Hancock (construction project U 31052-011).

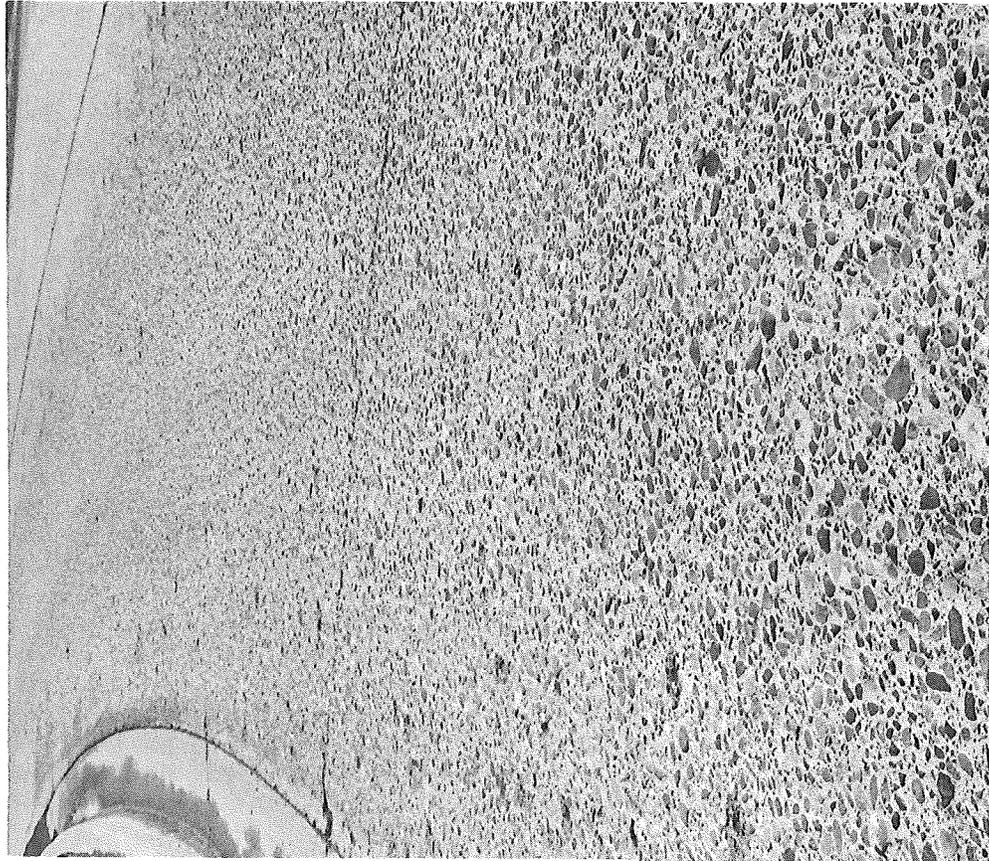
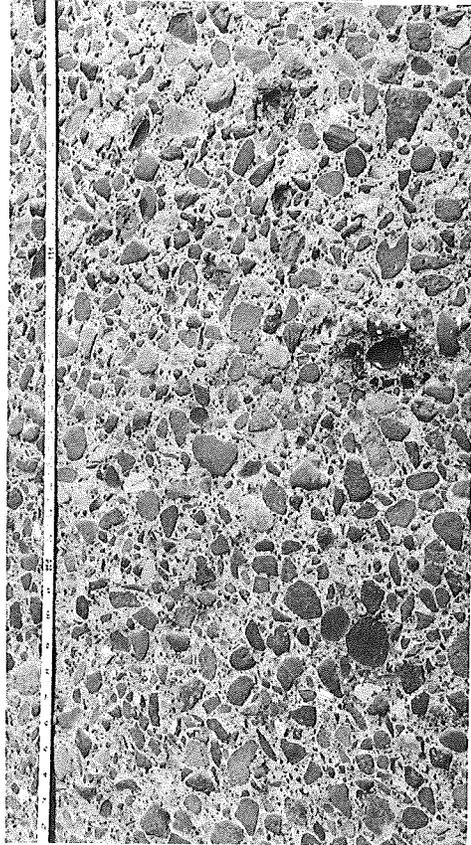
The south ramp of the Houghton-Hancock bridge (M 26 westbound) is shown in Figure 5. This rigid pavement was constructed in 1960. As with the bituminous pavements, finer surface particles have been removed leaving only coarse aggregate exposed.

Figure 5 (left and above). South ramp of Houghton-Hancock bridge. Westbound M 26.
