OFFICE MEMORANDUM

R-686

MICHIGAN
DEPARTMENT OF STATE HIGHWAYS

Subject: Expansion Joint Spalling on I 75. Construction Project I 09035E, C10.
Research Project 39 F-7(14). Research Report R-686.

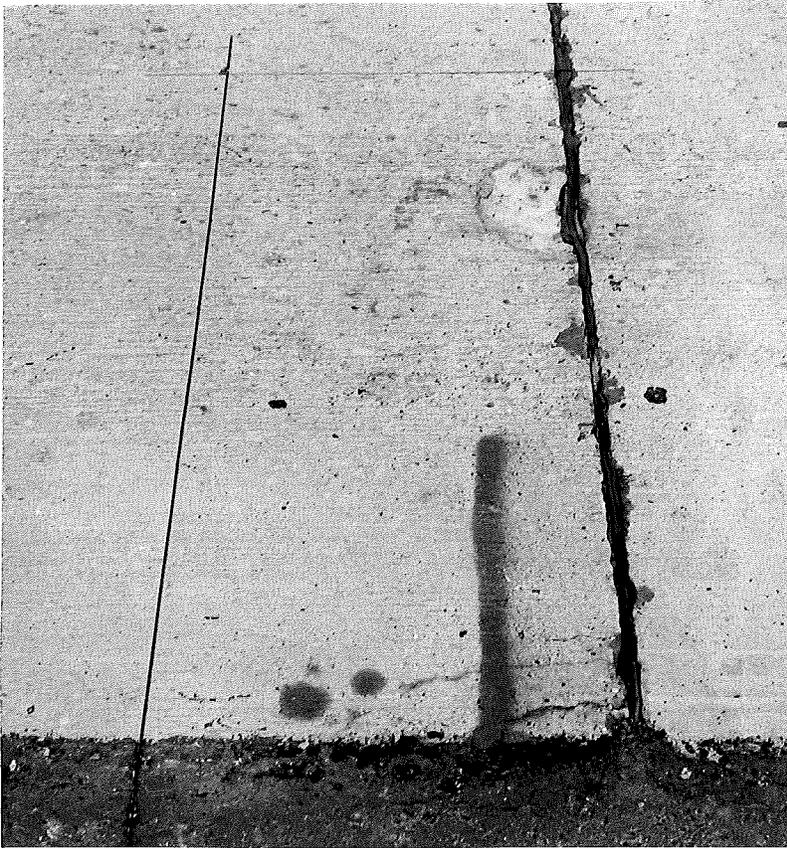
The joint selected for investigation is located at Sta. 1705+94 NB roadway. The air temperature at time of pour was 36F and the concrete temperature was 46F. A 2-ft wide portion extending 5 ft in from the outside edge of the traffic lane was removed and replaced on October 9, 1968 (Fig. 1). The visible spalled area in Figure 1 is quite small. However, from the spall to the lane edge the concrete had fractured horizontally from 12 to 18 in. back from the joint.

After the seal and concrete had been removed to the depth of the horizontal fracture, it was noted that the depth of the fracture at the joint coincided with the bottom of the joint seal groove. The reinforcement had been placed

at the level of the groove bottom and extended to within about 1 inch of the joint. The fracture followed the steel for 12 to 18 in. and then angled up to the surface. The groove had been sawed to a depth of approximately 1-3/4 in. and the remaining concrete to the top of the filler had been chiseled out. This resulted in the groove walls being somewhat tapered in the bottom portion and it appeared that in one area the concrete had not been removed completely to the filler. The groove was sawed about 1/2 in. off center with respect to the filler (Fig. 2). The spall and horizontal crack were located on the side of the groove where incorrect location of the saw cut resulted in the concrete overhanging the filler by at least 3/8 in. The average filler width after the concrete was removed full depth was 7/16 in. The dowel alignment was satisfactory, but a 1-in. bow in the joint groove was noted when a taut string was held from one edge of the roadway to the other.

Figure 1 (left). Limits of area removed and condition of joint at Station 1705+94 northbound roadway.

1. Remove all expansion joints where spalls or loose concrete are found. Even if only one lane exhibits spalls or loose concrete the joint in

both lanes must be removed to minimize unequal compression in the two lanes. The reinforcement must be left intact and a new expansion joint assembly and seal installed. The length in the longitudinal direction to be removed at each location is to be determined by the extent of the joint deterioration.

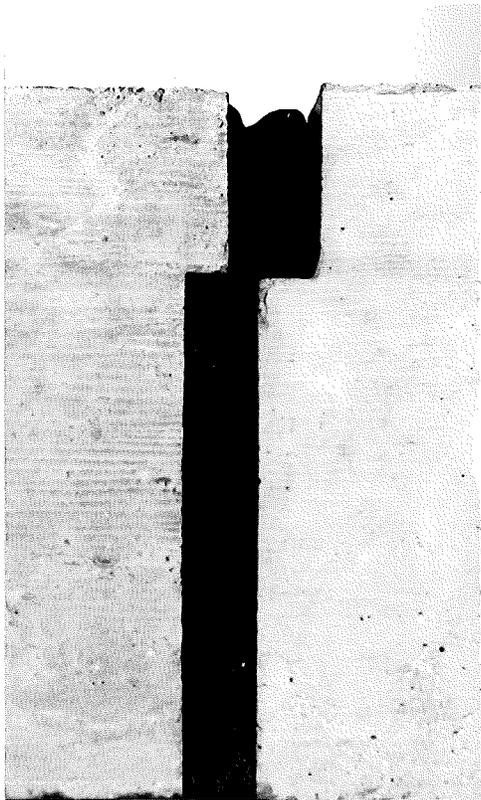
To verify the apparent failure cause, an expansion joint sample was constructed with the joint groove offset 5/8 in. from its required location, and tested to failure. The concrete blocks used to simulate the slab had a cross-sectional area of 9 by 9 in. and an average compressive strength of 4300 psi, when originally cast about a year ago. Fig. 4 shows the joint sample before testing. The filler width was 0.94 in. and the groove width 1.19 in. just before applying the compressive load in the direction of the pavement alignment and simulating pavement expansion. Groove depth was 2-1/2 in. and the width of concrete overhanging the filler was 1/2 in.

Figure 4 (left). Joint sample before testing. Concrete overhanging the filler by 1/2 in.

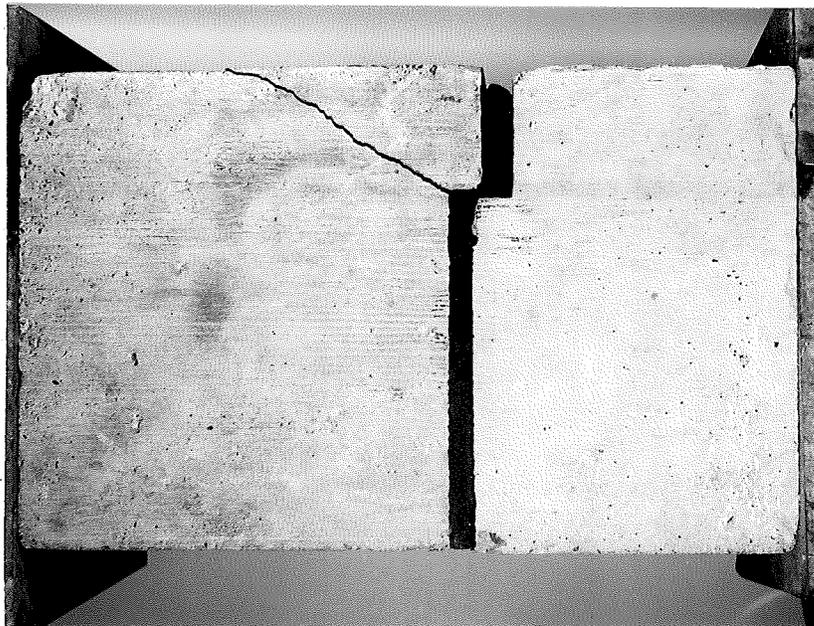
A tensile failure originated in the concrete at the inside corner of the overhang, resulting in the spall shown in Figs. 5 and 6. The width of the filler at time of failure was 0.33 in. and that of the seal 0.58 in. On the basis of

Figure 5 (below). Tensile failure crack caused by filler extrusion.

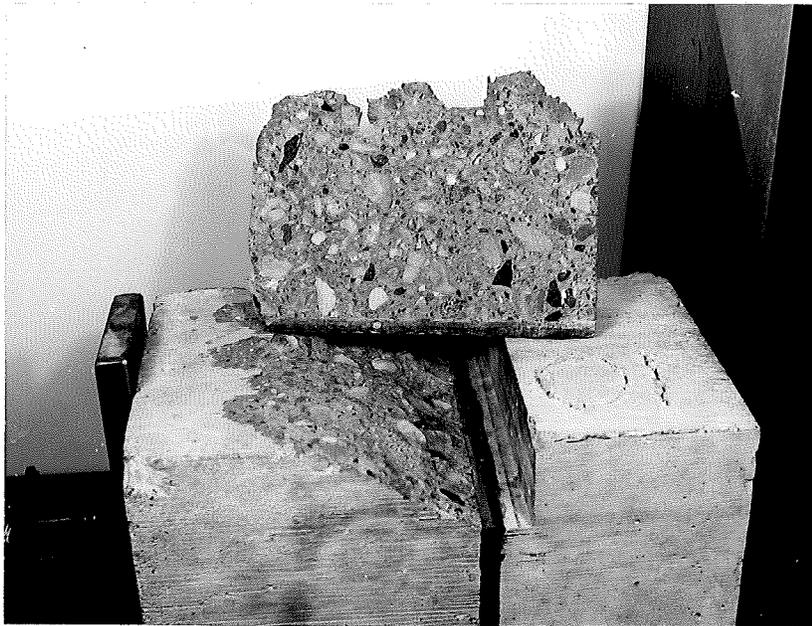
Figure 6 (left). Surface view of joint sample failure.
