INVESTIGATION OF PAVEMENT DAMAGE  
BY GASOLINE TRUCK FIRES TO M 20, (Control Section 56023)  
CITY OF MIDLAND AND US 27 (Control Section 37013, C4)  
SOUTH OF MT. PLEASANT

Research Laboratory Section  
Testing and Research Division  
Research Project 69 TI-2  
Research Report No. R-725

State of Michigan  
Department of State Highways  
Lansing, January 1970

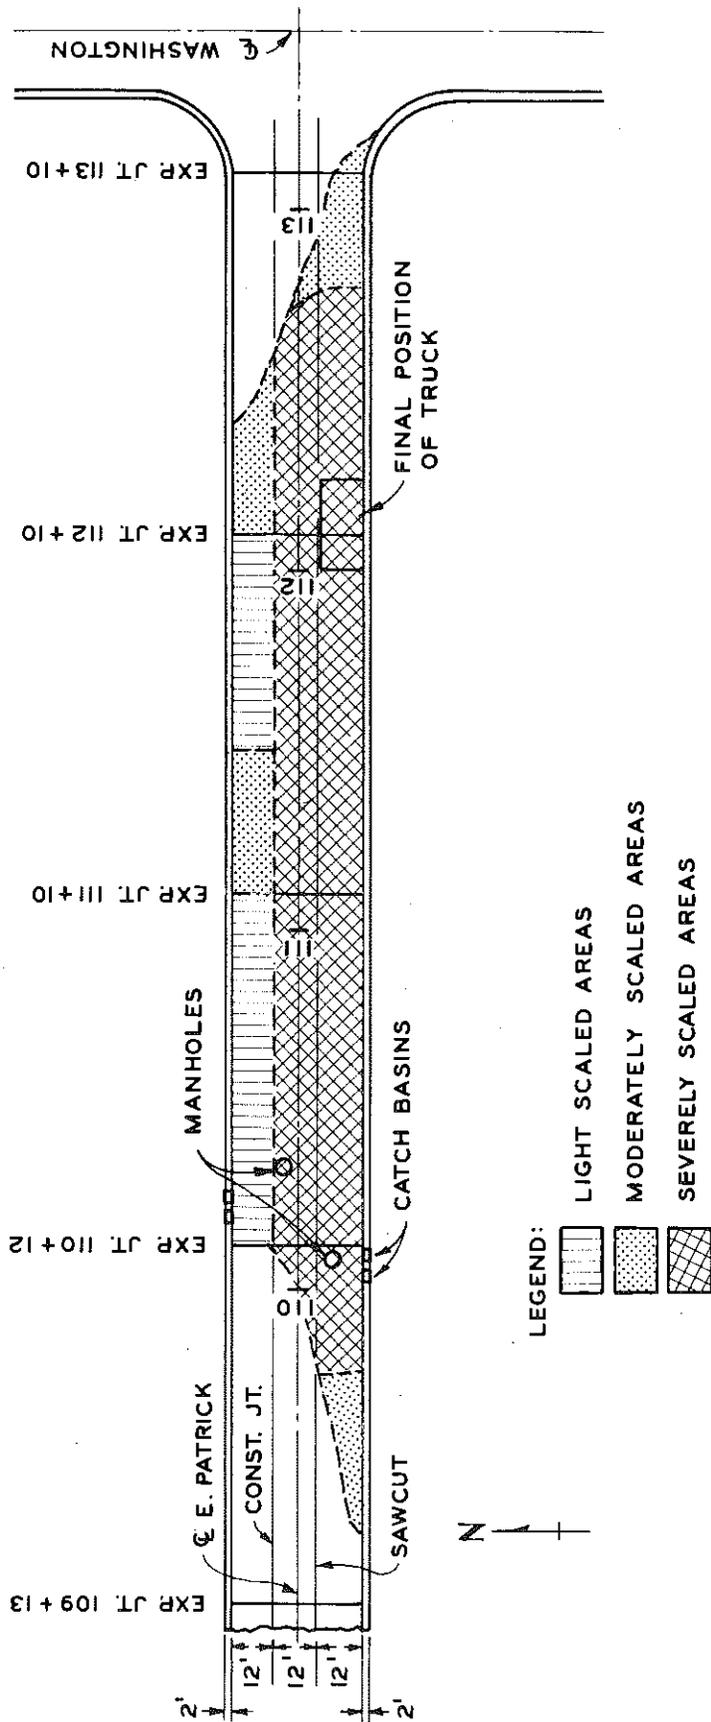
Figure 1. Westbound M 20 roadway damaged by fire in the city of Midland.

Figure 1 shows a diagram of the damaged pavement in Midland. The center and south lanes were heavily spalled from Sta. 109+75 to 112+75. Spalled areas of less severity extended approximately 40 ft further at either end. The north lane was damaged to a much lesser extent. Cores were taken at various positions in the affected area to help determine the depth of the damage. Figures 2 and 3 show the condition of the damaged area. After our inspection, Mr. Gleason arranged for a temporary bituminous wearing surface to be placed over the damaged pavement.

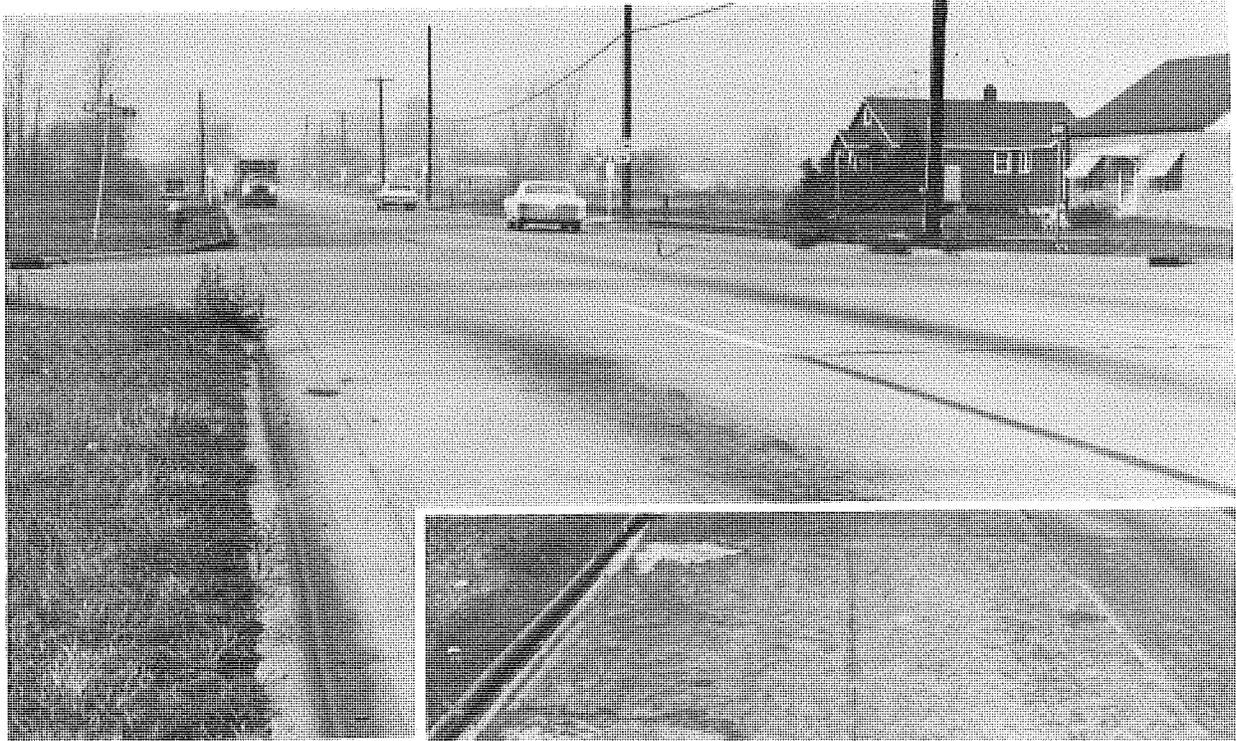
▲ General view of fire area looking west.

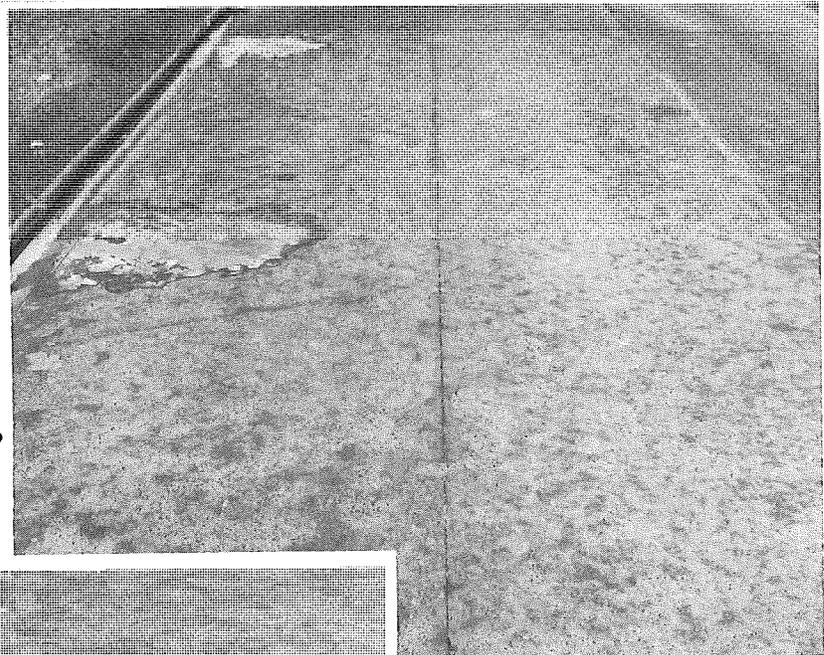
Western limit of damaged area; looking west from Sta. 110+10. ▶

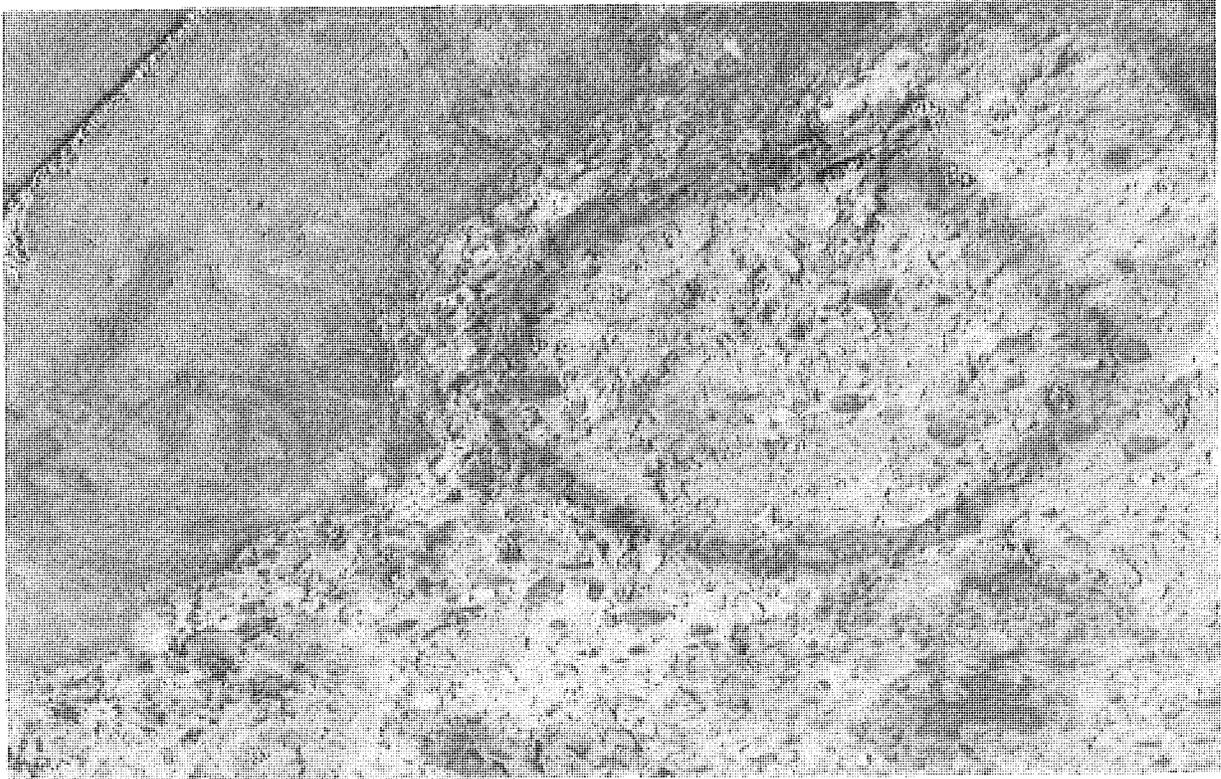
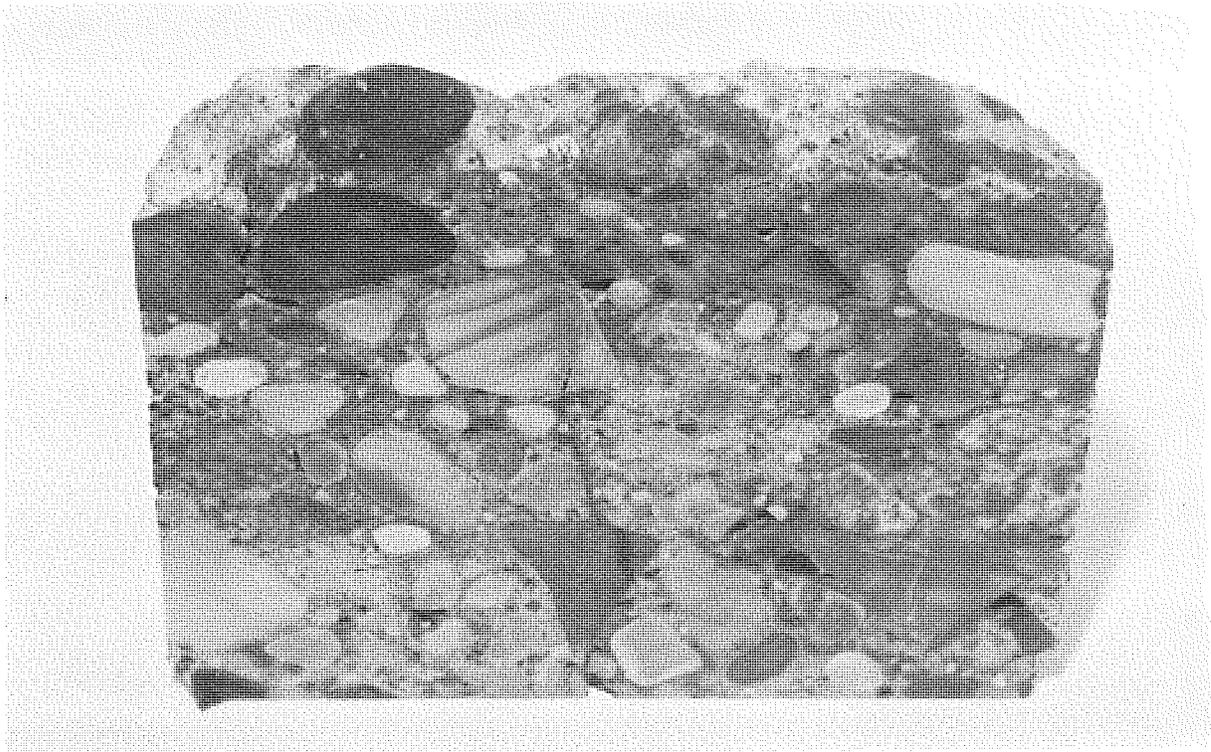
1. Differential thermal expansion, caused by the intense and sudden heat, had produced horizontal fracture planes from 1/8 to 1/4 in. below the concrete surface in the mortar areas. The same fracture planes in the large pieces of 4A aggregate were evident up to 3/4 in. deep. This variation in fracture depth occurred because the aggregate was a better conductor of heat than the air-entrained mortar.

2. The mortar at the top of the core, from 1/4 to 1/2 in. deep, had changed in color from a light gray to a pinkish-yellow. A study of available literature and consultation with our chemists revealed this to be cement from which the water of hydration had been driven by the heat. Hydrated portland cement attains its maximum expansion at 300 F; begins shrinkage at higher temperatures, and loses its water of hydration at 450 F. The shrinkage occurring in concrete exposed to these high temperatures over a significant length of time can ultimately equal or exceed a 0.5 percent decrease from its original dimensions and severe cracking results.

Figure 3. Condition of pavement at Sta. 112+37 showing close-up view where core No. 5 was taken (above) and an oblique view of a sawed cross-sectional slice from the core (below). Note darkened mortar strip at the top surface where intense heat drove hydrated water from the cement.

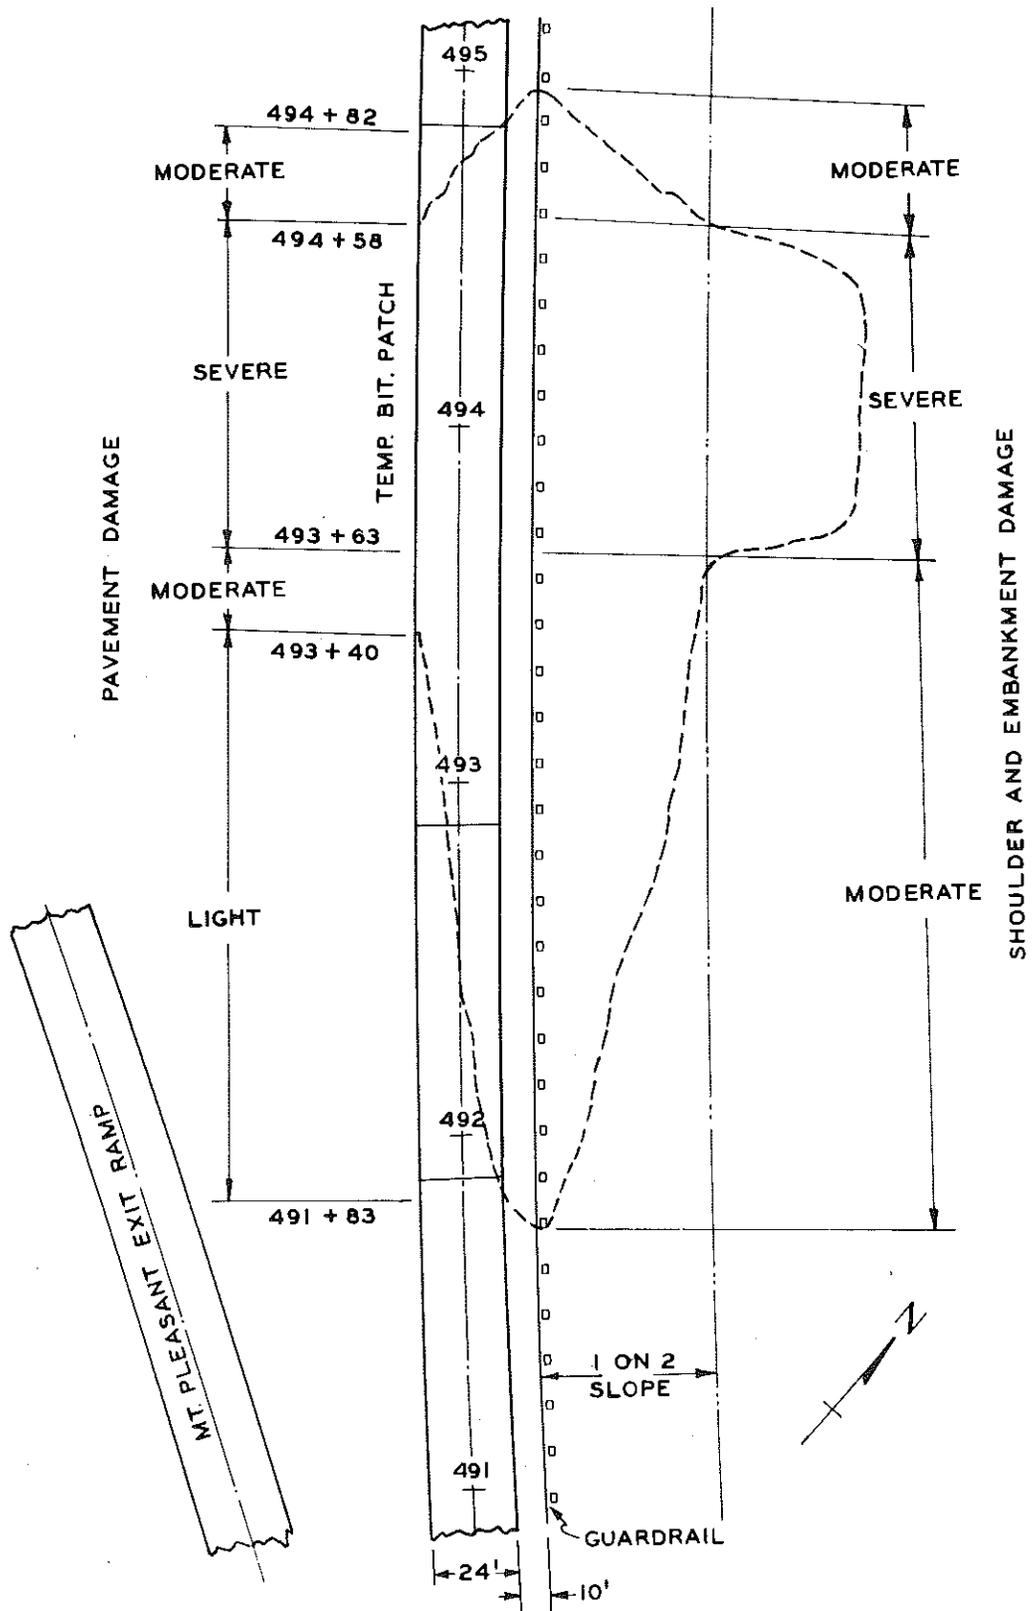
Figure 4. Northbound US 27 roadway damaged by fire near Mt. Pleasant

Figures 4 and 5 show a diagram and photographs of the damaged pavement on northbound US 27 south of Mt. Pleasant. The most heavily damaged portion on the superelevated horizontal curve was confined to 95 ft between Sta. 493+63 and 494+58. This area had already been temporarily repaired with a bituminous cap, presumably by District 5 maintenance personnel. The shoulder area and the guardrail, both of which had been badly damaged, had also been repaired. The sod was burned-off the entire height of the embankment.

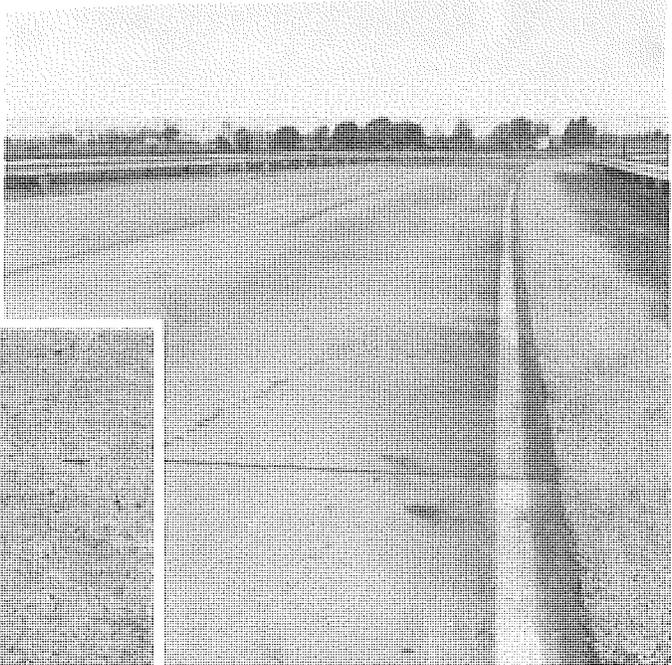
View of damaged pavement looking northwest from Sta. 491+80.

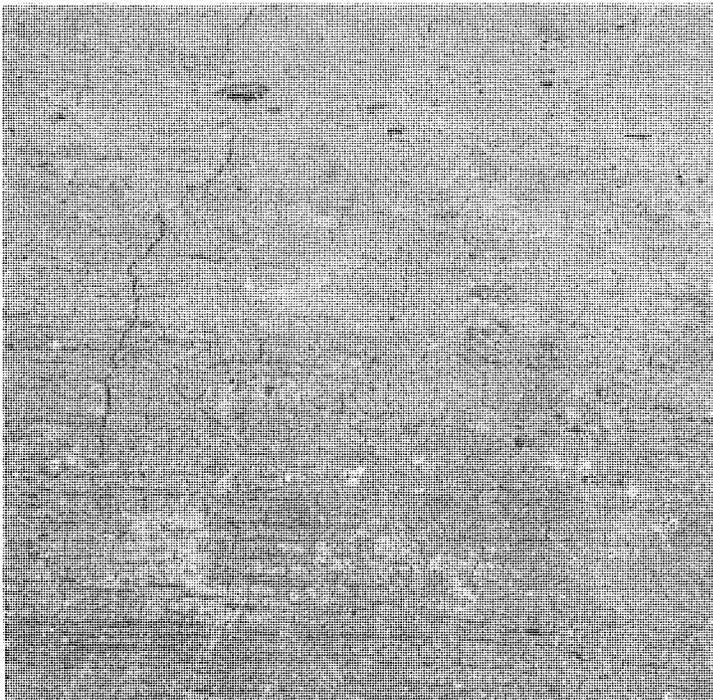
3. Craze or shrinkage cracks, whose formation was described above, were noted on the concrete surface of the Midland (M 20) cores, and on the area just north of the bituminous patch at the US 27 site (Fig. 5). The discolored portion of the core cross section slices from 1/4 to 1/2 in. below the top surface showed mortar separation cracks around the aggregate particles. These cracks will make the concrete very vulnerable to rapid freeze-thaw deterioration.

Close-up view of moderately damaged area northwest of patch. Note craze or shrinkage cracks resulting from the high temperature.

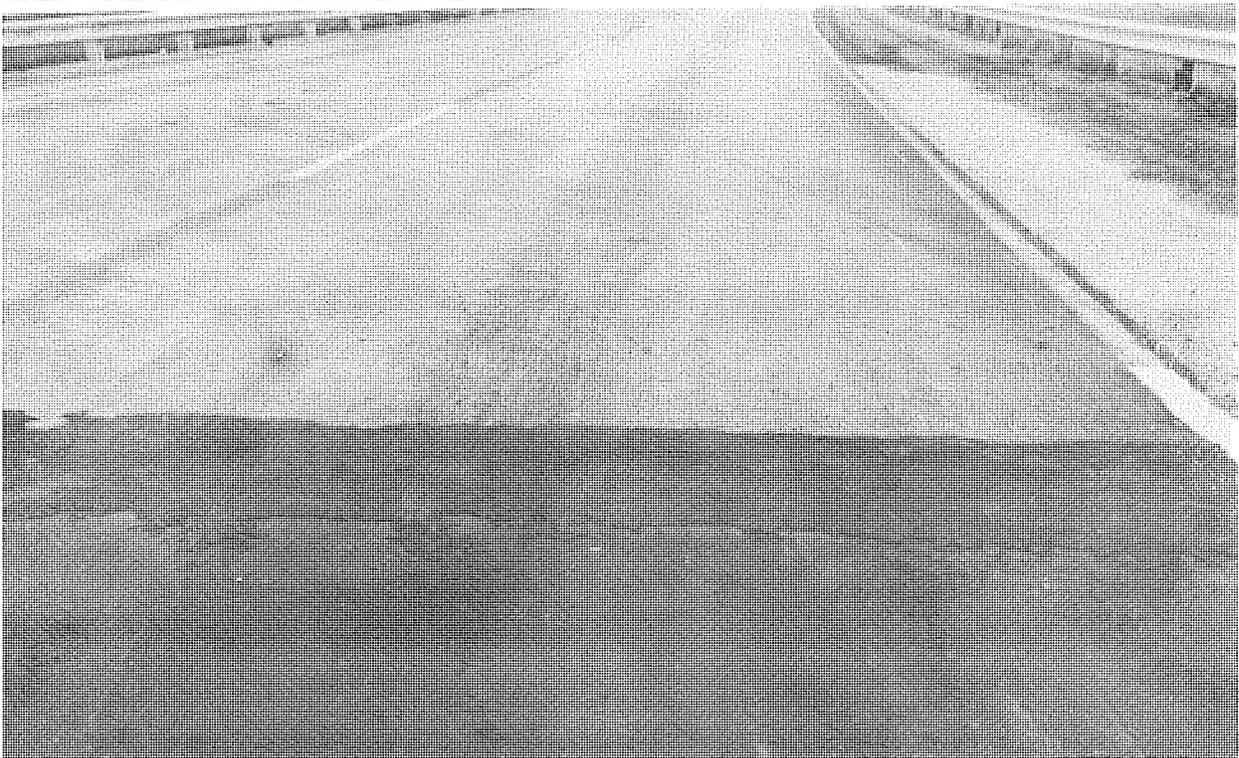
View of area looking northwest from patched area to moderately damaged area in background.
