ALLEGED DAMAGE TO THE RESIDENCE
OF H. C. DeWITT
DUE TO TRAFFIC-INDUCED VIBRATIONS

C. J. Arnold
L. E. DeFrain

Research Laboratory Section
Testing and Research Division
Research Project 70 F-119
Research Report R-768

Michigan State Highway Commission
Charles H. Hewitt, Chairman; Wallace D. Nunn, Vice-Chairman;
Louis A. Fisher; Claude J. Tobin; Henrik E. Stafseth, Director
Lansing, June 1971

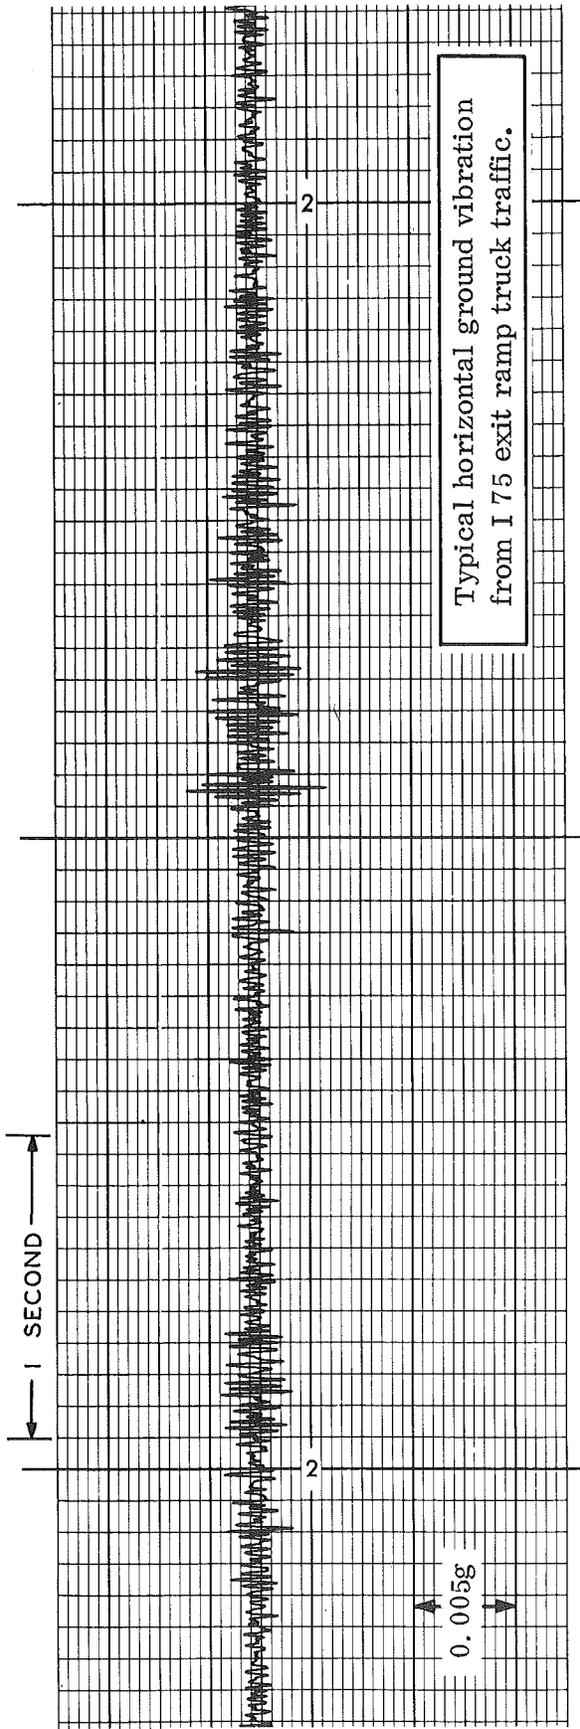
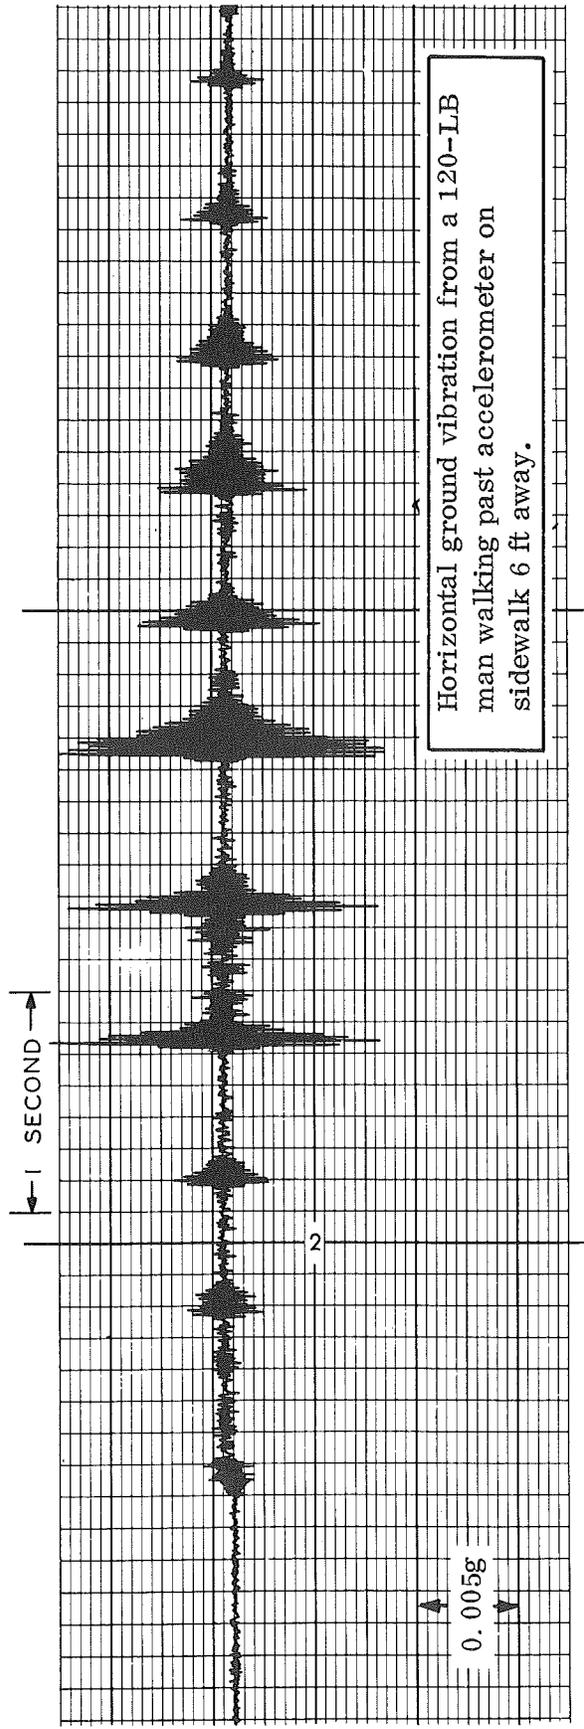
Figure 2. Traces from accelerometer located across street from DeWitt residence (Position 1).

Ground vibrations decrease quite rapidly with distance from the source and, since little vibration was noticeable near the house, a measurement site was chosen across the street nearer the ramp (Fig. 1). Two 2-1/2 g accelerometers to measure vertical and horizontal accelerations, were mounted on a 4-ft long steel stake, driven into the ground. Recordings of truck-induced ground vibrations were made over a one-hour period, resulting in a maximum acceleration of less than 0.01 g. The relative significance of such a vibration can be determined from the fact that a 120-lb man walking on the sidewalk near the accelerometers produced readings of 0.015 g. Comparison traces of truck-induced and 120-lb pedestrian vibrations are shown in Figure 2.

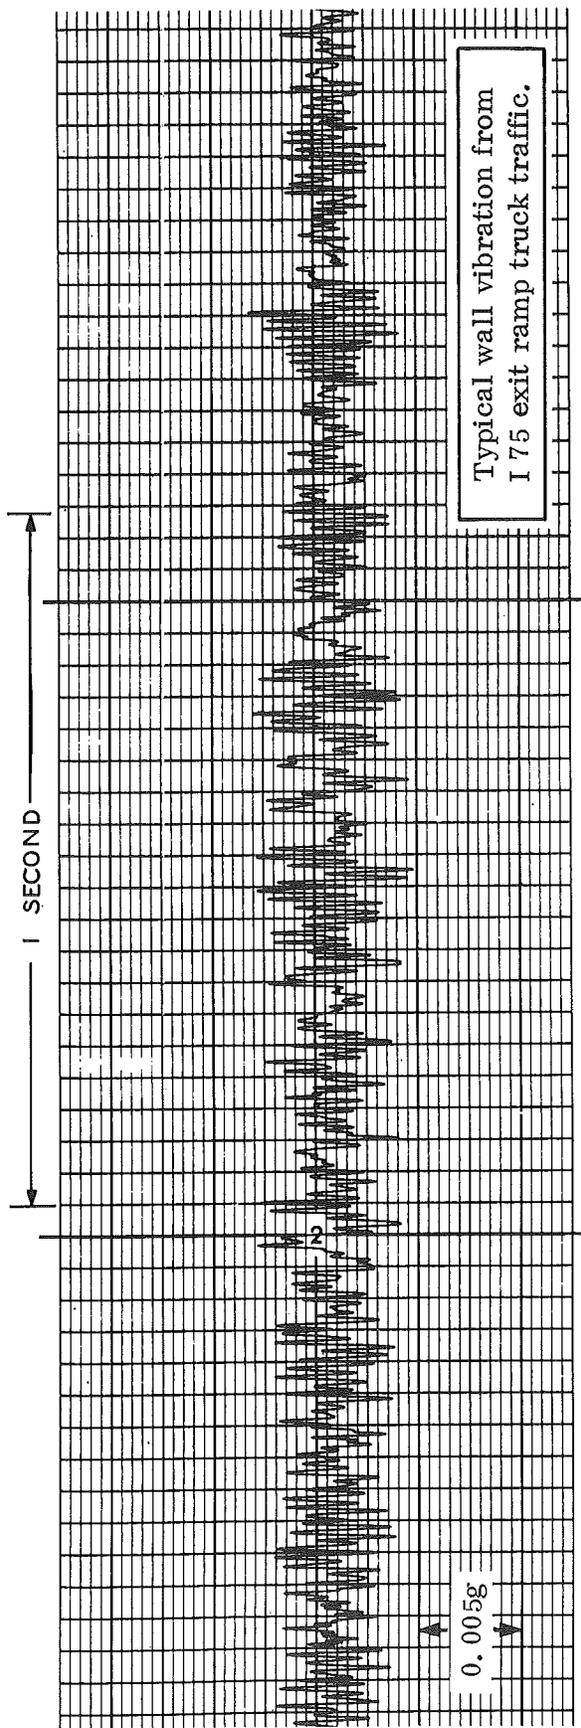
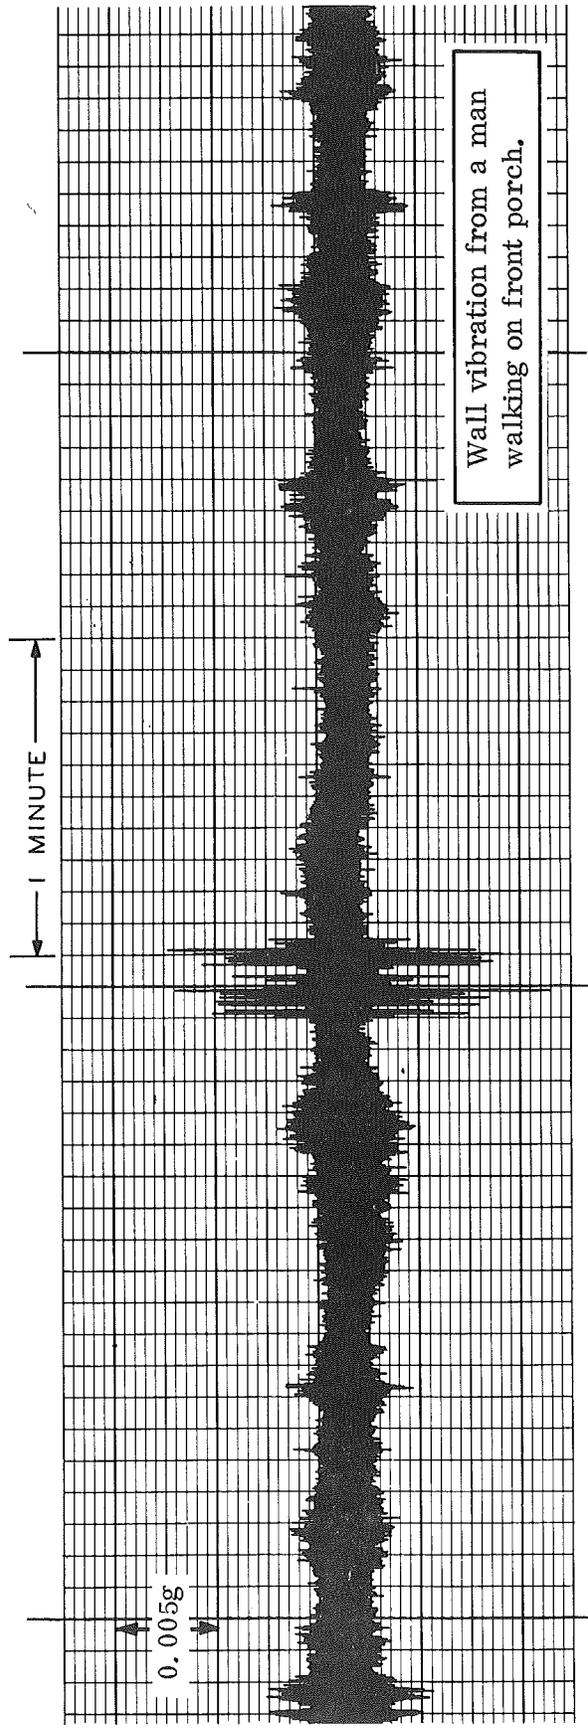
Figure 3. Traces from accelerometer mounted on front outside wall of DeWitt residence (Position 2).

Normal household activity was conducted to provide measurements for comparison with those indicated above. A man walked across the front porch and closed the front door in a normal manner. In general, the man walking and door closing produced maximum accelerations approximately 1-1/2 and 2-1/2 times greater, respectively, than the maximum values produced by truck noise (Figs. 3 and 4).

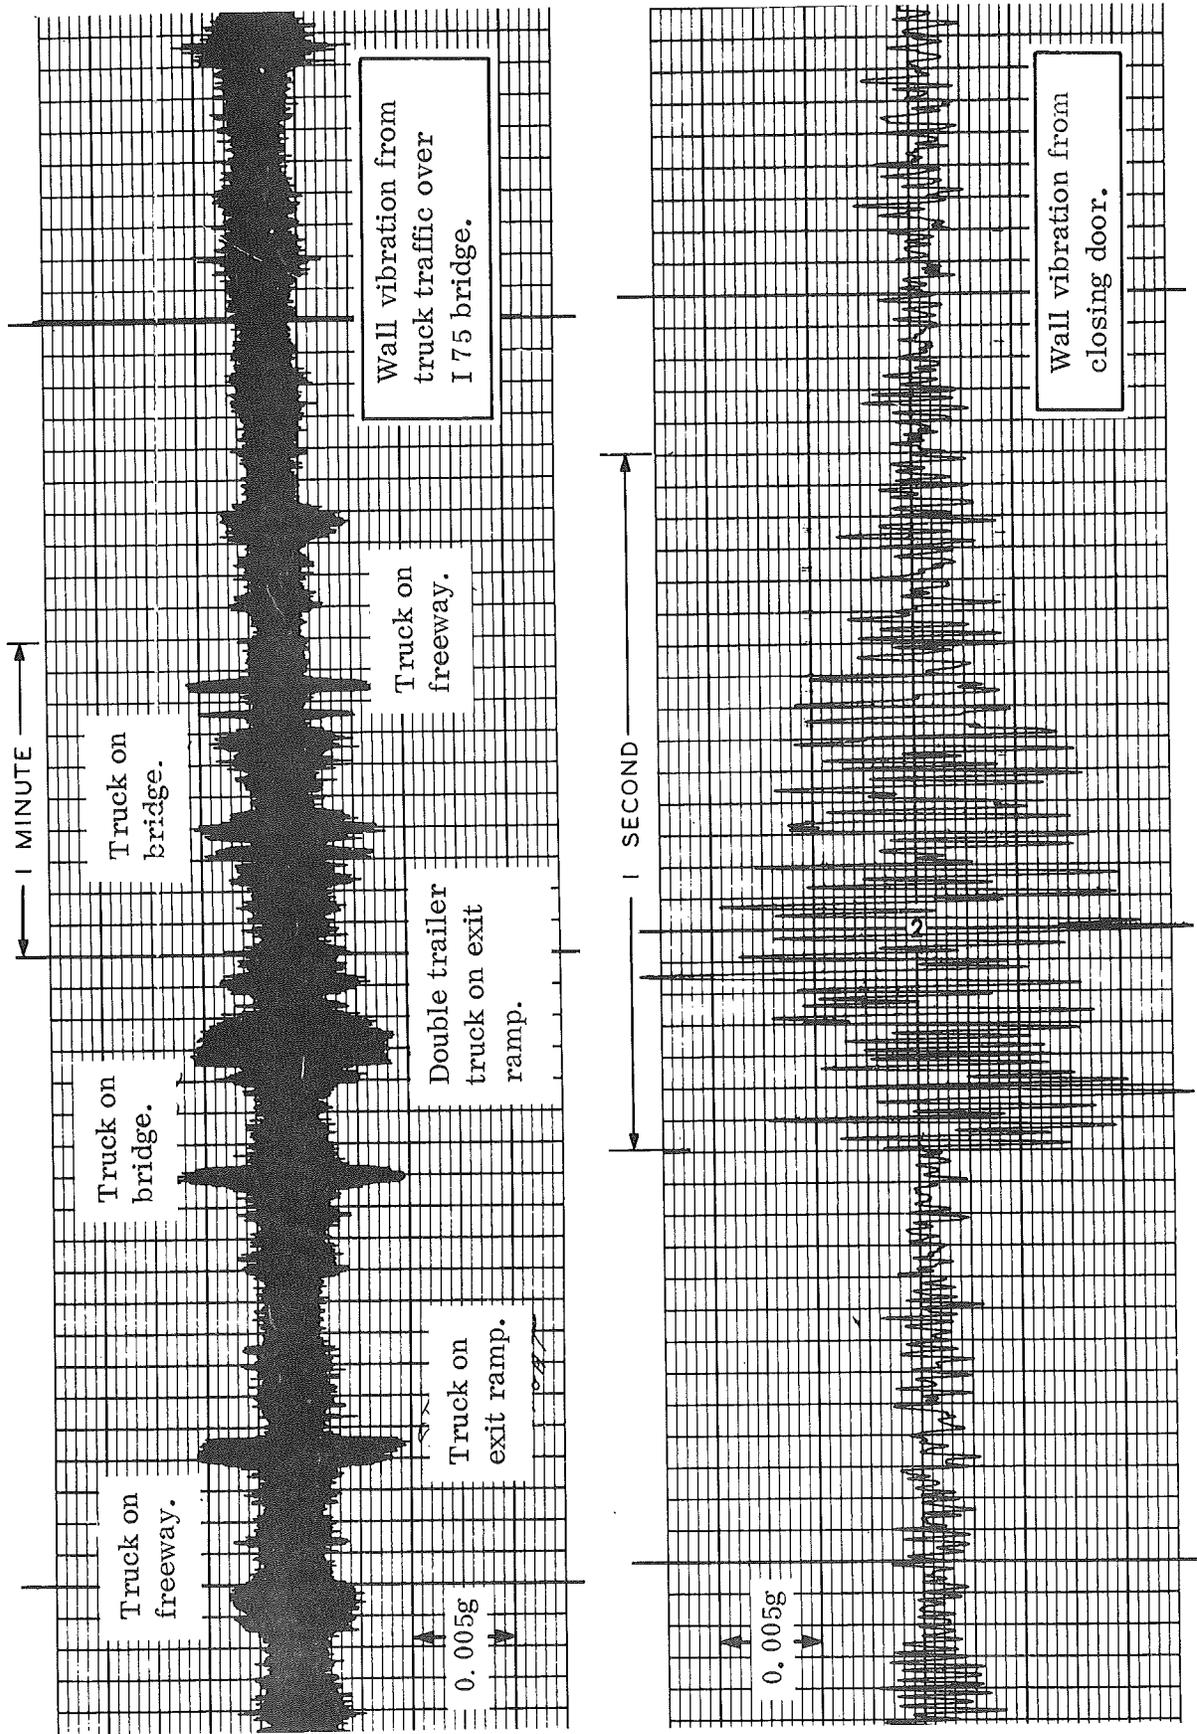
Figure 4. Traces from accelerometer mounted on front outside wall of DeWitt residence (Position 2).

Recordings of the horizontal accelerations of the front wall of the house were obtained by attaching an accelerometer to the outside of the wall, near the center. Vibrations due to typical truck traffic were recorded for one hour. Analysis of the recordings indicated that the house front was subjected to a continuing vibration of about 0.002 g, with maximum values less than 0.01 g due to truck engine noise. The maximum noise and wall acceleration occurred when trucks accelerated and changed gears while crossing the bridge over I 75, directly in front of the house (Fig. 4, top).
