BRIDGE DECK CRACKING INVESTIGATION ON
THE THREE CONTINUOUS SPANS OF B01 of 73101E
(I 675/Saginaw River)

H. L. Patterson
E. L. Marvin

Research Laboratory Section
Testing and Research Division
Research Project 71 TI-31
Research Report No. R-772

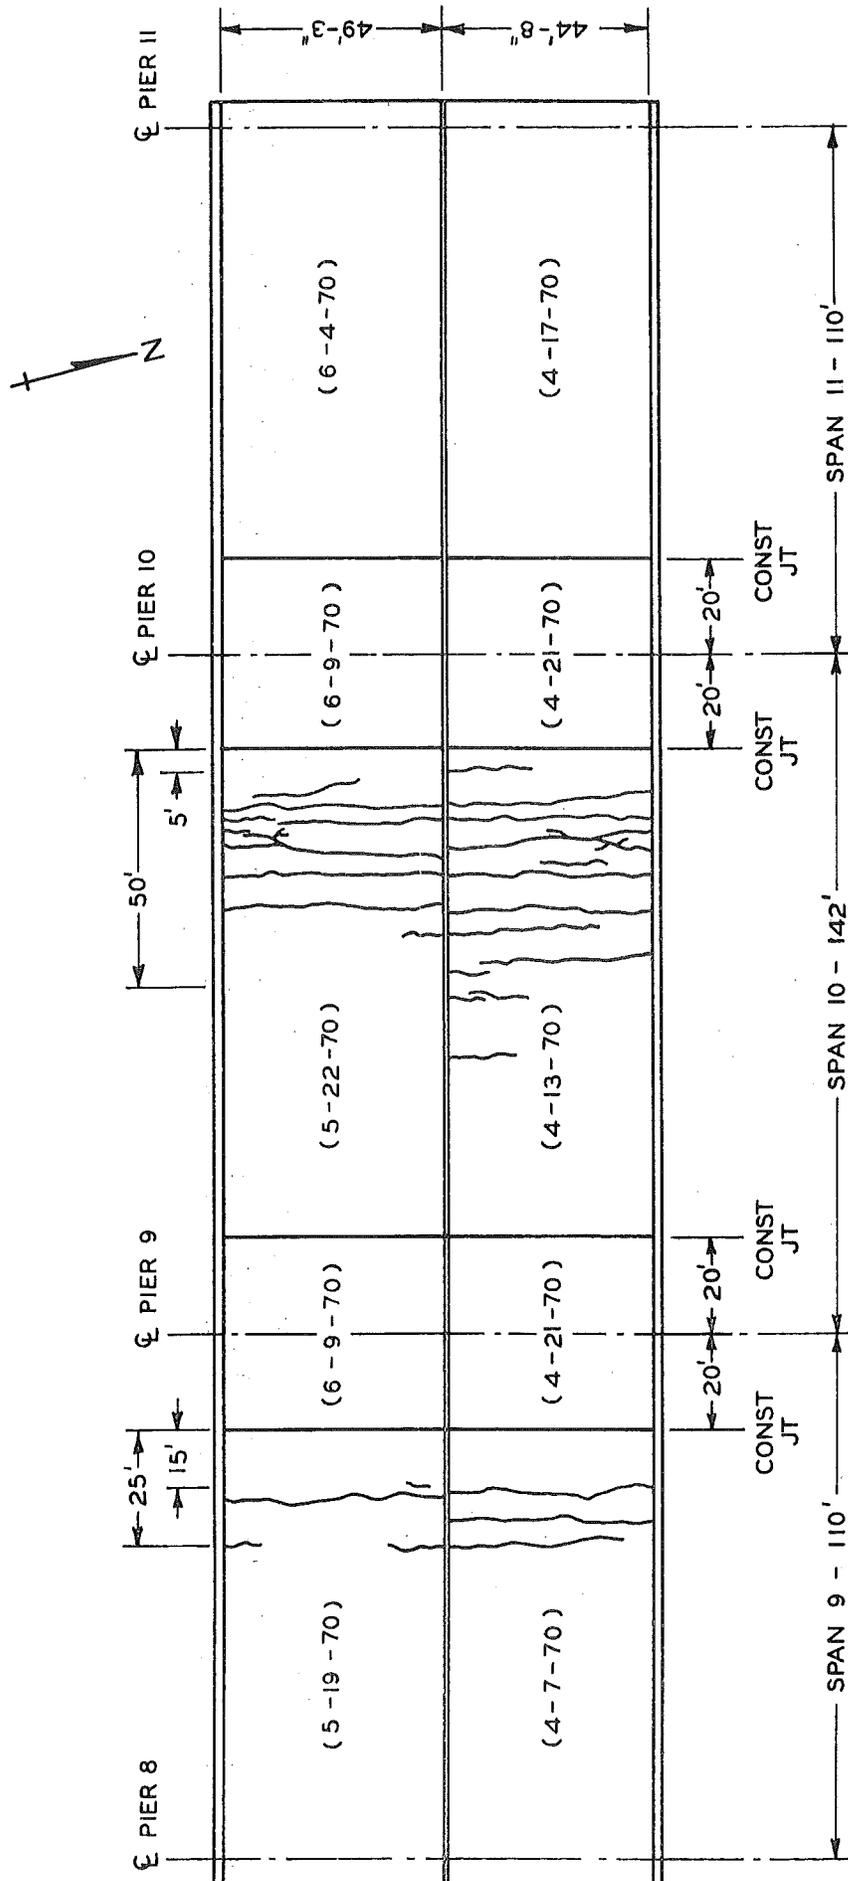
Figure 1. Bridge deck crack pattern on I 675 / Saginaw River.
B01 of 73101E

Figure 1 is a plan view diagram of the three continuous spans showing the locations of the transverse cracks. Since the cracks are not uniformly spaced across spans 9 and 10, and are completely absent in span 11, it becomes apparent that they are not caused by shrinkage restraint alone. When the sequence of pour dates is considered, it would appear that each subsequent pour caused variations in the girders elastic curve which caused cracking in the preceding pour. This effect can be illustrated in a line sketch as shown in Figure 2. Construction records indicate that a water reducer-retarder was used with a longitudinal finishing machine and the concrete was cured by wet burlap for all pours.

The maximum tensile stress in the concrete in span 9 was found to be 270 psi. The maximum tensile stress in the concrete in span 10 was found to be 240 psi. The location of the maximum computed tensile stresses coincided with the areas in the deck where cracking was observed. Considering that the concrete had been in place from four to seven days prior to pouring concrete in the adjacent spans, it is assumed that the concrete would have attained an ultimate tensile strength of about 200 psi. However, the stress analysis indicated that stresses as high as 270 psi could have occurred. It seems reasonable, therefore, to conclude that the observed cracks in the deck were probably caused by the construction loading conditions that have been discussed.

In order to prevent flexural cracking of composite, three-span continuous bridge structures, where shoring is not practical, it is recommended that pre-loading be used and that the concrete pouring sequence be changed. Generally, the positive dead-load moment areas in the tail spans should be poured first with a pre-load in place in the center span. For simplicity, the weight of the pre-load may be chosen equal to that of the concrete deck to be poured in the center span. Removing the pre-load prior to placing the center span concrete would induce compressive stresses in the concrete in the tail spans which would offset the tensile stresses induced when the middle span concrete is placed.

The required pre-load could be greatly reduced if the time interval between pours and curing methods could be controlled to insure the development of a specified minimum value of tensile strength in the concrete in the tail span prior to pouring the center span. For example, considering the subject Saginaw River bridge, if it is assumed that a tensile stress of 150 psi could have been carried by the tail span concrete at the time of placing the center span concrete, then a pre-load equal to about 40 percent of the concrete pour weight would have prevented flexural cracking.

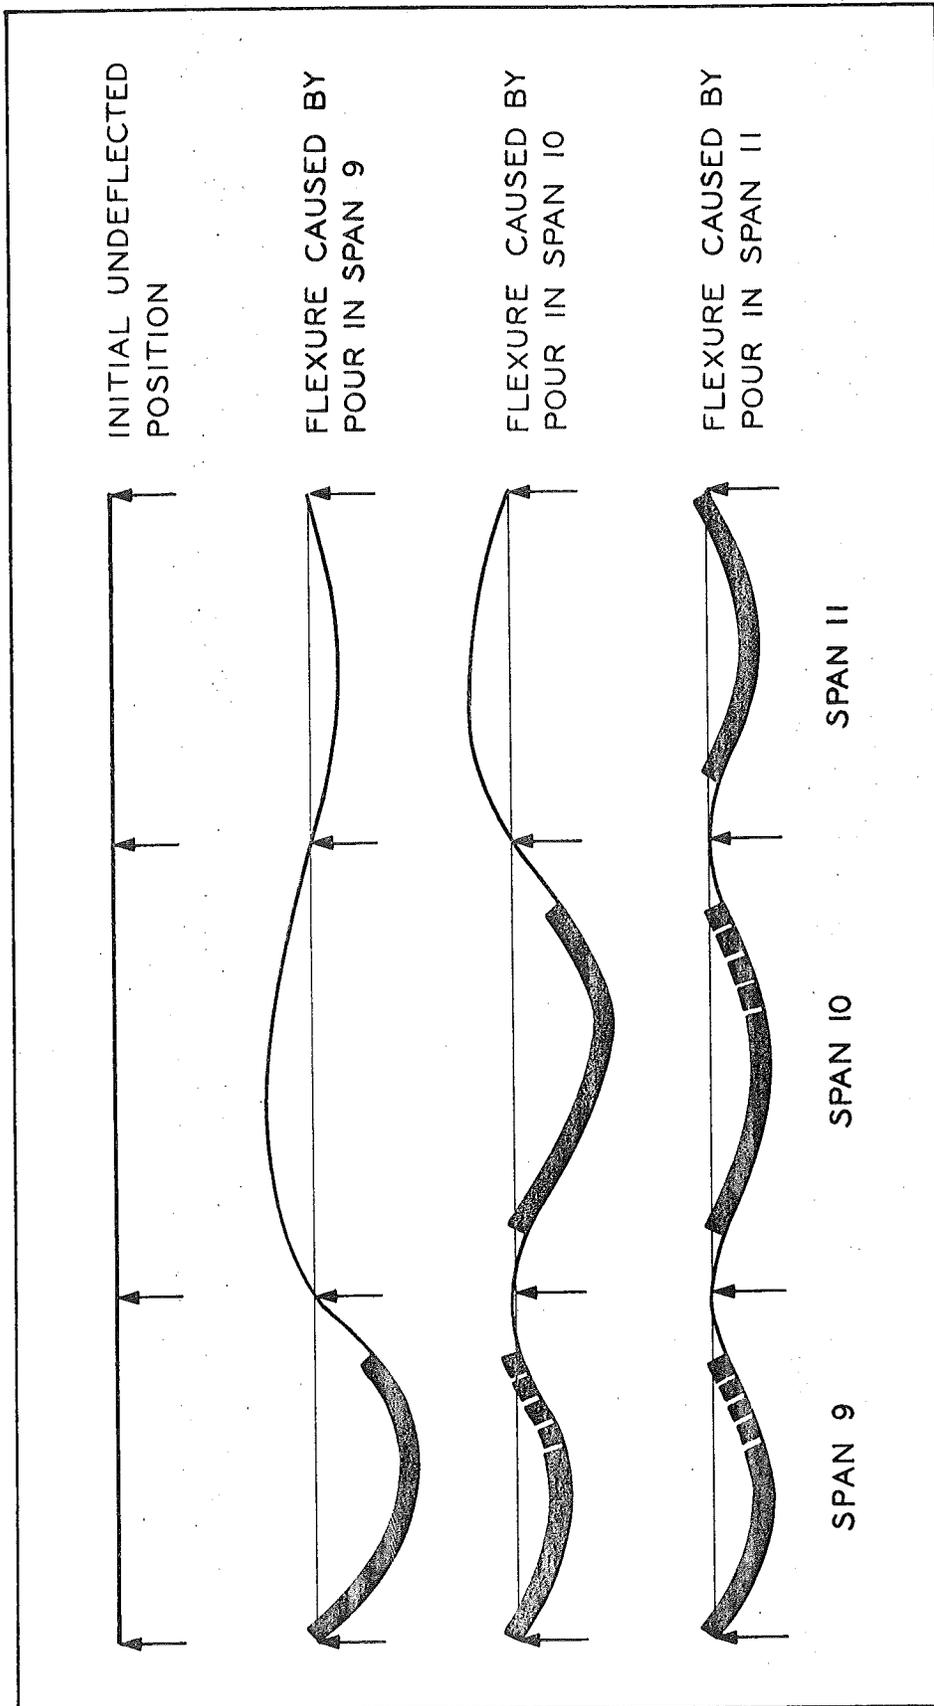
An analysis was performed to determine the likely magnitude of the tensile stresses that developed in the concrete deck that was in place when concrete was poured in an adjacent continuous span. In the first case considered, the deck in the dead-load positive moment portion of span 9 was assumed to be in place and acting compositely; the remainder of the three continuous spans was assumed to act non-compositely. A uniform load equal to the weight of the center pour in span 10 was then assumed to be applied, and the tensile stresses that would be induced in span 9, the tail span, were estimated. In the second case, it was assumed that the deck had been placed in the center span in addition to that in tail span 9 and that these portions of the spans would act compositely under additional load; the remaining portions of the three continuous spans were assumed to act non-compositely. It was then assumed that the concrete deck was placed in the

positive dead-load moment portion of span 11 and the resulting tensile stresses in the span 10 deck were investigated.

Figure 2. The exaggerated sketch shows the sequential positions of the continuous girder's elastic curve after successive slab pours in spans 9, 10, and 11.
