SURVEY OF PAVEMENT JOINT CONDITIONS

Research Laboratory Section  
Testing and Research Division  
Research Project 39 F-7(14)  
Research Report No. R 789

Subject: Survey of Pavement Joint Conditions.  
Research Project 39 F-7(14). Research Report No. R-789.

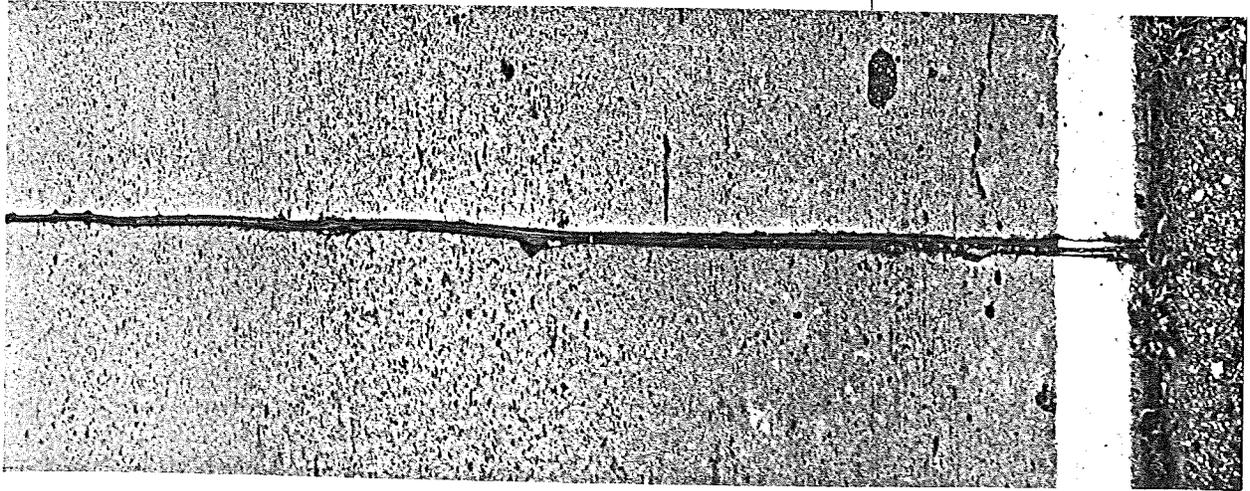
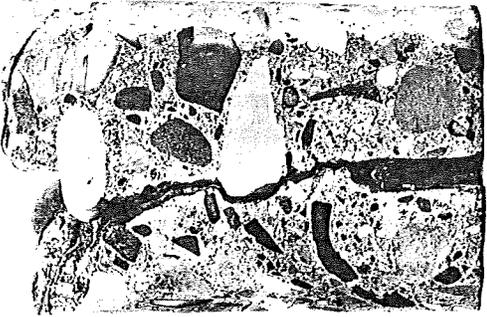
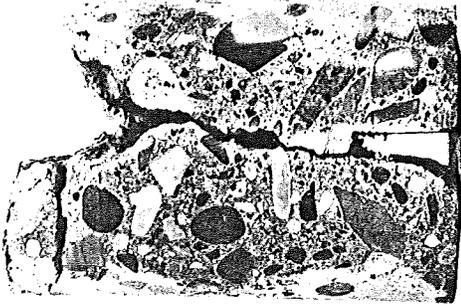
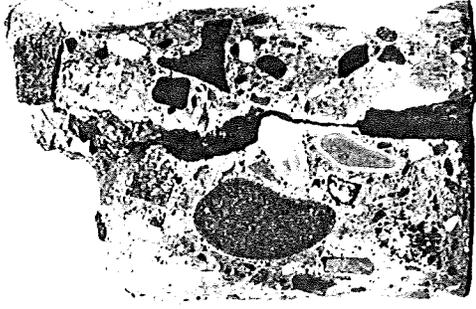
I96 LANSING  
9 YEAR OLD PAVEMENT  
BASEPLATE - FORMED GROOVE  
NEOPRENE SEAL (UNDERSIZE)

1. The oldest neoprene sealed joints (1962), even with an undersized neoprene seal, show a reduced rate of concrete deterioration at the interface as compared to hot-pour sealed joints of the same age. We may expect a few more years of service prior to serious joint problems but not an elimination of the problem.

◀ Typical condition of joint prior to coring.

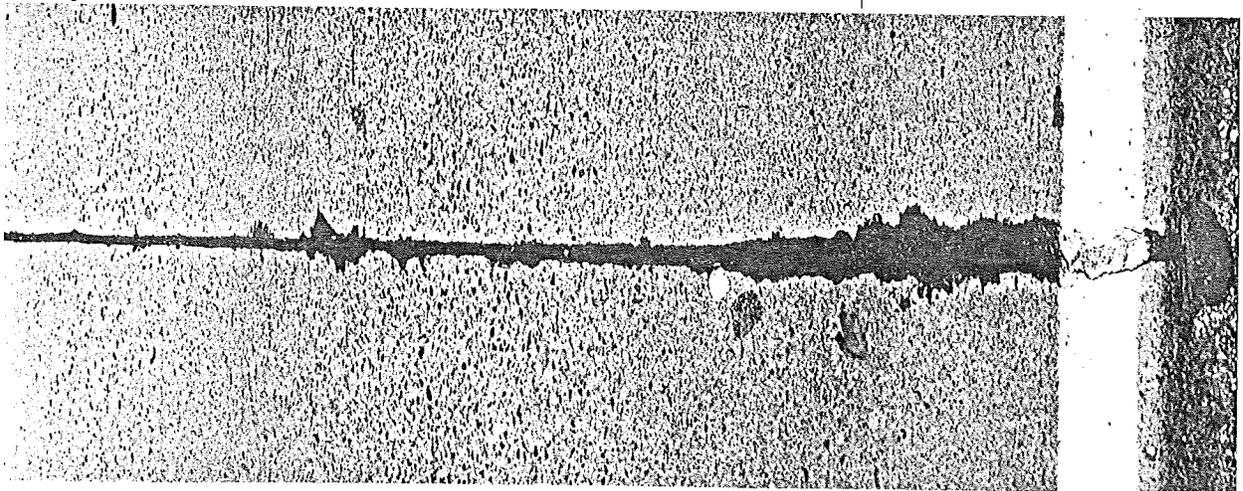
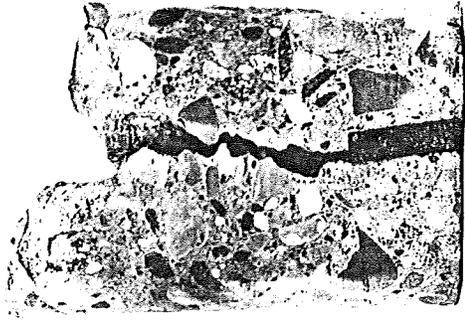
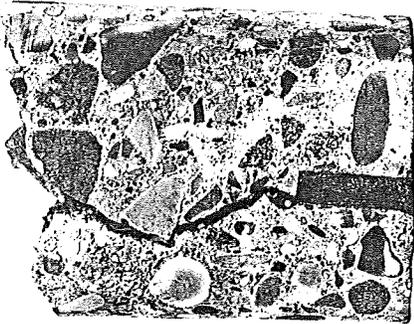
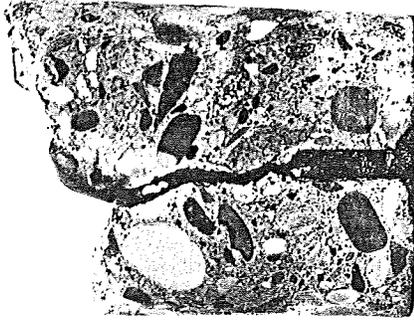
I96 LANSING  
9 YEAR OLD PAVEMENT  
BASEPLATE - FORMED GROOVE  
HOT-POURED RUBBER ASPHALT SEAL

◀ Typical condition of joint prior to coring.

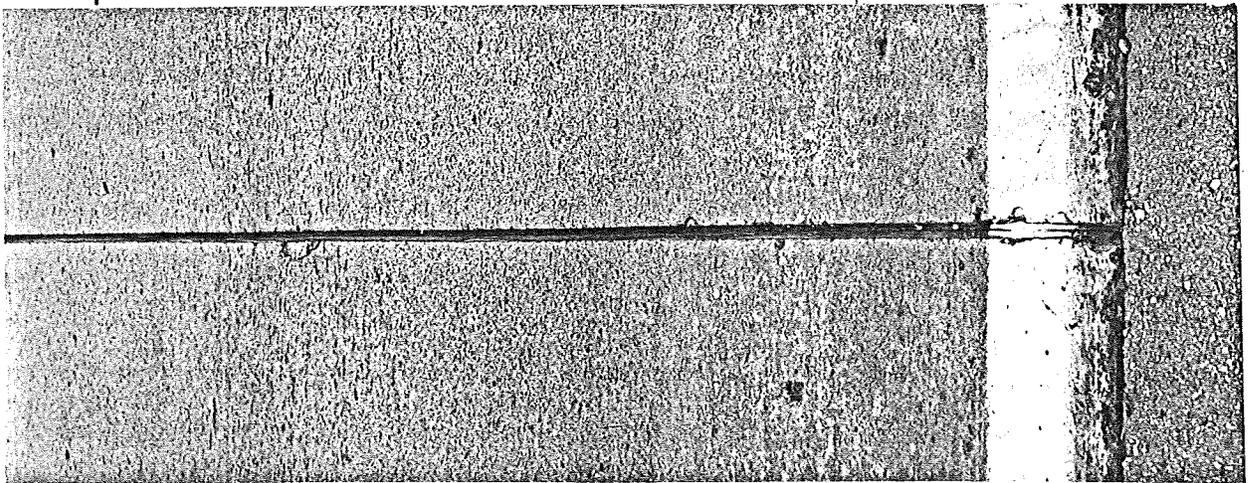
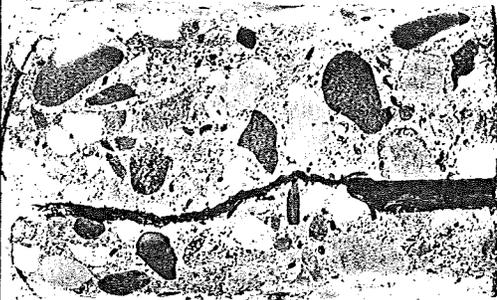
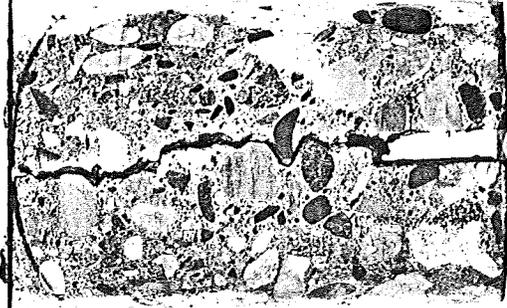
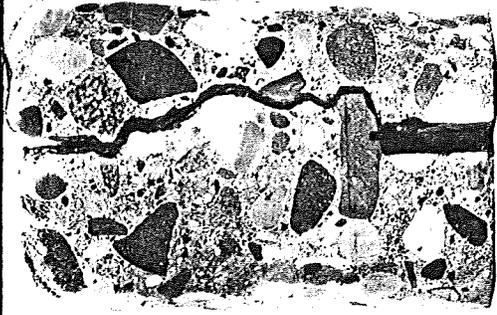
I69 COLDWATER  
4 YEAR OLD PAVEMENT  
NO BASEPLATE - SAWED GROOVE  
NEOPRENE SEAL

2. The neoprene seals in formed joint grooves and with a base plate (seven years of service) have a limited amount of concrete deterioration.
3. The neoprene seals in sawed joint grooves and without a joint base plate, while only four years old, show no deterioration to date. While this is our current design, the time of four years is short for complete reassurance. One of the three cores, however, under the same conditions except that a base plate was used, shows a fair amount of deterioration at the end of four years.

◀ Typical condition of joint prior to coring.

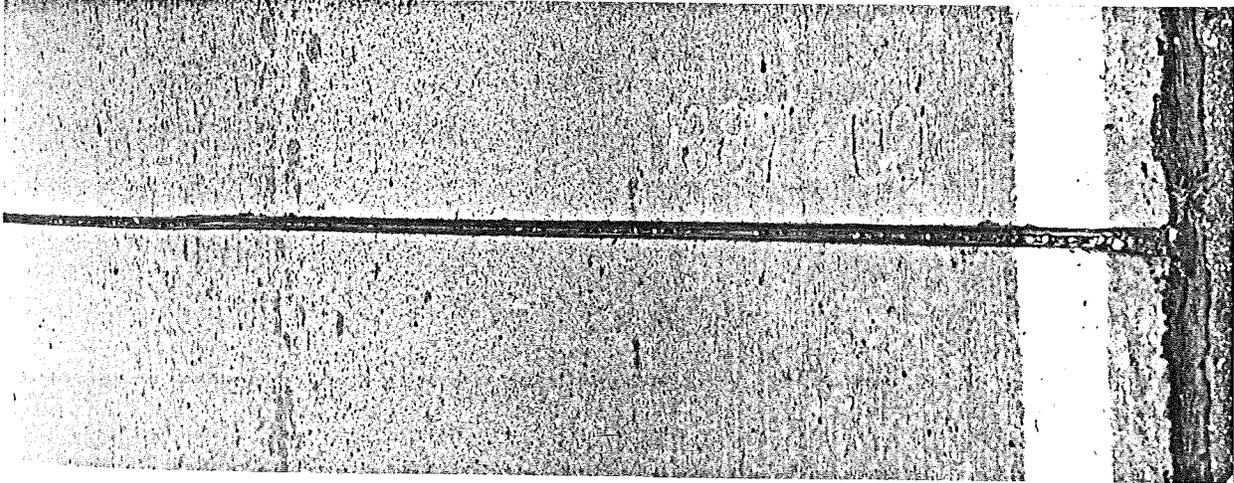
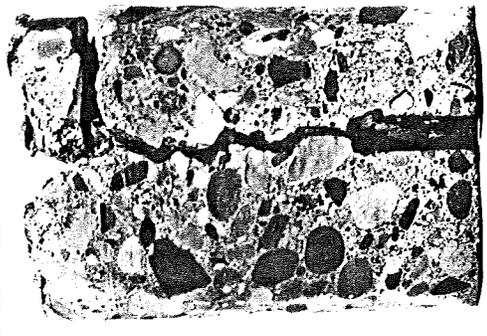
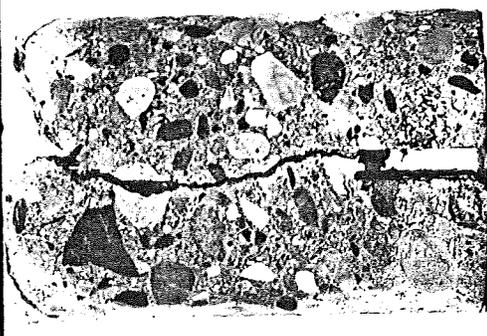
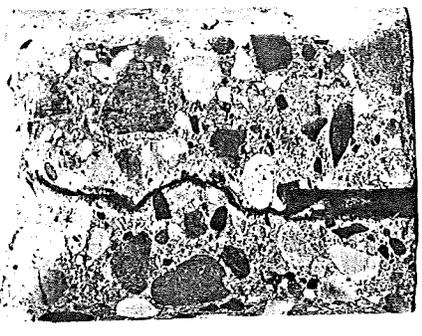
I69 COLDWATER  
4 YEAR OLD PAVEMENT  
BASEPLATE - SAWED GROOVE  
NEOPRENE SEAL

◀ Typical condition of joint prior to coring.

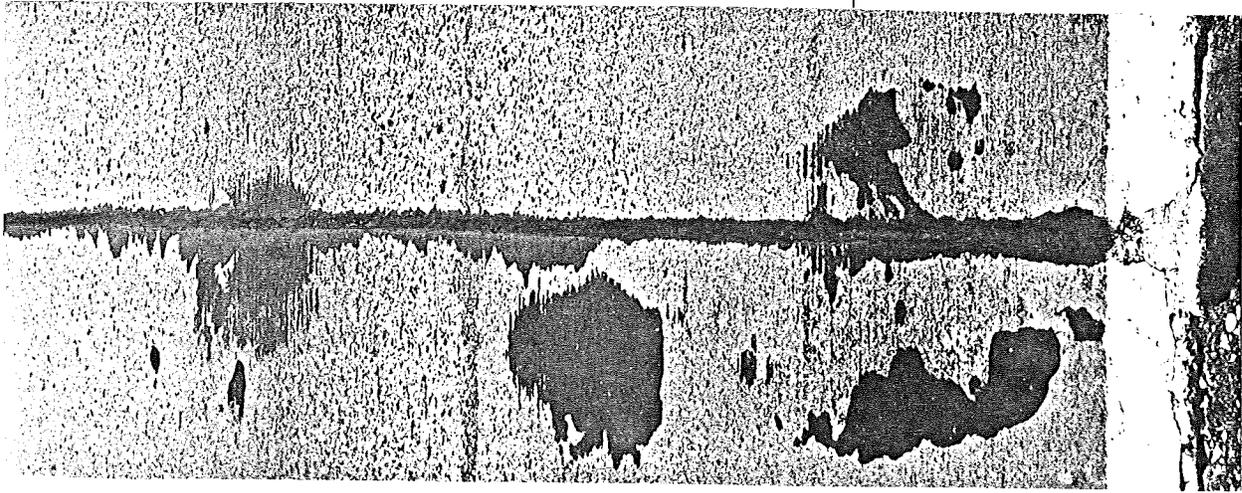
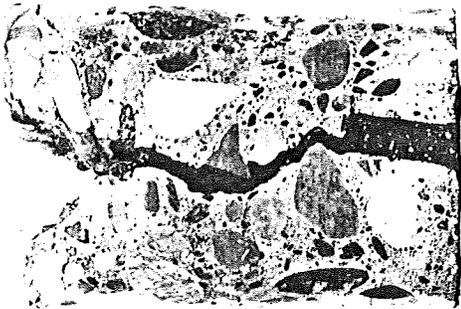
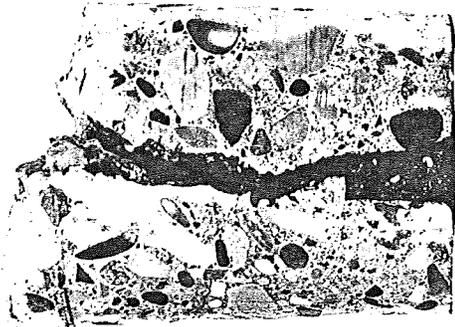
I 196 GRAND RAPIDS  
7 YEAR OLD PAVEMENT  
BASEPLATE - FORMED GROOVE  
HOT-POURED RUBBER ASPHALT SEAL

Typical condition of joint prior to coring.

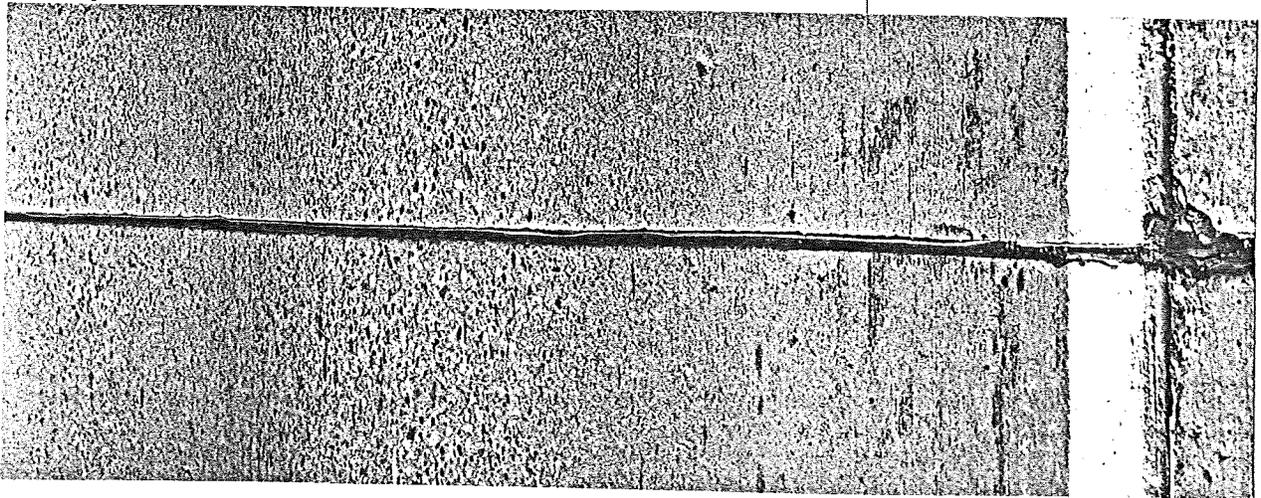
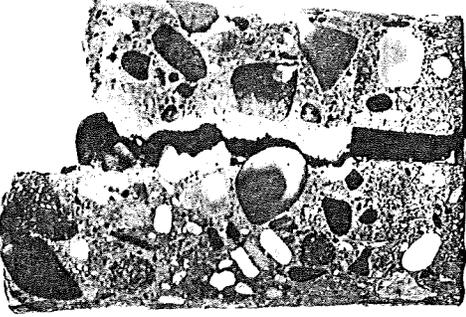
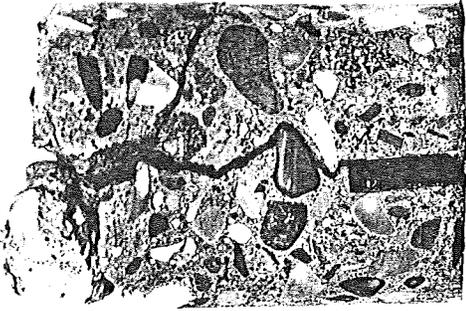
I 196 GRAND RAPIDS  
7 YEAR OLD PAVEMENT  
BASEPLATE - FORMED GROOVE  
NEOPRENE SEAL

◀ Typical condition of joint prior to coring.
