**DEVELOPMENT OF PROCEDURES FOR REPLACING  
JOINTS IN CONCRETE PAVEMENT  
Final Report**

J. E. Simonsen

Research Laboratory Section  
Testing and Research Division  
Research Project 70 F-118  
Research Report No. R-1020

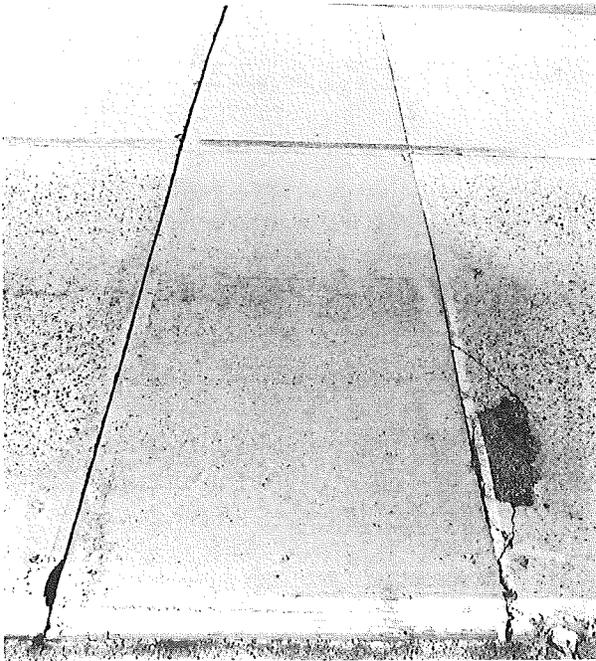
A common problem with repairs where the end limits were not sawed full-depth and the concrete was removed by breaking it with a demolition ball, was the early occurrence of spalling and general breakup of the old slab along the joint. Also, the breaking of the deteriorated slab section occasionally resulted in hairline cracks forming in the old slab. These cracks would open with time and in extreme cases contribute to the early failure at the repair. Examination of the experimental repair joints revealed no spalls of any consequence at any of the repairs in the 1972, 1973, and 1974 construction sequences, nor have any corner breaks or cracks in the immediate joint vicinity occurred. It appears that full-depth sawing and removal of the concrete by lifting it out in large pieces results in good joint faces on the old slab, provided the limits of the repair are located in sound concrete. Otherwise, deterioration as shown in Figure 1 may occur. The joint shown is tied with expansion anchors and hook-bolts. When installing the anchors it was noted that a horizontal hairline crack existed at the steel level. The installation of the anchors plus the effect of traffic probably caused the surface layer to fail.

Figure 1. Failure in old pavement slab along hook-bolted joint resulting from locating repair limit in unsound concrete.

6. The limits of the repairs must be located in sound concrete, otherwise premature failure of the joint edge in the existing slab may occur.

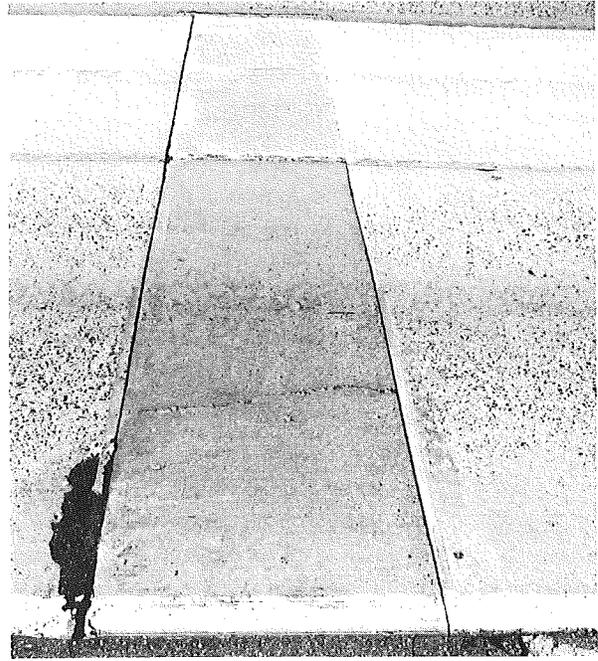
At another hook-bolted repair a spall developed in the summer of 1975 in the old slab at the outside edge of the repair. The spall is believed to be caused by the polyethylene filler being of less thickness at the corner. Thus, when the pavement expanded the compressive force at the corner was of sufficient magnitude to cause the spall and also to crack the slab longitudinally. Figure 2 shows the spall and longitudinal crack as it appeared during the 1976 survey.

Figure 2. Spall and longitudinal crack in 4-ft wide repair slab apparently caused by excessive compressive forces at the spalled corner.

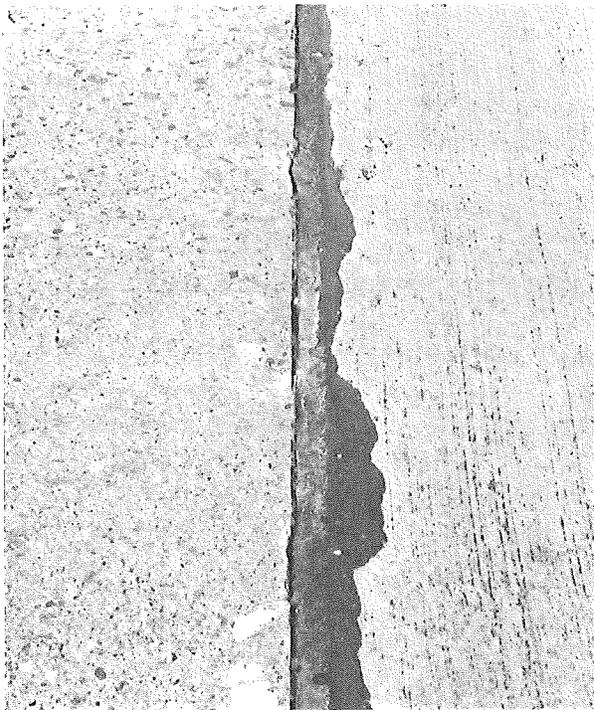
The hot-poured rubber-asphalt seals performed well the first winter. However, during the second winter, adhesion failures began to develop. These failures were of sufficient magnitude to allow infiltration of liquids and fine incompressible materials into the joint (Fig. 3). In the summer the expansion of the pavement and the action of tires "reseals" the joints. The polyethylene filler used at some joints does not in all cases exert sufficient pressure on the joint walls to prevent liquids and fine sand from entering the joints during the winter (Fig. 4). During expansion of the pavement the filler is compressed and seals out foreign material. The overall appearance of a typical repair with hot-poured seals and one with polyethylene filler is shown in Figure 5.

Figure 3. Adhesion failure in hot-poured rubber-asphalt sealer after two years service.

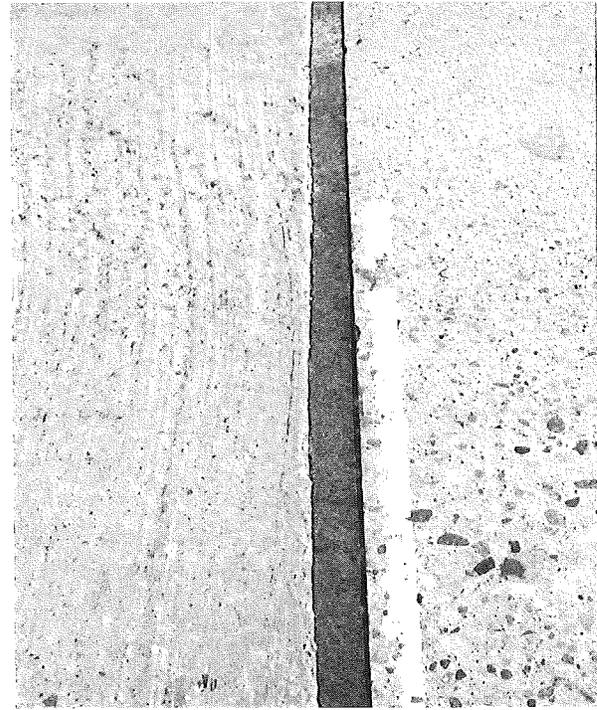
Figure 4. Failure of the polyethylene filler to exert sufficient pressure on the groove walls during cold weather results in foreign materials entering the joint.

7. Although the hot-poured seals and the polyethylene filler failed to completely exclude foreign material from the joints for the duration of the project it appears that sufficient reduction in the amount of infiltration occurs to warrant sealing of repair joints. If polyethylene filler planks are used provision for anchoring them in place must be made.

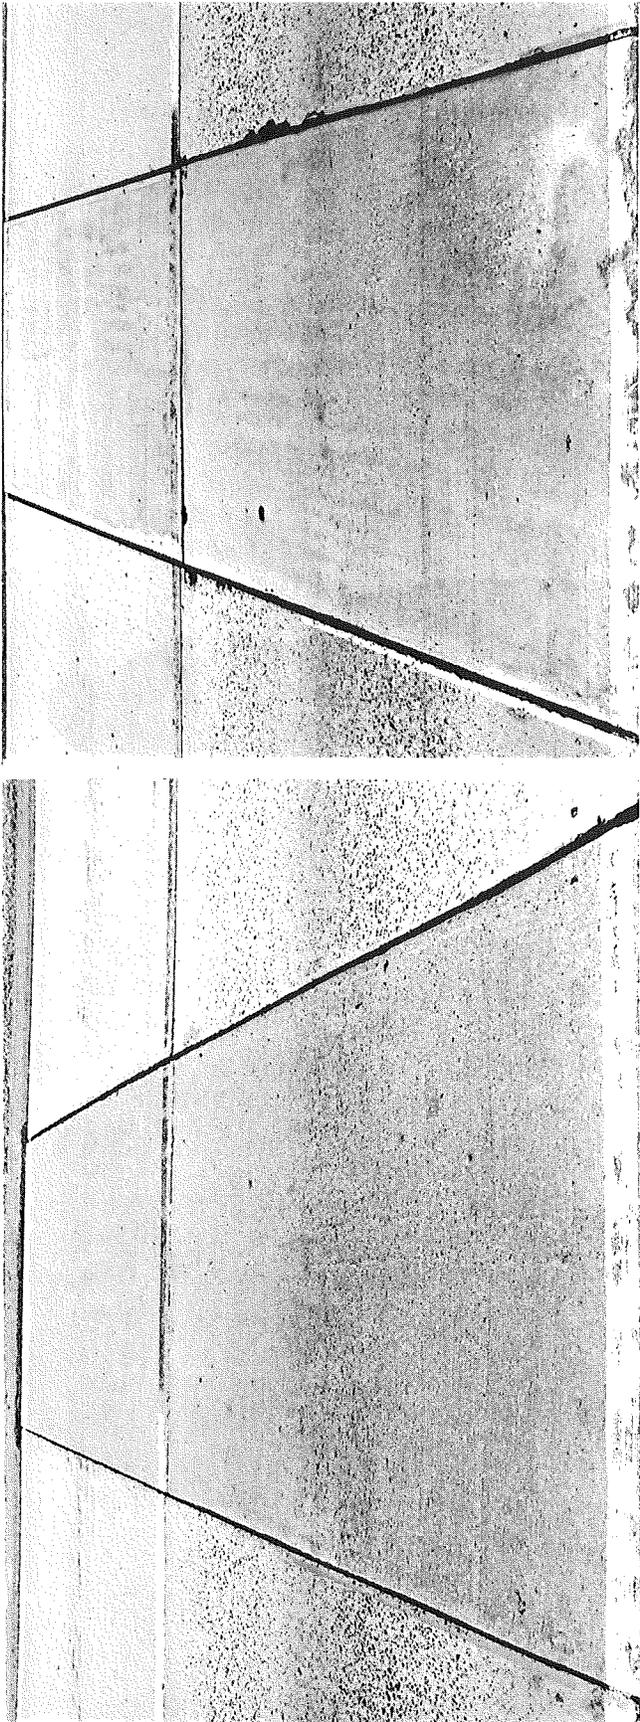
Figure 5. Overall condition of typical repair with hot-poured seals (right) and with polyethylene filler (left) each four and three years old, respectively.

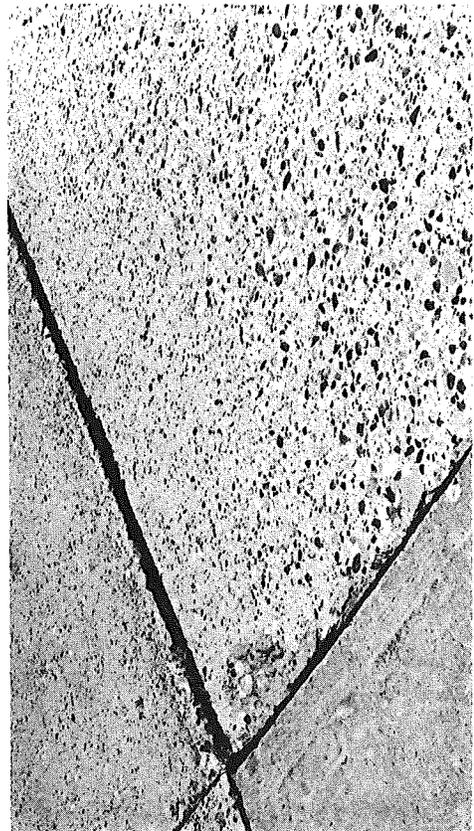
Figure 6. Faulting along existing pavement centerline joint at repair on eastbound I 96 in the winter of 1976.

Another problem noticed is the faulting of the longitudinal centerline joint adjacent to some failed or repaired joints. In all cases the traffic lane settles with respect to the passing lane. Since there is no load transfer at failed or repaired joints the load stresses approach those of a free slab edge. Apparently this increase in load stresses eventually causes failure of the centerline joint in the existing slab. On the experimental repair sections the 1976 winter survey revealed faulting of the longitudinal joint at 12 repairs. Figure 6 shows the faulted joint at a repair on east-bound I 96.

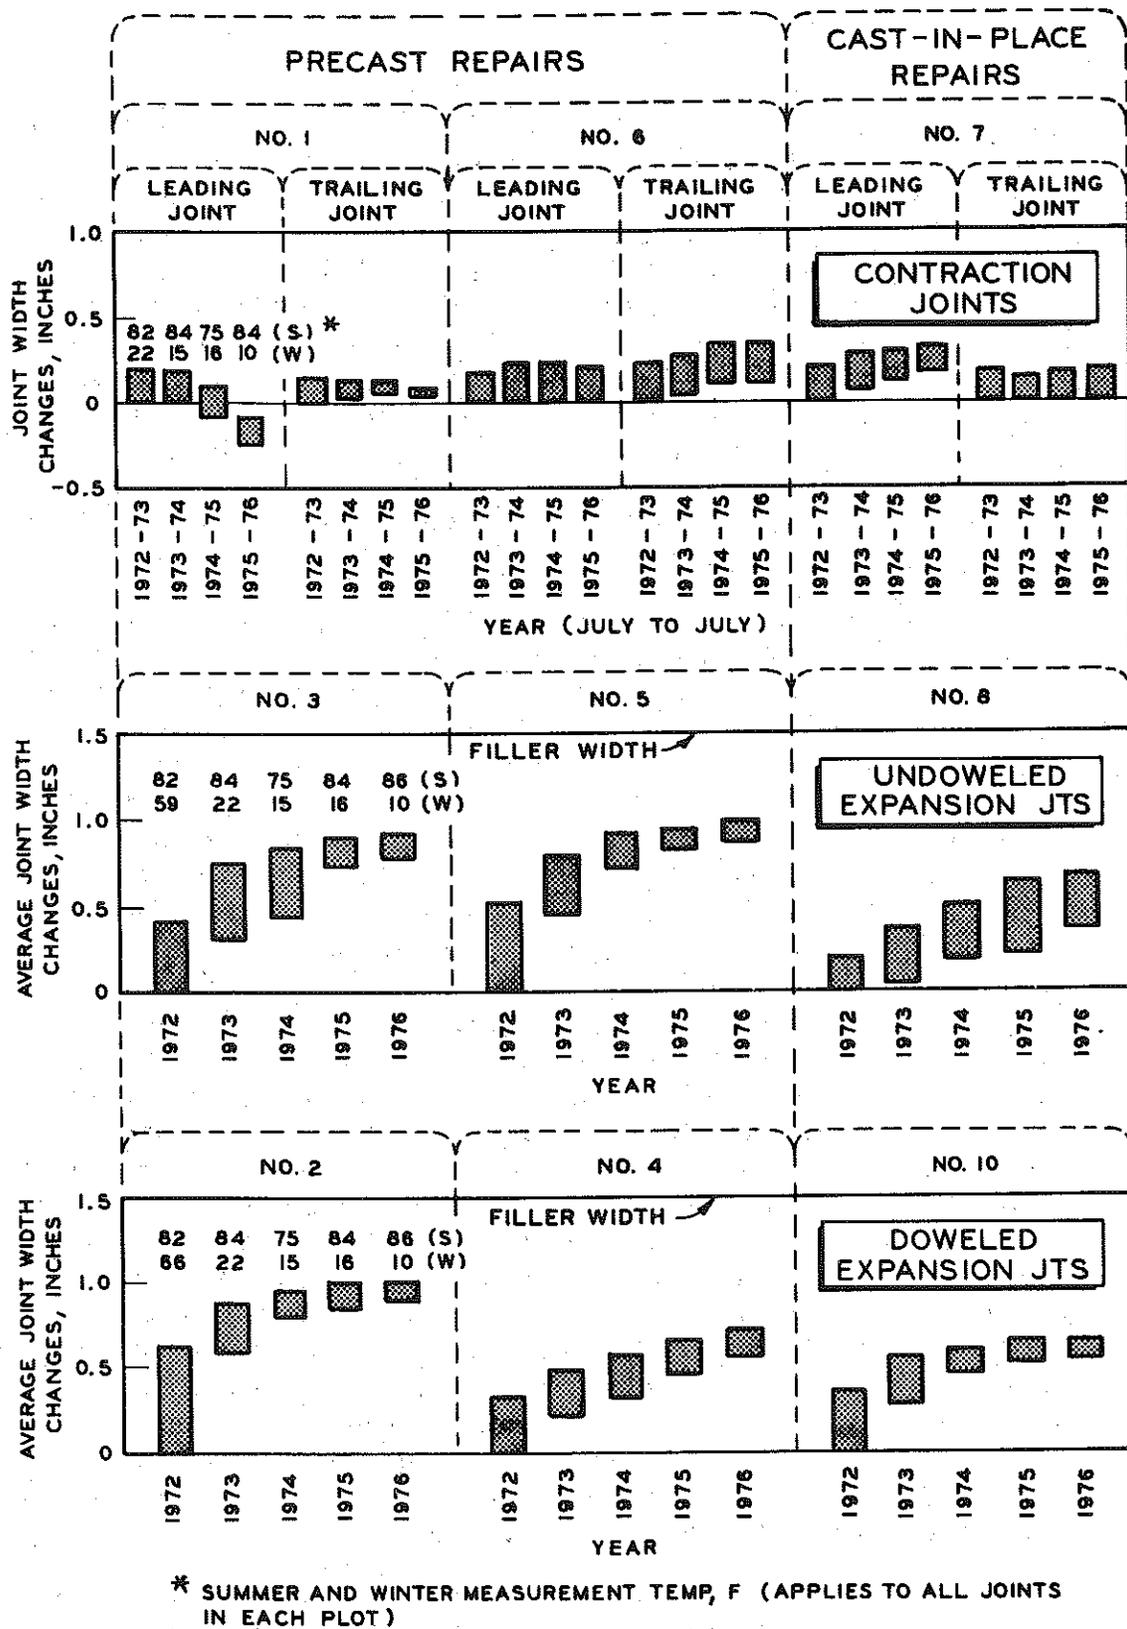
The contraction joints installed at repairs on westbound I 96 in 1972 were sealed with hot-poured rubber-asphalt. The groove dimensions were approximately 1-1/2 by 1-1/2 in. The movement experienced at the leading and trailing joint of each repair from summer to winter is shown in Figure 7. It can be seen that the leading joint at repair No. 1 acts like an expansion joint. Apparently the mortar installed in the gap between the precast slab and the existing slab was not sufficiently consolidated to withstand the compressive force developed during expansion of the pavement. The seals have worked fairly well in preventing the infiltration of incompressible materials but the permanent openings recorded at the trailing and leading joint of repairs No. 6 and 7, respectively, would indicate failure of the seals in these cases. The small movements recorded at the trailing joint of repair No. 1 are the result of an open transverse crack that formed close to the repair in the existing slab.

Figure 7. Average seasonal and yearly joint width changes at repairs installed on westbound I 96 in 1972.

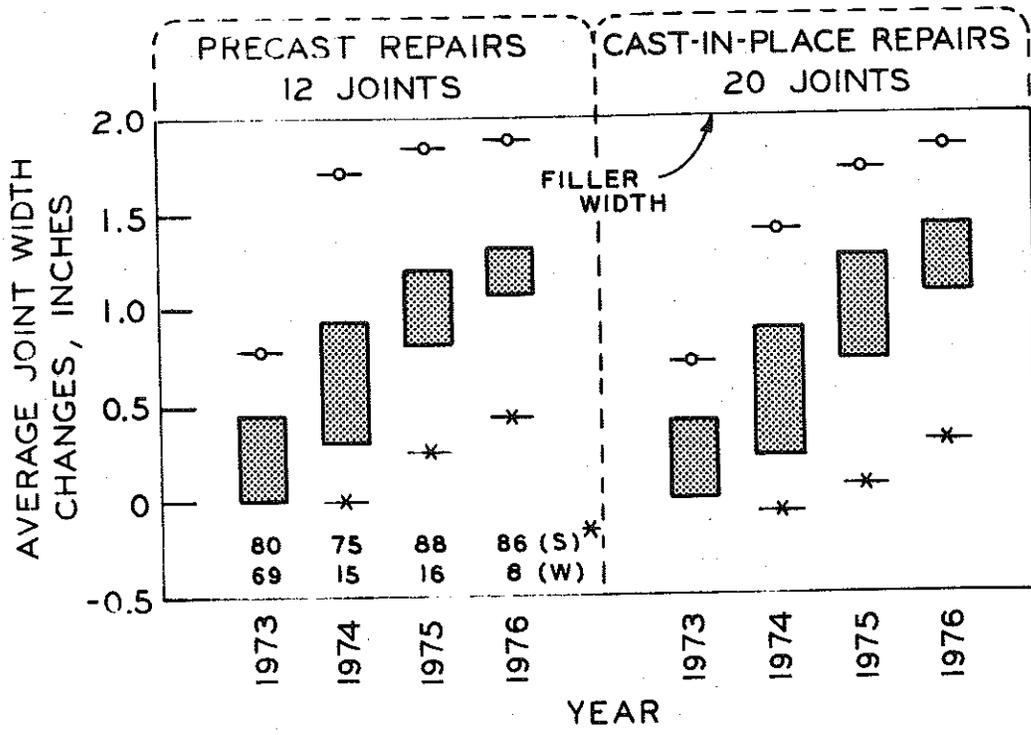
The movements at joints of both precast and cast-in-place repairs installed in 1973 on eastbound I 96 are shown in Figure 8. The joints at both

Figure 8. Average seasonal, yearly, and yearly high-low joint width changes at repairs installed on eastbound I 96 in 1973.

types of repair were constructed by use of polyethylene filler materials, and the summer-winter measured movements are nearly the same for both repair types. The progressive closure of the joints and the reduction in the amount of yearly movement are also close to the same for the two repair types. The average permanent closure after three years is just over 1 in. and the high summer reading indicates that pavement pressure may soon begin to increase at some repairs during hot weather.

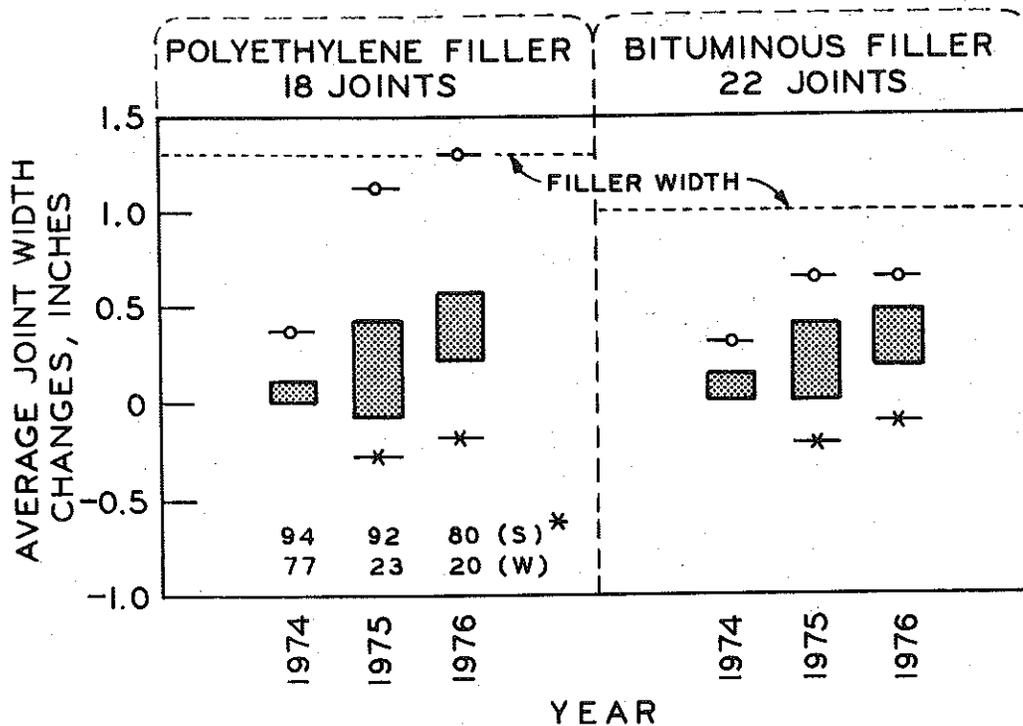
Figure 9 shows the changes in joint widths of repairs installed on westbound I 69 in 1974. These repairs were all cast-in-place, but both bituminous and polyethylene fillers were used. However, there is not much difference in the average movement at both types of joints. As in the case of the 1972 and 1973 repairs the average yearly movement is decreasing

Figure 9. Average seasonal, yearly, and yearly high-low joint width changes at repairs installed on westbound I 69 in 1974.

and the summer readings indicate that the compressive force at some joints may soon increase rapidly as no more expansion space is available.

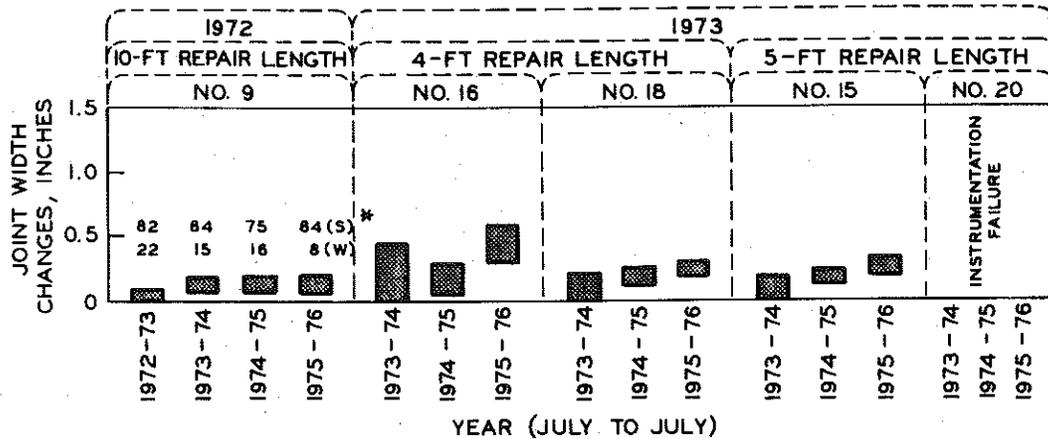
Although the installation of the expansion anchors was done without too much difficulty their performance is very disappointing. As can be seen in Figure 10 all joints opened the first winter and the winter openings have increased each year. Since the anchors failed to hold the joints together no other performance tests were made on these repairs.

Figure 10. Seasonal and yearly movements at hook-bolted joints.

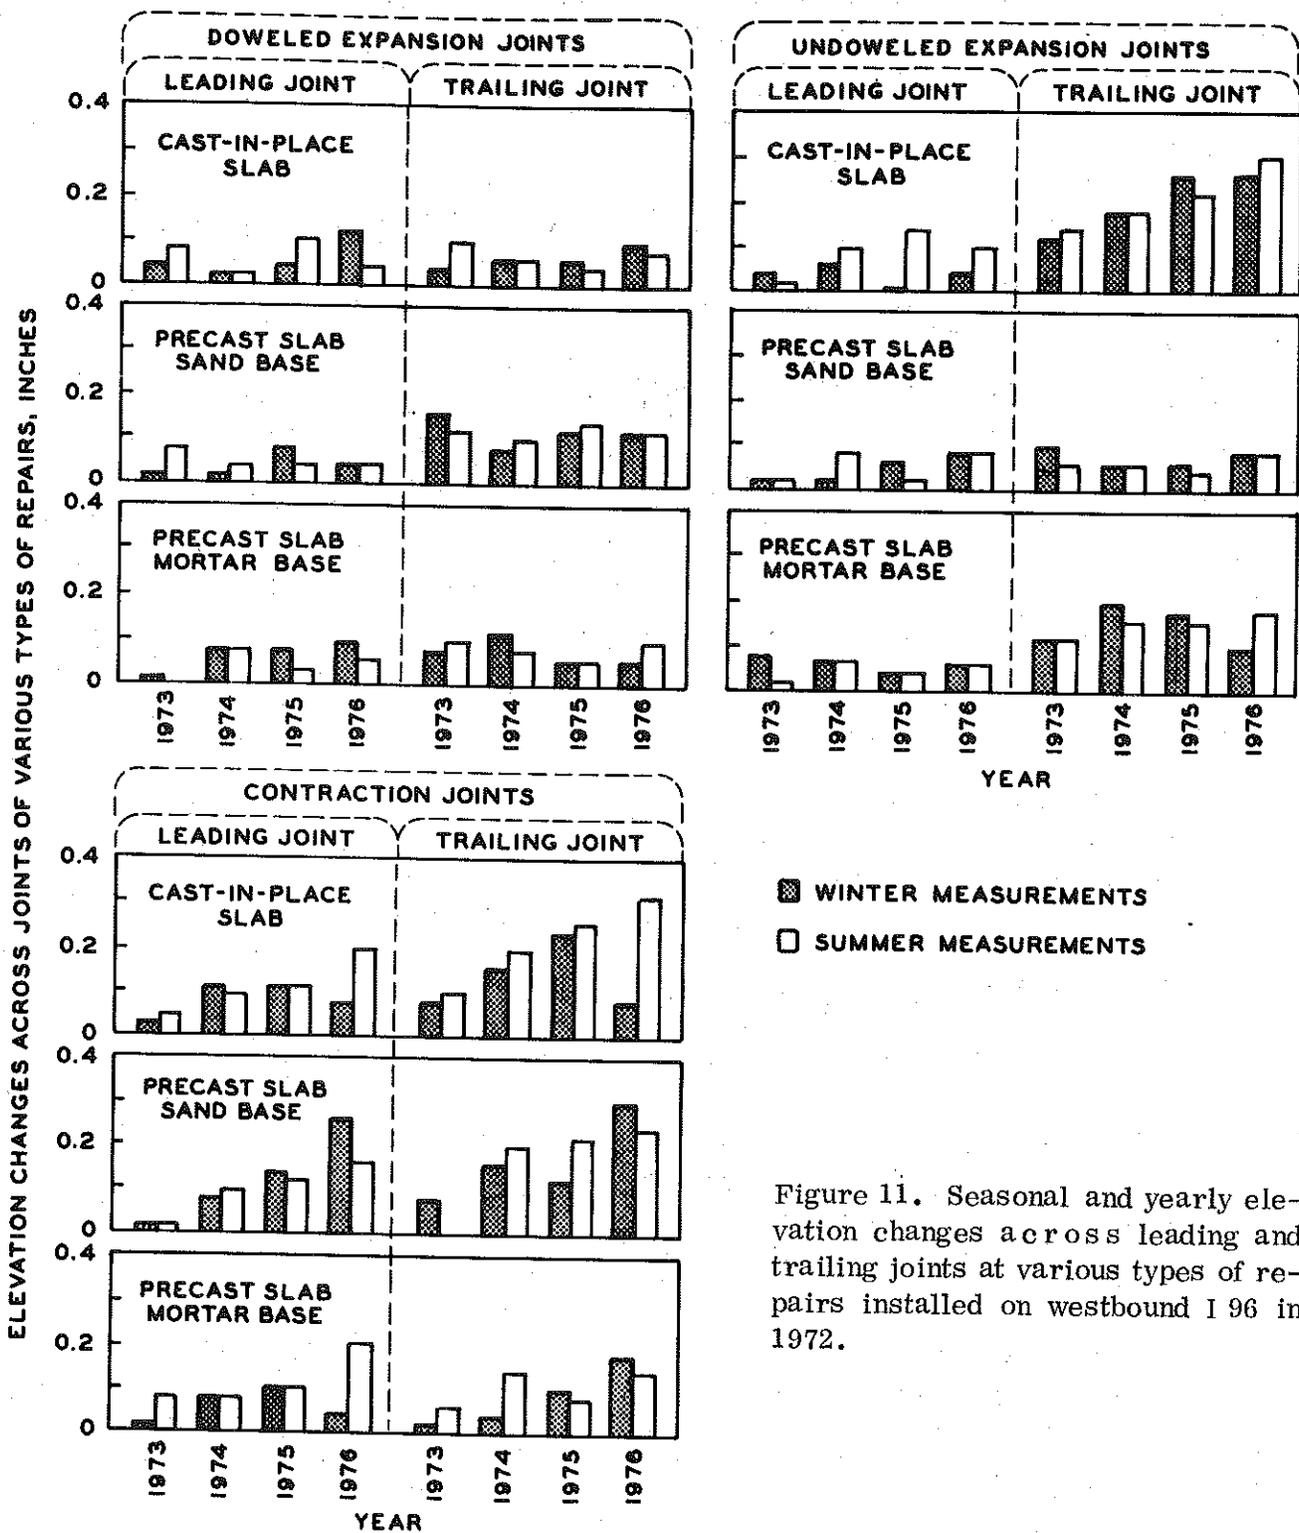
1972 Repairs - The joint faulting measurements recorded during the summer and winter of each year are shown in Figure 11. Since several variables were involved, the faulting at the leading and trailing edge of each repair is shown. For comparison purposes, the performance of the three different types of joints are shown in each group. The figure shows that

Figure 11. Seasonal and yearly elevation changes across leading and trailing joints at various types of repairs installed on westbound I 96 in 1972.

the doweled joints have faulted somewhat less than the undoweled joints. The amount varying from approximately 0.02 to 0.10 in. over the years since construction. Both the precast and cast-in-place repairs have performed about equally well.

The performance of the undoweled expansion and contraction joints is nearly equal. In both cases it appears the leading joint faulted less than the trailing joint. For example, the amount varied from 0.06 to 0.20 in. at the leading joints in the summer of 1976 whereas at the trailing joint the variation for this date was 0.08 to 0.32 in. The rate of increase in faulting with time varies from one repair to another. Basically there has been no increase in the amount of faulting at the doweled expansion joints, nor at the precast repairs with undoweled expansion joints. However, at the remaining repairs the faulting has increased over the years, especially at the trailing joints. The reason for the variation in the amount of faulting is believed to be differences in the support and drainability of the base at the various repair locations.

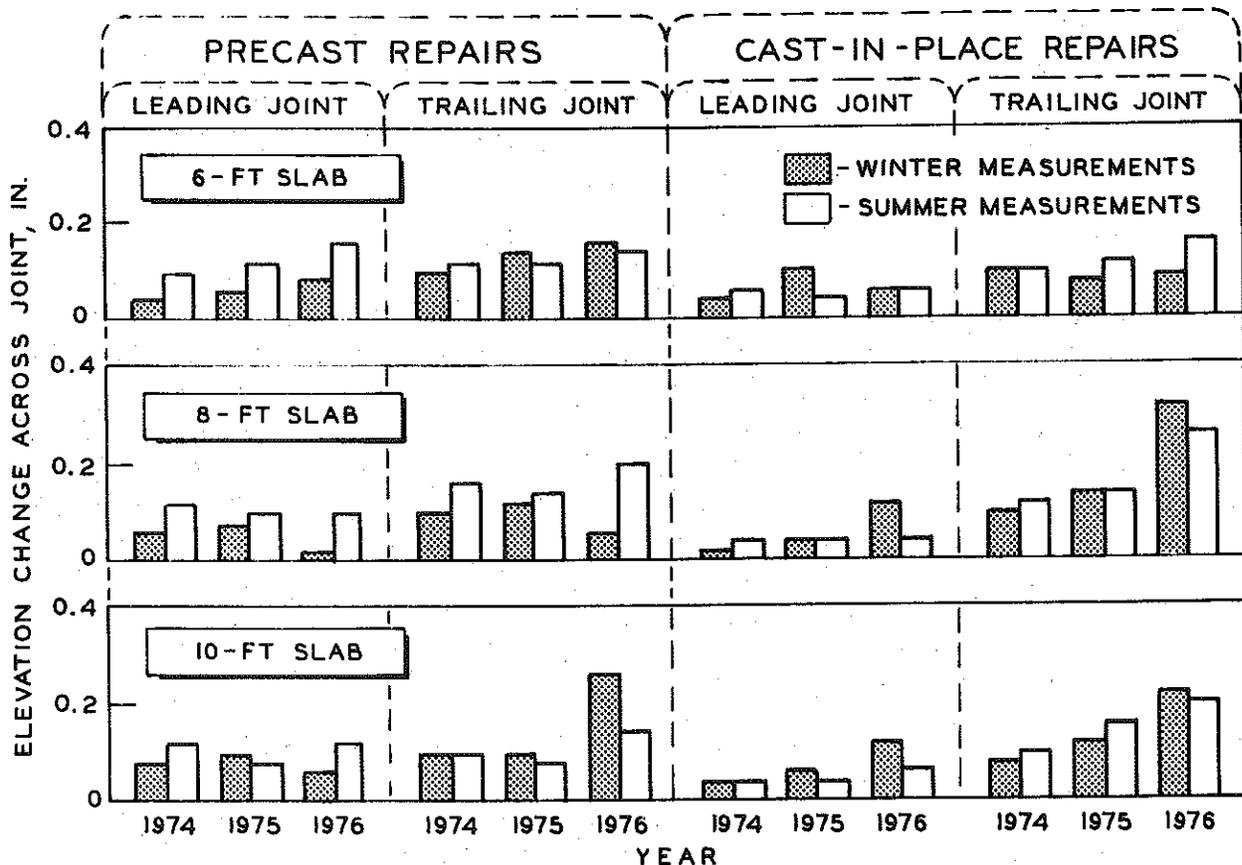
1973 Repairs - These repairs were all constructed with undoweled expansion joints using polyethylene filler material. The average faulting for 6, 8, and 10-ft long repairs of both the precast and cast-in-place types is shown in Figure 12. For the precast slab repair the three length groups have performed almost equally well. There has generally been little variation in the semi-yearly amount of faulting and there has been very little increase in the amount of faulting with time. The 1976 average summer measurements at the leading joint for 6, 8, and 10-ft repairs were 0.16, 0.10, and 0.12 in., respectively, and 0.14, 0.20, and 0.14 in. at the trailing joint of the 6, 8, and 10-ft repairs.

The elevation changes across the leading joint in the three length groups of cast-in-place repairs have been small and have varied little with time. After three years of service the elevation changes for 6, 8, and 10-ft slabs were measured to be 0.06, 0.04, and 0.06 in., respectively. The elevation changes at the trailing joints have been larger than those at the leading joints and some increase with time can be noted. The latest readings indicate an average elevation change of 0.16, 0.26, and 0.20 in. for the 6, 8, and 10-ft long repairs, respectively.

Figure 12. Average seasonal and yearly elevation changes across leading and trailing expansion joints at 6, 8, and 10-ft long precast and cast-in-place repairs installed on eastbound I 96 in 1973.

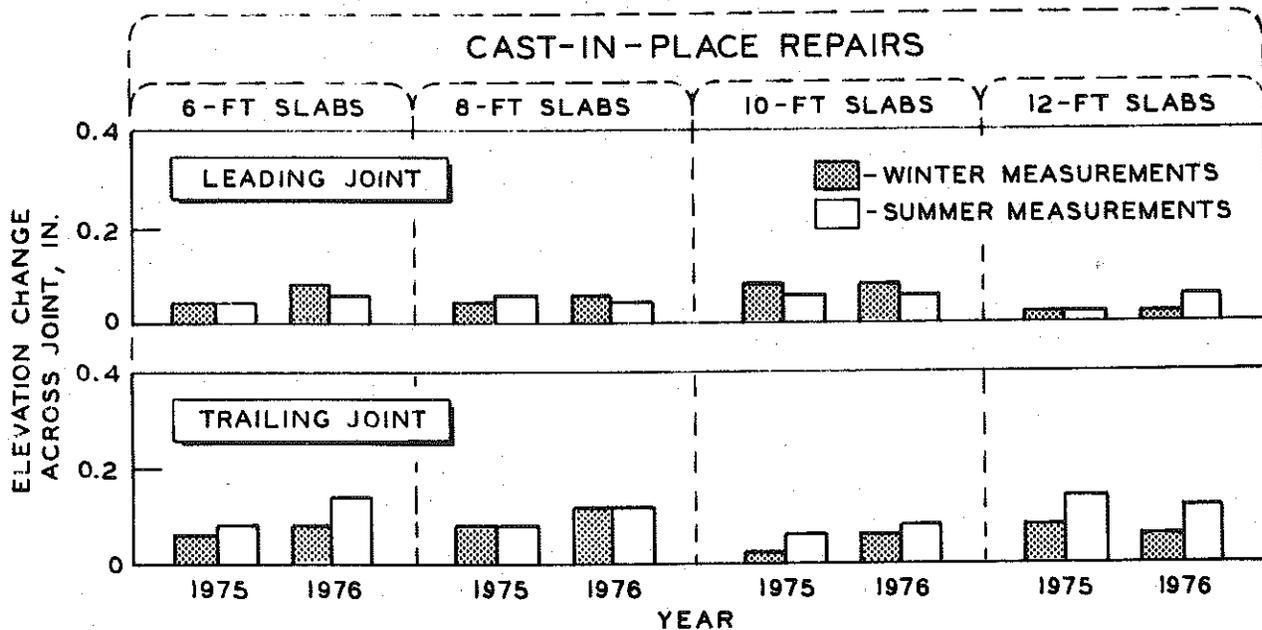
1974 Repairs - Only one type of repair (cast-in-place) was used in this repair sequence. Four slab lengths, 6, 8, 10, and 12 ft were used and the measured elevation changes across the leading and trailing joints for each repair length are shown in Figure 13. Since these repairs have only been in service for two years the data do not as yet indicate any specific trends

Figure 13. Average seasonal and yearly elevation changes across leading and trailing expansion joints at 6, 8, 10, and 12-ft long cast-in-place repairs installed on I 69 in 1974.

with respect to variation in the amount of faulting with time, nor are there any indications if one length of repair will perform better than any other one. At the leading joints the highest average change to date has been 0.08 in. and at the trailing joints it has been 0.14 in.

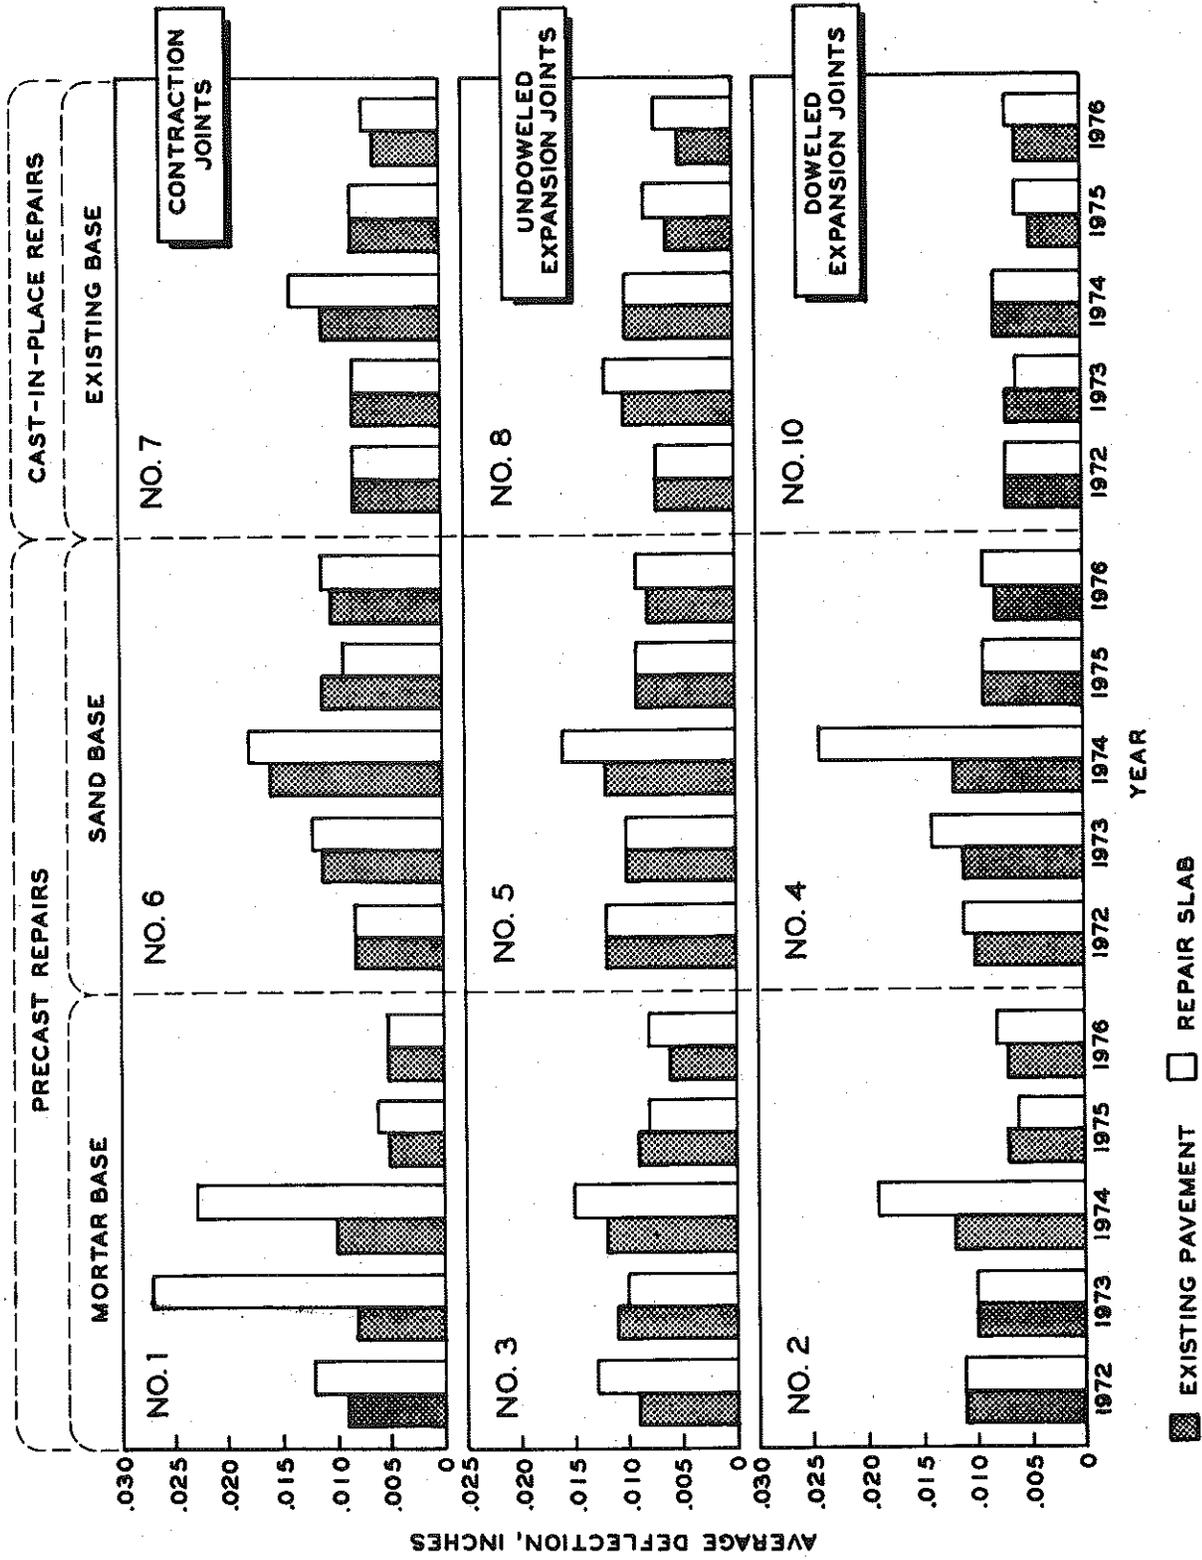
1972 Repairs - The measured deflection at each repair for each of the five years since construction is shown in Figure 14. There appears to be no significant differences in the performance of the three types of joints. The deflections have been close to 0.01 in. throughout the five year service period, except for one 1973 and a few 1974 measurements. These unusual large deflections could possibly have been caused by instrumentation problems since subsequent readings are back in the normal range. The deflections at the doweled joints are about of the same magnitude as those at undoweled joints, which would indicate that dowels installed in 0.06 in. oversized holes have little effect on deflections of the magnitude measured.

Figure 14. Daytime load deflection versus time at the leading joint of precast and cast-in-place repairs on westbound I 96.

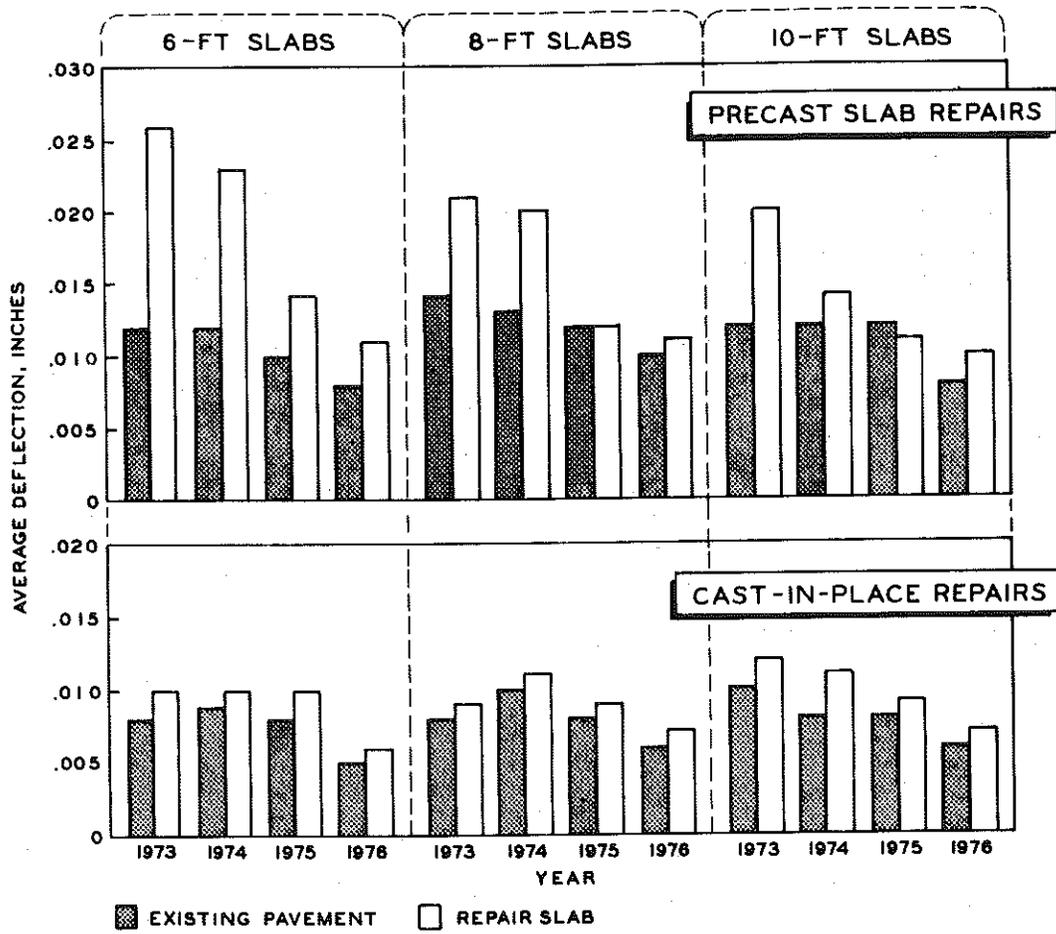
1973 Repairs - The average deflections measured at the leading joint of 6, 8, and 10-ft precast and cast-in-place repairs during the past four years are shown in Figure 15. As in the case for the 1972 repairs the deflections measured at the leading edge of the precast repairs for 1973 and 1974 are unusually large. Otherwise, the deflections have ranged from 0.008 to 0.012 in. at the existing pavement, and from 0.010 to 0.014 in. at the repairs. For all three length groups in the cast-in-place category the deflections have been somewhat smaller through the years than those recorded at the precast slab repairs. For the existing pavement the deflections have varied from 0.005 to 0.010 in, and for the repairs the range

Figure 15. Average daytime load deflection versus time of the leading joint of precast and cast-in-place repairs on eastbound I 69.

has been from 0.006 to 0.012 in. It appears that the deflections measured in the summer at the two repair types and for all repair lengths used, do not increase with time.

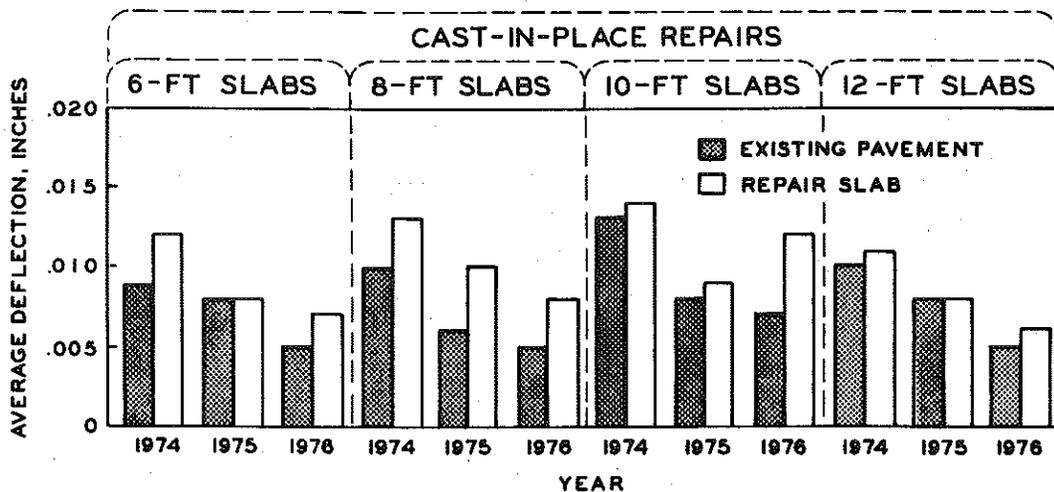
1974 Repairs - The average deflections measured at these repairs (Fig. 16) are in about the same range as those measured at the cast-in-place repairs in 1972 and 1973. Also, the various lengths of repairs deflect about the same amount and there are no indications that the deflection will increase as the repairs get older.

Figure 16. Average daytime load deflection versus time of leading joint of cast-in-place repairs on westbound I 69.

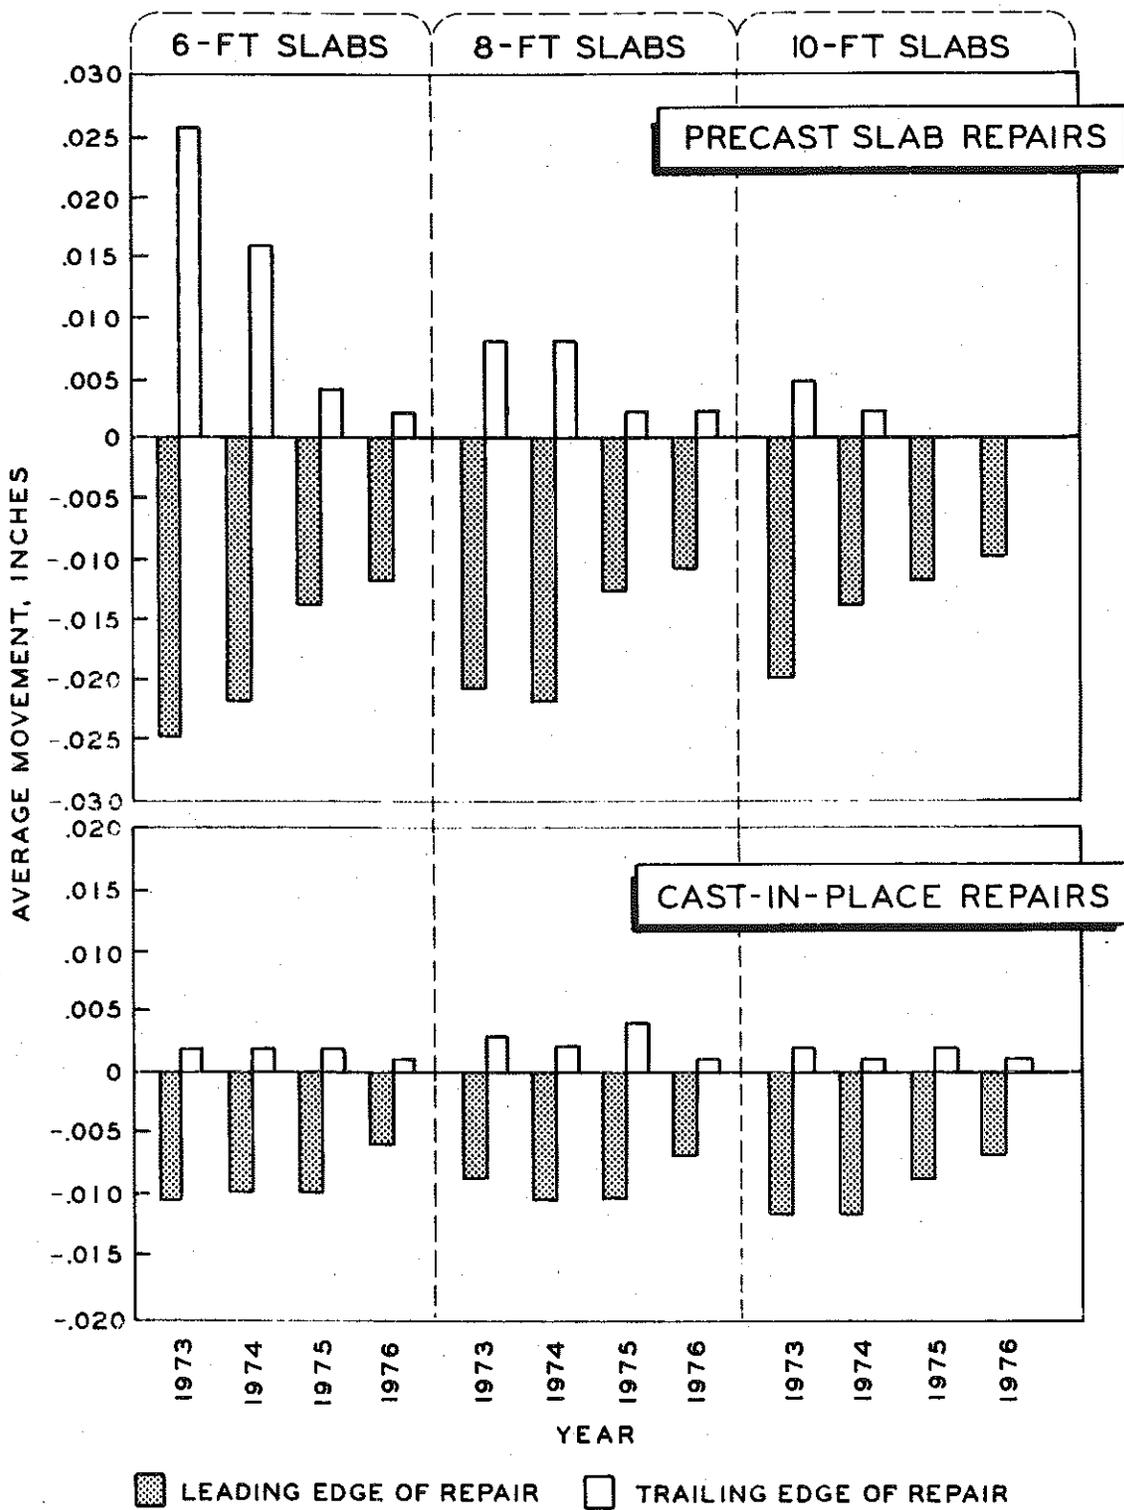
On the eastbound roadway, repairs of 6, 8, and 10-ft lengths were used. Some amount of rocking was noted, especially at the precast slab repairs (Fig. 17). As can be seen, the amount of rocking decreases as the length of repair increases. It can also be noted that the slabs appear to "settle down" after a few years service. For the cast-in-place repairs on eastbound I 96 (Fig. 17) and for the same type of repairs on I 69 (Fig. 18) there is not much variation in the amount of rocking for 6, 8, and 10-ft slabs. The 6, 8, and 10-ft long repairs all show a slight upward movement (maximum average of 0.003 in. in 1976 at 8-ft slabs on I 69). Only the 12-ft long repairs on I 69 have not shown any rocking during the years they have been in service.

Figure 17. Rocking of repair slabs on eastbound I 96 precast repairs (top) and cast-in-place repairs (bottom).

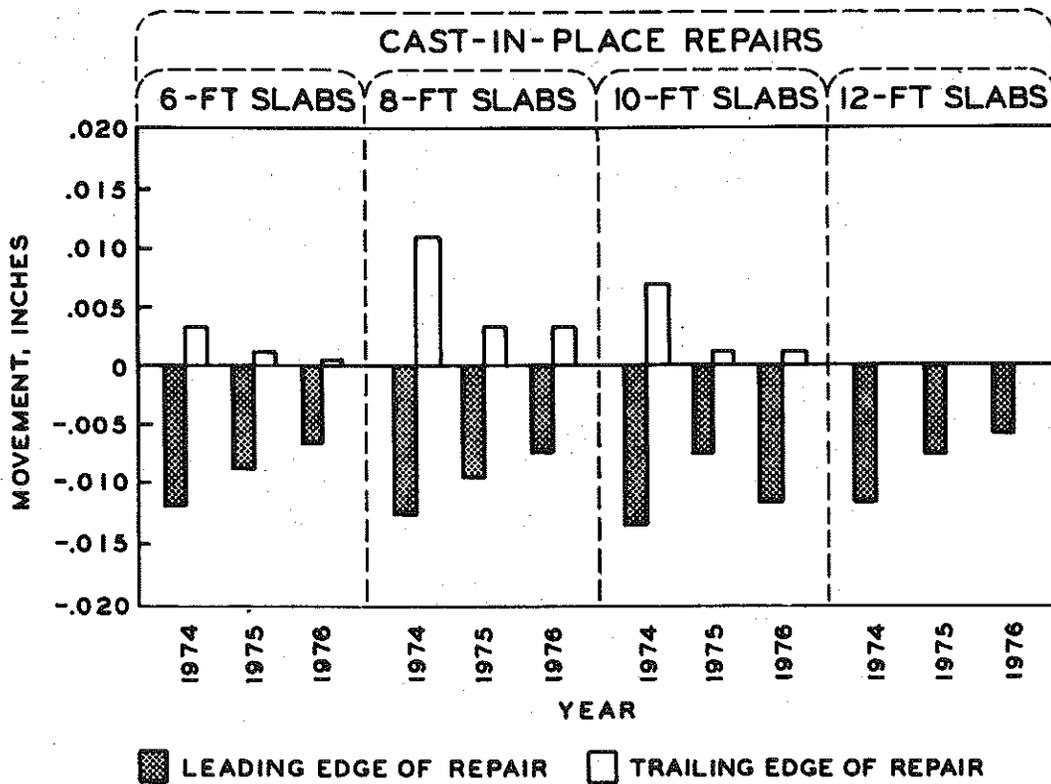
Figure 18. Rocking of repair slabs on westbound I 69.
