SECOND PROGRESS REPORT ON THE
EVALUATION OF VARIOUS TYPES
OF RAILROAD CROSSINGS

Research Laboratory Section
Testing and Research Division
Research Project 75 F-143
Research Report No. R-1079

Michigan State Highway Commission
Peter B. Fletcher, Chairman; Carl V. Pellonpaa,
Vice-Chairman; Hannes Meyers, Jr., Weston E. Vivian
John P. Woodford, Director
Lansing, March 1978

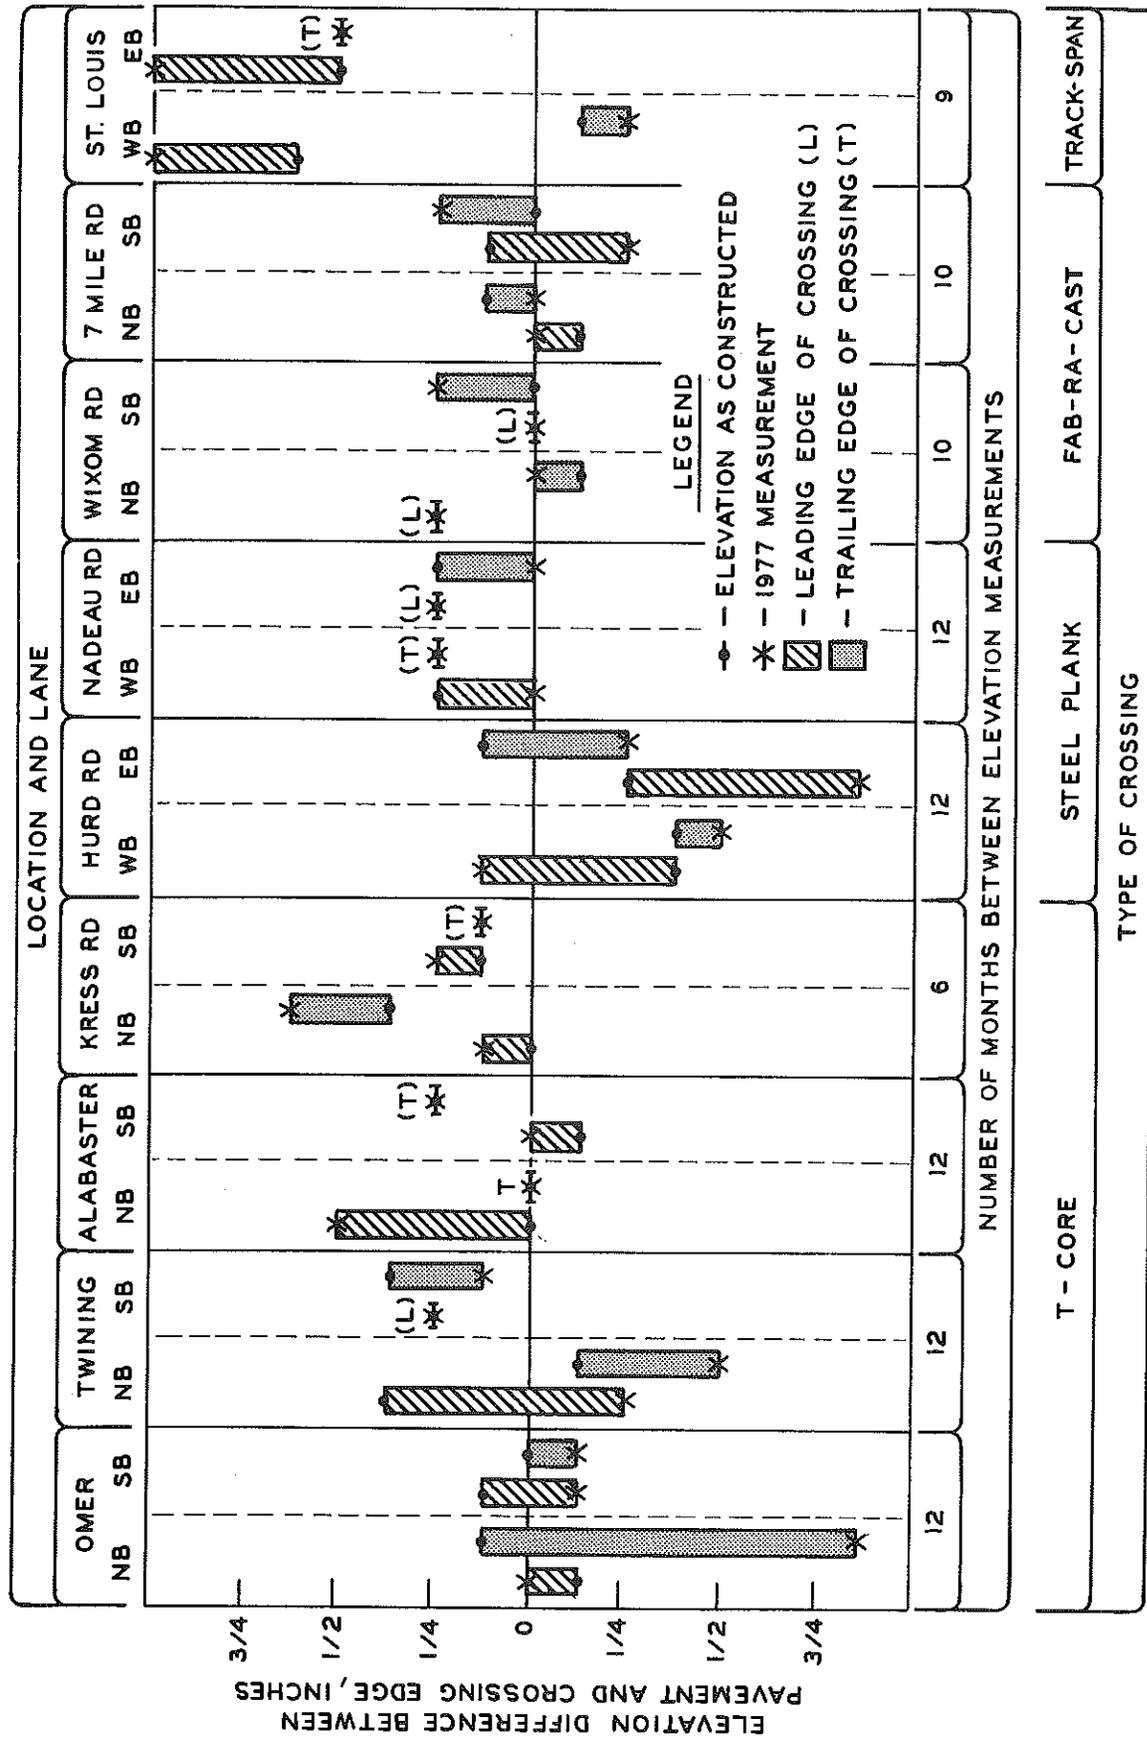
Figure 1. Elevation differences between pavement and crossing edge at nine experimental crossings.

Level measurements taken at the crossing sites indicate relatively little change in the pavement edge profiles. The most change has occurred at the joint between the crossing and the pavement. The elevations with respect to the pavement as constructed, and six to twelve months later, at the leading and trailing edge at each roadway edge or curb line at each of the nine crossings constructed in 1976 are shown in Figure 1. The change in elevation from the as-constructed elevation is quite small in most cases. Since the elevations are measured along the pavement edge, the elevation differences shown do not necessarily reflect the 'bump' that may be felt in the wheel tracks. However, it is anticipated that the measurements eventually will show whether or not the elevation difference from the pavement to the crossing surface will become a serious problem.

Changes are being incorporated into the reconstruction procedures which should improve the overall performance of crossings. Wherever possible, the roadway traffic is detoured to allow the use of techniques and equipment that should increase the quality of the crossing. Drainage is now being considered when outlets are available, and filter cloths are beginning to be used to prevent contamination of the ballast. Changes on the Standard Plan for Track Crossings have been made to require full-depth bituminous material to be placed and compacted in a space, 1-ft wide, along the crossing edges when the crossings are located in either bituminous or concrete pavement, and when existing concrete headers are required to be removed during reconstruction. Current plans also indicate the rate of pavement taper at crossings where the reconstruction procedure requires the crossing to be raised. Implementation of these plan changes is anticipated to improve the joint area performance.

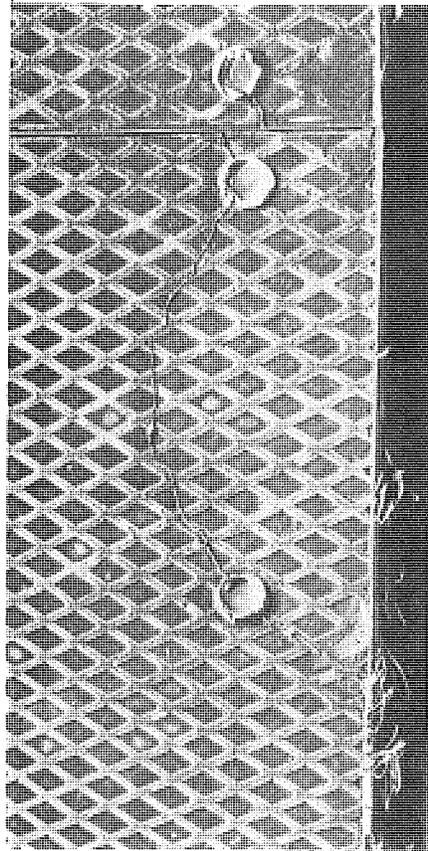
noted in the surface shortly after the crossings were installed. At the Omer crossing, cracks were noted in the surface and the supports under two side pads fractured after three months service. The two side pads were replaced in October 1976. Further cracking developed during the winter and 15 pads were replaced in April 1977. Our September 1977 survey revealed cracks in one center and one side pad. Cracks in the surface were also noted at the Twining crossing in the fall of 1976, and four of the center pads were replaced in April 1977. As of September 1977, there were five center and seven side pads with surface cracks. Three of the cracked side units also have fractured supports. At the Alabaster crossing, cracks in the surface were not noted before April of 1977 when three center pads were found to have cracked. These pads were exchanged with uncracked ones from outside the traffic area of the crossing. When surveyed in September 1977, one center pad was found to have cracked for its full width and a 6 by 6-in. piece of its surface had been punched out. Three side units were cracked and one of these also had a fractured support.

Condition of crossing on US 23 in Omer after one and one-half years of service (left). Cracked surface in side pad (above).

As a result of the cracking experienced at these three locations, the use of the T-Core crossing was suspended by the Department about a year ago. Discussions with the supplier indicate that the cause of the failures has been traced to a batch of contaminated material and their testing also indicates a need for an increase in the strength of the supports at crossings with heavy and high-speed traffic volumes. According to the supplier a "heavy duty" crossing with stronger supports under the side pads, extra supports under the center pads, and manufactured under more stringent quality control conditions should be available in the late spring or early summer of this year. Until then, the Department will continue to suspend the use of T-Core crossings.

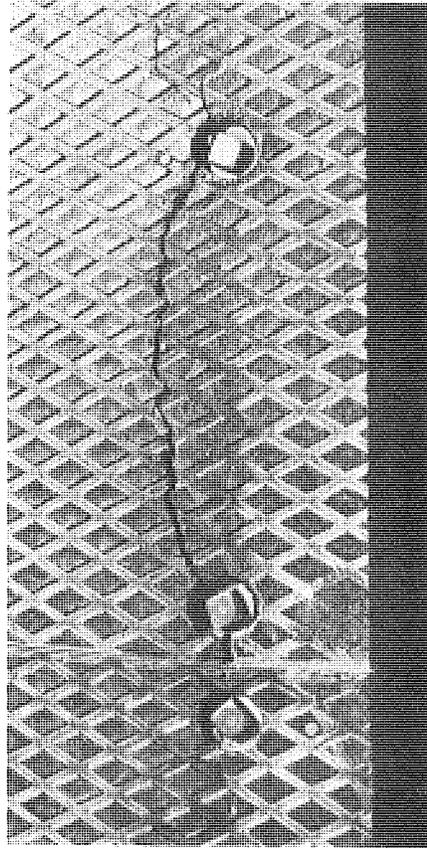
Condition of crossing on M 65 in Twining after one and one-half years of service (left). Cracked surface in side pad (above).

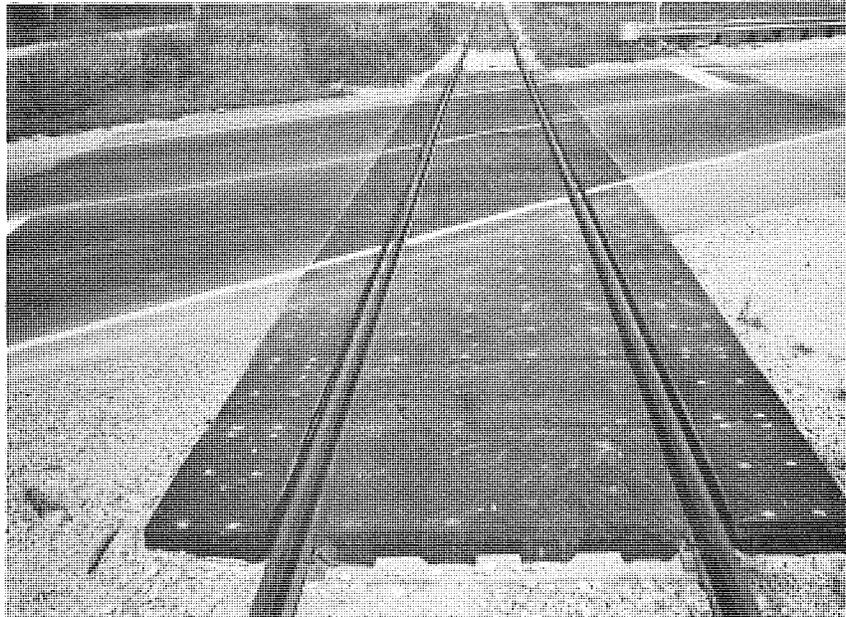
T-Core crossing on US 23 in Alabaster.

Condition of crossing after one and one-half years of service.

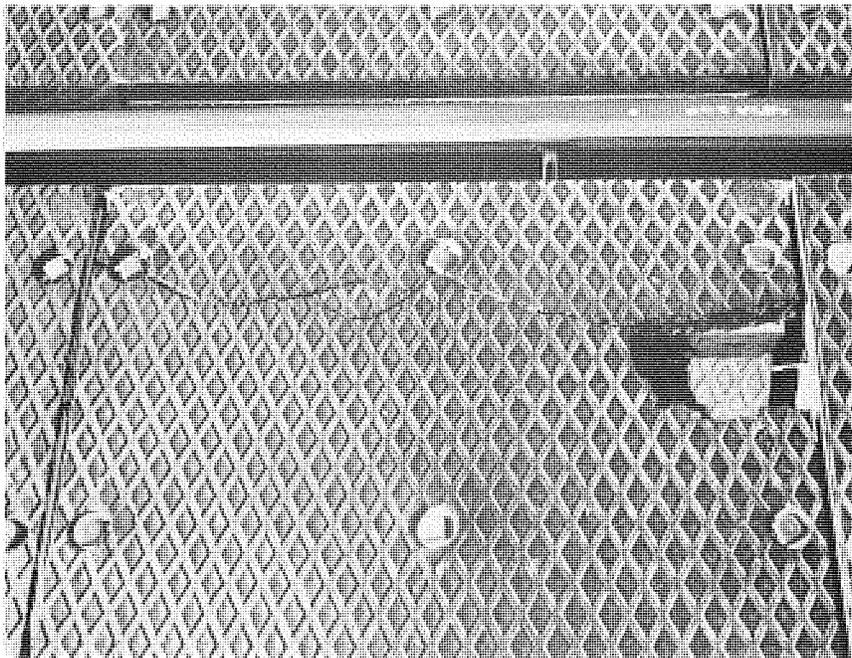
Cracked and fractured surface of a center pad.

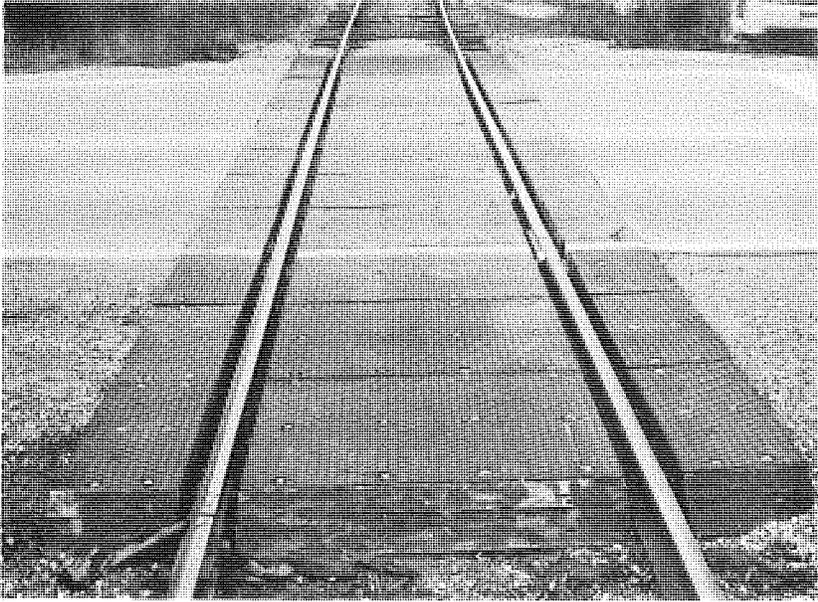
The two-year old Kress Rd and the one-year old 34th St T-Core crossings have performed satisfactorily to date and their smoothness is rated 'Good.' Both of these crossings are subjected to only relatively low traffic volumes (1,800 and 400 ADT for Kress Rd and 34th St, respectively) and commercial traffic is negligible at both locations.

Condition of crossing on Kress Rd after two years of service.

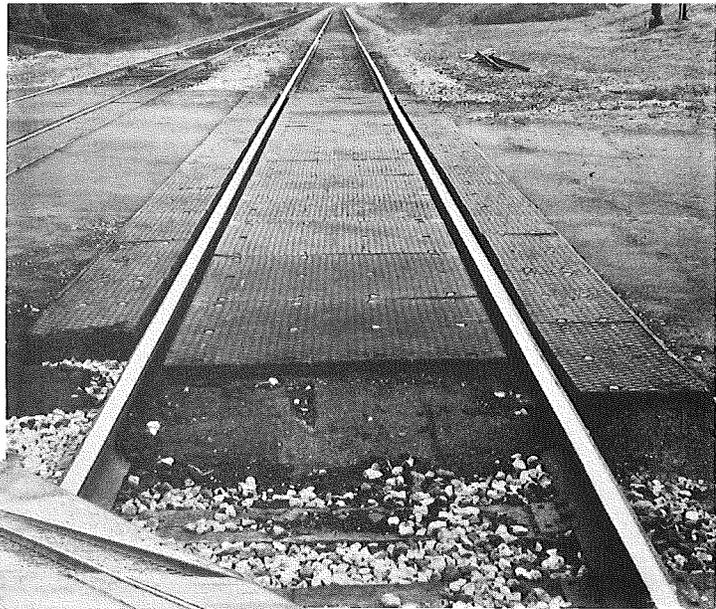
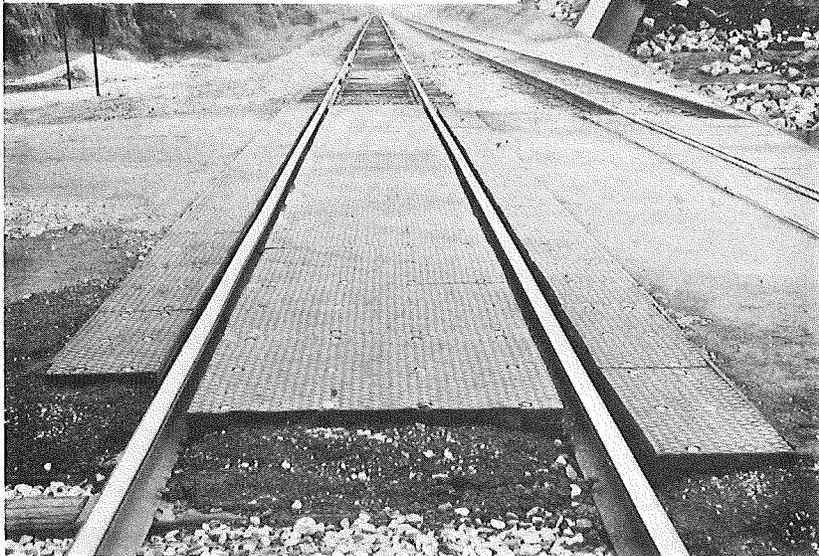
Condition of crossings on 34th after one year of service. South crossing (right) and north crossing (below).

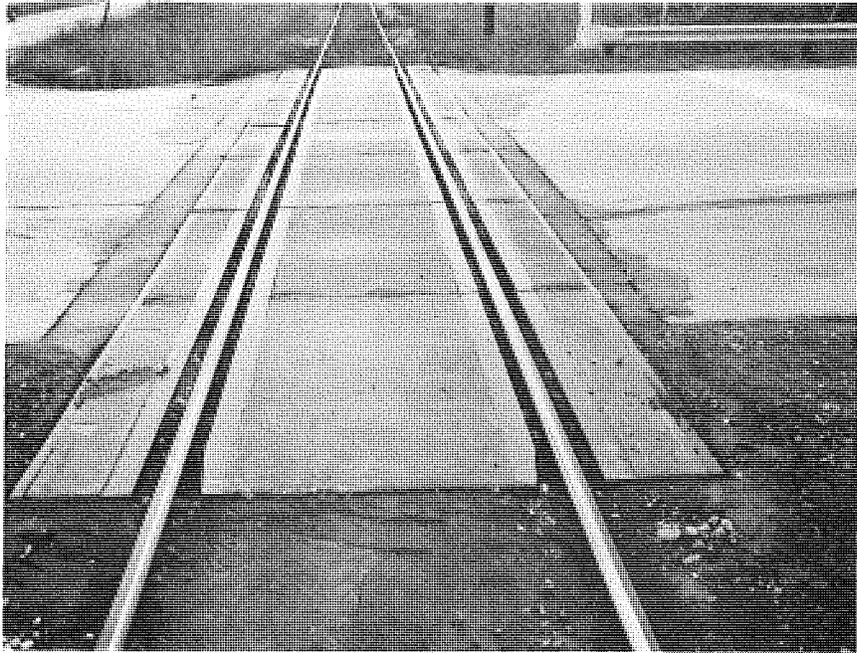
Crossing on Wixom Rd.

broken on the Seven Mile Rd crossing and one was missing on the Wixom Rd crossing. These bolts were found to have been replaced when the summer survey was conducted. Two side slabs appear to deflect under traffic at the Seven Mile Rd crossing and most of the side slabs at the Wixom crossing also appear to deflect. The rails were securely fastened and the pavement joints, which at these locations are about 12 in. wide, were performing satisfactorily. There appeared to be no slowdown in traffic and consequently, the smoothness of the crossing was rated 'Good.'

Condition of the Fab-Ra-Cast crossings after one year of service. Spalls are developing on the joints between slabs.

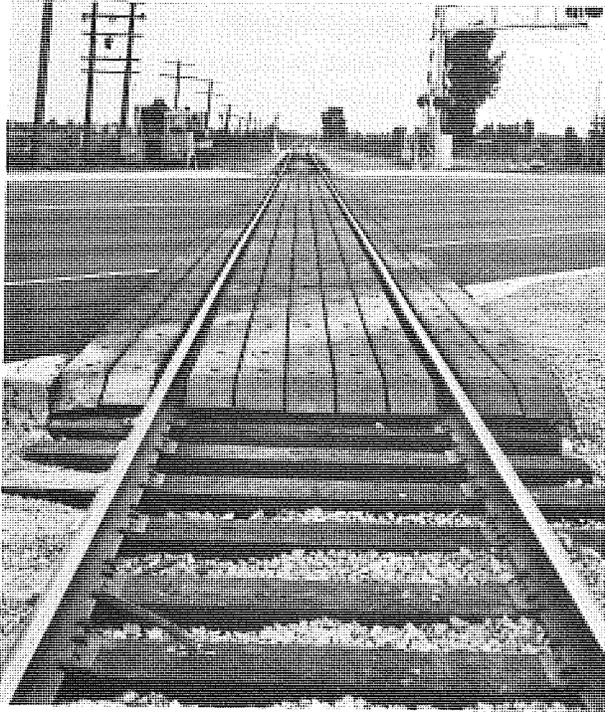
The M 50 crossing, constructed in June 1977, was performing satisfactorily and was given a smoothness rating of 'Good' when inspected in August of 1977. The Hurd and Nadeau Rd crossings have been in service about a year and a half and the epoxy coating is showing signs of wearing off in the wheel paths. A derailed car was dragged over both crossings prior to the summer survey. The north end panels and all center and all west side panels on both crossings sustained damage, but not to the extent that repair was necessary to maintain traffic. Alignment and fastening of the panels and fastening of the rails appeared satisfactory. The bituminous pavement adjacent to the crossing edges exhibited cracks in some areas. The damage inflicted by the derailed car increased the roughness somewhat and some slowdown in traffic was noted which resulted in the crossings being rated 'Fair' with respect to smoothness.

◀ Crossing on M 50 after two months of service.

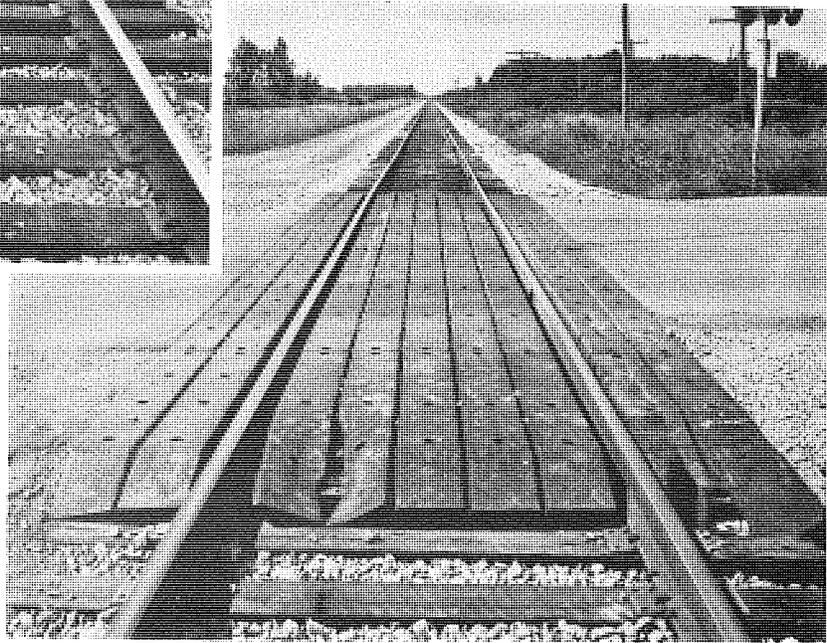
▶ Crossing on Nadeau Rd after one and one-half years of service. Damage was caused by derailed car being dragged over crossing.

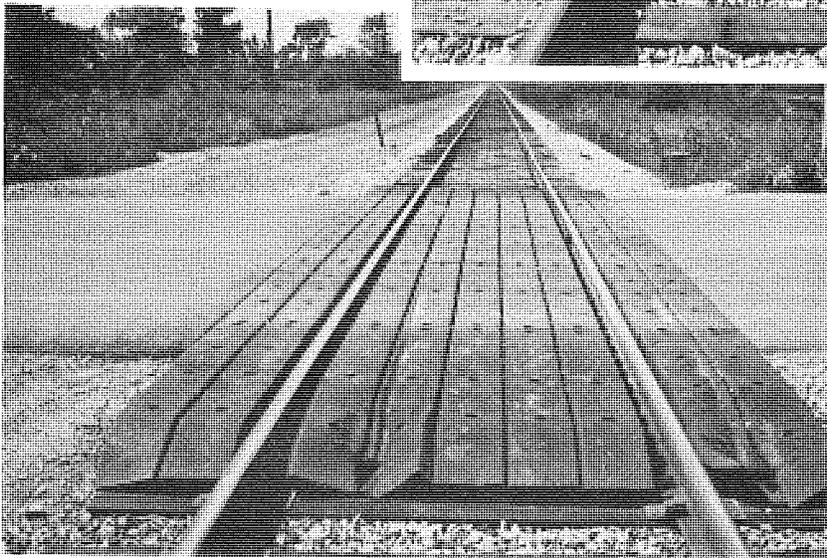
▶ Crossing on Hurd Rd after one and one-half years of service. Damage was caused by derailed car being dragged over crossing.

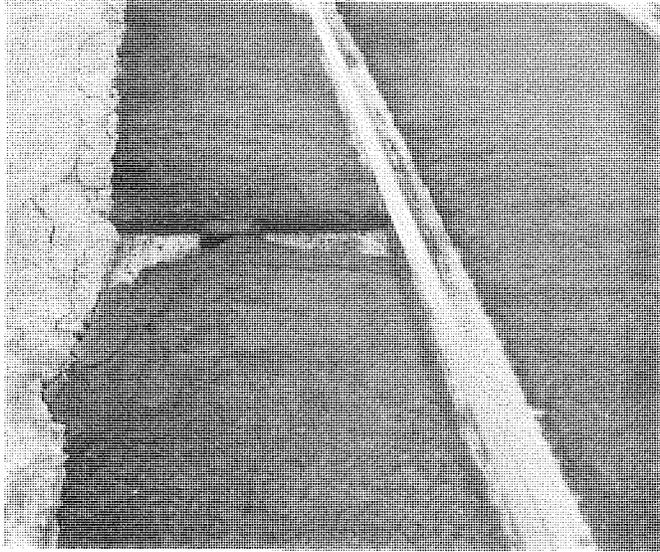
After one year service, the crossing surface shows no measurable wear. Cracking in the surface layer in the westbound lanes has developed and small pieces of the surface are missing where a night joint was made during pouring of the top layer. The rails appear securely fastened. Cracking in the bituminous overlay along the crossing edges has occurred. The smoothness of the crossing is rated 'Good.' Repair of the cracked area was begun by the manufacturer last fall, but was discontinued because of cold weather.

◀ Crack problem in the surface layer at the night joint and crack development in the bituminous overlay.

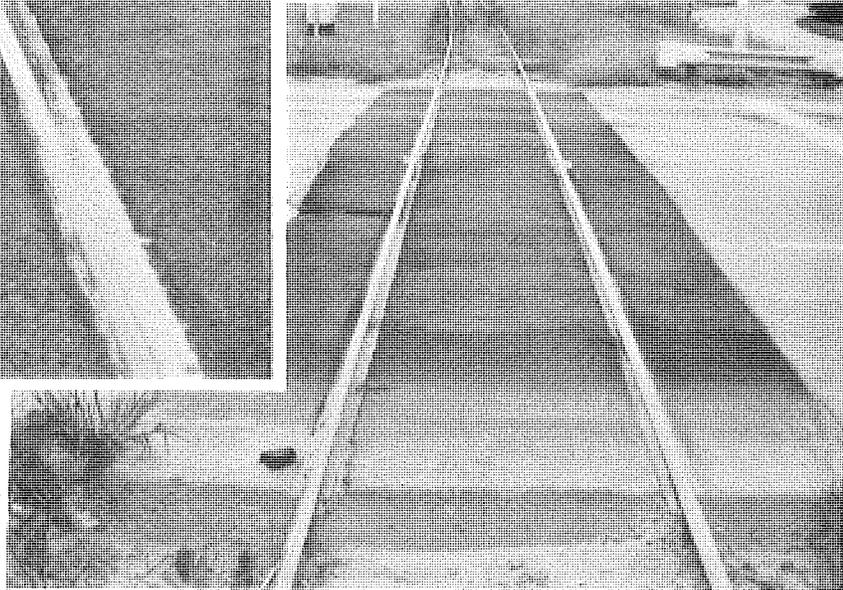
Track-Span crossing in St. Louis.

Condition of crossing after one year of service. ▶

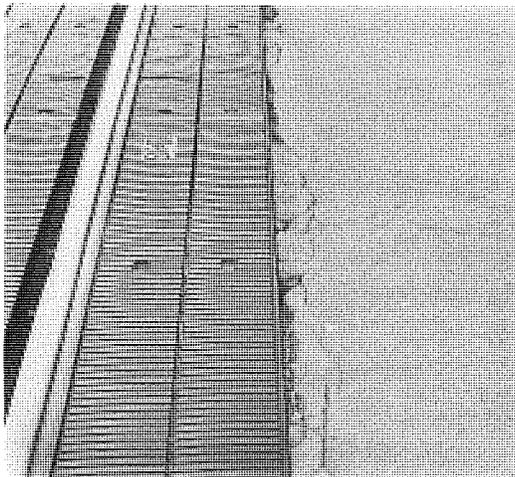
This crossing, on Oakland Ave in Lansing, was constructed in November 1976, and has shown no surface wear to date. A small cut in the surface was noted to have occurred during the winter. Alignment and fastening of the units, and also fastening of the rails, are satisfactory. Cracking in the asphalt along the west crossing edge has developed. The smoothness of the crossing is rated 'Good.'

◀ Cracks developing in the bituminous overlay next to crossing edge.

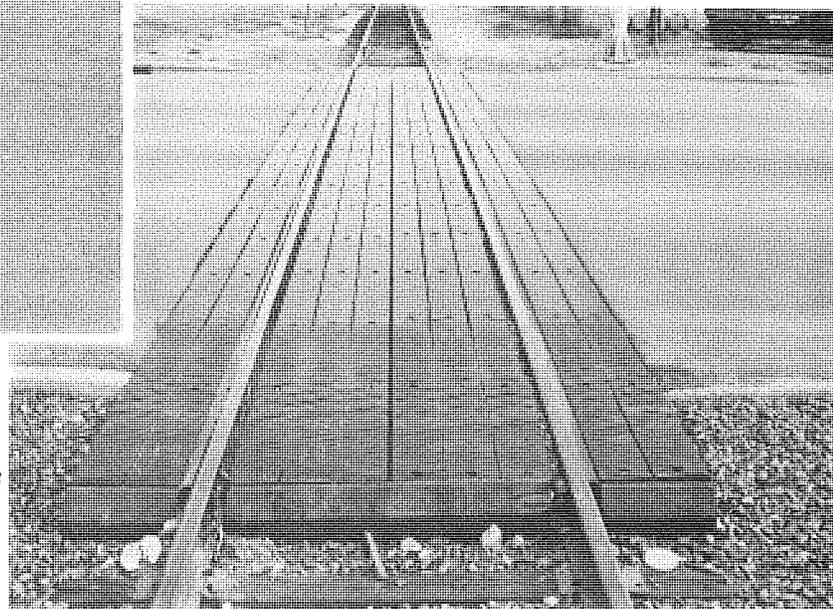
Saf and Dri crossing on Oakland Ave in Lansing.

Condition of crossing after 10 months of service. ▶
